**Coopers Beach Holiday Park,  
Church Lane, East Mersea,  
Colchester, Essex**

*Archaeological Evaluation*

CA Project: SU0406  
CA Report: SU0406\_1  
OASIS ID: Cotswold2-505706  
HER Ref: ECC4701

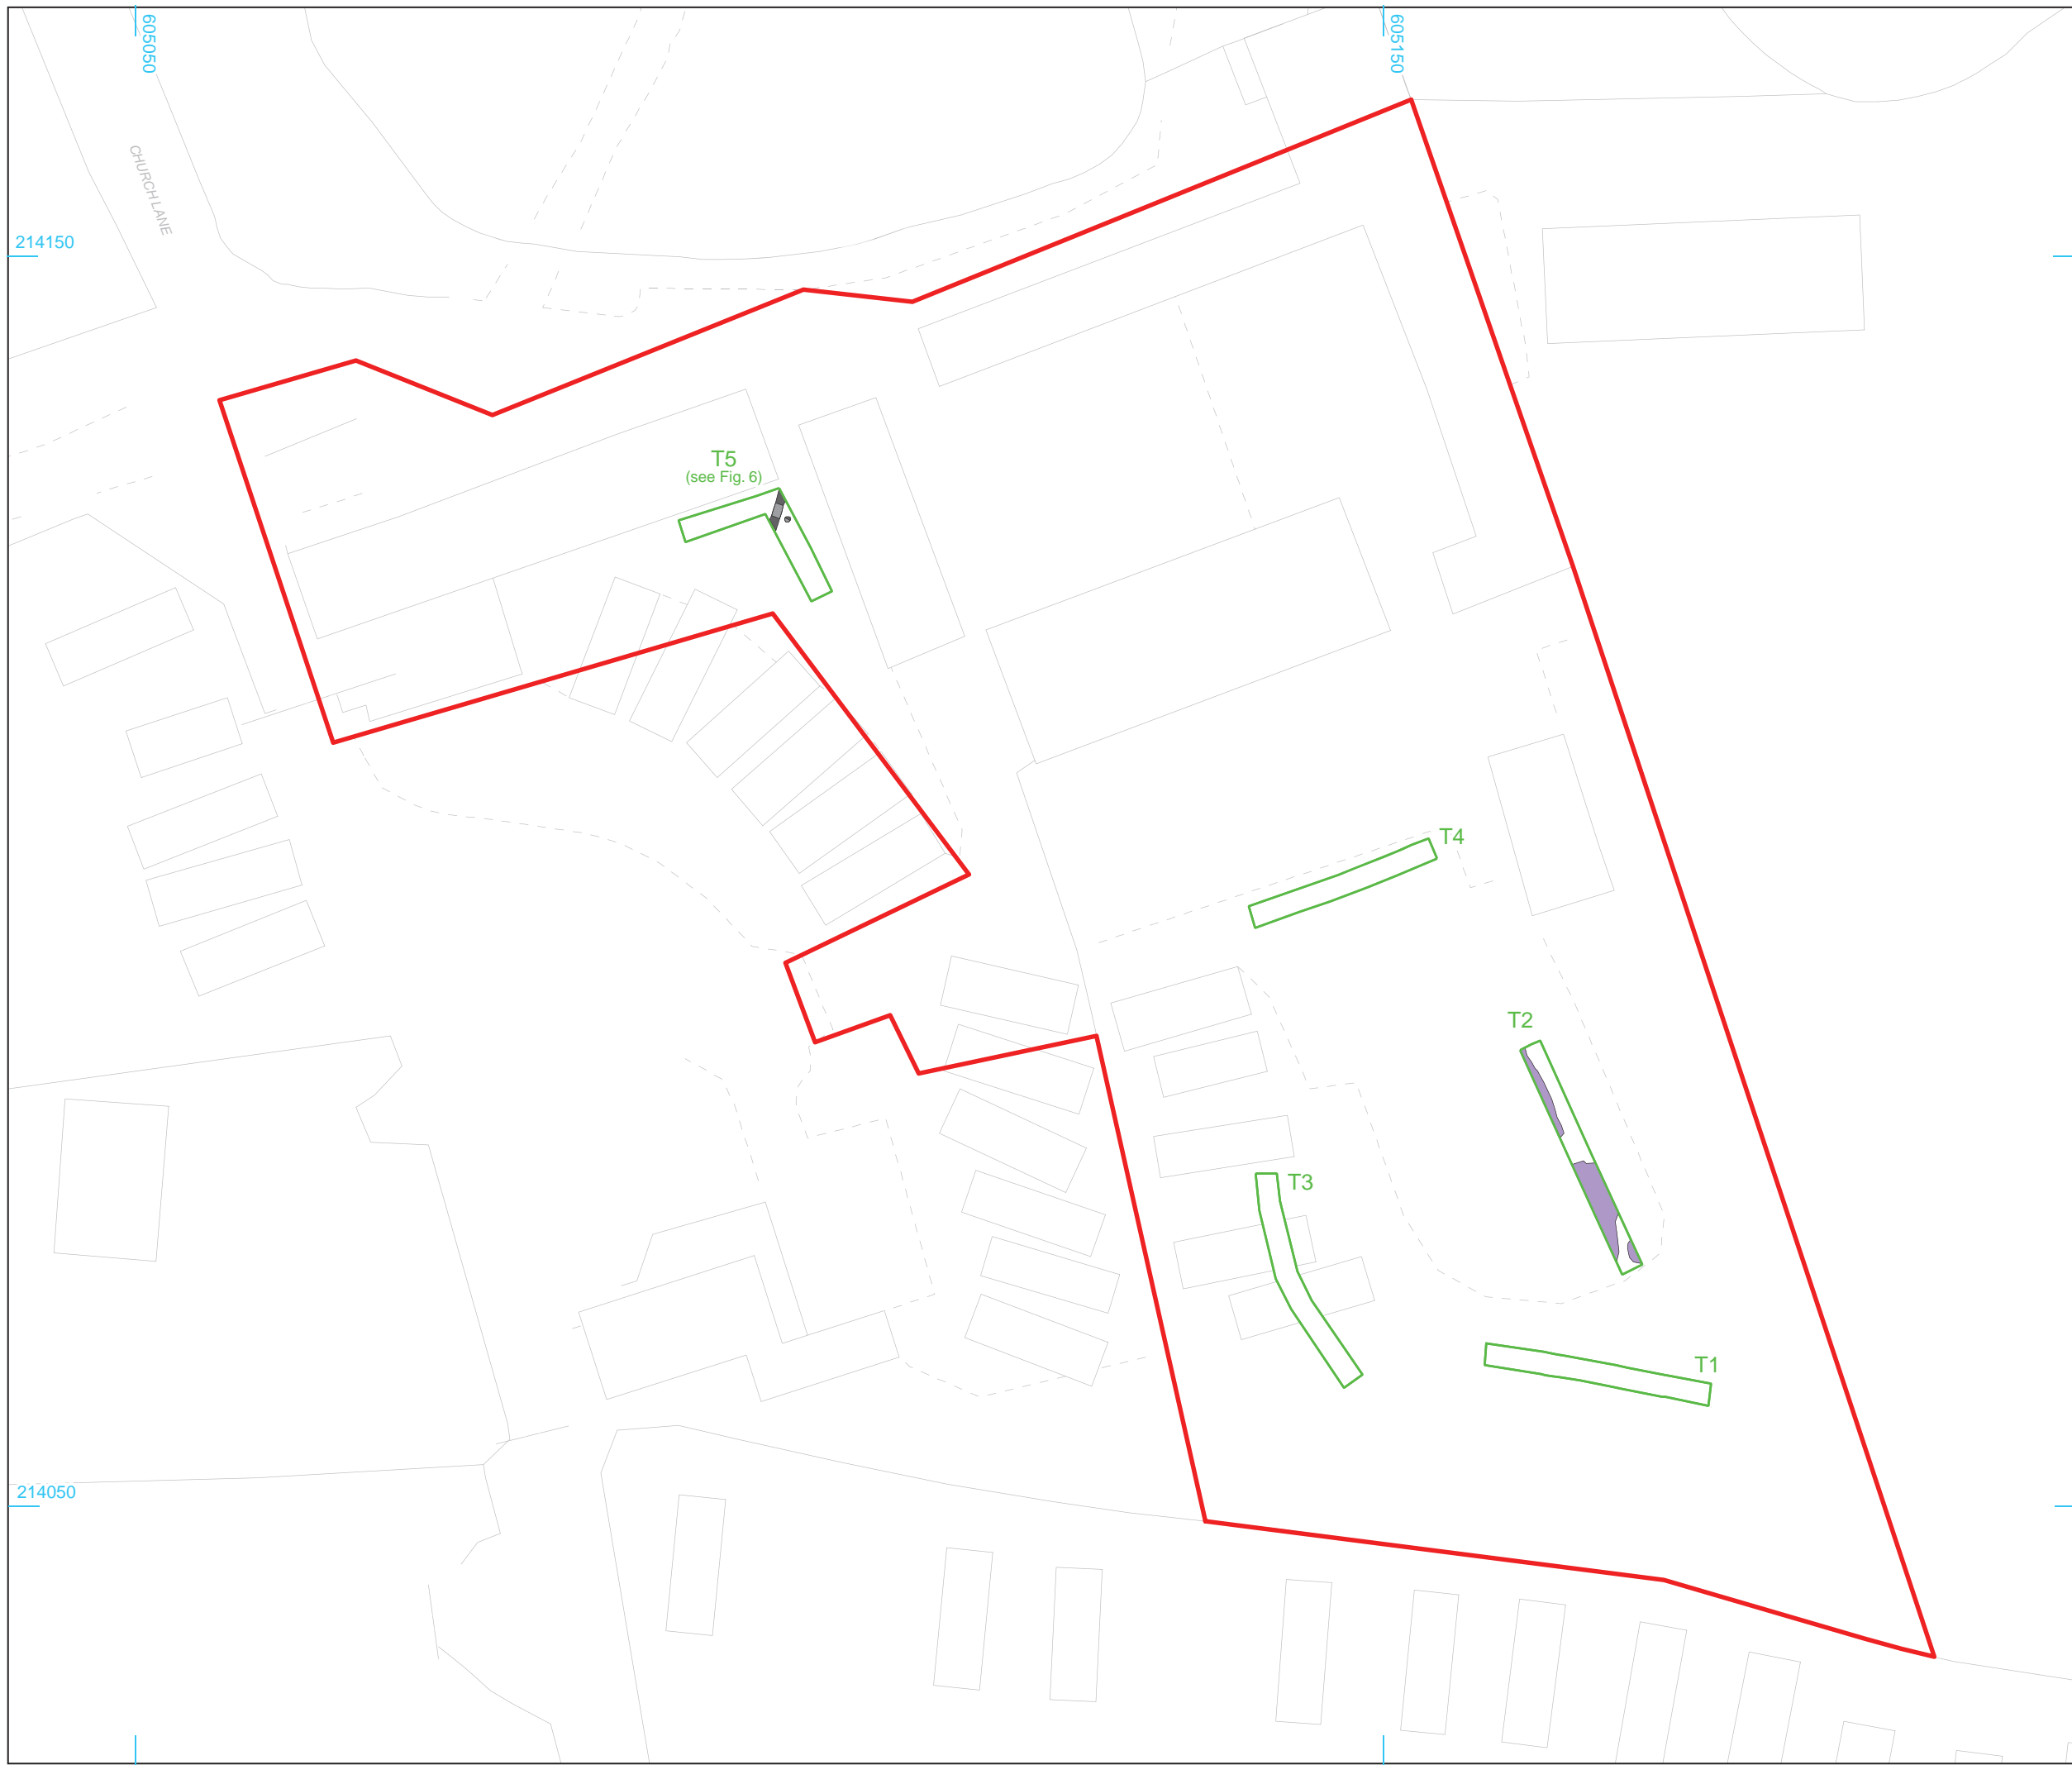
**FIGURE TITLE**  
 Site plan showing archaeological survey results

- 4.1. The evaluation fieldwork comprised the excavation of five trenches (Fig. 3). Trenches 1 to 3 were located within the footprints of the proposed structures whilst Trenches 4 and 5 were within areas of parking or landscaping.

- 4.2. Trenches were set out on OS National Grid co-ordinates using Leica GPS although due to the presence of concrete surfaces and permanently plumbed caravans it was not possible to excavate the trenches precisely as planned. This affected Trench 1, which was moved slightly to the north, Trench 3, which was moved slightly to the west and curved around a caravan, and Trench 5, which was cut in an 'L' shape. Trenches 2 and 4 were excavated in their planned locations.

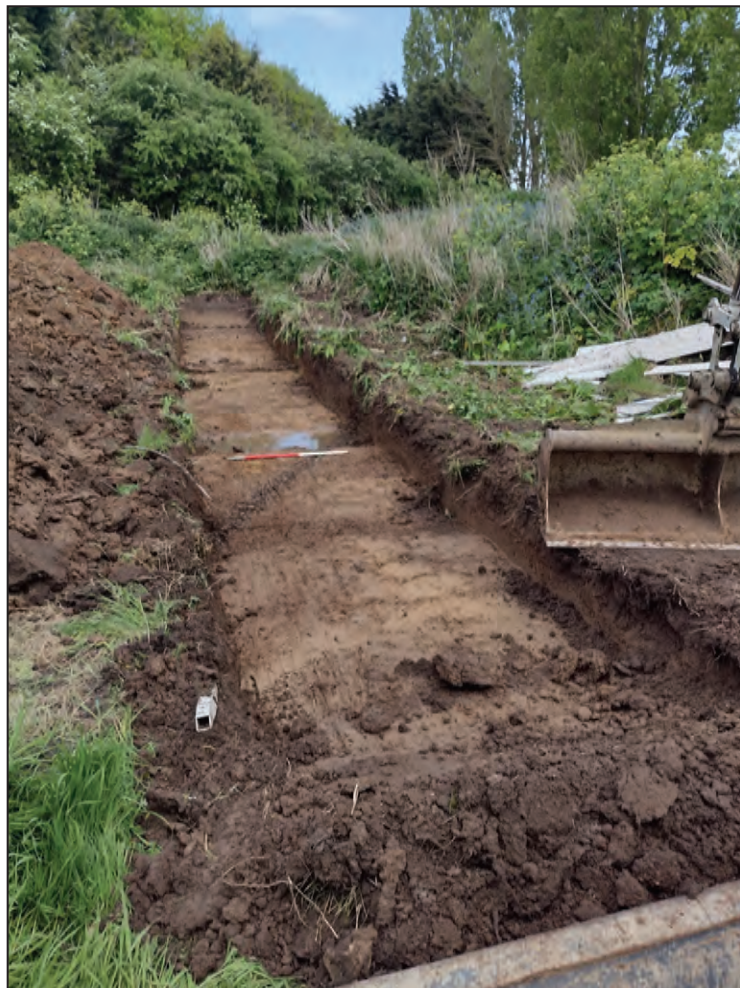
- 5.3. Trenches 1 and 3, at the south end of the evaluation area, produced similar results. Both exposed a natural subsoil of pale yellow/orange clay with areas of fine gravel with an orange sand, particularly towards to the eastern end of Trench 1 and southern end of Trench 3, at depths of around 0.5m below ground level. The overburden comprised topsoil over a subsoil of pale brown silty clay which in turn overlay the natural subsoil. No significant archaeological features or artefacts were identified in either trench.

Trench 1, looking east (scale 1m)

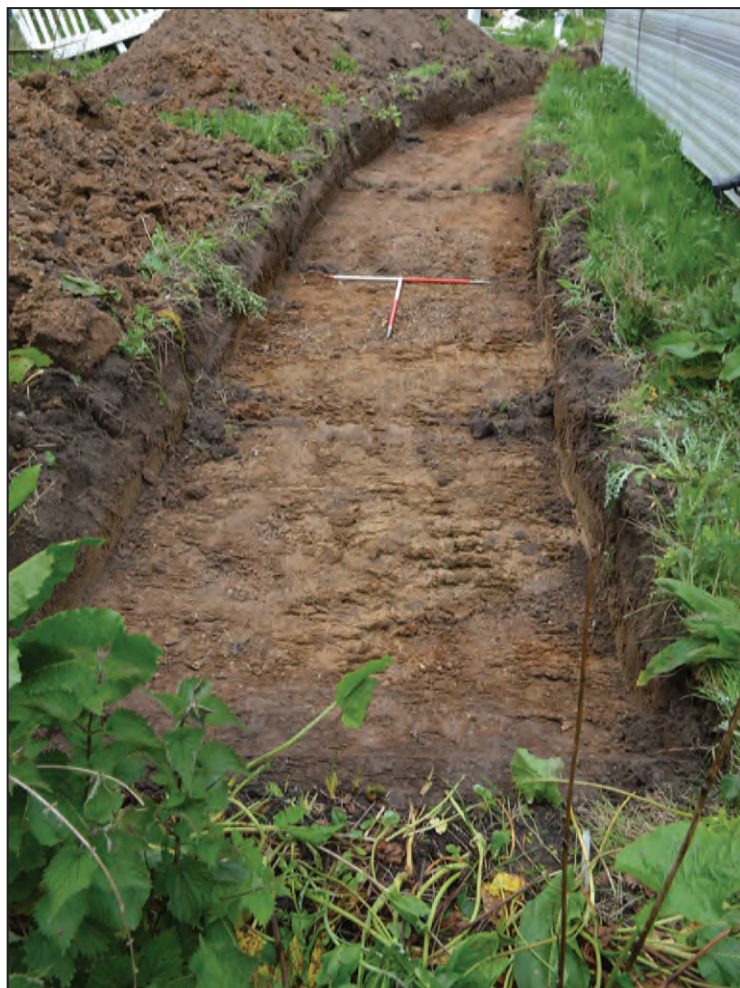
Trench 3, looking north-west (scales 1m)

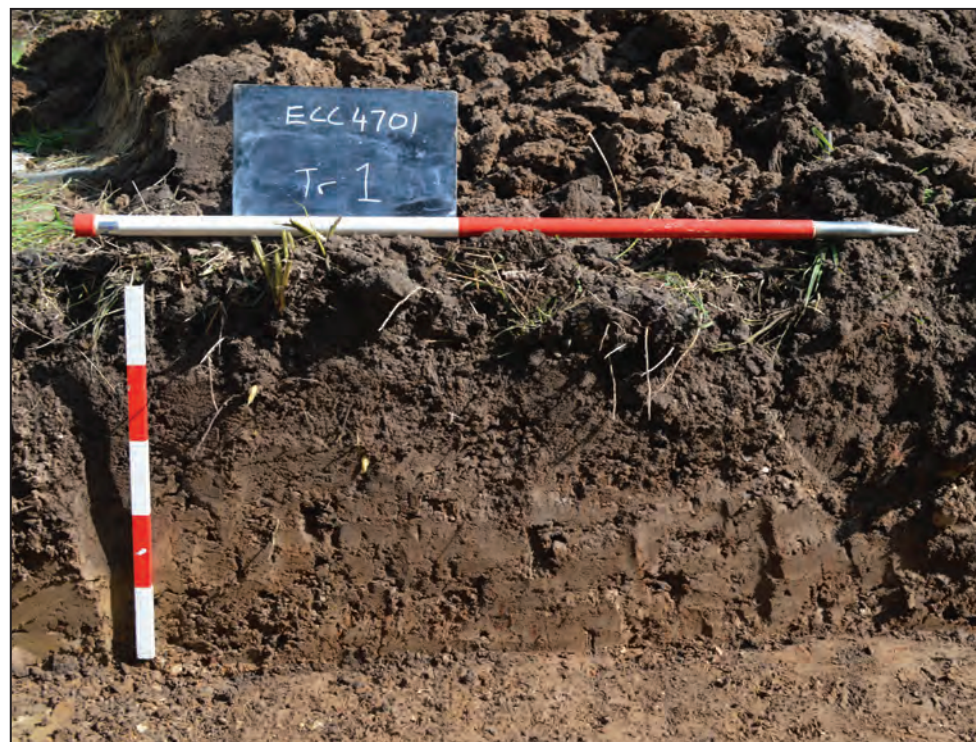
Trench 1, representative section (scales 0.5m and 1m)

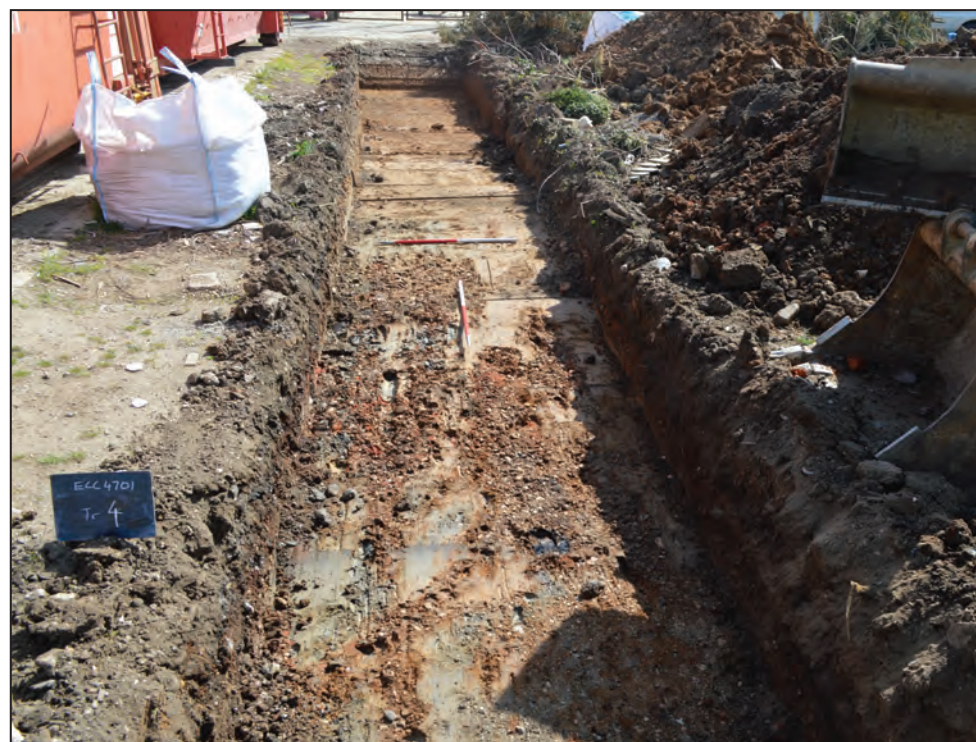
- 5.5. An east-west trench. Natural subsoil of pale yellow/orange clay at the west end, fine gravel with orange sand to the east was encountered at depth of 0.6m. The overburden comprised a thin topsoil over a dense layer of gravel with small flint cobbles interpreted as a former yard surface. This overlay a layer of silty sand and gravel which in turn overlay the natural subsoil.

Trench 4, looking north-east (scales 1m)

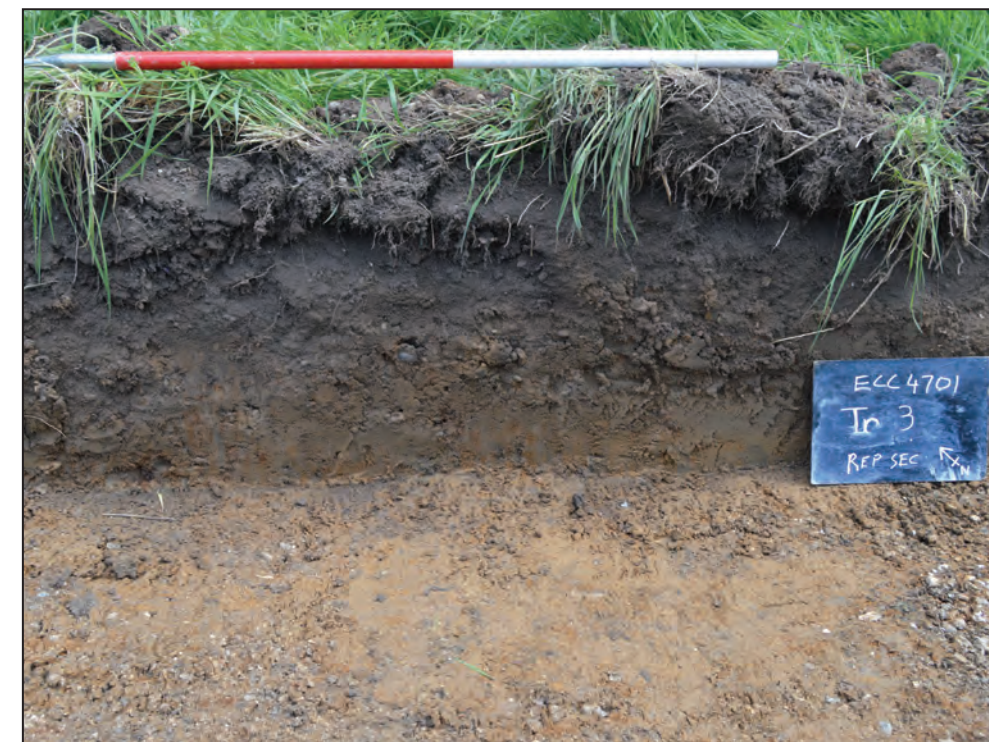
Trench 3, representative section (scale 1m)

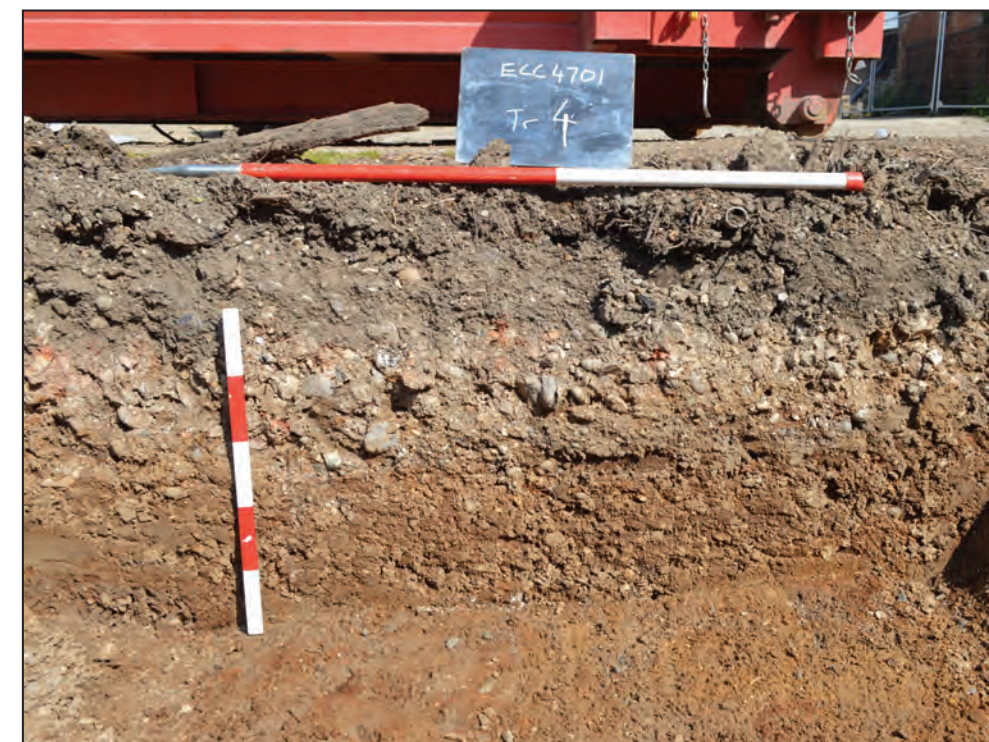
Trench 4, representative section (scales 0.5m and 1m)

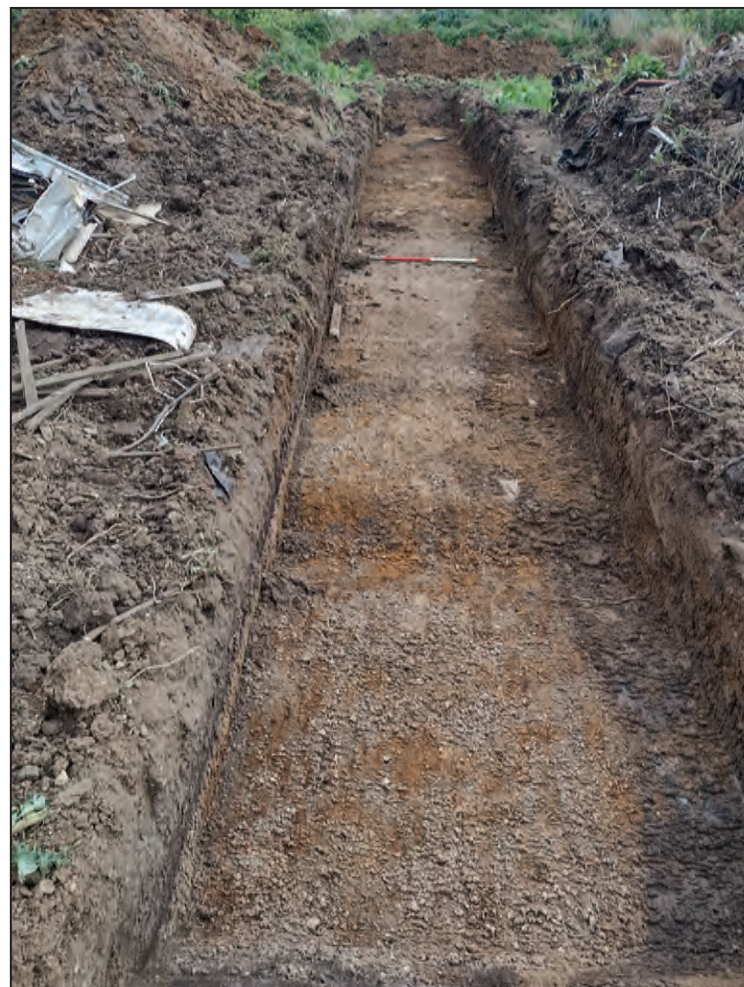
- 5.4. This comprised a roughly north-south aligned trench towards the eastern edge of the evaluation area. It too revealed a natural subsoil of pale yellow/orange clay with occasional areas of fine gravel and orange sand at a depth of around 0.5m. Three areas of modern disturbance were noted. One comprised a pit c.2m by at least 0.7m, located towards the southern end of the trench and filled with a dense deposit of modern debris including plastic, glass and scrap metal. The northern two-thirds of the trench were mostly taken up by two large areas of disturbance, both c.8m in length and extended beyond the trench to the west. Both were filled with redeposited natural subsoil but with a clear lens of topsoil containing modern brick, tile and fragments of roof slate around the edges that were visible within the trench. The overburden comprised a mixture of redeposited natural subsoil and modern debris over a layer of buried topsoil which in turn lay directly over the natural subsoil.

Trench 2, looking south (scale 1m)

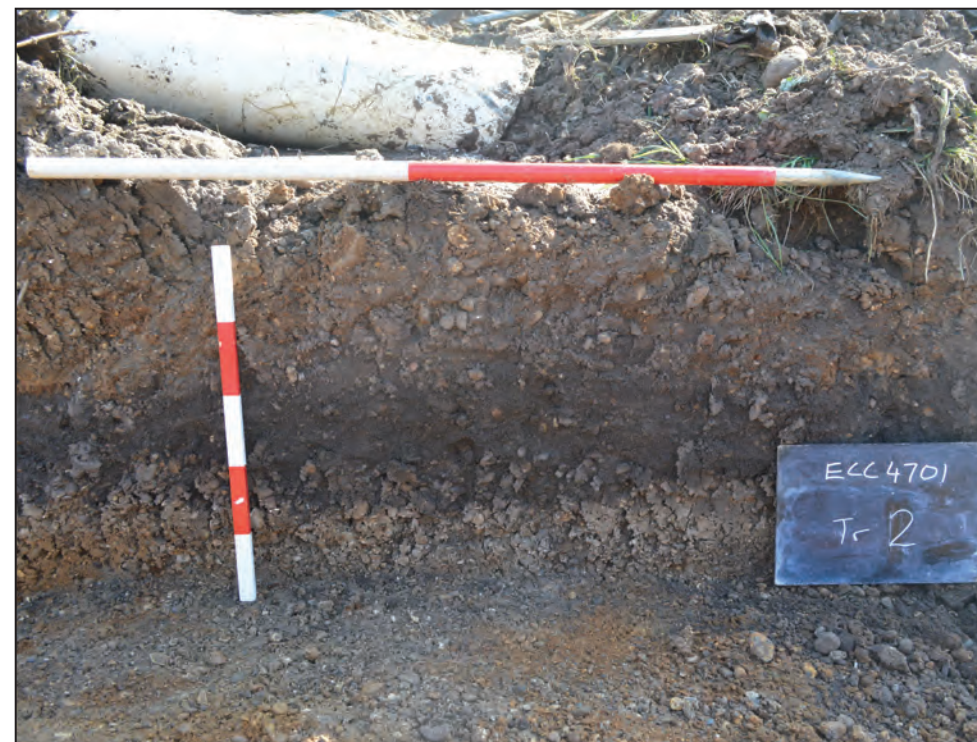
Trench 2, representative section (scales 0.5m and 1m)

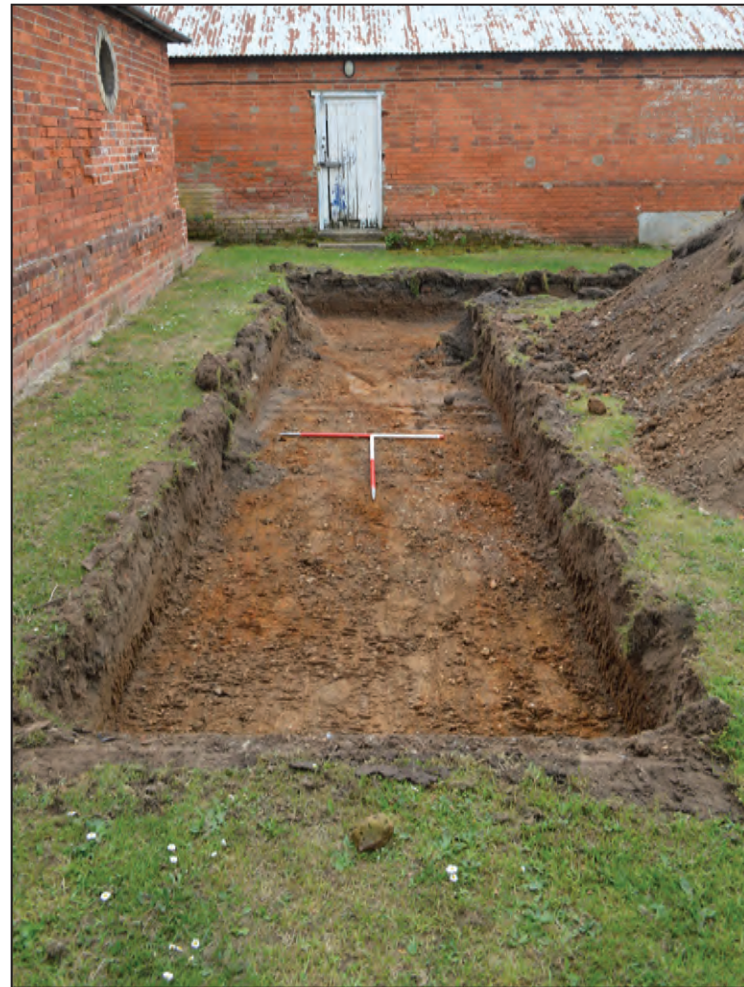
- 5.6. An 'L' shaped trench excavated in corner between two of the 19<sup>th</sup> century farm buildings. Natural subsoil of orange sand and gravel was encountered at a depth of 0.45m below ground level. The overburden comprised topsoil over a layer of brown sand and gravel. Two features were recorded, a small pit or possible posthole, 502, and a linear cut, 0504.

Trench 5, looking north-east (scales 1m)

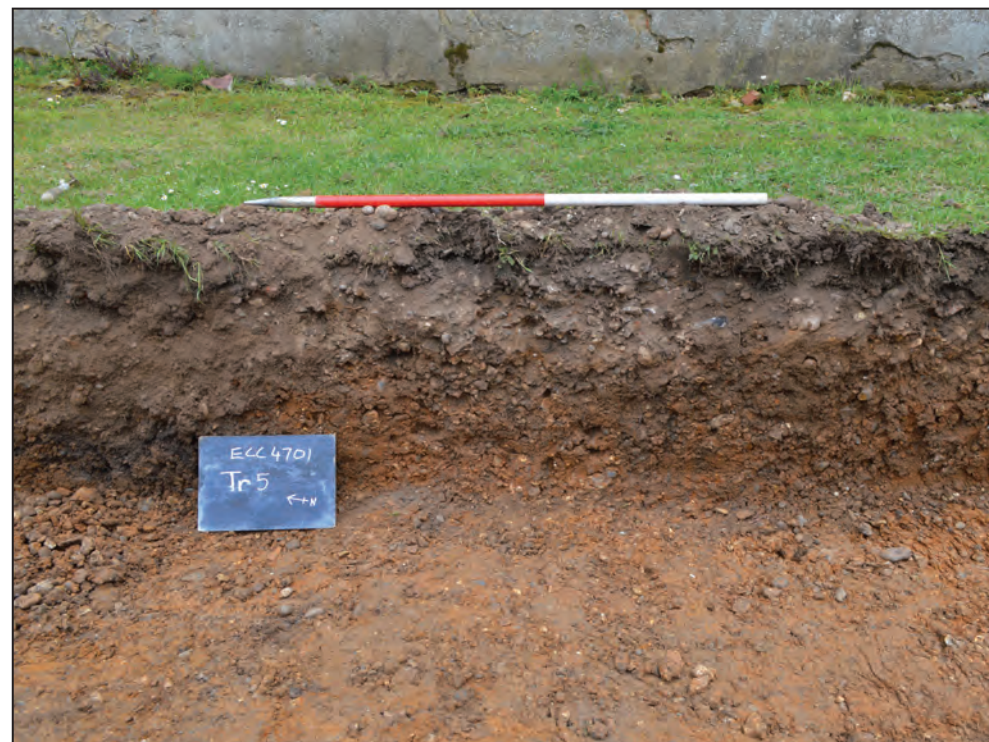
Trench 5, representative section (scale 1m)
