**Bullymore's Lodge Farm
Grafton Road
Brigstock
Northamptonshire**

Archaeological Evaluation

CA Project: 660362
CA Report: 14526

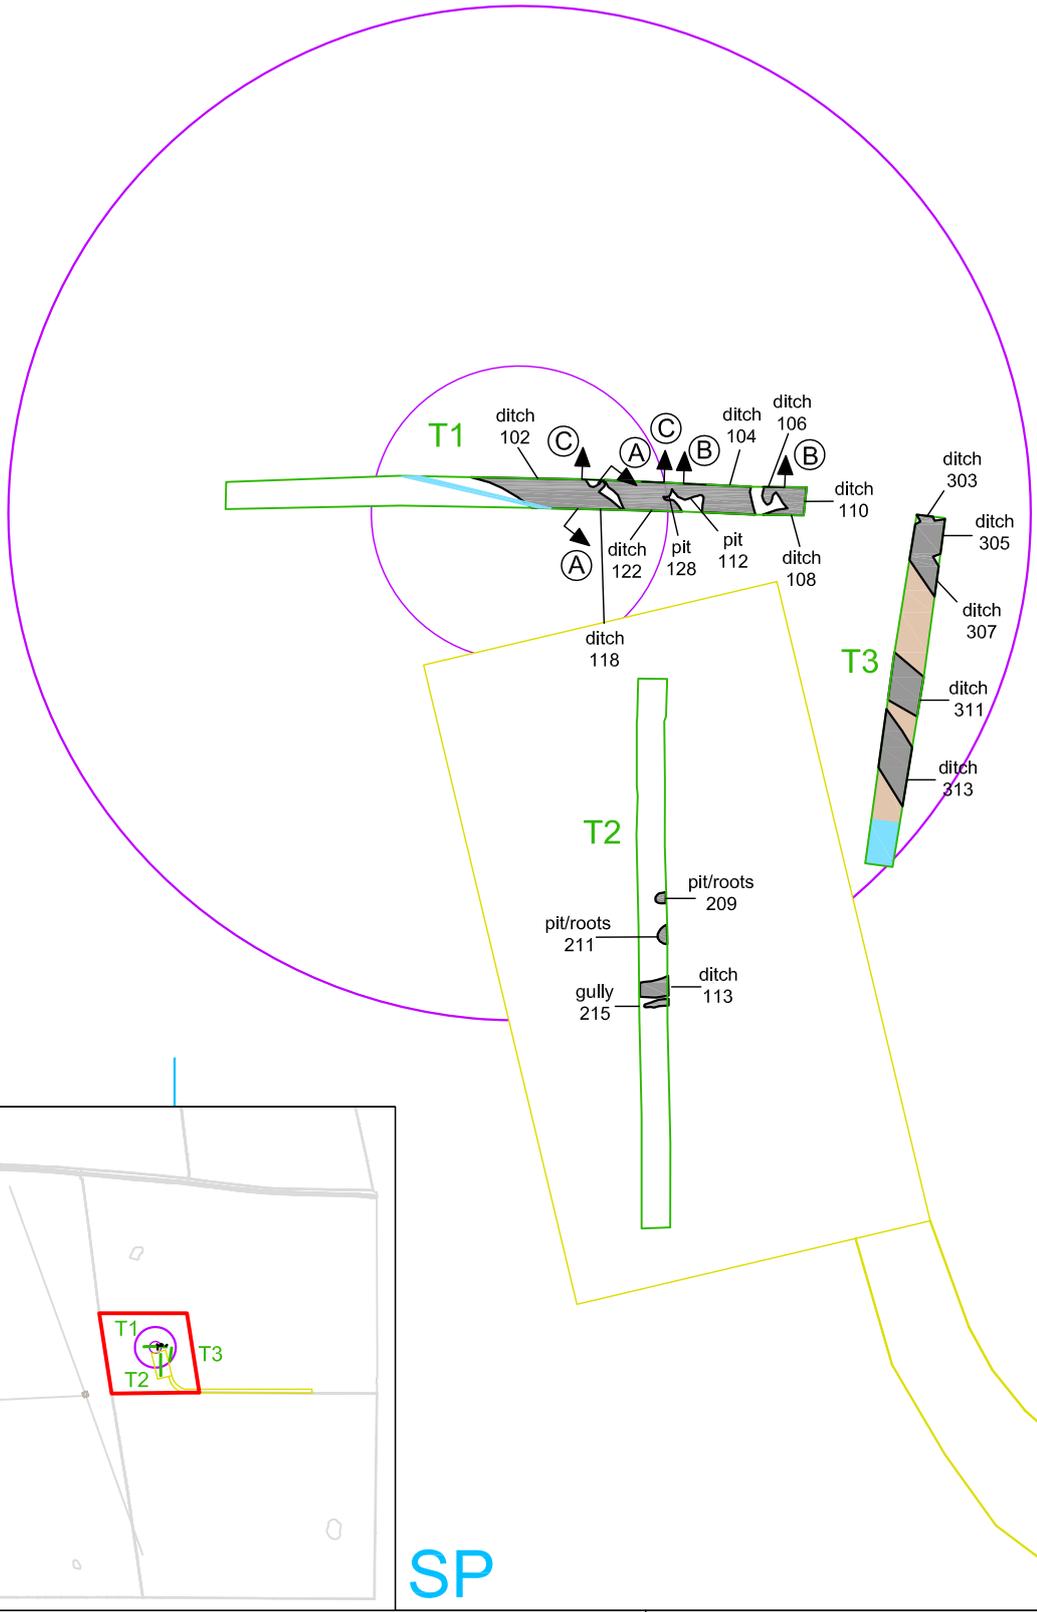
FIGURE TITLE
 Site location plan, showing
 archaeological features

- 1.10 The evaluation comprised the excavation of three trenches in the locations shown on the attached plan (Fig. 2). The original trenching scheme comprised two 30m trenches in a T-shaped arrangement, targeting the base of the turbine and the crane platform; to determine the south-eastwards extent of the archaeological remains revealed in these trenches, an additional 20m trench was excavated, with the agreement of CgMs and NCCAAA.

- 1.2 The evaluation, the scope of which was agreed following consultation between CgMs and Liz Mordue, Northamptonshire County Council's Assistant Archaeological Advisor (NCCAAA), was preceded by a *Historic Environment Assessment* prepared by CgMs (2014). The evaluation comprised the excavation of three trenches in the positions shown in Figure 2.

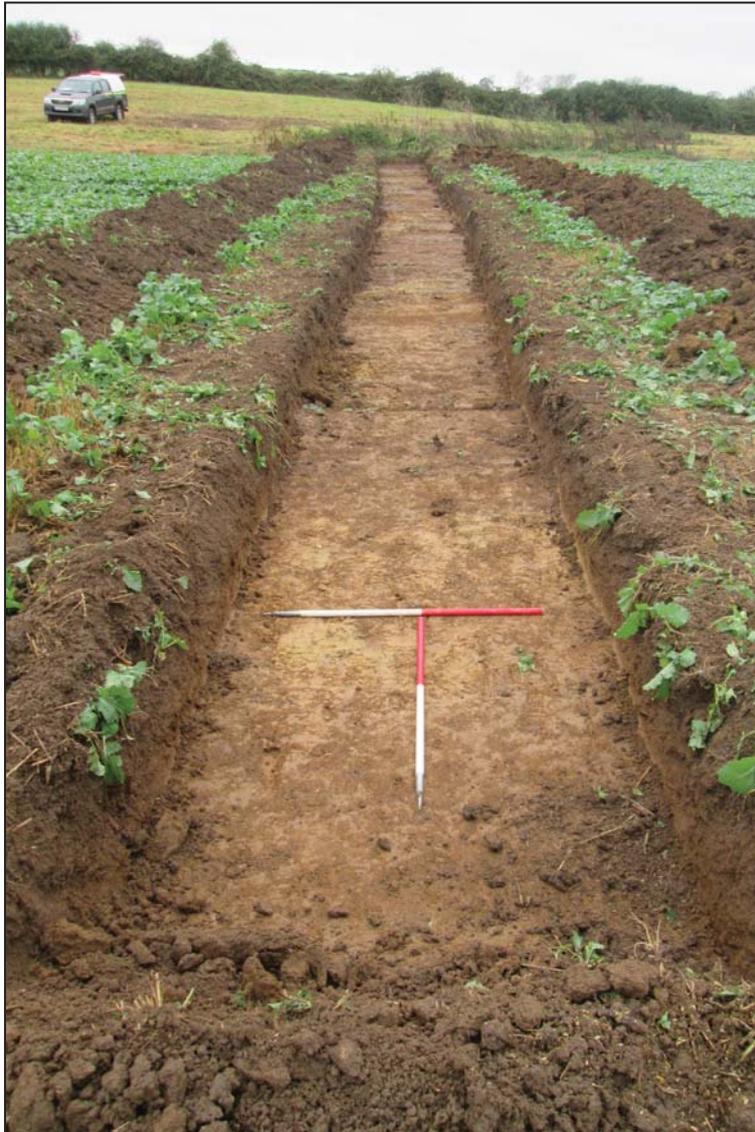
- 2.3 Trench 1, which was 30m long and aligned east to west, targeted the centre of the proposed turbine base. A complex of Romano-British ditches was encountered in the eastern half of the trench.

3 Trench 1, looking west (scales 1m)

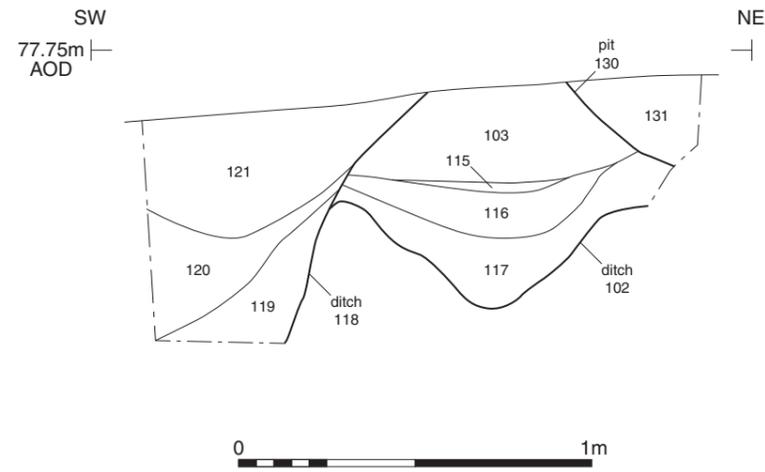
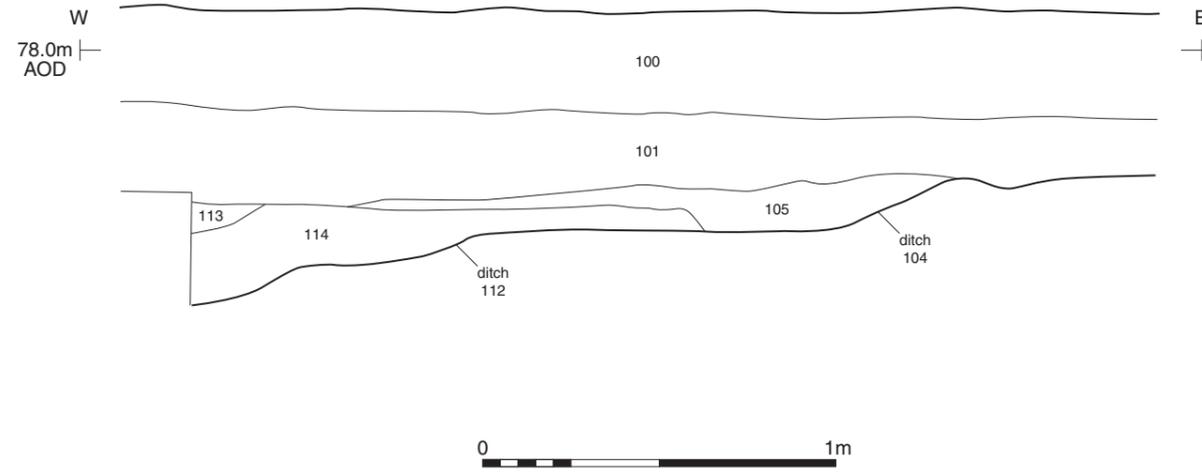
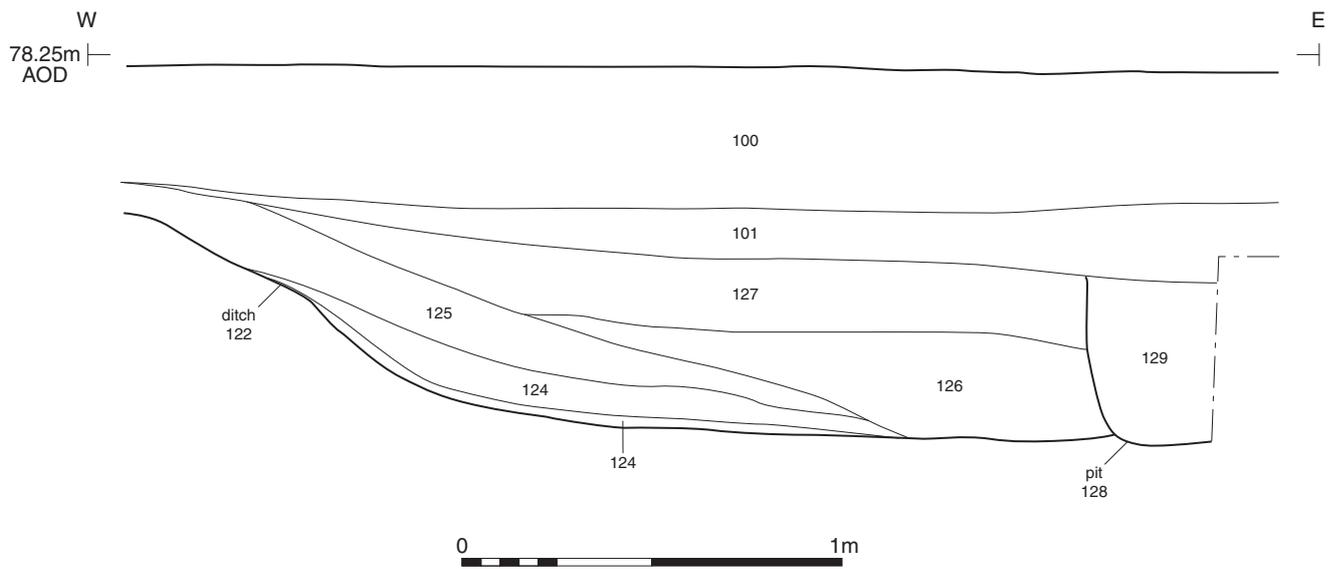
Trench 1: section and photograph

- 2.4 Passing through the centre of the trench on a north-west to south-east alignment and roughly corresponding with the cropmark in this area were ditches 102 and 118. The earlier ditch, 102, which measured 1.0m wide by 0.65m deep and had a V-shaped profile, was filled with a sequence of deposits from which was recovered sherds of mid 1st to 2nd-century pottery. Charred cereal grain and glume bases were recovered from one of its fills, suggesting that crop processing was being undertaken nearby. The south-western edge of the ditch was cut by parallel ditch 118, which was 1.5m wide and in excess of 0.7m deep (base not attained); the sides of this ditch were very steep, suggesting that it may be in excess of 1.2m deep. The upper fill contained sherds of mid to late 1st-century pottery and fragments of animal bone. It is likely that one or both of the ditches continue into Trench 3 (ditch 311).

- 2.5 On a similar alignment and to the east of ditches 102 and 118 was ditch 122. This measured 2.5m wide by 0.45m deep and had a shallower profile with a flat base. It was filled with a sequence of deposits, one of which contained sherds of early to mid 1st-century pottery. The ditch probably continues to the south-east, into Trench 3 (ditch 313). Cutting the eastern edge of ditch 122 was an oval pit, 128, which measured 1.3m long by 0.9m wide by 0.44m deep. The pit contained no artefactual dating evidence but it was sealed by subsoil, suggesting that it is likely to be contemporary with the Romano-British settlement.

2.6 Towards the eastern end of the trench was ditch 104, which was aligned north to south and measured 2.7m wide by 0.22m deep. Its fill contained sherds of mid 1st to 2nd-century pottery and fragments of animal bone. The western edge of the ditch cut pit/tree throw 112.

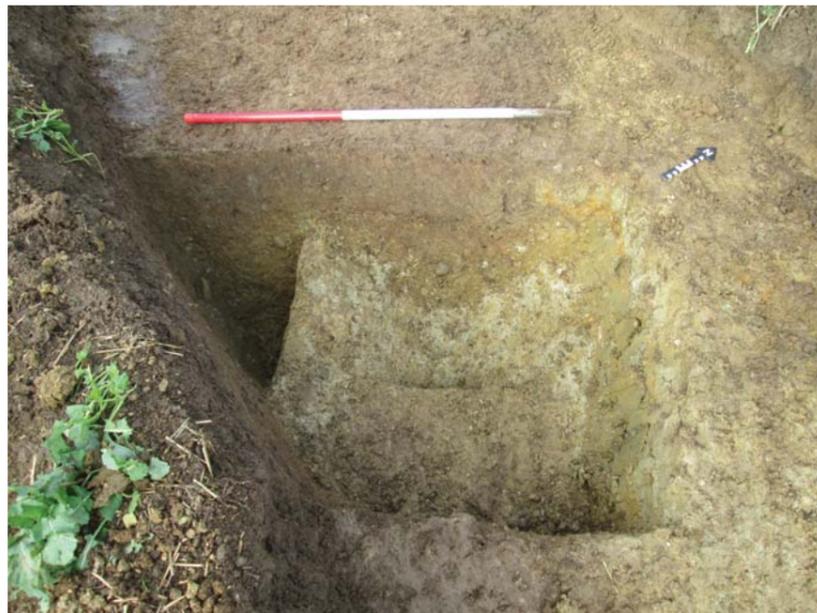
Ditches 102 and pit 118 looking north-west (scale 1m)

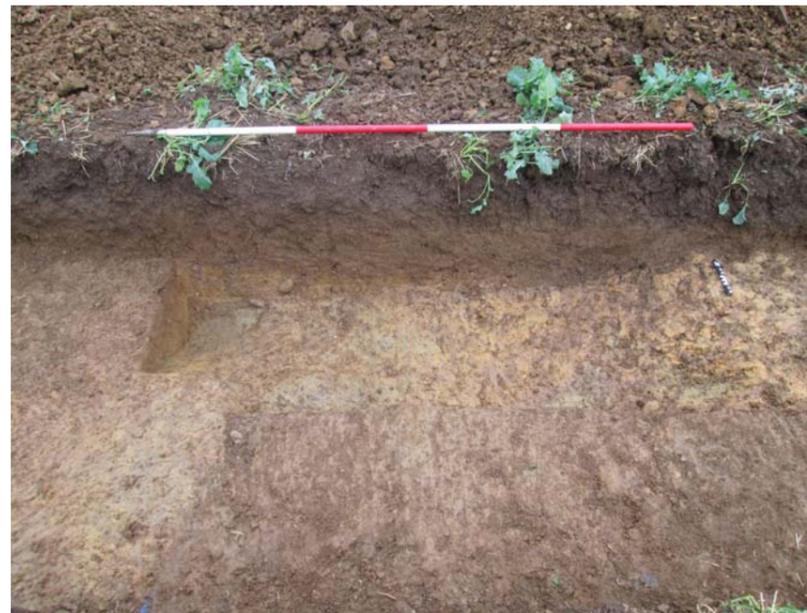
Ditch 104 and pit 112 looking north (scale 2m)

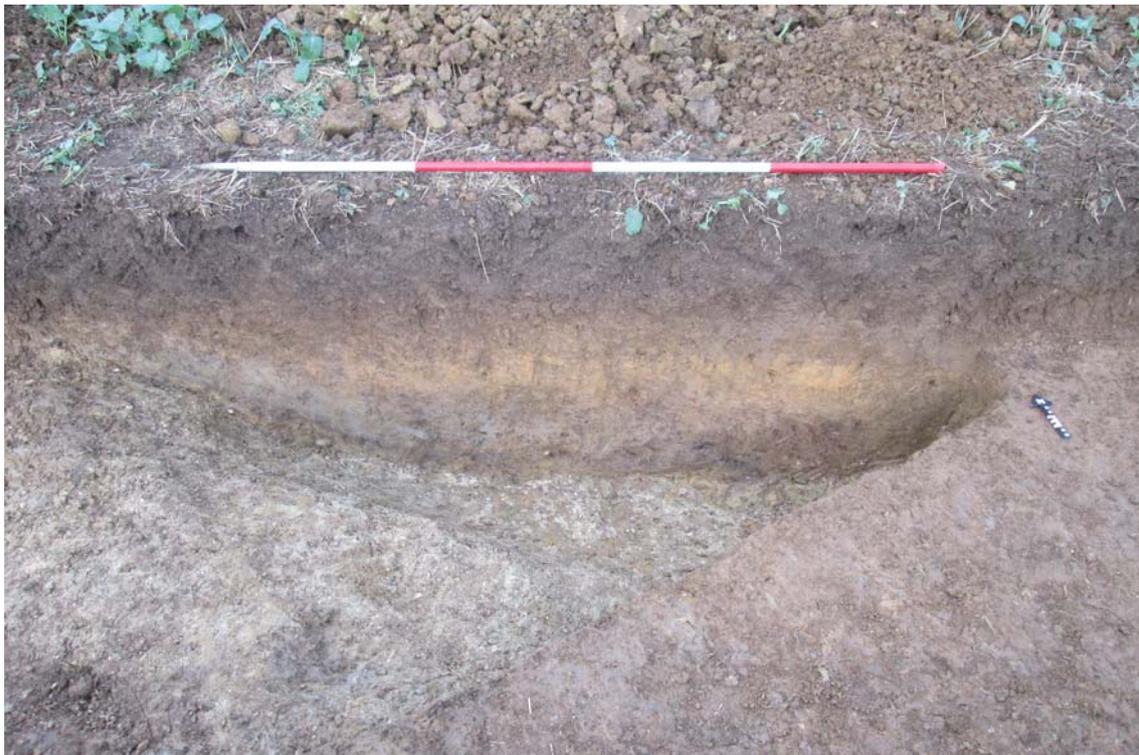
Ditches 122 and pit 128 looking north (scale 2m)

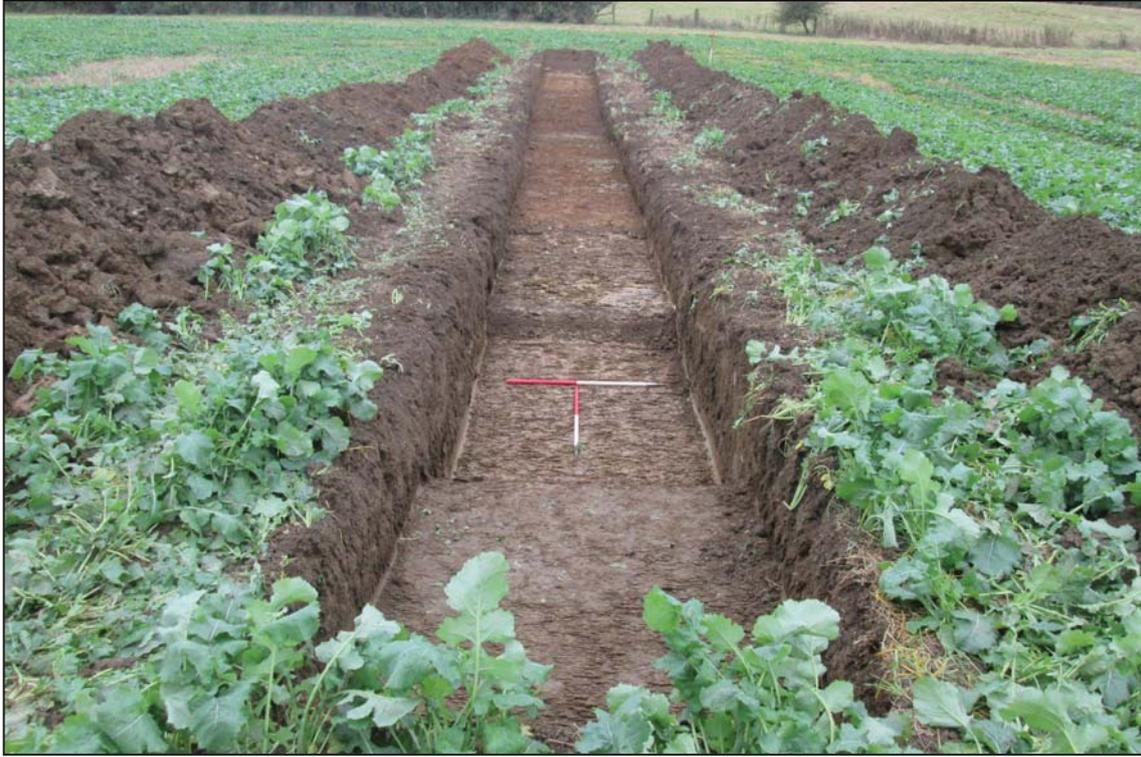
2.8 Trench 2, which was 30m long and aligned north to south, was positioned to investigate the area of the proposed turbine's crane pad. The most significant feature was the silted-up and backfilled course of a former stream (palaeochannel), 103. It was over 10m wide and occupied the low ground in the base of the small valley in which the proposed turbine site is located. A machine-dug sondage was excavated through the channel fills to a depth of c. 2m, revealing a thick deposit of homogenous, mineralised brown clayey silt, 207 sealed by a buried topsoil and subsoil. The latest course of the channel, 217, appears to have been backfilled with clay and limestone rubble (206 and 205 respectively).

- 6 Trench 2, looking south (scales 1m)
- 7 Palaeochannel 203, looking west (scale 1m)

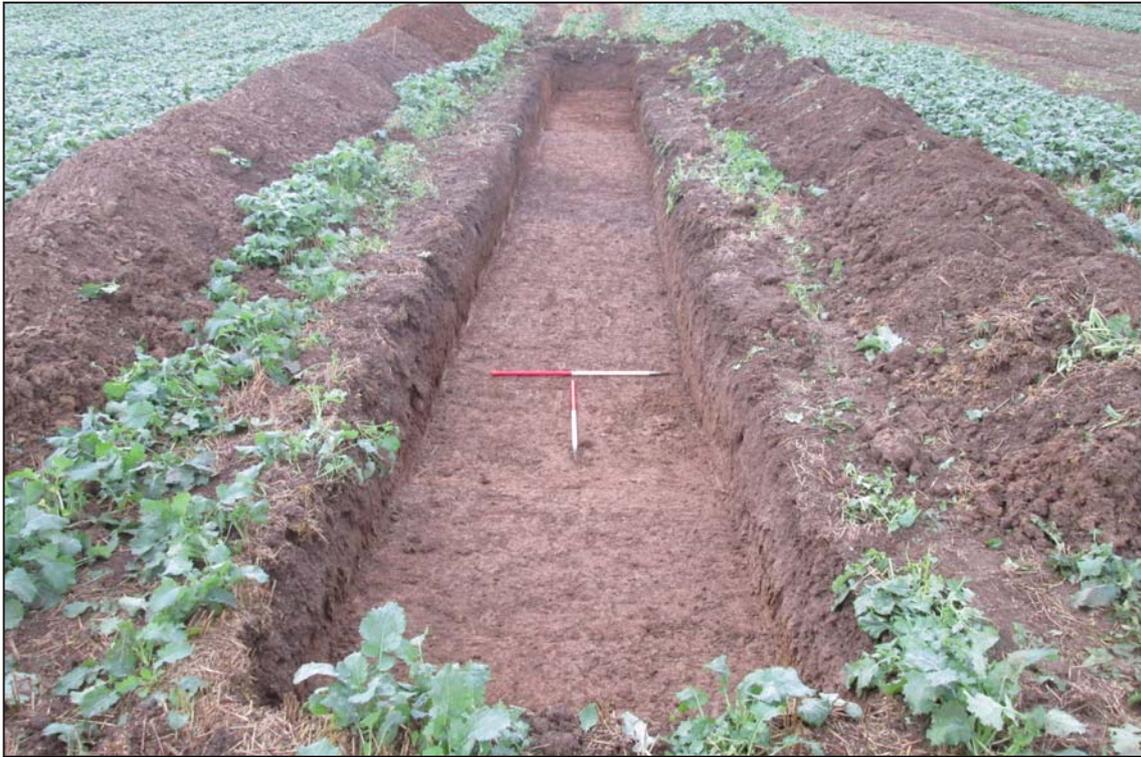
2.10 Trench 3, which was 20m long and aligned north to south, was positioned to investigate the south-eastwards extent of the archaeological remains revealed in Trench 1. The course of the former stream encountered in Trench 2 was found to continue through this area and several of the ditches investigated in Trench 1 continued into the trench, cutting through the silty channel deposits (see Trench 1 for possible correlations).

2.11 The backfilled course of the former stream recorded in Trench 2 (217) was identified at the southern end of the trench, 315. Here, it was in excess of 2.5m wide and its fill contained a fragment of modern drain pipe.

8 Trench 3, looking south (scales 1m)
