Land next to Somerdale Pavilion Trajectus Way Keynsham Bath and North East Somerset

Archaeological Watching Brief

CA Project: CR1095 CA Report: CR1095_1 OASIS ID: cotswold2-506780

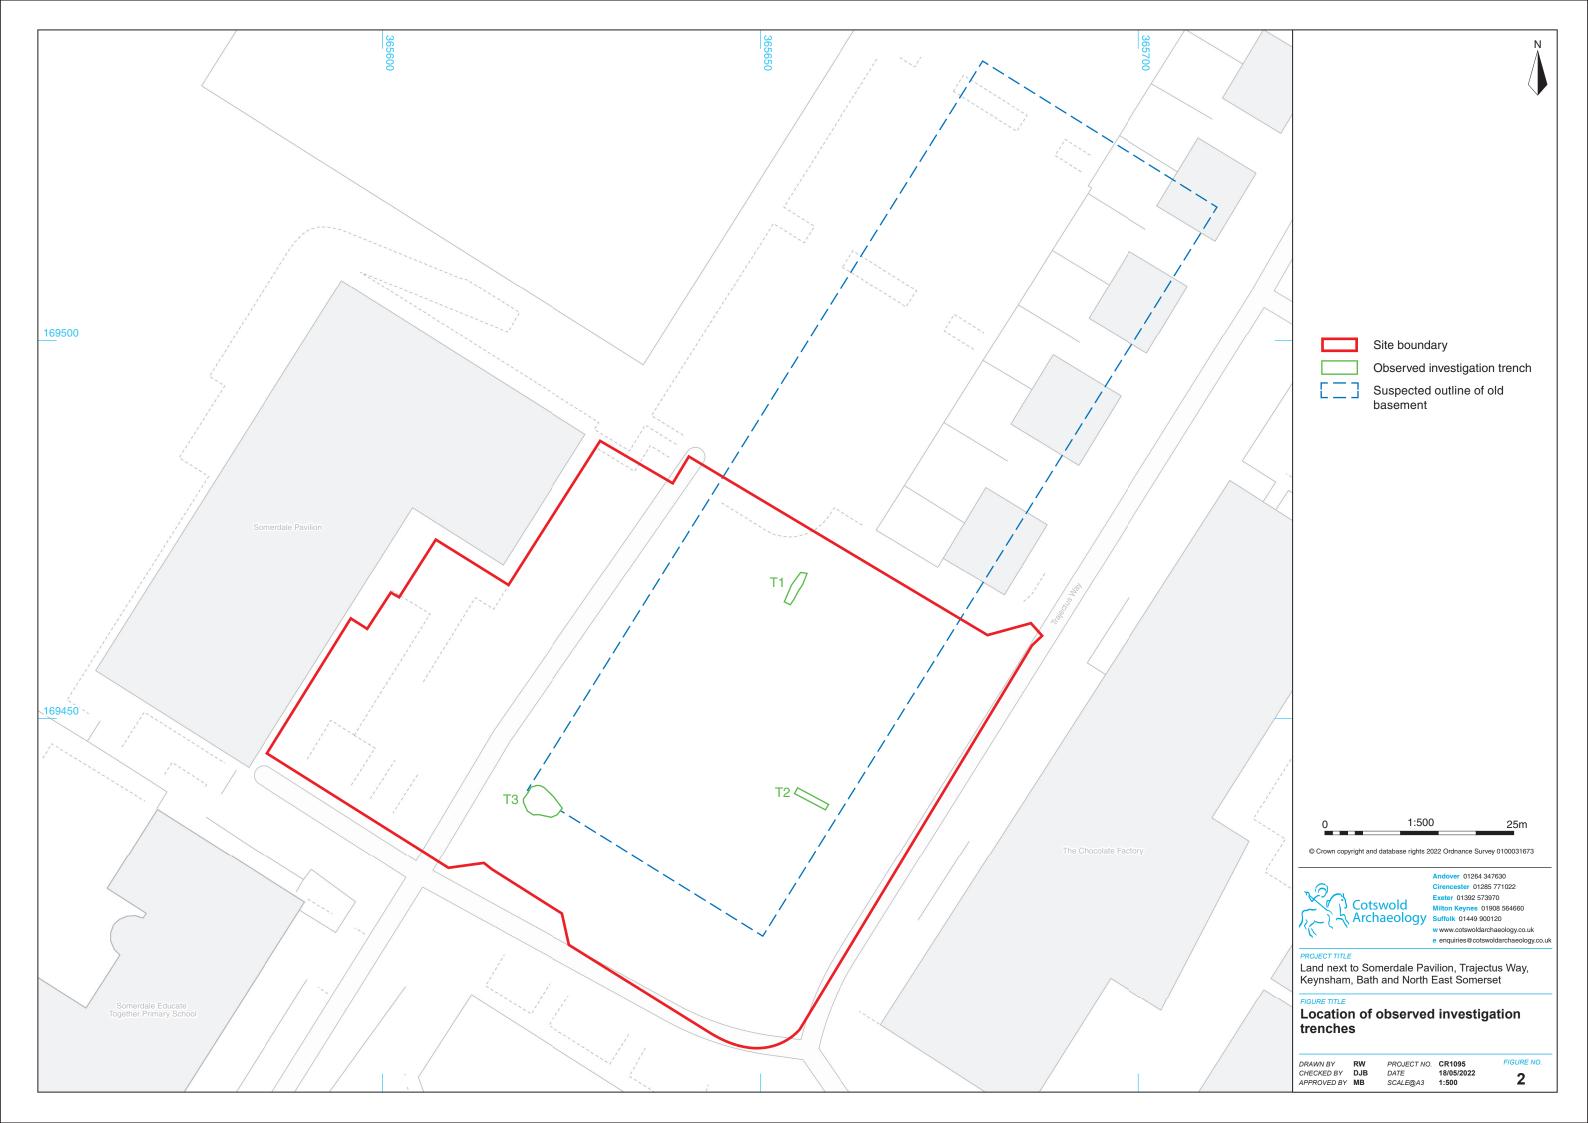
- 4.1. The watching brief comprised the observation by a competent archaeologist of the mechanical excavation of three SI trenches associated with the proposed development (see Fig. 2).
- 4.2. Records were maintained in accordance with *CA Technical Manual 1: Fieldwork Recording Manual*.
- 4.3. No deposits were identified that required sampling.
- 4.4. CA will make arrangements with Roman Baths Museum for the deposition of the project archive. The archives (museum and digital) will be prepared and deposited in accordance with *Standard and guidance for the creation, compilation, transfer and deposition of archaeological archives* (ClfA 2014; updated October 2020).
- 4.5. A summary of information from this project, as set out in Appendix C will be entered onto the OASIS online database of archaeological projects in Britain.

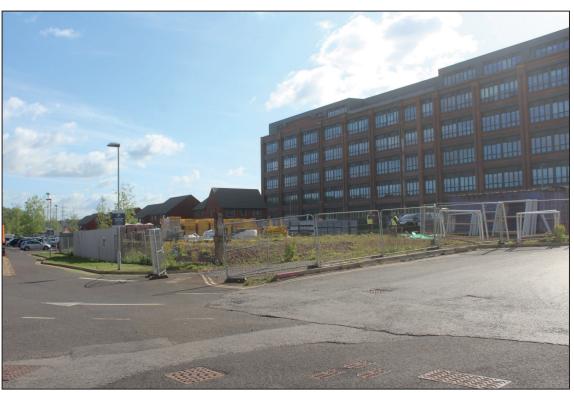
FIGURE TITLE Site photograph

No features or deposits of archaeological interest were observed, and no artefactual material was recovered. Modern dumped deposits were identified across the site, representing infilling of a former basement.

The site, looking north-east

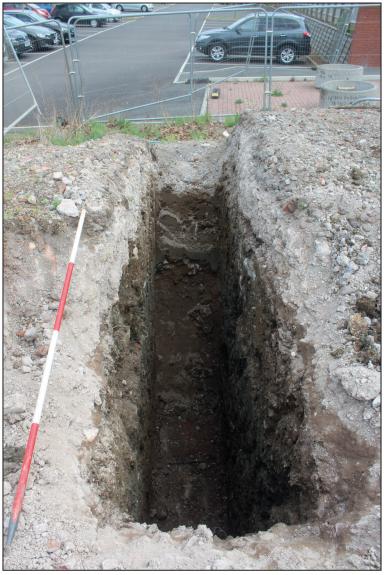
FIGURE NO. 4

5.2. The natural geological substrate was not revealed during the observed SI works. The earliest deposit identified consisted of a concrete floor, presumably of the basement of the now-demolished 1960s factory, which was encountered in Trenches 1 and 3 at a depth of between c. 4.1m and 4.3m below present ground level (bpgl). This was overlain by a series of modern dumped deposits, evidently backfilling the basement area to make up the current ground level, and modern structural elements. The modern dumped deposits extended below the limit of excavation in Trench 2, which was excavated to a depth of c. 5.3m bpgl.

Trench 1, looking north-east (2m scale)

FIGURE TITLE Trench 1 photograph

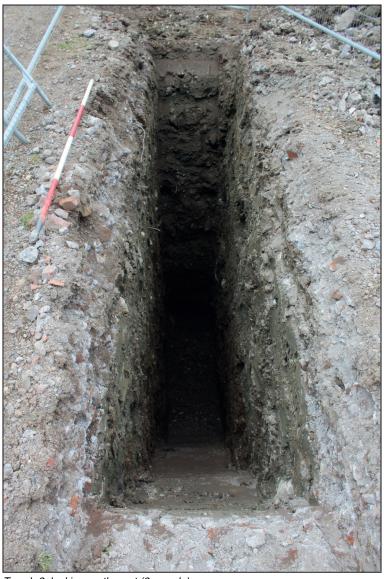
FIGURE TITLE Trench 2 photograph

Trench 2, looking north-west (2m scale)

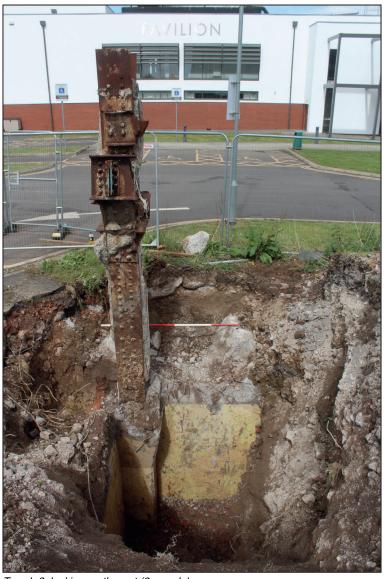
FIGURE TITLE Trench 3 photograph

3	301	Structure	Foundation	Concrete and brick ring beam and concrete and steel stanchion of western corner of 1960 factory	1	>1.1	3
3	302	Structure	Floor	Concrete slab			
3	303	Deposit	Made ground	Mid brown gritty silt clay with frequent pebbles, stone blocks, CBM and metal			3
3	304	Deposit	Construction backfill	Redeposited natural mixed with stone rubble

Trench 3, looking north-west (2m scale)
