Gloucester City Campus Gloucester

Archaeological Evaluation

CA Project: CR0920 CA Report: CR0920_1

May 2022

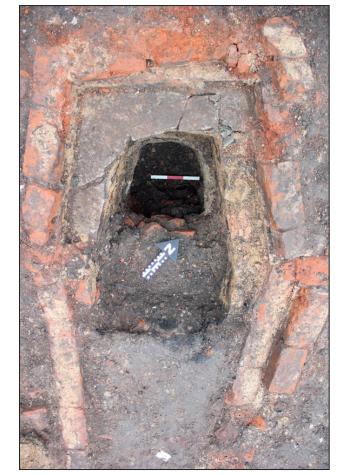
Excavated slot in burial vault 119, looking north-west (0.3m scale)

- 5.10. Second phase burial crypts 111, 115, 117 and 119 were coffin-shaped and typically measuring 2.5m in length by 1m in width.
- 5.11. The crypts were not excavated during the evaluation; however, a small intervention, sufficient to determine the presence of surviving human remains, was excavated through backfill 120 of crypt 119. The intervention revealed a cranium at a depth of 1.16m below the top of the crypt (16.33m AOD; Fig. 3), at the north-western end.

- 5.12. This intervention also identified light yellow grey-lime mortar deposit 132, measuring at least 0.5m in thickness, upon which the brick chamber for burial crypt 119 was constructed. Due to the limited size of the intervention, it was unclear if the mortar

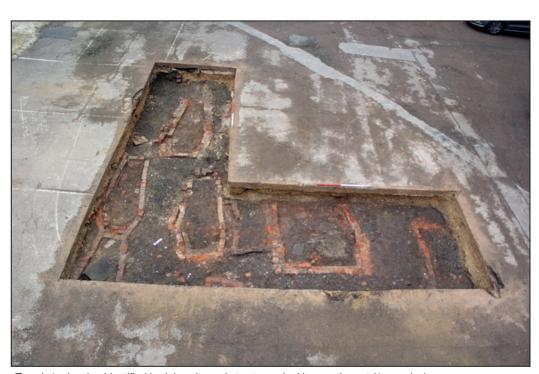
Trench 1, showing identified burial vaults and structures, looking south-east (1m scales)

- 5.6. Eight brick-built burial crypts were partially or wholly exposed within the trench and two phases were identified. All crypts were orientated north-west/south-east.

- 5.7. First phase burial crypts 123 and 124 were rectangular in plan. Crypt 124 measured 1.8m in width and at least 1.9m in length, suggesting a potential for a multiple-inhumation plot. Crypt 123 measured approximately 1.5m in length with an internal chamber length of approximately 1.2m and may suggest a child's burial crypt.

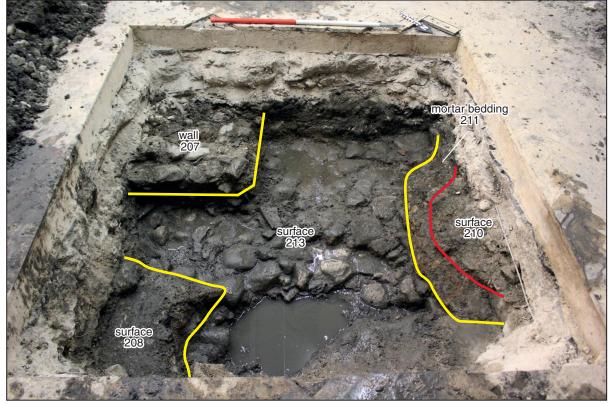
Test-pit 2, looking south-west (1m scale)

- 5.15. The earliest deposit recorded in Test Pit 2 was mortar bedding 214 for cobbled surface 213. Three fragments of Roman CBM and a fragment of cattle bone were recovered from bedding 214, along with a small sherd of mid-16th to 18th-century pottery. Due to the small size of the sherd (2g) and the proximity to post-medieval/modern deposits immediately above cobbled surface 213, this sherd is highly likely to be intrusive.

- 5.16. Cobbled surface 213 was approximately 0.2m thick and constructed from rounded stones, approximately 200mm in diameter. Three sherds of 2nd to 4th century AD pottery, 26 fragments of Roman CBM, a stone tessera and 15 animal bone fragments were recovered from cobbled surface 213 and it likely represents an external yard or street surface. The surface was overlain by mortar bedding deposit 209/211, which was in turn covered by floor surface 208/210, which was constructed from limestone slabs. No finds were associated with the later floor surface, although it is likely of Roman date. It was covered by rubble demolition deposit 206, from which modern material was recovered.

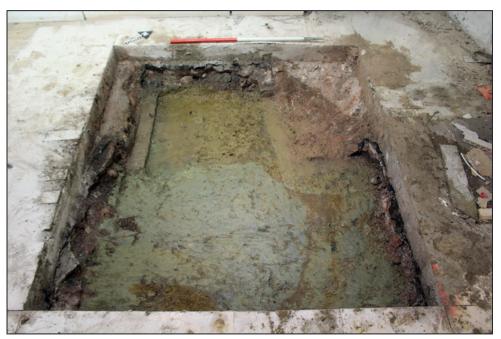
Test pits 3,5 and 8: plan and photograph

Test-pit 5, looking north-west, showing modern structures 505 and 507 (1m scale)

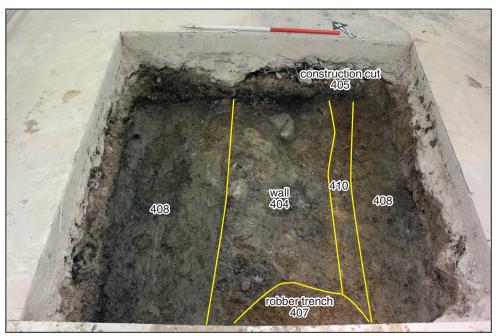
Test-pit 4, wall 404, looking north-east (1m scale)

- 5.21. The natural geological substrate, 409, was encountered at a depth of 0.57m bpgl (13.86m AOD) within Test Pit 4. It was overlain by alluvial deposit 408, which measured approximately 0.15m in thickness. The alluvium was cut by construction cut 405 for wall 404, and backfilled by deposit 410, from which a sherd of 2nd-century pottery was recovered. The wall was broadly aligned north-east/south-west, measured 0.6m in width, and was constructed from roughly squared limestone blocks. At the south-western end of the test pit, the wall was truncated by robber cut 407, which measured approximately 0.8m in width and was backfilled with sandy gravel 406, from which three sherds of late 1st to 2nd-century pottery was also recovered.
- 5.22. The construction cut backfill was sealed by modern made ground and floor surfaces.

- 8.3. Wall 404 was aligned parallel with walls identified during the Craster excavation in 1955. The nearest wall was approximately 6m to the south-east and suggests that they could be associated with the same structure. However, the lack of levels from the Craster excavation makes this difficult to conclude. An *opus signinum* floor was also previously recorded in the area between the walls but was not identified within Test Pit 4.
