Land South of Old Warden Park Old Warden, Biggleswade Bedfordshire

*Archaeological Strip, Map and Sample Investigation and
Archaeological Monitoring*

For:
The Shuttleworth Trust

CA Project: 661262
CA Report: 661262_1
Site Code: OWP19
Accession Number: BEDFM 2018.14

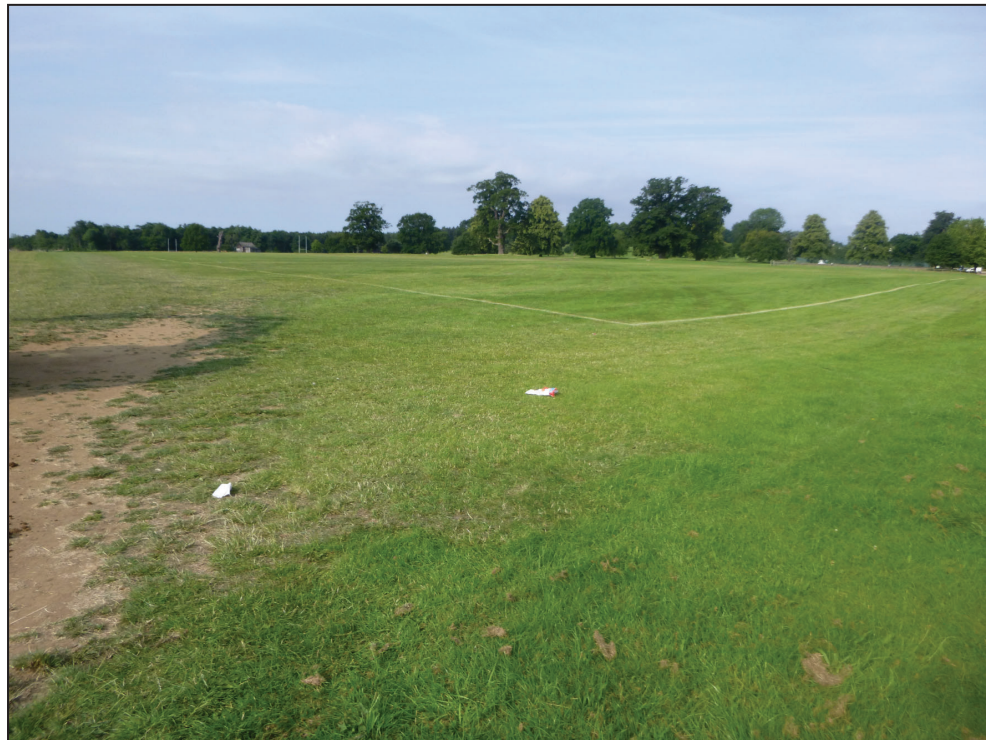
General view of strip, map and sample area, looking south-west

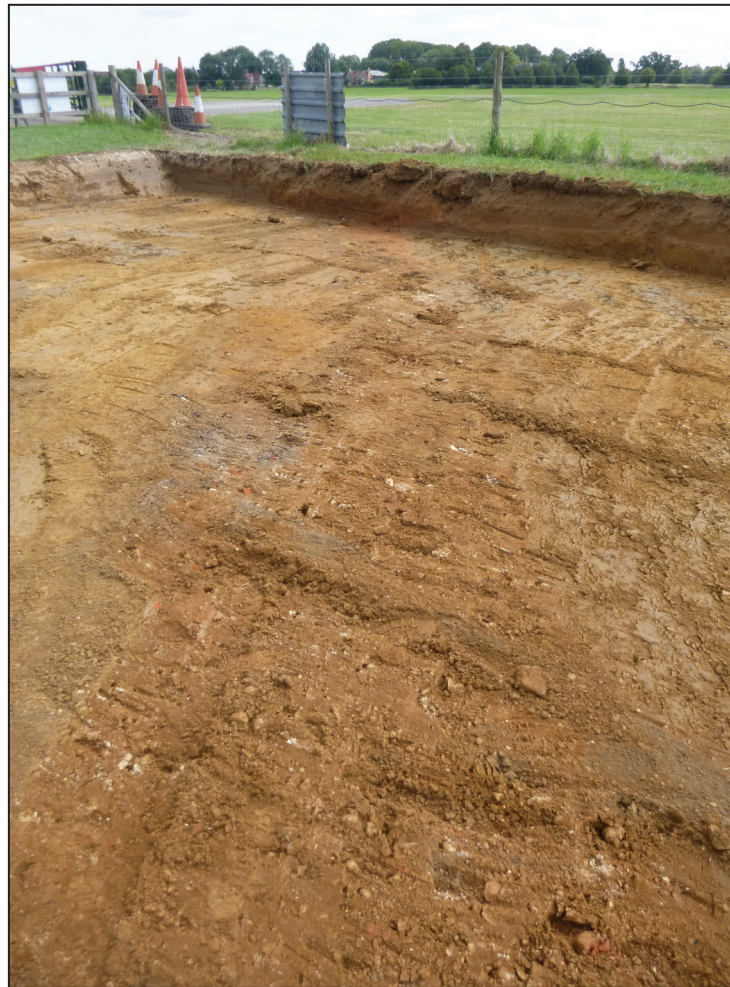
Cropmark 1 ditch 103, looking north-east

- 6.1 The aim of the SMS investigation was primarily to identify and record any evidence for a continuation of the possible field system or garden earthworks indicated by cropmark evidence to the east of the development area and a number of linear cropmark features extending across the route of the new track. (see sections 2 and 3 above). The SMS investigation exposed only one of these ditches, ditch 103, in the northern limits of the site. Both the ditch and the cropmark correspond with a tree lined boundary depicted on a 1872 estate map of the Old Warden Estate and the 1st edition Ordnance Survey (OS) map of 1885 (CA 2018), partitioning land within Old Warden Park.

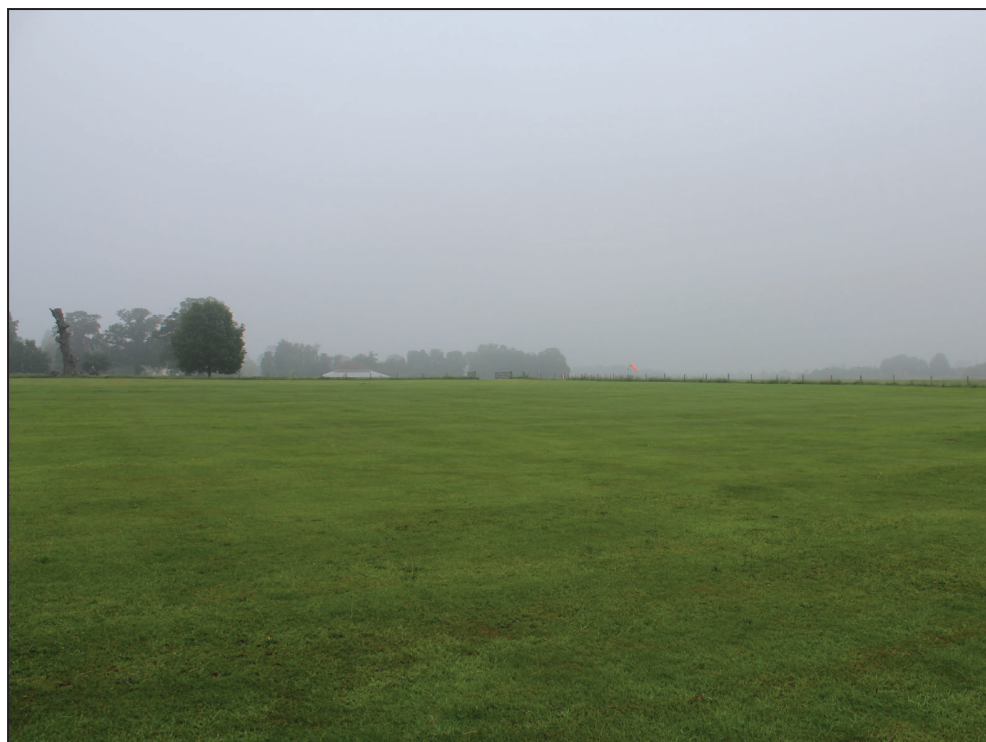
General view of strip, map and sample area, looking south-east

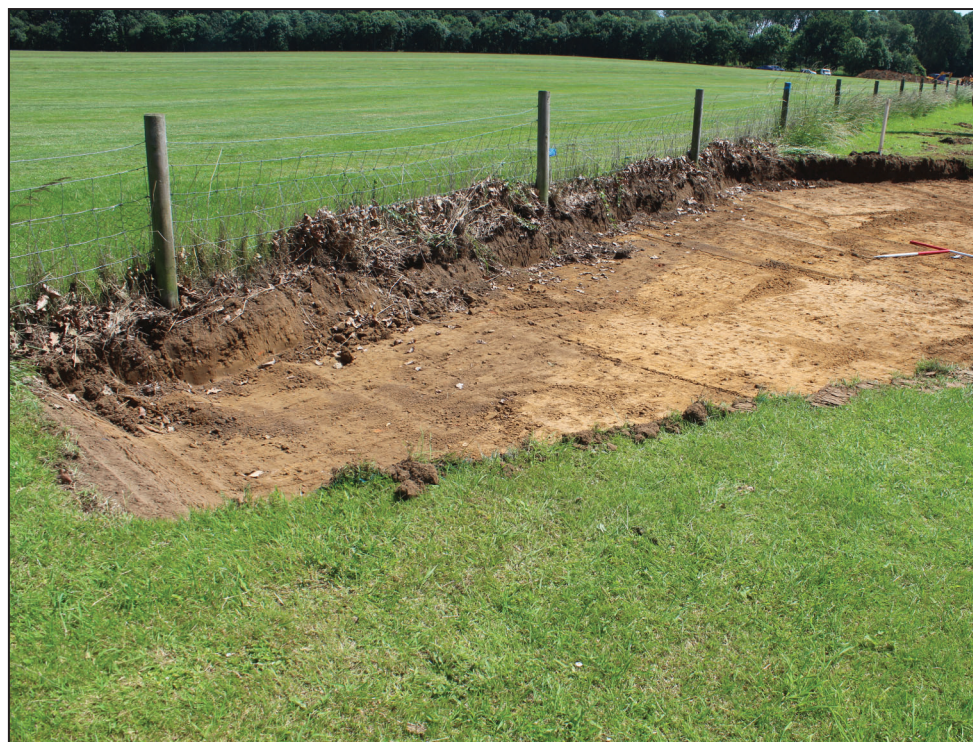
Cropmark 2 modern ditch 105, looking south (1m scales)

5.3 The two other cropmarks (2 and 3 respectively) to the south, likely relating to the same field system, were not conclusively identified within the SMS area, although the line of an historic field boundary corresponding with cropmark 2 was noted to still be demarcated by a modern post and wire fence running along a probable infilled ditch (105) that was only partially exposed and noted to contain brick and clinker in the surface of the backfill material (Fig. 4).

- 6.2 The two other cropmarks (2 and 3 respectively) to the south, potentially relating to the same field system depicted on the 1872 estate map, were not conclusively identified within the SMS area, although the line of the central boundary was noted to still be demarcated by a modern post and wire fence running along a probable infilled ditch (Fig 4). The 1885 OS map shows that by that time all that remained of the central boundary was a row of trees, while the southern field boundary had been removed but was still marked on the map by a dotted line and the abbreviation 'def'. It is likely that these boundaries and any associated trees were removed and infilled when the landing strip was established.

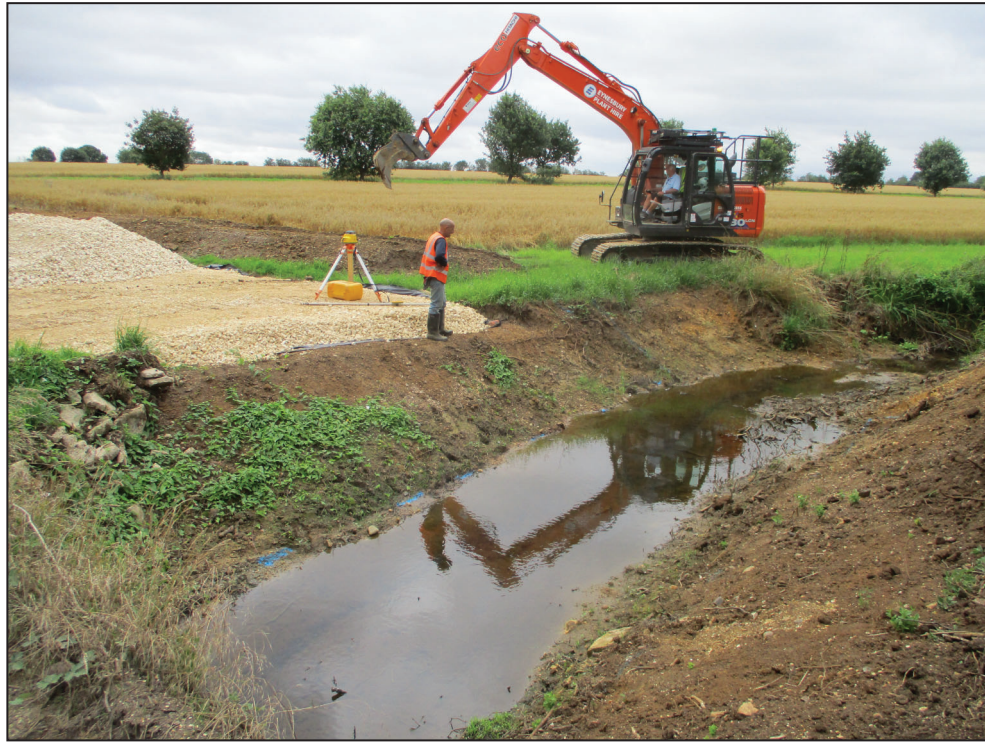
Culvert ditch pre-excavation, looking north-east

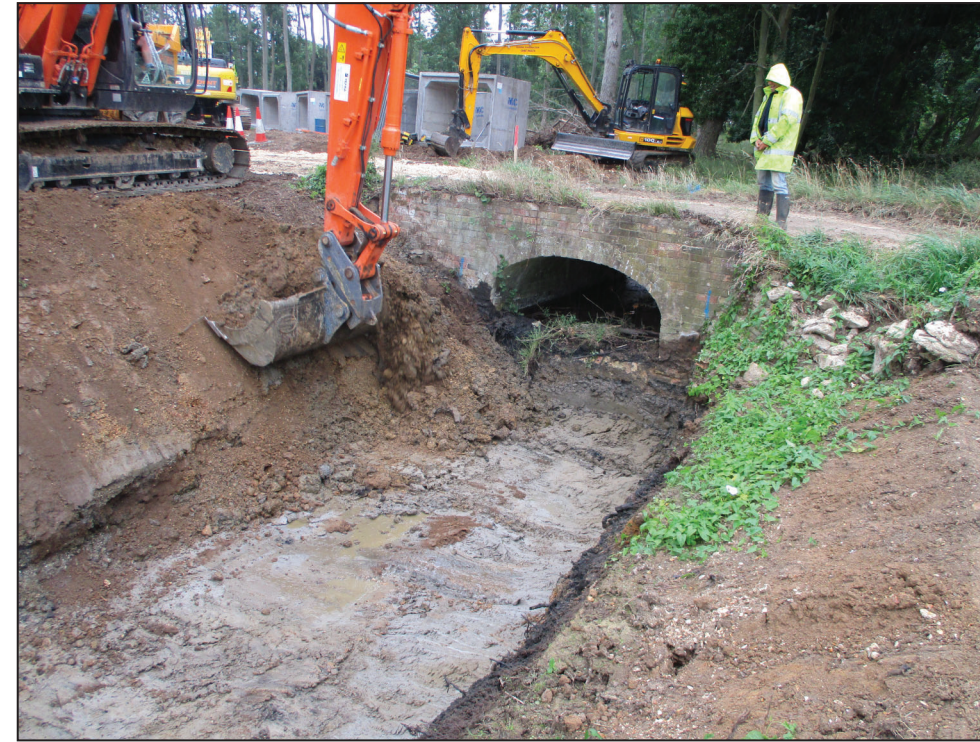
Culvert 2 under excavation, showing existing 20th century bridge

5.7 Excavations for culvert 2 also involved the demolition of a bridge carrying the old trackway over the ditch. This measured approximately 4m by 7m and comprised concrete walls with a brick facade in stretcher bond over a brick-built arch with a mid orange brown sandy silt and rubble core. While the bricks used for the facade were a light yellow pink and unfrogged, the bricks from the rubble core were frogged and were stamped with 'Marston Bespres'. The bridge was likely constructed in the

early-mid 20th century as the original Marston Valley Brick Company, manufacturers of the 'Marston Bepres' brick was formed in 1929.

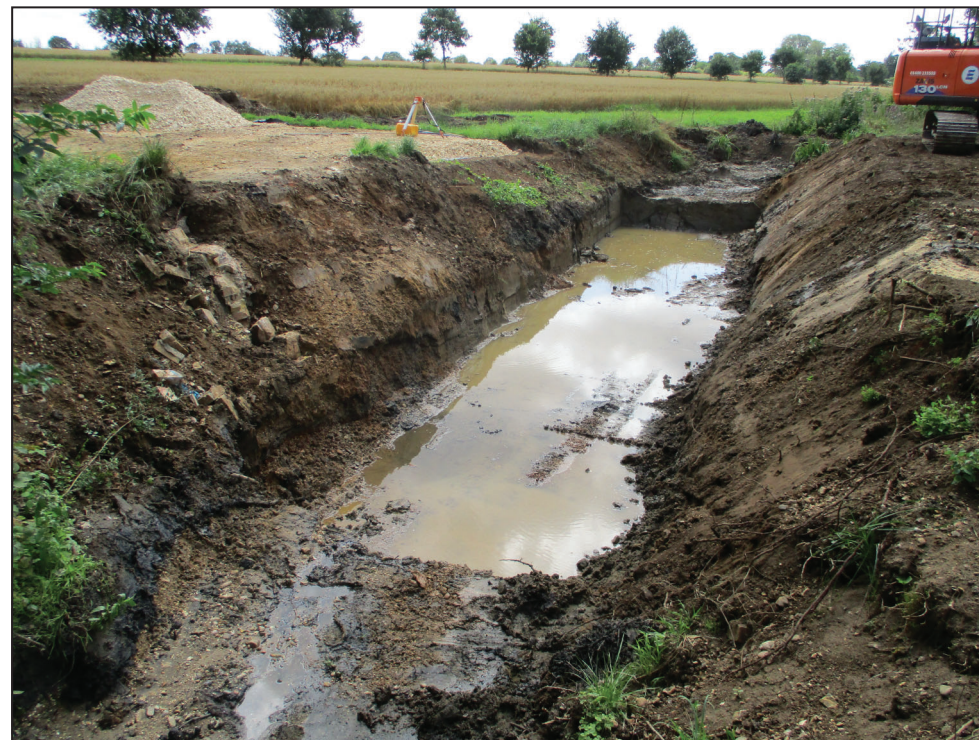
Culvert 2 post-excavation, looking south

5.6 Works for culvert 2 involved the excavation of a 16m length section in the base of the existing ditch. The current base of the ditch was approximately 1.5m below existing ground level, with excavation to 0.8m below this depth. These excavations encountered a substrate of alluvial material (202) at a depth of 0.22m below the current base of the ditch, comprising mid brown grey clay silt. This was overlain by a 0.22m thick layer of fluvial gravels (201) comprising mid grey yellow sand and small stones. Some of the overlying topsoil (200) along the edges of the ditch was scraped off to a depth of 0.25m without revealing any underlying deposits (Fig. 5).
