New Footpath and Decking Chedworth Roman Villa Gloucestershire

Archaeological Watching Brief

CA Project: 6838
CA Report: 19031

February 2019

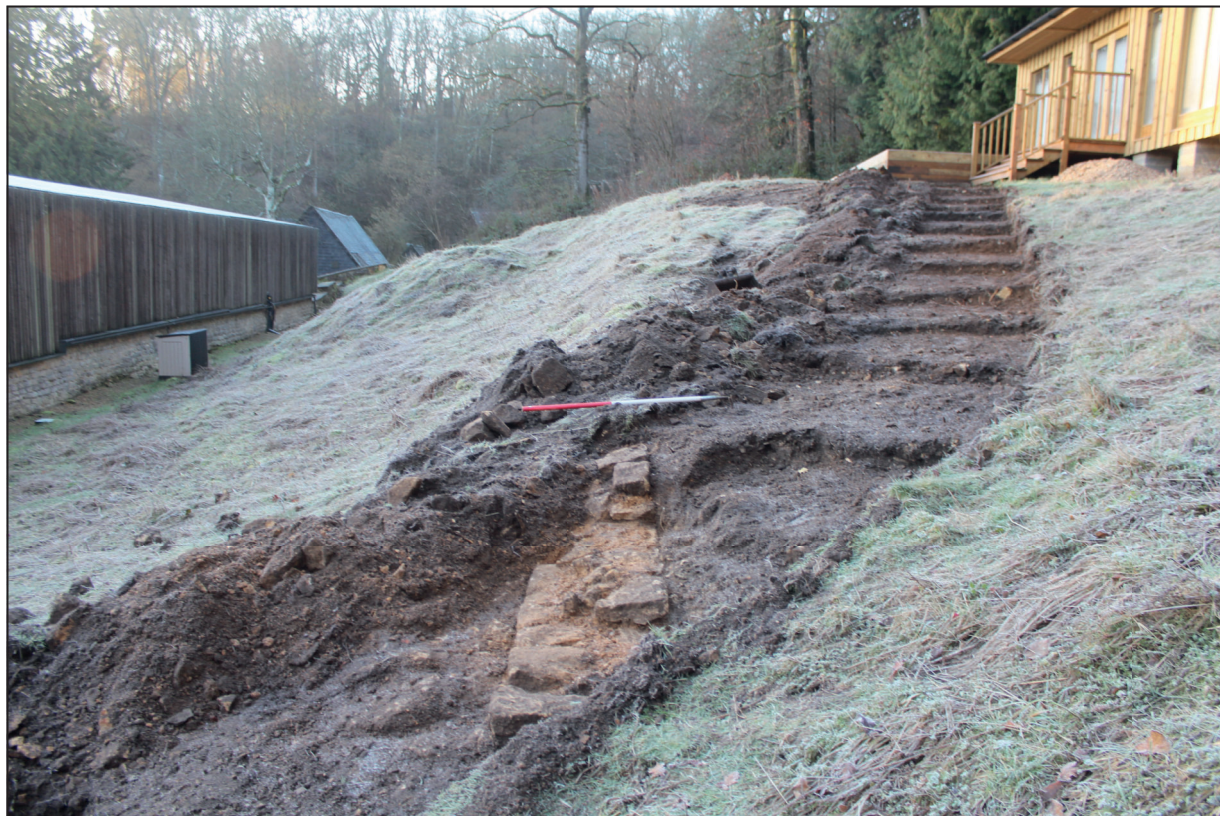
- 5.1 The earliest deposit encountered, at a depth of 0.2m bpgl, was north-south aligned wall 103 (northern end exposed at NGR: 405244.72 213482.12; southern end exposed at NGR: 405245.01 213479.69). It was of rough limestone block construction, bonded by yellow sandy mortar. It measured 0.55m in width and survived to a depth of at least 0.35m. It did not appear to continue across the entire width of the footpath strip, although this assertion is necessarily tenuous given the limited depth of groundworks undertaken. Butting wall 103 to both the east and west was partially exposed, undated, deposit 102. It comprised compact dark grey brown silt clay with abundant limestone and mortar fragments that may be indicative of demolition debris. The foregoing deposits were overlain by heavily root affected subsoil 101, which was in turn sealed by topsoil and turf.

Wall 103, looking south (1m scale)

- 6.1 The date of wall 103 remains unclear and its precise function remains equally uncertain, primarily due to the restricted view afforded by the limited depth and extent of the groundworks undertaken. Its alignment parallel to the west range of the villa complex suggests that it may be of Roman origin. However, it should be noted that a later date of construction/rebuilding of this wall cannot be wholly discounted at present given the absence of direct dating evidence recovered from it. The form and location of wall 103 suggests that it most likely represents part of a boundary or similar, the presence of which has previously been suggested in this location from at least the mid 19th-century. It remains possible, given its alignment, that it represents a continuation of a wall previously identified adjoining the Nymphaeum to the north (see *archaeological background* above).

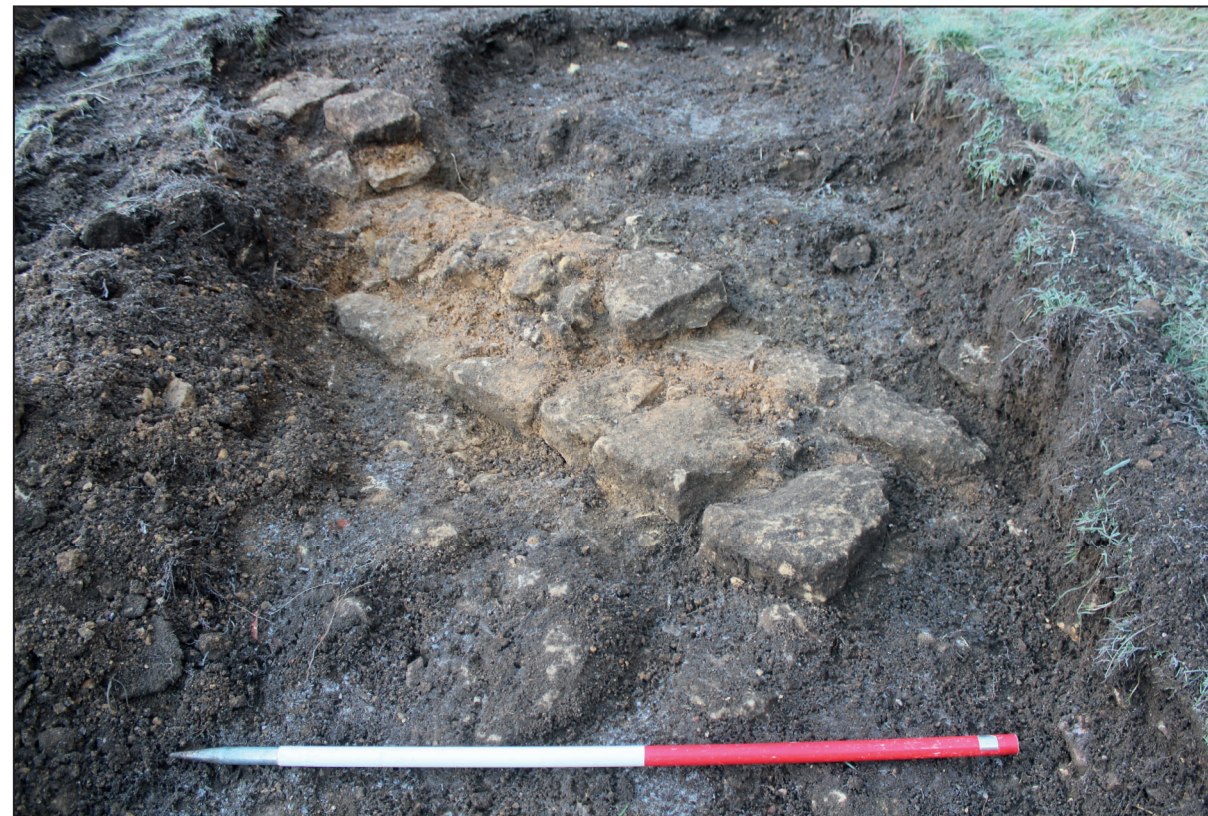
Wall 103 and deposit 102, looking west (1m scale)

- 6.2 The presence of compact stony deposit 102, partially exposed immediately to the east and west of wall 103, appears to indicate that this wall was at least partially demolished. The date and extent of this postulated demolition remains unclear due to the limited view afforded by the groundworks undertaken and the absence of dating material within deposit 102. However, a seemingly comparable deposit identified within an evaluation trench previously excavated immediately to the north (TNT 2018, Trench B), contained modern artefactual material suggesting that any possible demolition may have occurred in the relatively recent past.

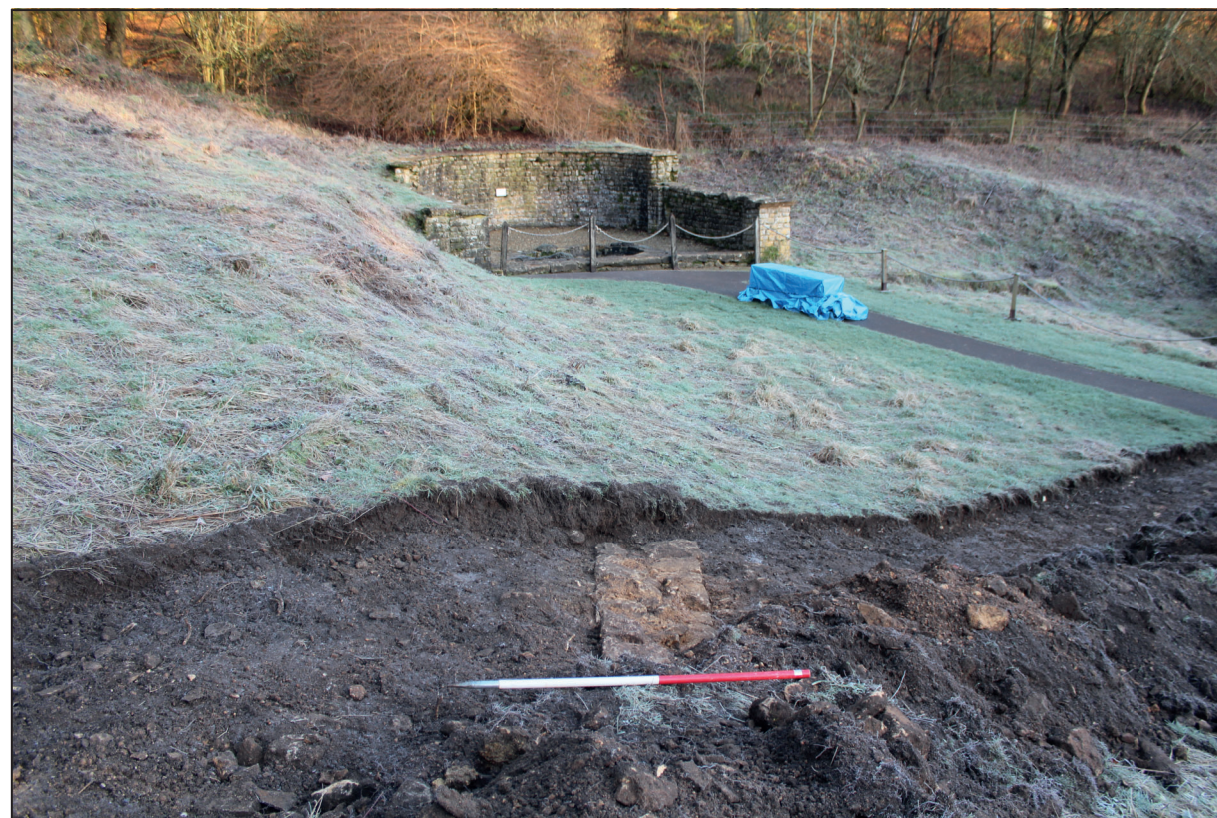
Wall 103, looking north towards Nymphaeum (1m scale)
