Birchgrove Extra Care Community Home Brighton Road, Godalming, Surrey

Archaeological Evaluation

CA Project: AN0582
CA Report: AN0582_1

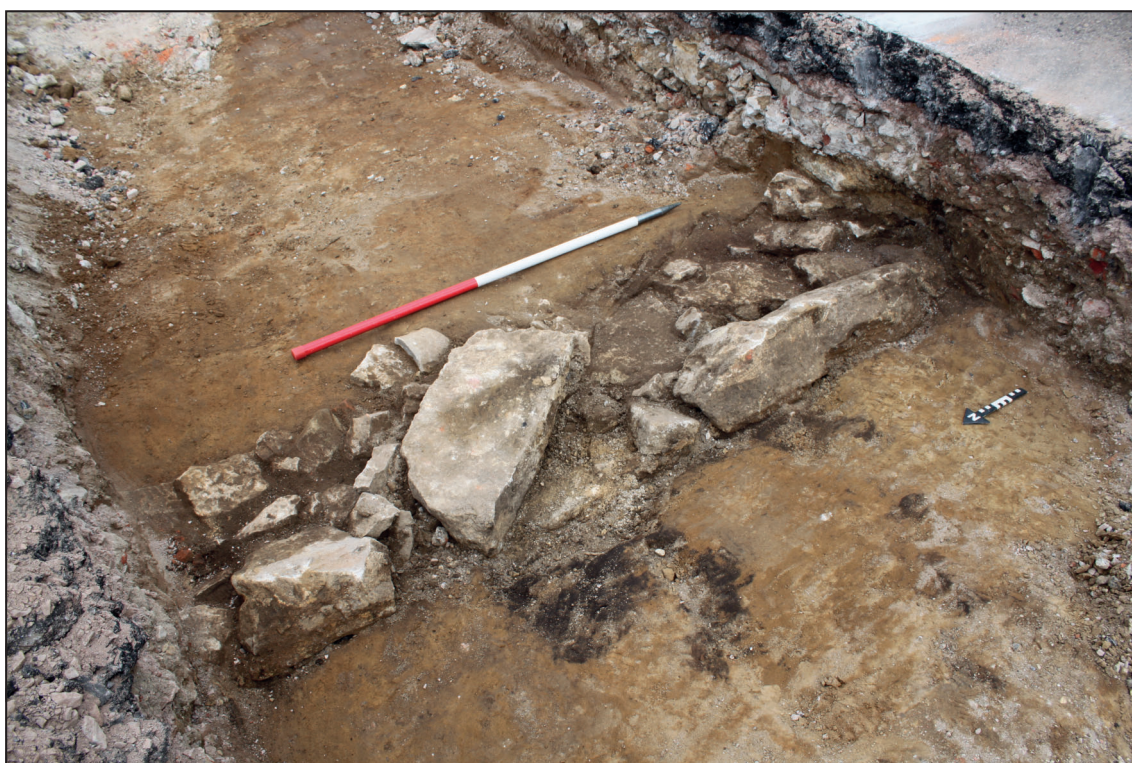
Trench 1: plan, section and photograph

Wall 105, looking south-east (1m scale)

- 5.3. Natural substrate 108 was exposed 0.33m bpgl. It was cut by construction cut 104 for wall 105. This wall was north-north-west/south-south-east aligned. It was constructed of mortar-bonded, roughly-hewn limestone blocks, with no regular coursing. It was 0.62m wide and survived to 0.26m in height.
- 5.4. The natural substrate lay at a lower level (0.53m bpgl) to the east of wall 105. A deposit of modern rubble (103) was present in this area. The surface of wall 105 were sealed by concrete layer 102, which was covered in turn by modern crush 101 and modern tarmac surface 100.

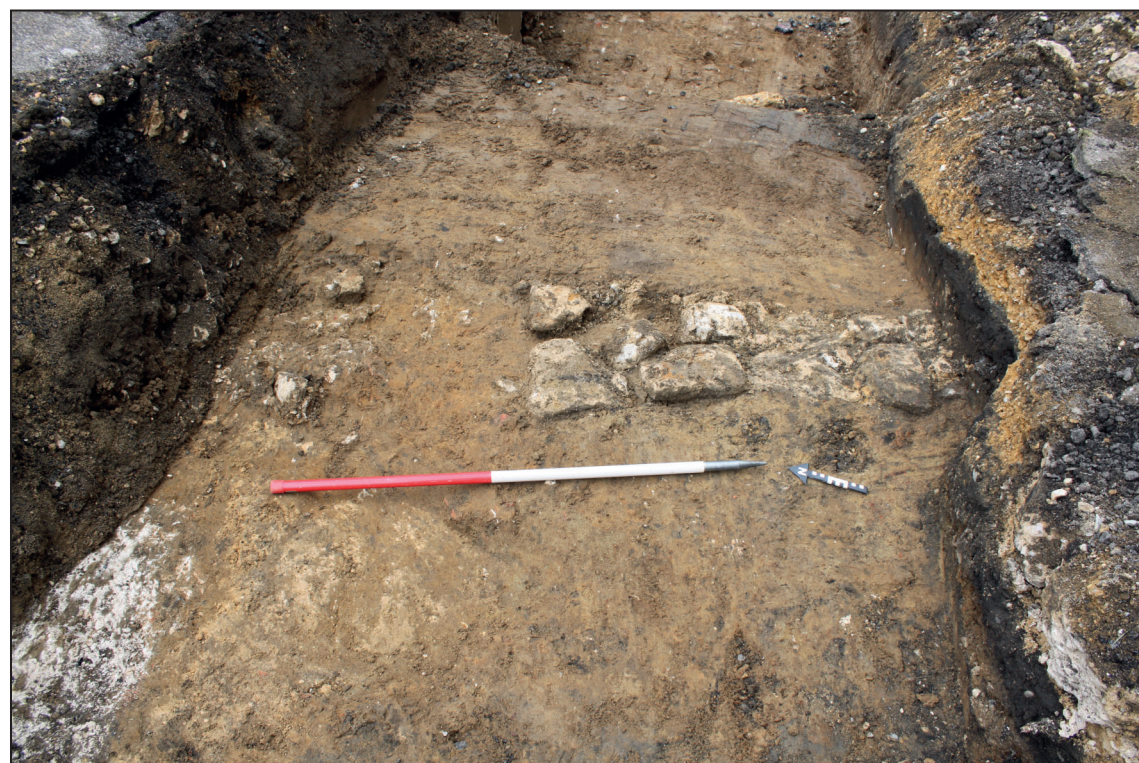
Wall 312, looking east (1m scale)

- 5.5. Natural substrate 306 was exposed 0.94m bpgl. It was sealed by made ground deposit 305. North-north-west/south-south-east aligned wall 312 was cut into layer 305 (construction cut 313). This wall was constructed of mortar-bonded, roughly-hewn limestone blocks, with no regular coursing. It was 0.42m wide and survived to 0.12m in height. The upper surface of wall 312 was sealed by post-demolition deposit 314, which was covered in turn by made ground layer 303.
- 5.6. A series of other levelling/demolition deposits and the remnants of modern surfaces were present elsewhere within the trench (302, 304, 307–311). The trench was sealed by modern tarmac surface 300 and its associated bedding layer, 301.

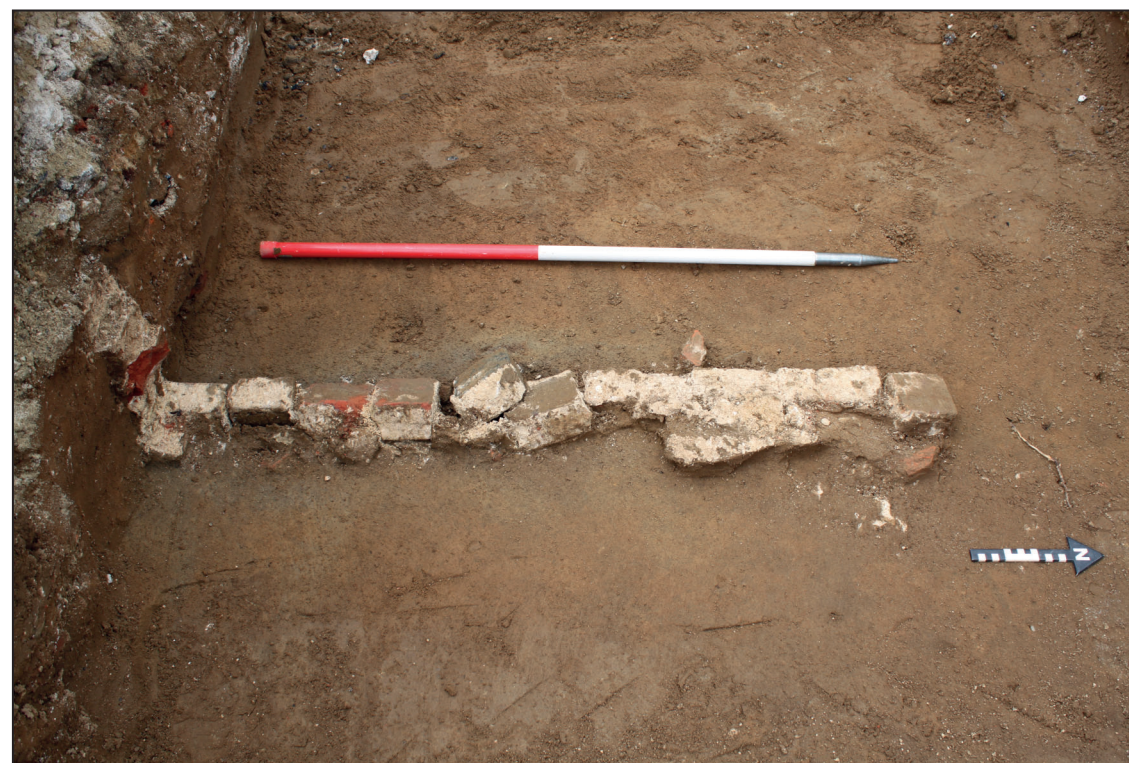
Wall 410, looking west (1m scale)

- 5.7. Natural substrate 406 was exposed 0.59m bpgl. It was cut by construction cut 409 for north/south aligned wall 410. This wall was constructed of red brick. It was 0.13m wide and survived to 0.34m in height.
- 5.8. The natural substrate was partially sealed by rubble deposit 404. The remainder of the natural was sealed by chalk deposit 405, which was covered in turn by tarmac

402. This sequence (including the upper surface of wall 410) was sealed by former concrete surface 401, which was covered in turn by modern tarmac surface 400.

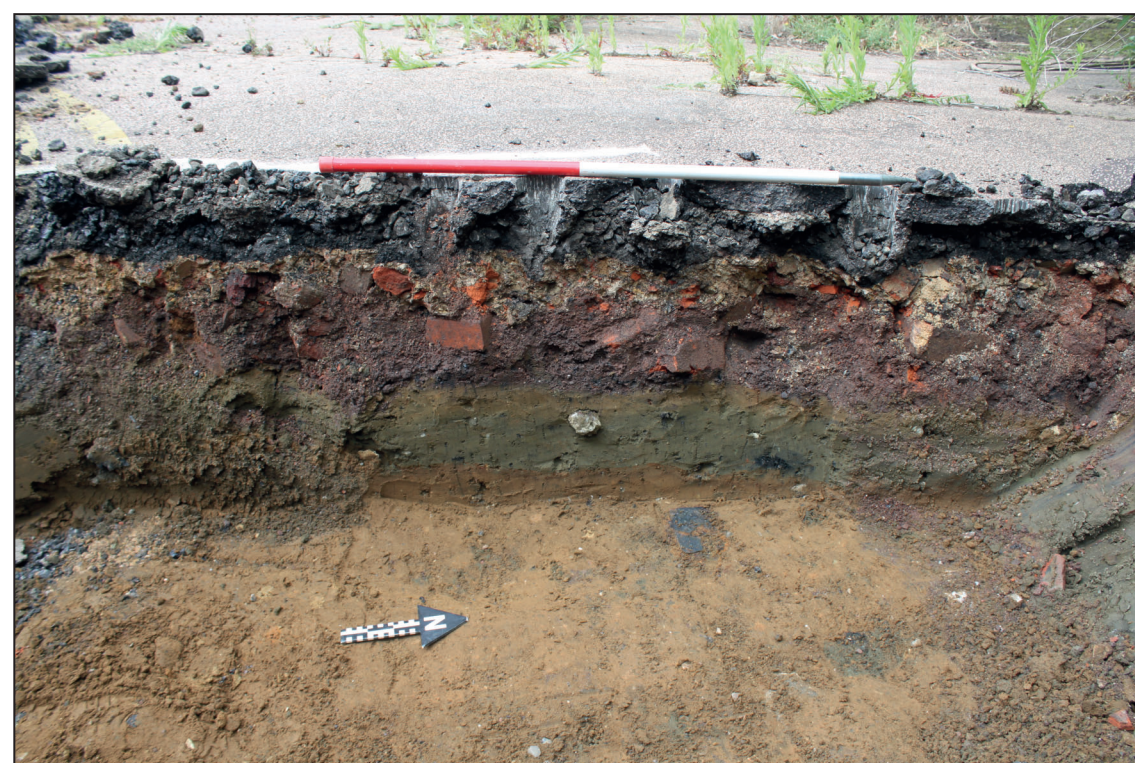
Trench 5 representative section, looking west (1m scale)

- 5.9. Natural substrate 505 was exposed 0.62m bpgl. It was sealed directly by a series of modern levelling/demolition deposits, which were covered in turn by modern tarmac surface 500 and its associated bedding layer (501).
