St. Stephen's Church, Ipswich, Suffolk

Archaeological Monitoring and Recording

CA Project: SU0515
CA Report: SU0515_1
OASIS ID: cotswold2-512341
HER Ref: IPS 277

April 2023

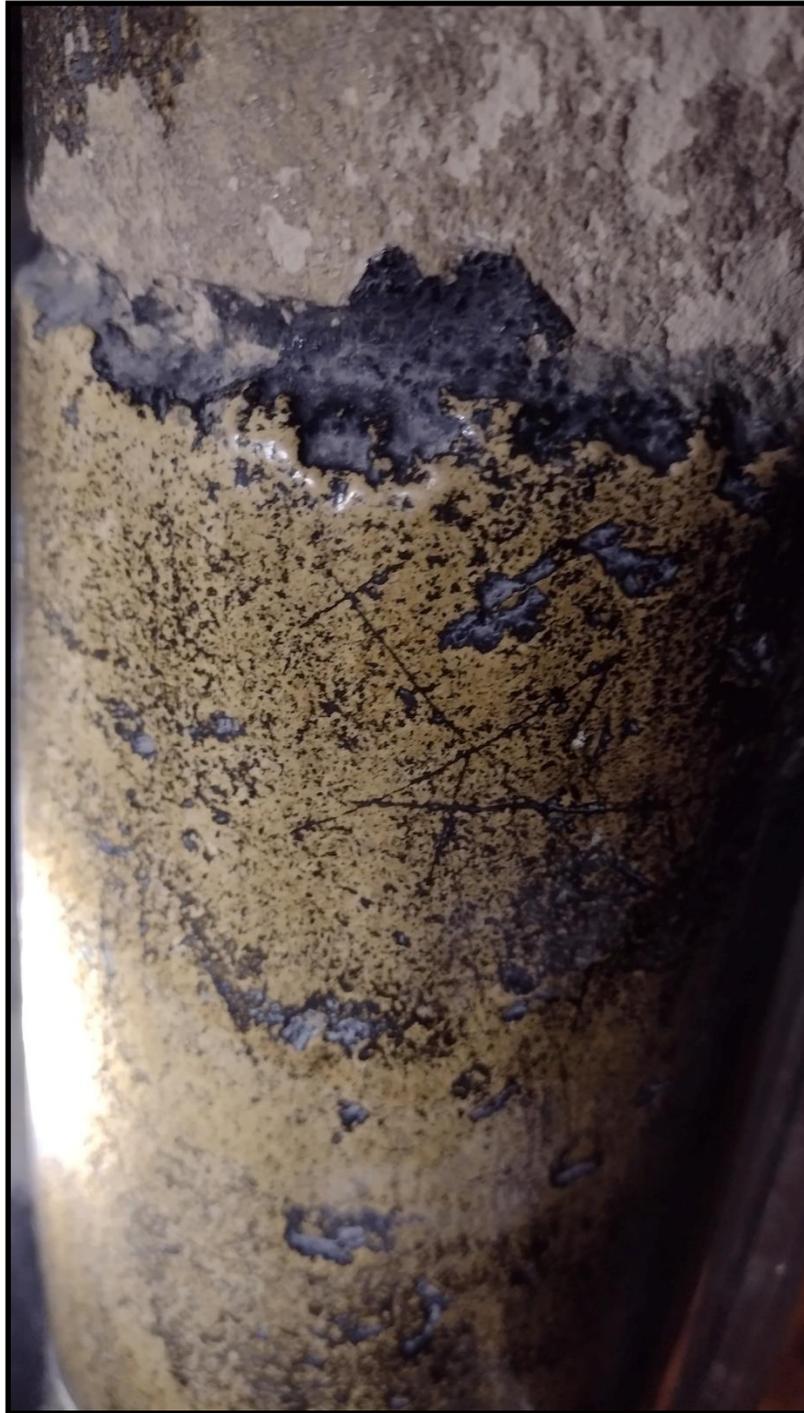
- 5.21. Historic graffiti was identified inside the stairwell of the church's west tower. It consists of incised lines cut into the stonework of the central axial column of the stair. The majority of visible graffiti is located near the base of the stairwell. Much of it could not be deciphered at the time of discovery, although one piece appeared to consist of six scratched lines forming a vertical cross flanked by two smaller diagonal crosses, perhaps representing Calvary (Appendix C). The worn nature of the graffiti, like the stonework it is cut into, suggests that it is of some antiquity. The graffiti is located in an area not subject to the present redevelopment of the church, and so lies beyond the scope of the current archaeological monitoring. The existence of the graffiti is noted here, as it does not appear to have been recorded in any previous surveys of the church and may be of future interest.

- 6.8. The incidental discovery of historic graffiti inside the stairwell of the west tower may be of interest to future research, particularly as it was carved in an area which would have had restricted access, unlike the more public of the church such as the nave or porch. The graffiti does not appear to have been surveyed or recorded previously.

Example of historical graffiti identified in the stairwell of the west tower.

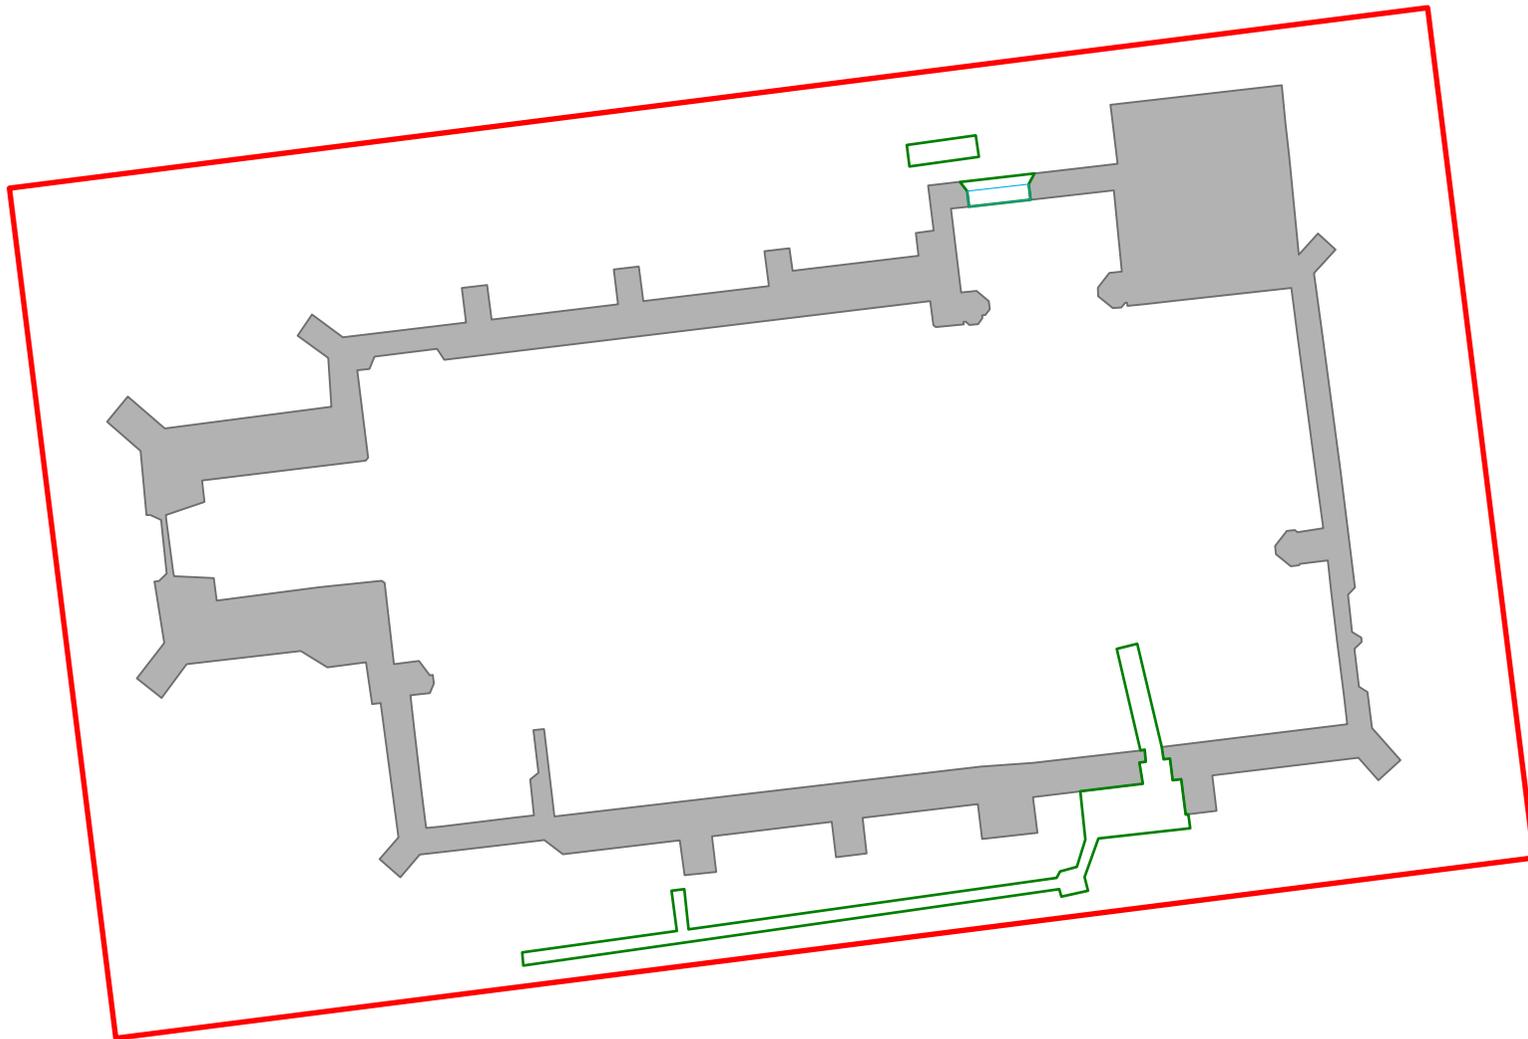
FIGURE TITLE
Monitored Areas

- 5.1. Three areas of the development were subject to archaeological monitoring: the excavation of a trench for a new drain, the removal of a segment of 19th century wall, and the installation of a new access ramp (Fig. 2).

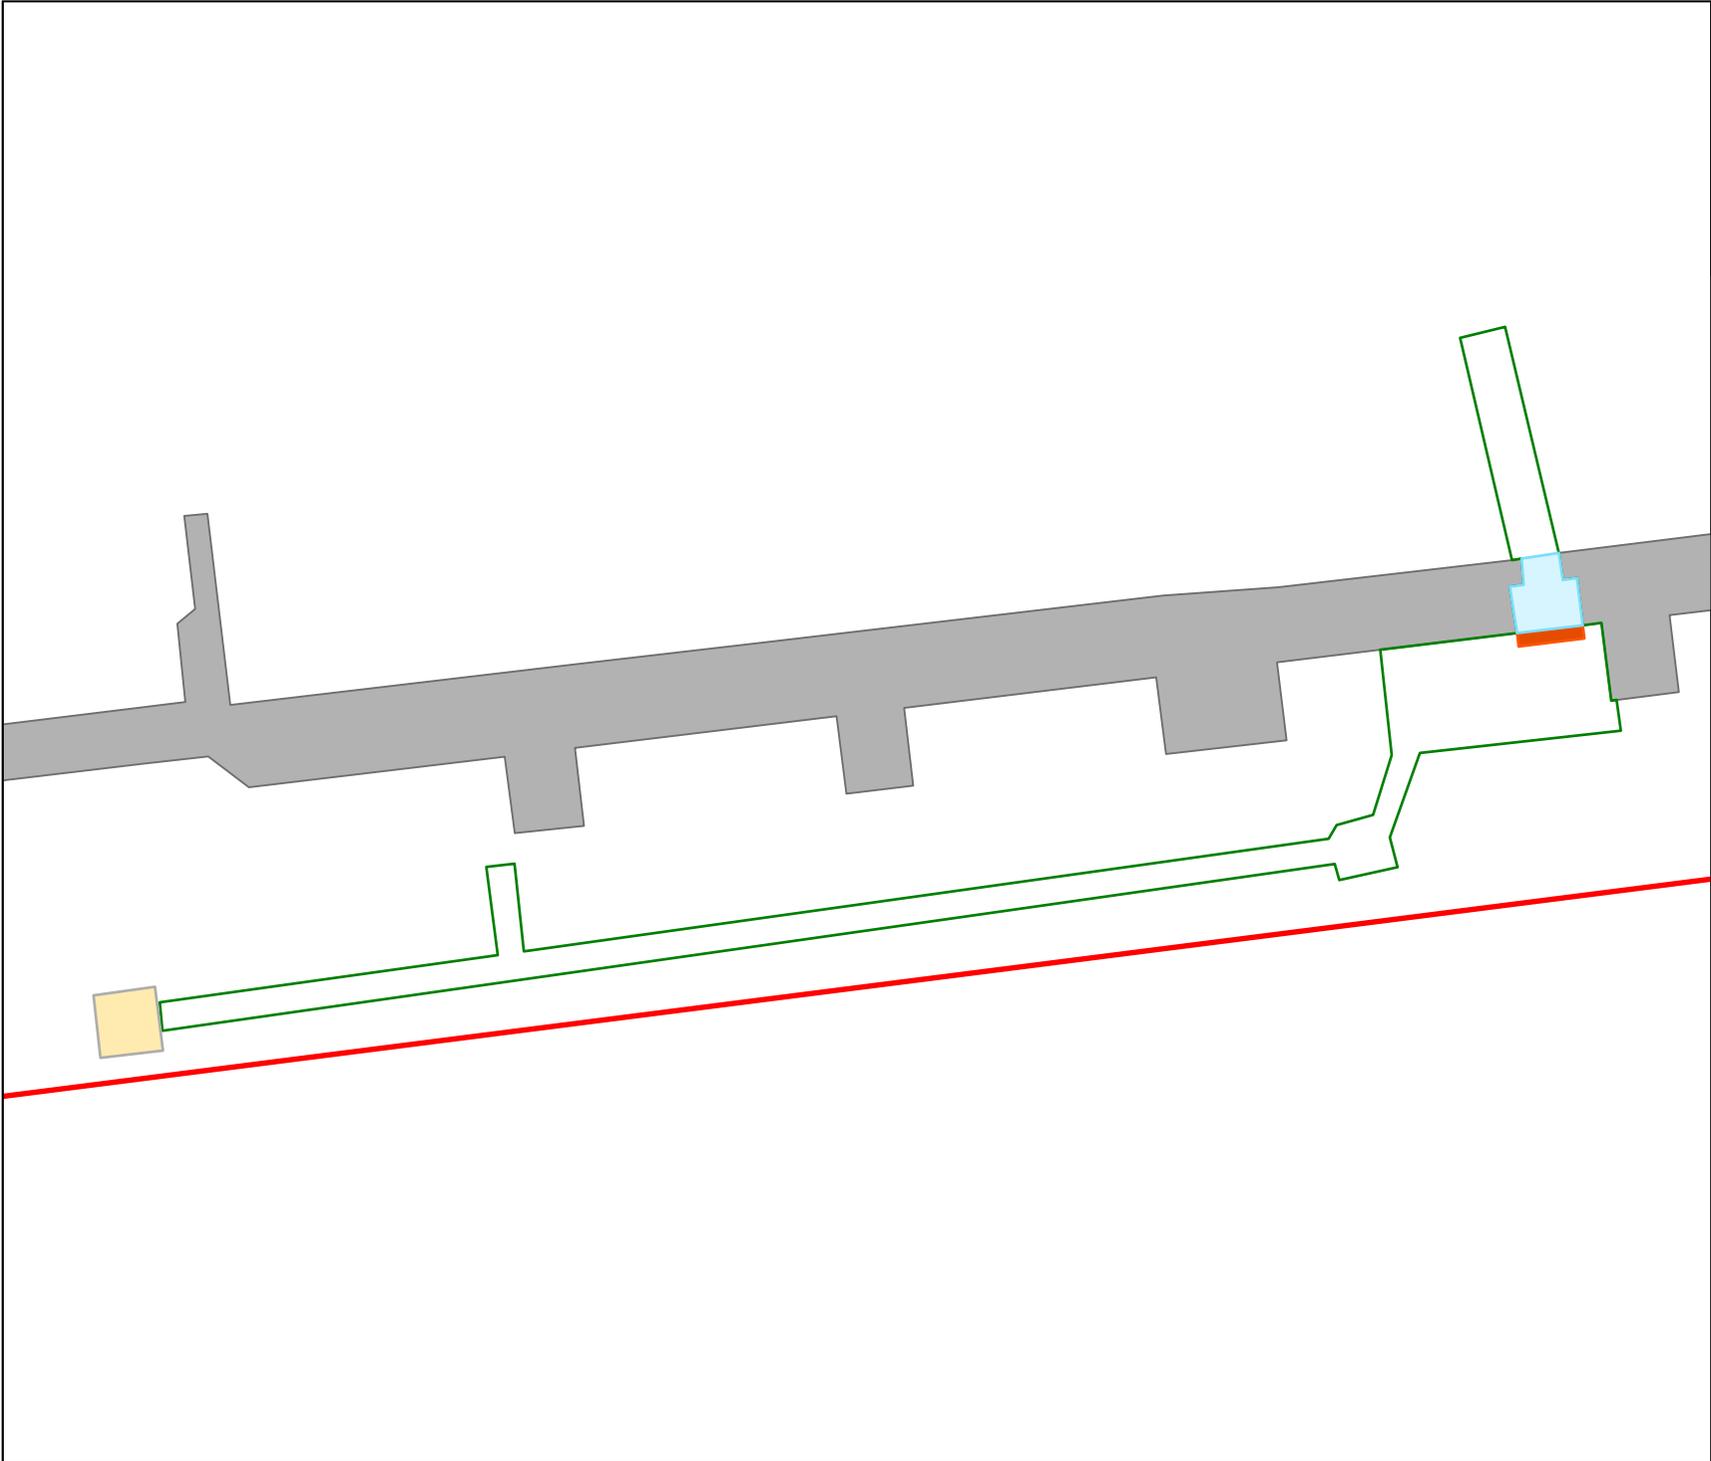
FIGURE TITLE
Monitored Area, south side

- 5.2. Contractors hand-excavated a trench for new drain pipes, connecting an existing manhole located outside the church with the intended location of new toilet facilities in the interior of the building (Figs. 2 and 3). This work also involved cutting a hole through the foundation of the church wall.

- 5.5. The trench was then tunnelled through the foundation of the southern wall of the former Rush Chapel (Fig. 3 and 6), starting from its exterior face at a point 0.20m west of the easternmost buttress in the church's south wall. The top of the tunnel was located around 0.28m below the original ground level of the path outside the church and 0.45m below the top of the wooden decking forming the current floor surface of the church interior. The height of the excavation was 0.40m, and the initial width was c.0.80m. After a distance of c.0.50m from the exterior face of the church, the excavation through the foundation narrowed to a width of 0.40m.

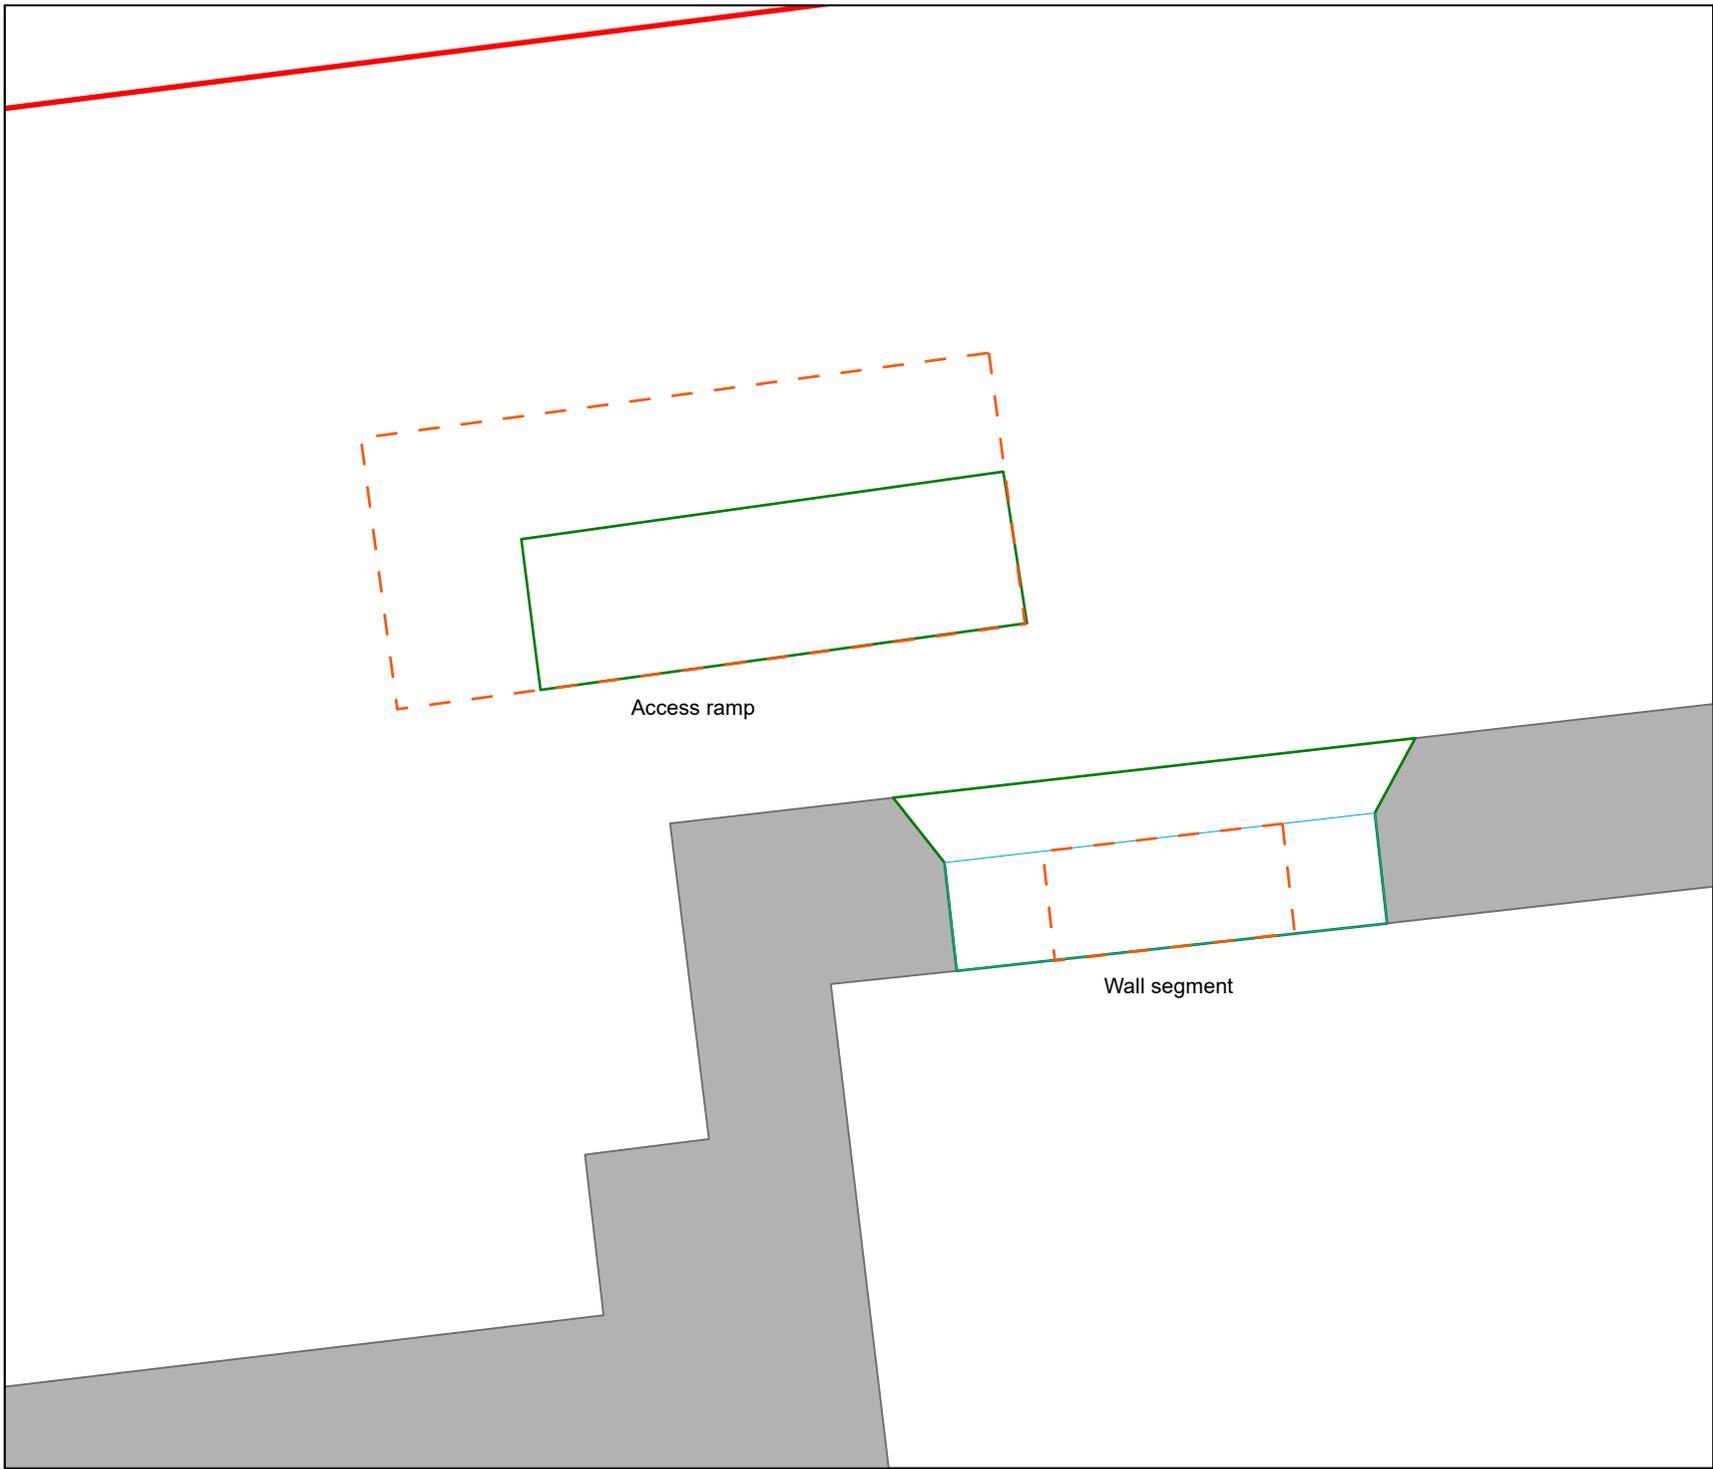
FIGURE TITLE
Monitored Area, north side

5.14. After the removal of the wall, contractors excavated a 1.40m long, c.0.60m wide and c.0.50m deep trench beneath where the demolished wall had been located, to accommodate a foundation for the threshold of a new doorway (Fig. 4, where its location is depicted with a pale blue outline, and Fig. 9). The trench was cut through the flint and mortar foundation of the wall. The remains of an earlier brick vaulted structure were uncovered during this work, located 0.30m in from the eastern end of the trench and around 0.30 – 0.40m below the floor level. The visible extent of the structure in the trench is indicated on Figure 4 with a dashed line.

5.15. It appeared to be the top of a vaulted chamber formed of red bricks, measuring 0.80m wide east to west, and crossing the full width of the trench. The arrangement of the

structure suggested it had a north to south alignment. The brickwork consisted of two, or perhaps three, courses of red bricks, around 10cm long by 10cm wide, bonded as headers, forming a gently arced dome or vault. They were set in a hard white-yellow, chalky lime mortar. The wall foundation had been built over and around this brick structure. A void was partially exposed underneath the brick vaulting, which was filled with brick rubble and dark soil. A measurement was taken, which suggested the void could be at least 1.20m deep. The structure was initially interpreted as a well due to the depth of the void below and its apparent north to south alignment, although it could have been part of a vaulted burial chamber.

- 5.16. Contractors consolidated the void inside the brick structure prior to the construction of the new doorway, capping it with concrete blinding.

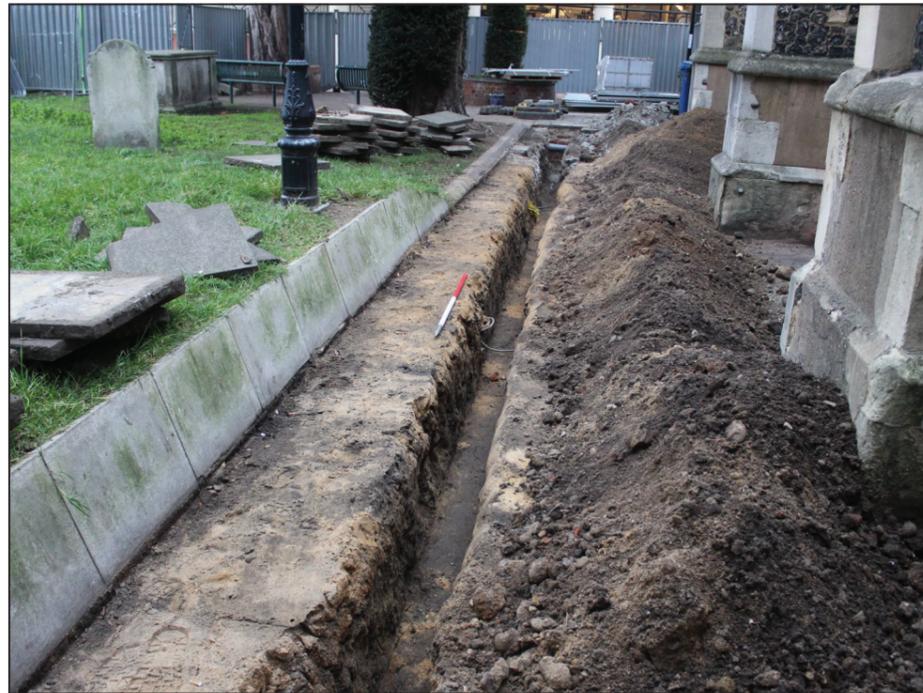
- 5.3. The exterior section of the trench was excavated through the pavement of a footpath, which runs past the southern wall of the church between St. Stephen's Lane and Brook Street (Figs. 3 and 5; see also paragraph 2.3, above). The western end of the trench began at an existing manhole, located around 2.50m south of the church's south porch. From the manhole, the trench ran east-northeast, parallel and c.2.00m south of the church wall. The first 2.70m of the trench east of the manhole measured 0.50m wide, narrowing to 0.30m beyond that. After a distance of 11m from the manhole, contractors excavated a 1.00 x 1.00m square for a new manhole. From the

- 5.4. The concrete paving slabs of the pathway had been lifted prior to the commencement of the monitoring. The depth of the contractors' excavation varied between 0.50 and 0.60m below the ground level under the paving slabs. The upper c.0.30m of the trench was excavated through the bedding layers of the paving slabs, formed of yellow sand, concrete rubble and hardcore. Beneath this, there was a layer of dark greyish brown, silty sand, probably representing cemetery soil (Fig. 5). This was cut through by numerous modern services, several of which were deeper than the limit of the contractors' formation level. As a result, in much of the trench the cemetery soil was probably reworked as backfill in intercutting modern service trenches. Thirteen pieces of disarticulated human bone, mostly fragments of tibia, fibula, radius and ulna, but also a vertebra, were found in the cemetery soil, alongside two large pieces of animal bone joints, one of which was cattle, several small pieces of oyster shell and one sherd of yellow and brown glazed 18th or 19th century pot.

Drain trench, looking west (1m scale)

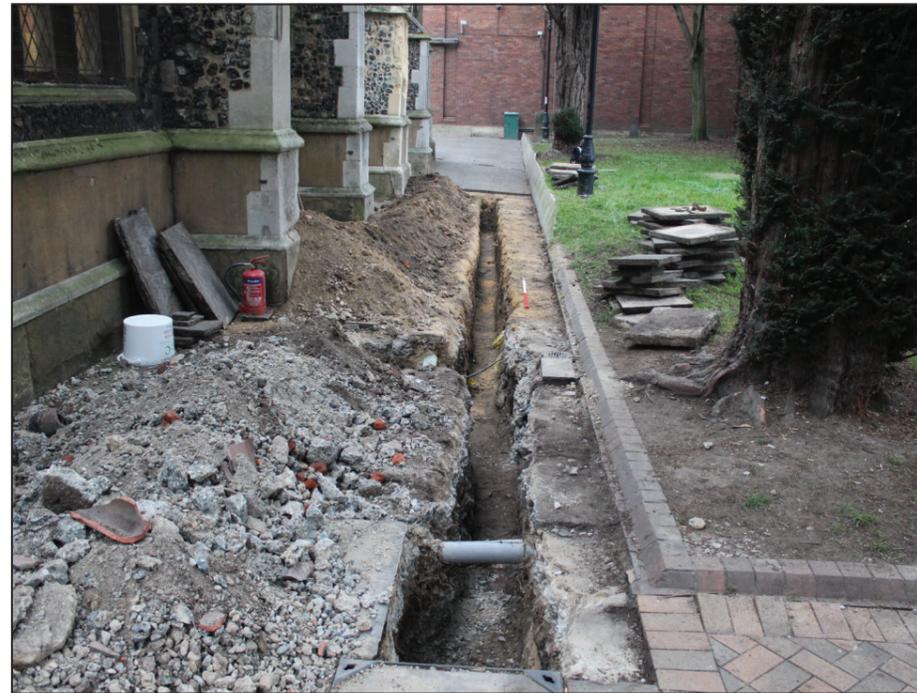
Drain trench, looking east (1m scale)

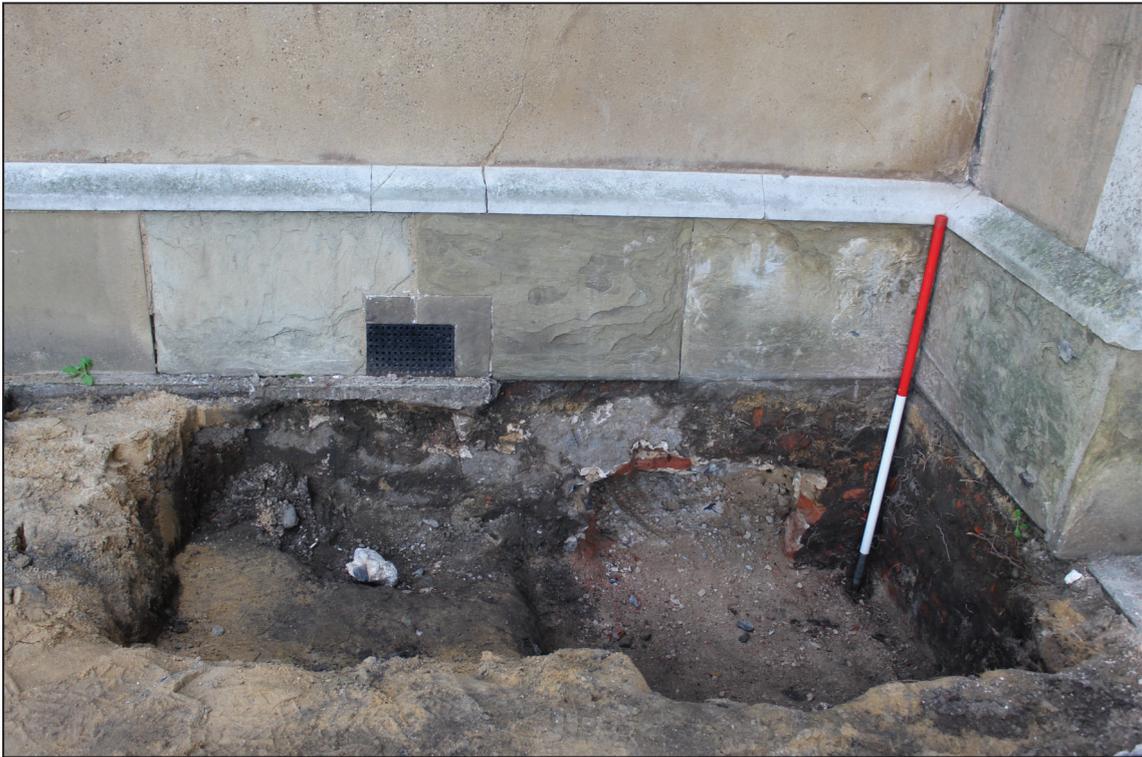
- 5.6. The exterior of the foundation was faced with brickwork. This consisted of red, unfrogged bricks, measuring 22cm long, 11cm wide and 7cm high, set as stretchers in a hard, white-grey chalky mortar. The thickness of the brick facing was around 0.14m. It appeared to support the stone panels that form a skirt around the base of the wall's exterior (Fig. 6), which are a 19th century addition, and is probably contemporary.

Drain trench excavation through foundation, looking north (1m scale)

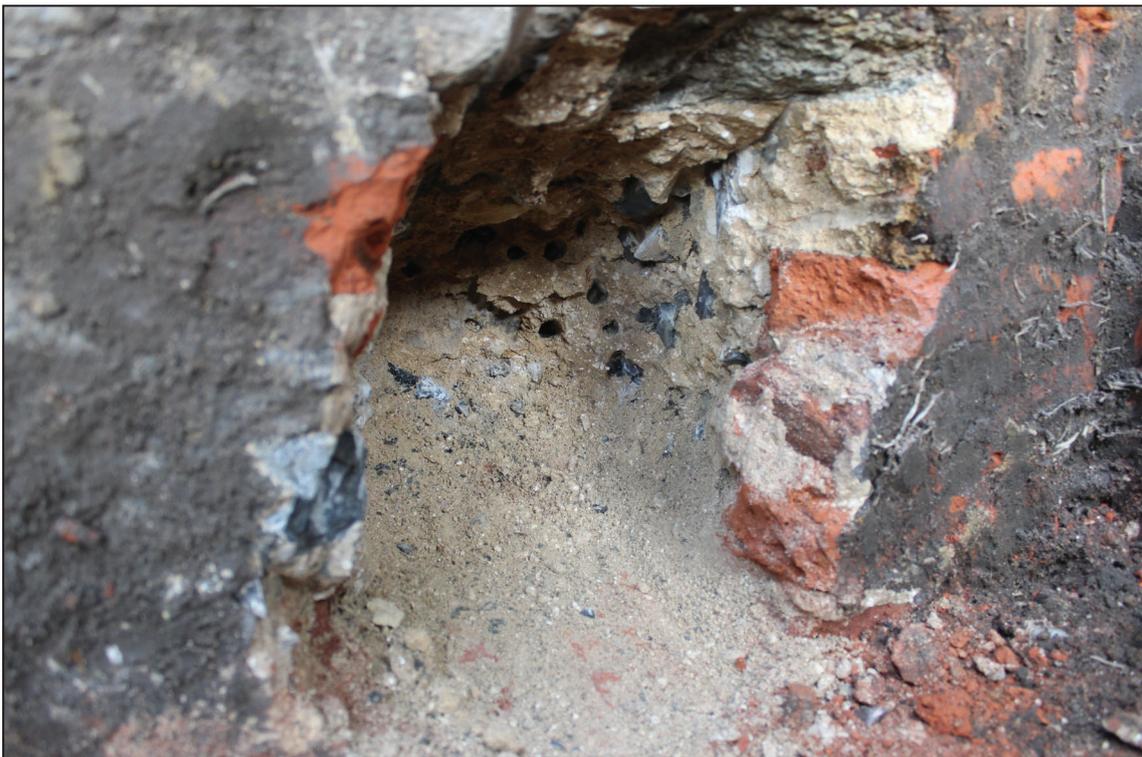
5.7. The stone foundation of the 15th century chapel wall was encountered behind the brickwork. This foundation was just over 0.80m in width, only marginally wider than the wall it supported. The extent of the trench excavation did not locate the top or base of the foundation. The foundation mainly consisted of blue-grey flint nodules, resembling those used in the superstructure, set in a yellow, chalky lime mortar. Apart from flints, there were also rare nodules of quartzite and septaria, alongside a large, 0.30 – 0.40m sized nodule of gneiss. Small, broken fragments of red brick could also be seen in the foundation. These were similar in appearance to the bricks seen in the flint walls of the Rush Chapel.

6.3. Whilst the composition of the Rush Chapel's foundation suggests it was largely built using the same flint as in the walls of the superstructure, the rare nodules of septaria might be spolia from the earlier fabric of the church. The large nodule of gneiss in the foundation must have been imported into Ipswich. It might be a glacial erratic from the clay till of the local region, although it is possible that it arrived as ship ballast (S. Boulter, *pers. comm.*).

Drain trench excavation; foundation detail, looking north-east

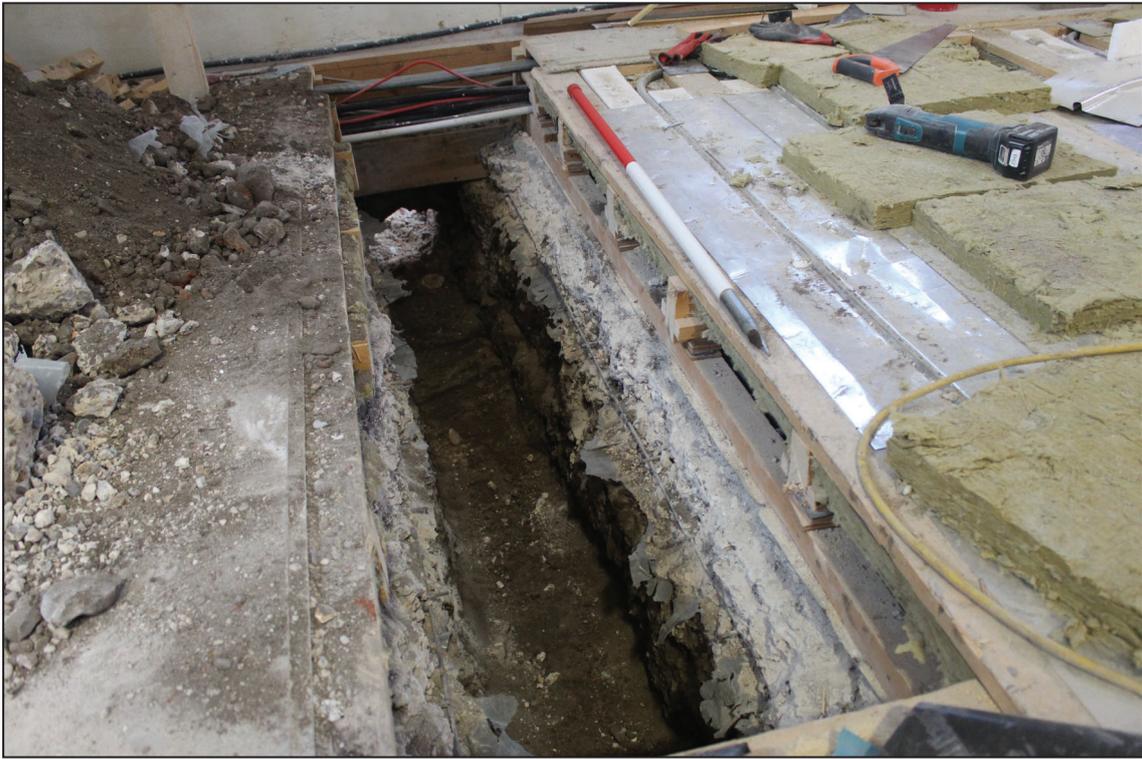
5.8. From where it was tunnelled through the wall foundation, the trench continued into the interior of the church for a distance of around 2.30m on a north-northwest alignment (Figs. 3 and 7). The trench was 0.50m wide and 0.75m deep. The top of the trench was excavated through the wooden decking of the church floor, which was 0.20m thick, and 0.25m of underlying, reinforced concrete. Beneath the concrete was a layer of dark greyish-brown, silty sand, excavated to a depth of around 0.20m, without reaching the base of the deposit. This layer resembled the cemetery soil encountered in the trench outside the church, although it was not as dark and contained more stones. Two pieces of human bone, consisting of a near-complete ulna and a fragment of limb bone, were recovered from it.

Drain trench, looking south (1m scale)

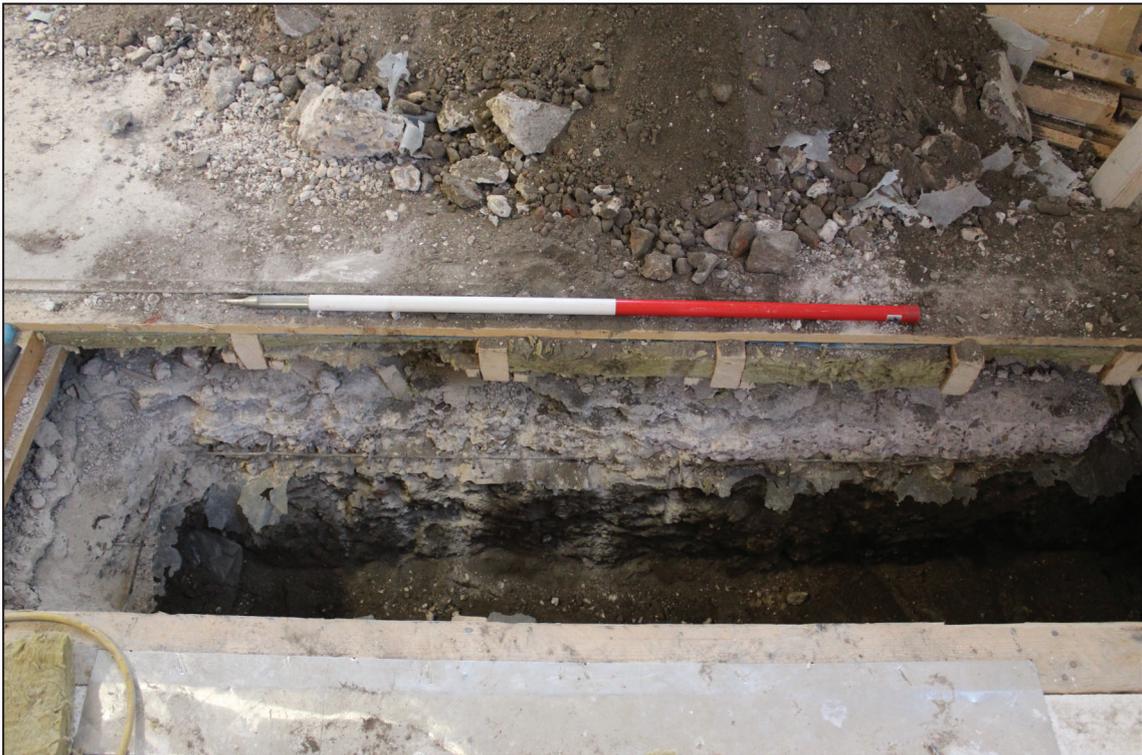
6.4. The floor under the Rush Chapel was found to be a concrete slab sitting directly onto the underlying remains of cemetery soil, and any earlier floor surfaces have gone. The cemetery soil and disarticulated human bone uncovered beneath the floor suggests that the chapel is built over what had been part of the burial ground prior its late 15th century construction, and therefore *in situ* burials could be located below it.

Drain trench, looking east (1m scale)

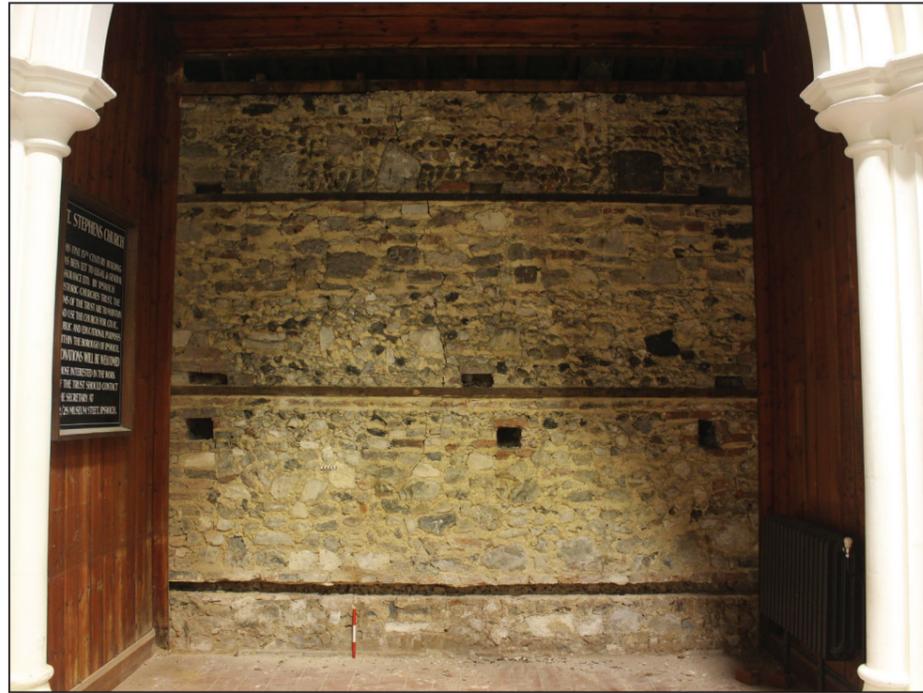
5.10. The wooden panels lining the interior face of the wall were removed to reveal the underlying stonework (Figs. 8, 9 and 11). The panelling was attached to the stonework by three horizontal wooden battens. The exposed stonework consisted primarily of flint rubble, with occasional fragments of moulded limestone (Fig. 9) and reused red brick, set in a white, chalky lime mortar. The stonework appeared to be reused medieval and Tudor church fabric, whilst the rough finish of the wall's interior face and its lack of regular courses perhaps suggests that it had always intended to be covered by panelling.

5.12. There were two separate horizontal courses of red bricks running across the interior face of the wall, one 0.45m above the floor level and the second 1.60m above the floor level. The bricks, which were set as stretchers, were of various sizes, some being whole and others fragmentary, the largest measuring c.20m long by 5cm high. There were also six possible putlog holes visible in the interior wall face, arranged in two rows, with three to each row. The lowest row of holes was located 0.90m above the floor surface, and the upper 1.70m above the floor. The lower set of holes were almost square in shape, measuring 0.14m high and 0.18m wide, whilst those of the upper row were about half the size in height but of similar width. The holes were lined with red bricks. All the bricks visible in the interior face of the wall appeared to be reused, and based on size and appearance were probably Tudor or early-Modern in date.

Interior face of wall prior to removal, looking north (0.3m and 0.1m scales)

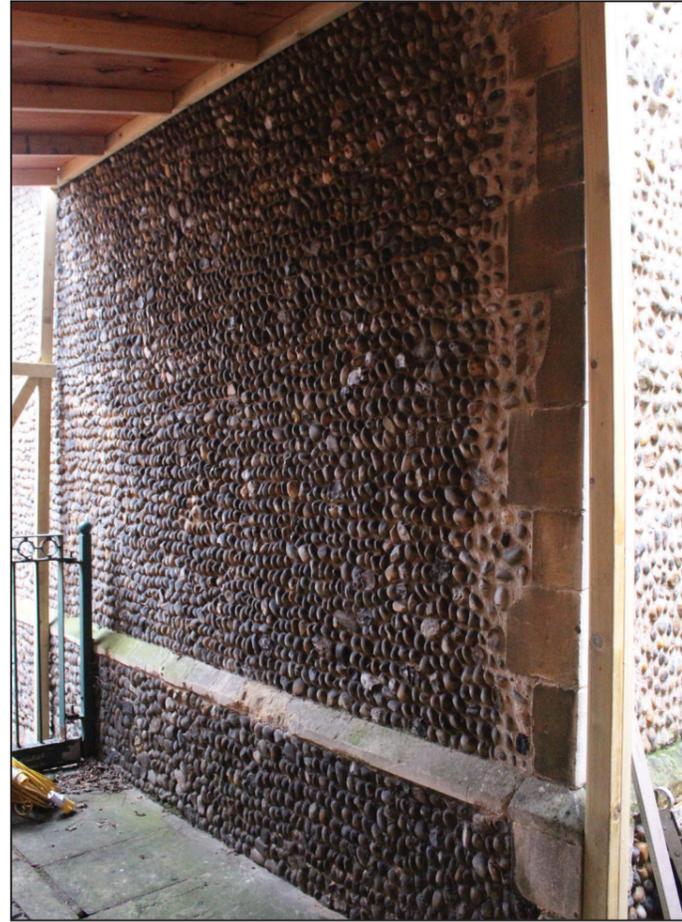
5.13. The exterior face of the wall consisted of neatly laid, rounded flint cobbles, set in regular horizontal courses (Fig. 8). The lower part of the wall projected out slightly from the wall face, and was capped with a string course of dressed limestone.

Exterior face of wall prior to removal, looking south-east

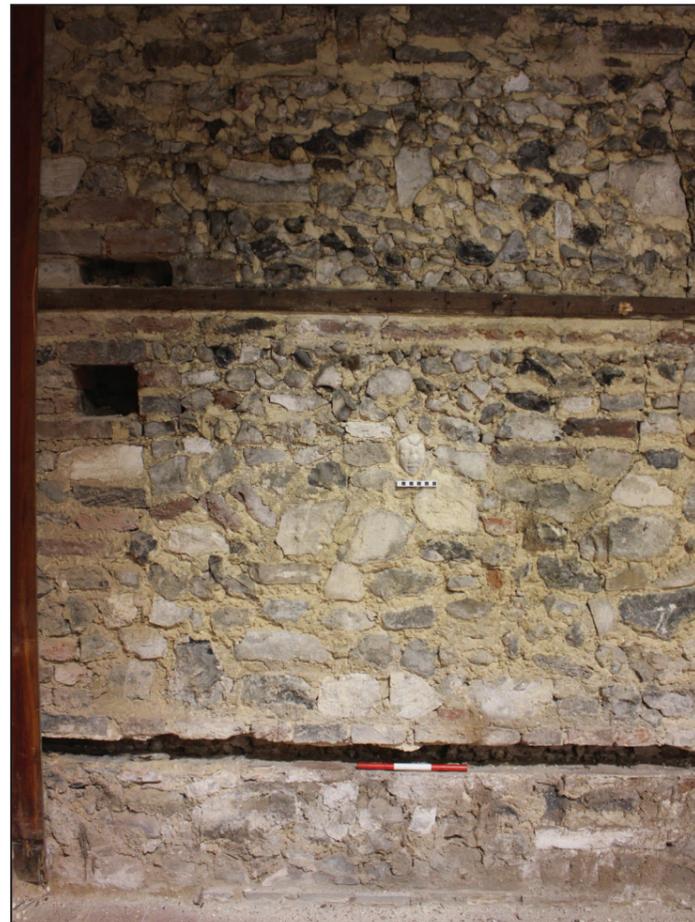
5.11. A notable piece of moulded stonework in the wall fabric was a small, carved limestone head, measuring 11cm high by 8cm wide (Figs. 8 and 10). This was set c.1.10m above the floor level in the centre of the wall, facing the church interior. It appeared to be the remains of a decorative corbel or label stop, c.14 – 15th century in date, representing a hooded female figure, wearing a caul or wimple. The good condition and lack of weathering seemed to indicate that it had been an interior feature.

Medieval carved stone head in situ; location. Looking north (0.3m and 0.1m scales)

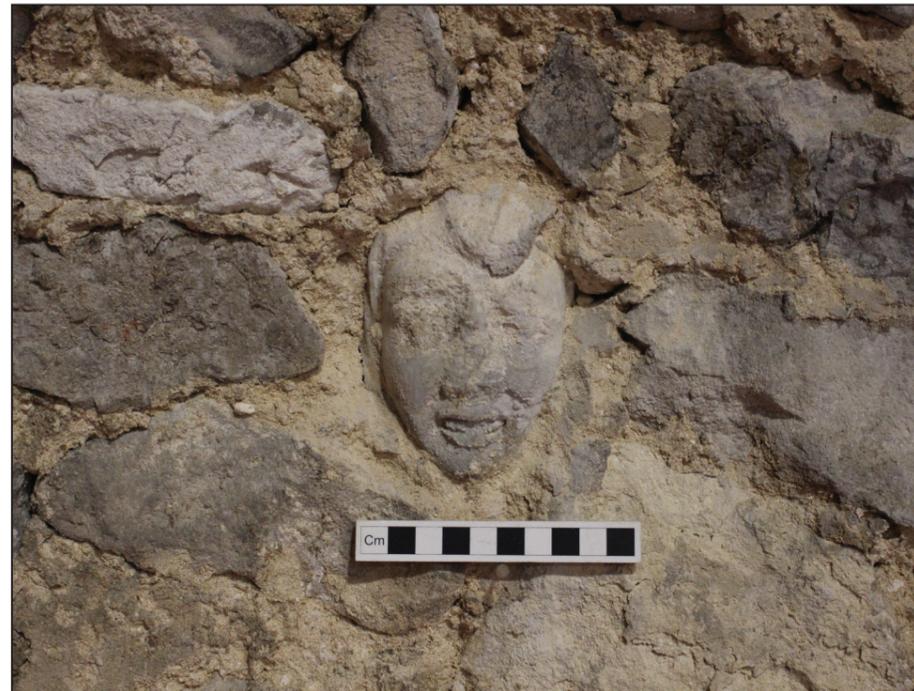
Medieval carved stone head in situ; detail. Looking north (0.1m scale)

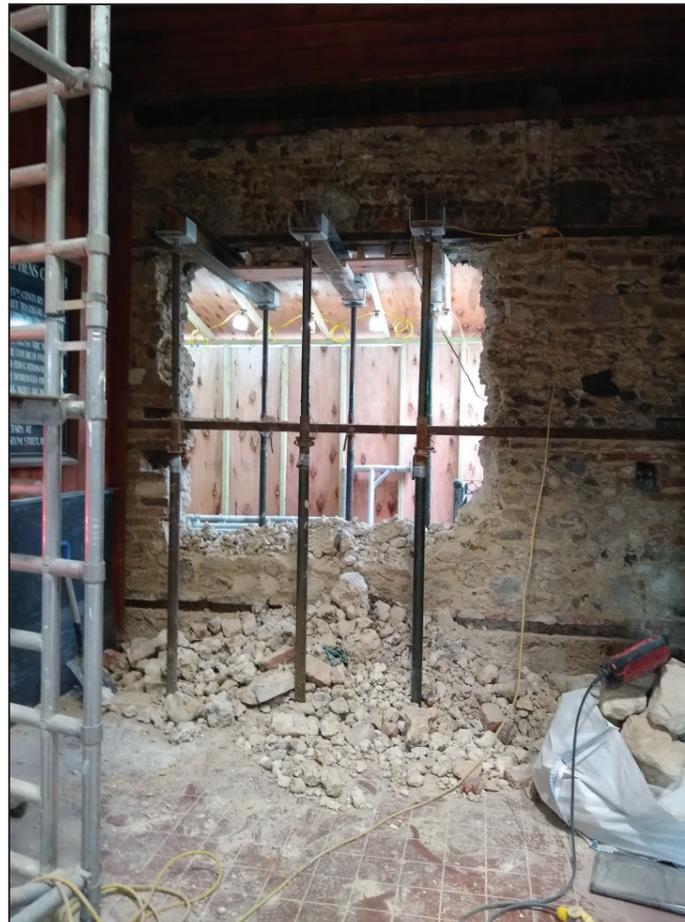
5.9. A c.1.40m segment of 19th century wall on the north side of the church was taken down by contractors to create a passage for a new doorway (Figs. 2, 4, 8 – 10). The segment was part of the exterior wall of a Victorian extension attached to the chancel.

Removal of wall underway, looking north-west

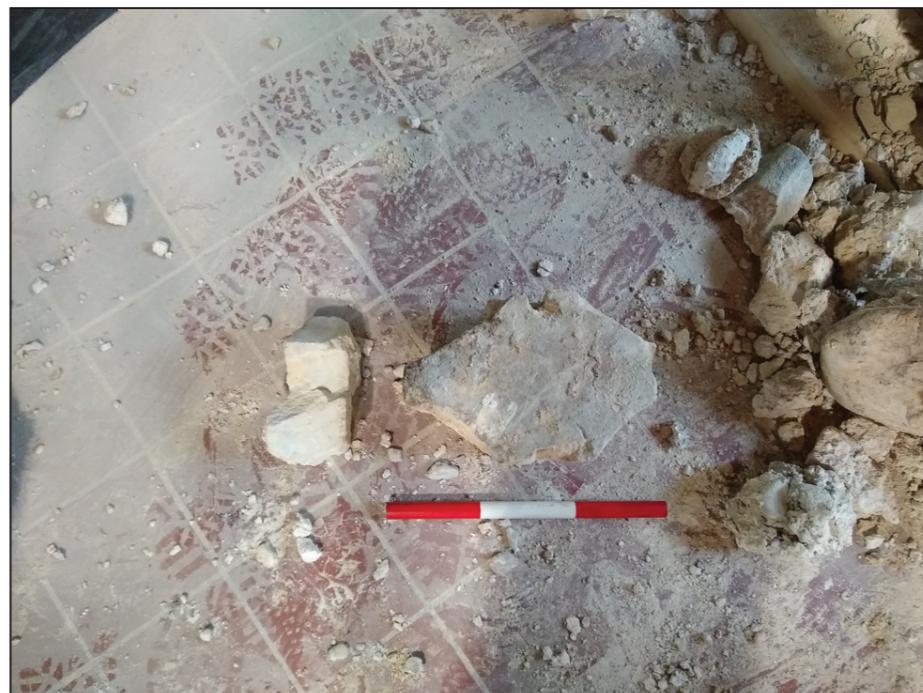
6.5. The removed segment of wall belonging to the 19th century extension on the north side of the chancel was partially constructed from pieces of masonry taken from the fabric of the medieval and Tudor church, such as moulded limestone and bricks; some of the material may have been sourced from the original north wall of the chancel itself, which would have been demolished to allow for the extension. The carved stone head reset in the 19th century wall must have been part of an interior feature due to its good condition; comparable examples survive either side of the arch over the southern door to the nave.

Moulded limestone from wall (0.3m scale)

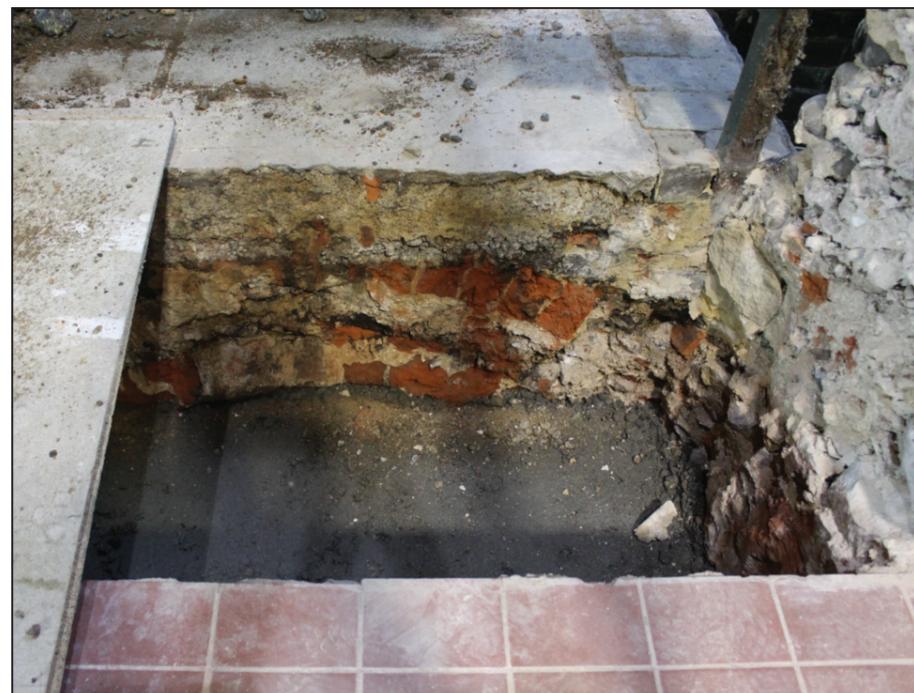
6.6. The vaulted brickwork discovered underneath the 19th century extension could be the top of a burial vault, similar to the one found just north-west of it during the groundworks associated with the new access ramp, although its apparent north to south orientation makes this interpretation problematic; instead, it could be the dome

cap or part of the puteal of a drinking well, or perhaps a soakaway. Despite being built over by the wall and partially incorporated into the foundation, the condition of the vaulted brickwork suggests that no attempt was made to remove the structure or consolidate its interior during the wall's construction, and the rubble and soil inside it appeared to be the result of incidental collapse. Prior to the 19th century extension, it would have been located outside the church in the cemetery.

Vaulted brickwork beneath wall, looking north
