St. Stephen's Church, Ipswich, Suffolk

Archaeological Monitoring and Recording

CA Project: SU0515
CA Report: SU0515_1
OASIS ID: cotswold2-512341
HER Ref: IPS 277

April 2023

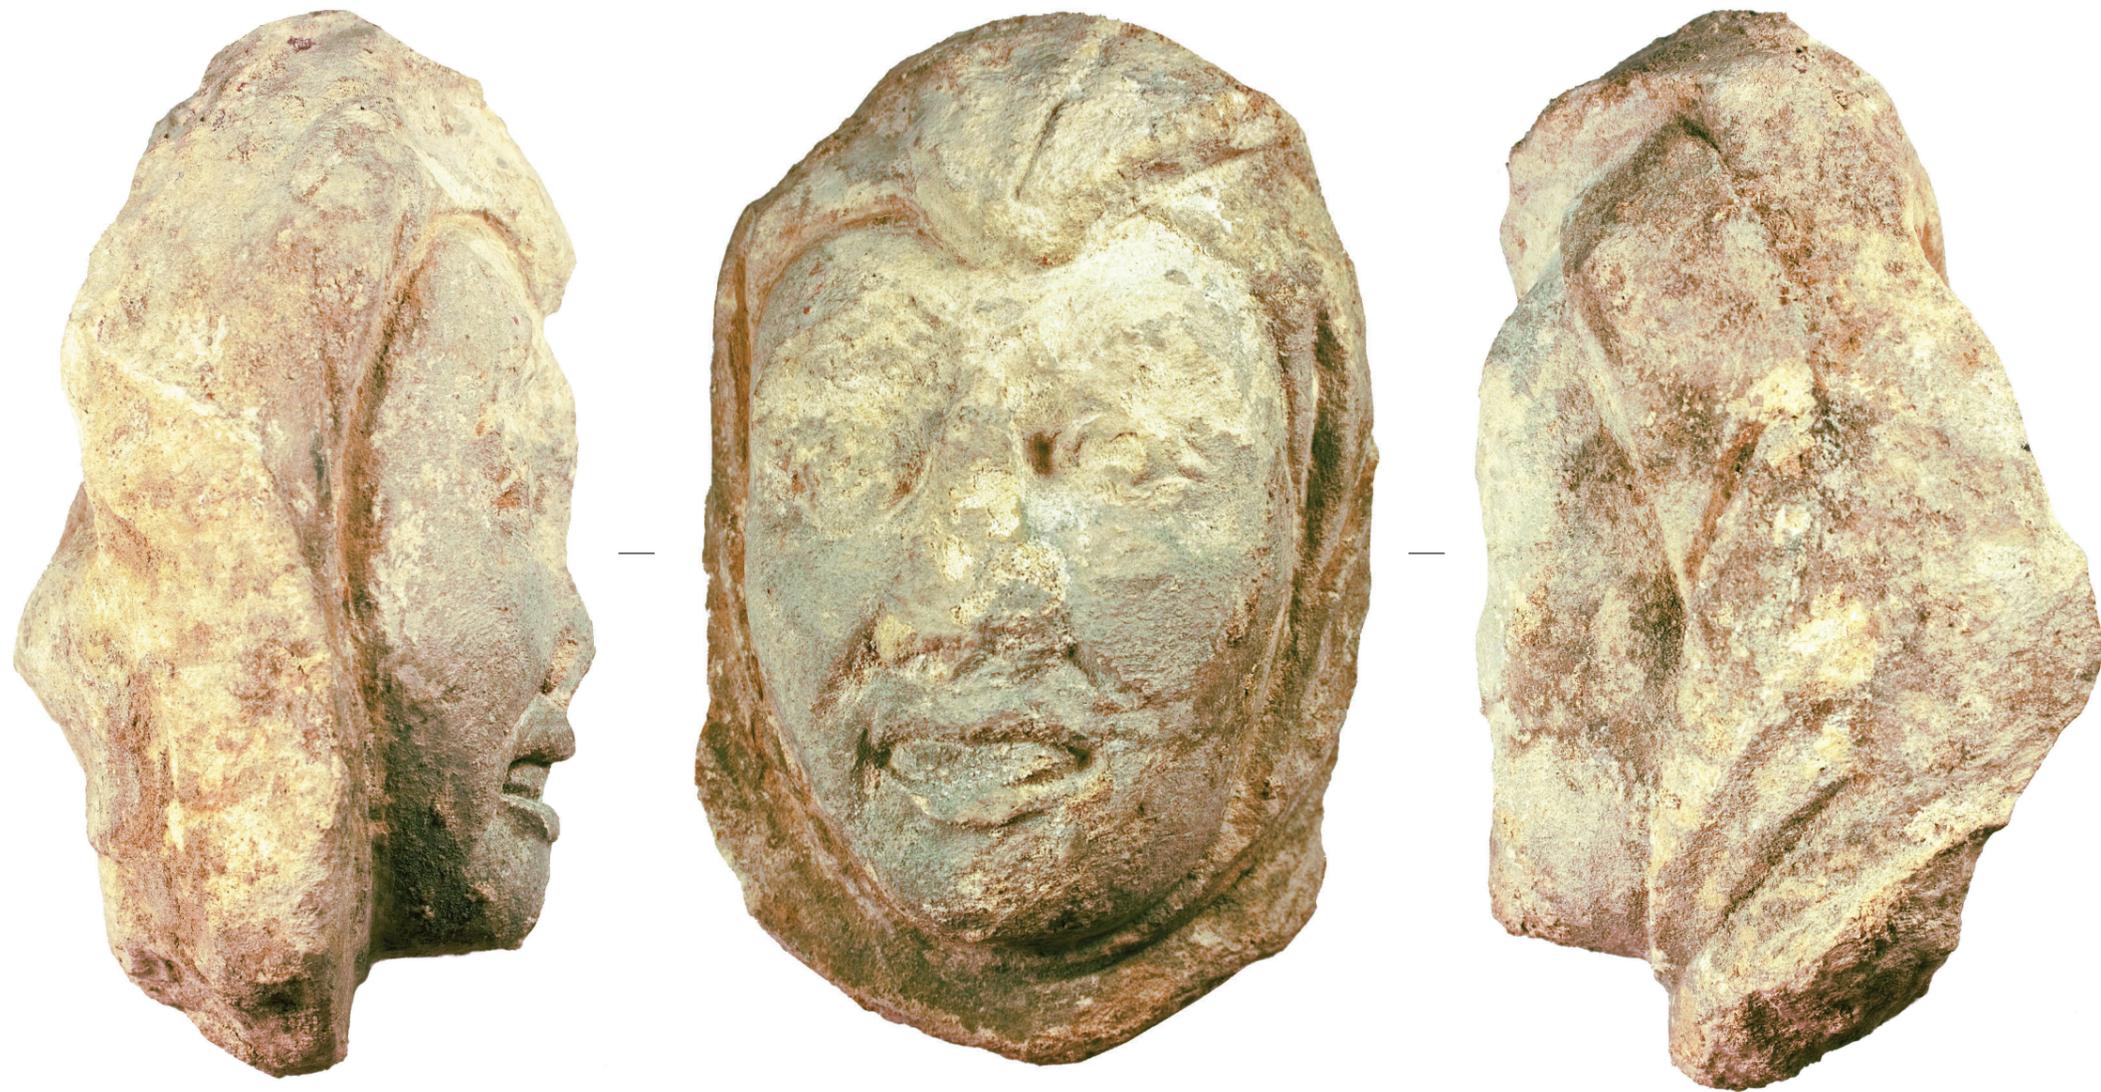
FIGURE TITLE
Medieval carved stone head from wall:
photographs

5.11. A notable piece of moulded stonework in the wall fabric was a small, carved limestone head, measuring 11cm high by 8cm wide (Figs. 8 and 10). This was set c.1.10m above the floor level in the centre of the wall, facing the church interior. It appeared to be the remains of a decorative corbel or label stop, c.14 – 15th century in date, representing a hooded female figure, wearing a caul or wimple. The good condition and lack of weathering seemed to indicate that it had been an interior feature.

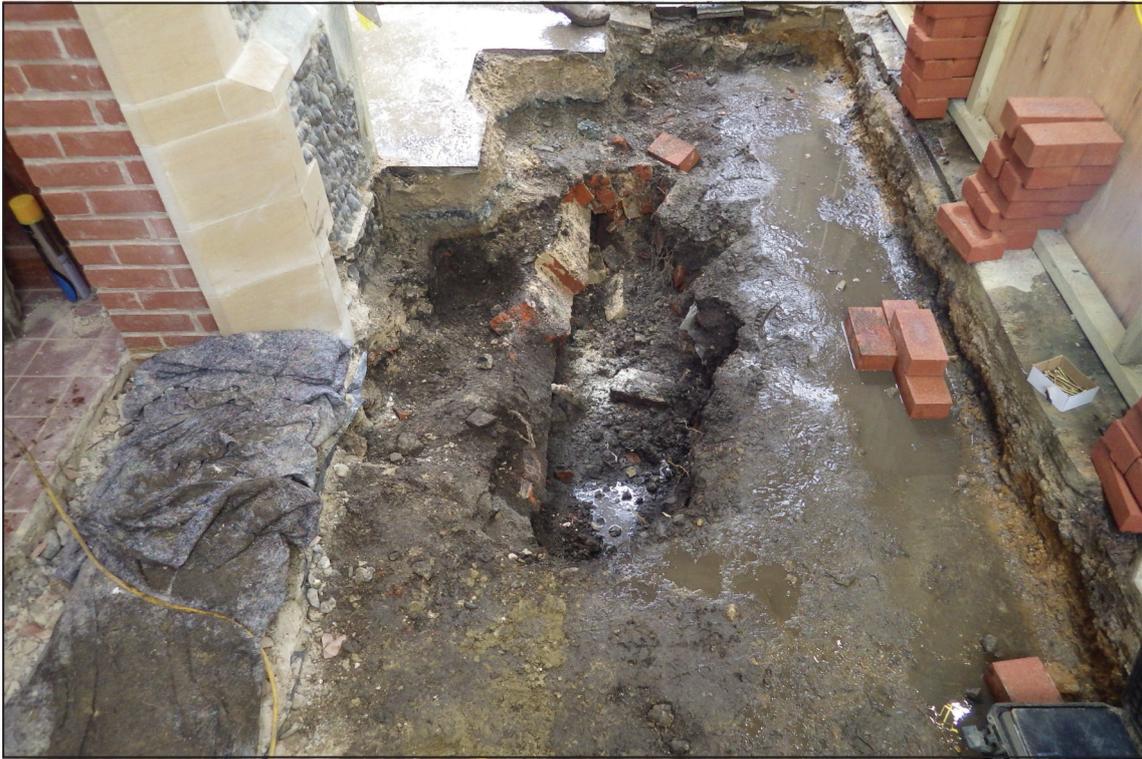
- 5.17. Contractors removed the concrete paving outside the church north and north-west of the demolished section of wall to prepare for the construction of a new access ramp (Figs. 2 and 4). The pavement and bedding layers were 0.30m thick in total, below which was a layer of dark greyish-brown silty sand, resembling the cemetery soil seen in the drain trench to the south of the church. Two small fragments of human bone were found in this layer. Whilst the contractors' excavation did not extend into this soil, the work did expose the top of a brick-lined 18th or 19th century burial vault, located about 0.50m north of the removed wall (Fig. 11).

- 5.18. The vault was aligned roughly east to west. The top of the structure was exposed on the surface for a distance measuring 1.60m long, on its east to west axis, and 0.50m wide, on its north to south axis. Measurements taken inside the vault suggested it was around 2.10 or 2.20m long and 0.90 to 1.20m wide. Figure 4 depicts the extent of the structure exposed on the surface within the contractors' excavation footprint in green and the projected extent of the structure, based on the interior measurements, with dashed lines. The structure was formed of red bricks with no frogging, measuring 23cm long by 12cm wide and 6cm thick, set in a pale white lime mortar. The bricks were laid as stretchers, and arced to form a barrel vaulted ceiling over the chamber. The top of the eastern end of the chamber vault had evidently collapsed or been removed at some point in the past, as the brickwork was missing at that end.

- 6.7. The 18th or 19th century brick burial vault found north of the church during the construction of the access ramp had been damaged at some point in the past, with the top of the eastern end of the vault missing. The cause of the damage, whether by collapse and/or deliberate removal, could not be ascertained, although the size of the hole left behind was probably too small to be used to remove a coffin or body, suggesting it was not the result of clearance. The size of the vault chamber was similar to the extant table tombs located around the outside of the church.

Exposed burial vault, looking west

- 5.20. Contractors consolidated the void inside the vault, and covered the structure with a layer of concrete blinding prior to constructing the new access ramp over it.

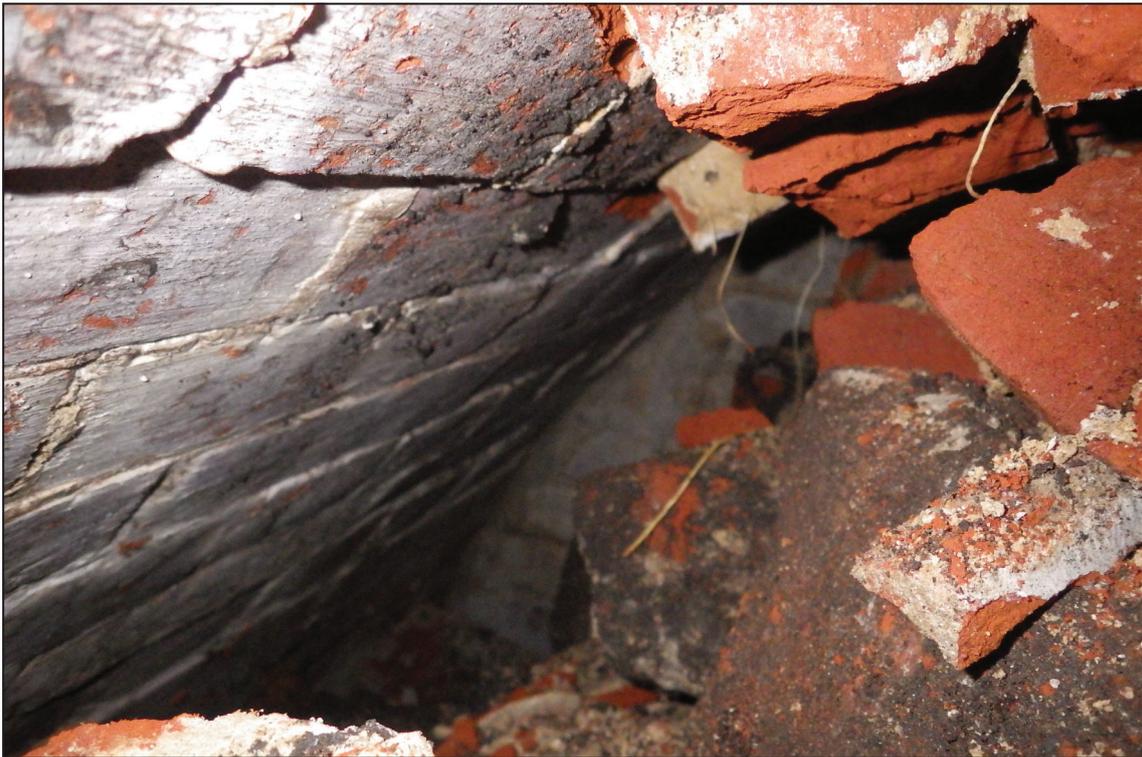
- 5.19. The interior of the chamber was largely filled with dark soil and rubble, and it could not be ascertained if it still contained burials. The interior face of the burial vault walls

had been whitewashed. There appeared to be a dark coloured painting or image on the face of the western interior wall. Unfortunately, the vault contained too much rubble and debris to confirm this; it is just visible behind the collapsed brickwork and soil in the photo of the vault interior in Figure 11.

Interior of burial vault, with whitewash, looking west
