**Bodmin Jail  
Bodmin  
Cornwall**

*Archaeological Watching Brief*

CA Project: 880137

CA Report: 16434b

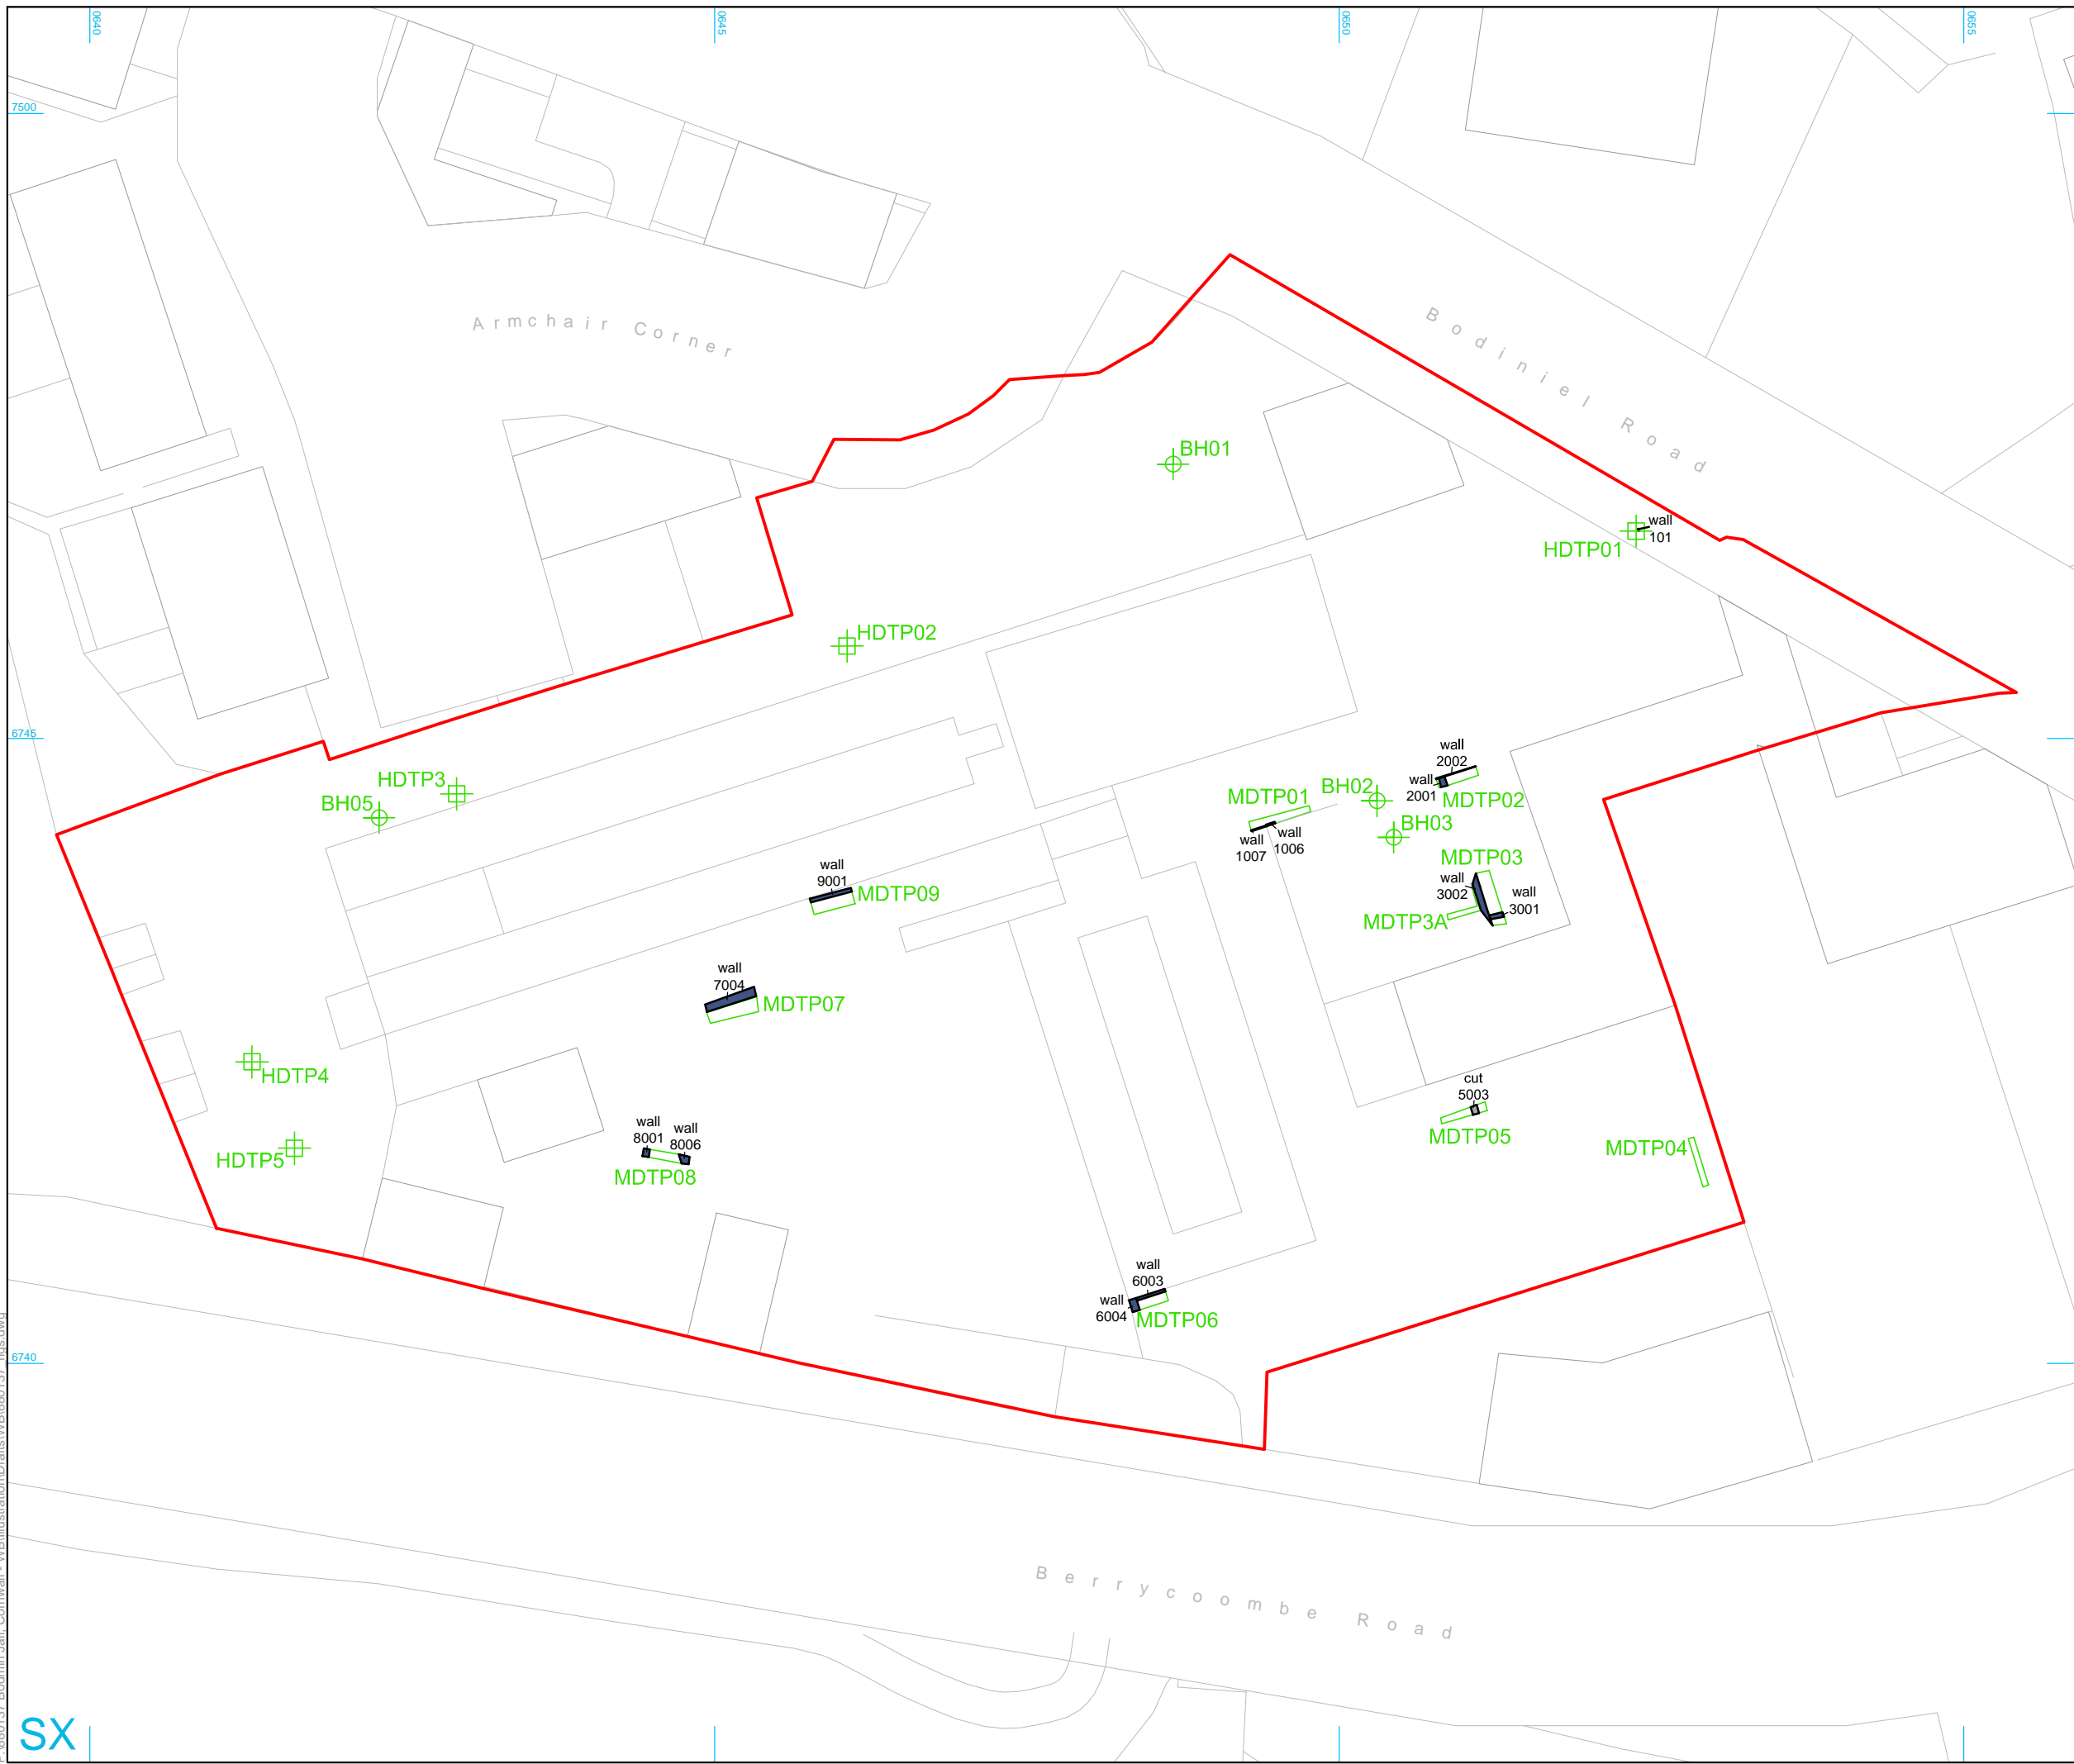
**FIGURE TITLE**  
Monitored groundworks, showing archaeological features

5.1 This section provides an overview of the watching brief results. Detailed summaries of the recorded contexts can be found in Appendix A. The locations of recorded structures and features are shown on Figure 2.

5.2 Several of the trial pits in the central, southern and eastern areas of the site exposed walls. These walls were all constructed of fairly well coursed and faced mudstone/sandstone bonded with lime mortar.

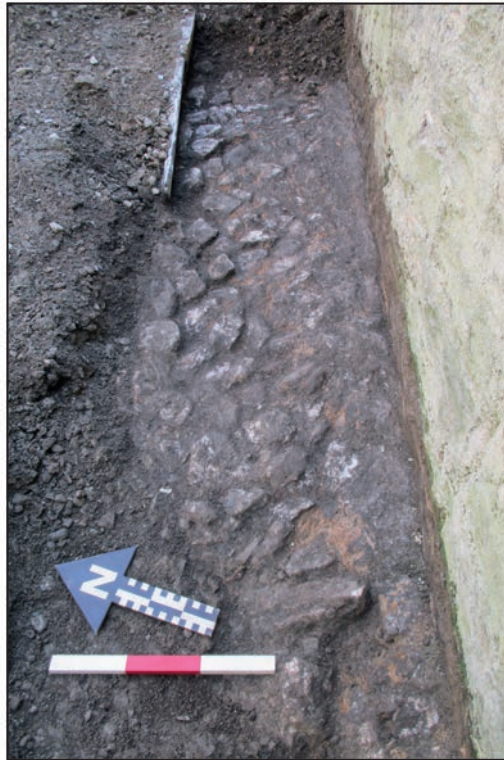
5.13 Wall 1006 was abutted on its northern side by sandstone drain 1005 (not shown on Fig. 2); this drain was overlain by cobbled surface 1003 (Fig. 3; not shown on Fig. 2). Surface 1003 was truncated by cut 1002 (not shown on Fig. 2), which extended down to the level of the natural substrate and was filled with rubble deposit 1001.

3 MDTP01: cobbles 1003, looking east (0.3m scale)

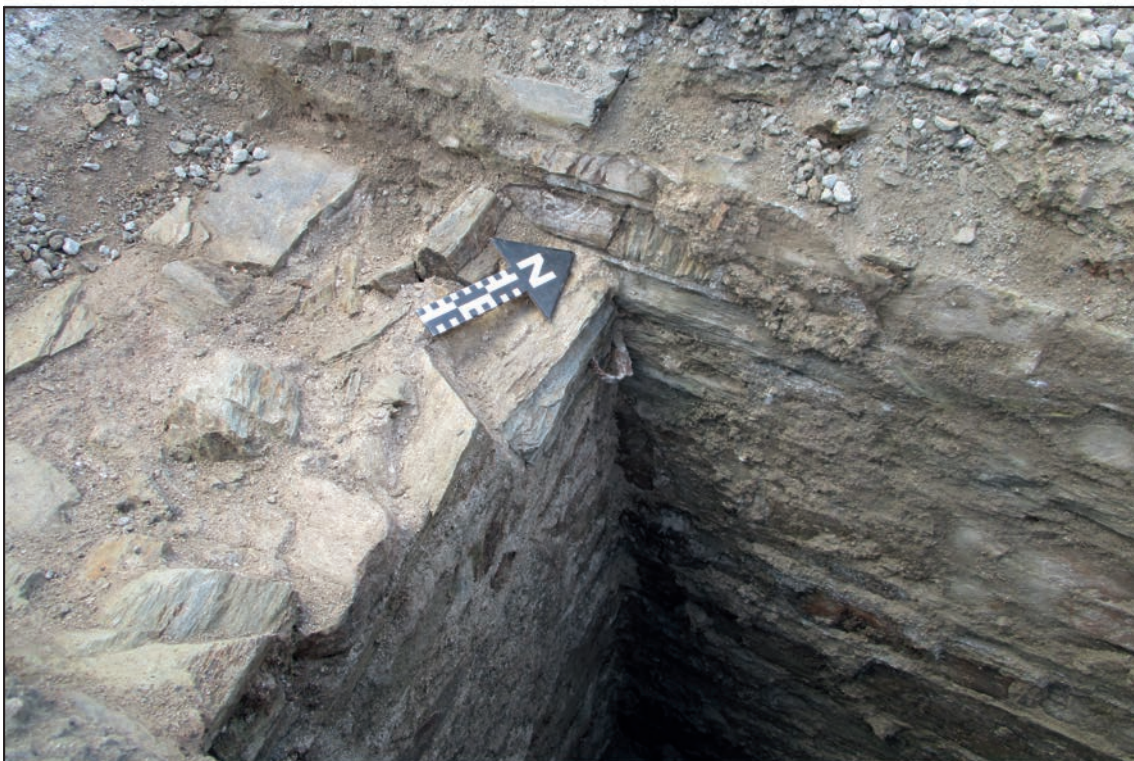
- 5.14 This trial pit was excavated to a depth of 2.3m bpgl. The natural mudstone was not reached. Two abutting walls, 2001 and 2002, were exposed (Fig. 4). The tops of these walls lay 0.25m bpgl; their bases were not reached. They were covered by rubble deposit 2000.

4 Junction of walls 2001 and 2002, looking north-west (north arrow is 0.15m scale)

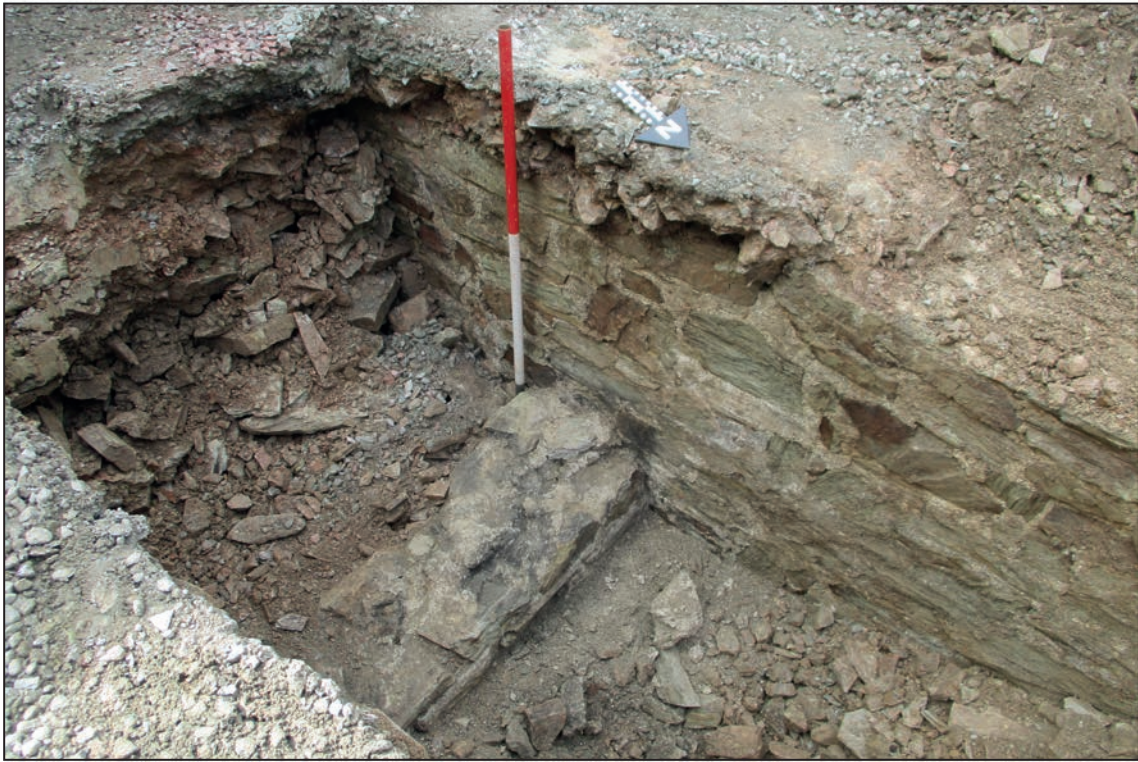
- 5.15 This trial pit was excavated to a depth of 2.6m bpgl. The natural mudstone was not reached. Two abutting walls, 3001 and 3002, were exposed (Fig. 5). The top of wall 3002 lay 0.2m bpgl; the top of wall 3001 lay 0.9m bpgl. The bases of these walls were not reached. The walls were covered by two overlying rubble deposits, 3003 and 3000.

- 5 MDTP03: walls 3001 and 3002, looking south-east (1m scale)
- 6 MDTP06: junction of walls 6003 and 6004, looking west (4m staff)
- 7 MDTP07: wall 7004, looking north-east (2m scale)

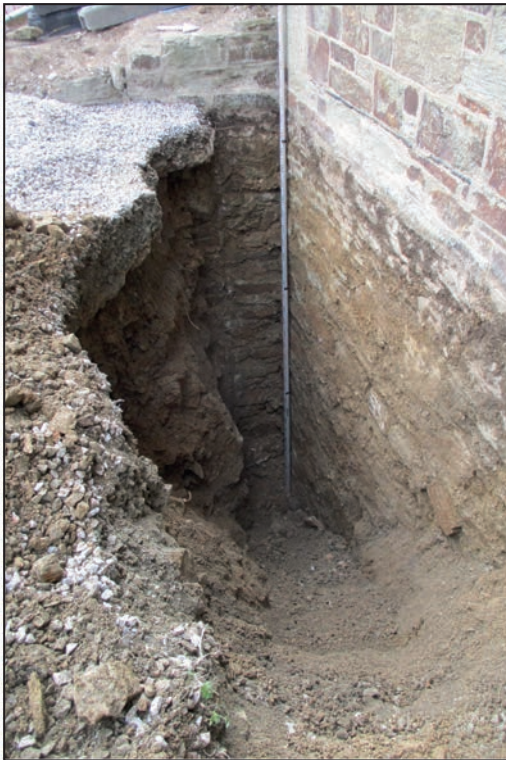
6

- 5.18 This trial pit was excavated to a depth of 3.25m bpgl. The natural substrate was not reached. MDTP06 was excavated against the southern wall of the Naval Prison (60003) and an extant wall running from the corner of the prison block (6004); both of these structures were found to continue down beyond the bottom of the trial pit (Fig. 6). Lying against these walls was rubble deposit 6002, which was sealed in turn by 0.3m of modern concrete and stone chippings (6001 and 6000).

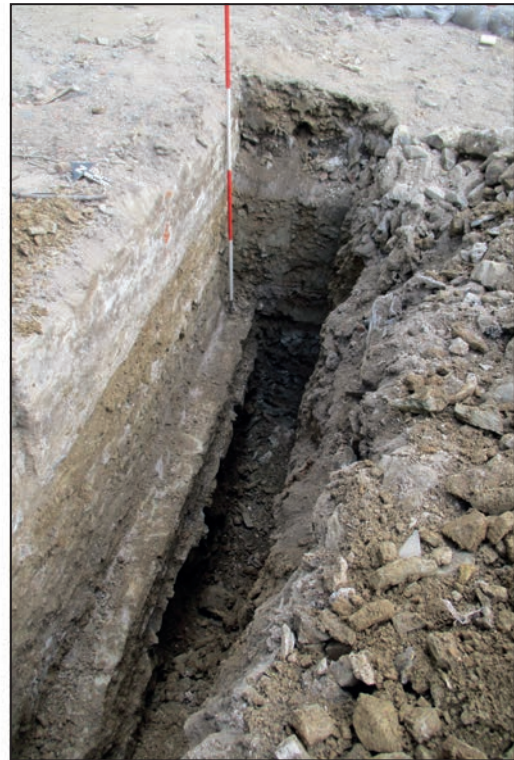
7

- 5.19 This trial pit was excavated to a depth of 3.1m bpgl. Natural mudstone 7007 was exposed 1.6m bpgl. MDTP07 was excavated against an extant wall (7004; Fig. 7), the foundation of which was found to be cut into the natural. Lying against this wall was 0.85m of redeposited natural layer 7003, which was overlain by the fragmentary remains of slate floor 7002. The trial pit was sealed by 0.6m of rubble 7001 and 7000.
