Former VAT House (external): retaining wall Gunns Mill Flaxley Gloucestershire

Archaeological Evaluation and Watching Brief

CA Project: 5769
CA Report: 16103

June 2016

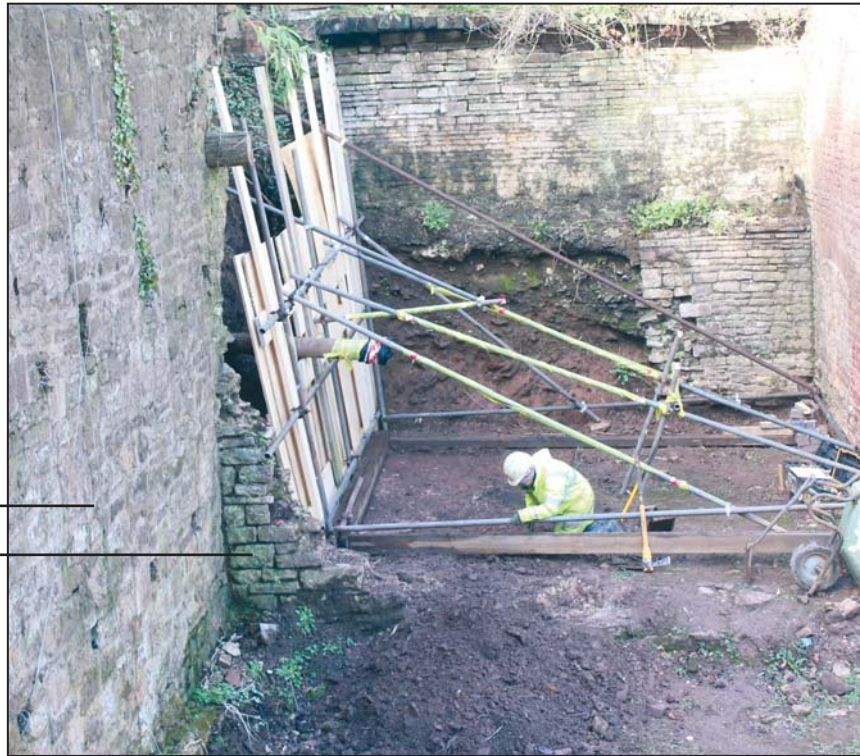
wall E
wall F

4 Trench 1 general view, looking north-west

- 5.3 The natural substrate 111 comprised mid red pink/brown sandy clay and plated sandstone bedrock and was encountered at the north-western extent of the trench. It was cut by the construction cut 109 for wall 102. This wall was aligned approximately north-west/south-east and measured at least 2.7m in length, 0.85m in width and at least 0.2m in depth. It was constructed from roughly dressed sandstone blocks bonded with a lime mortar, although the heavy mortaring obscured the coursing and size of stone. It appeared to have been terraced into the natural substrate at its northern extent and was deeper at its southern extent. Due to the location of the shoring erected to protect the archaeological team, no relationship could be established during the evaluation with a wall (Wall F on Fig. 2, CA 2015) which lay immediately to the south of the trench. Once the scaffolding was removed wall 105 was observed in the standing section to the west of the evaluation trench. It had a width of 0.85m (see Fig.6). It was not possible to recover a clear relationship between walls 105 and 102 during the evaluation, but the subsequent watching brief clearly established that walls 102 and 105 were bonded together and built using the same construction techniques.

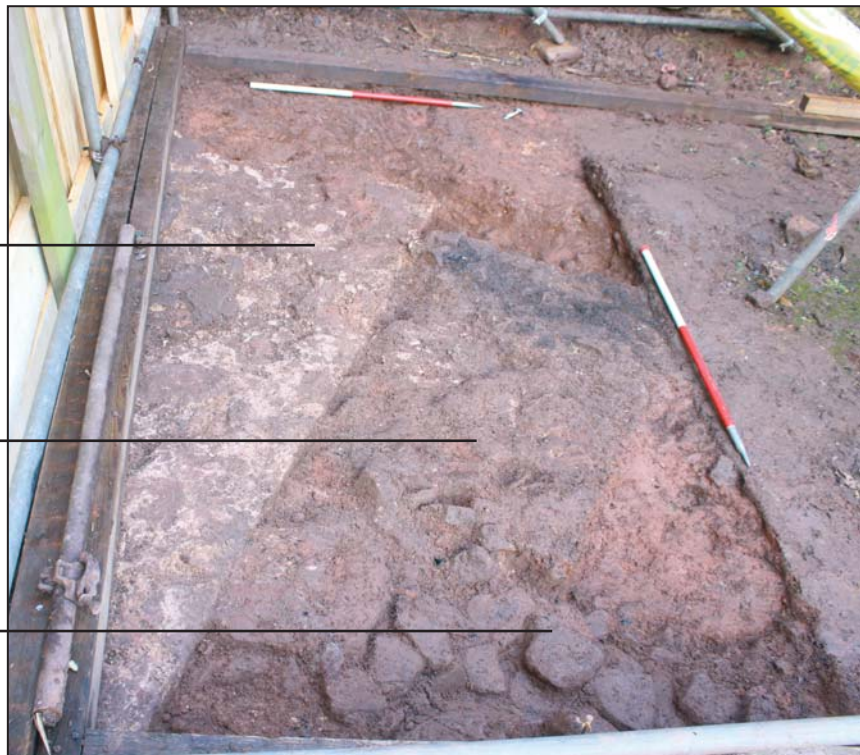
wall 102

levelling /
demolition
deposit 104

stone rubble
107

5 Trench 1 general view with archaeological features,
looking north-west (scales 1m)

- 5.4 Stone rubble 107, comprising irregular sandstone pieces up to 0.15m by 0.15m by 0.1m, lay at the southern extent of the trench. It was likely contained within cut 108 which cut the natural substrate 111; it was aligned approximately north-east/south-west and measured at least 0.1m in depth. Stone rubble 107 appeared to butt wall 102 although this was not definitively proved. It was cut by Wall F which lay immediately to the south of the trench.
- 5.5 Both wall 102 and stone rubble 107 were covered by a levelling layer 104 which consisted of mixed and compacted sandstone and pink clay. Deposits 103 and 106 were small localised dumps of material within layer 104 which was in turn sealed by a modern trample deposit 101 which derived from the clearing of the area of collapse in August 2015 as outlined above.

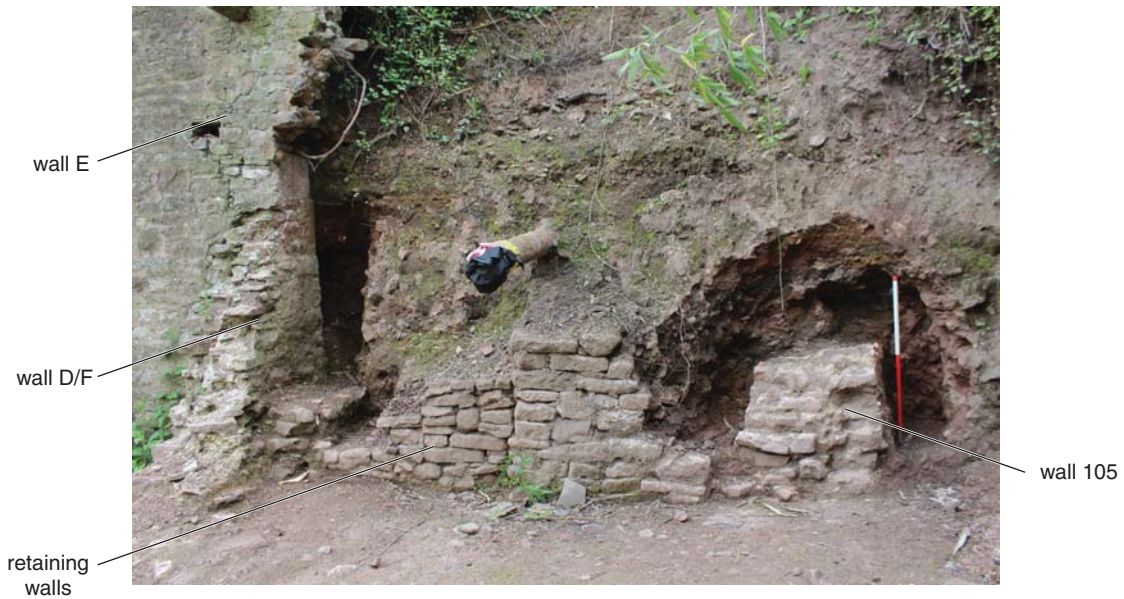
DRAWN BY	SO	PROJECT NO.	5769	FIGURE NO.
CHECKED BY	LM	DATE	08/06/2016	6
APPROVED BY	REY	SCALE@A4	1:75

FIGURE TITLE
 Elevation and photograph of section to south-west of trench 1 (scale 1m)

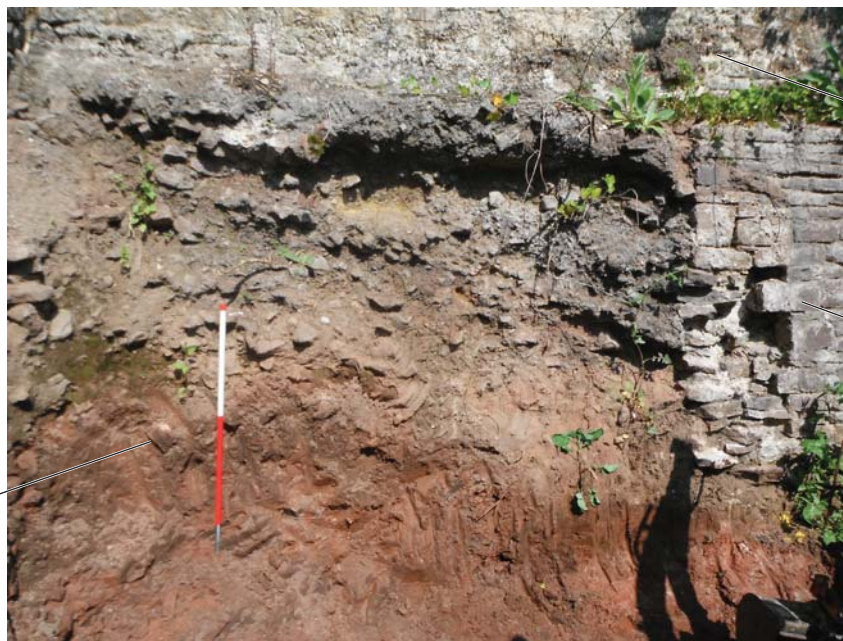
FIGURE NO.
 7

FIGURE TITLE
 Elevation and photograph of section to north-west of trench 4 (scale 1m)

- 5.6 The groundworks observed during the first phase of the watching brief were located directly to the north-west of evaluation Trench 1. The natural substrate 403 was observed as continuing at the level at which it was recorded during the evaluation (at 0.2m below present ground level). This was sealed by levelling deposit 402, which consisted of mixed and compacted sandstone and pink clay; this was in turn covered by modern trample deposit 401.
- 5.7 In the section to the north-west of Trench 4 (Fig. 7), the natural substrate extended to a height of 1.25m above the level of the modern ground surface and was sealed by mixed bank material. This was being retained in part by Wall G and was topped by Wall H.

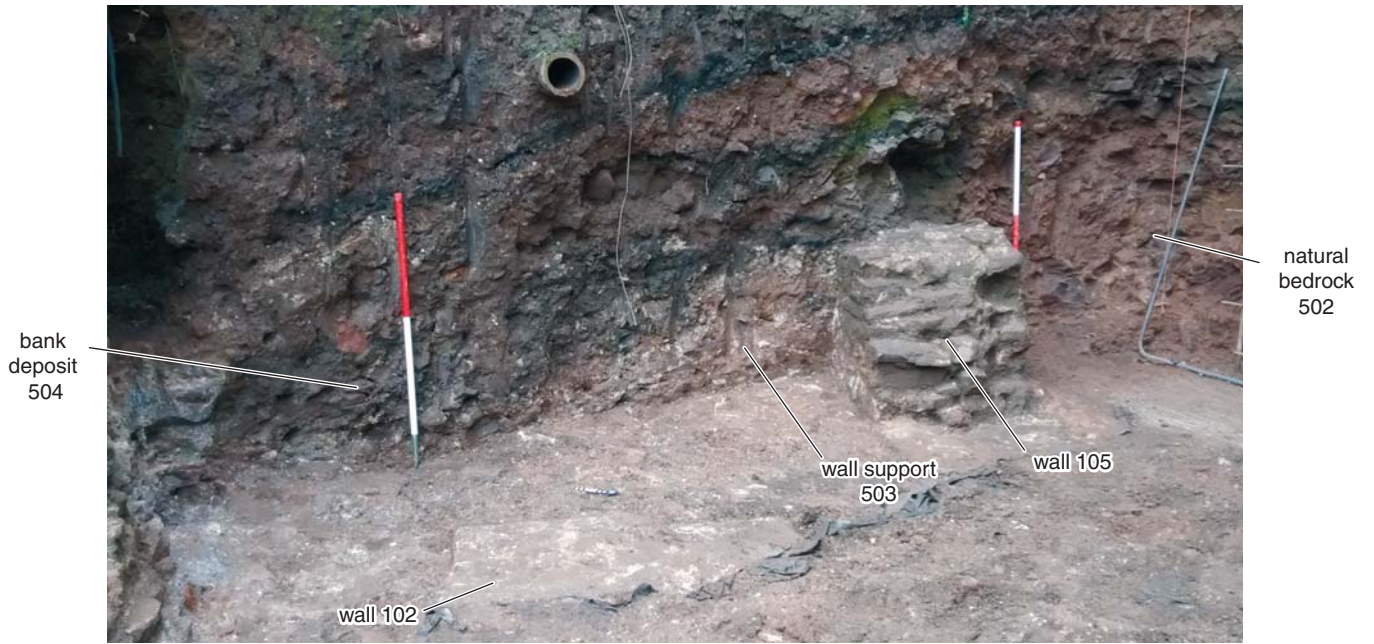
Photograph of section to south-west of trench 5 (scales 1m)

- 5.13 Both wall 102 and stone rubble 507 were covered by a levelling layer 501 which consisted of mixed and compacted sandstone and pink clay. Deposit 506 was a small localised dump of material within layer 501. It was, in turn, sealed by modern trample deposit 500 which derived from the clearing of the area of collapse as outlined above (paragraph 5.5). In the north-west section of Trench 5 (Fig. 8), the

natural substrate extended to a height of 1.2m above the level of the modern ground surface and was sealed by mixed bank material.

- 7.2 A review of the cartographic evidence, stratigraphy and topography of the site, as well as a review of comparable sites in the Forest of Dean, notably Camp Mill (Kemp 1987, Mullin 1989) suggests that rather than representing part of a building, wall 102 represents instead the northern extent of a retaining wall at the base of an earthen dam for a mill pond, with a perpendicular return, in the form of wall 105, exposed within Trench 5 during later investigations by the FoDBPT and the groundworks accompanying the watching brief (see Fig. 6). It appears almost certain that walls 105 and 102 were contemporary as they were clearly bonded together, identical in width and constructed utilising the same techniques and materials. It is also apparent from both the evaluation and watching brief that both walls had been terraced into the natural substrate. If the walls represented an earlier phase of mill building then at least some level of artefactual retrieval would be reasonably expected, even if it was simply processing waste from the mill buildings. Further support for this interpretation was provided by deposit 504 which appeared to form part of a bank which overlay both wall 105 and consolidation deposit 503, and was in turn overlain by several layers of earthen and brash bank material (see Fig.8).

- 7.5 The dating of wall 505 remains unclear but it is likely that it belongs to a later phase of activity on the site as it cut bank deposit 504, stone layer 507 and appeared to be a repair to Wall F (see Fig. 8).

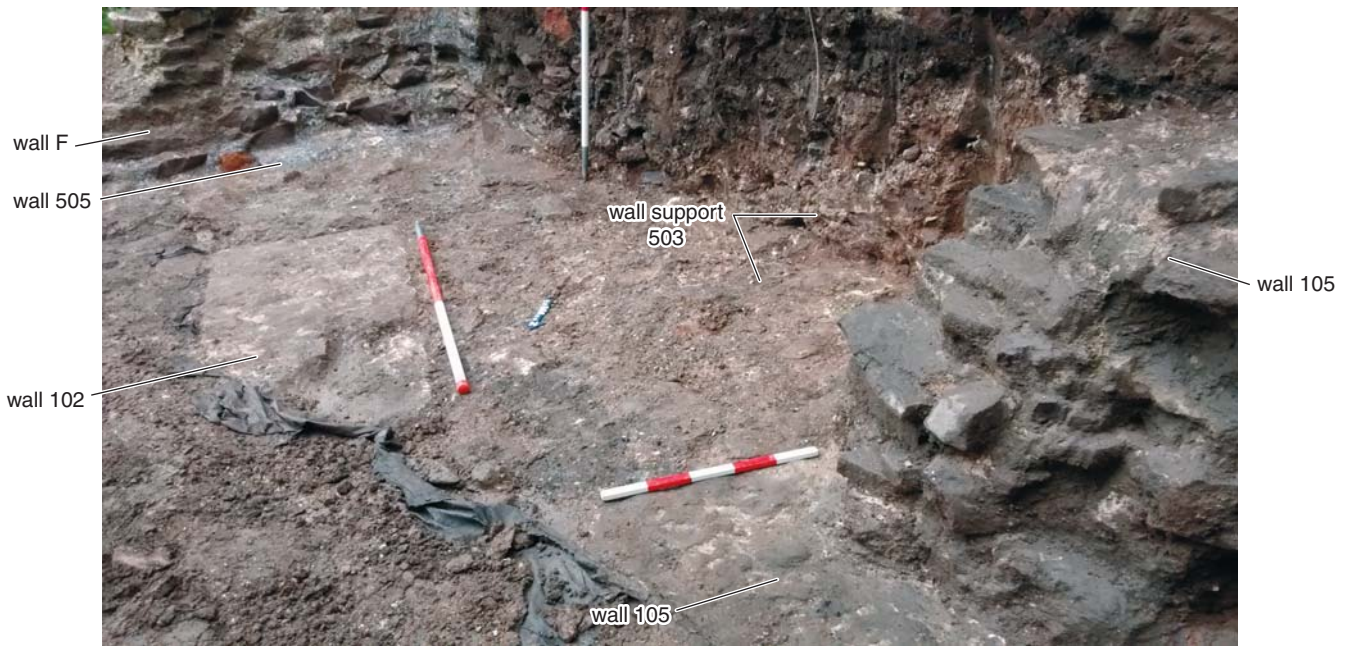
Photograph of walls 102, 105 and 505, looking south-east (scales 1m & 0.5m)

east/south-west and was constructed from roughly dressed and unevenly coursed sandstone blocks bonded with a lime mortar. It measured at least 1.3m in length, 0.85m in width, at least 0.62m in height and was terraced into natural substrate 502 at its northern extent. Deposit 503, a pink-red sandy clay containing sandstone and fragments of lime mortar deposited in intermittent tip lines, butted up to the south-east face of wall 105 and south-west face of wall 102. It appeared to serve as a crude buttress for both walls as it extended up to the extant height of wall 105 and to the southern end of wall 102 (see Fig. 3). The height of deposit 503, which was identical to that of wall 105, could suggest that the extant remains of wall 105 may be fairly representative of its original height, although it is entirely possible that both have been truncated. Both wall 105 and buttress material 503 were overlain by bank material 504, which was cut by wall 505 (see below) and sealed by later earthen and brash bank material.

- 5.10 The south-western extent of wall 102 was exposed in plan but not excavated. It appeared that it may have been robbed out along its southern edge. No relationship could be established with a wall which lay immediately to the south-east of the trench (Wall F on Fig. 2, CA 2015). Walls 102 and 105 were clearly bonded together using the same lime mortar but the form that this bonding took was obscured by the heavy mortaring present on both walls.

- 5.11 Wall 505 lay at the southern extent of the trench on a south-west/north-east orientation and was partially keyed into Wall F. It was constructed from roughly dressed and unevenly coursed sandstone and orange-red brick, bonded with a grey cinder-rich lime mortar. It measured 1.3m in length, 0.32m in width and 0.4m in height.
