**Bath Quays North
Bath
BANES**

Archaeological Evaluation

CA Project: CR0239
CA Report: CR0239_1

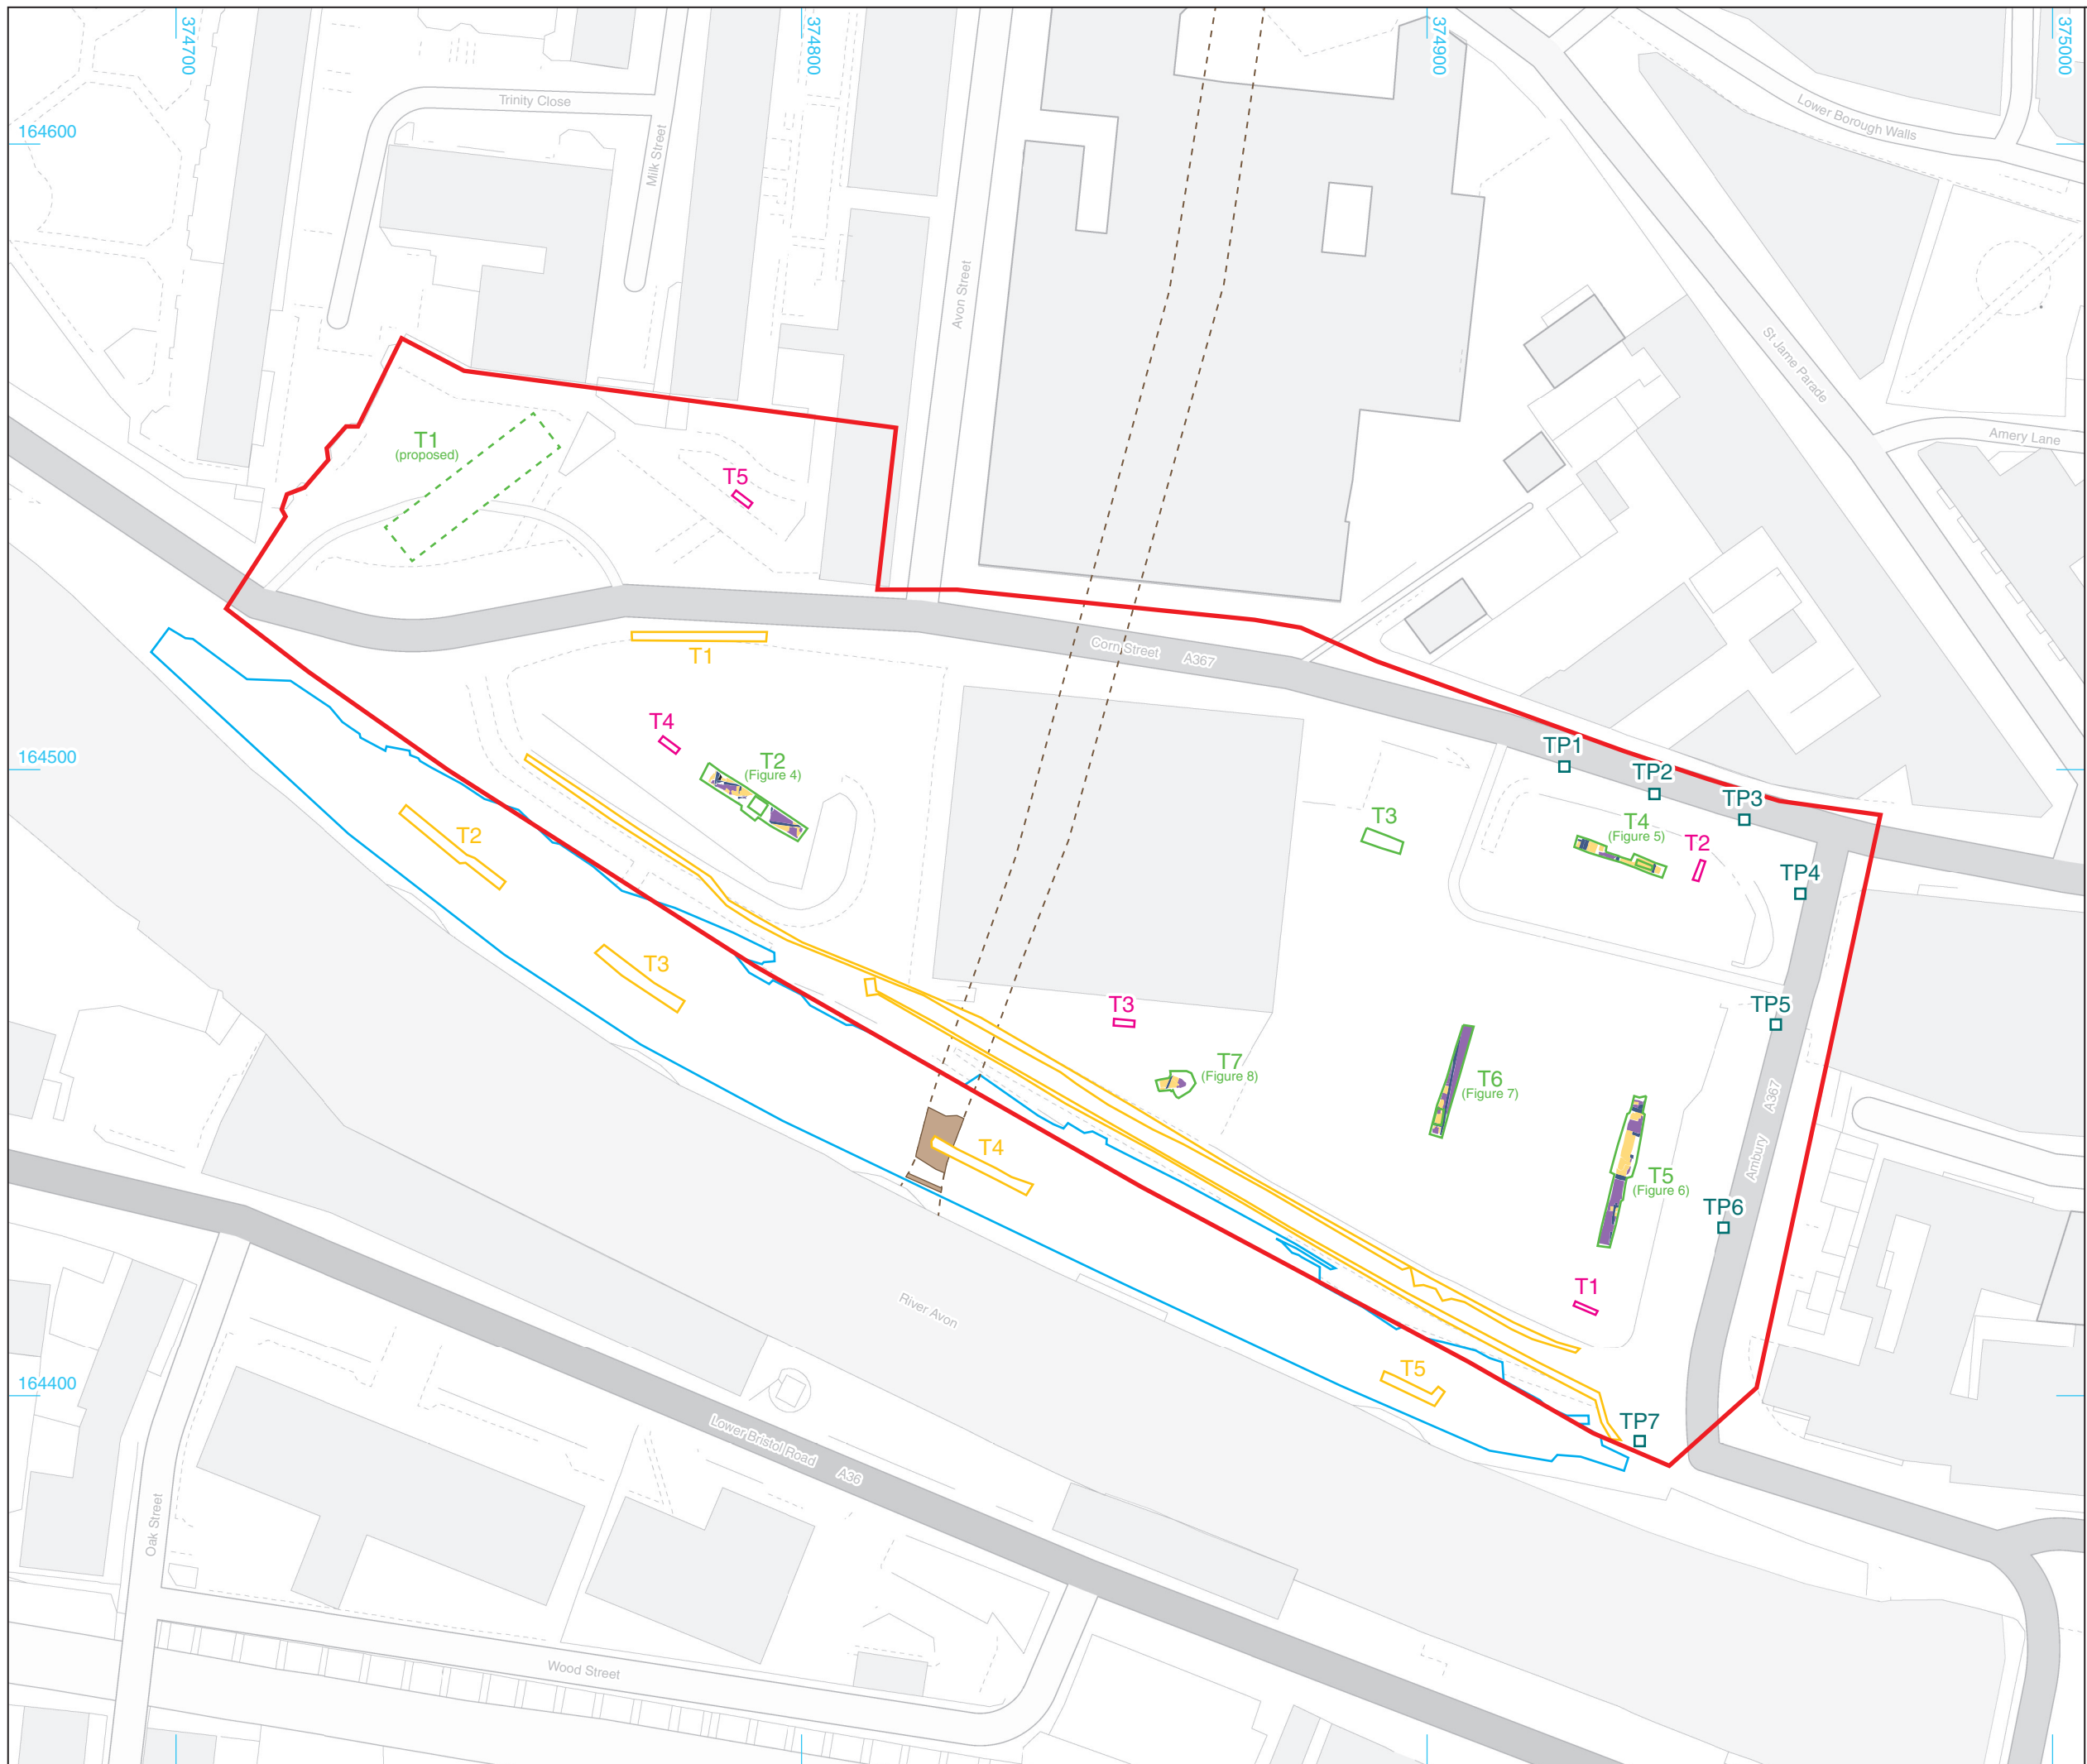
FIGURE TITLE
Trench location plan showing archaeological features and previous works

- 2.6. Until the early 18th century, meadows, orchards and market gardens stretched across the site down to the river from the city walls. The successful creation of the Avon Navigation in 1727, as well as the growth of the town as a spa in those years, led to the development of the area from the late 18th century onwards, with residential, religious and industrial premises (many of which will have been cellared) being constructed within the new suburb. These are extensively depicted on historic mapping (see Fig. 3). An evaluation undertaken just outside of the site boundary in 2016 identified extensive and well-preserved structural remains of 18th to 19th-century buildings (WA 2016; see Fig. 2) and subsequently the remains of structures associated with the post-medieval development of the area, including inns, dwellings and industrial premises, were recorded during the course of excavations along the quayside immediately to the south of the current site area (WA 2018; Mason 2020; see Fig. 2). Further structural evidence was also recorded during a watching brief directly to the north and east of, and partially within, the site (AC 2021; see Fig. 2).

- 2.7. The Bath City Iron and Brass Foundry was located on Avon Street, which was located in the centre of the site, during the latter half of the 19th century (CA 2015). A watching brief undertaken in the site during geotechnical trial-pit excavation revealed the remains of a Bath stone masonry foundation in the north-east corner of the proposed development area, alongside the remains of five ceramic crucibles, which have been interpreted to be associated with this activity (CA 2019; see Fig. 2).

- 4.1. The evaluation fieldwork comprised the excavation of six trenches, Trenches 2-7, measuring between 7m and 24m in length (Fig. 2).
- 4.2. The trenches were located to provide a representative sample of the site in a way to avoid known services within the car park. The locations and dimensions of all trenches required adjustment during the course of the fieldwork to avoid buried services and other constraints. Trench 3 was abandoned following initial machine excavation due to the discovery of a large quantity of previously unknown buried services and Trench 1 remains to be excavated at a later date.

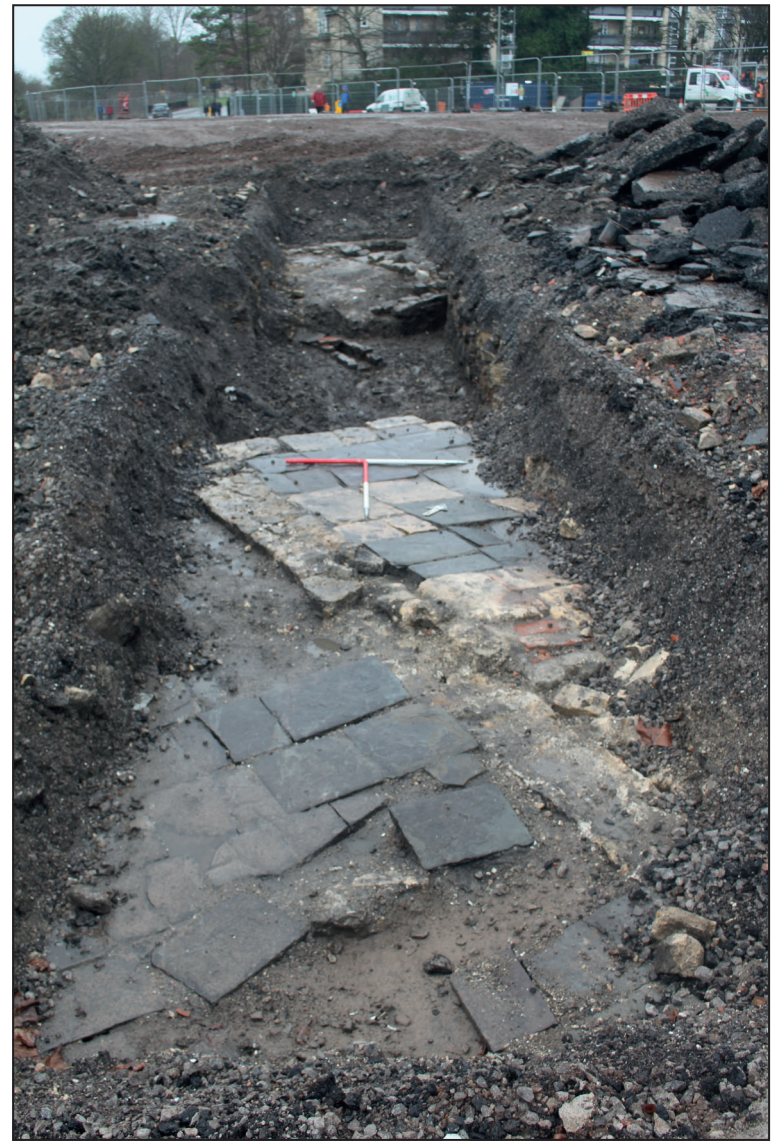
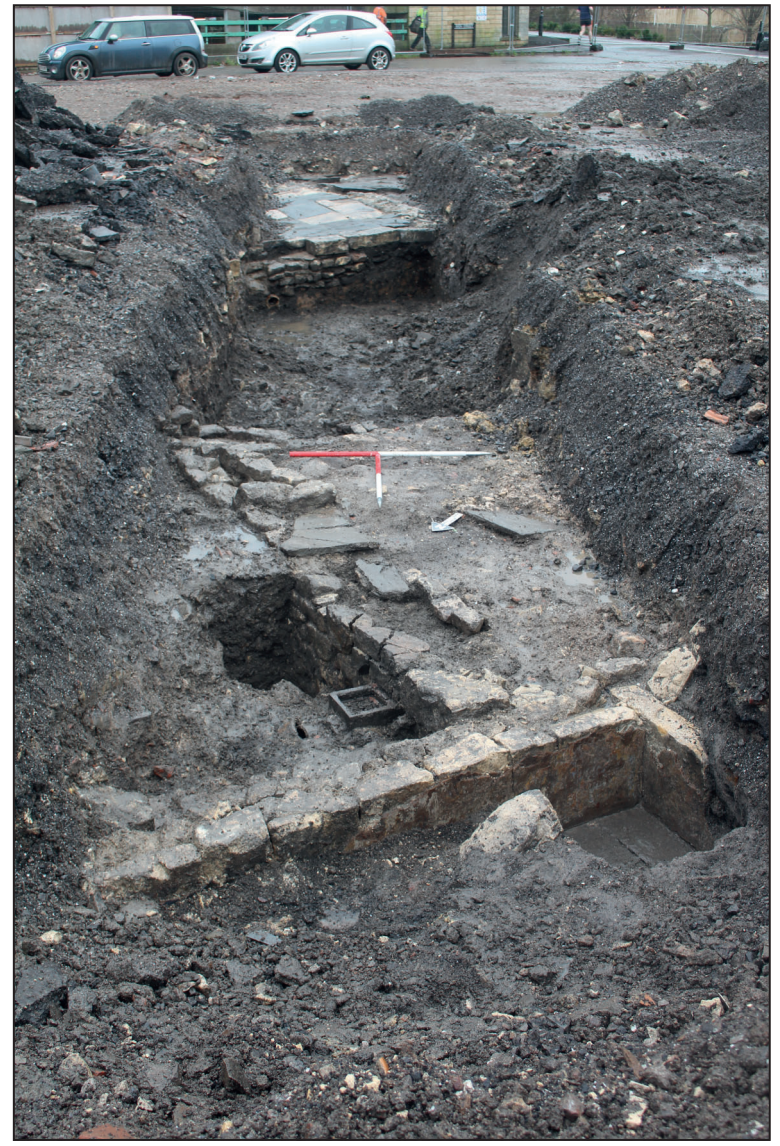
FIGURE TITLE
Trench 2: plan and photographs

- 5.3. Alluvium 244 was identified within a sondage excavated within the centre of Trench 2, at a depth 2.39m bpgl (16.78m AOD). It was cut by east/west aligned possible construction cut 242, which measured roughly 1m in width. Whilst unexcavated (due to health and safety reasons) it was observed to contain stony fill 243. This was overlain by up to 0.3m of garden soil/made-ground 220/228, which was in turn sealed by 0.35m of garden soil/made-ground 229, from which an artefactual assemblage dating to the 19th to 20th centuries was recovered.

- 5.4. Within the south-eastern end of Trench 2, walls 225 and 221 were observed cutting garden soil/made-ground 229. These walls were aligned north/south and east/west respectively and comprised of rough Bath stone blocks bonded by ashy mortar. They were both butted by flagstone surface 223, possibly representing an internal surface, and wall 221 was butted to the south by flagstone surface 219.

- 5.5. Towards the north-western end of Trench 2, garden soil/made-ground 229 was cut by east/west aligned wall 213, comprising mortar-bonded Bath stone blocks. Wall 213 was butted at its eastern end by north/south aligned Bath stone wall 217/241 and at its western end by north/south aligned walls 212, 239 and 208, of Bath stone blocks, with the western face of wall 208 rendered in a fine mortar wash. Mortar spread 216 and flagstone surface 238 were recorded butting walls 213 and 239 to the north and west respectively, probably representing a rough internal surface, and flagstone surface 210 was recorded butting wall 208 at the north-western end of the trench, likely representing an internal basement floor. Drain 214 was recorded butting against wall 212 to the west, and is likely contemporary.

- 5.6. The structural remains recorded within Trench 2 showed very good correlation to dwellings depicted fronting on to Avon Street to the east and Milk Street to the west on historic mapping, with the open central area of the trench likely correlating to the garden plot/yard of the buildings fronting on to Avon Street (Fig. 3).

- 5.7. Mortar surface 216 and wall 217/241 were truncated within the centre of Trench 2 by stone slab and brick-built culvert 231, which drained into soakaway 230. The culvert was sealed by levelling material 204.

Trench 2, looking north-west (1m scales)

Trench 2, looking south-east (1m scales)

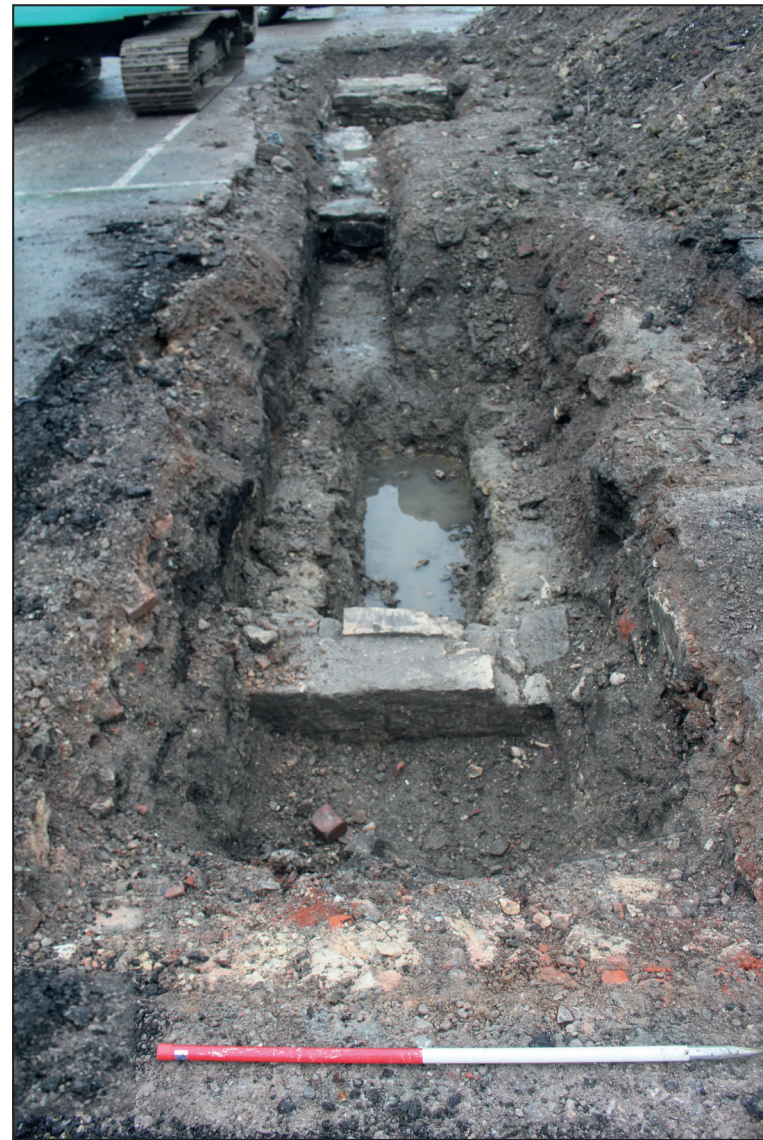
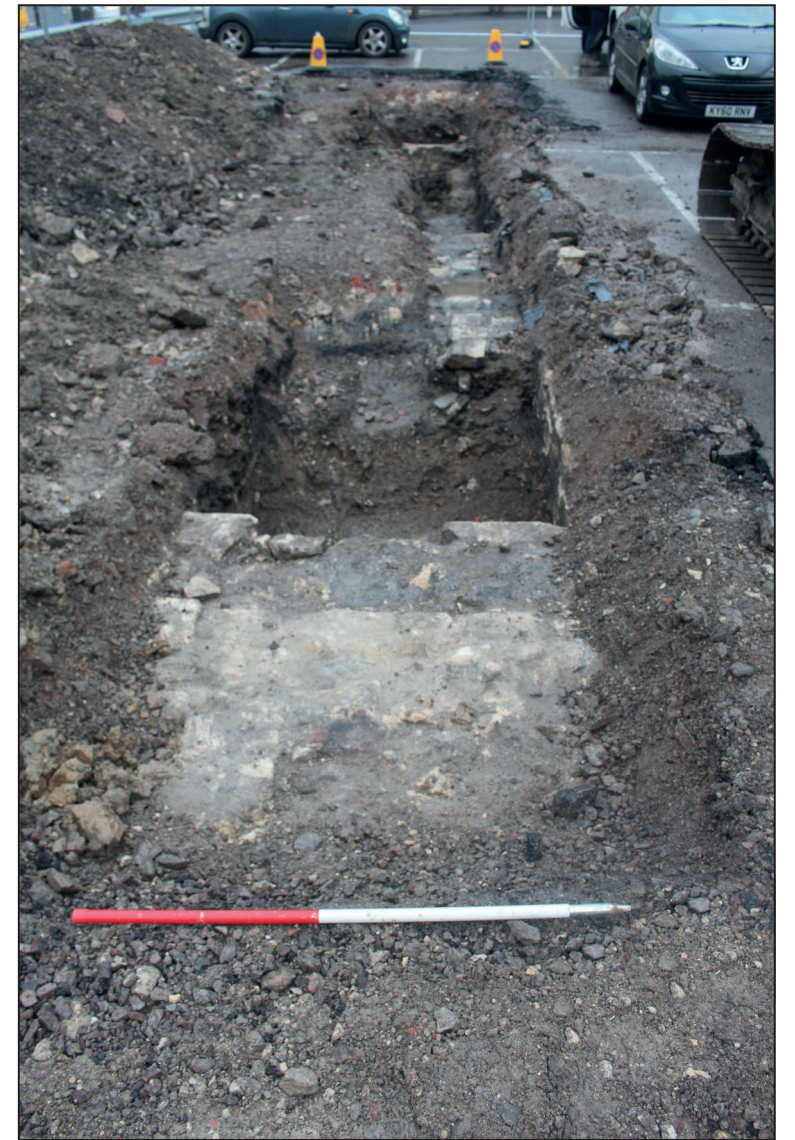
FIGURE TITLE
Trench 4: plan and photographs

- 5.10. A series of Bath stone block and ashy-mortar walls were identified at the north-western end of Trench 4. Wall 431 was aligned broadly north/south and was butted to the west by north/south wall 432, which was in turn butted by perpendicular wall 433. These walls were butted by levelling deposit 434 to the west and to the east by a series of made-ground and levelling deposits 429-424 (inclusive), measuring a total of 1.06m in thickness.

- 5.11. At the south-eastern end of Trench 4, wall 415 was identified on a broadly north/south alignment, comprising of irregular courses of Bath stone blocks. It was butted to the east by levelling deposit 413 and to the west by rough sandy mortar surface 411/412, which was overlain by successive made-ground and levelling deposits 410-404 (inclusive) totalling approximately 1.37m in thickness.

- 5.12. Within the centre of Trench 4 the uppermost levelling deposit (404/424) was cut by north/south aligned wall 417, and east/west wall 423 (not visible in plan), both of Bath stone block and ashy-mortar construction. Both walls were butted by stone surface 422, probably representing an internal floor.

- 5.13. The structural remains identified within Trench 4 correlate very well to the location of buildings depicted fronting on to Corn Street to the north on historic mapping, including an 'Aerated Water Manufactory' shown on the 1888 Ordnance Survey Town Plan (Fig. 3). They were sealed by 0.35m of demolition/levelling deposit 402/403, which was in turn overlain by 0.35m of modern bedding and surfacing.

Trench 4, looking north-west (1m scale)

Trench 4, looking south-east (1m scale)

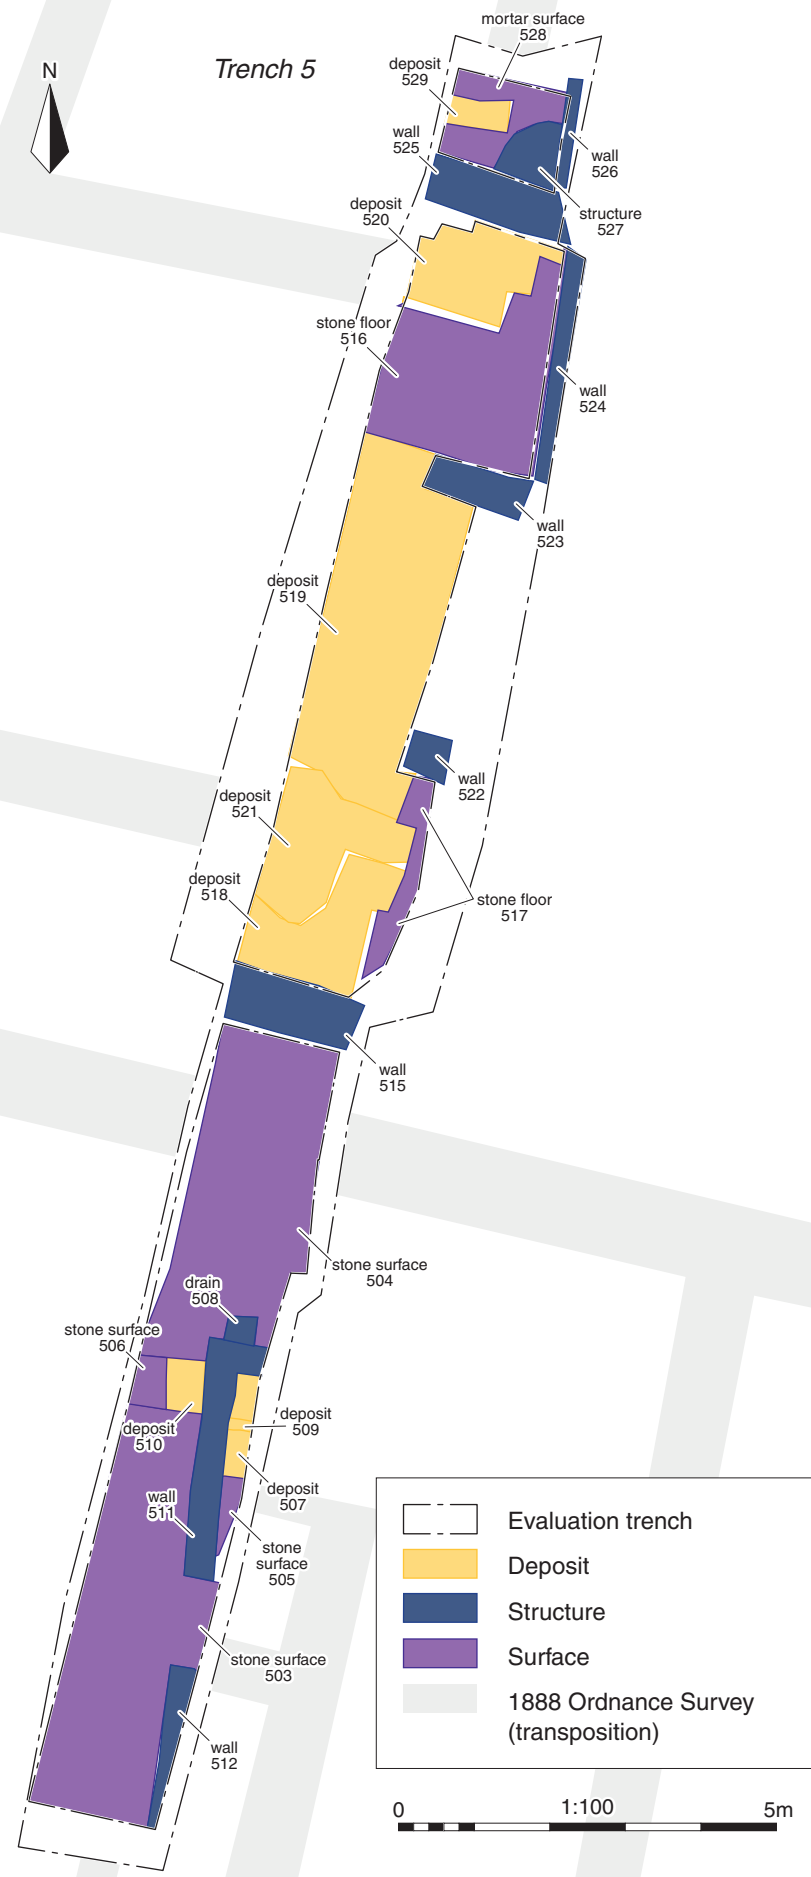
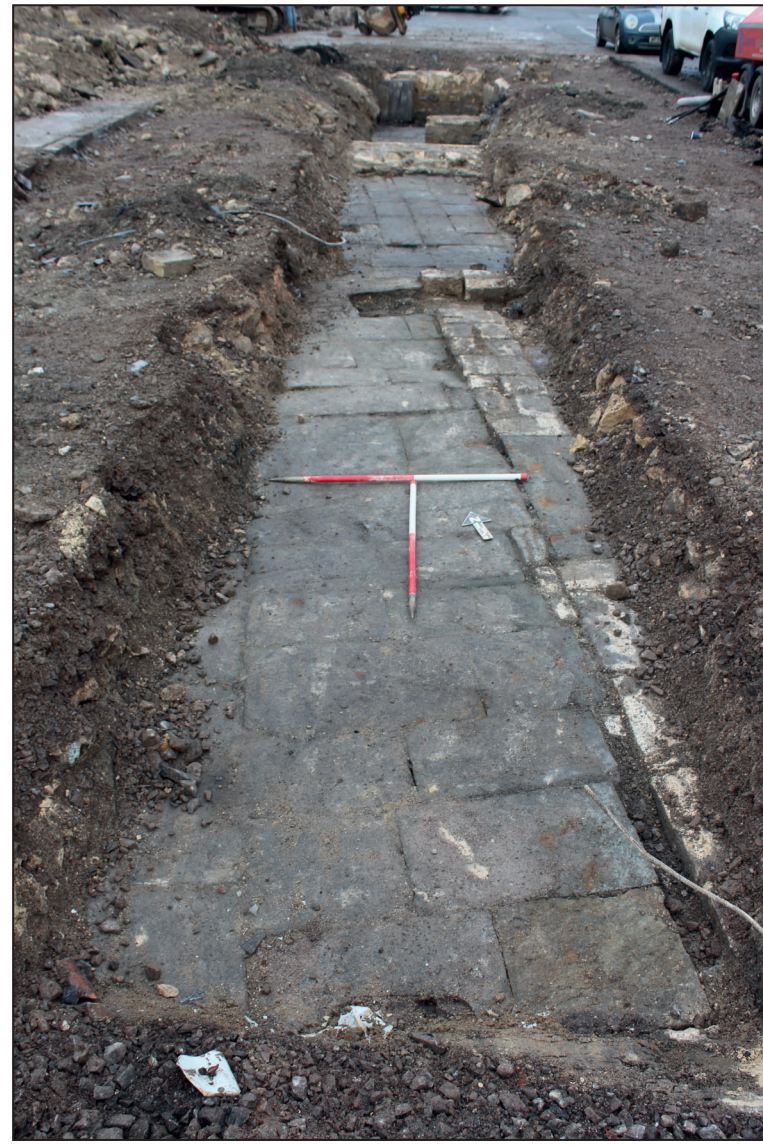
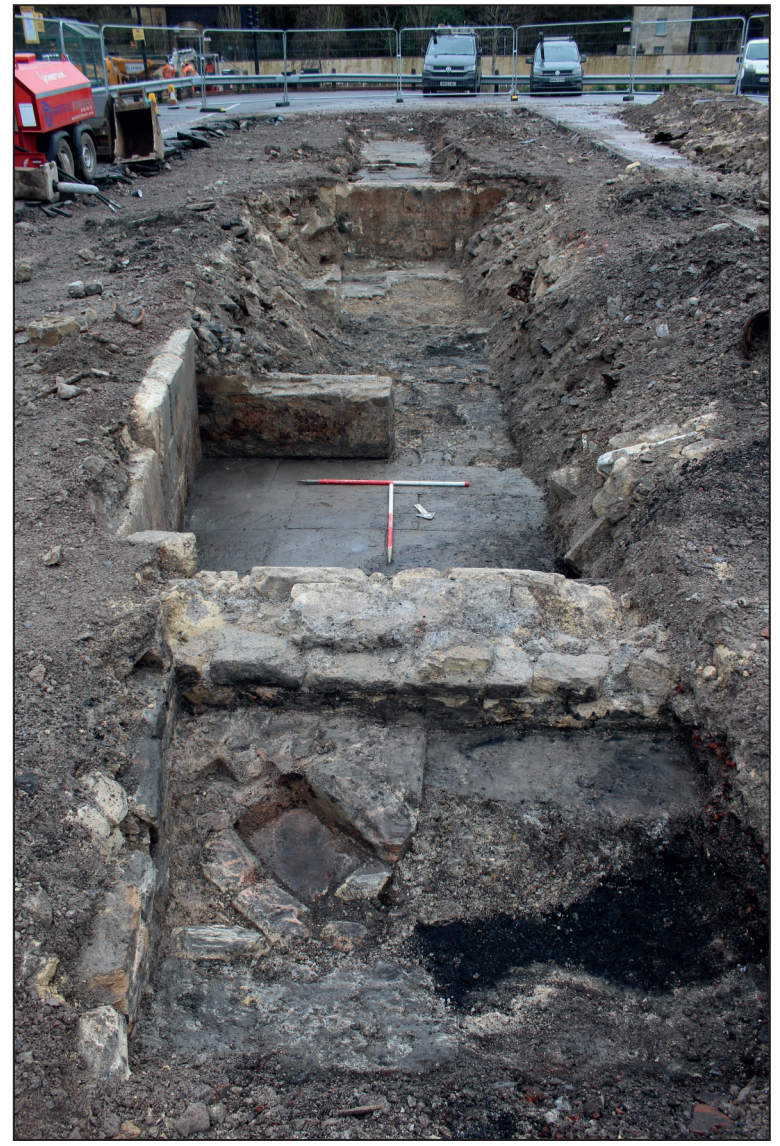
FIGURE TITLE
 Trench 5: plan and photographs

- 5.14. Identified within the northern part of Trench 5, a series of deposits, surfaces and walls formed a large, cellared area. This was defined to the north by east/west aligned wall 525, to the south by east/west aligned wall 515 and to the north-east by north/south aligned wall 524, all formed from regular, squared Bath stone blocks

and measuring up to 1.07m in height. Smaller east/west walls 522 and 523 were identified within the central space of the probable basement, likely forming partition walls and/or supports for the ceiling of the cellar. The walls were all butted by levelling deposit 521, which was overlain by bedding layers 518 and 519/520 for stone surfaces 517 and 516 respectively. A total of five sherds of late 17th to 18th-century pottery were recovered from bedding deposit 520.

- 5.15. To the north of this cellared area, north/south aligned Bath stone and mortar wall 526 was recorded butting against wall 525. Both of these walls were butted by stone structure 527, which comprised of a curved plinth with squared internal chamber, which showed some evidence of being heat-affected, suggesting that structure 527 may represent a pyrotechnical feature of unknown function, although possibly related to the '*Timber Workshops*' depicted on historic mapping. Butting structure 527, and also overlying ashy bedding deposit 529, mortar surface 528 was recorded at the far northern extent of the trench.

- 5.16. Within the southern part of Trench 5, Bath stone and mortar walls 511 and 512 were identified on a north/south alignment. They were separated by a 1.25m wide doorway, with the northern end of wall 511 turning towards the east. Wall 511 was butted to the east by levelling and bedding deposits 509 and 507, which were overlain by stone surface 505. To the west, both walls were butted by bedding deposit 530, which was overlain by stone surface 503/504, with integral drain 508. This surface also butted basement wall 515 to the north. Bedding deposit 510, overlain by stone surface 506, likely represents a repair of the wider surface.

- 5.17. The structures recorded within Trench 5 show very good correlation to a mixture of commercial, residential and industrial premises depicted on historic mapping as fronting on to Back Street to the north, The Ambury to the east and Broad Quay to the south (Fig. 3). The walls, surfaces and interior of the cellared area were sealed by demolition deposit 502, which measured between 0.32m and 0.87m in thickness, and from which modern material was recovered. This was overlain by 0.2m of modern bedding and surfacing.

Trench 5, looking north-east (1m scales)

Trench 5, looking south-west (1m scales)

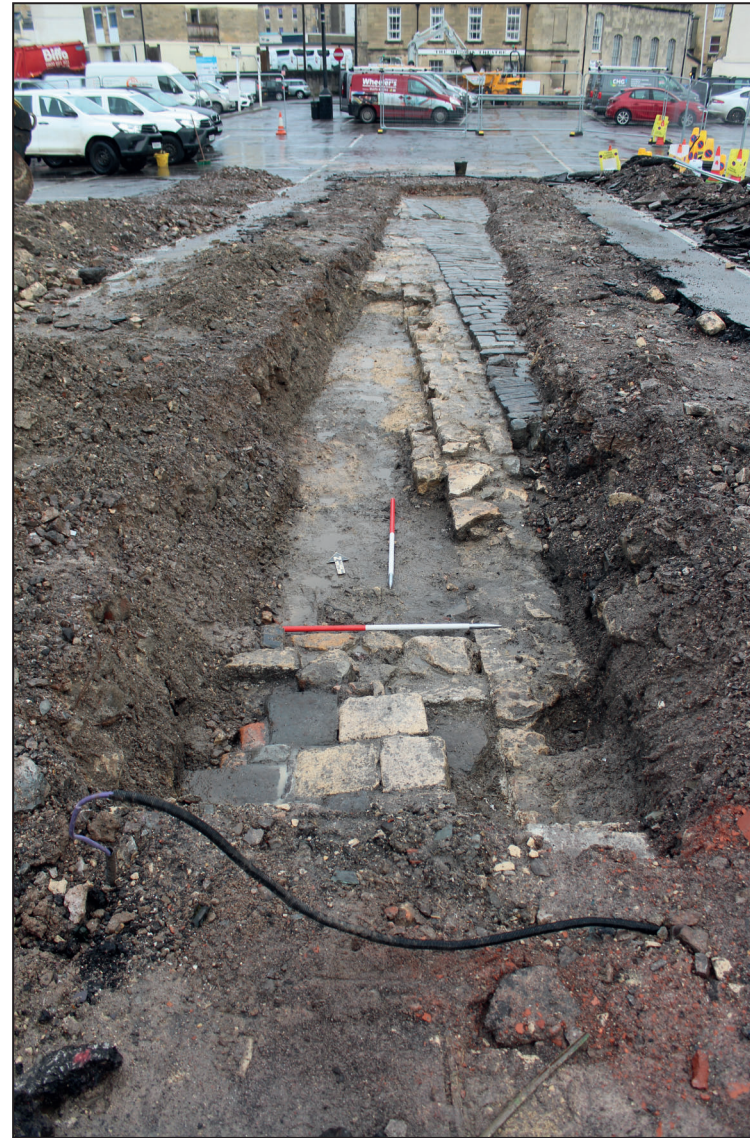
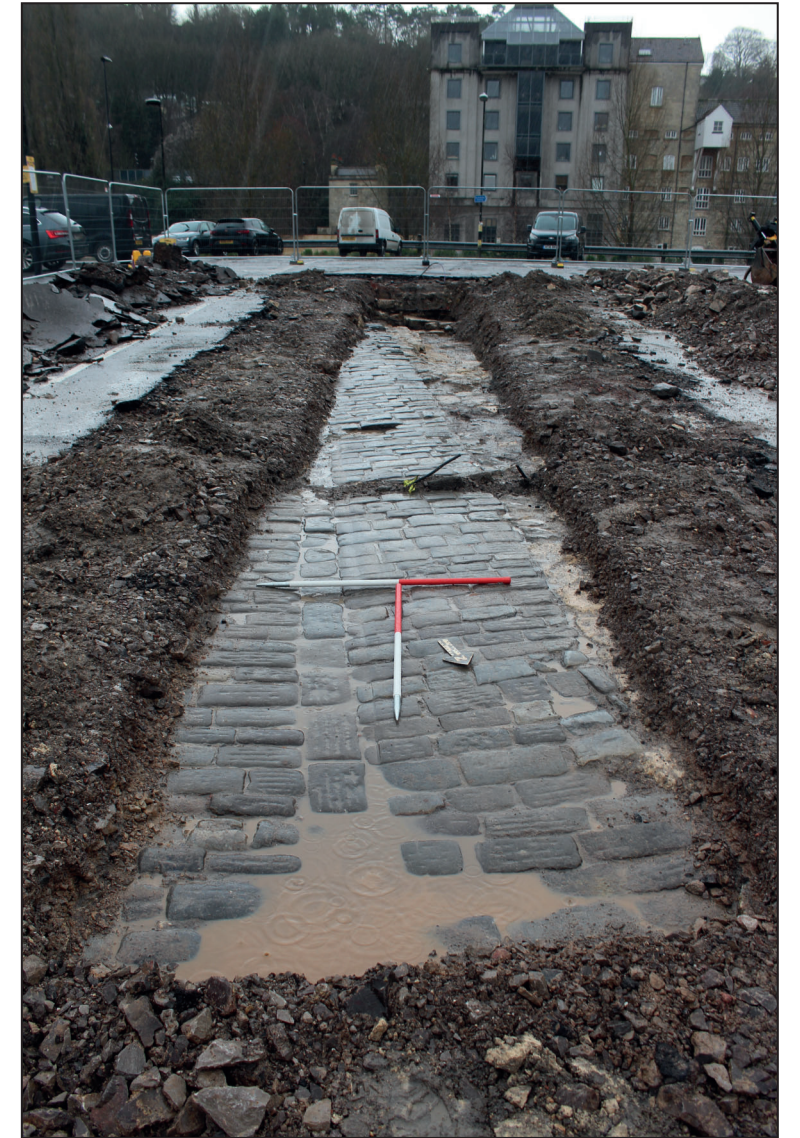
- 5.18. Within a sondage excavated towards the southern end of Trench 6 alluvium 626 was identified at a depth of 2.4m bpgl (16.57m AOD). It was overlain by 0.53m of

- 5.19. Cutting into re-worked alluvium 265, construction cut 627 for north/south aligned wall 612 was identified. Wall 612 extended the length of the excavated trench and comprised of randomly coursed Bath stone blocks, and was recorded to a height of 1.47m.

- 5.20. Within the western extent of the trench, clay made-ground deposit 624 was recorded butting against wall 612. This was overlain by east/west aligned Bath stone block wall 607, which was butted to the south by bedding 609 for stone floor 606, which had been cut by drain 610.

- 5.21. Wall 607 was butted to the north by 0.7m of levelling/made-ground material 618/621. This was overlain by small buttress wall 614, which was butted by the fragmentary remains of mortar surface 615/616/617, which was in turn overlain at its northern extent by 0.27m of levelling deposit 620.

- 5.22. To the east of wall 612, bedding deposit 619 was recorded butting against wall 612 and was overlain by cobbled surface 613. This comprised of regularly laid, squared cobbles, forming a north/south aligned street surface.

- 5.23. Cobbled surface 613 correlates very closely to the location of 'Back Street Place', leading on to Back Street to the north, as depicted on historic mapping (Fig. 3). Walls 607, 612, 614, and related surfacing likely represent the premises depicted to the west of Back Street Place.

Trench 6, looking north-east (1m scales)

Trench 6, looking south-west (1m scales)

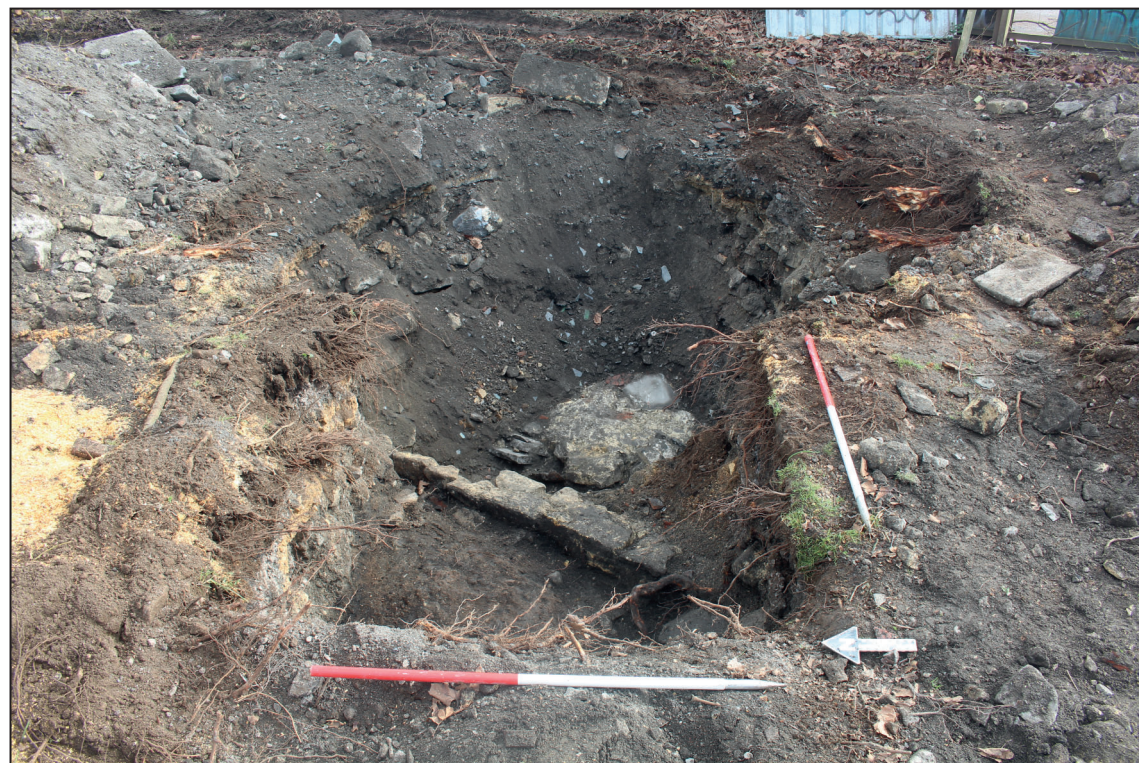
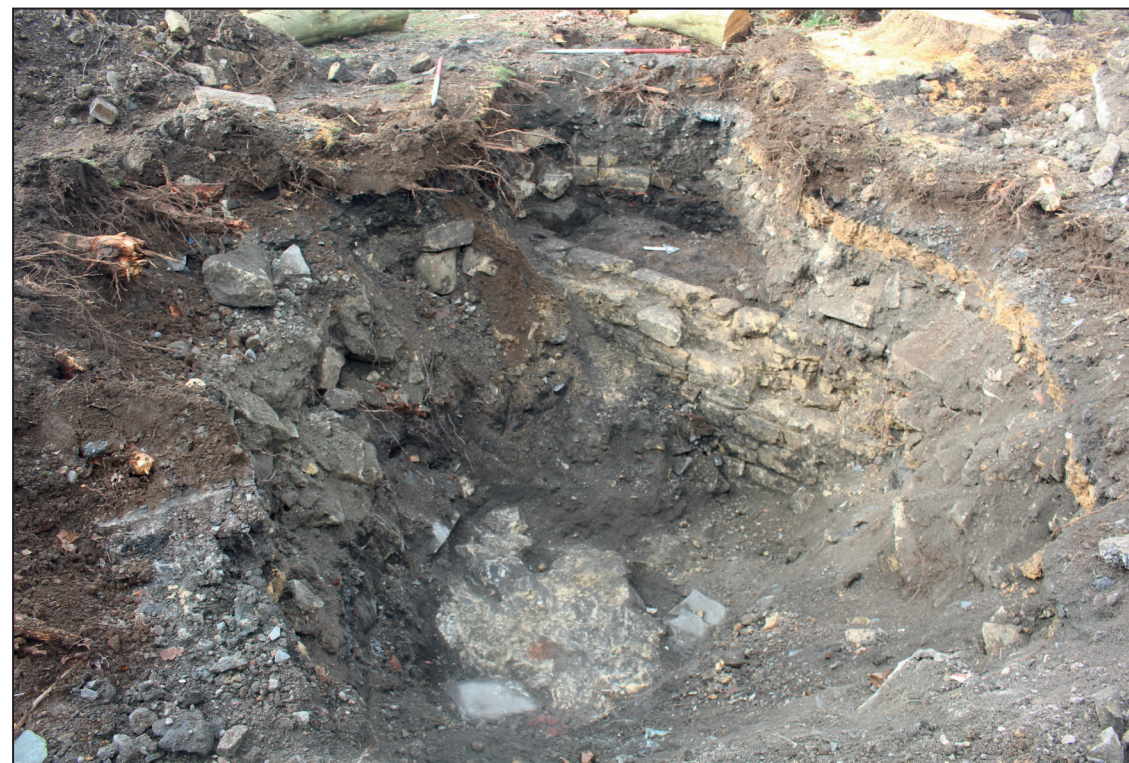
- 5.25. Identified within the centre of Trench 7, wall 707 was aligned north/south and comprised of randomly coursed Bath stone blocks and was recorded to a height of 1.03m. It correlated closely to the location of the eastern side of a possible warehouse depicted on historic mapping (Fig. 3). It was butted to the west by levelling deposit 706, which was in turn sealed by ashy made-ground deposit 705,

- 5.26. To the east, wall 707 was butted by levelling deposit 710, which was overlain by 0.1m of bedding/levelling material 709 that was in turn sealed by mortar surface 708, which measured 0.18m in thickness. Surface 708 was overlain by 0.58m of demolition material 704, from which modern dating material was recovered.
- 5.27. Demolition material 704 and made-ground 705 were both overlain demolition material 703, measuring between 0.43m and 0.98m and from which modern dating material was recovered. This was overlain by 0.41m of modern bedding, surfacing and topsoil materials.

Trench 7, looking east (1m scales)

Trench 7, looking west (1m scales)
