**The Laws
High Street
Turvey
Bedford Borough**

Historic Building Recording

CA Project: MK0732

CA Report: MK0732_1

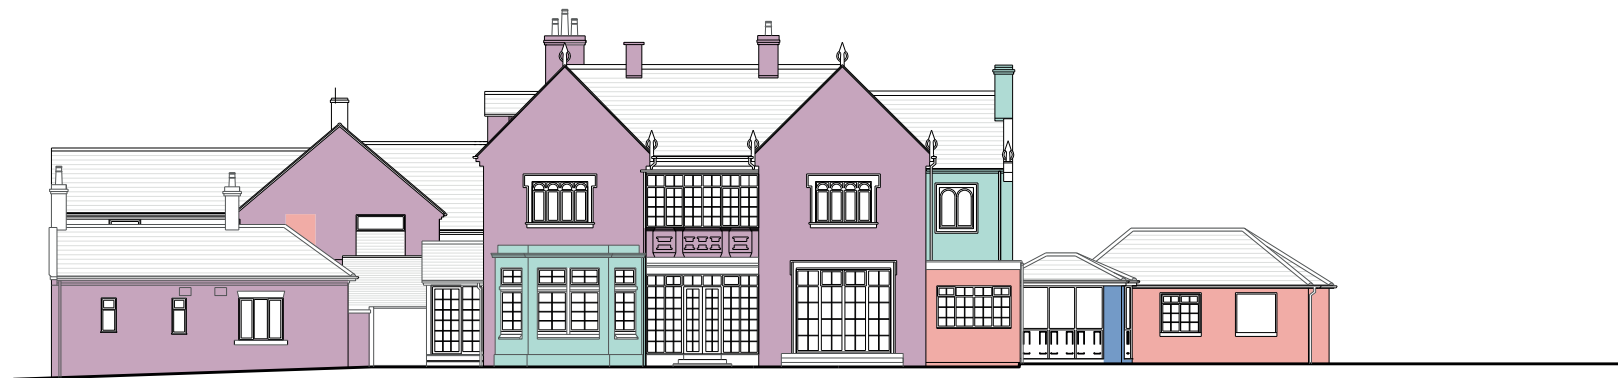
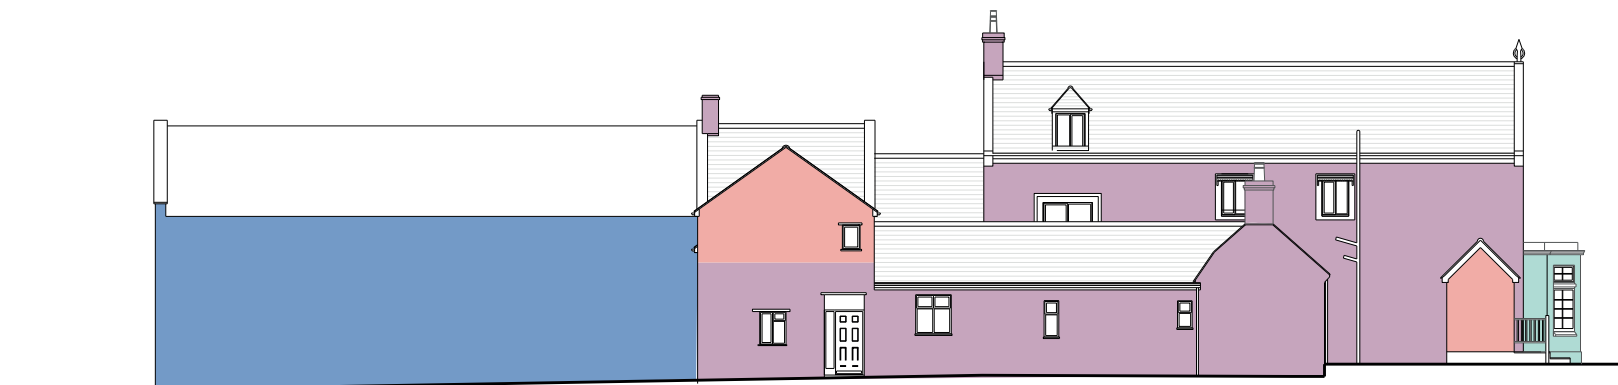
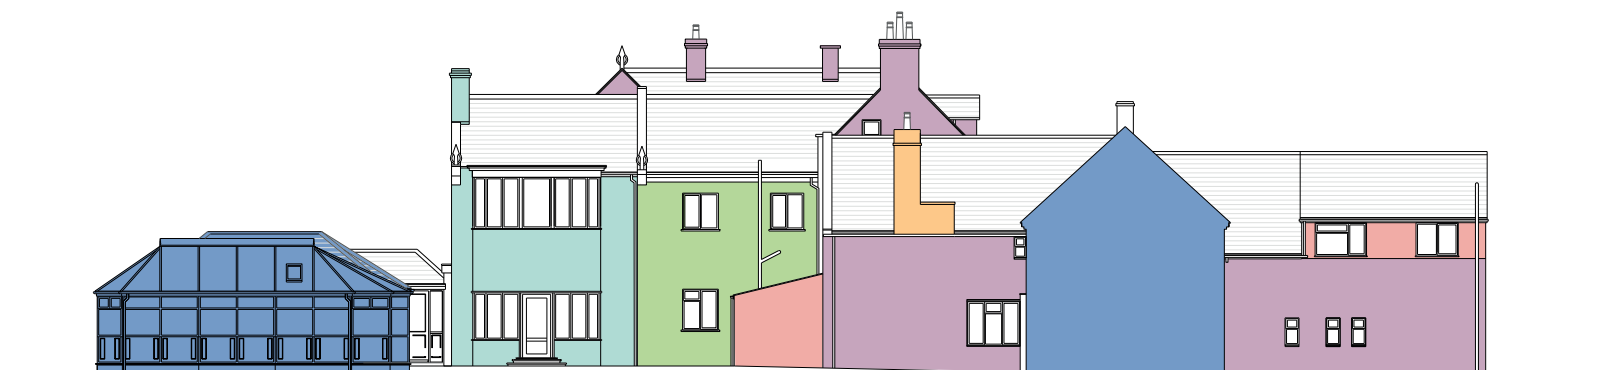
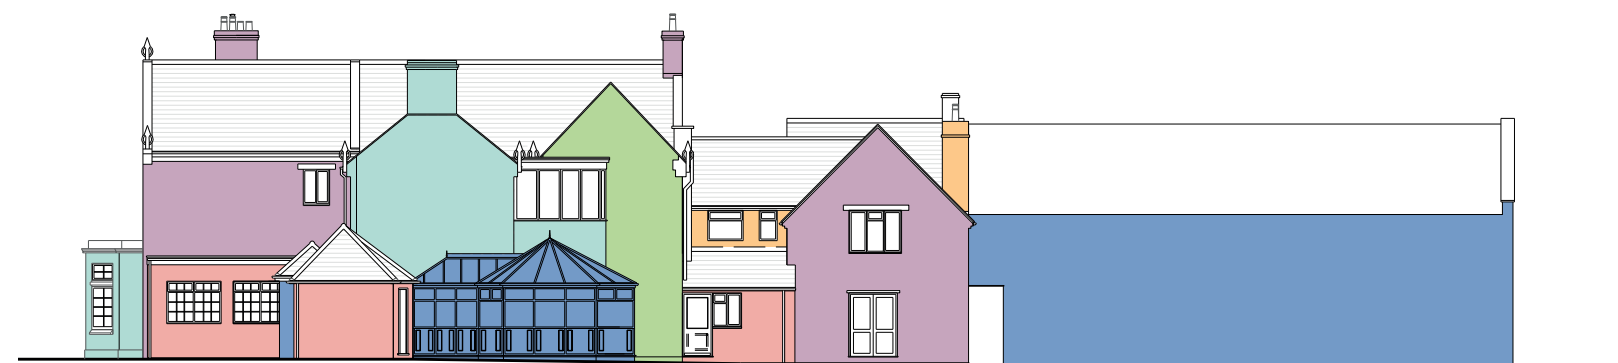
South facing elevation

West facing elevation

East facing elevation

North facing elevation

- Phase A: 1830s / 1840s construction
- Phase B: mid to late 19th-century additions
- Phase C: 1929 additions / alterations
- Phase D: 1933 additions / alterations
- Phase E: mid to late 20th-century additions
- Phase F: 1990s additions / alterations

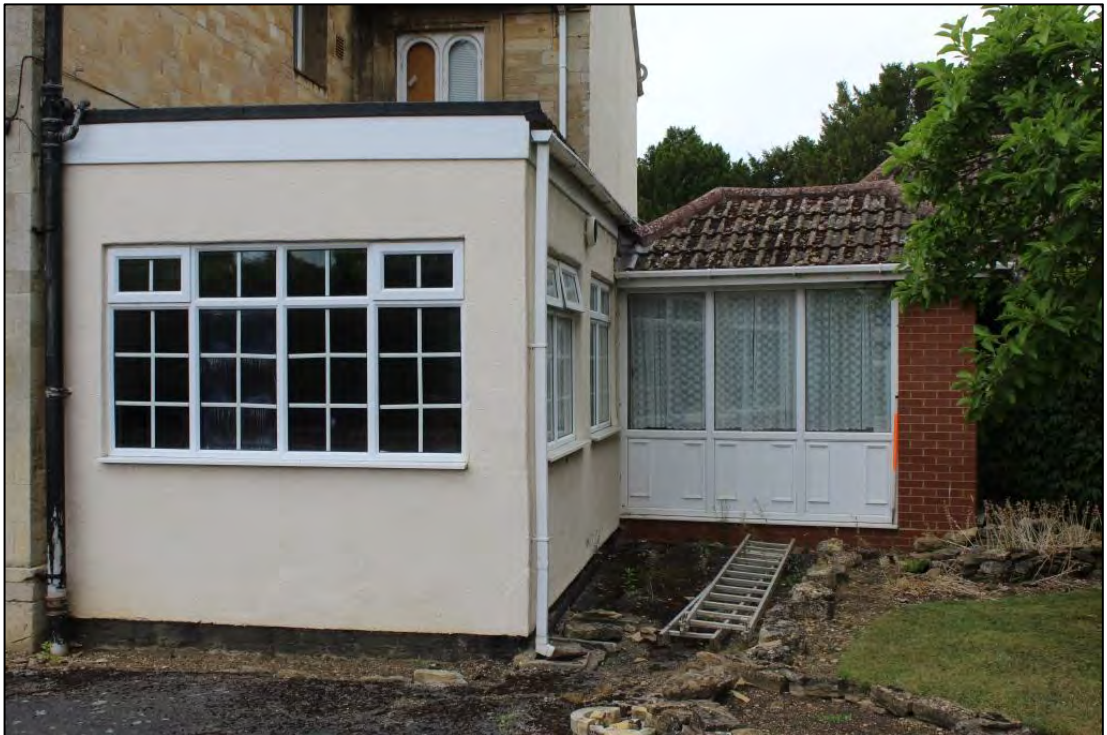
Photo 4: Eastern extensions to the building

- 4.9. The eastern elevation of the building (Photos 4 and 5) incorporates several phases of development, including a predominantly glazed structure dating to Phase E (Photo 4), a upvc conservatory structure (Photo 5), and converted outbuilding that links the conservatory to the principal building (Photo 5). The converted outbuilding does not appear on historic OS maps until 1977/78 (Fig. 6) and was likely constructed in the early to mid 20th century (Phase E), possibly as a service building for the building's hotel function.

4.25. Room 8 comprises a modern extension (Photo 4) that incorporates no historical decorative features and is glazed with large upvc window units. A conservatory was depicted in this position on historic maps (Fig. 5) and on the 1929 plan (Fig. 18); however, the present structure appears to be a later incarnation and incorporates a greater degree of masonry fabric. Whilst earlier fabric may remain within the structure, it is likely to have been built between the mid to late 20th century (Phase E).

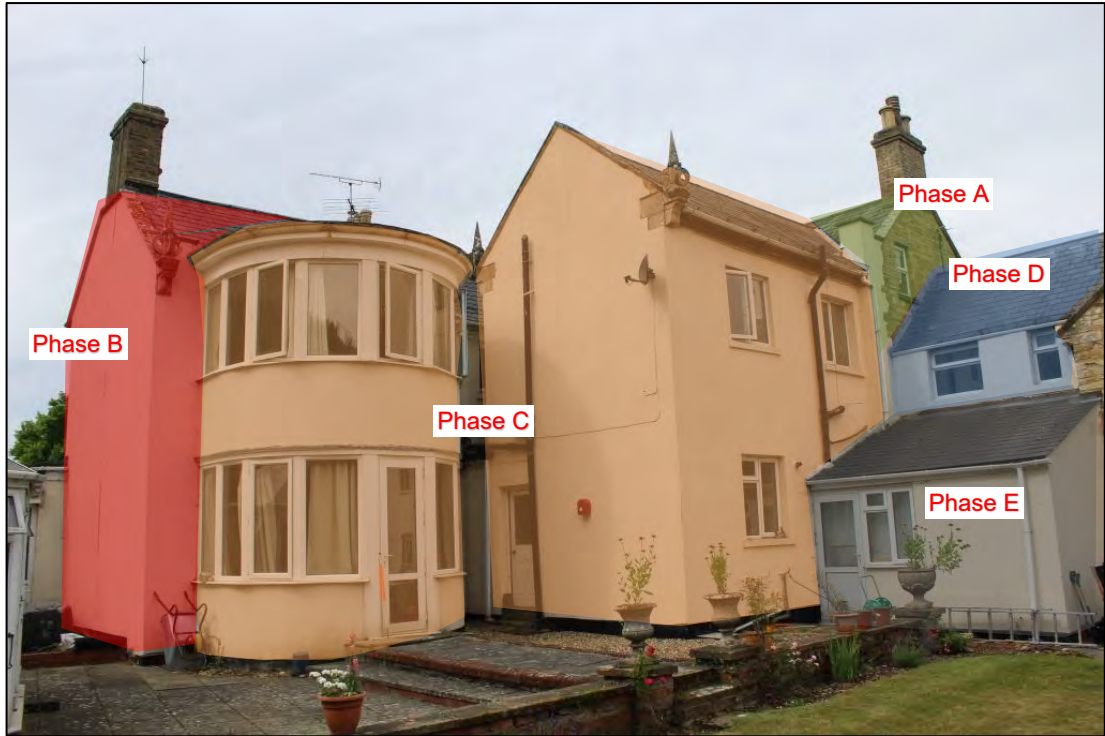
Photo 6: Overview of northern and north-eastern elevations

- 4.10. The northern and north-eastern elevations of the building (Photo 6) illustrate the multi-phase development of the building that predominantly occurred during the 20th century. The Phase A element of the building was extended between 1843 and 1899 (Figs. 2 and 4) before multiple accretions beginning with the Phase C elements following the 1929 application, including a two-storey wing and bow window. The application plans depict only a single-storey bow window; however, the addition of the second storey cannot be confirmed and the construction accords closely with that of the ground floor element so both storeys may have been constructed as part of Phase C. A mid 19th-century painting of the building records the form of the building at that time and illustrates the original elevations of Phase A, now substantially obscured or removed (Fig. 14).

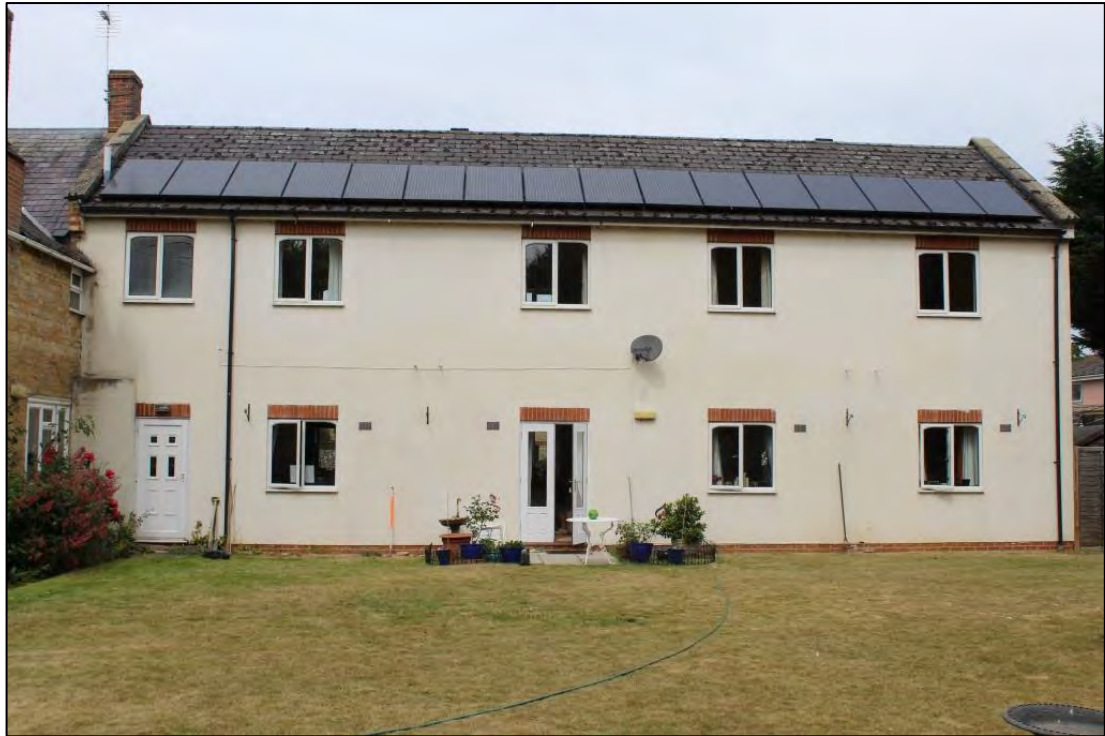
Photo 8: Phase F extension, looking west

4.12. A large extension extends northwards from the building (Photo 8), which was constructed in c.1991/92 (Phase F) to provide additional rooms for the hotel (F. Mack, pers com, 12/7/22). The extension comprises stone facing to the western elevation but is rendered on the eastern elevation. The extension comprises two storeys, featuring upvc casement windows and red brick lintels.

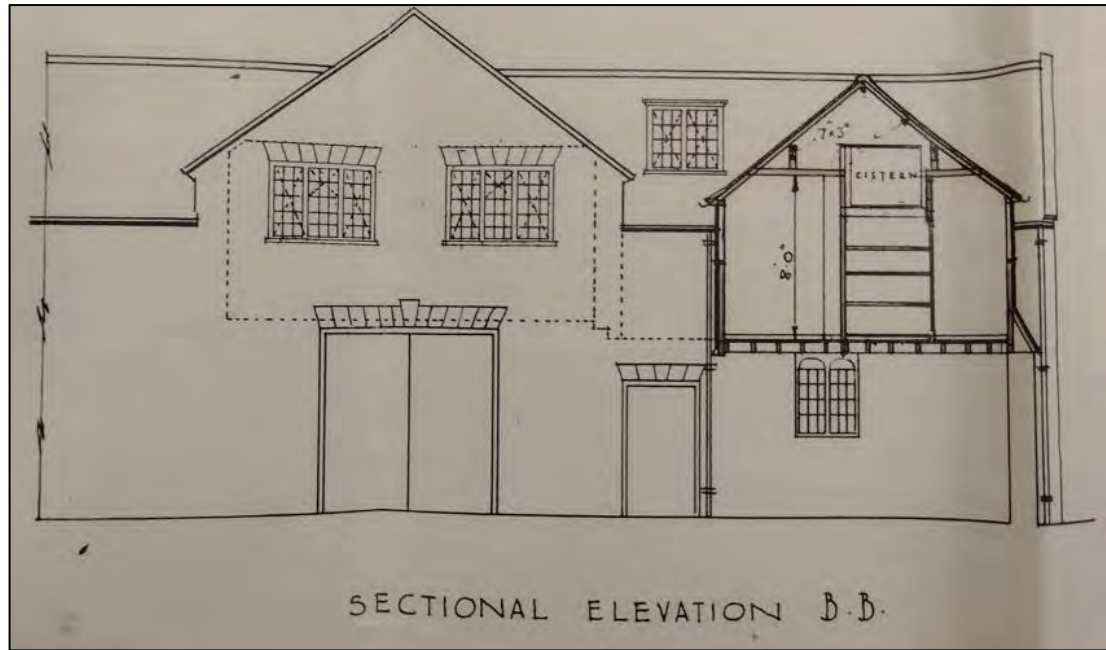
Fig. 16: Extract from the 1933 plan

- 4.14. At the northern extent of the courtyard is a mid to late 20th-century wall that represents a widening of the barn structure (Phase E) whilst the western wall of the courtyard is defined by a late 20th-century infill (Phase F). The extent of these later extensions is visible from elevated vantage points where the modern flat and pyramidal roofs can be observed in contrast to the earlier pitched roofs (Photo 10). Behind Phase E, the historical gabled southern elevation of the barn can be seen. Historically, this structure incorporated a pair of first floor windows within the gable wall, however, one has since been infilled and one truncated, both during the 20th century, as evidenced by the 1933 plan (Fig. 16). The plan also evidences that Phase D has obscured the former large ground floor opening to the barn (Fig. 16).

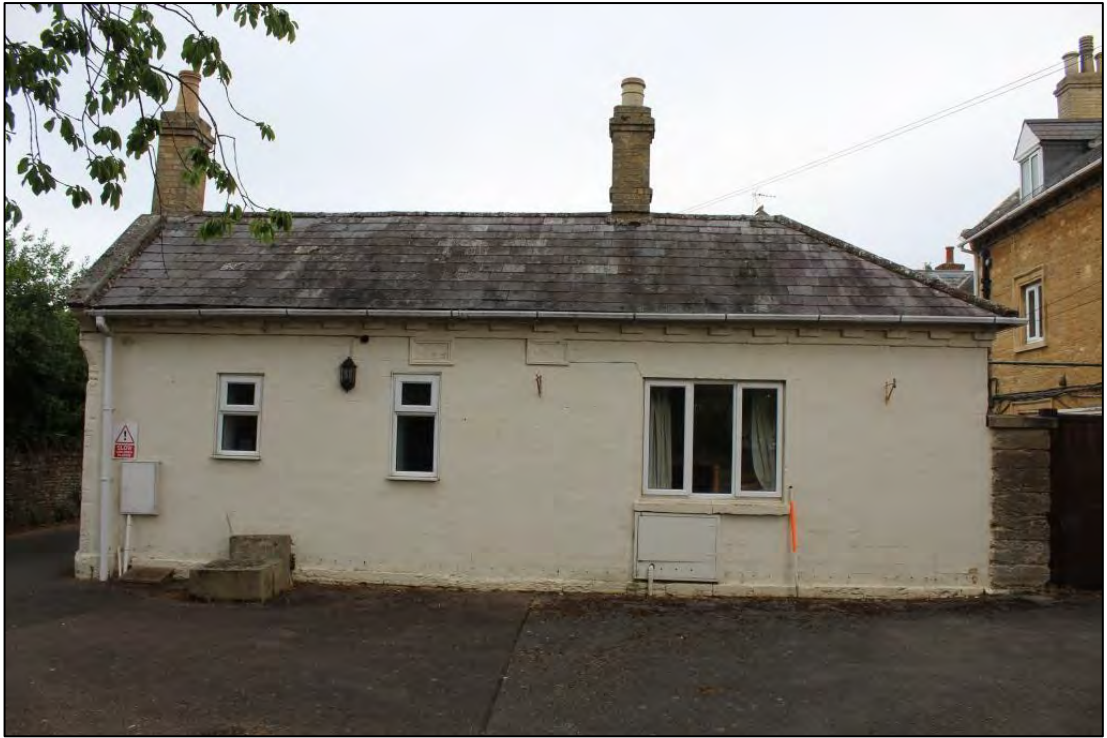
Photo 11: Southern elevation of stable block

- 4.15. The single-storey western range (Photo 11) comprises a stone construction with hipped slate roof and dentiled eaves which matches a similar feature found on the principal house building. All documentary (Figs. 2 and 3) and physical evidence suggests that the stables were built in tandem with the principal house, except for a small portion of stables that was constructed during the 19th century to link with the barn (Fig. 4). Formerly, the stables would have formed an L-shaped southern and western boundary to the former courtyard, now infilled. Three upvc windows punctuate the southern elevation within apertures of the stables, of varying sizes. The south-western corner of the structure is curved, likely to allow the easement of horses and horse drawn vehicles past the building (Photo 12). As with the principal house building, the public facing elevation incorporated worked stone whilst the flanking elevation features coursed rubble stone (Photo 12).

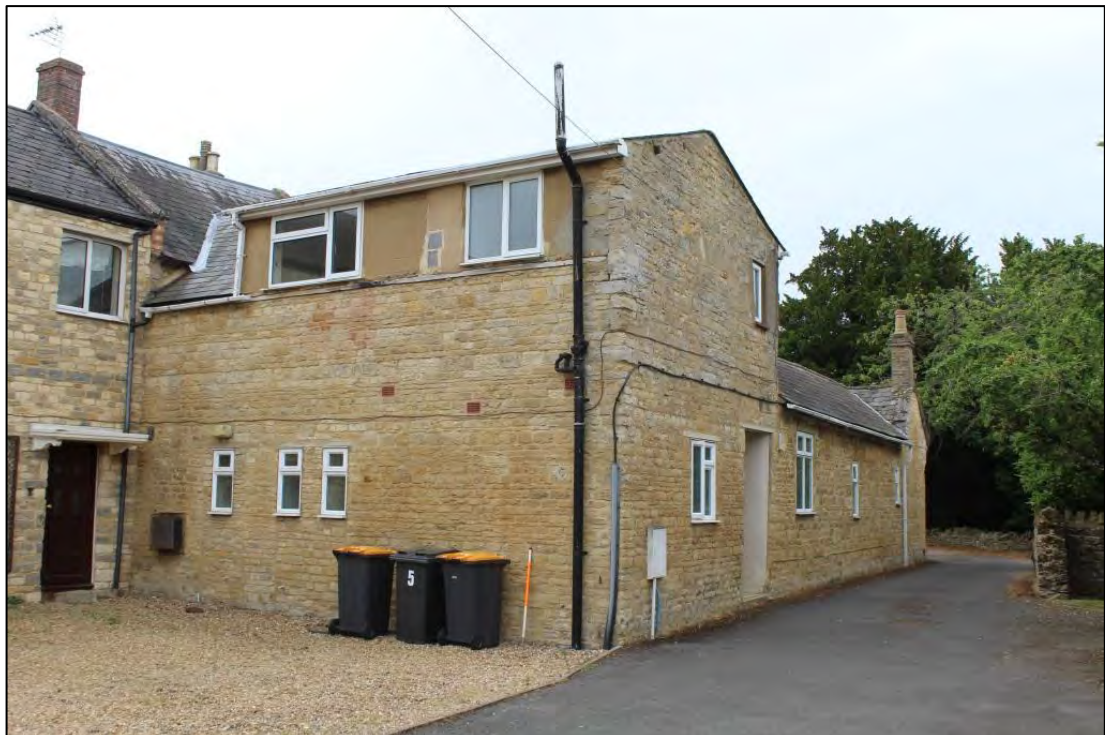
Photo 13: Oblique view of stables and barn, looking south-east

- 4.16. The western elevation of the stables connects with the western elevation of a two-storey structure referred to as the barn (Photo 13) (F. Mack, pers com, 12/7/22). Whilst not referring explicitly to a stable, a 1894 sales inventory (Appendix 2) records the presence of a 'Back of Stables' and 'Hayloft'. For the purposes of this assessment, both internal and exterior elements of the structure will be referred to as 'the barn'.

- 4.17. The barn incorporates a western door within a deep reveal with two upvc windows within the gable end, one on the first floor, one on the ground floor. Three small upvc windows are present on the northern elevation, providing light and ventilation to modern WC rooms behind. The second floor of the barn has evidently been altered to raise the ceiling for two bedrooms (Rooms 42 and 43), likely carried out during the early to mid 20th century as part of the building's conversion to a hotel, thus increasing bedroom capacity. The shallow roof pitch, surface finish and aperture dimensions are all indicative of this period.

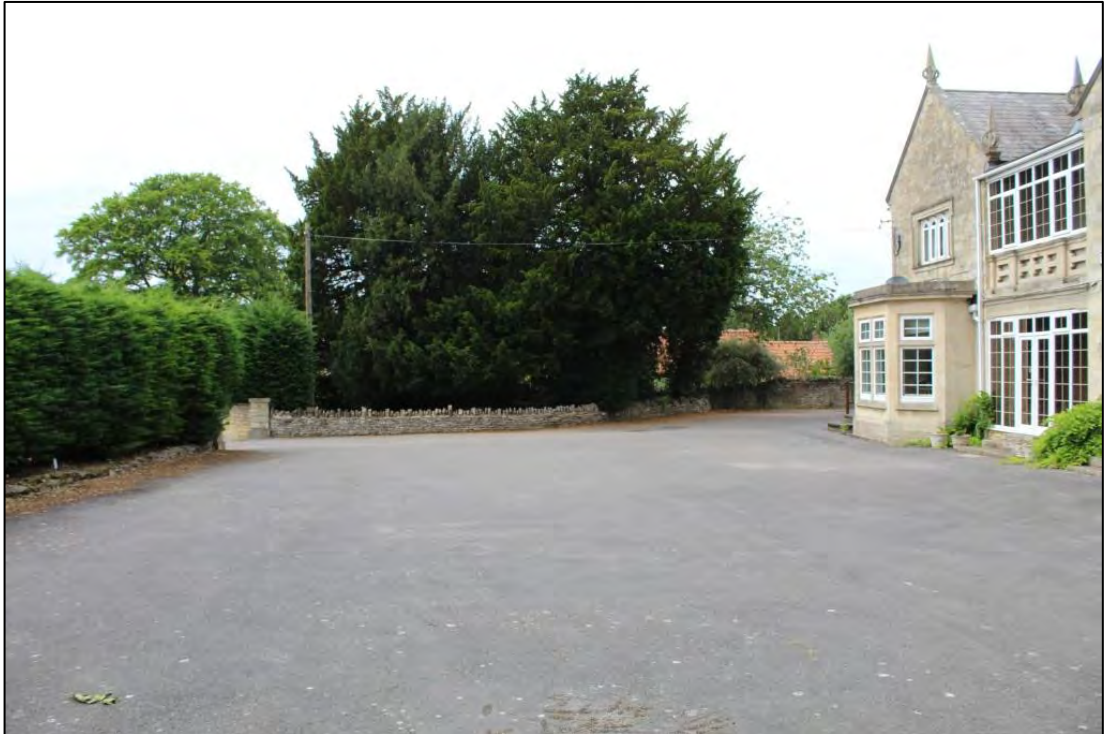
Photo 14: Overview of car park and southern boundary

- 4.18. The building is situated within a spacious plot and is detached on all sides. The building is set back approximately 17m from the public carriageway and is presently set within a large tarmac car park to the south, that is bounded by a low stone wall and mature vegetation to the south (Photo 14). The building accommodates a large rear garden (Photo 15) that appears to comprise a longstanding feature (Fig. 2). The

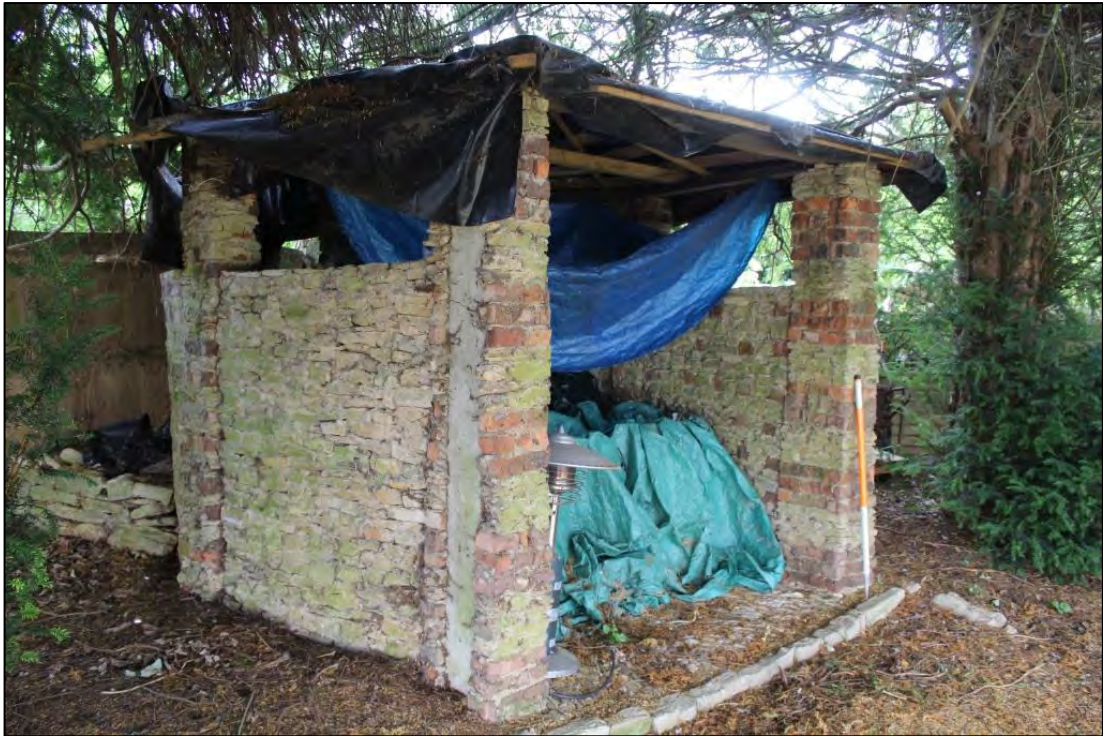
Photo 16: Possible former potting shed

1894 inventory includes a potting shed, the remains of which may be attributable to a standing brick and stone structure at the northern extent of the garden (Appendix 2; Photo 16).

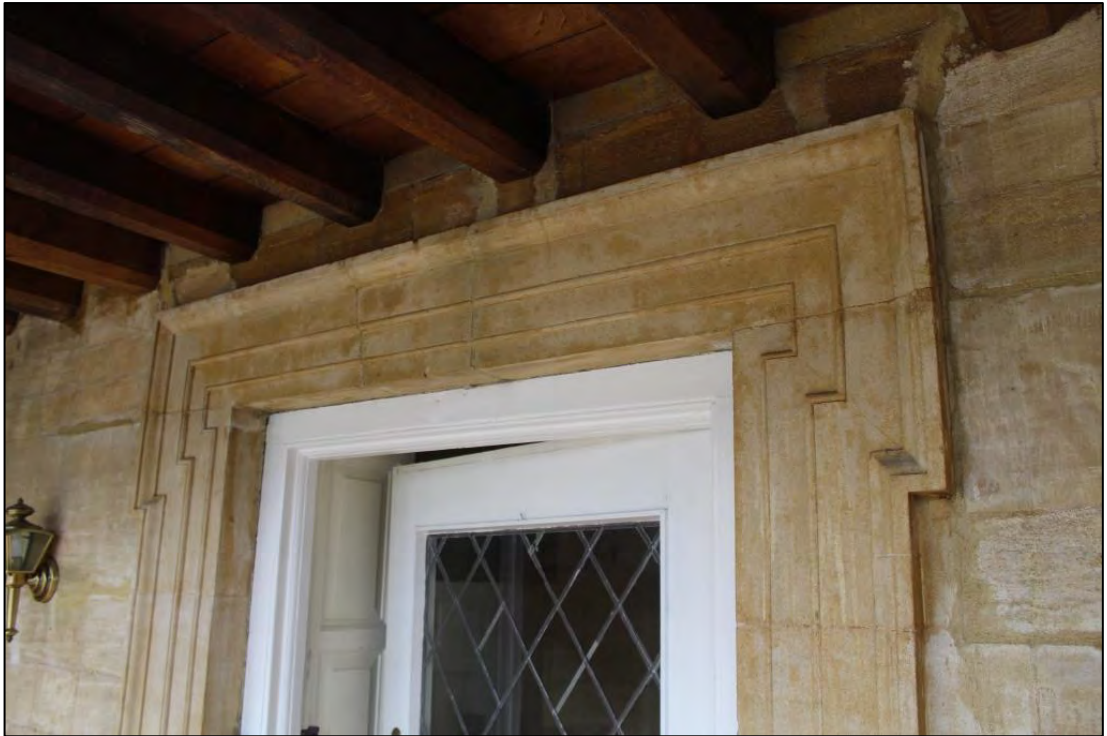
Photo 17: Detail of principal doorway hood mould

- 4.19. The principal entrance to the building is within the centre of the southern elevation and is positioned within an enclosed porch. Historically, the porch was an open feature that incorporated a pair of columns supporting the balcony above (Fig. 3). The former external aspect is reflected in the retention of the stone hood mould and dressings surrounding the principal doorway (Photo 17).

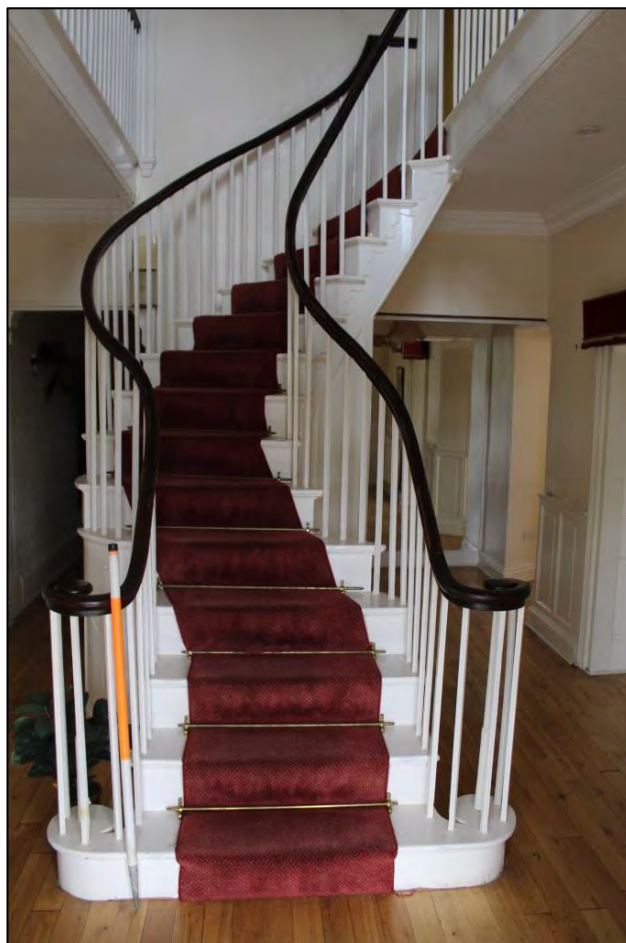
Photo 18: Overview of Room 1, looking north

- 4.20. Room 1 (Photo 18) functions as the entrance hallway and accommodates the principal staircase, centrally positioned, which rises in a skewed fashion before a dog-leg to the first floor. Whilst the building was constructed at the tail end of the Georgian period, the staircase is characteristic of Georgian style, incorporating plain stick balusters, curved hardwood handrail ends (Photo 19) and decorative tread ends beneath an open string (Photo 20). The skew arrangement is non-standard and may have been necessary due to space constraints. The lower half of walls in Room 1 incorporate wainscotting that accords with the panelling beneath the staircase (Photo 20).

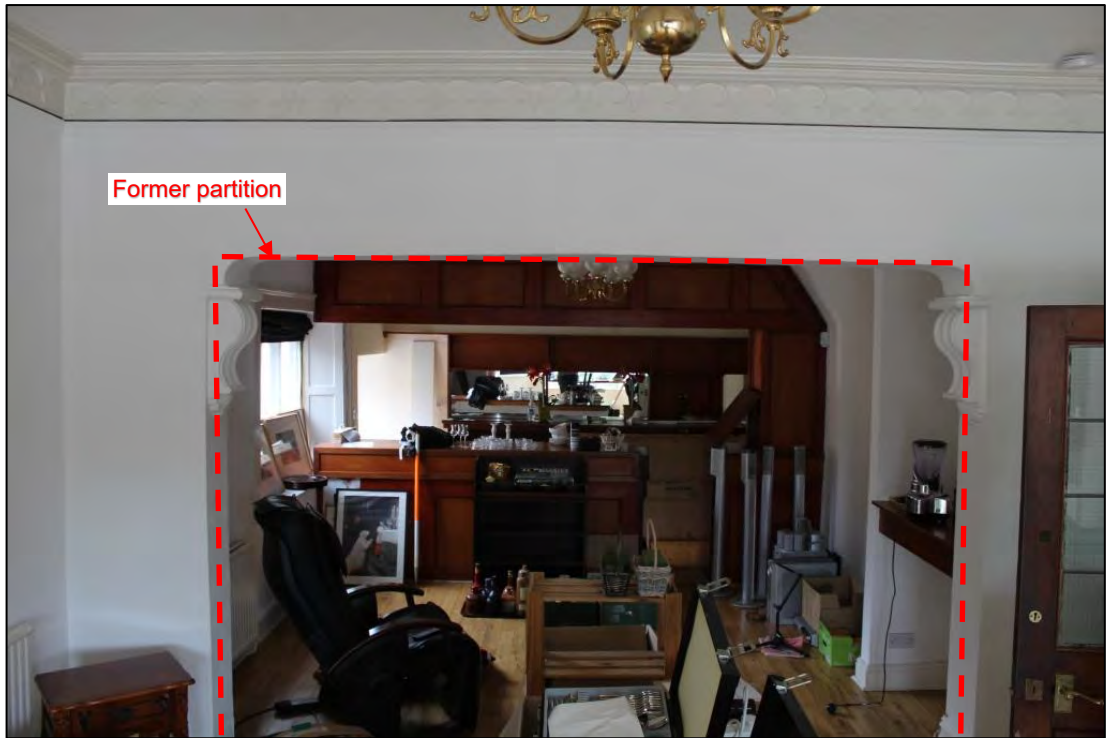
- 4.22. Rooms 4 and 5 (Photo 21) are positioned to the west of Room 1 and comprise a pair of large function rooms that are presently connected but were formerly divided into separate rooms, according to the 1929 plan (Fig. 17), labelled as a sitting room and kitchen respectively. Room 4 features more elaborate decoration, reflecting its higher status at the front of the building, and incorporating the bay window and decorative cornice (Photos 22 and 23). The chimney breasts in both rooms survive but are blocked up and no longer incorporate fire surrounds. The 1929 plan confirms that a staircase formerly existed along the line of the former partition (Fig. 17) which once led downwards, as confirmed by the redundant stone staircase in the cellar (Photo 24). Clearly, Room 5 was once an active service area, historically labelled as a kitchen and incorporating a second staircase at the northern extent of the room, leading to the first floor, whilst a former doorway led to the scullery (Fig. 17; Room 12), now blocked up.

Photo 21: Overview of Rooms 4 and 5, looking north

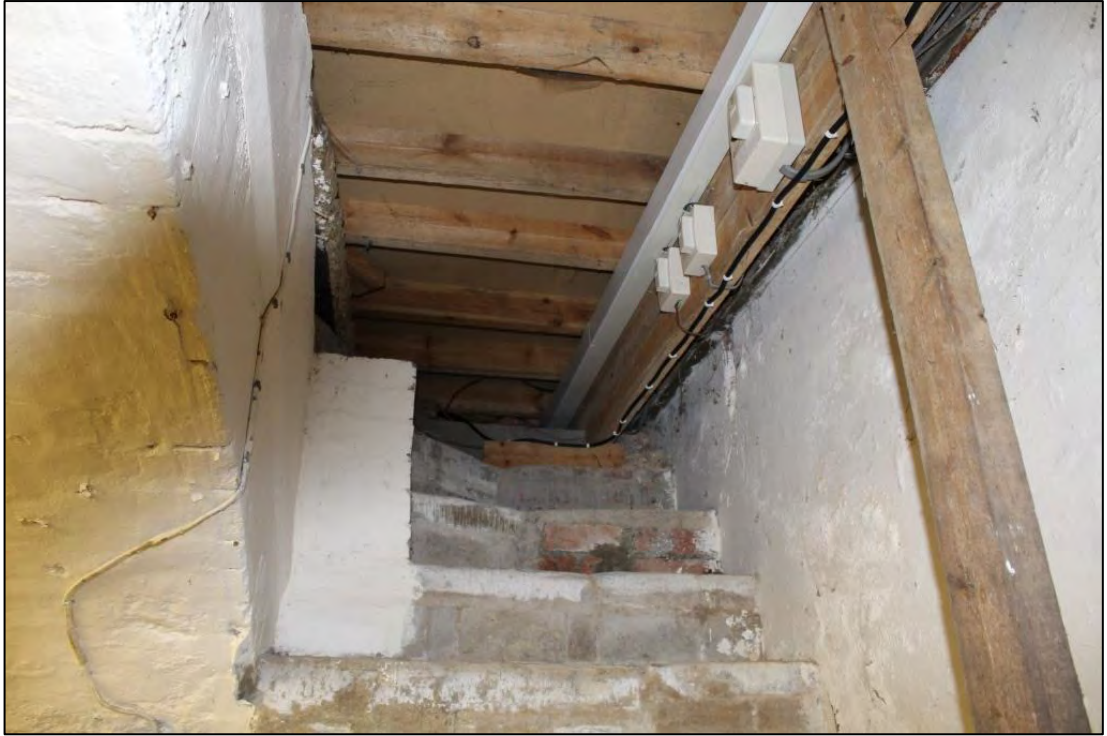
Photo 24: Former staircase leading to Room 5, viewed from within cellar (Room 52)

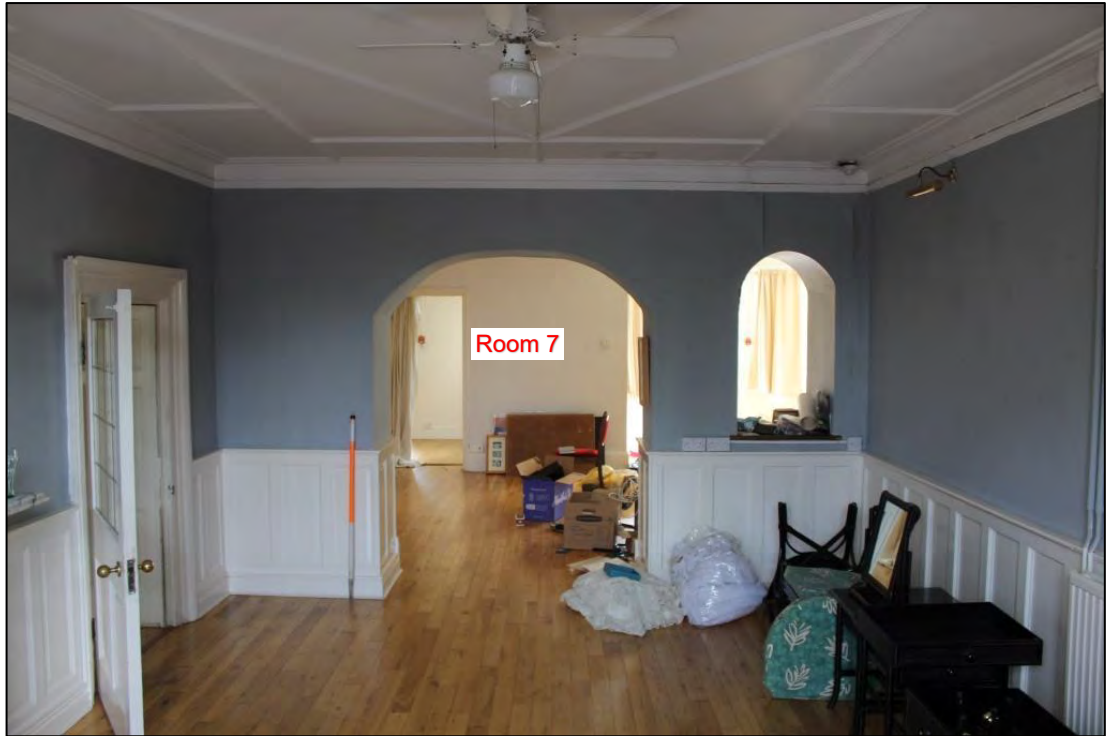
Photo 25: Overview of Room 6, looking north

- 4.23. A doorway within the eastern wall of Room 1 leads to Room 6, which was most recently used as a sitting room but was labelled on the 1929 plan as a drawing room. Currently, the room is linked to Room 7 via an archway within the northern wall alignment (Photo 25): however, this is a 20th-century alteration as the rooms were historically separate, as confirmed on the 1929 plan (Fig. 18). Room 6 incorporates decorative elements such as reeded pilaster surround (Photo 26) and marble fire surround of neo-classical appearance (Photo 27). The ceiling features a decorative geometric pattern that is characteristic of 19th-century decoration but, equally, may have been applied during the 20th century. A door within the eastern wall once led through to Room 8 but is now blocked up.

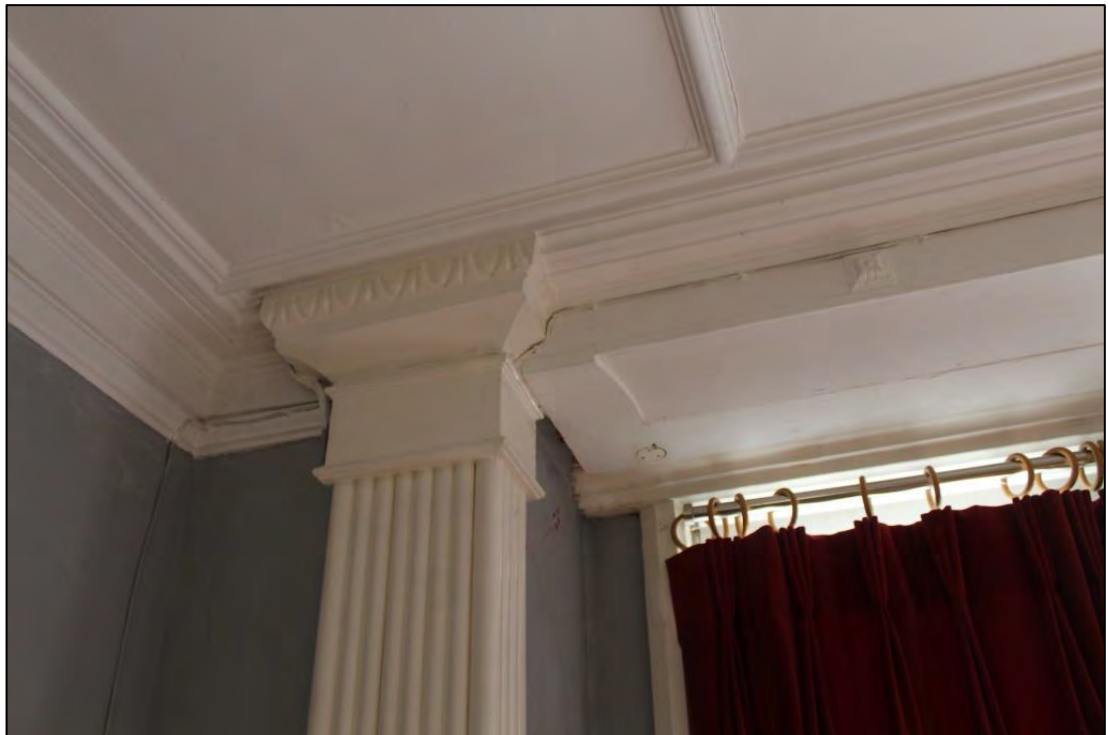
Photo 26: Detail of reeded pilaster and cornice, Room 6

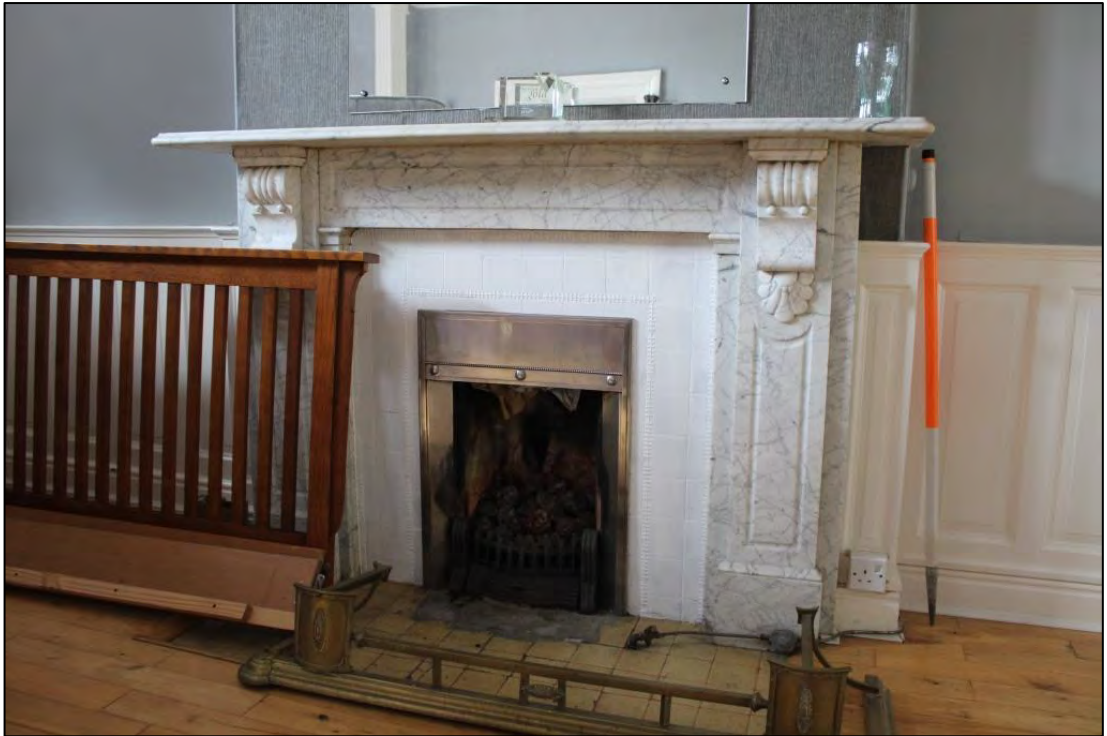
Photo 27: Detail of marble fire surround in Room 6

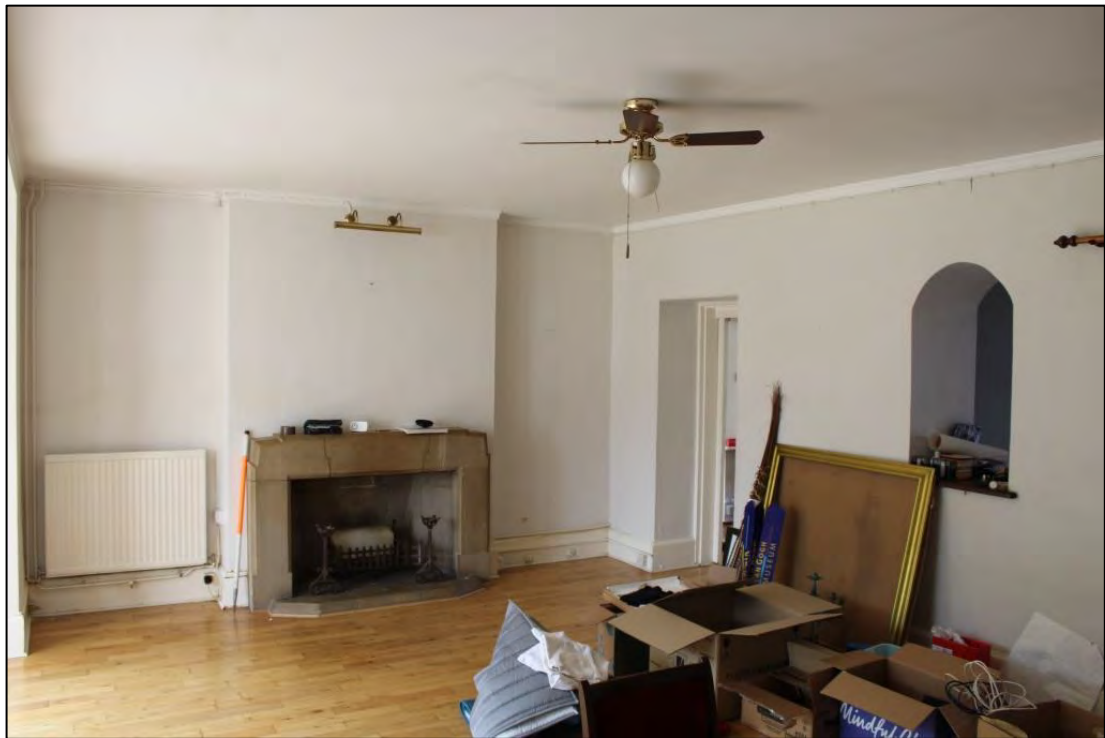
Photo 28: Overview of Room 7, looking south-east

4.24. Room 7 (Photo 28) is accessed from both Rooms 1 and 6 and was constructed between 1843 and 1899 (Figs. 2 and 4). This is further evidenced by the absence of the room on the 1840s painting of the rear of the building (Fig. 14). The room was labelled as a dining room on the 1929 plan (Fig. 18) and was most recently used as part of the restaurant of the former hotel. The room incorporates a stone fire surround of early 20th-century style and a large bow window within the northern wall that was constructed as part of the 1929 plans (Fig. 18). The form of the bow window appears, however, to have changed since, increasing the size of the window and making it double height.

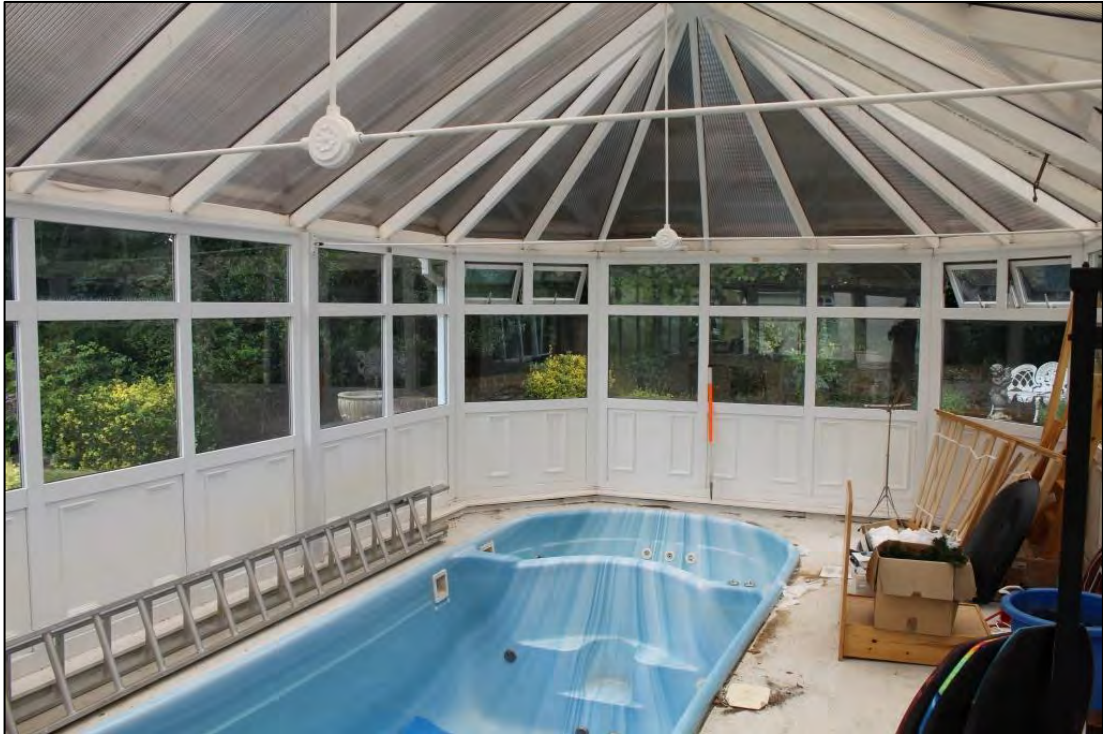
Photo 29: Overview of Room 11, looking east

4.26. Room 8 leads into Rooms 9 to 11 which comprise a sequence of modern rooms, including a conservatory structure incorporating a swimming pool (Room 11; Photo

29). Room 10 comprises the converted outbuilding, likely constructed during the mid to late 20th-century; however, all other aspects of Rooms 9 to 11, including internal fixtures and fittings, date to 1995 (F. Mack, pers com, 12/7/22).

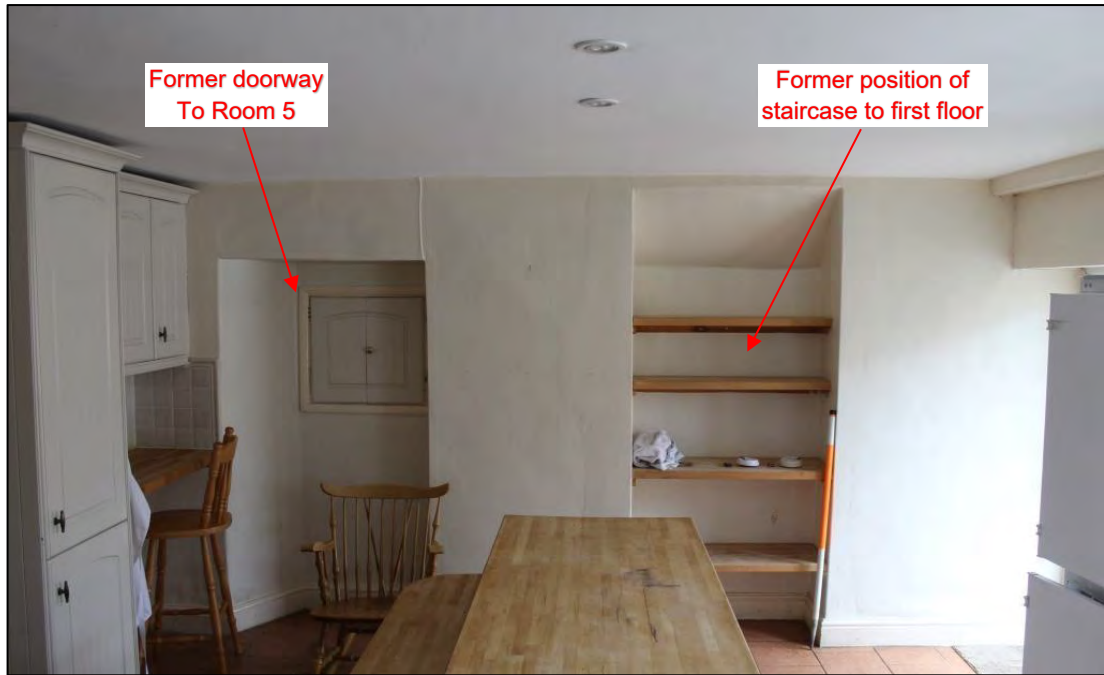
Photo 30: Overview of Room 12, looking south

4.27. Room 12 is situated immediately north of Room 5 and most recently functioned as a kitchen (Photo 30). The room was labelled as a scullery on the 1929 plan and would have formerly incorporated a doorway access to Room 5 (Photo 30) and a small lobby and WC at its northern extent (now demolished). The room's service status is evidenced by the lack of decorative features and relative position towards the rear of Phase A.

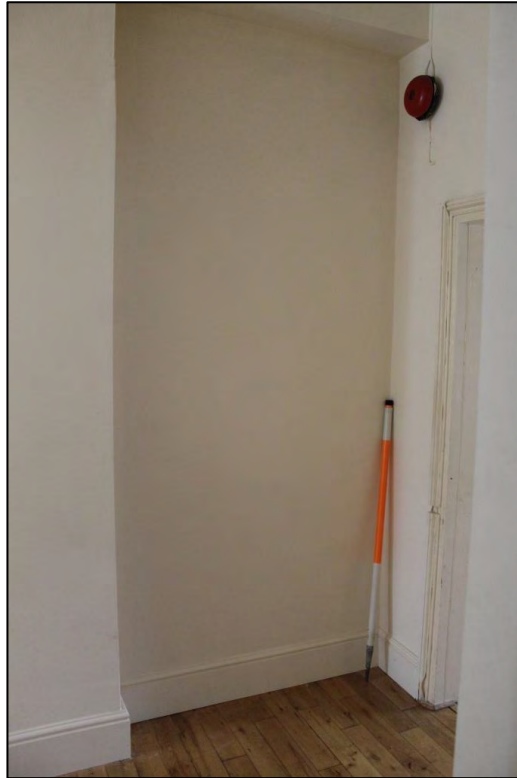
Photo 31: Former doorway between Rooms 3 and 13, viewed from Room 13

4.28. Rooms 13 and 14 are positioned within the Phase C element that was constructed as part of the 1929 additions (Fig. 19). A former doorway to Room 3 has been blocked up (Photo 31) and the former pantry (Room 14; Photo 32) is now a kitchenette; however, functionally, the rooms have broadly maintained their original proportions and access. The north-western portion of Room 13 was labelled as a 'heating chamber' on the 1929 plan (Fig. 19), however, it presently comprises a through corridor to Room 15.

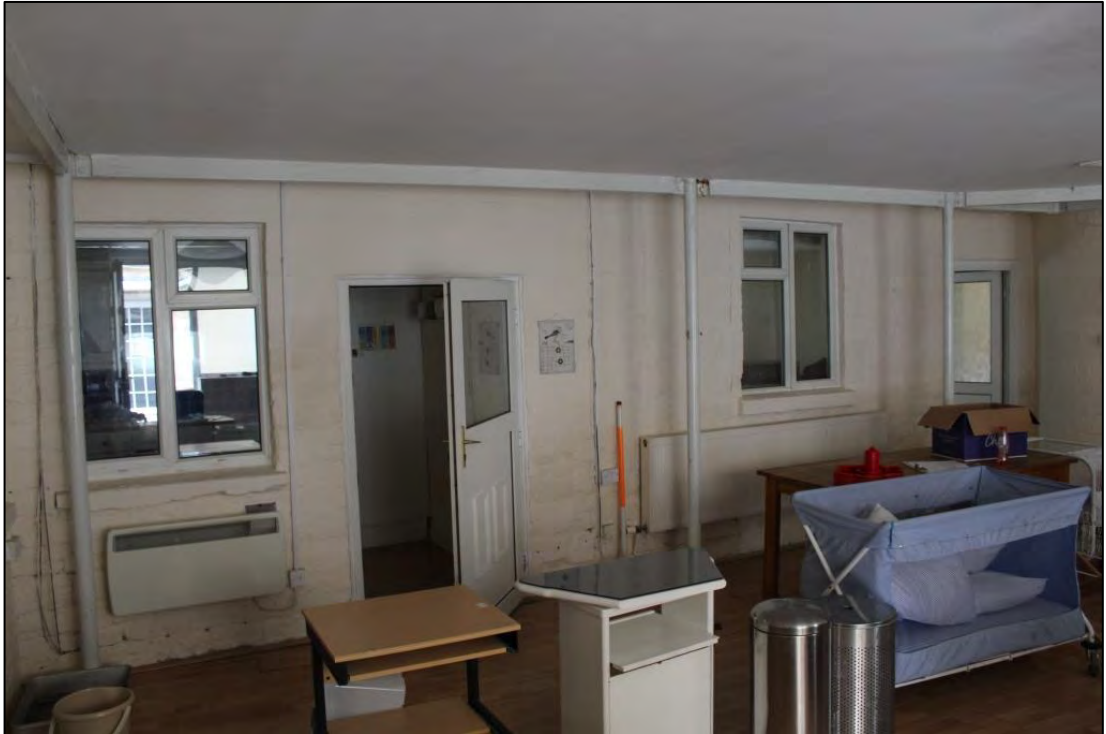
Photo 35: Overview of Room 19, looking west

- 4.31. Room 19 (Photo 35) forms part of the Phase F iteration of alterations and comprises the enclosure of the western extent of the former courtyard between 1992 and 1995 (F. Mack, pers com, 12/7/22) (Photo 10). Whilst the eastern and northern wall alignments of the room are modern (i.e. Phases E and F), the western and southern alignments comprise the external alignments of the former stables. These are characterised by a broad sequence of wide doorways and adjacent tall windows, indicative of individual stables. The stonework elevations and segmental lintels remain visible above each aperture within the sequence. The eastern and internal walls of Rooms 24 and 25 are possibly Phase B, owing to the gap present on the Tithe map in this position (Fig. 2).

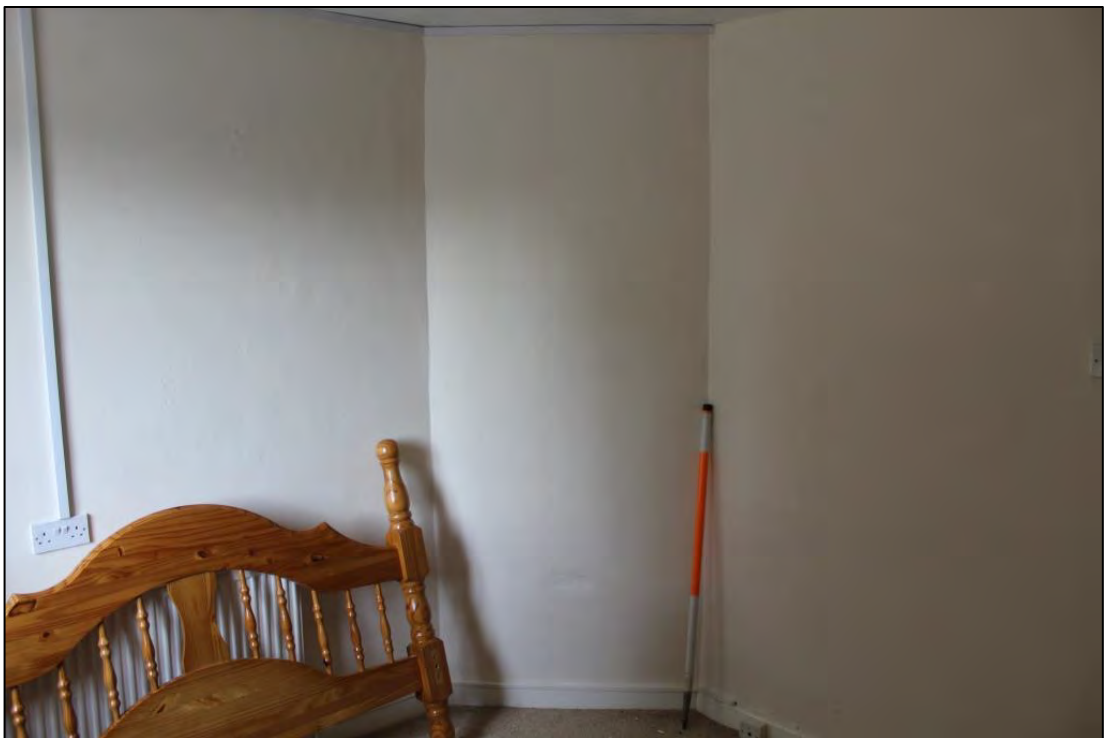
Photo 36: Former fireplace within room 20, looking north-west
