**The Laws
High Street
Turvey
Bedford Borough**

Historic Building Recording

CA Project: MK0732

CA Report: MK0732_1

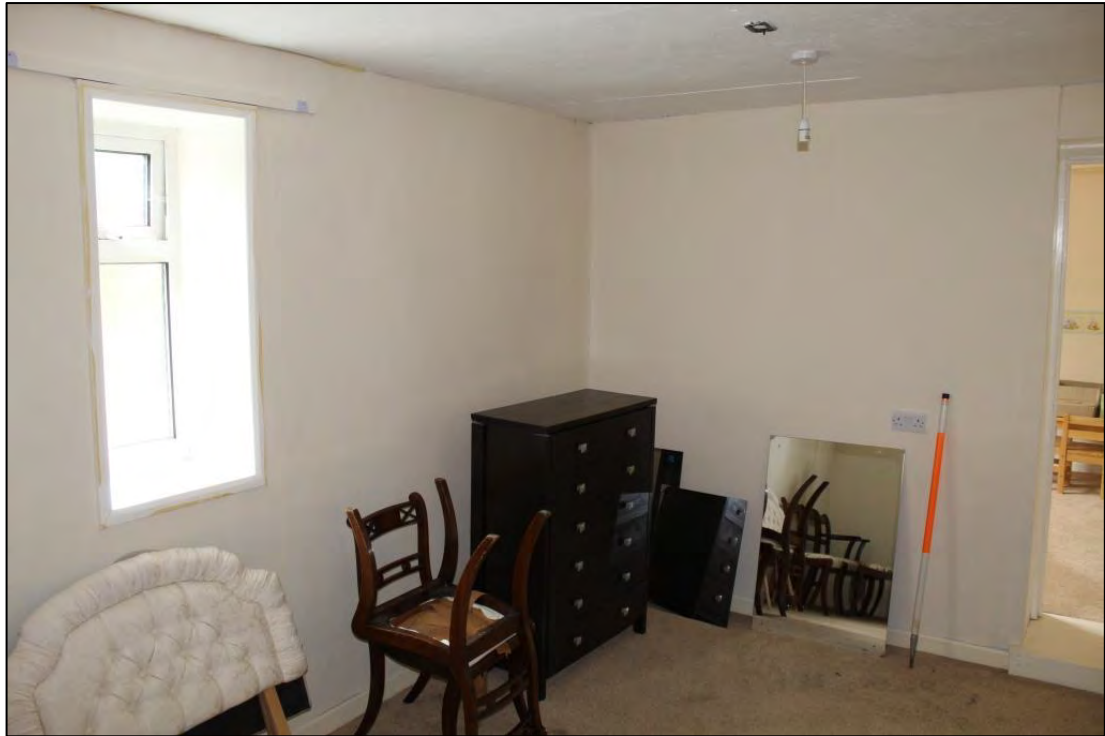
Photo 37: Overview of Room 24, looking north-west

- 4.32. Rooms 20 to 25 comprise the former stables and associated rooms of the former stable block. Presently, these rooms are characterised by their previous, domestic use as bedrooms, kitchens, bathrooms and study. Each room features entirely modern decoration and finishes, with upvc window and door units throughout, including the elevation fronting the former courtyard (Photo 35). Room 22 is an example of a possible former stable hand room, owing to the presence of a former fireplace (Photo 36) within the north-western corner of the room. Room 20 also incorporates a former fireplace within the western wall and may comprise the former saddle room, as mentioned within the 1894 inventory; a saddle room would have

required a source of heat to maintain the condition of the saddles. Otherwise, Rooms 21, 23 and 24 (Photo 37) are likely former individual stalls for horses; however, no historical fixtures or fittings remain.

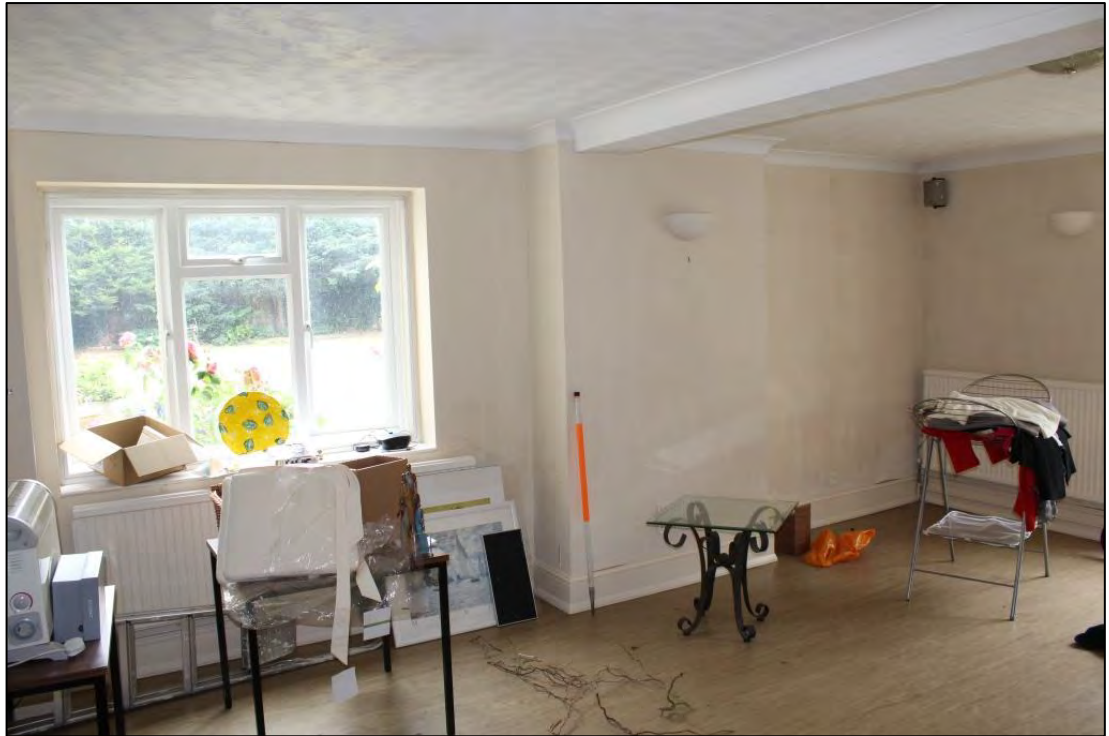
Photo 38: Overview of Room 26, looking east

- 4.33. Room 26 (Photos 38 and 39) comprises a large, single space within the structure known as ‘the barn’. A former fireplace is located within the north-eastern wall where a structural beam projects from the chimney breast southwards across the room. The room was most recently used as a function room and incorporates a large opening to the bar within Room 17 (Photo 34) that, as described above, likely represents the former southern external entrance to the barn, as depicted on the 1933 plans (Fig. 16). Room 26 incorporates an exclusively late 20th/early 21st century decorative scheme that features no visible historical features. Any impression of the room once forming a ‘barn’ structure is no longer readable beyond the room’s appreciable proportions.

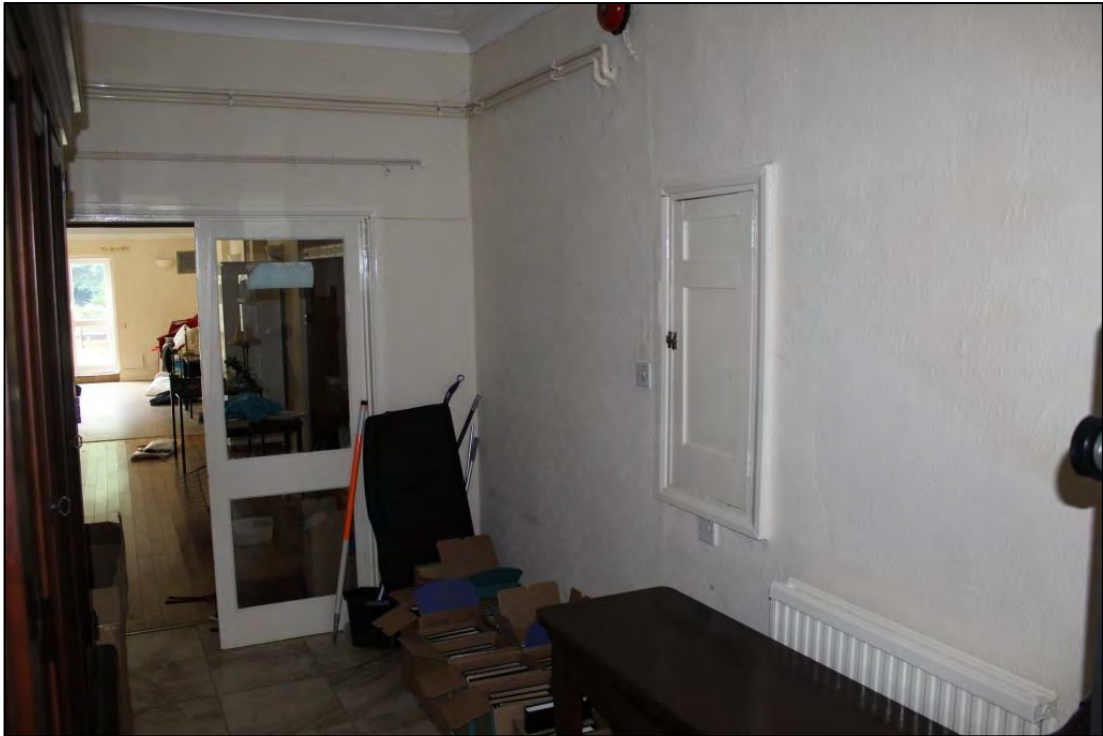
Photo 40: Overview of Room 27, looking south-east

- 4.34. Rooms 27 (Photo 40) to 29 comprise a hallway and WCs rooms that incorporate 20th-century partitioning, fixtures and fittings. A small niche with timber door (Photo 40) incorporates a small cupboard whilst there is evidence for a possible former doorway to Room 25 within the south-western wall.

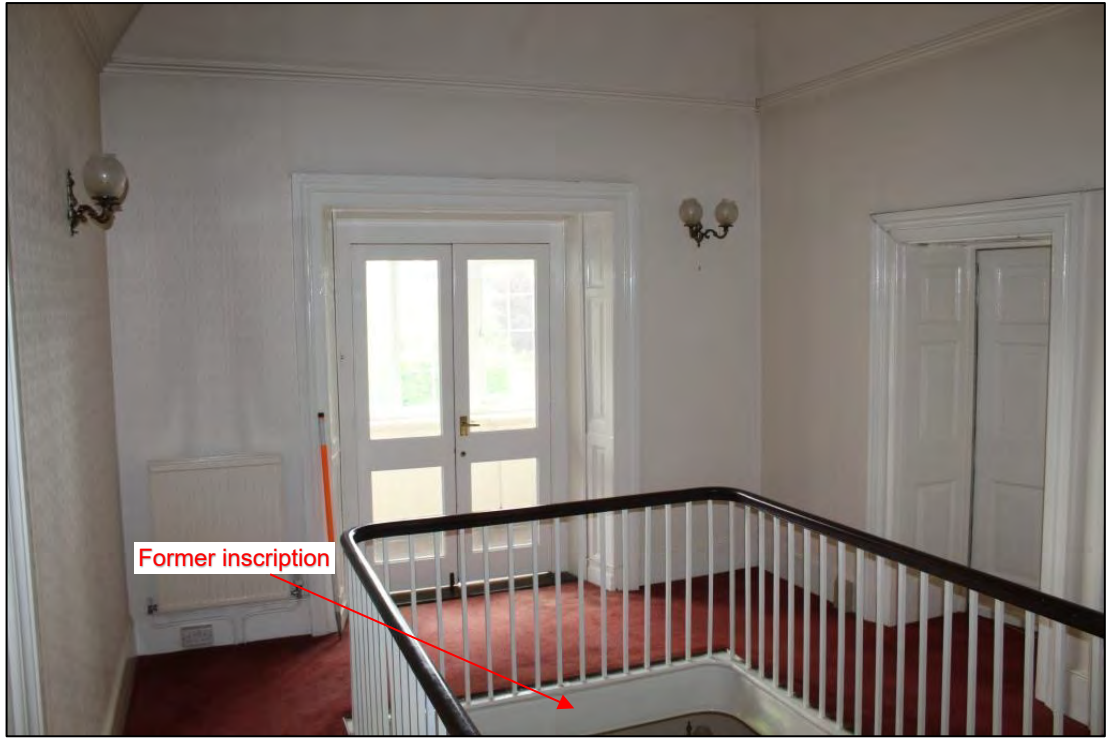
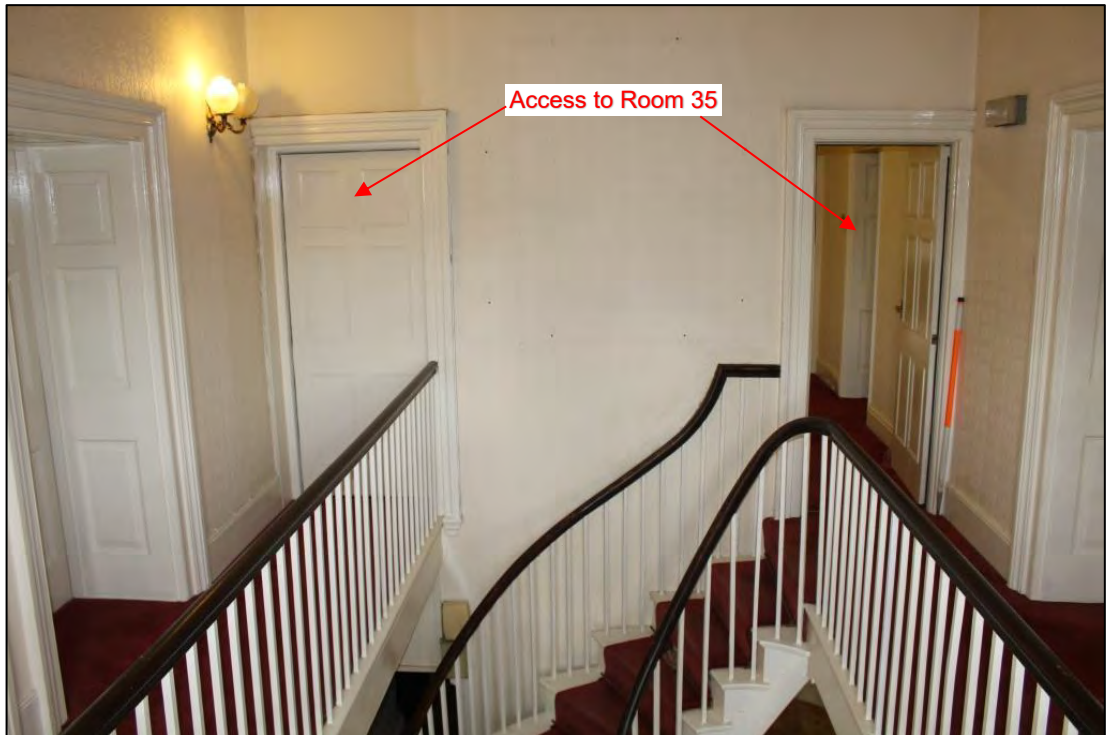
- 4.36. The principal staircase in Room 1 ascends to a landing (Room 34; Photos 41 and 42), which features a vaulted ceiling with decorative tile panel at its centre (Photo 43). The fascia of the landing structure is presently painted white but the relief of an inscription can be faintly discerned, which formerly read as “That House Shall Stand Where God is Heard And Obeyed” (F. Mack, pers com, 12/7/22). At the southern extent of the room is a pair of timber and glazed French doors that lead onto an enclosed balcony that was historically open prior to the installation of glazing.

Photo 41: Overview of Room 34, looking south-west

Photo 42: Overview of Room 34, looking north-east

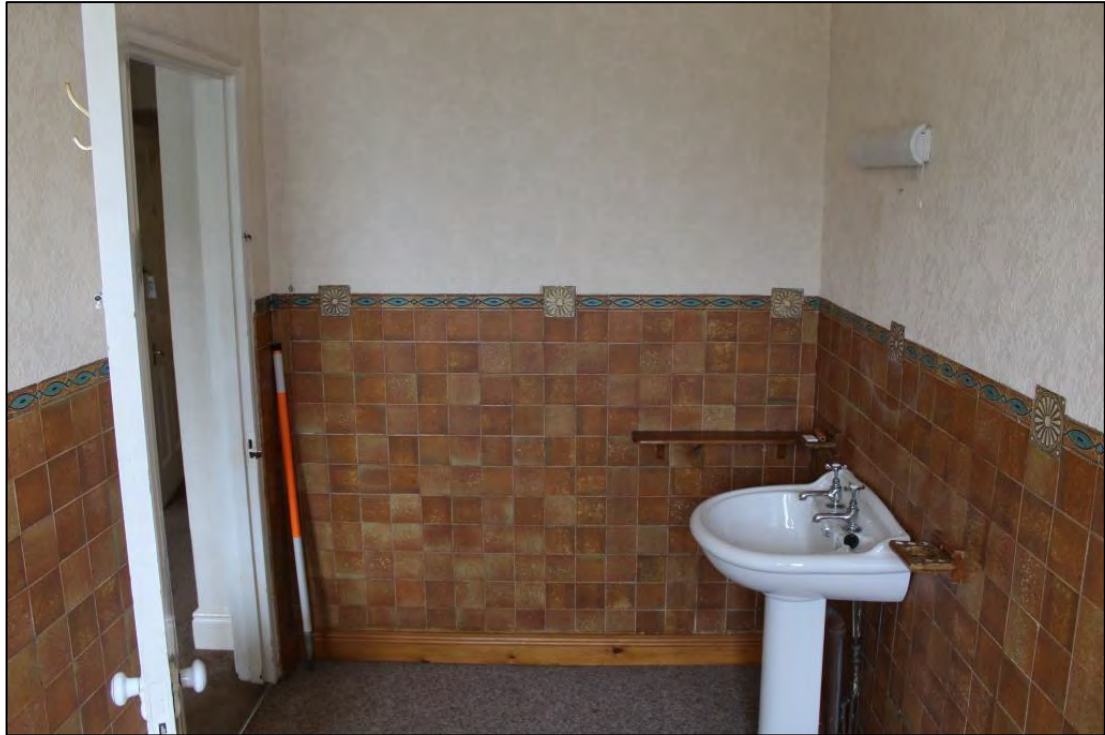
Photo 44: Detail of tiling in the ensuite of Room 36

- 4.38. The majority of rooms on the first floor comprise individually numbered former bedrooms of the hotel. Room 36 (bedroom 1) is accessed from Room 35 and incorporates a bedroom with ensuite. The ensuite incorporates decorative ceramic tiles of a hand finished character that were likely applied following the room's construction during 1929 or the early 1930s (Photo 44) where it was designed as a bathroom originally and therefore maintains its historical use (Fig. 21).
- 4.39. Room 36 itself is presently a bedroom but was also constructed as a bathroom with WC (Fig. 21). In contrast to the present configuration of bedrooms with ensembles or jack-and-jill bathrooms, the 1929 plan (Fig. 12) confirms that at that time, the principal bedrooms within Phase A were bedrooms only, with no attached bathroom facilities. As such, Room 36 was evidently constructed as two bathrooms to provide the

necessary shared bathroom capacity for the hotel during the early to mid 20th century. It is not clear at what point the bedrooms were subsequently reconfigured to incorporate ensembles, thus allowing Room 36 to be converted to a bedroom. The room's original function as a bathroom is also telegraphed via the lack of a chimney breast.

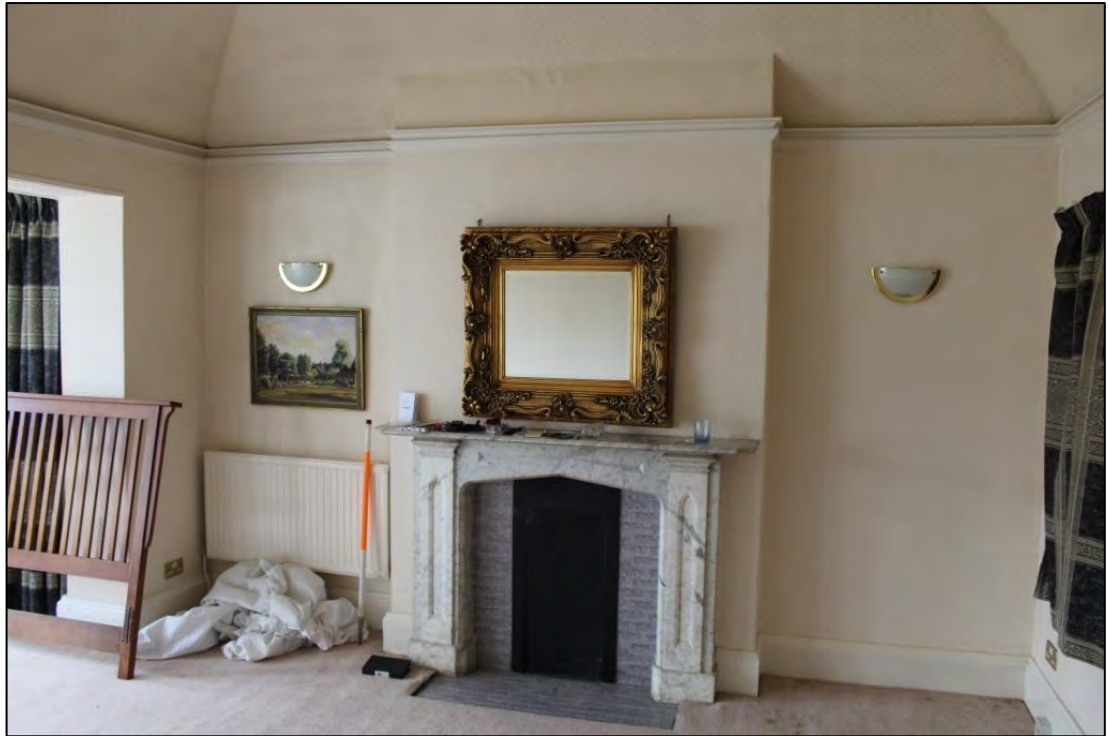
Photo 45: Overview of Room 37, looking east

- 4.40. Room 37 appears to represent the principal guest bedroom of the building as it incorporates the most elaborate decorative scheme, including marble fireplace of perpendicular style (Photo 45), vaulted ceiling with geometric grid pattern (Photo 46) and the large bow window at its northern extent. The 1929 plans (Fig. 22) confirm that a partition was installed at the time, creating a dressing room at the room's western extent. It may have been at this time that the decorative ceiling was constructed as it would have allowed for symmetrical proportions of the new room with the ceiling and bow window positioned centrally. This partition appears to have been moved slightly eastwards at a later date as it now intersects the natural profile of the vaulting at this point (Photo 46). Furthermore, the bow window appears to be a later addition to the northern elevation and may have been added in the mid to late 20th century, according to its absence on both the 1929 (Fig. 22) and 1933 plans (Fig. 13).

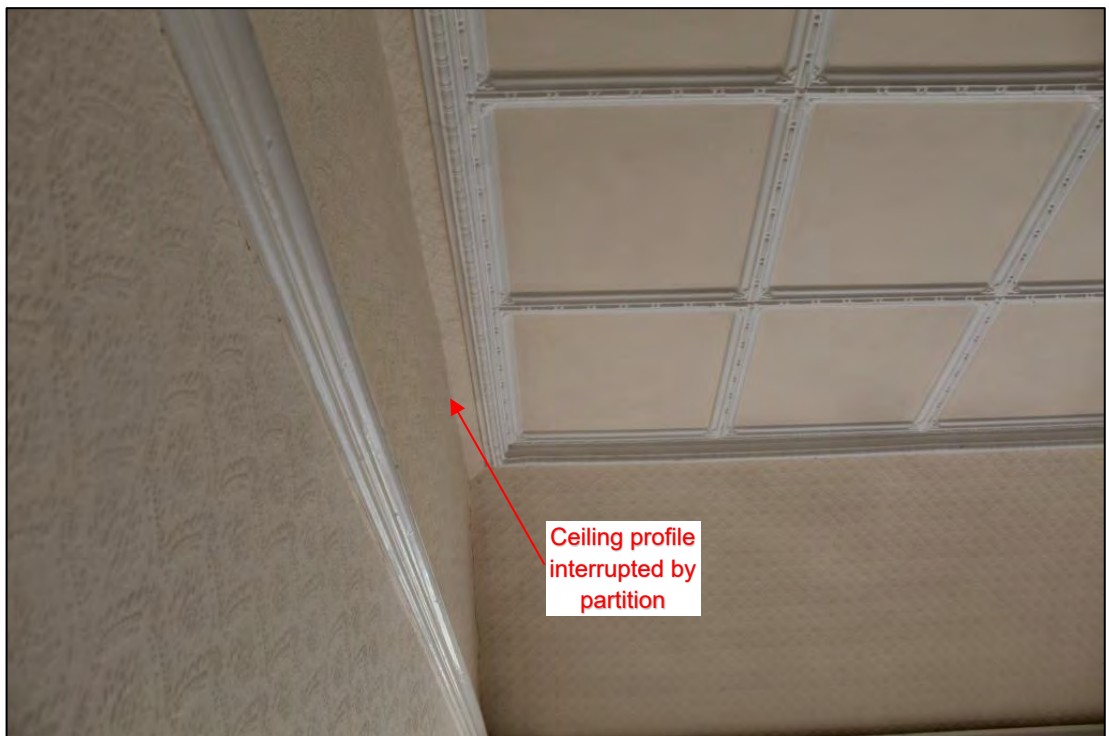
Photo 46: Detail of geometric ceiling panel and partition intersection

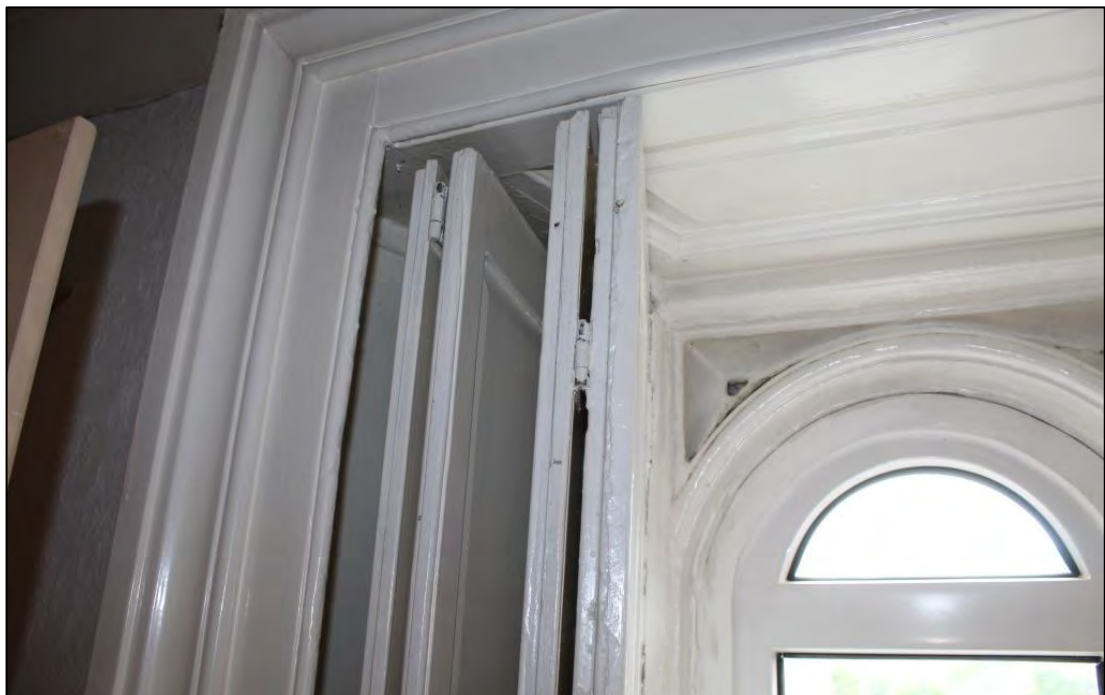
Photo 47: Detail on window shutters in Room 38

- 4.41. Room 38 is connected to Room 37 via a jack-and-jill bathroom with modern fixtures. The room is modest in size owing to its truncation through the addition of the bathroom and has no fire surround within its chimney breast on the western wall alignment. The window to within the southern wall incorporates four Romanesque arches above rectangular lights, all with modern upvc units fitted. The window reveals retain their timber shutters which can be stowed within niches within either side of the reveal (Photo 47).

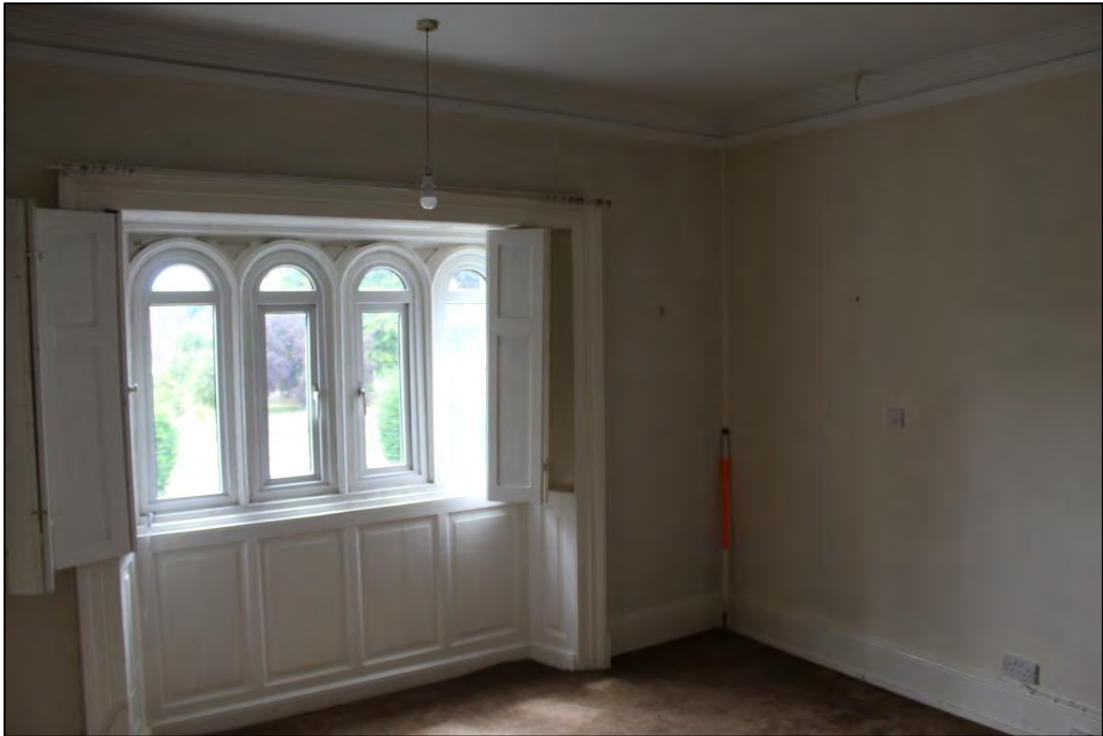
Photo 48: Overview of room 39, looking south-west

-
- 4.42. Room 39 (Photo 48) is situated at the south-western corner of Phase A and retains its historical proportions, save for the insertion of a doorway within the room's north-western corner for access to an adjacent bathroom. The window mirrors the arrangement in Room 38 and also retains timber shutters within the reveals. The window is decorated with wainscoting beneath and incorporates a timber architrave around the aperture. A chimney breast is located centrally within the eastern wall but no longer retains a fire surround.

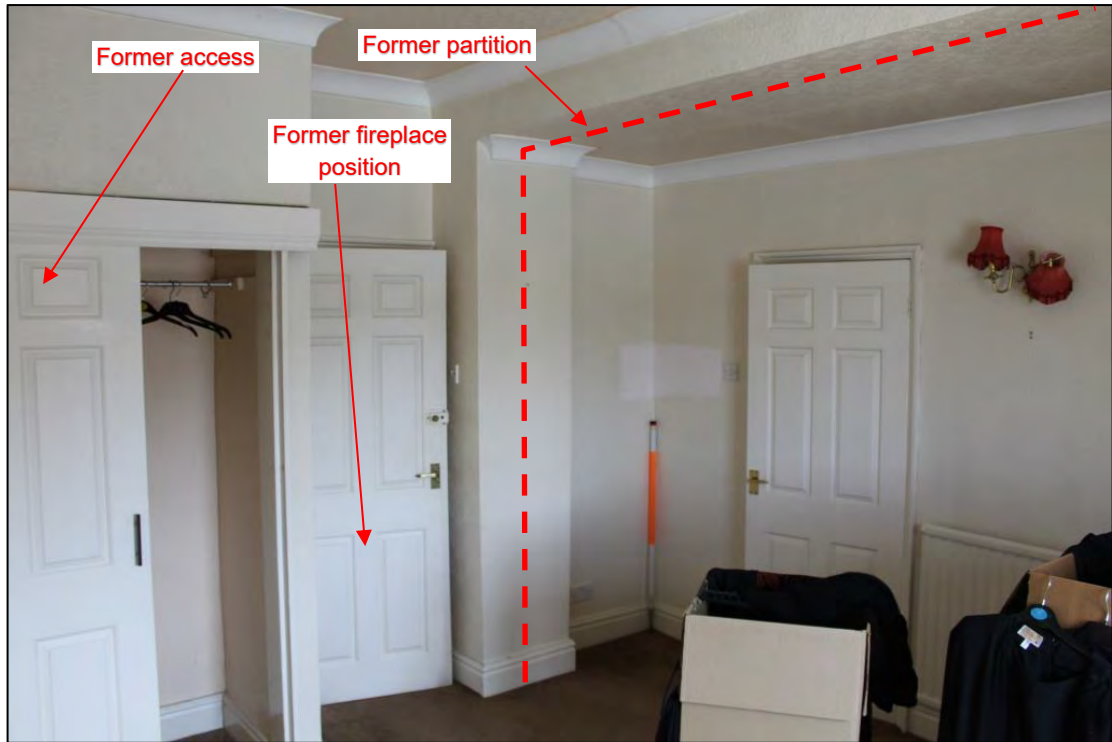
Photo 49: Overview of Room 40, looking south

- 4.43. Room 40 (Photo 49) comprises a bedroom on the opposite side of a shared jack-and-jill bathroom and has been considerably altered during the 20th century, as evidenced by the removal and insertion of various partitions and doors over time. The 1929 plan (Fig. 23) confirms that the room was once smaller, as defined by the beam present in the room currently and was only accessed through a door at the north-eastern corner. A fireplace was formerly positioned at the south-eastern corner but no evidence of this remains. During the 20th century the room was enlarged and a pair of ensuites created between this room and Room 39, at the expense of a third bedroom that was formerly positioned between them (Fig. 23). The former access to Room 40 is now blocked off and is used as a storage area whilst the former ensuite has also been decommissioned and is now used for storage only.

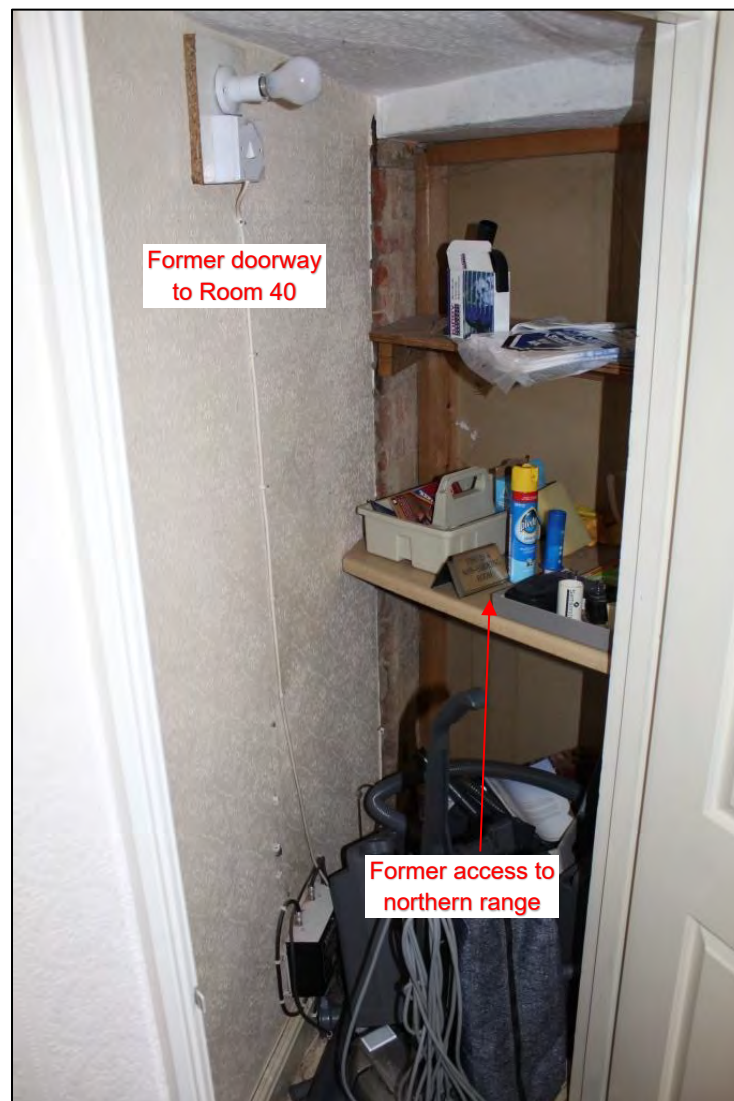
Photo 50: Former access from Room 35 to northern range and Room 40

4.44. Within Room 35, at the north-western corner is the former access to the northern range of Phase A, as shown on the 1929 plan (Fig. 21). This access would have formerly accommodated the doorway access to Room 40 and the onward corridor towards Rooms 41 and 42. This access has since been closed off and is now used as a store (Photo 50). This access was closed off during the mid to late 20th century when a new circulation route was created from Room 35, utilising a former external area above a flat roof, now incorporated within the internal space of the building.

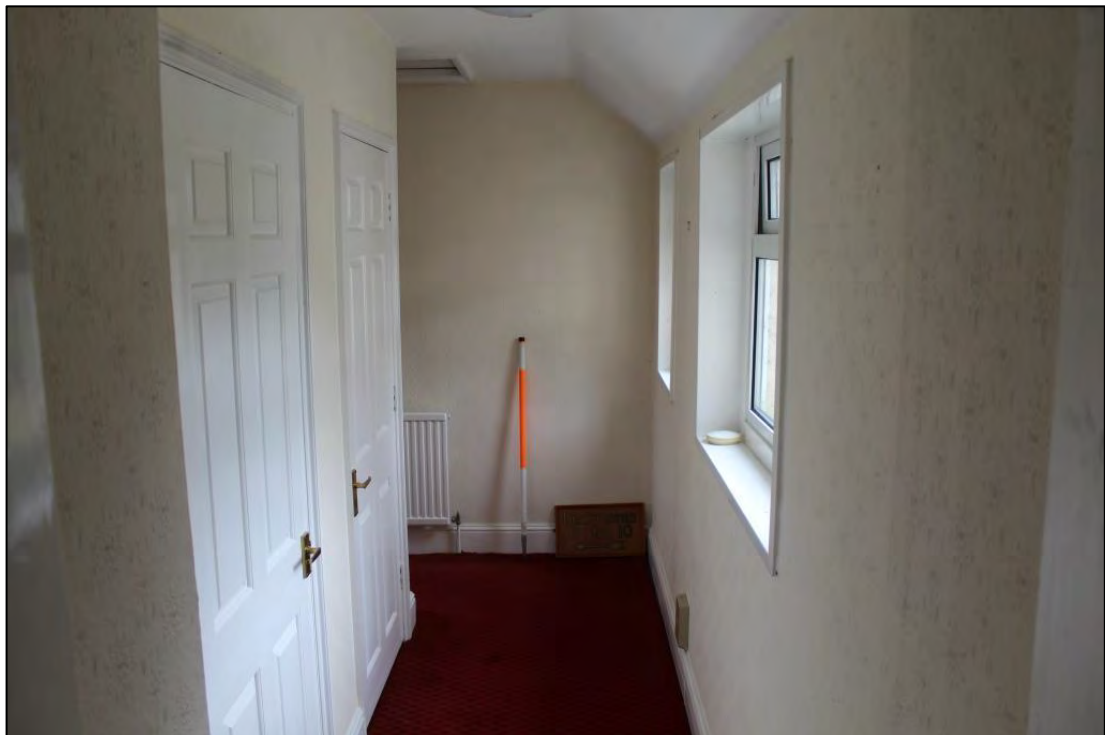
Photo 51: Link corridor constructed as part of the 1933 plans

4.45. A corridor leads past Room 41, which comprises a former bedroom with no surviving historical features, towards Room 42 (Photo 51), which was constructed as part of the 1933 plans (Fig. 24) to allow for a link to the upper floors of the former barn, which

is assumed to have gradually been integrated within the hotel function of the building over Phases D and E. Room 42 has been reconfigured slightly since its construction through the removal of a WC and integration of the bathroom into Room 41 as an ensuite.

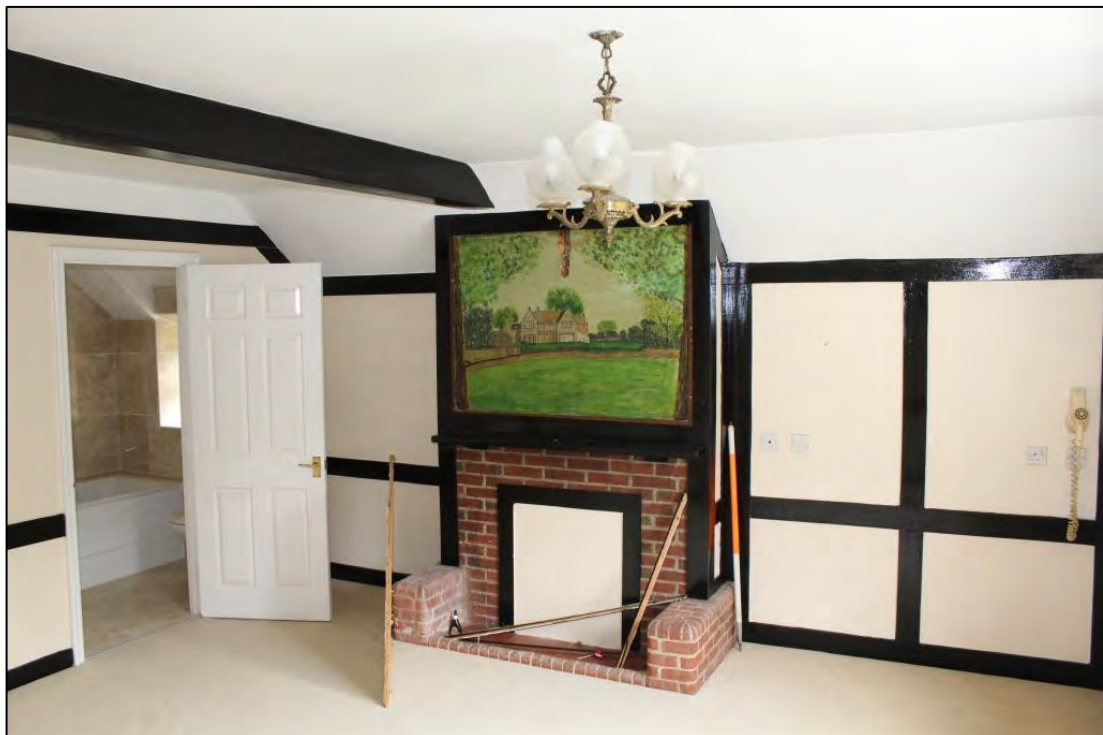
Photo 52: Overview of Room 43, looking north

- 4.46. Room 43 (Photo 52) was also included as part of the 1933 plans and is assumed to have been converted from the former hayloft, above the ground floor of the barn. The room features a distinctive decorative scheme of faux timber-framing around each wall whilst a central, brick fireplace emphasises the vernacular aesthetic. The timber-frame aesthetic was included on the 1933 plans and therefore survives since the room's conversion. A painting of the building is featured on the chimney breast above the fireplace (Photo 53) which is assumed to depict the building around the 1930s. The painting records the adjacent stable and barn as well as the outbuilding to the east, which is likely to have been constructed around the same time, or slightly later (i.e. Phase E). Room 8 is shown in an earlier incarnation that is likely to have been replaced since that time.

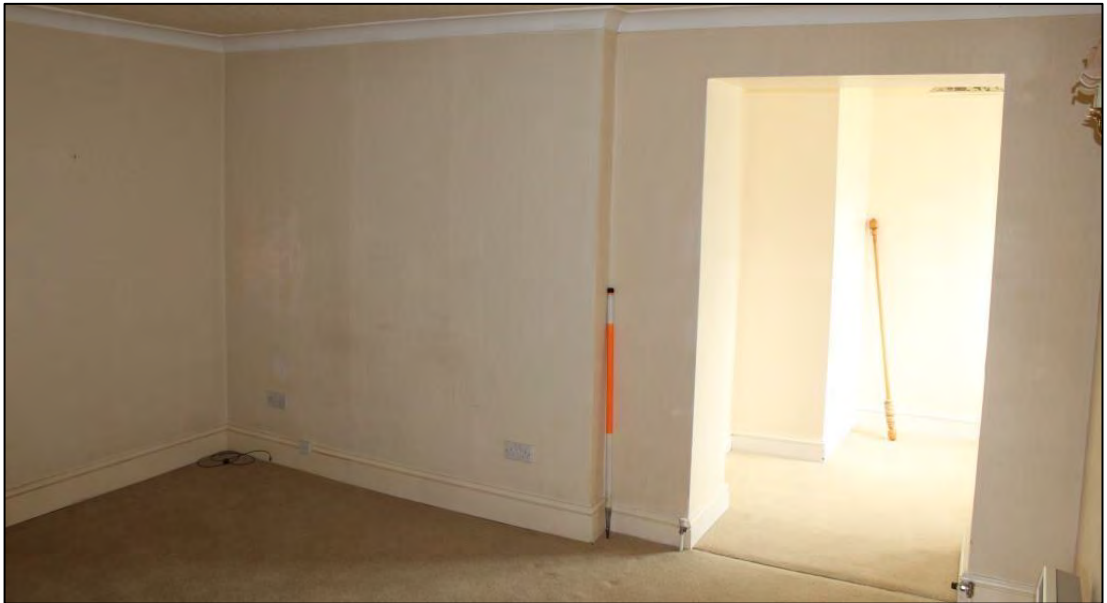
Photo 54: Overview of Room 44, looking north-west

- 4.47. Room 44 was configured during the mid to late 20th century and incorporates a bedroom, ensuite and additional floor space within Phase F. The room has evidently been reconfigured more than once, as depicted on the 1933 plan where the room was formerly a pair of 'maids rooms', with a partition intersecting the former fireplace. The present partitions were then installed at a later date to create the present configuration (Photo 54).

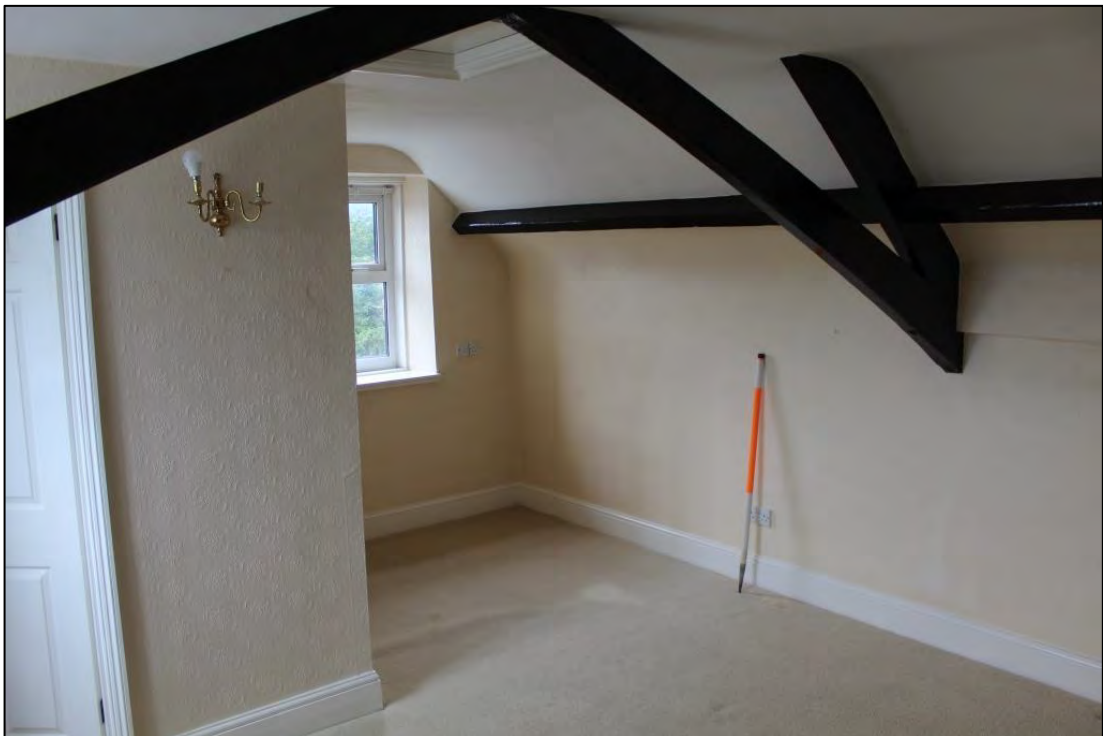
Photo 55: Overview of Room 47, looking north-east

-
- 4.48. A staircase within the northern range of Phase A leads up to a second floor which contains only Room 47 (Photo 55). The room incorporates timber roof members in an arrangement to allow for sufficient head height. A modern ensuite is positioned at the north-western extent of the room. A small access hatch is located at the top of the staircase that permits access to the roof void above Rooms 39 and 40 (Photo 56). The loft space allows sight of three sequential king-post roof trusses that were a common feature of 19th-century roof construction.
- 4.49. Rooms 48 to 51 comprise the first floor of the Phase F extension at the northern extent of the building, constructed in 1991/92. As with Rooms 30 to 33, each room incorporates a wholly modern decorative scheme with no historical features (Photo 57).

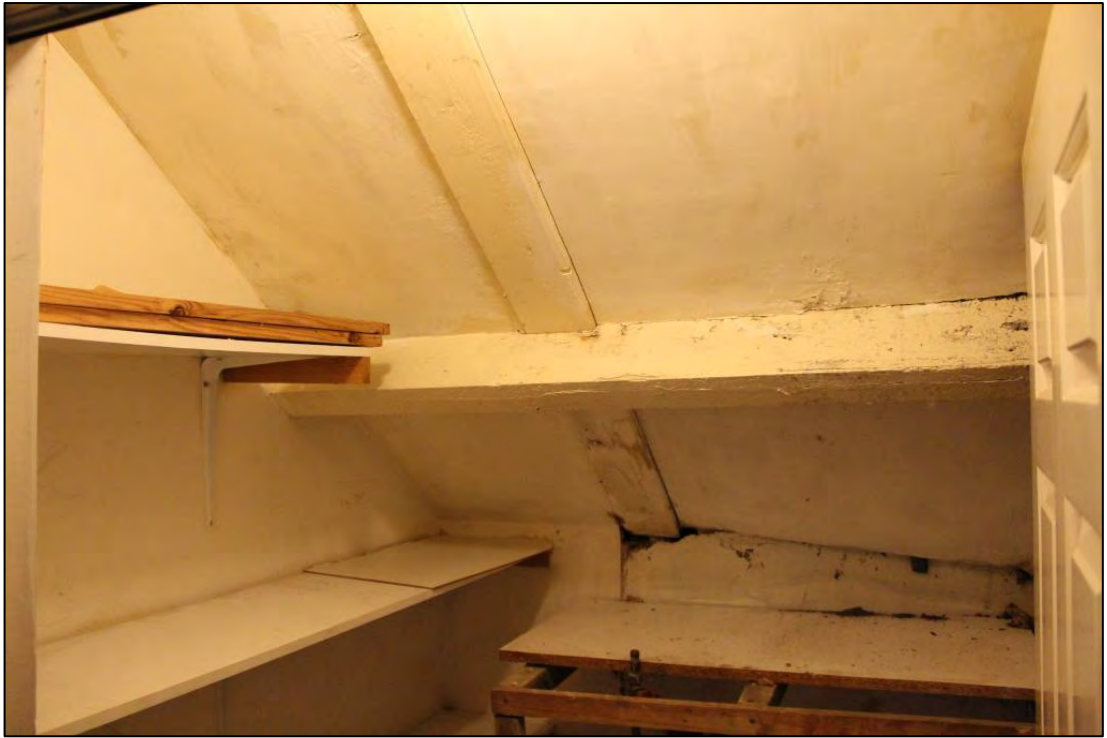
Photo A31: Detail of roof structure within former barn
