Roman Baths Museum The Archway Project York Street Bath

Programme of Archaeological Works

CA Project: 6494
CA Report: 18148

February 2022

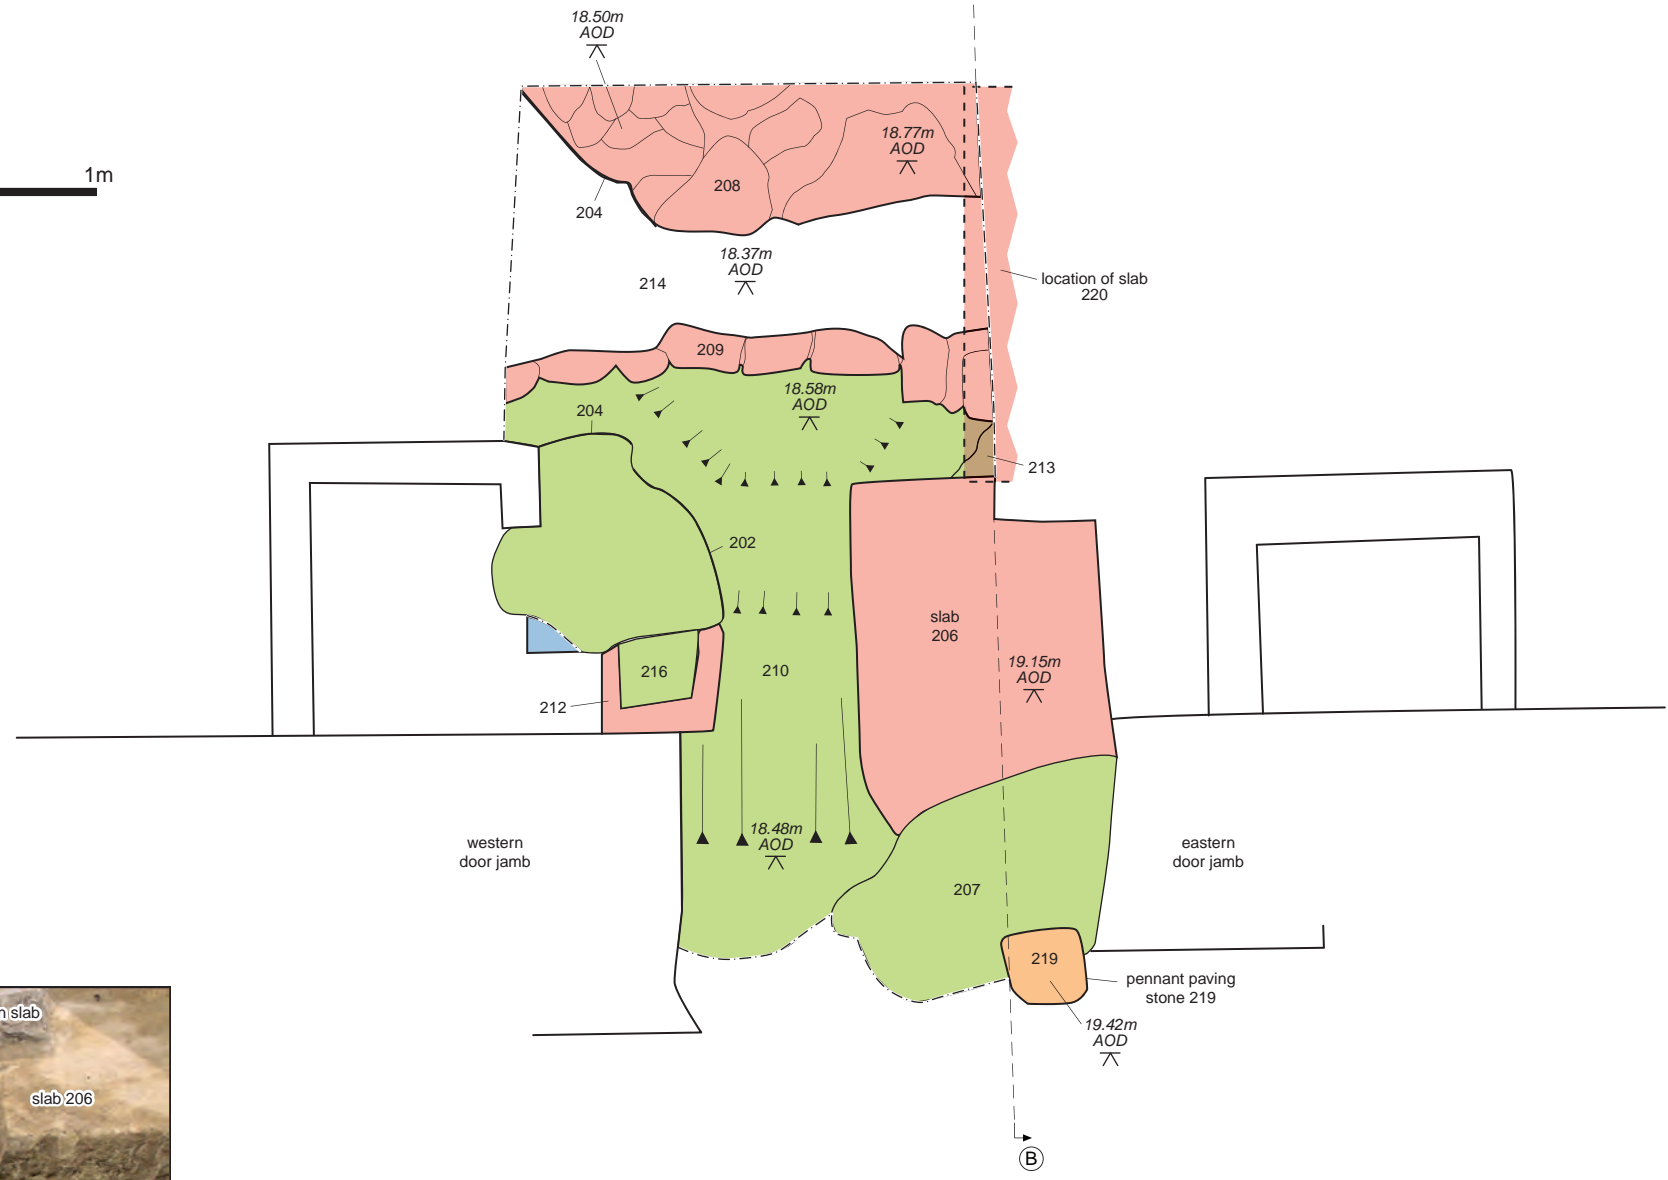
Area B, looking east (0.4m and 1m scales)

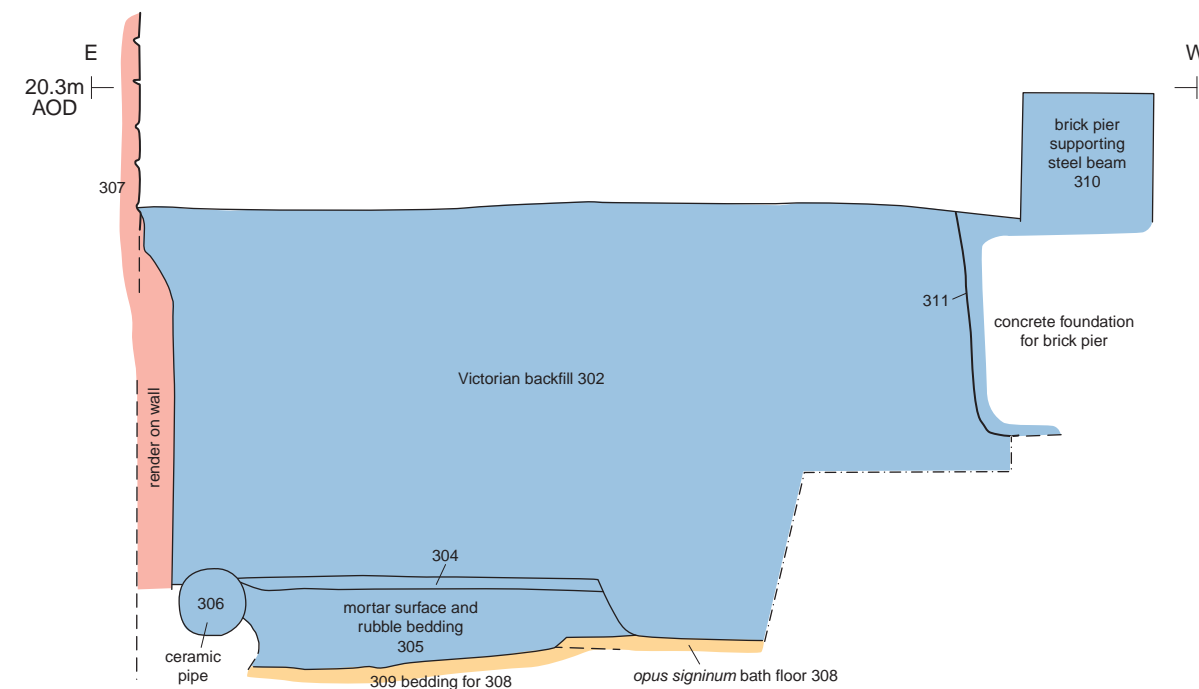
Area C, looking south-east (0.4m and 1m scales)

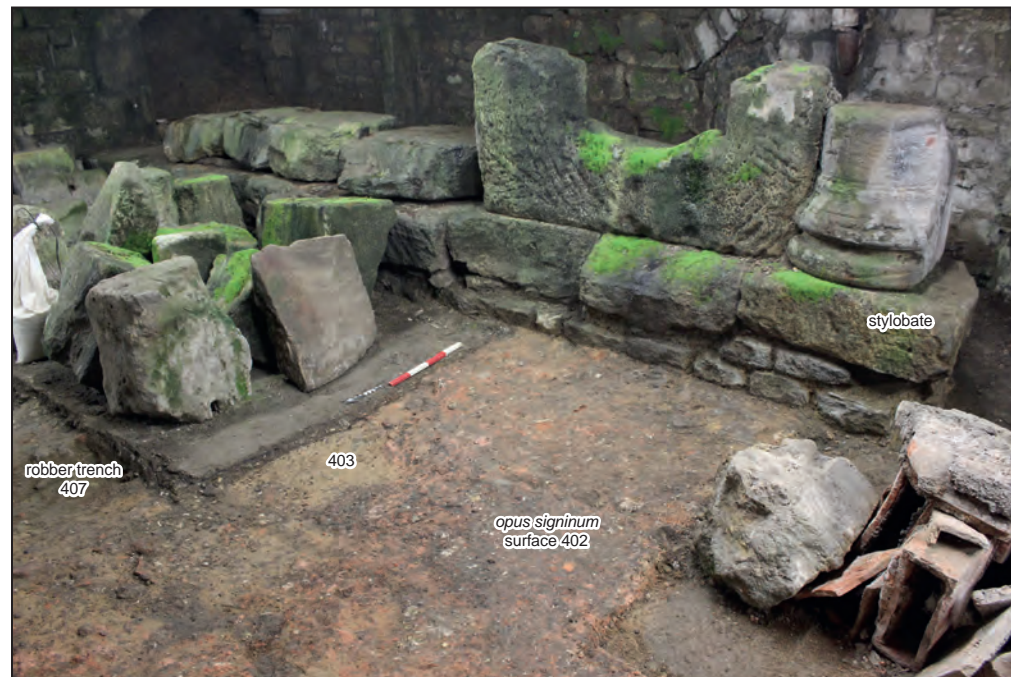
Area D western extent, looking south-east (0.4m scale)

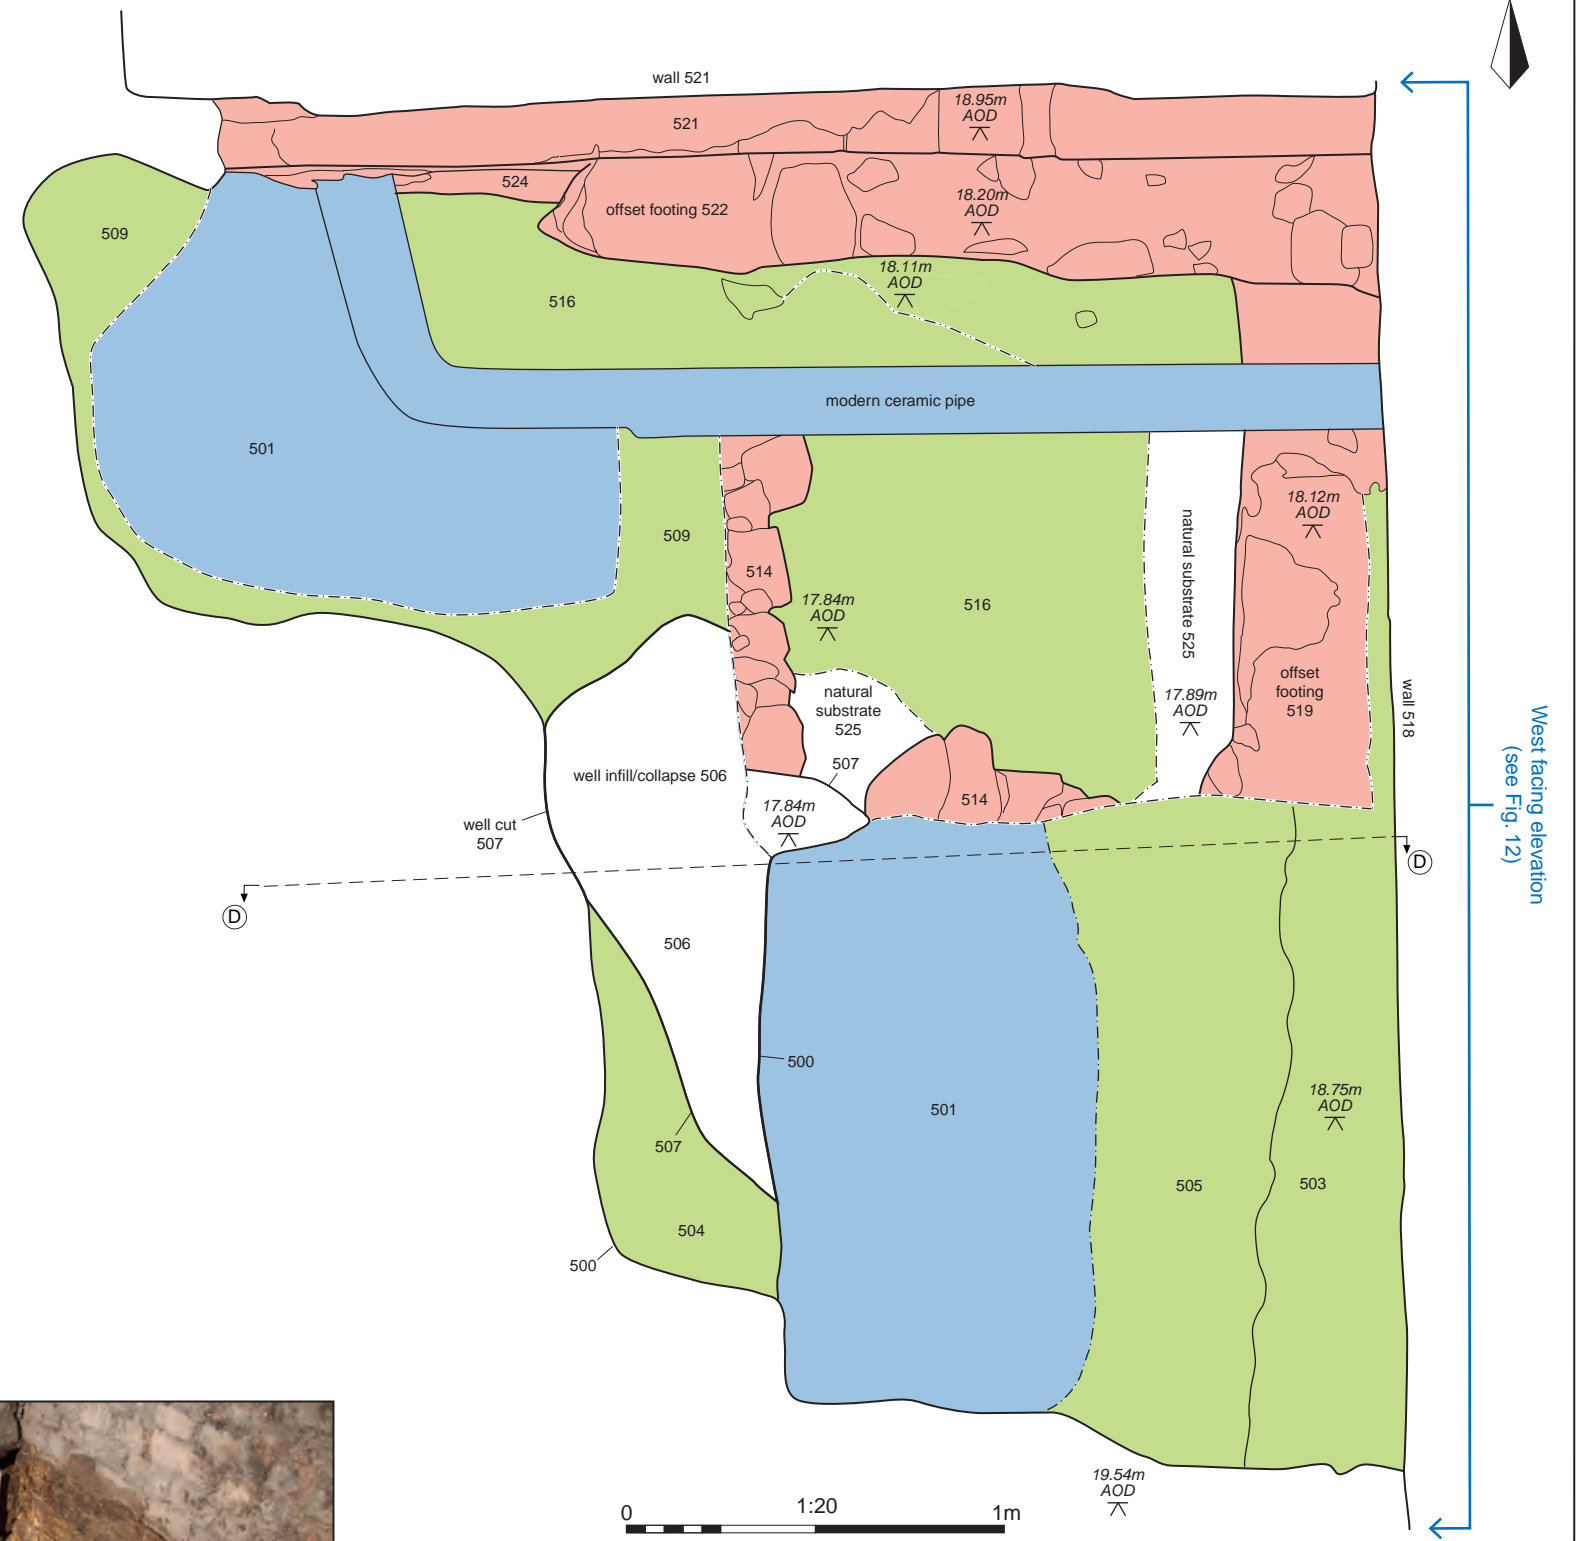
Area E section, looking south-east (0.4m and 1m scales)

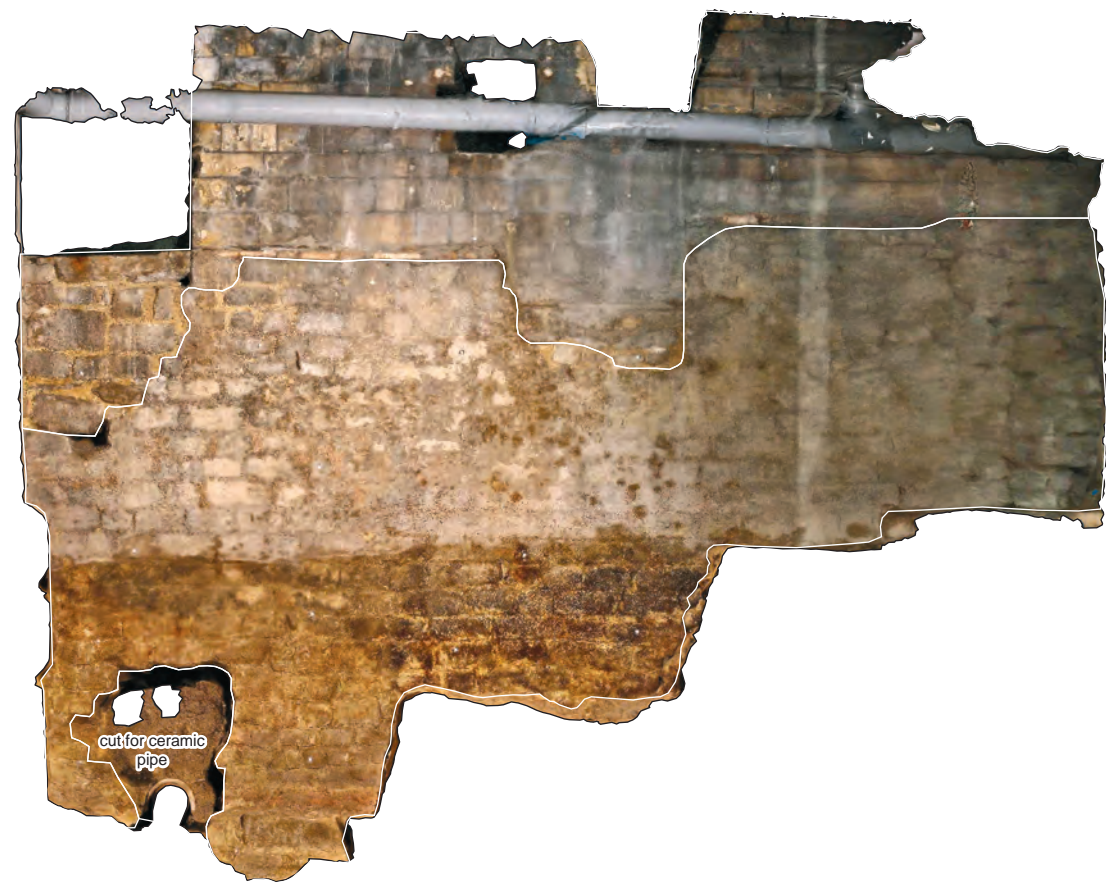
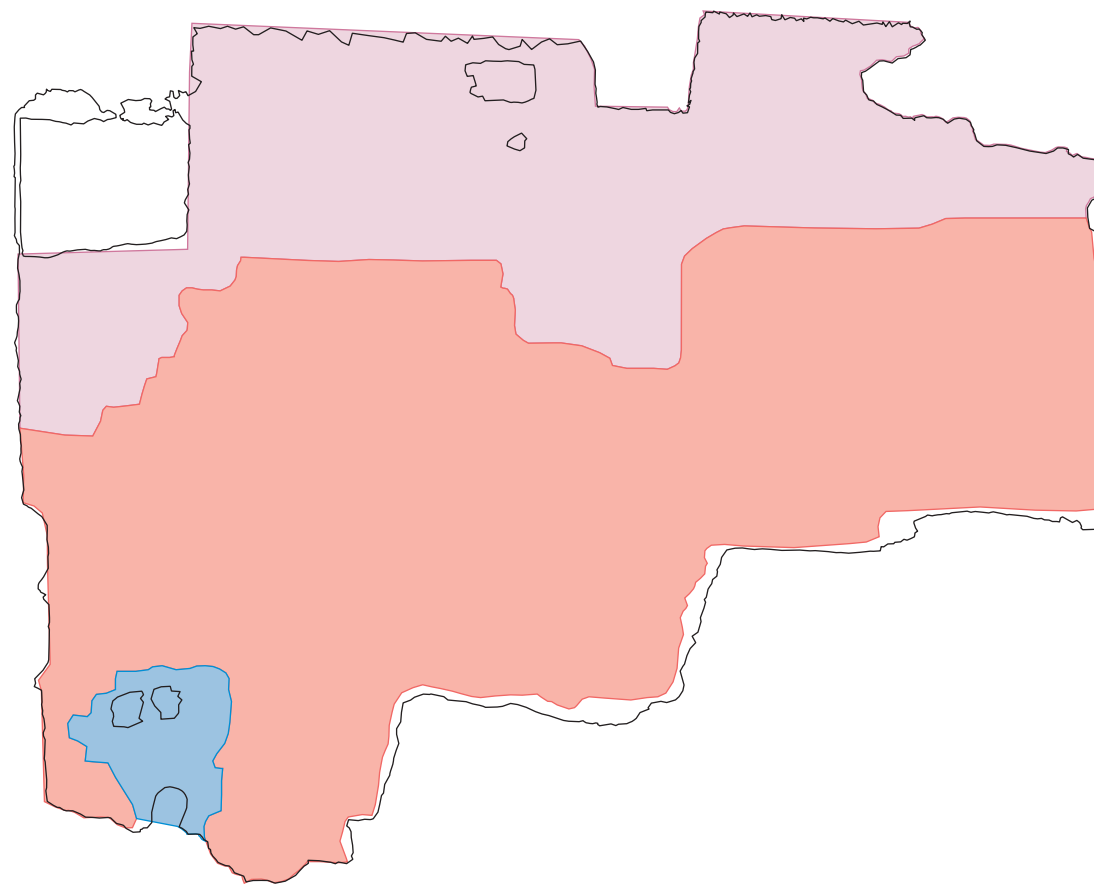
FIGURE TITLE
Phase 1, Area E: west-facing elevation
of wall 518

- Modern
- Victorian
- Roman

- 5.23 A pitched stone footing 514 (equating to Cunliffe's Layer 9), of unworked limestone blocks measuring between 0.12m and 0.3m in length set on edge against each other in a mortar matrix, overlay the natural substrate. The footing was sealed by a thin white mortar layer 513 (not noted by Cunliffe), which was laid level with the upper part of offset footing 519. It is therefore probable that 513 was a preparation or bedding layer for 512, the "red mortar floor" identified by Cunliffe as Layer 8. This comprised crushed and compacted CBM that, on average, measured 0.04m in depth. It butted wall 518, completely sealing the offset footing 519.

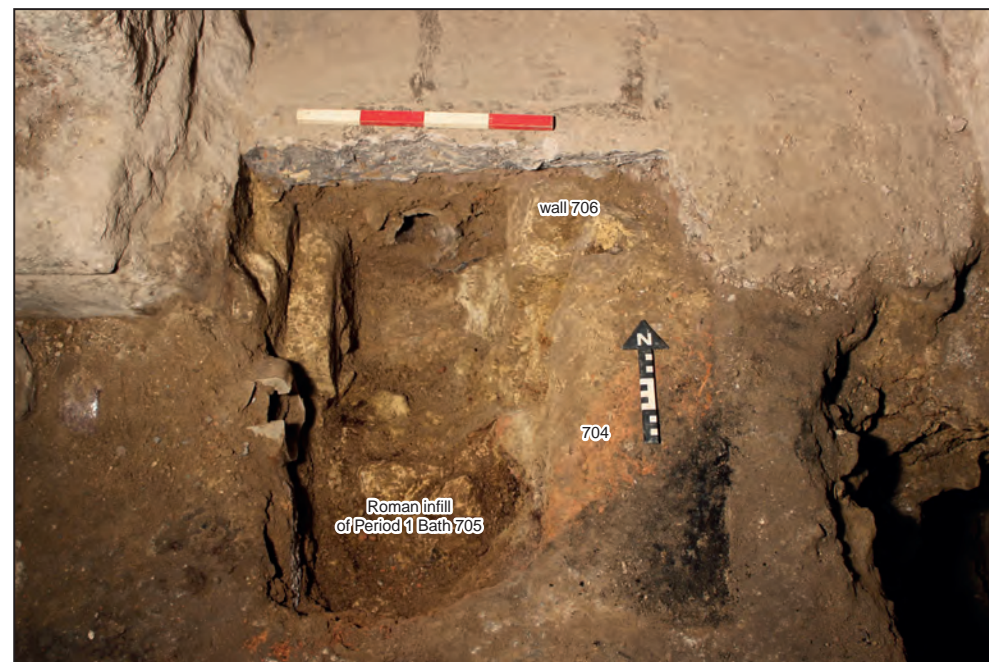
Area G, looking north (0.4m scale)

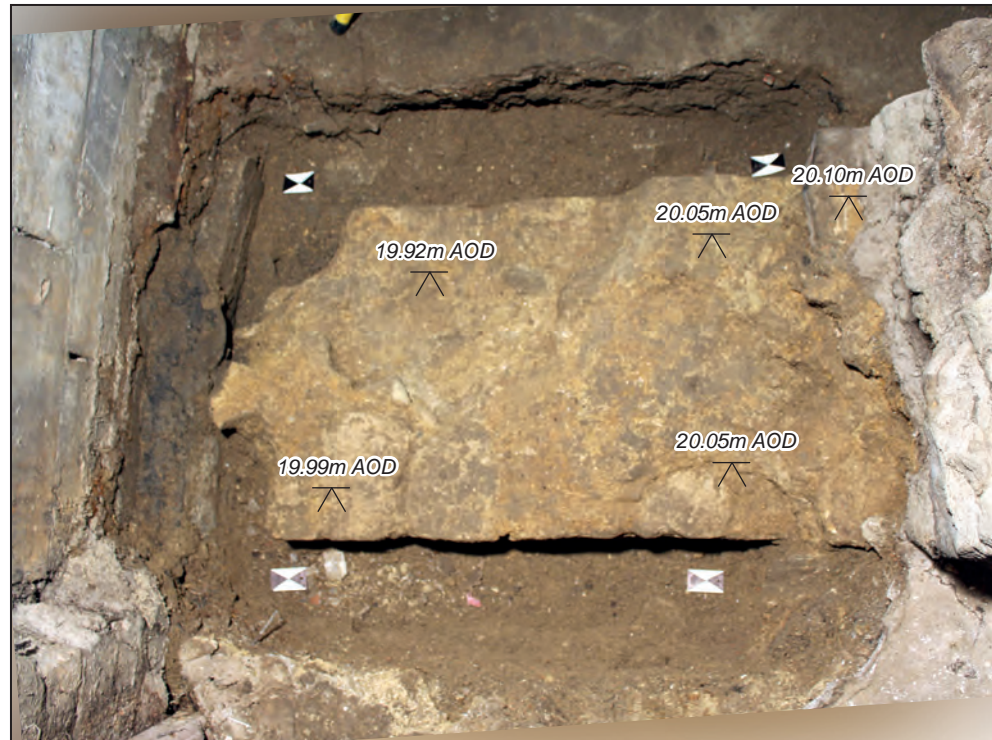
Trench I, Wall 901

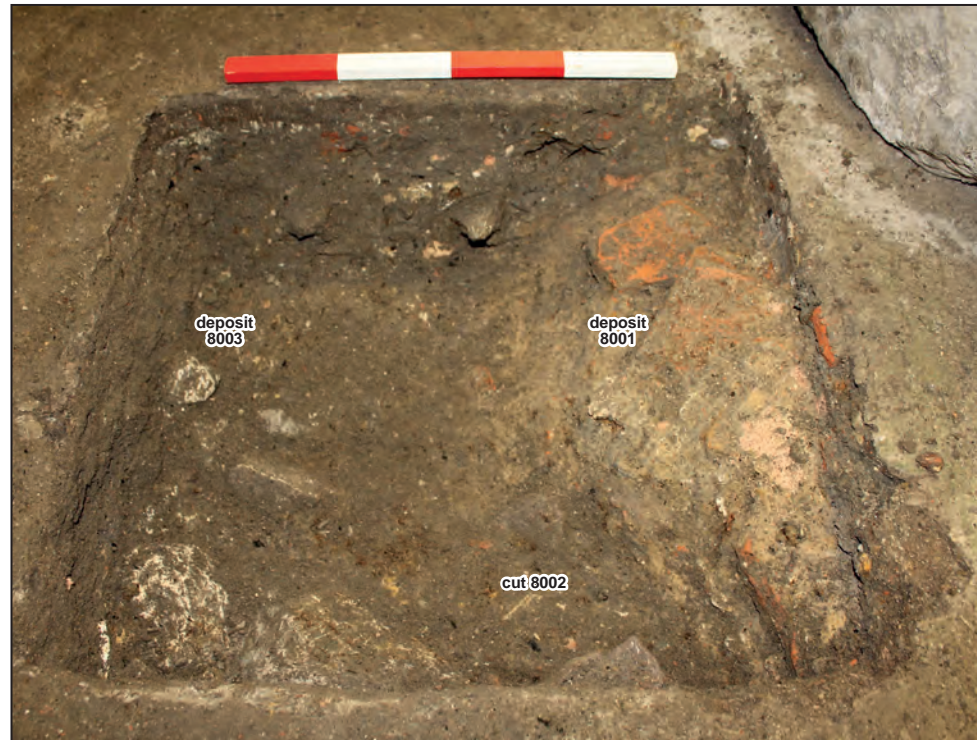
Test pit 8, looking east (0.4m scale)

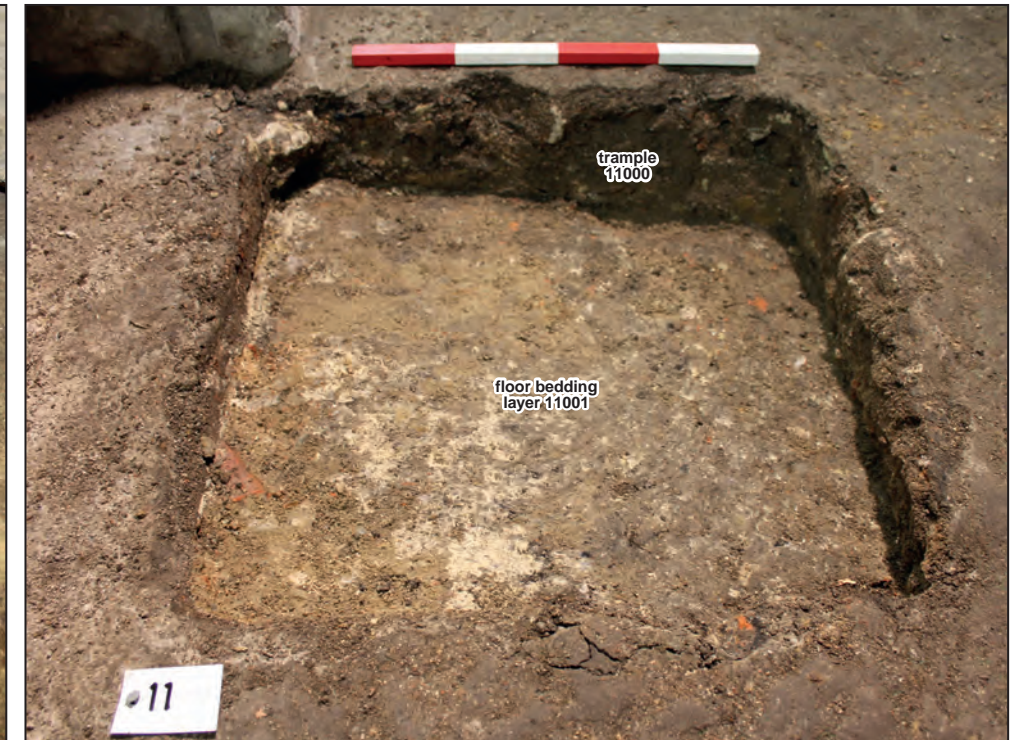
Test pit 11, looking west (0.4m scale)

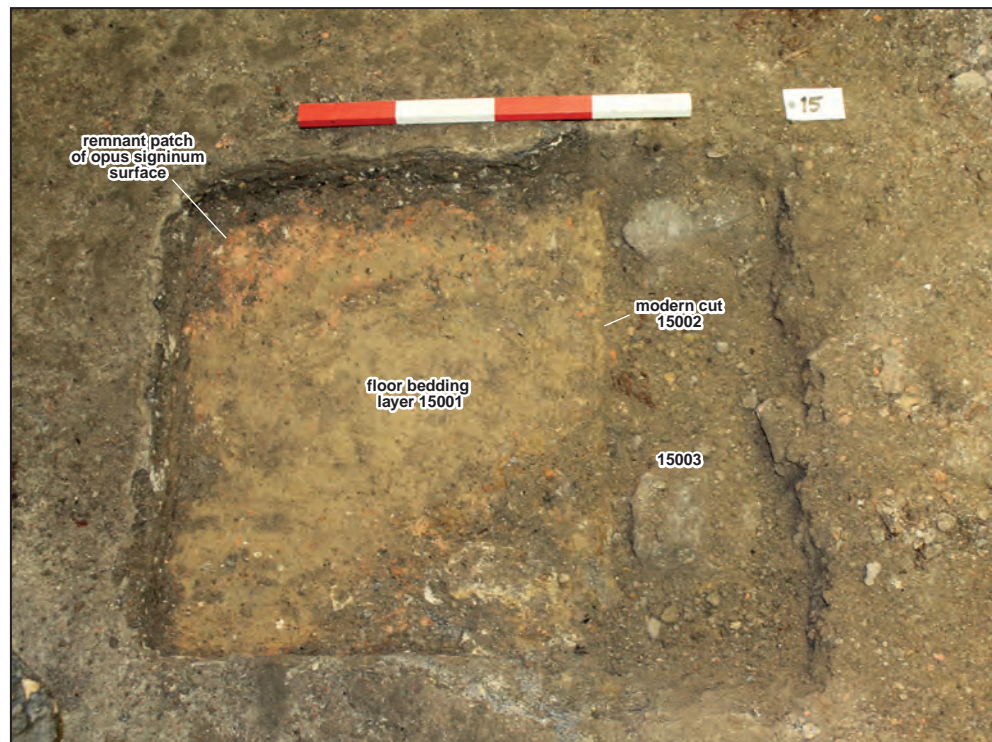
Test pit 15, looking east (0.4m scale)

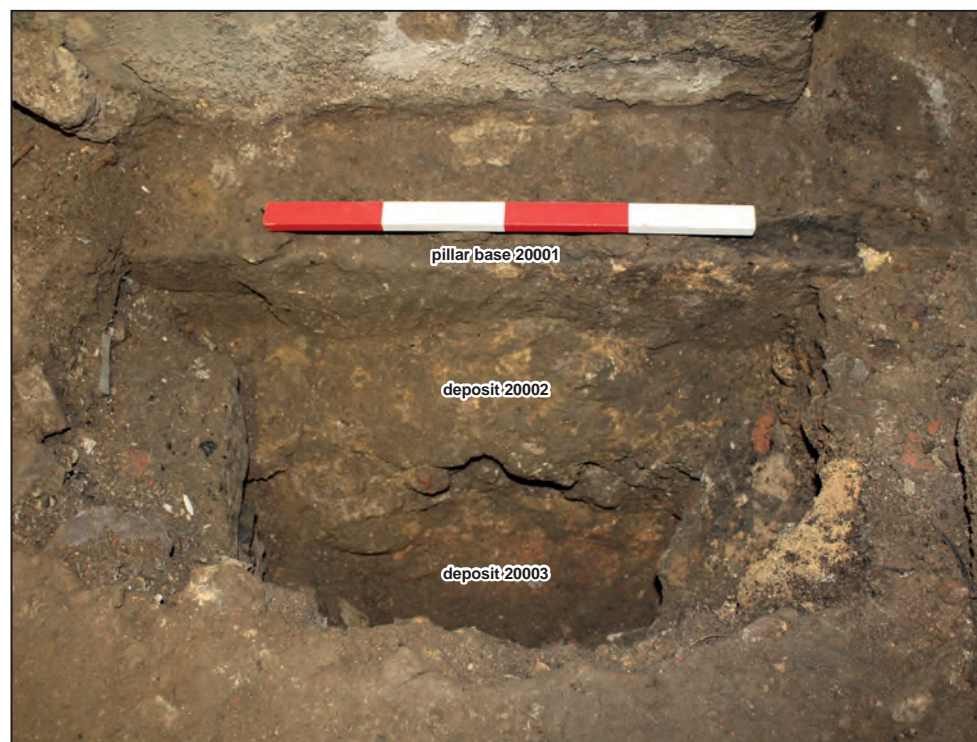
Test pit 20, looking south (0.4m scale)

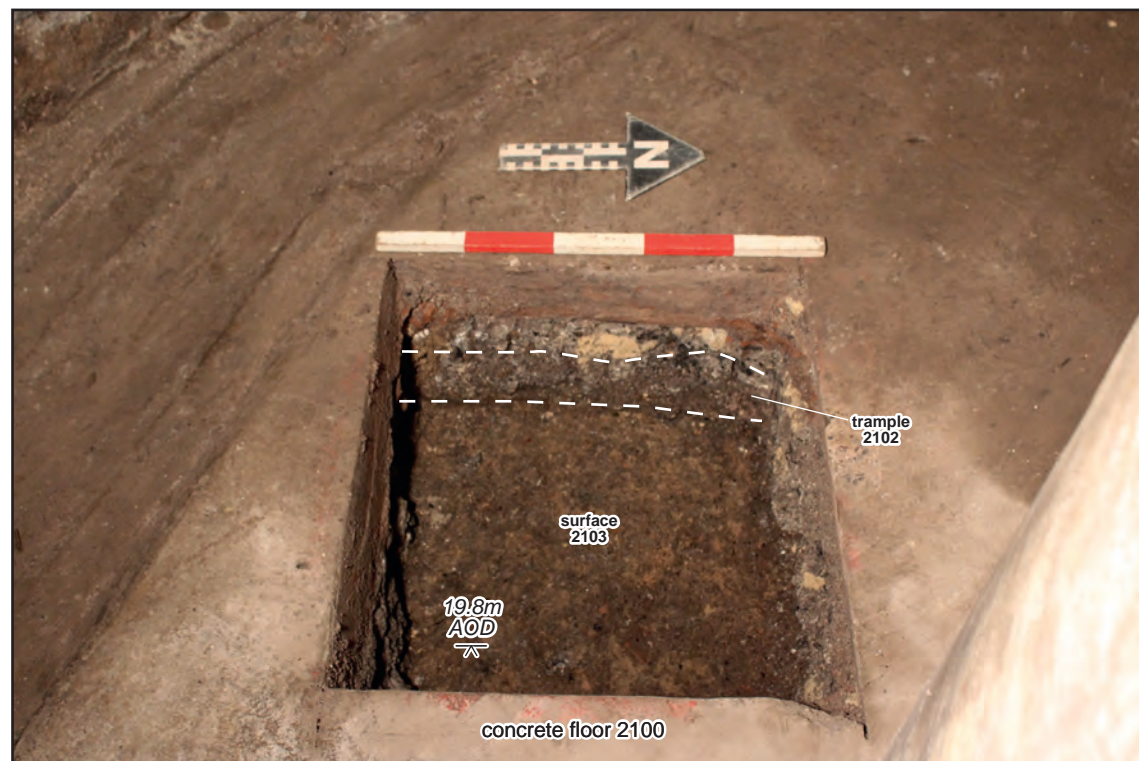
Test Pit 21, facing west (0.5m scale)

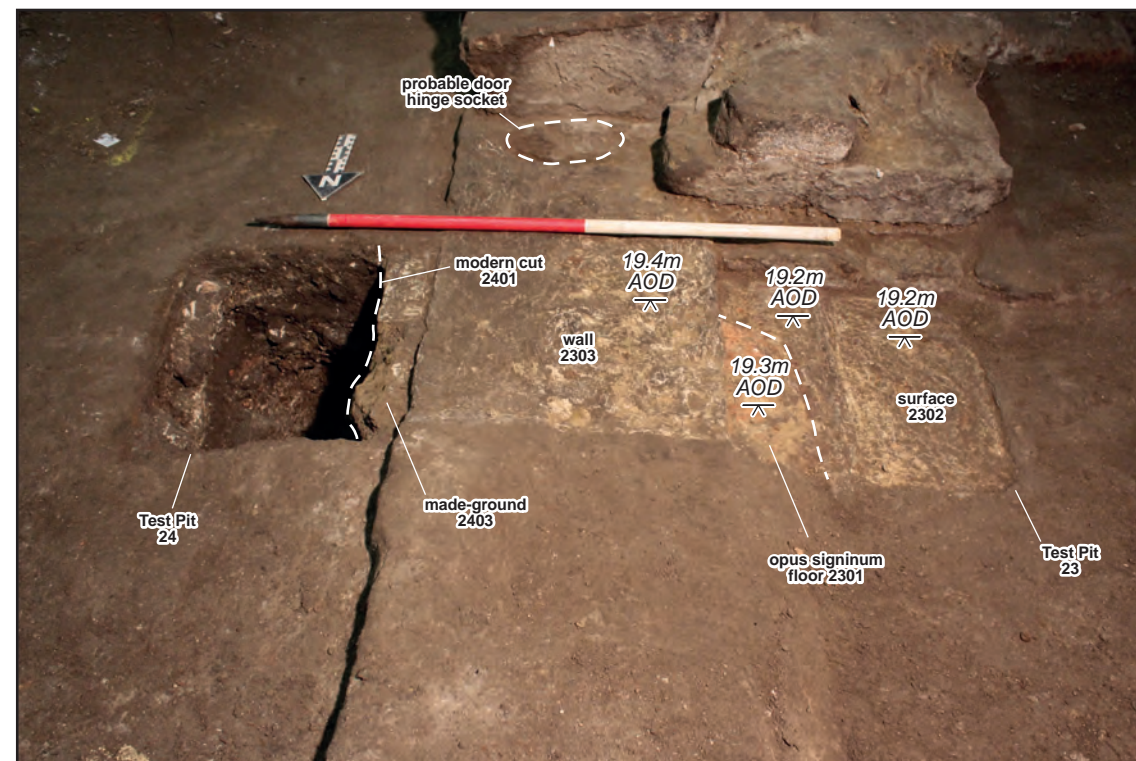
Test Pits 23 and 24, facing south (1m scale)

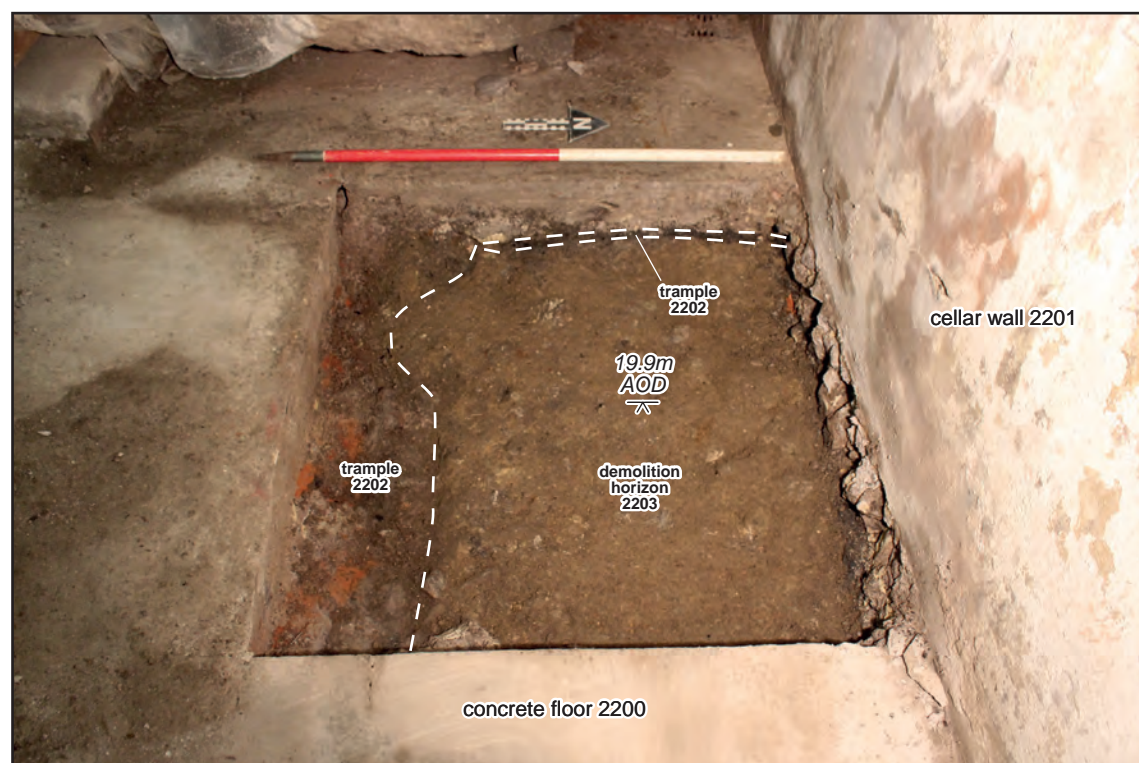
Test Pit 22, facing west (1m scale)

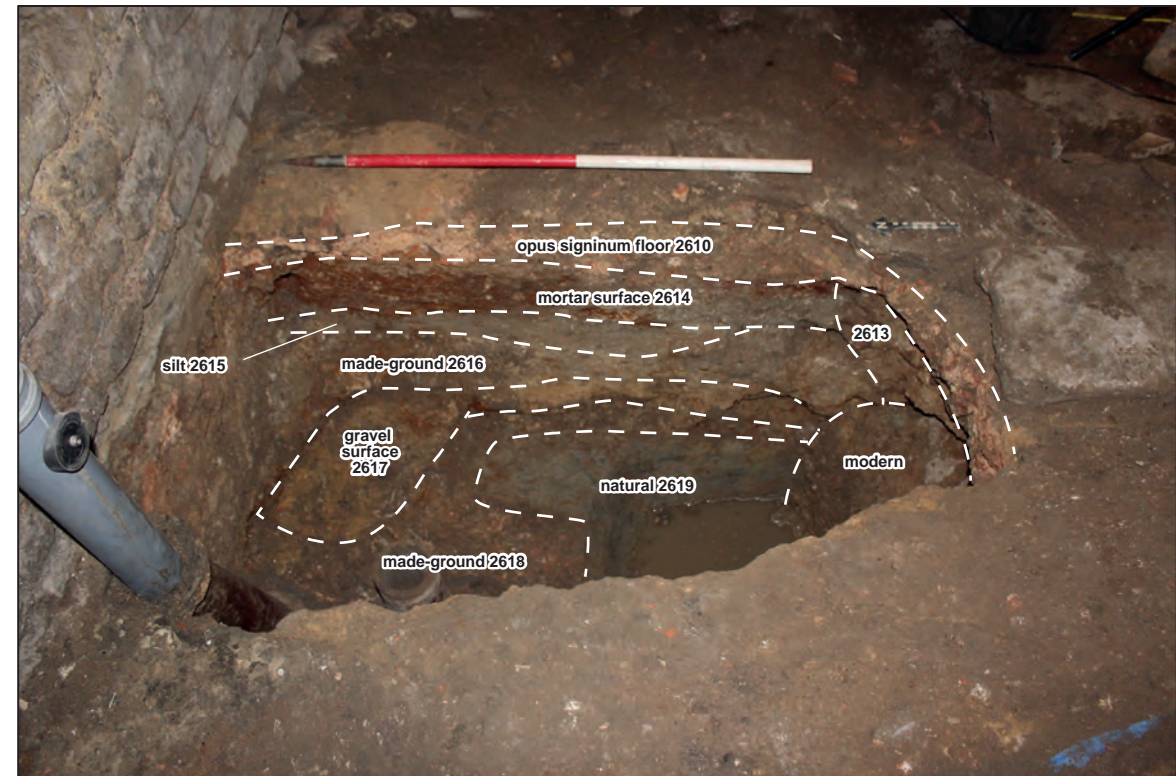
Gravel surface 2617 and made-ground 2618, facing east (1m scale)

- 5.70 The sequence in the west side of the trench, as noted above, was different. There, culvert 2620 cut consolidation layer 2623 (18.66m AOD) that measured approximately 0.3m thick and was formed of limestone rubble and clay, very different from the deposits on the other side, 2618–2616. It was sealed by clay silt 2622 (18.7m AOD), in turn overlain by levelling layer 2621 (19.01m AOD) that measured approximately 0.35m thick. These were also cut by Culvert 2620.

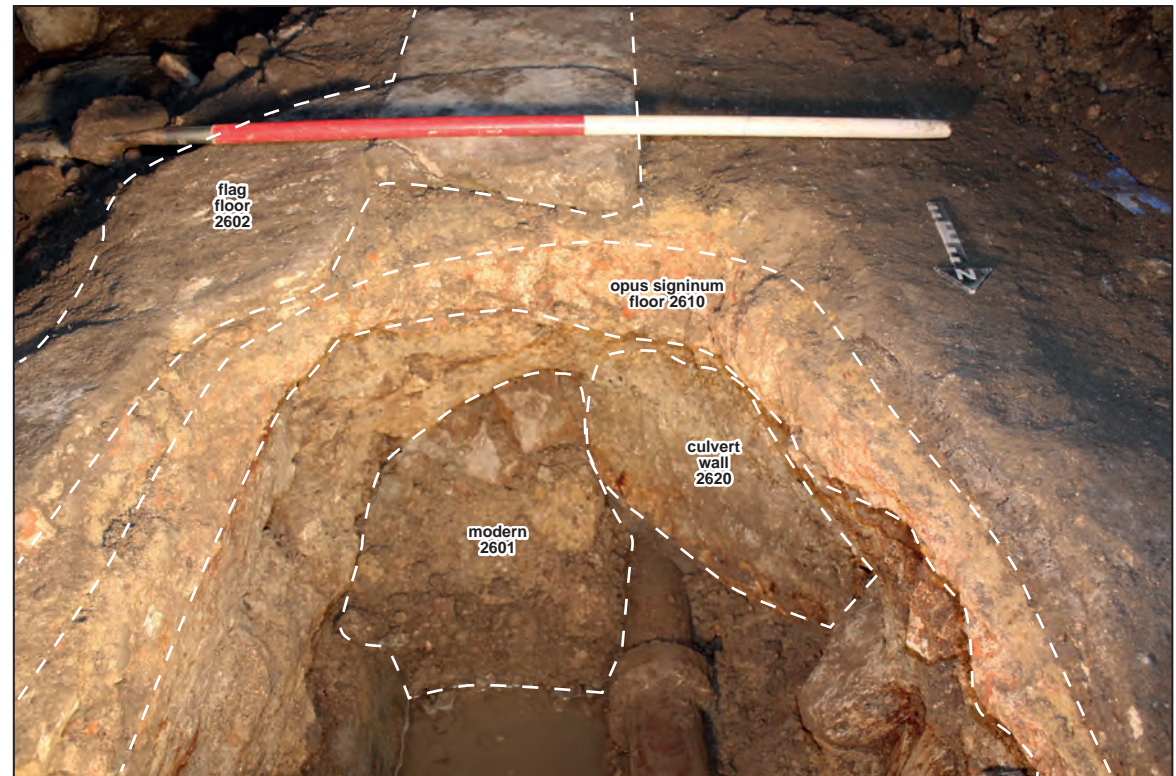
Flag floor 2602, opus signinum floor 2610 and culvert wall 2620, facing south (1m scale)

- 5.71 The thick mortar layer 2614, the fill of the culvert cut and layer 2621 were all sealed by a solid *opus signinum* floor 2610 (19.12m AOD), which was identified in all sections (and in plan over most of the area west of wall 2303). It measured approximately 0.15m thick and was of high quality, made of highly hydraulic lime mortar and brick and tile fragments. The *opus signinum* floor 2610 was replaced by a pennant slab

floor, 2602 (seen in substantial patches over all this area west of wall 2303) which was laid on a mortar bedding, 2608/9. It was clear that the *opus signinum* floor had suffered wear, levelled out by the bedding for the new slab floor. In the western section, lenses of gravel and trample layers formed over the *opus signinum* and the later bedding, between 19.27m and 19.16m AOD (2603, 2604, 2605, 2606 and 2607). All these layers were, of course, cut by the cut of the tunnel and later excavation (2600) which, at depth, was rectangular in plan with vertical edges. It measured 1.75m in length, 0.72m in width and 1.15m in depth and contained ceramic pipe 2624, backfilled with deposit 2601, from which a nail cleaner strap end was recovered with incised peacock design dating to the late Roman period (See Section 6, Appendix D2 below and Fig. 39).

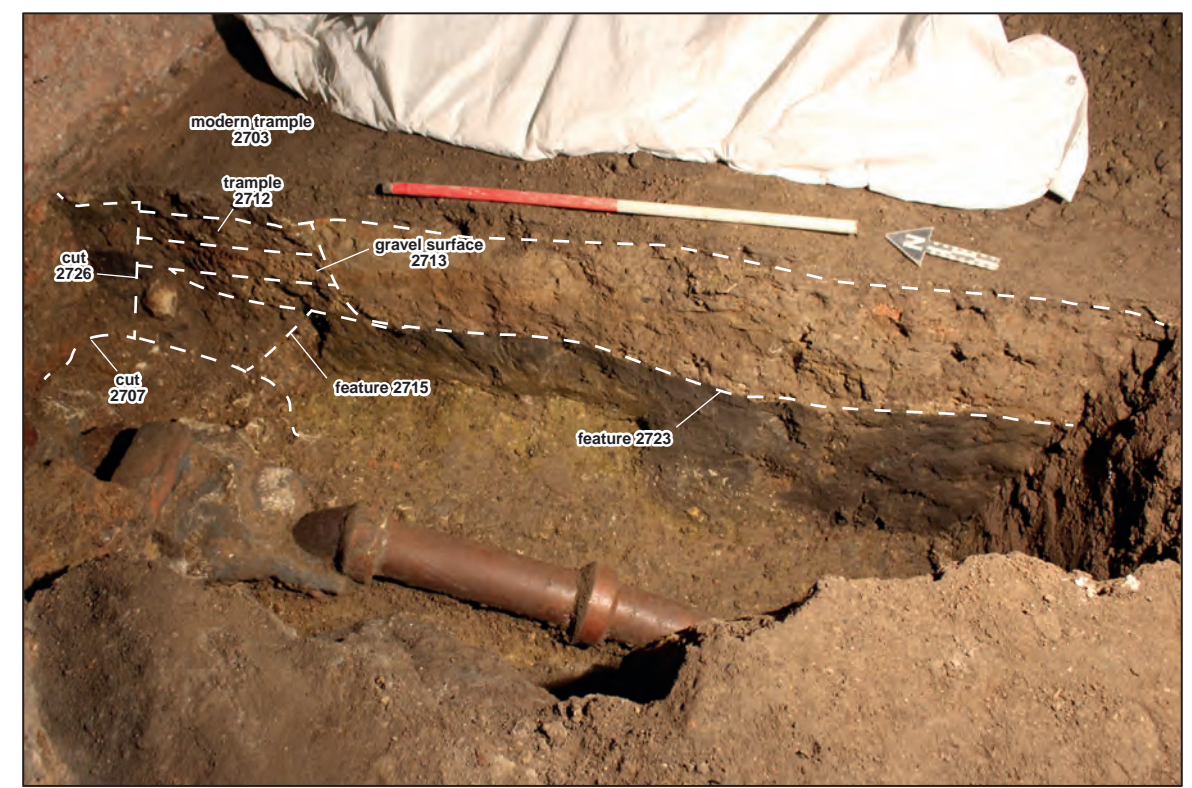
Wall construction 2707, trample 2712, ground surface 2713, and cut features 2715 and 2723, looking north-east (1m scale)

- 5.74 The narrow cut 2726 along the wall that cuts the fills of 2715 and the layers above it, is also undated. It is recorded as the construction trench for the baths south wall but this is clearly not the case, as it is cut from 0.4m above the render on the wall. It seems to bottom on the base of the cut 2715, above the actual foundation trench cut. It contained a series of deliberate infills (2725, 2711, 2710, 2709 and 2708), all of which remain undated. These are somewhat puzzling, as they are almost perfectly horizontal, which implies that they were carefully packed into the narrow slot and not just carelessly shovelled in. This interpretation is also supported by the choice, type and sequence of deposits, where the lowest layer, 2711 is a mortar and stone mix, topped with dark grey clay, 2710 and then two silty layers 2709 and 2708.

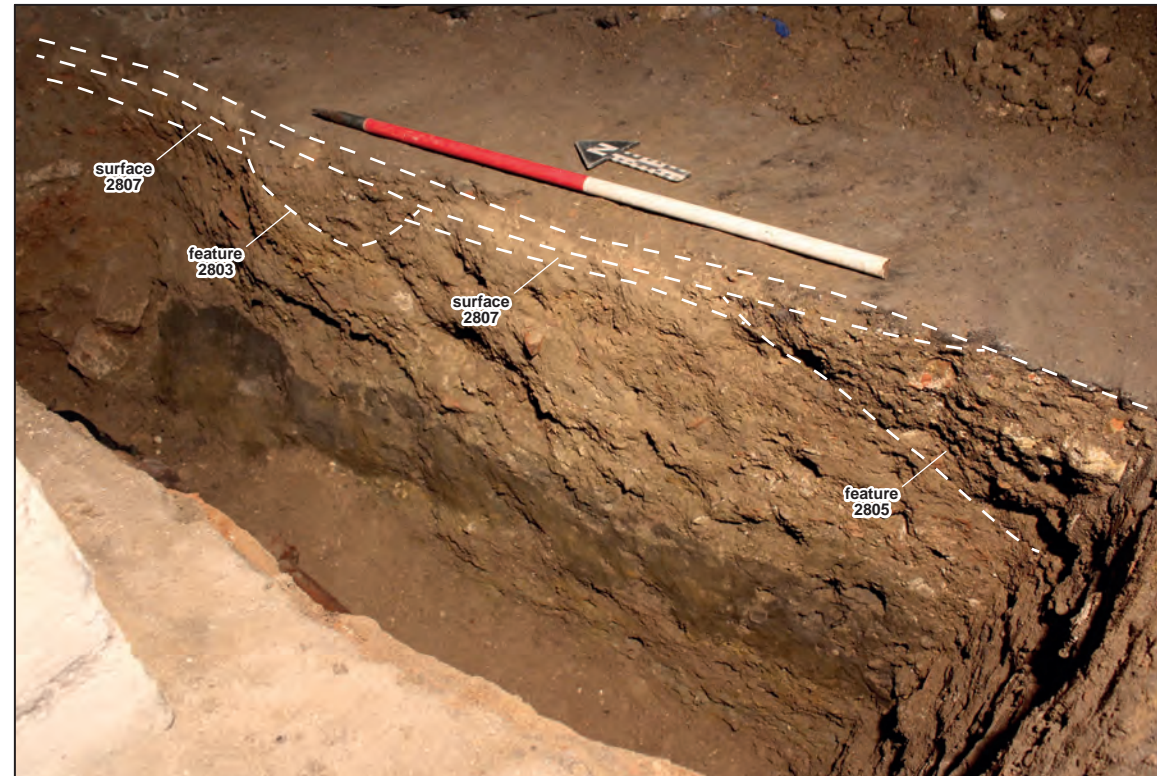
Features 2803 and 2805, and surface 2807, looking north-east (1m scale)

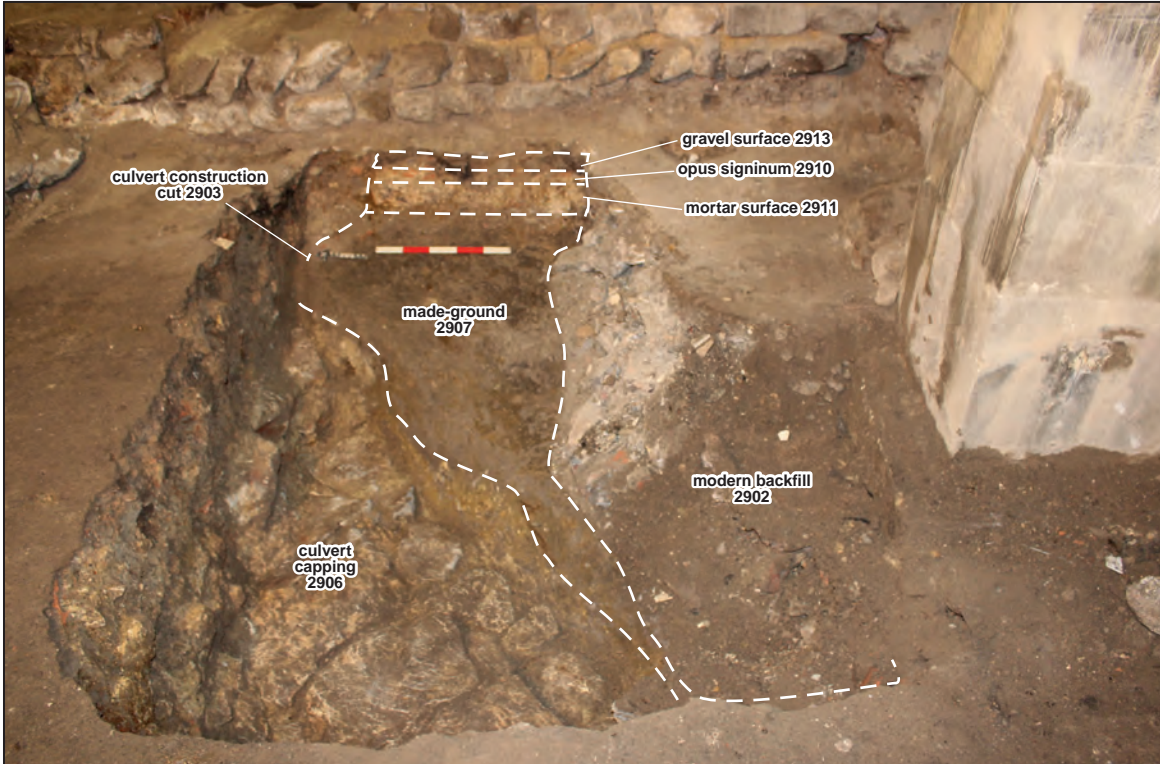
Trench 29, looking east (0.5m scale)

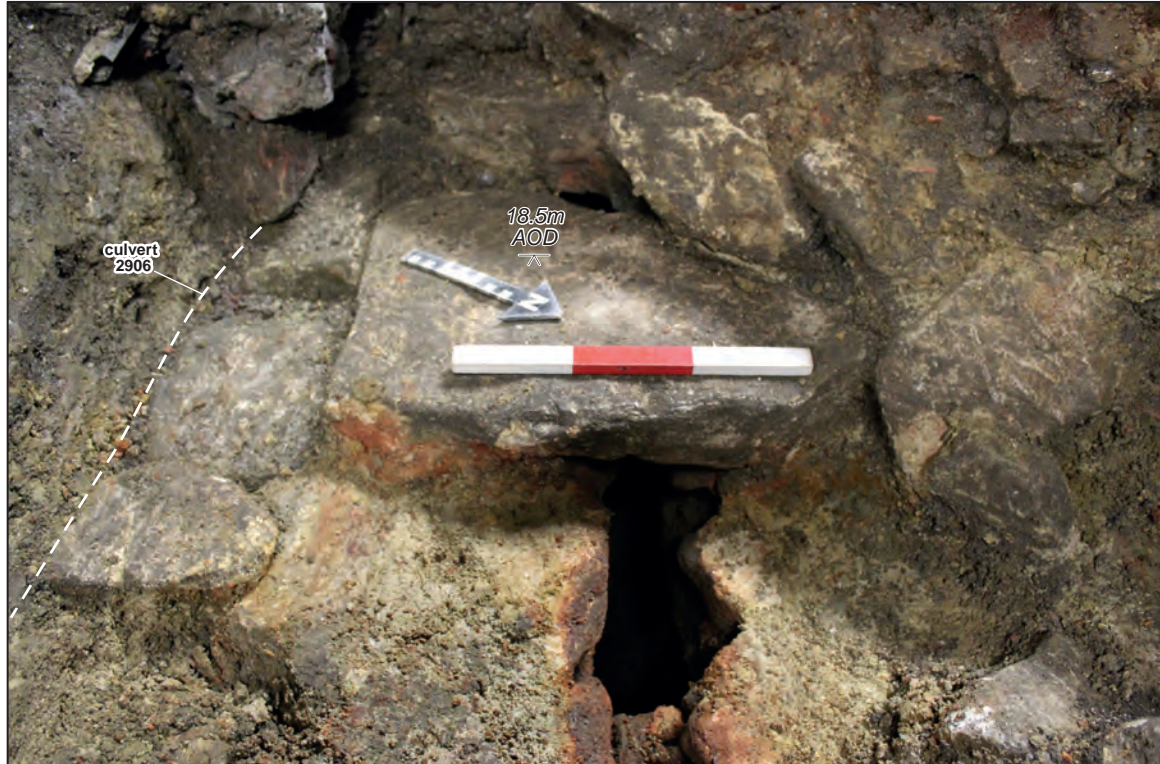
Culvert 2906, looking south-west (0.3m scale)
