Roman Baths Museum The Archway Project York Street Bath

Programme of Archaeological Works

CA Project: 6494
CA Report: 18148

February 2022

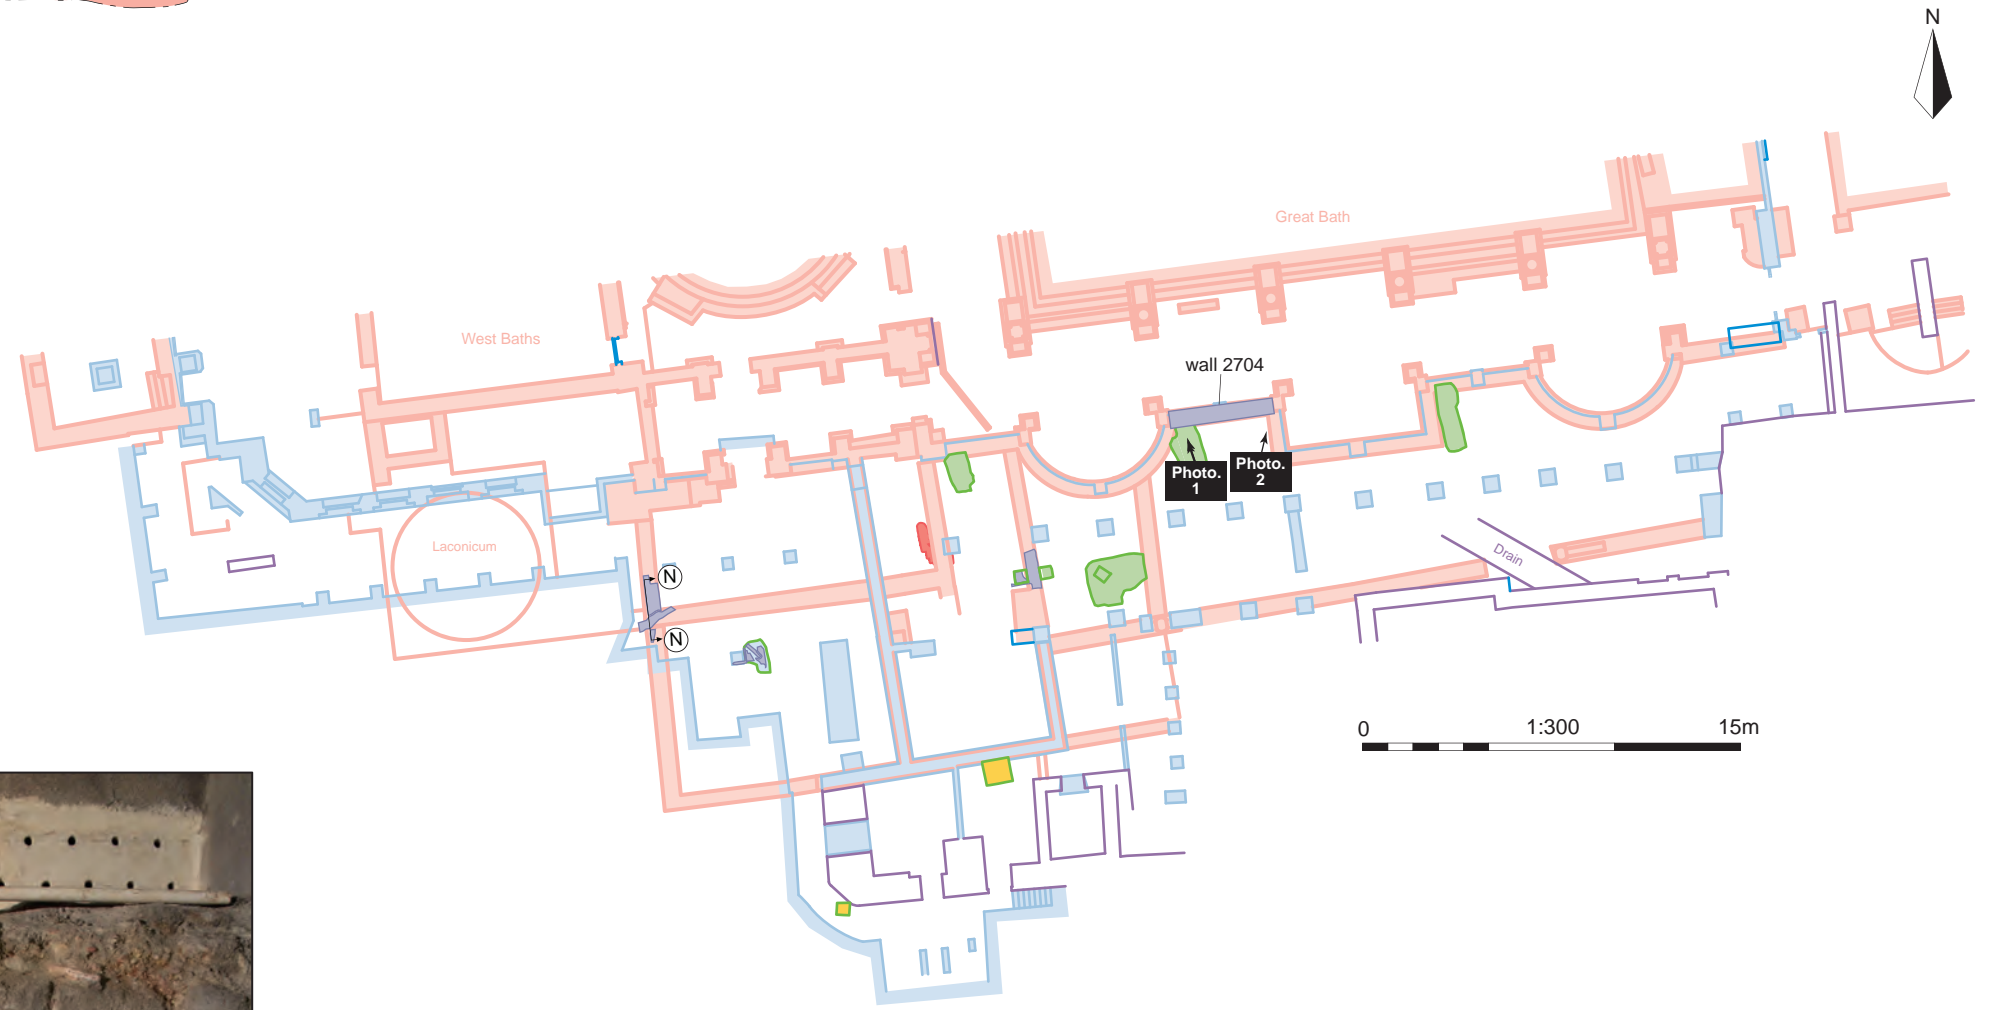
Photograph 1. Western butt joint of wall 2704, looking north (1m scale)

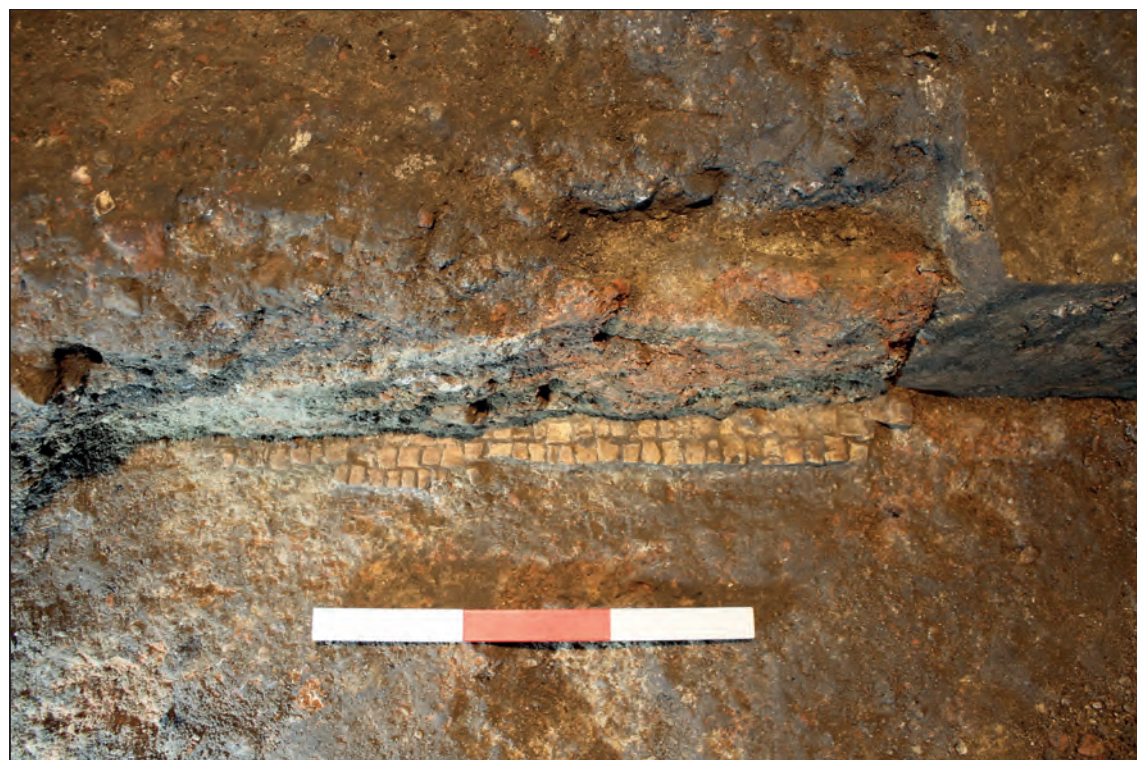
Roman mosaic 181340, looking north-east (0.3m scale)

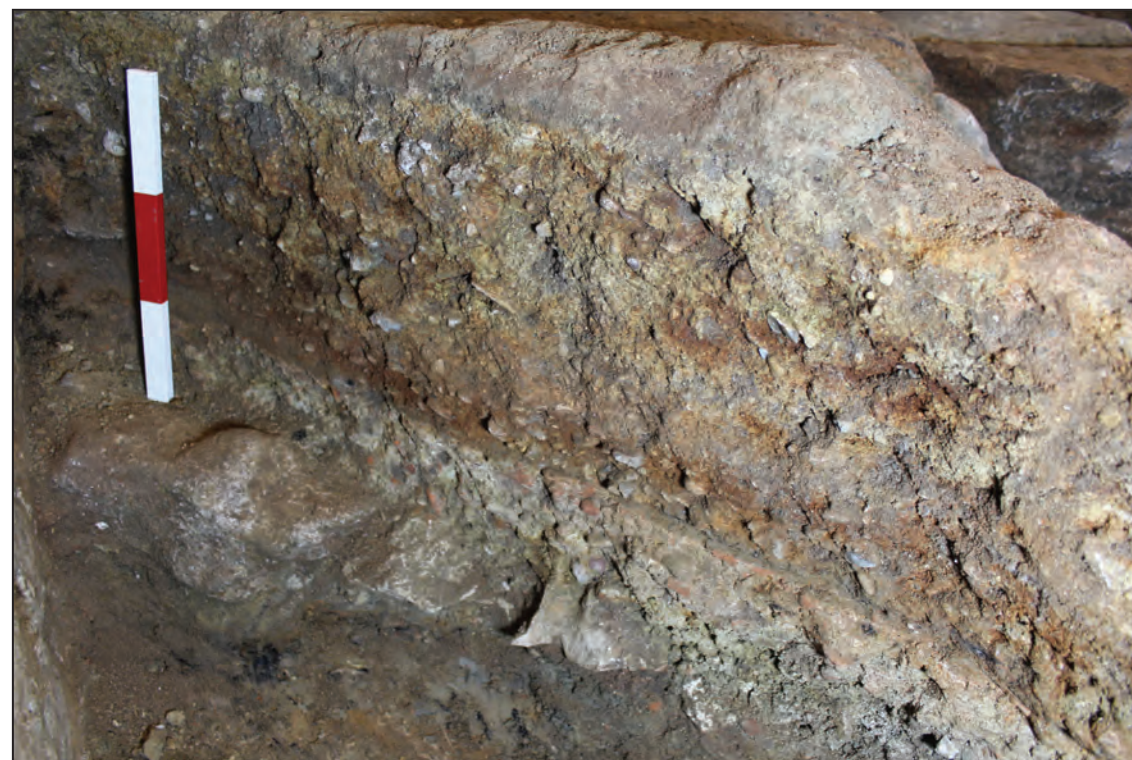
Floor surface 181372, looking east (0.3m scale)

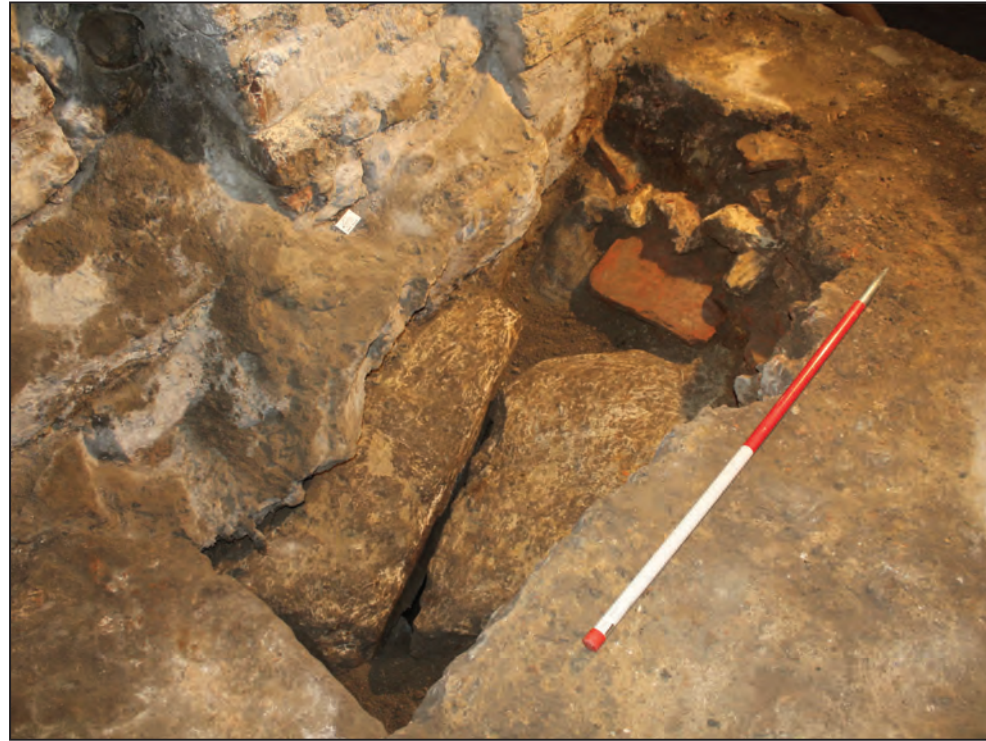
Photograph A: Capping stone 187228, looking north-east (1m scale)

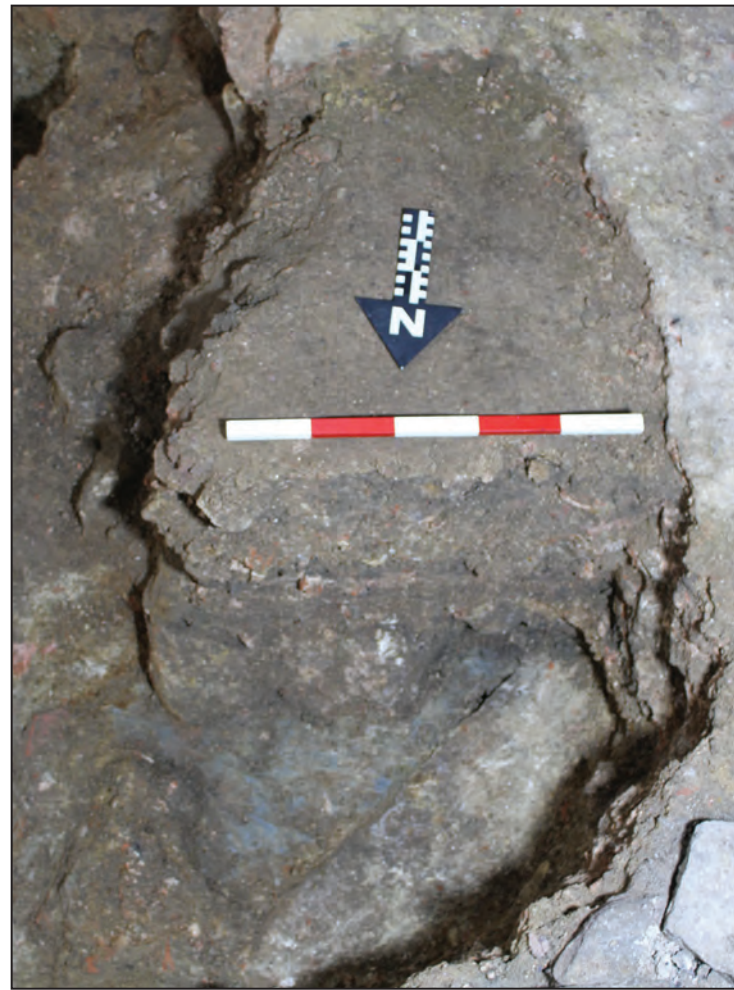
Photograph B: Capping stone 187252, looking south (0.5m scale)

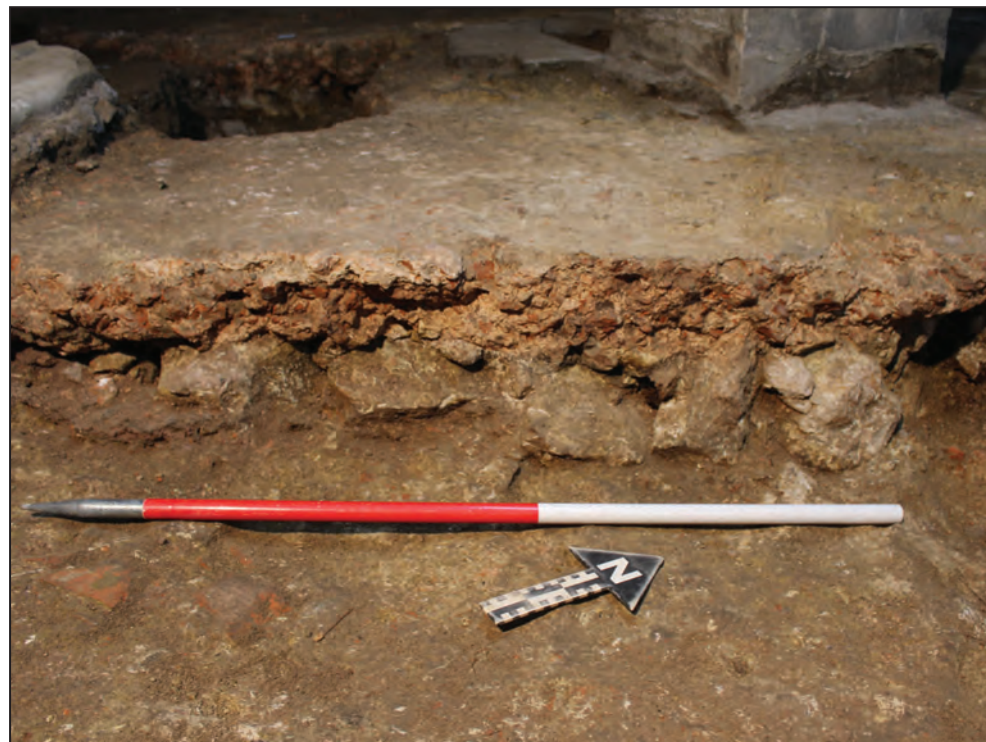
Photograph C: Opus signinum floor 183000/187035, looking north-west (1m scale)

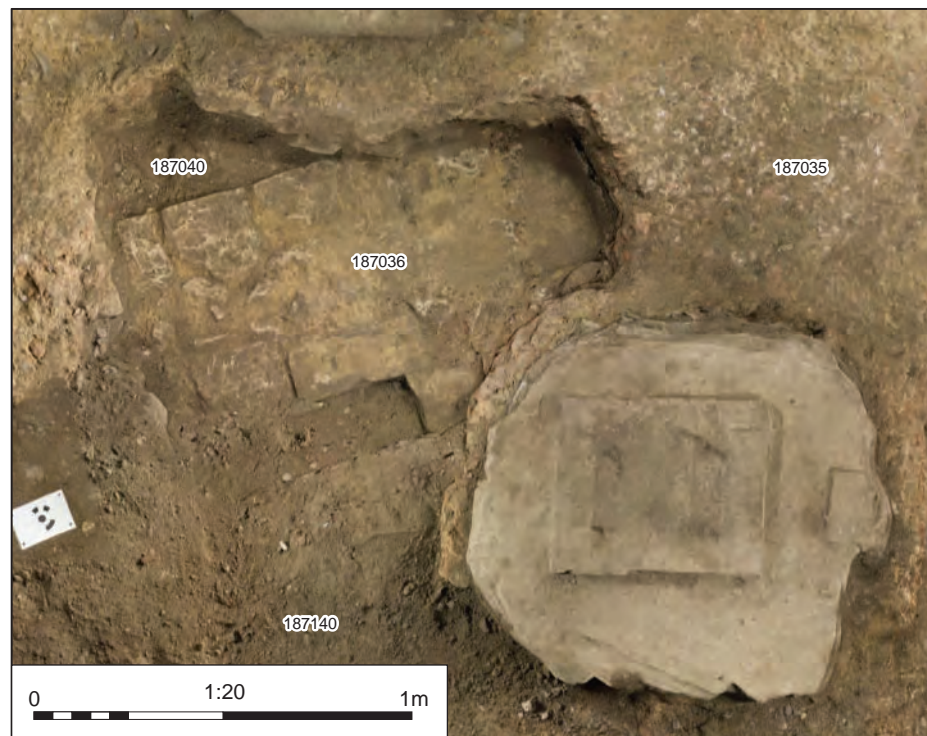
Photogrammetry: Opus signinum floor 183000/187035 and stone structure 187036 (1:20)

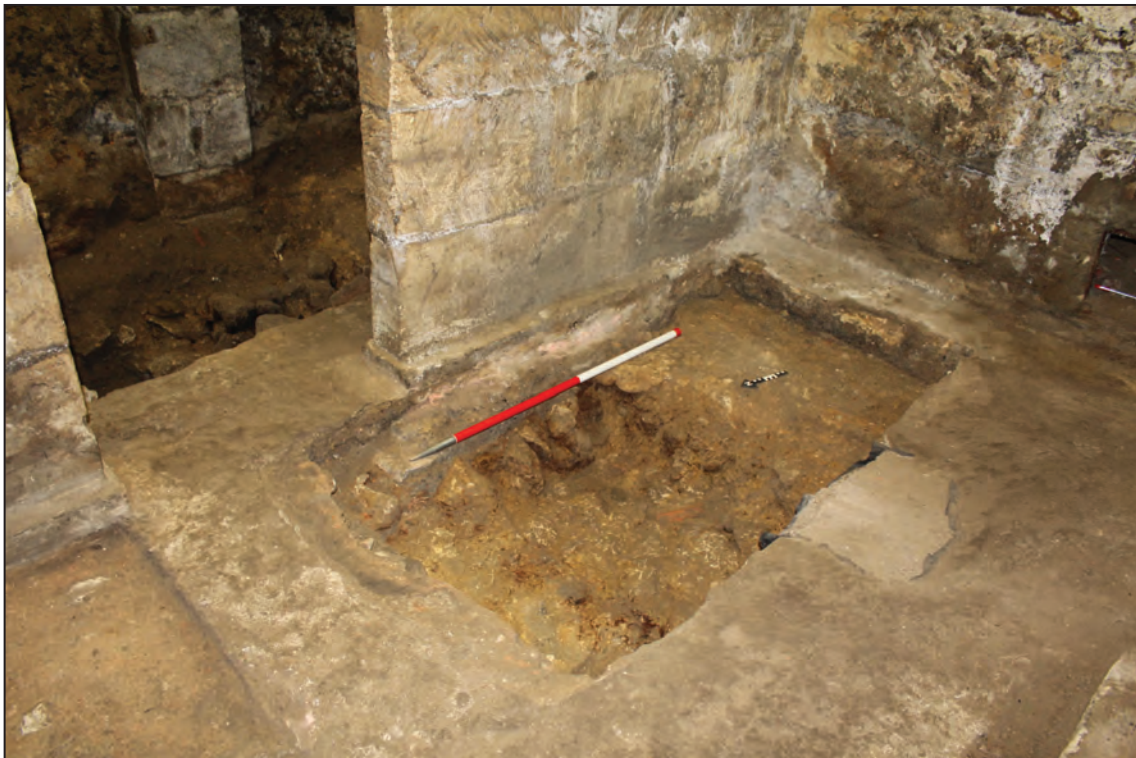
Wall 187312, looking south-east (1m scale)

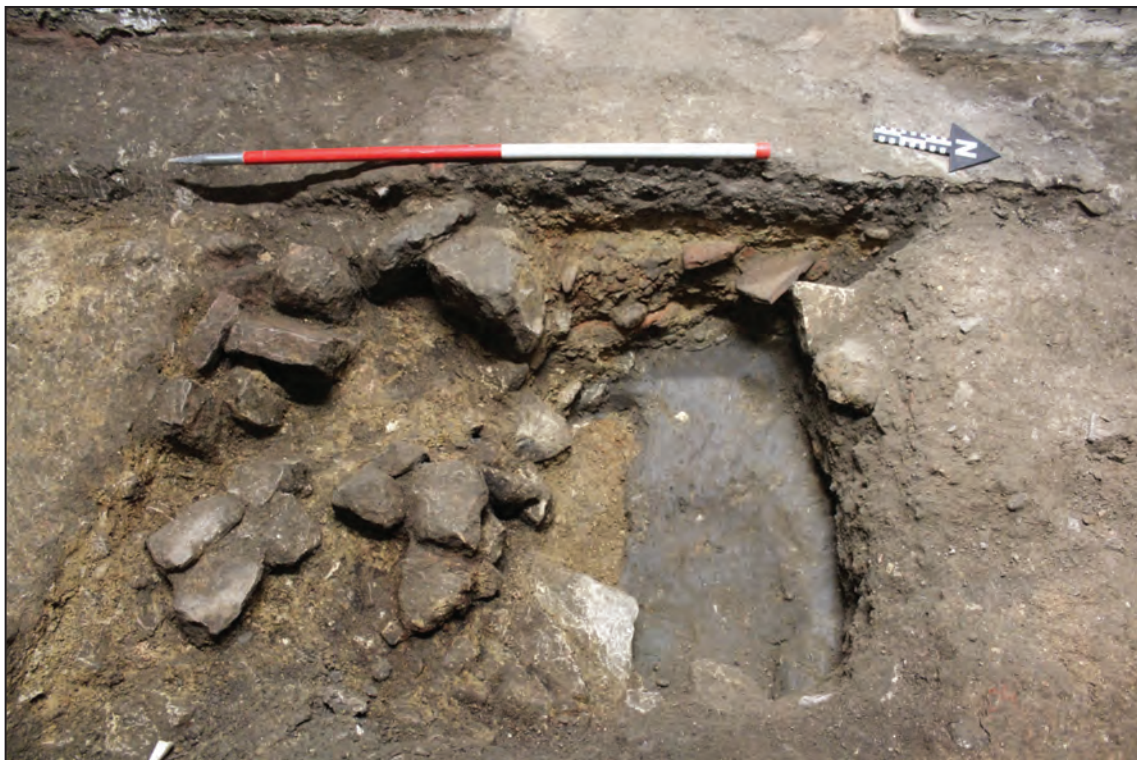
Wall 187233, looking west (1m scale)

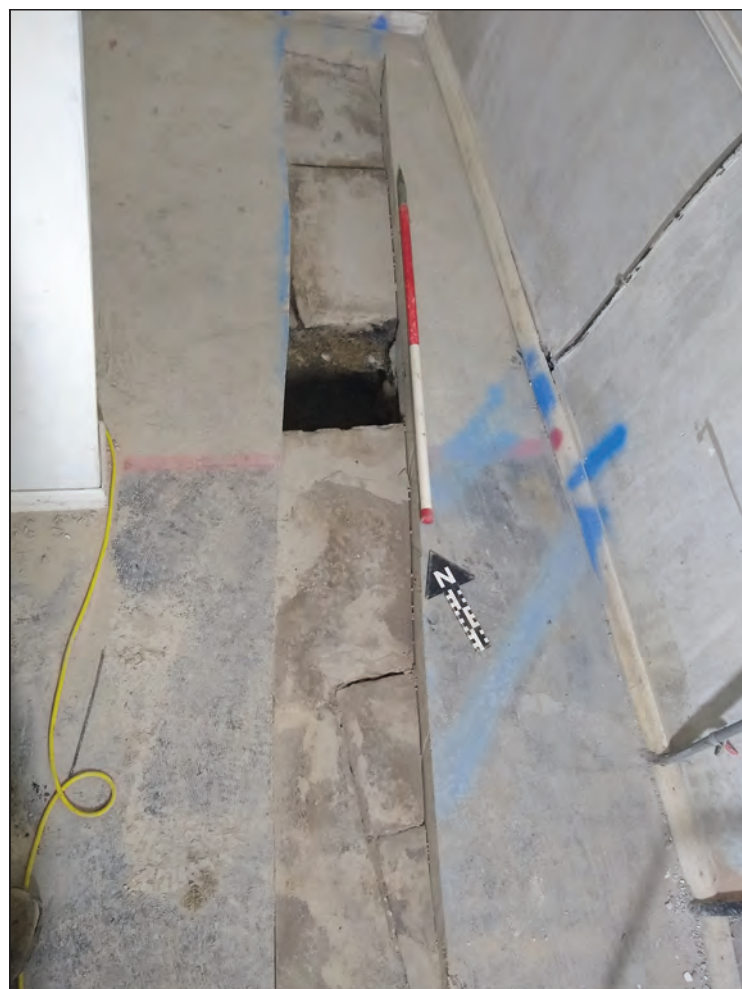
Trench A containing floor A101, looking north (1m scale)

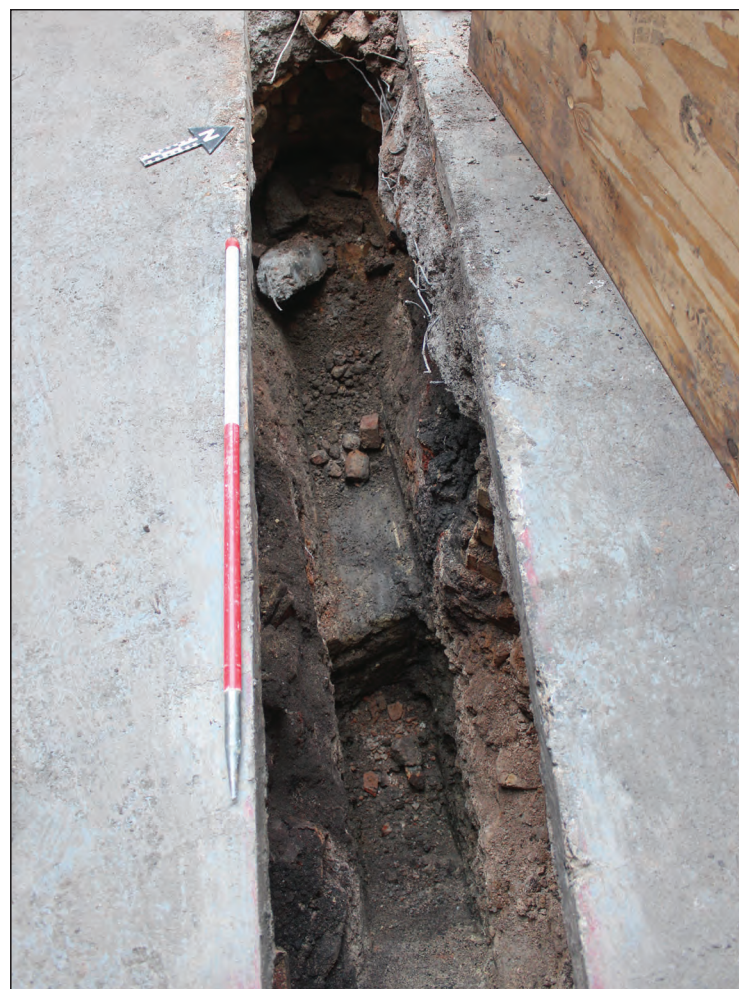
Trench B3 containing wall B304, looking west (1m scale)

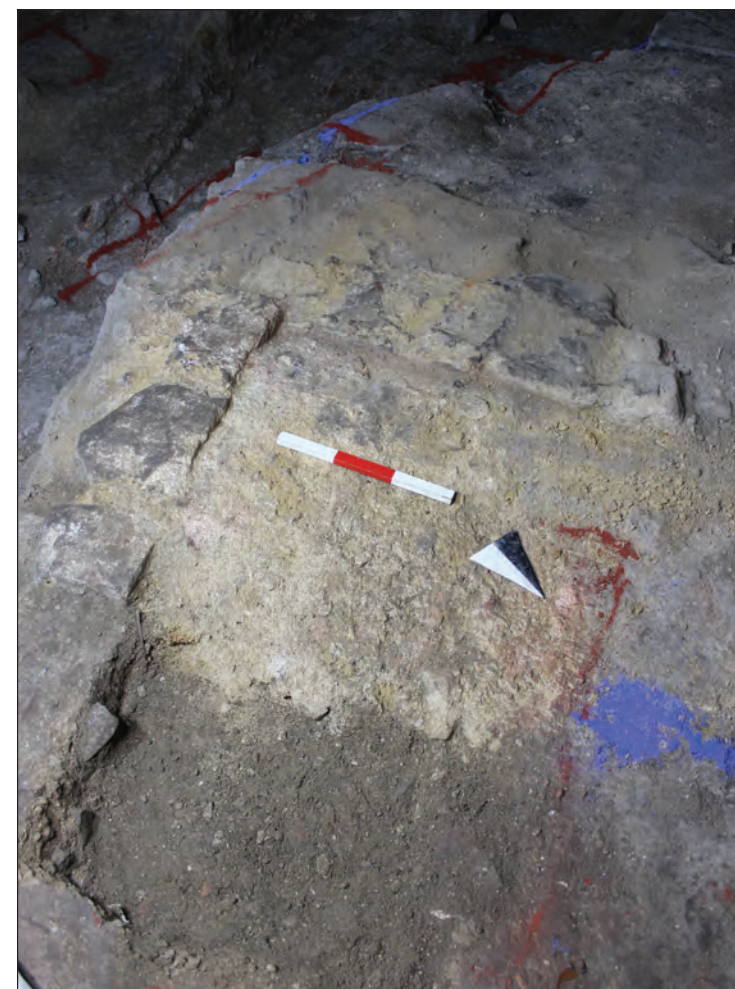
Walkway Pad 3 containing wall 303/181273, looking south-west (0.3m scale)

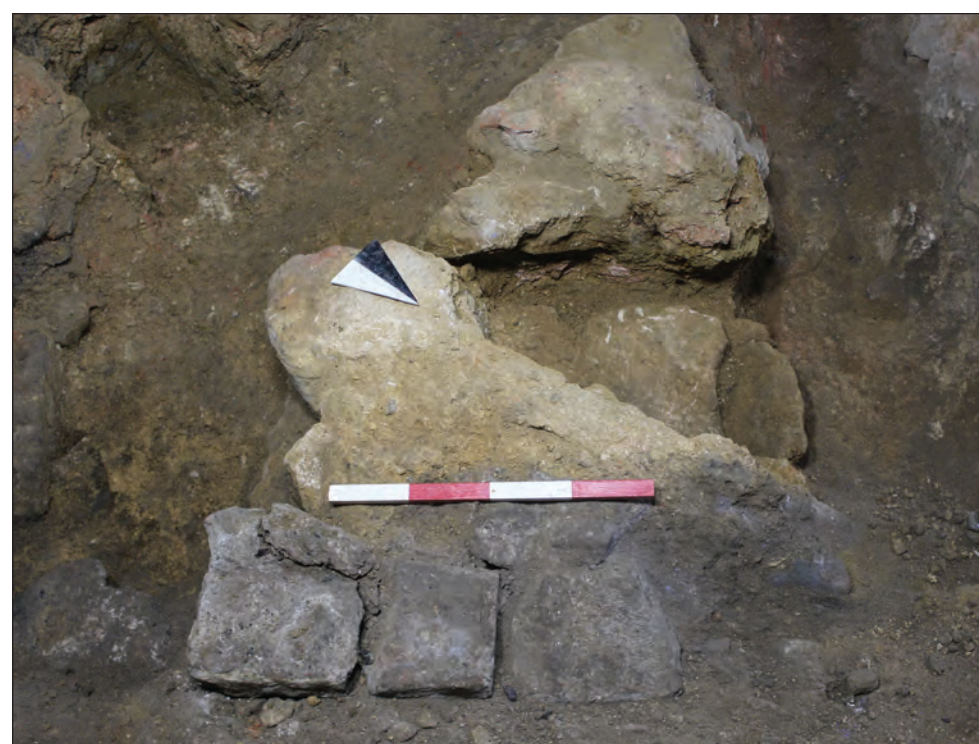
Walkway Pad 4 containing wall 410, looking south-west (0.4m scale)
