**The Air Balloon Public House
Birdlip
Gloucestershire**

*Historic Building Recording
Level 3*

CA Project: CR1437

CA Report: CR1437_1

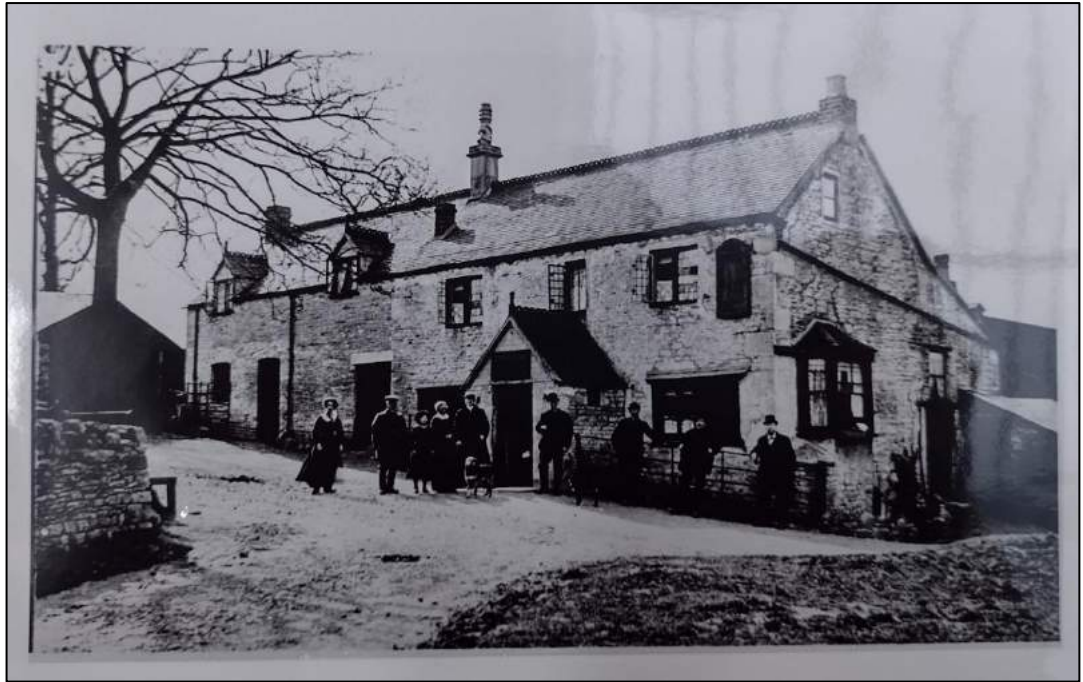
Photo 1 **The pub in 1900 (GRO DC86/80)**

- 3.14. A photo of c.1900 (GRO DC86/80, Photo 1) depicts the Building at this time with its distinctive porch and canted bay window in situ. As mentioned in paragraph 2.30 the Building was sold as part of the Ullenwood Estate in 1934. A photo from the sales brochure for the estate (GRO DC86/80, Photo 2) illustrates the roadways around the Building, with there being a change in height between the Crickley Hill roadway and that going on past the pub to Birdlip. This provides an explanation for the triangular feature on the OS mapping, it forms an earth bank around which the car or cart would execute a hairpin turn to access the Birdlip road.

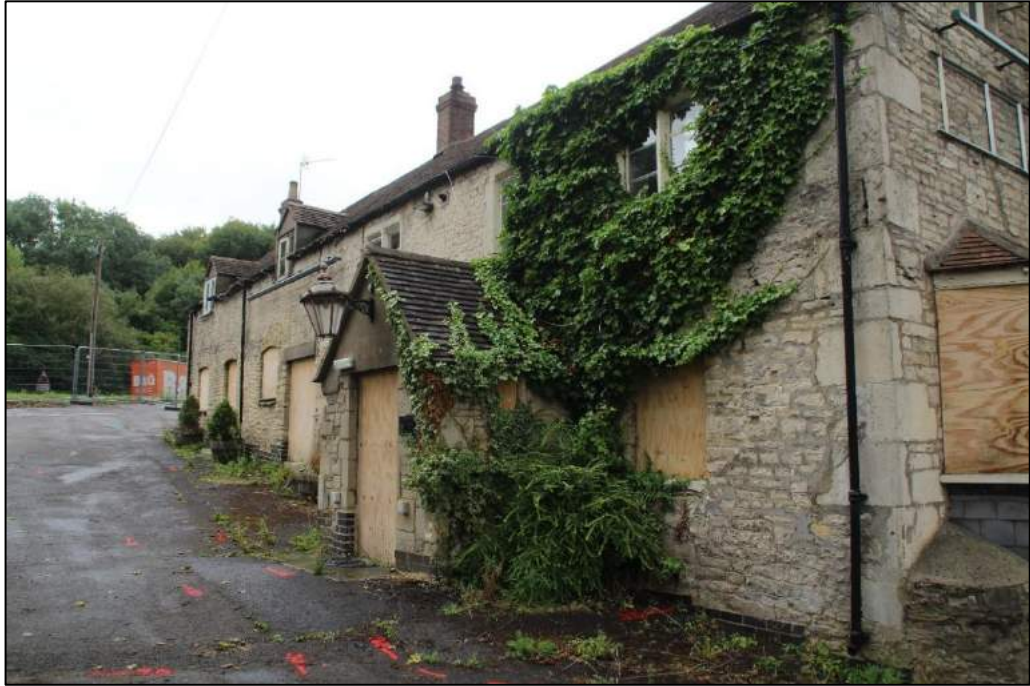
Photo 4 **The front, eastern elevation, seen from the north**

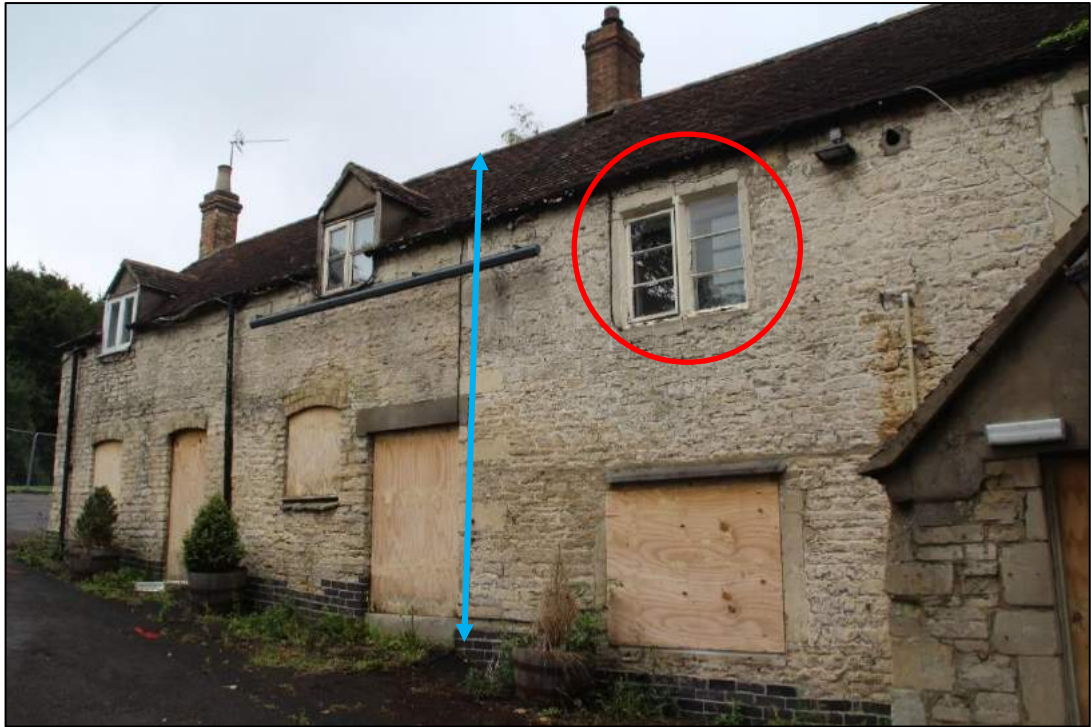
Photo 6 The front, eastern elevation, seen from the east (building junction annotated in blue)

- 4.3. The windows of this former northern cottage indicate phases of change. The upper windows are stone dressed with two lights and one hinged and one fixed casement. The mullion of the southern upper window (circled in Photo 6) has a crisp appearance which suggests that it may be a repair or a more recent insertion. The casements appear to be early 20th century cast iron with replaced glass and repair work is suggestive of the 1980s or 1990s work. The image in Photo 2 from 1900 shows leaded light casements which indicate that the windows were replaced post 1900.

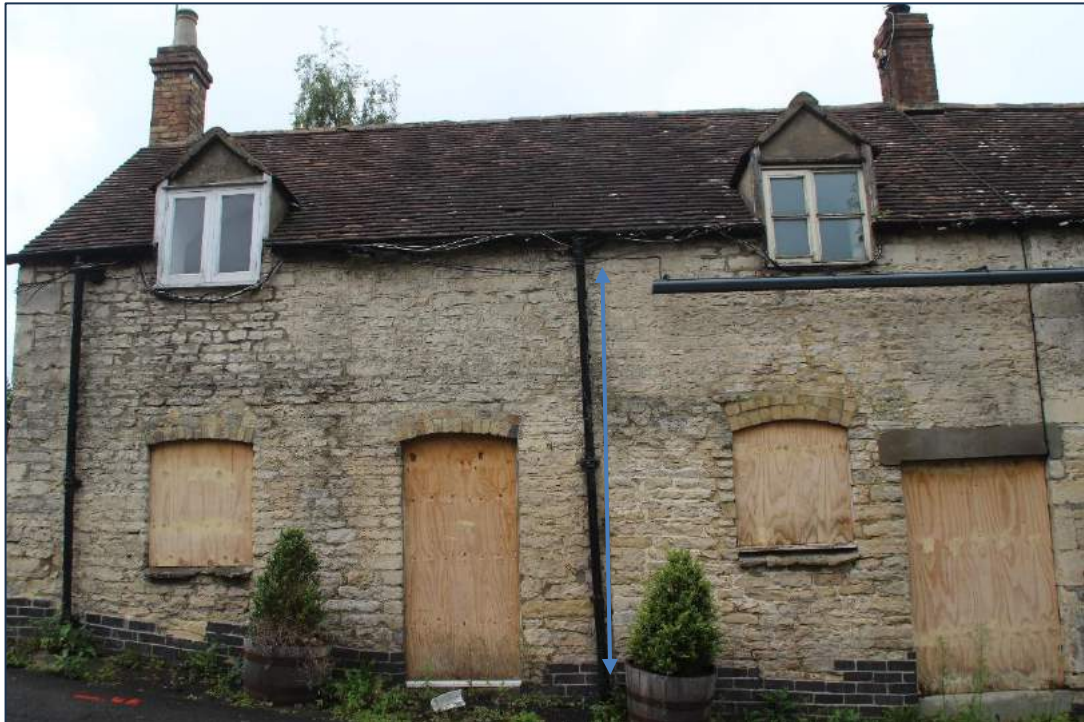
Photo 7 The southern section of the eastern façade (building junction annotated)

-
- 4.8. The southern 'cottage' is two sectional and this is seen on plan, as well as in a junction seen externally (annotated on Photo 7). The upper windows are ridged timber dormers, set partially into the eaves of the clay tile roof, again a more vernacular feature possibly denoting a lower status). Both have replacement timber casement windows, though the northernmost one appears to be of greater age. The brick chimney at this end has the character of a 19th century addition, being constructed of fairly uniform bricks which suggests they are factory made.

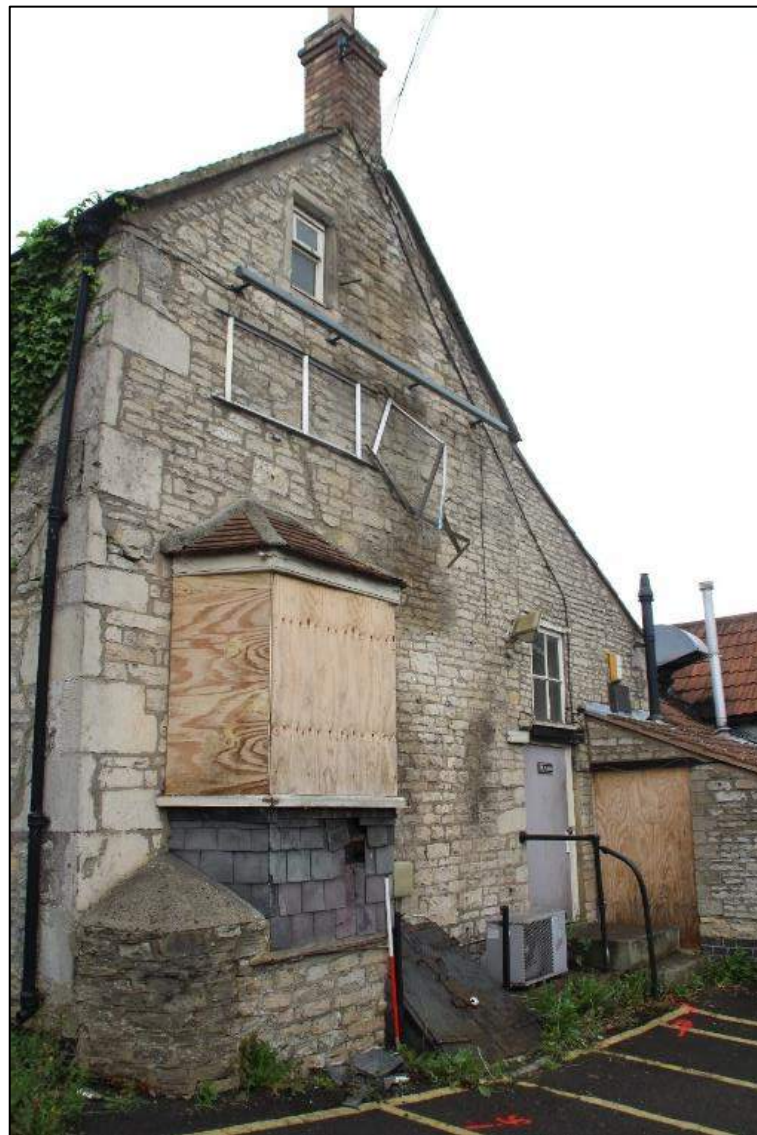
Photo 8 **The northern elevation**

- 4.9. The northern elevation consists of a gable end constructed in coursed rubblestone under the clay roof with slightly overhanging eaves with exposed eaves rafters (Photo 8). The 1900 image of the inn (Photo 2) illustrates the roof with decorated pierced ridge pieces, which are not present now, indicating the roof has been replaced or repaired. The elevation is largely blank bar a small off centre gable apex window and the hipped bay window which lies the upper ground floor level (taking account of the sloping site). It has been altered in recent years with the addition of slate hanging tiles to the apron, presumably for weather protection. The bay window appears on 19th century mapping, and is likely dated to 1777 or later in the 19th century and symbolises the gentrification of the inn with a typical 18th century detail.

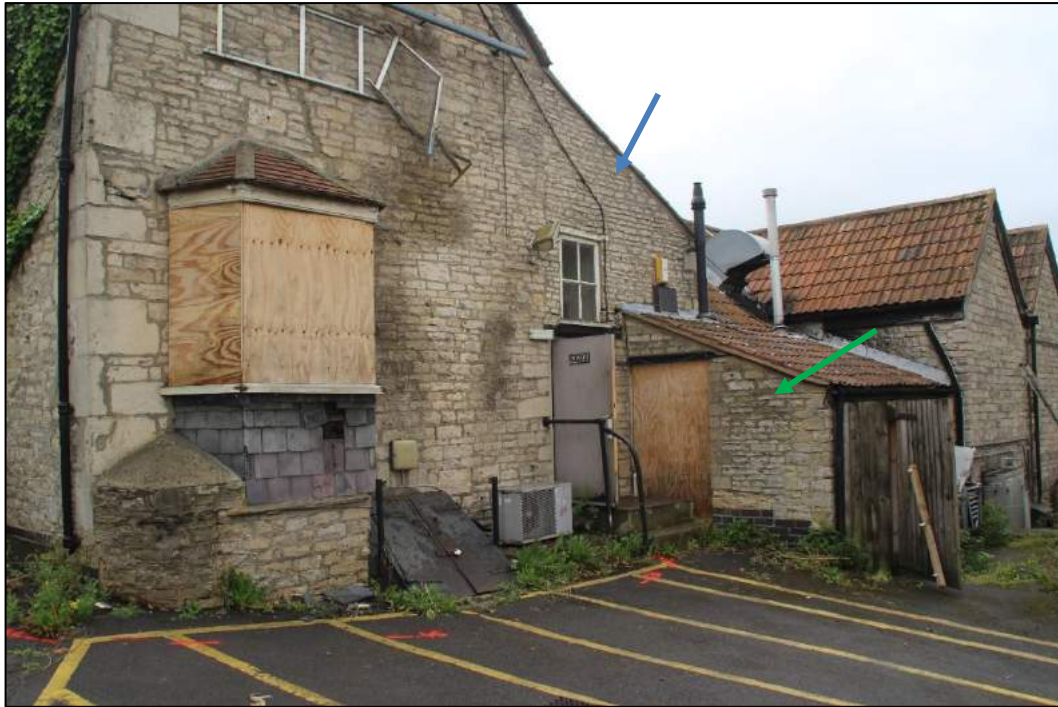
Photo 9 The northern (blue) and western (green) lean to

4.10. To the west of the main gable is a lean-to structure which links into the main roof of the east-west wing of the 'L' (Photo 9). There is a clear line denoting the junction between the gable end (with quoins evident in the lower part) and the lean-to and the stone work of the lean-to on this side is neater and clearly of a different phase to that of the main Building. Within it there is a doorway with 4 light cross window above. Neither the door nor the window appear to be historic, though the openings may well be. The character of this work suggests a 19th century date and aligns with the extension and alteration of this wing in the 19th century. A small lean to sitting to the north of the east-west wing is also present on mapping of the 19th century and it is suggested that the west facing lean-to is contemporaneous with the northern facing one.

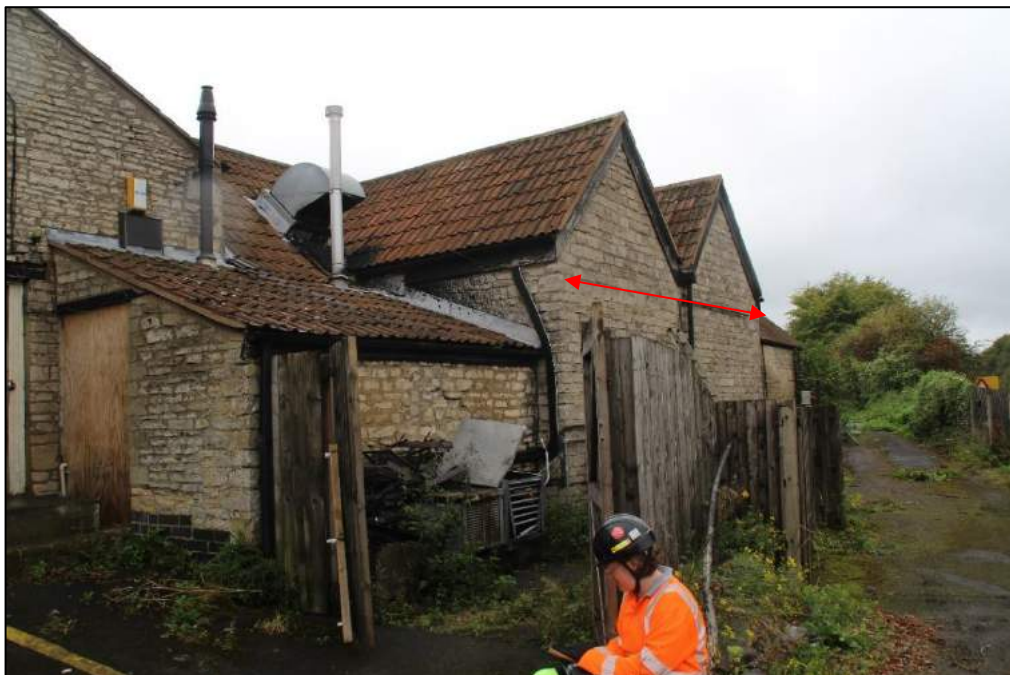
Photo 10 The two 1980s gabled structures (arrowed)

4.11. The northern elevation of the east-wing (leg of the 'L') is largely modern in nature, as depicted in Figure 4a and discussed in the building development narrative in Section 3. There are two 1980s gabled structures appended to the eastern end of the east-west wing (Photo 10), which is the pub kitchen, internally these hold large walk-in refrigerators which explains their construction.

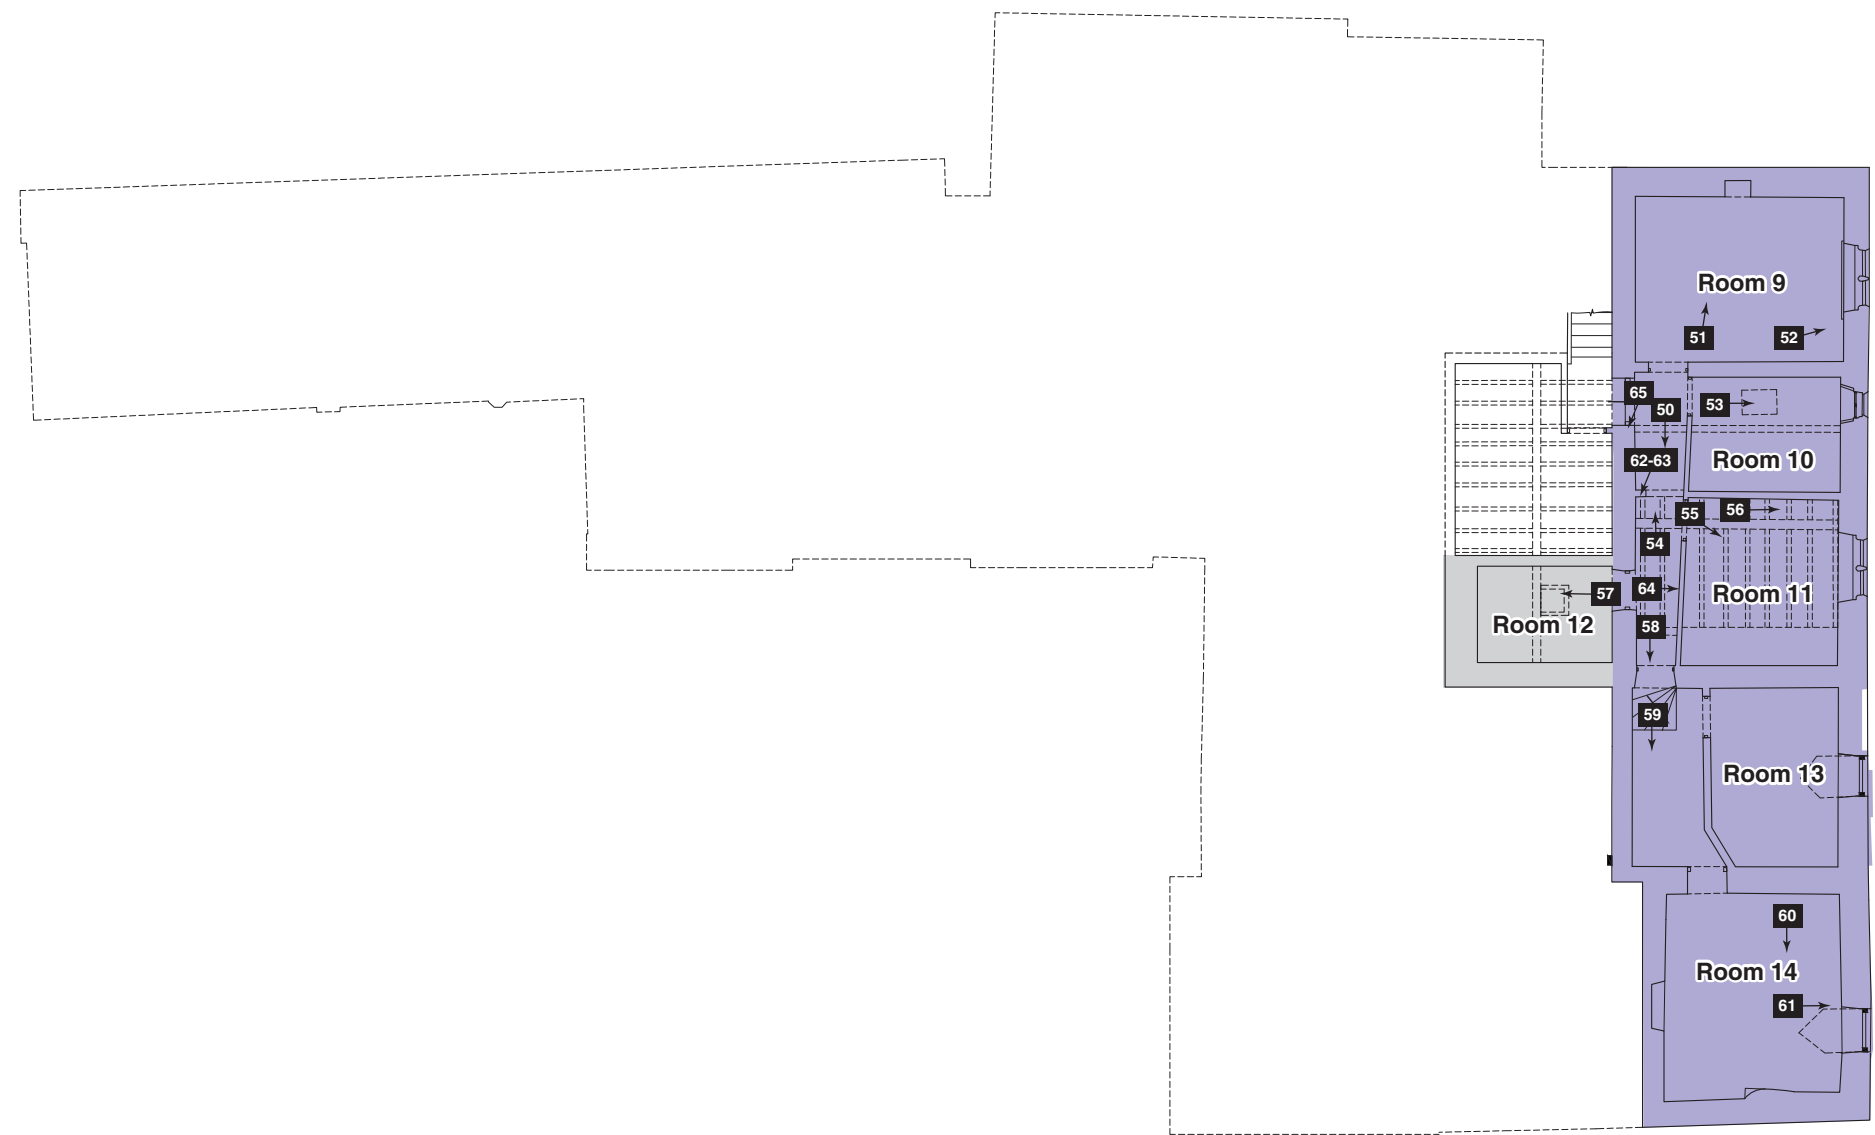
FIGURE TITLE
Ground floor plan showing ceiling detail

- Original 17th century
- 19th century alterations
- 19th century
- Early 20th century with significant late 20th century alterations
- Late 20th century
- Between 1920–1970
- ← 2 Photograph location

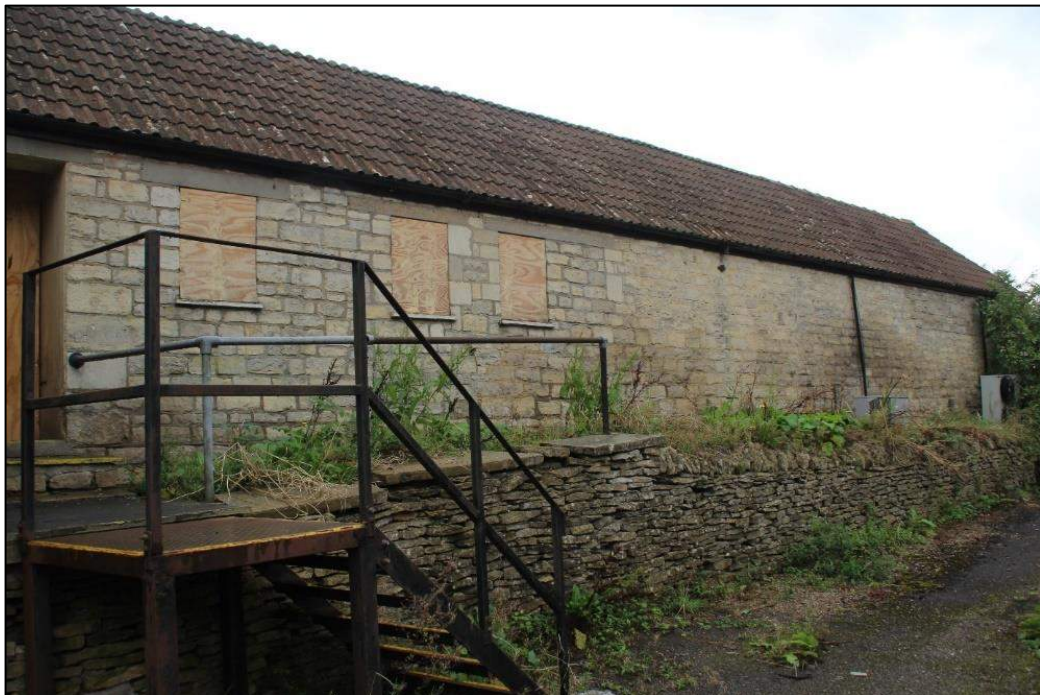
Photo 11 **The western section of the east-west wing (northern elevation)**

4.12. Further west, there is a long single storey range which lies on the approximate footprint of an early 20th century structure, but which is clearly largely or wholly rebuilt as it contains modernised spaces internally, such as toilets and food storage areas and it has a different footprint to that seen in 1974 (Fig. 2). This is supported by its appearance, which features uniformly coursed stonework pointed in cement with concrete lintels over the three, bathroom window openings. The roof is clearly recent with clay pantiles. The western end appears more original to a 1900-1920s construction (Photo 11) in terms of the appearance of the stone work. It is bordered by a historic retaining dry stone wall.

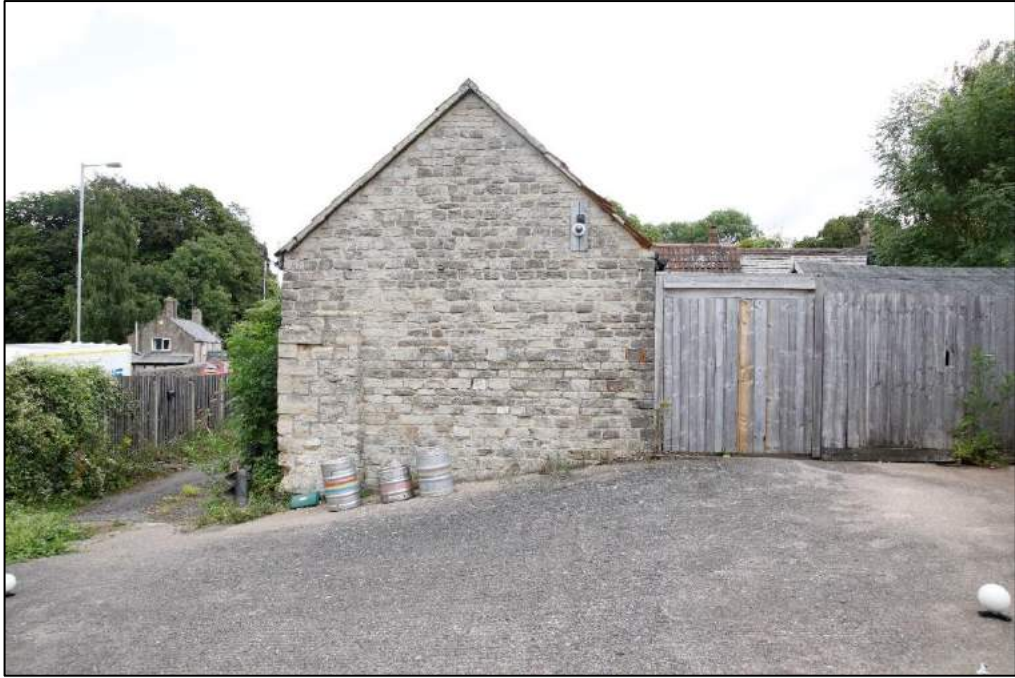
Photo 12 **The western elevation of the east-west wing**

4.13. The gable to this east-west wing is depicted in Photo 12. It is a blank stone wall of likely 1980s date attached to close boarded fence denoting the functional internal courtyard of the ancillary areas. No internal access to this western section of the east-west wing was possible but it appeared to contain walk-in cool storage areas (judging by the air conditioning equipment affixed externally), accessed via the internal courtyard which contained sheds and a walk-in fridge (Photo 13). The walls to this side are cement rendered.

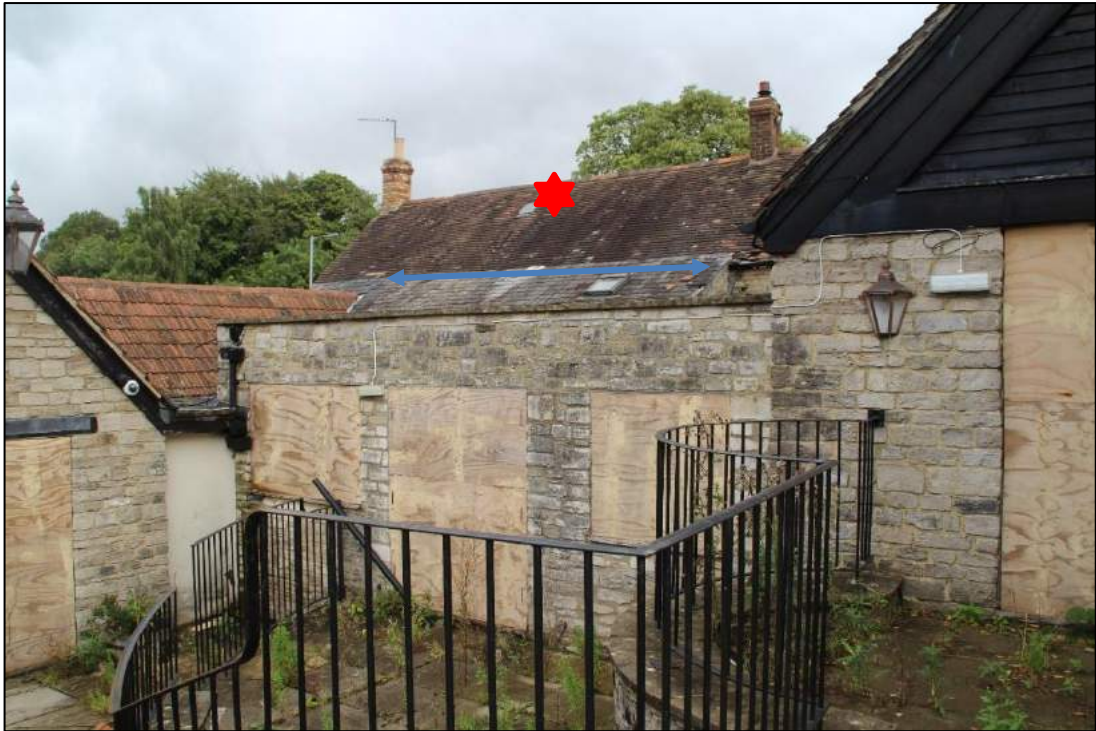
Photo 15 1980s/90s additions to the rear of the historic Building (starred) with the mid-20th century extension arrowed

4.14. Various 1980s and 1990s structures sit to the rear (west) of the historic Building and this is best understood in Figure 4a (floorplans). These include a covered entrance area to the extended rear of the east-west wing (Photo 14) and extensions to the western elevation of the historic main wing (Photo 15). A small extension of mid -20th century date is seen to the rear of the late 20th century additions; this is annotated in Photo 15. A large vaulted entrance hall to the southern part of the pub was constructed as part of the 1996 works (Photo 16). These new accretions were all laid around a pub courtyard garden created in 1996.

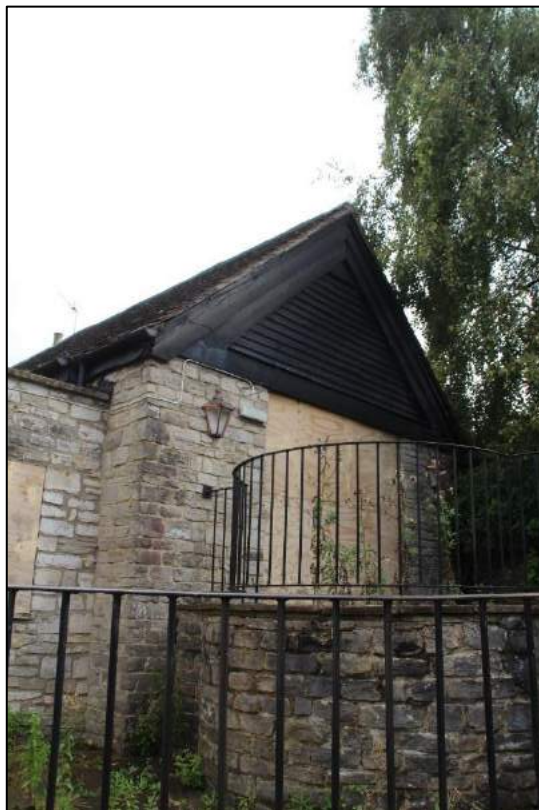
Photo 16 The 1996 entrance structure appended to the southern section of the historic Building

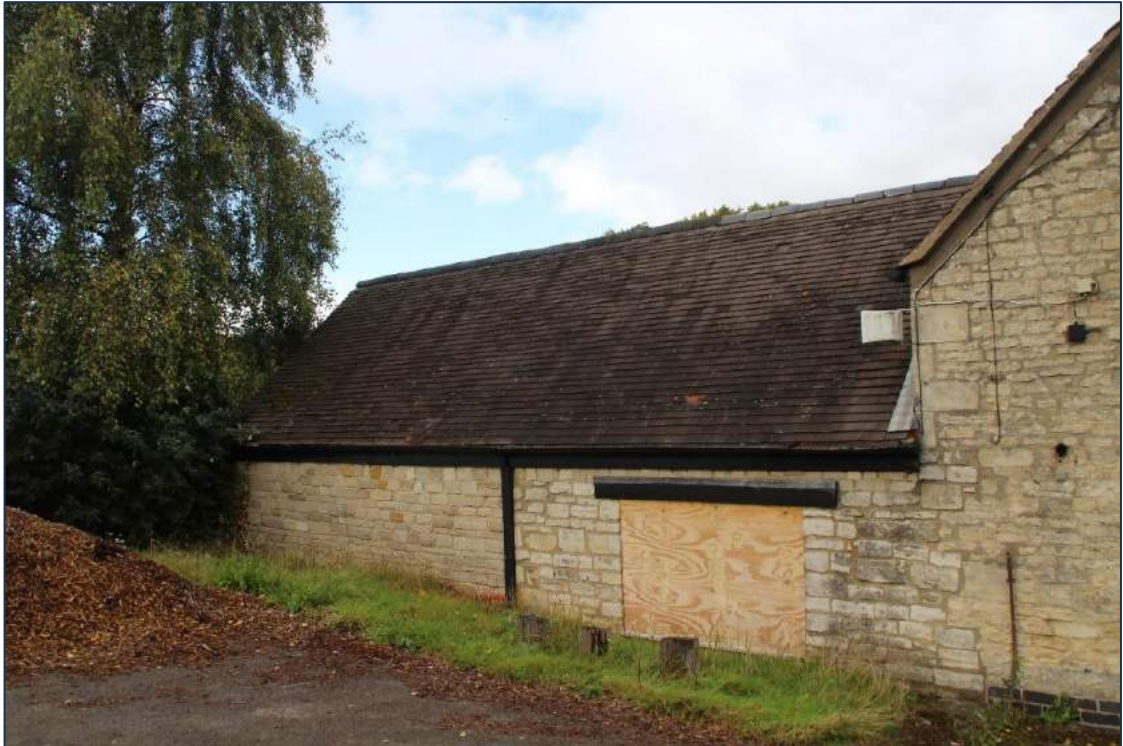
Photo 17 **The western section of the southern elevation**

-
- 4.15. The western section of the southern elevation of the Building is a modern one storey structure with a clay tile roof constructed in the 1980s and extended in the 1990s. These two phases of work are visible in the elevation depicted in Photo 17. The 1980s section knits into the historic southern gable, and is formed of large coursed stones, where the westernmost section has a different and more uniform character.

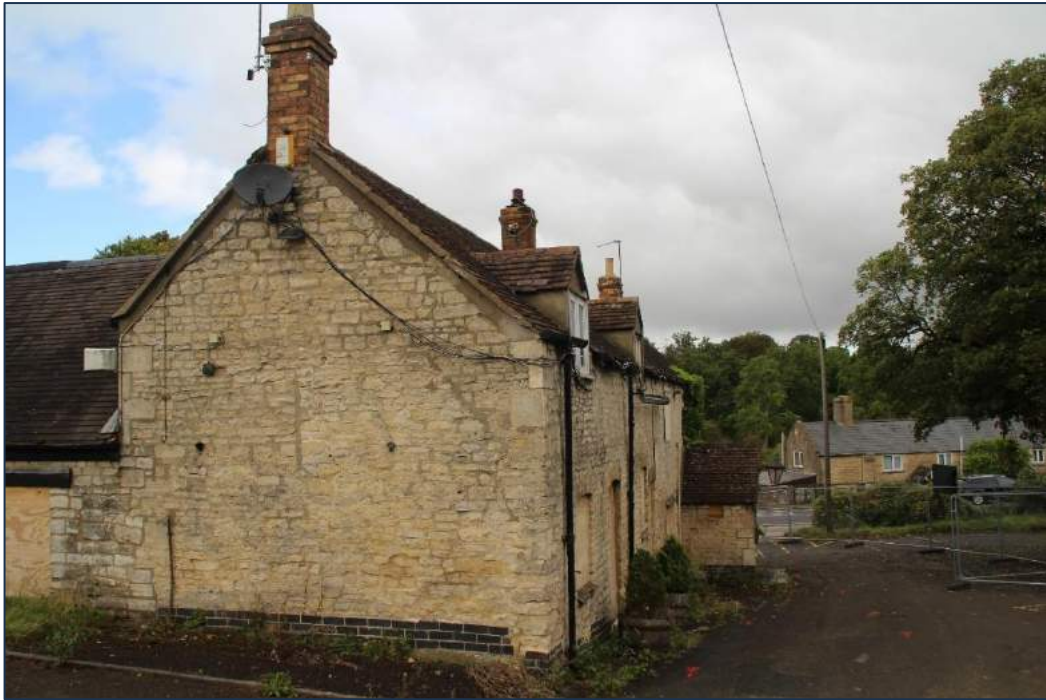
Photo 18 **The southern gable end to the historic Building**

- 4.16. The southern gable to the historic Building is illustrated in Photo 18. It is a blank elevation with quoins to each corner, exposed eaves rafters and random rubblestone walling with the aforementioned brick plinth. Various poor pointing repairs have also been undertaken which account for the lines seen within the façade.

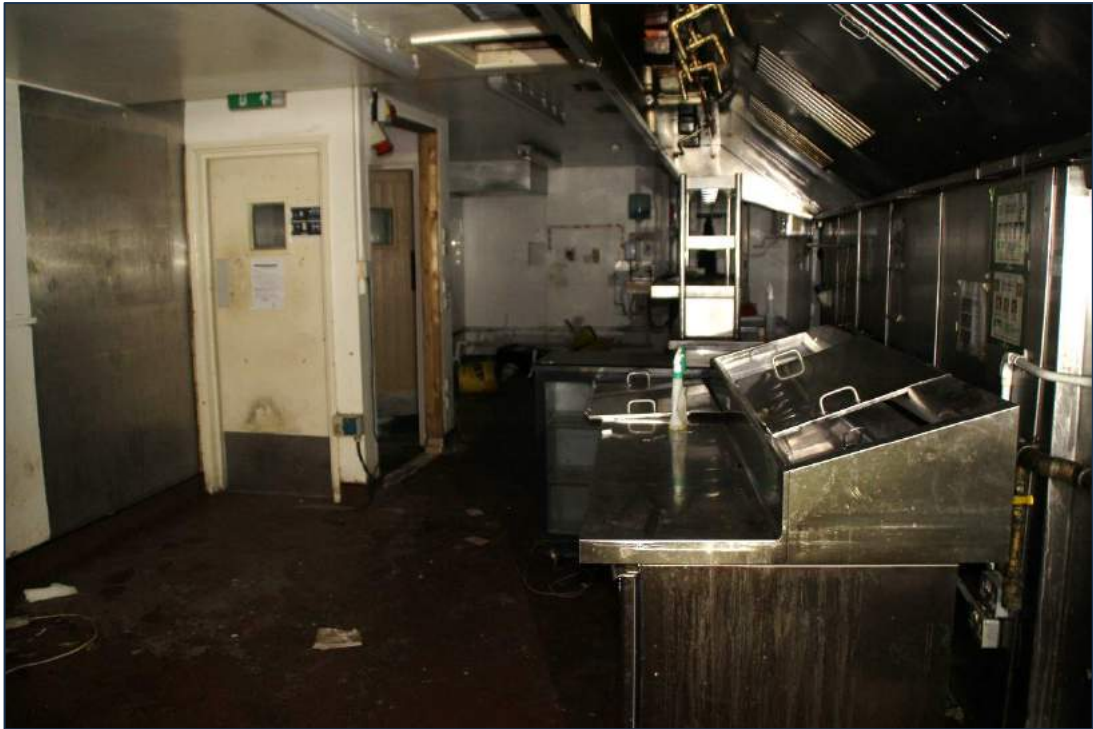
Photo 19 **The kitchen (Room 1) looking west**

- 4.18. Room 1 is the current kitchen of the Building, and has likely been the location of ancillary functions for much of the Buildings history, being a one storey range akin to a servants wing. This space has been present since at least the 1840s (Figure 2) and is likely contemporaneous or near contemporaneous with the establishment of the inn in 1777. It has clearly been modernised and layered over time and is now a fully converted and modernised space commensurate with its use as a commercial pub kitchen. Walls, floors, ceiling, doors, fixtures and fittings are all late 20th century in date (Photos 19 and 20).

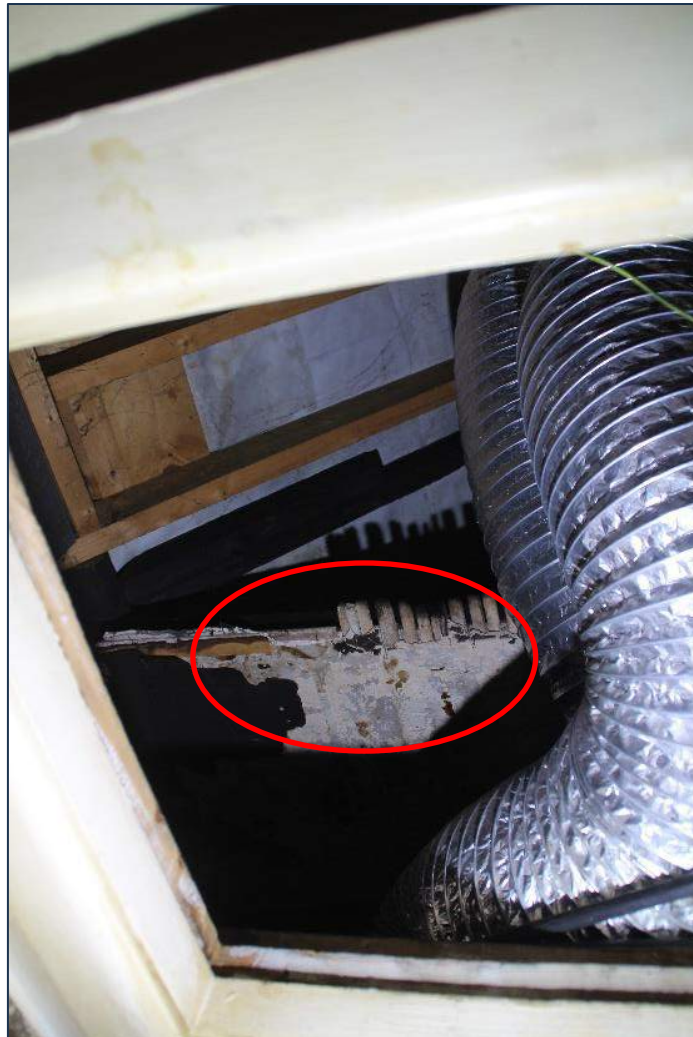
Photo 21 View of the roofspace of the kitchen with remnant lathe and plaster

4.19. The roof space of the kitchen area was accessible for view from the ground. Modern pine timbers were visible suggesting a wholesale replacement of the roof structure, likely at the time of the 1980s or 90s refurbishment (Photo 21). Remnants of lathe

and plaster appear to indicate the presence of an original or historic ceiling above the current ceiling.

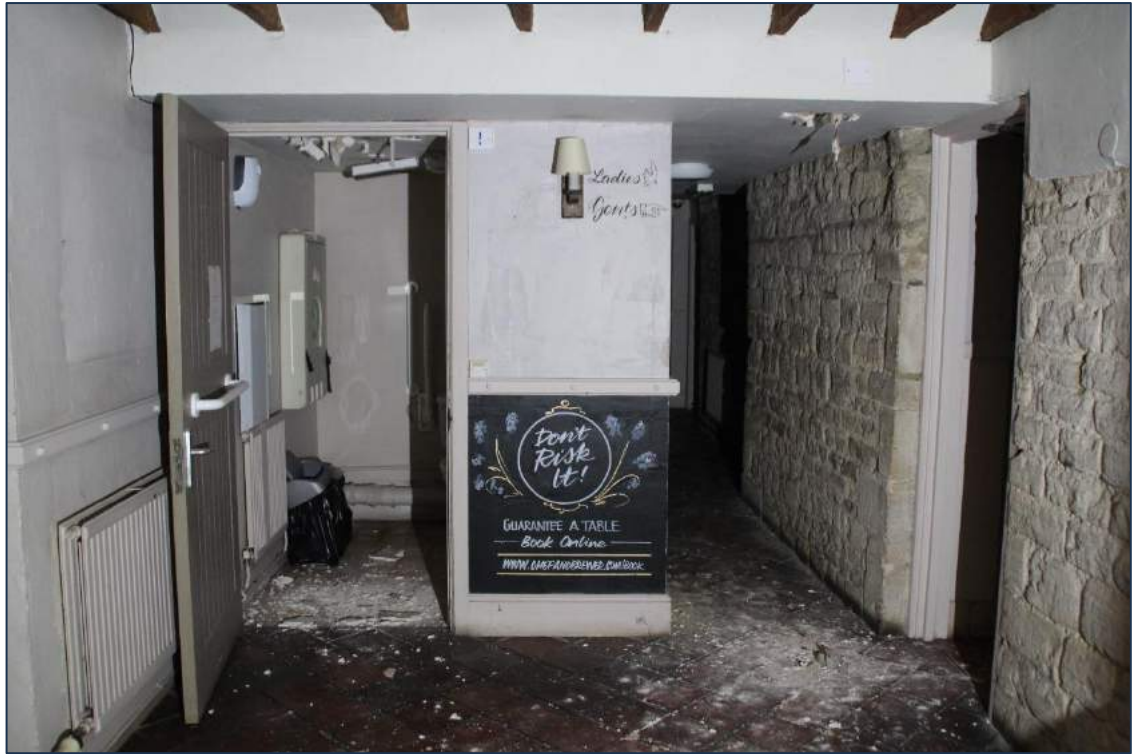
- 4.20. Room 2 is the main bar area of the pub and is a space created in the 1980s and 90s. It connects to Room 3, which is the historic area of the main Building, via a wide doorway. Photo 22 depicts the western end of the space, with bathrooms located both left and right of the image. The stone walling on the right of the image is formed of former external historic walling of Room 1 and the early 20th century east-west range.

Photo 22 View looking west in Room 2 towards the ancillary spaces of the modern extensions

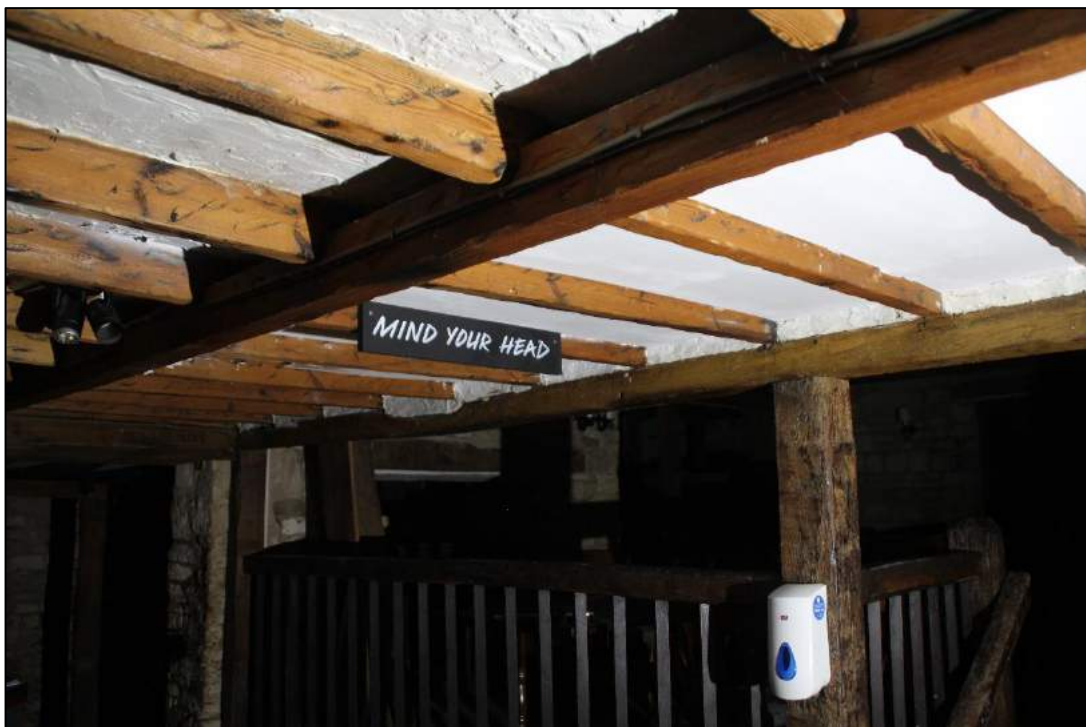
Photo 24 View of new distressed timbers in Room 2, constructed late 20th century

- 4.21. The work of the 1980s/90s was undertaken with a pastiche mindset in the sense that the extensions and modern spaces have all been historicised to appear similar to the historic building vernacular. This includes the addition of stained and falsely distressed exposed timbers and joists and other timber features.
- 4.22. Photo 23 illustrates the view looking east towards the bar area in Room 2, all of which were created in the 1980s and 90s. The rubblestone walls behind the bar area are formed of the former external walls of east-west historic range. Otherwise all features and fixtures are modern in date despite appearing to be historic. Photo 24 illustrates a typically 'distressed' timber of the 1980s/90s work,

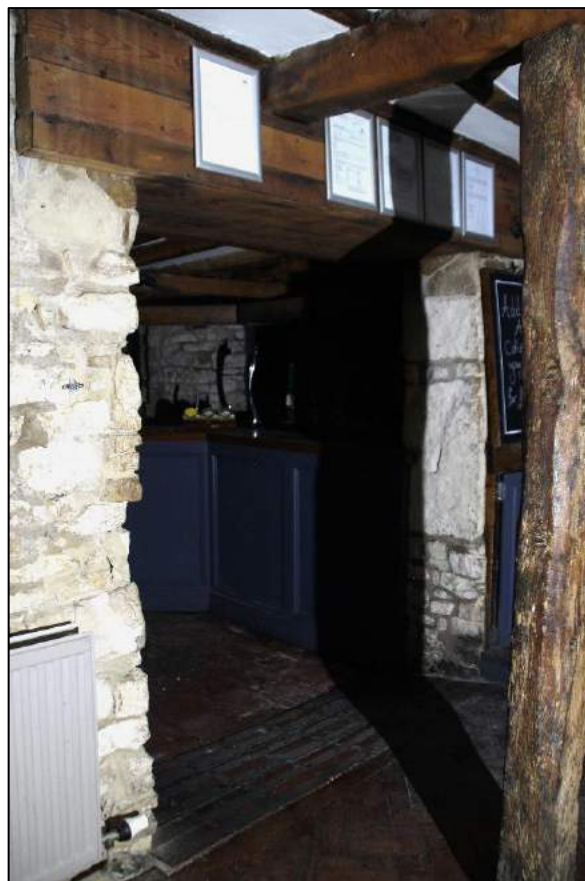
4.24. Room 3 is an historic space within the original Building. It is accessed from Room 2 via a wide opening in the former rear wall of the historic Building (Photo 25). The building plan provides evidence that a wall has probably been removed (annotated on Figure 4a) to the north of the main entrance and that there was a separate northern room with its own fireplace (as evidenced by the chimney at the gable apex on this elevation). This fireplace is no longer extant and its location has been absorbed into a cupboard serving the bar area. The room now is open plan and extends the whole length of the northern 'cottage' (Photo 26). There is a large open inglenook fireplace, and window seats at both the bay window and the front, northern window. The floor is modern pine timber, abutting to an earlier parquet floor in the southern part of the room, the parquet likely installed in the late 19th or early 20th century (Photo 27).

Photo 25 The opening from Room 2 to Room 3 in the former rear wall of the historic building

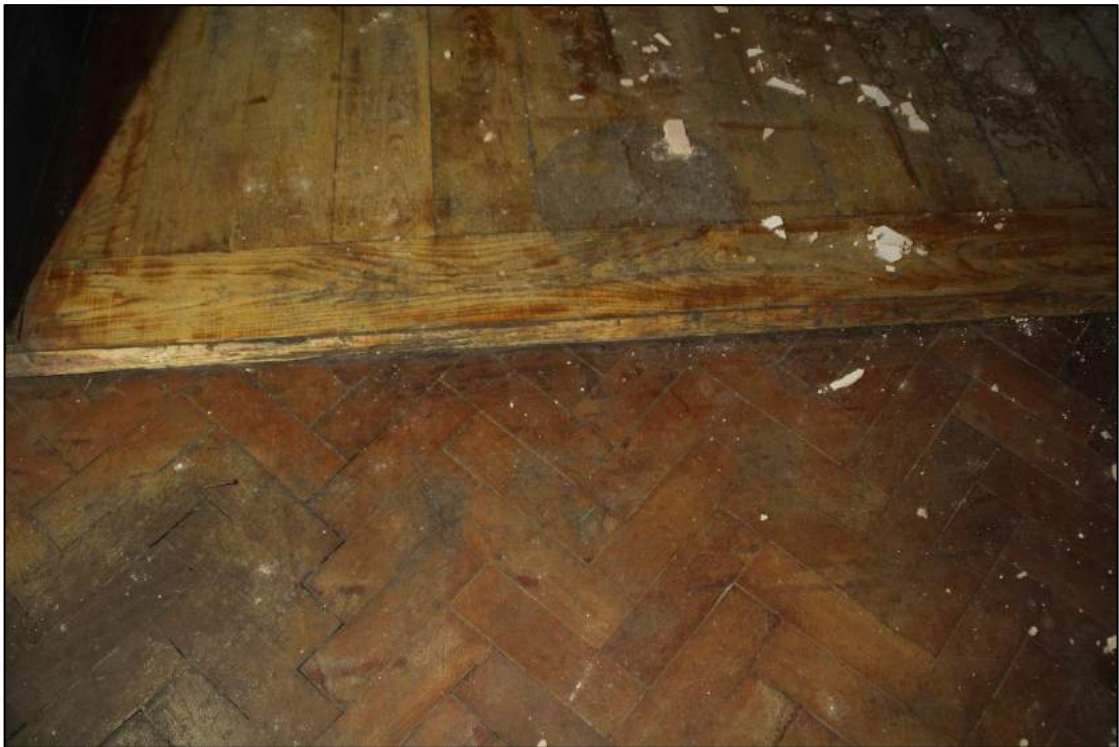
Photo 27 The flooring change in Room 3

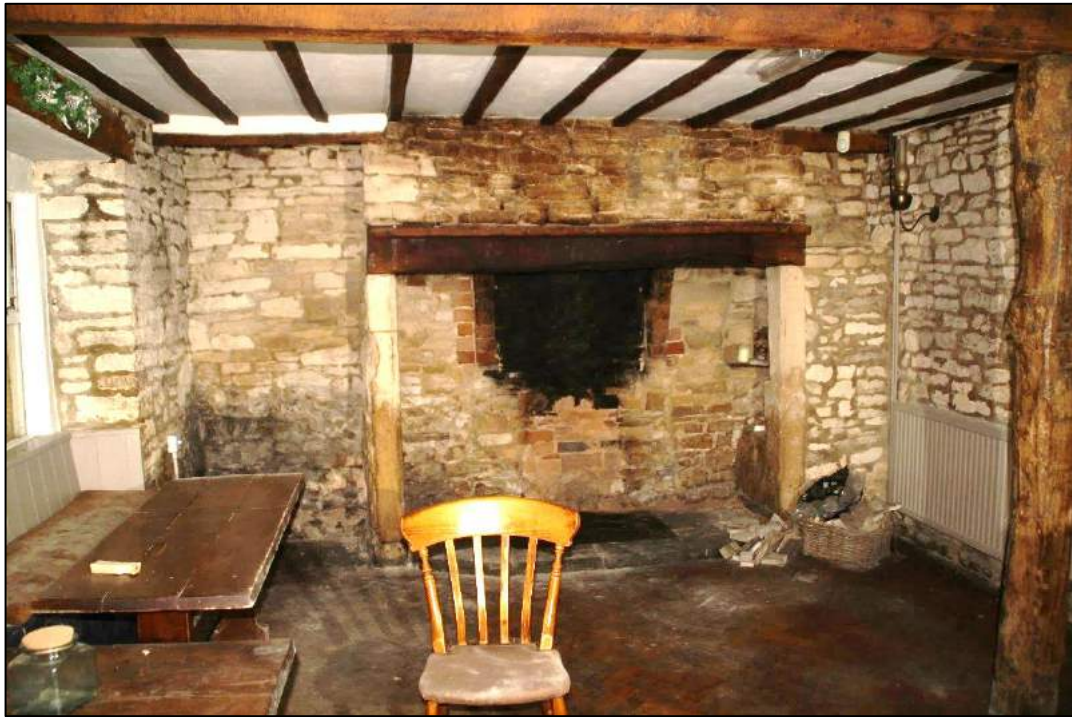
Photo 28 **The southern section of Room 3**

which evidences the Building's origins as separate cottages and suggests that ground floor access between the two sections of the inn was never subsequently installed, implying that they had different functions when operating as an inn. This is suggested in paragraphs 4.6 and 4.7 above that the southern section may have formed the small brewery or even stables element of the early inn based on its different external appearance, which has a lower status character.

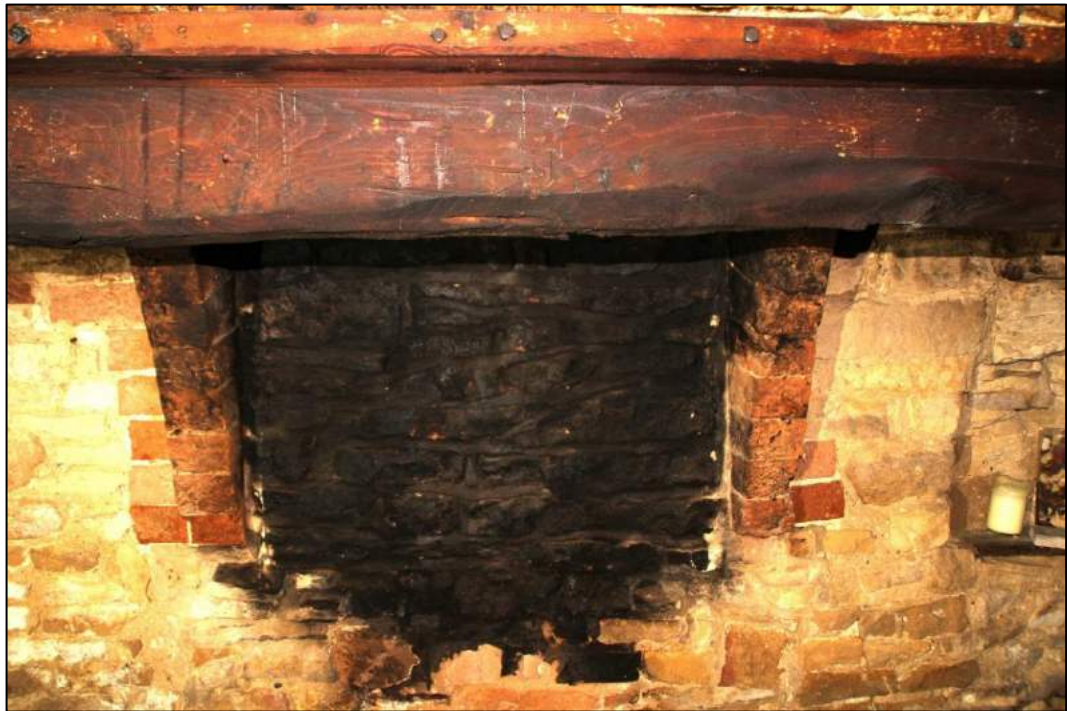
Photo 29 **Detail of the fireplace lintel and brick consoles**

- 4.26. As seen in Photo 29, the rear of the fireplace appears to have been altered with the addition of brick consoles which appear to support a chimney infill board which features a flue hole cutout. This suggests that a wood burner or stove once sat on the hearth, which is now flagstone tiles laid up to the parquet. The lintel appears to be a recent insert (Photo 29) or at least not original as it has less patina than would be expected of a 17th or 18th century fireplace lintel, and indicates a level of change to the fireplace, possibly when the stove was inserted. Above it is a thinner horizontal timber piece which may represent part of an earlier lintel. This has large square headed screws in it and may also relate to the support for the internal chimney infill boarding. The lintel is supported on stone work piers.

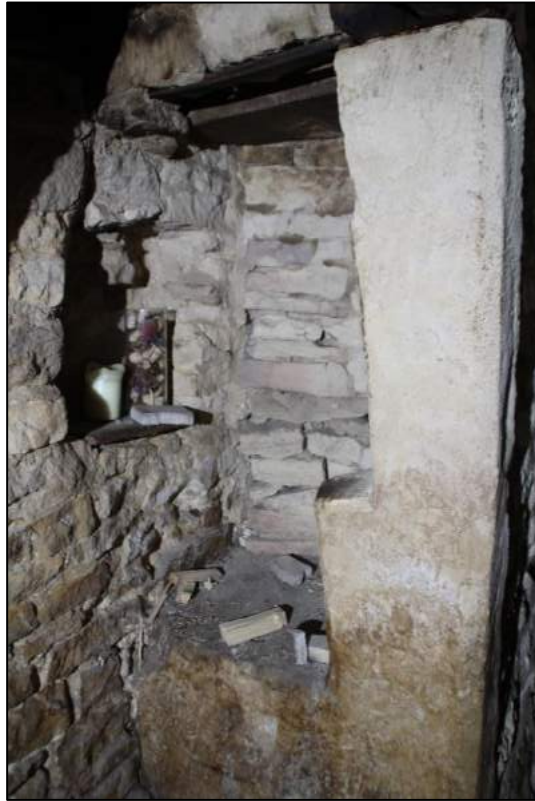
Photo 30 Sitting alcove with ledge above to the right (west) of the fireplace

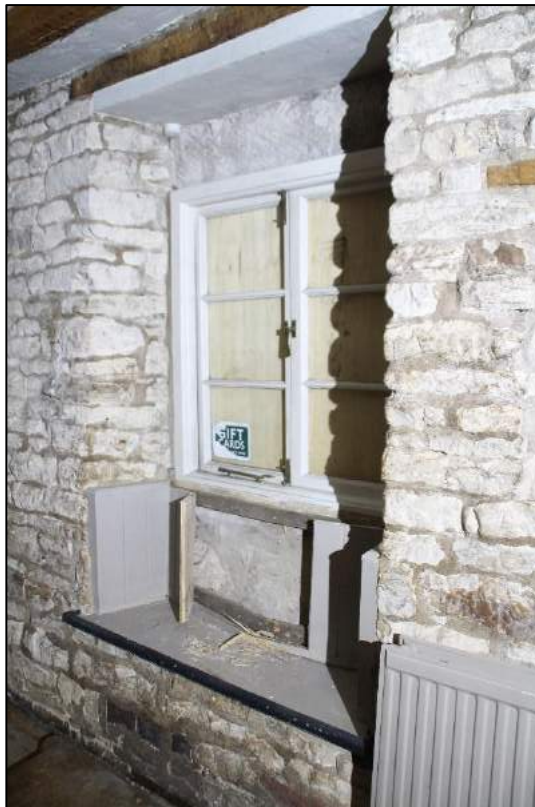
- 4.28. The windows of Room 2 are all modern timber replacements in the traditional vernacular (Photo 31) though they have been inserted into the historic openings.

Photo 31 The north-western window in Room 3
