**The Air Balloon Public House
Birdlip
Gloucestershire**

*Historic Building Recording
Level 3*

CA Project: CR1437

CA Report: CR1437_1

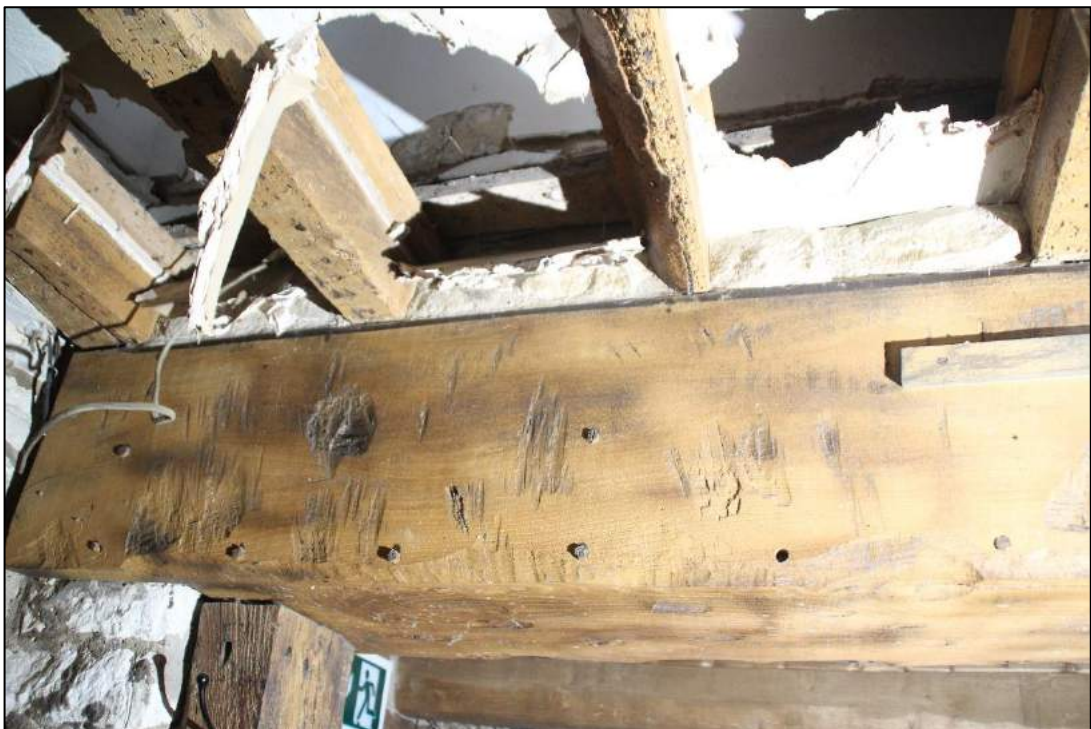
Photo 32 **Detail of the modern central beam to Room 3 with replaced joists above**

4.29. Areas of timber replacement were evident throughout the space, suggesting that the refurbishments of the late 20th century may have been quite intrusive, and also suggesting deterioration of the condition of the building fabric at that point. Given the amount of change over time, it is difficult to gauge which timbers are original and in their original location and not reused. In particular the main beam which supports the opening created by the removal of the wall in the northern section of the room (seen via the nibs on Figure 4a) is a large pine beam which has been 'distressed' and which may even be cladding laid onto a steel RSJ (Photo 32); typical of 1980s work. Above this new beam there is evidence of change to the joists above, though some appear to be historic (Photo 33).

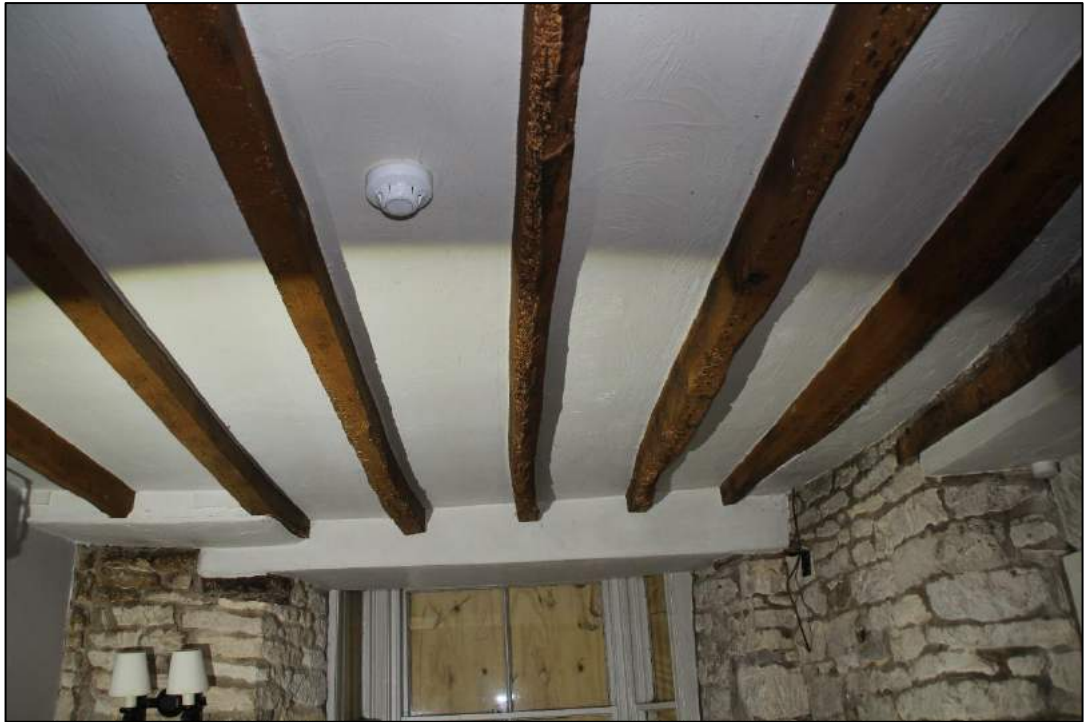
Photo 33 **Detail of ceiling with exposed joists, Room 3**

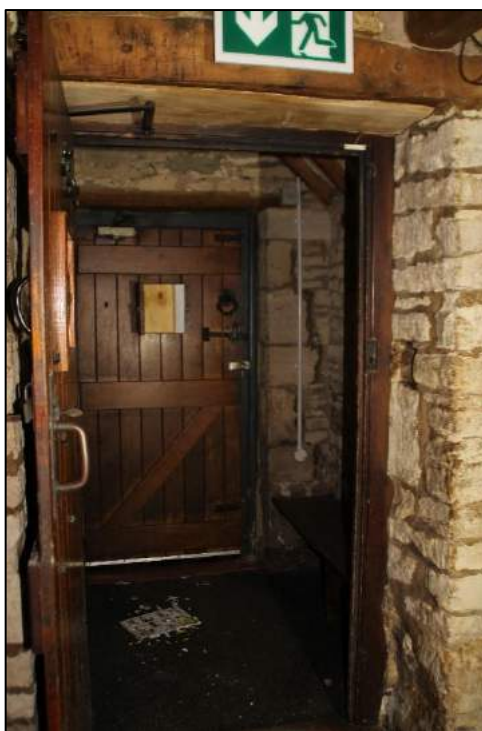
Photo 34 View of porch from Room 3

- 4.30. The porch structure is accessed from Room 3. As discussed above, the porch appears to be an added structure, though it was in place by the late 19th century. The internal door lintel appears historic, but like much in this Building it may be a reused or 'faux' piece. Internally it has a small window to each flanking wall, and modern plank doors, it acts as a lobby (Photo 34). The vaulted roof structure appears to have been replaced in the 20th century, this is evidenced by the faux distressed plaster and timbers in Photo 35, though it was difficult to ascertain due to light levels whether the timbers were perhaps older than thought. The presence of poor quality cement repointing internally also points to a poor quality late 20th century repair.

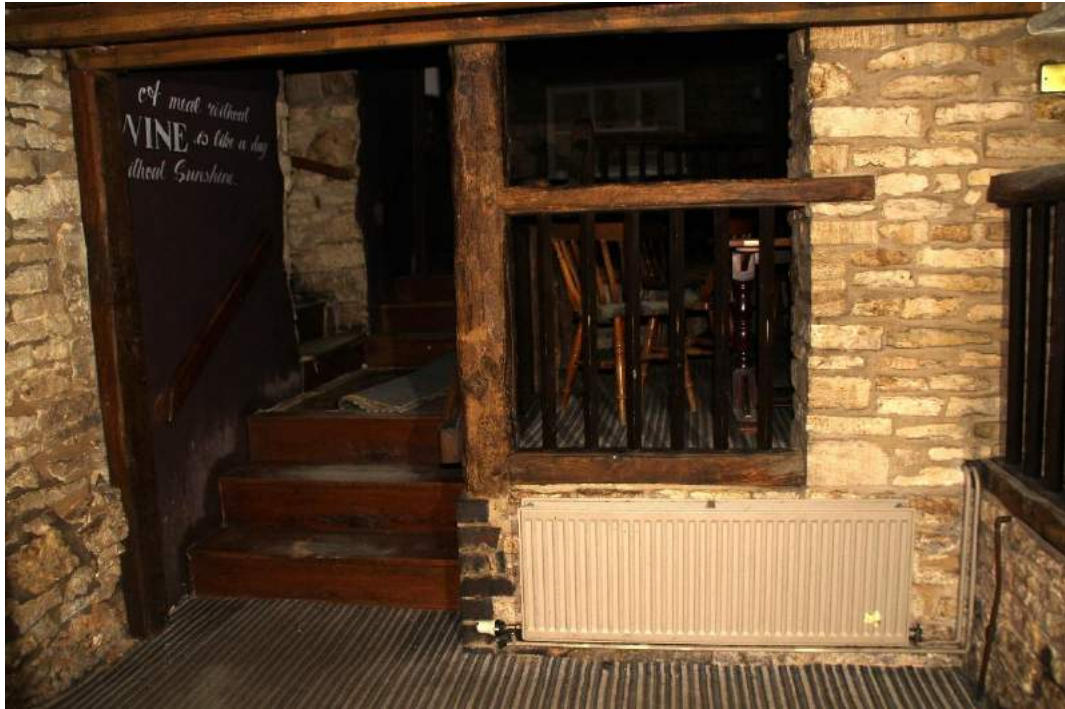
- 4.31. Room 4 is accessed from the bar area, and bar the sections of walling to the east (which is formed of the former rear wall of the inn), it is all work from 1980s and 1990s (Photo 36).

Photo 36 The access from the bar into Room 4, which is raised on a platform

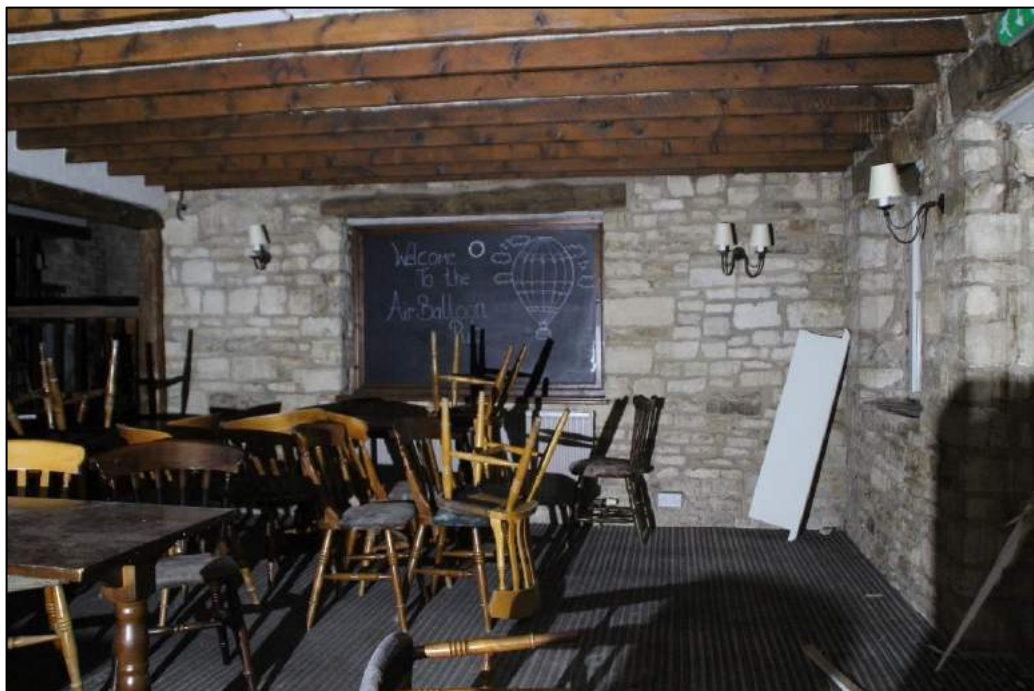
Photo 37 Room 4 seen looking south

- 4.32. Room 4 itself is a restaurant space and as with all other elements of the 1980s/90s work, it has been completed in a vernacular 'olde worlde' style to match the historic wing (Photo 37). Clearly some reuse of timbers has occurred however, as a new opening in the 1980s work is supported by an historic timber lintel (Photo 38).

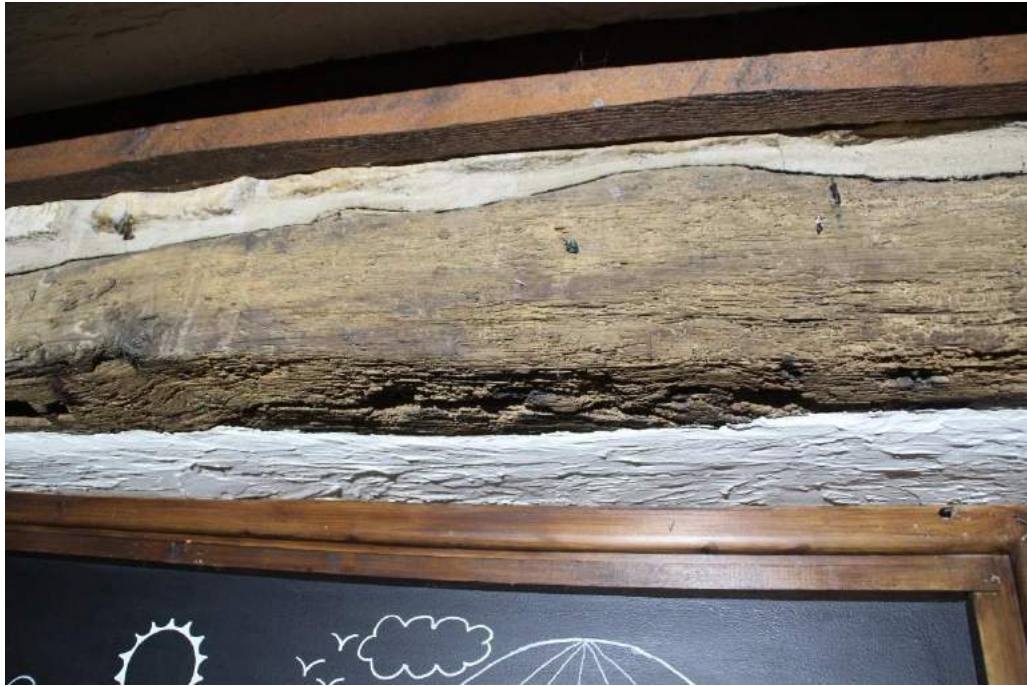
Photo 38 Historic reused timber in lintel of 1980s work

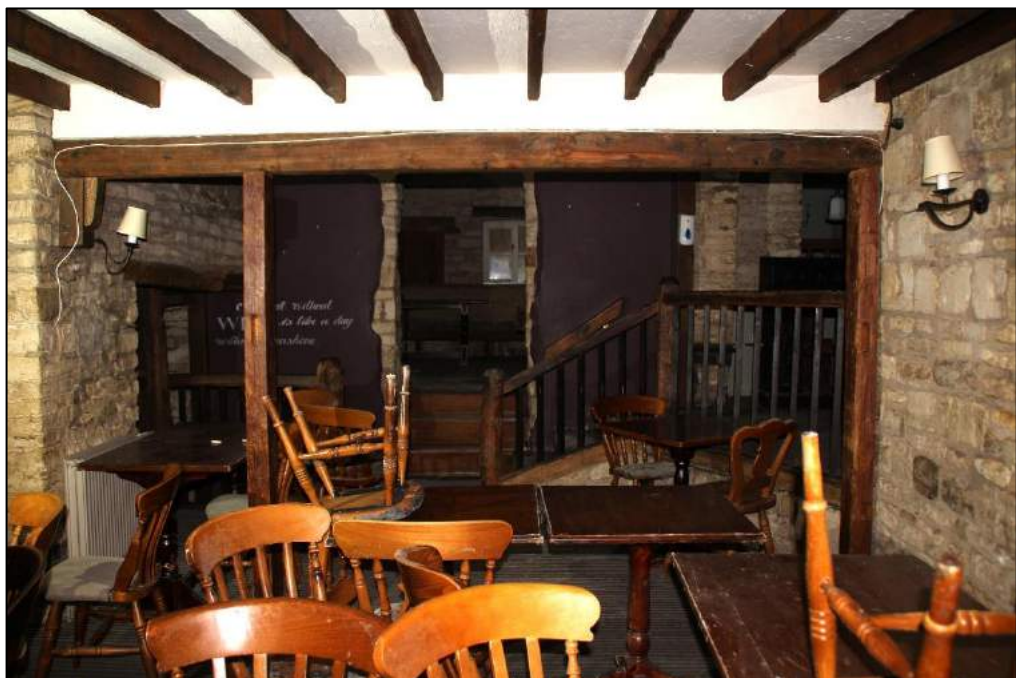
Photo 39 View looking east from Room 4 towards Room 7

- 4.33. Rooms 5 and 6 are similarly of the 1980s/90s phase of works. They access Rooms 7 and 8 which are the historic areas of the southern range (Photo 39). Room 5 was created in 1990 as a vaulted entrance hall to the southern parts of the inn accessed from the car park (Photo 40).

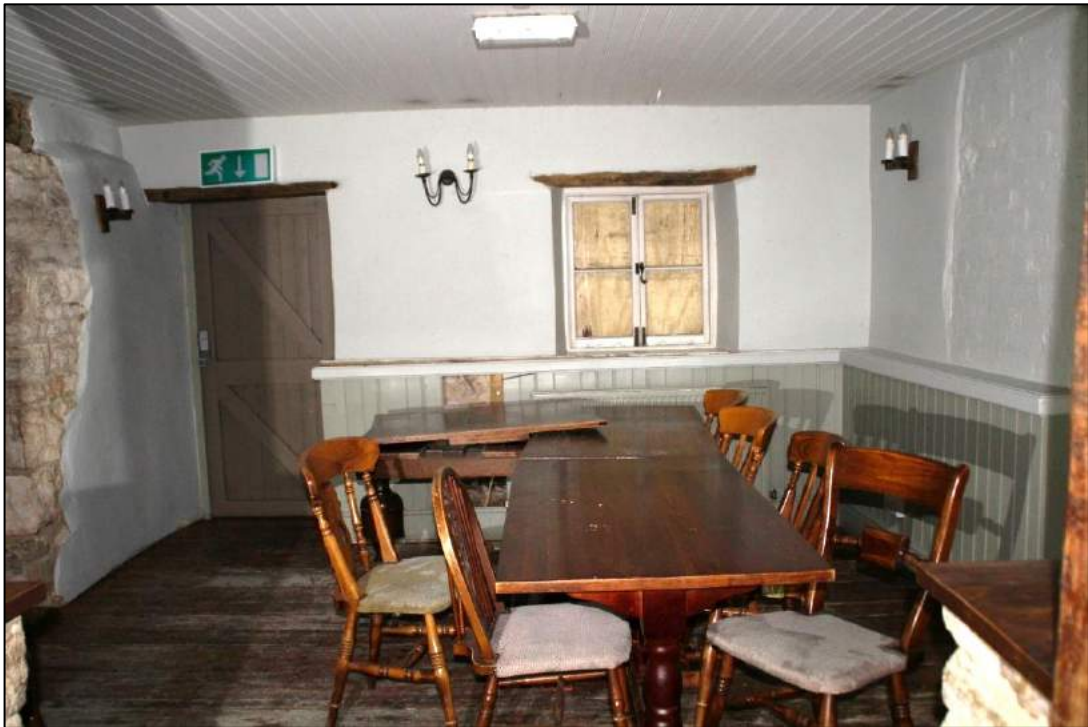
Photo 41 View of Room 8 looking east

- 4.34. Room 8 is the southernmost Building of the historic range (Photo 41) and it has been clearly modernised with the addition of tongue and groove panelling to walls and ceiling. A large opening has been created in the solid wall between this room and Room 7. The thickness of the wall as seen demonstrates that it is likely this southern 'cottage' was two sectional, without internal access between them, suggesting separate ancillary uses, such as discrete storage or brewery areas, or even stabling. An opening appears to have been filled in on the west side of the southern wall (see Figure 4a) though there is no evidence of this externally which suggests the infilling is historic or that a near total rebuild of this southern gable elevation has occurred when the western range was added in the 1980s and 90s. Internally the wall surface is different between the infilled area and wall, also suggesting a possible opening. In the first floor there is evidence of a fireplace in this gable end (supported by the gable chimney stack externally), which suggests that the change to this elevation has also involved removal of a ground floor fireplace, possibly in the location of the infill.

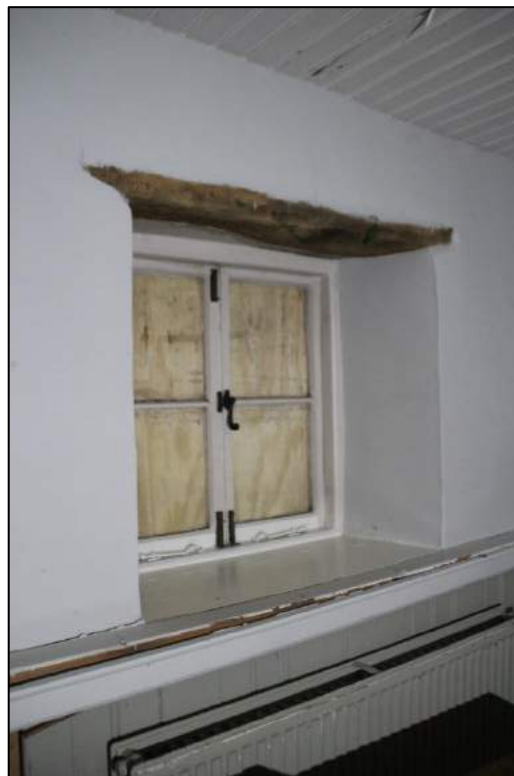
-
- 4.35. The window to the east has an historic lintel and wide reveals, though the window insert itself is modern timber casement (Photo 42).

Photo 42 Window facing east in Room 8 with timber lintel

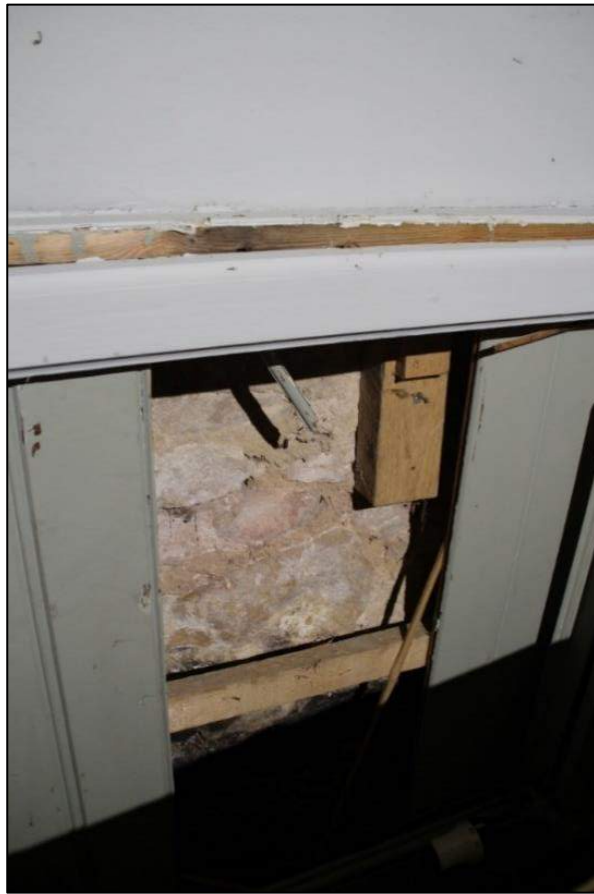
-
- 4.36. Areas of removed tongue and groove reveal the rubblestone masonry underneath though areas of the room have been plastered in the last phase of works (Photo 43).

Photo 43 Stone masonry below modern tongue and groove wainscoting

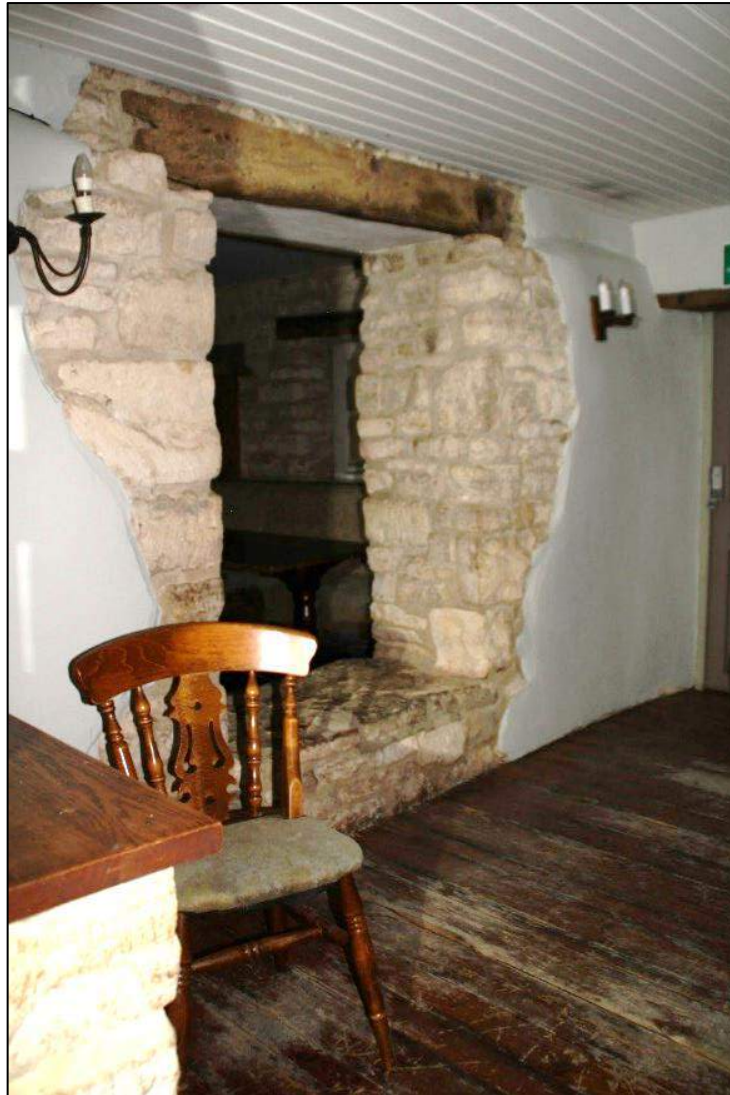
Photo 44 **The opening between Room 7 and Room 8**

- 4.37. The opening between Rooms 7 and 8 has clearly been created through thick masonry and has been created as a feature, with plasterwork accentuating the extreme depth of the walling and the low level masonry retained to create a sort of step, suggesting the opening was created for visibility/light rather than normal access between the two rooms (Photo 44). The opening has been decorated with timber lintels each side; these appear to be decorative rather than structural as they do not span the entire depth of the opening (Photo 45). Historic timbers appear to have been reused, however.

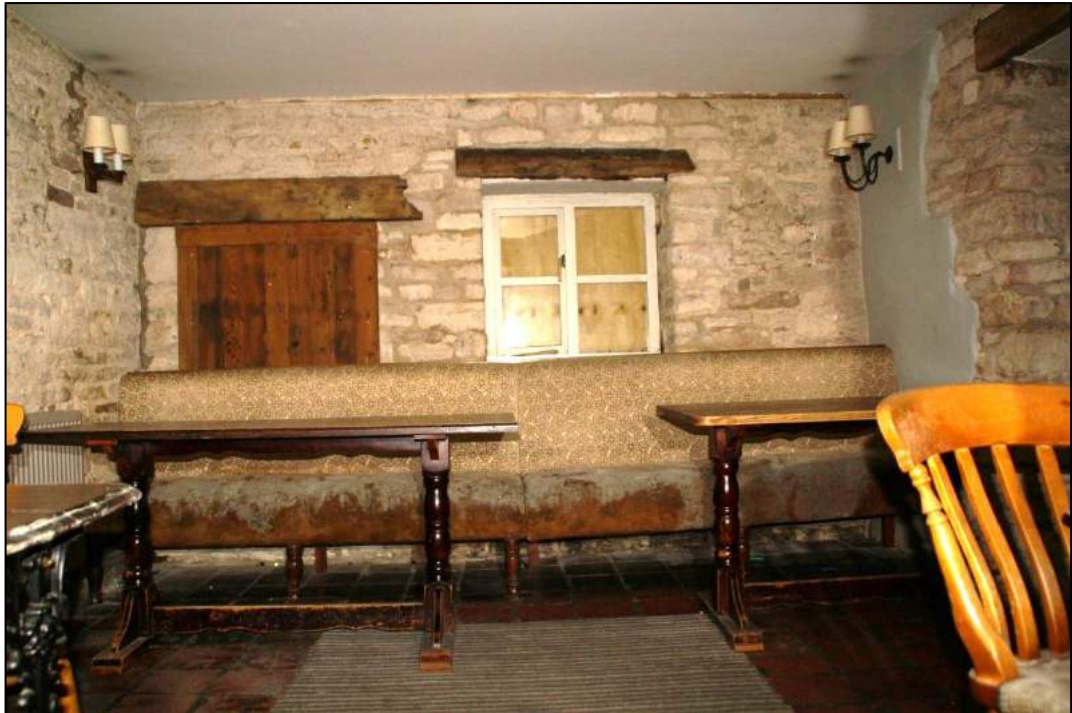
Photo 46 Room 7 seen looking east

- 4.38. Photo 46 depicts Room 7 which is the northern section of the southern Building. This has a modern ceiling with a built-in bench set over the former doorway here which has a decorative faux lintel planted on. The walls are bare masonry and the floor is quarry tiling. The window has what appears to be a historic lintel, but a modern timber casement insert (Photo 47). An opening has been instigated between Room 4 and Room 7 which may have been a former window to the rear of the historic Building. Alongside this opening is a curved wall (Photo 48) which likely represents the riser of the stair between Rooms 11 and 13 on the first floor (accounting for rising ground levels).

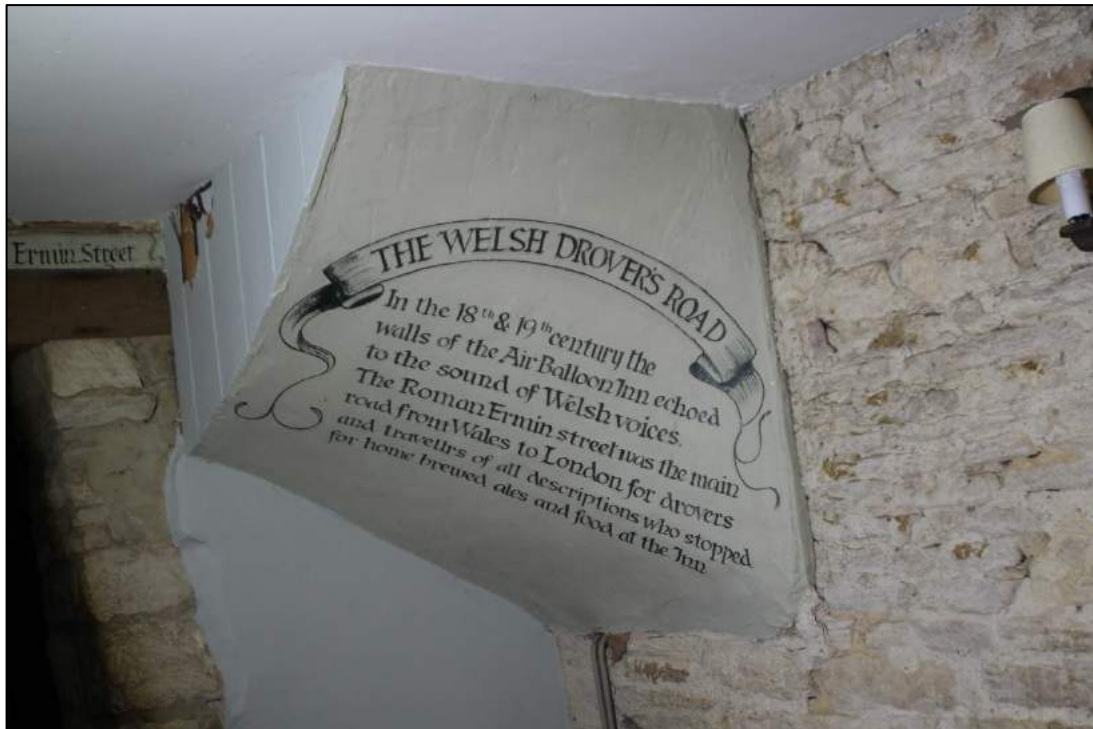
Photo 48 **The underside of the stair riser in Room 7 (related to stairs on the first floor)**

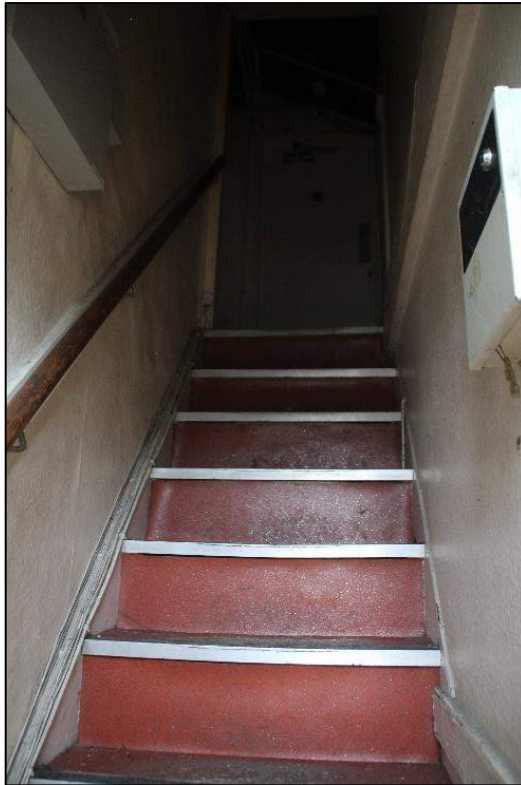
Photo 49 The stairs accessing the first floor

- 4.40. The first floor is accessed via a modernised set of steps adjacent to the kitchen entrance (Photo 49). The first floor is laid out as a series of six small rooms accessed off a main rear (west) corridor. The rooms appear to have been modernised into ancillary living accommodation in the 20th century, with some refurbishment work appearing to have occurred relatively recently. The corridor itself certainly appears to be the result of 20th century reconfiguration. Doors and door architraves are all of modern appearance.

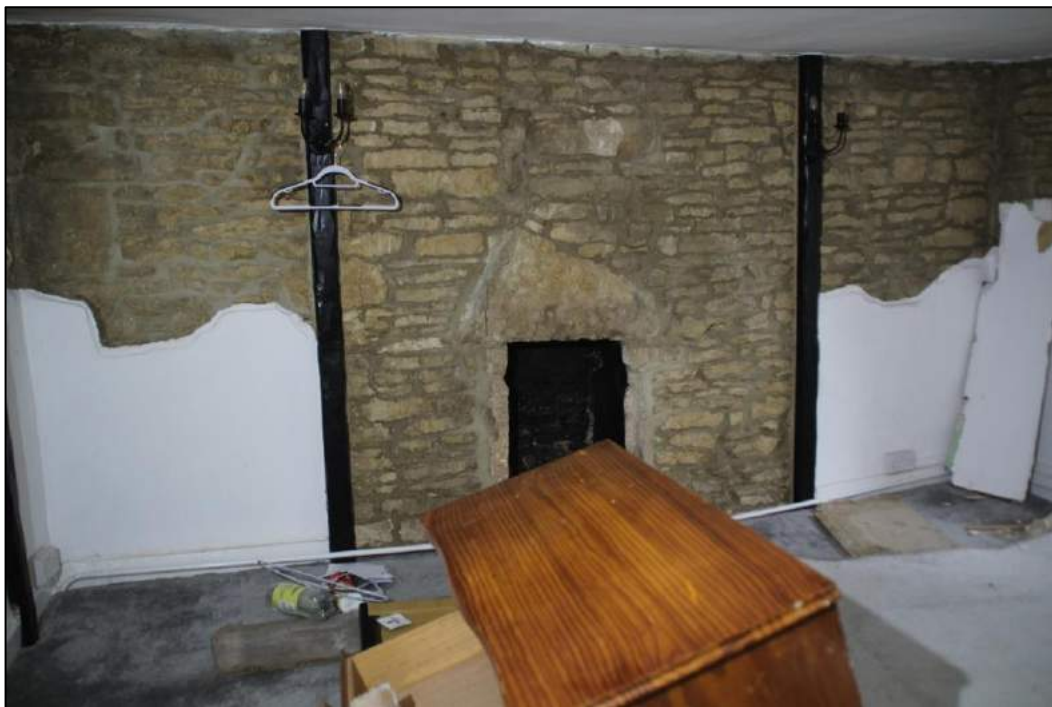
Photo 51 **The northern room, first floor, looking north**

4.41. The northernmost room on the first floor, Room 9, (Photo 51) has undergone some removal of plaster to reveal the stone masonry structure, which has uncovered a fireplace opening supported on a large triangular stone lintel. This was likely once covered with lime plaster and some form of mantle, with a fire grate within the fireplace opening. It appears that the traditional wall coverings, which were likely either some form of wainscoting, or lime plaster, were removed in renovation schemes, and the most recent phase of works has resulted in the installation of half height wavy-edged gypsum plaster, presumably in an attempt to create an aesthetic vernacular effect. The ceiling appears to be a replacement version with modern plasterboard and plaster.

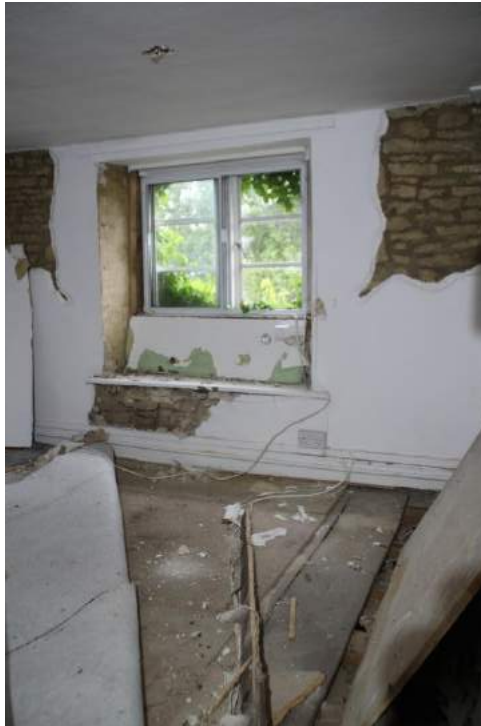
Photo 52 View of the window in Room 9

4.42. The window in Room 9 has a window seat inset in the apron and has metal casement inserts with three panes which have an early 20th century character (Photo 52). The floor surface was covered with carpet but is likely to be either timber boarding or floorboards which have been replaced in one of phases of renovation including the removal of a wall in the room below and the insertion of a new timber beam.

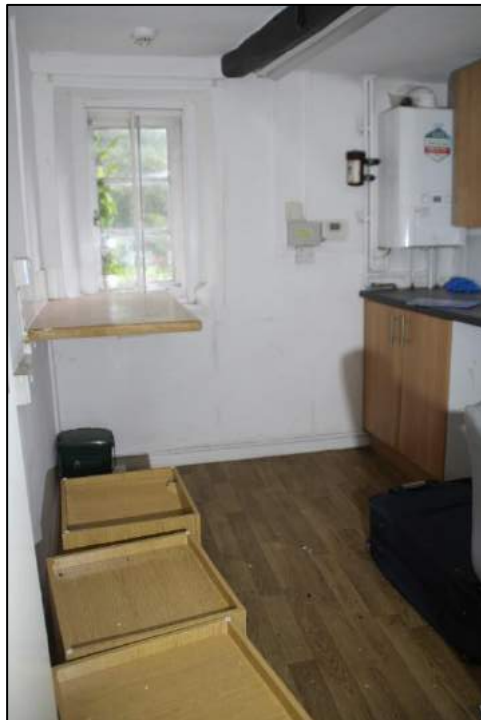
Photo 53 View of the modernised kitchen, Room 10

- 4.43. Room 10 has been converted into a kitchenette and has been modernised, though a rough cut timber beam was evident running laterally east to west at ceiling level. The metal three paned casement window, likely early 20th century, is secondary glazed (Photo 53).

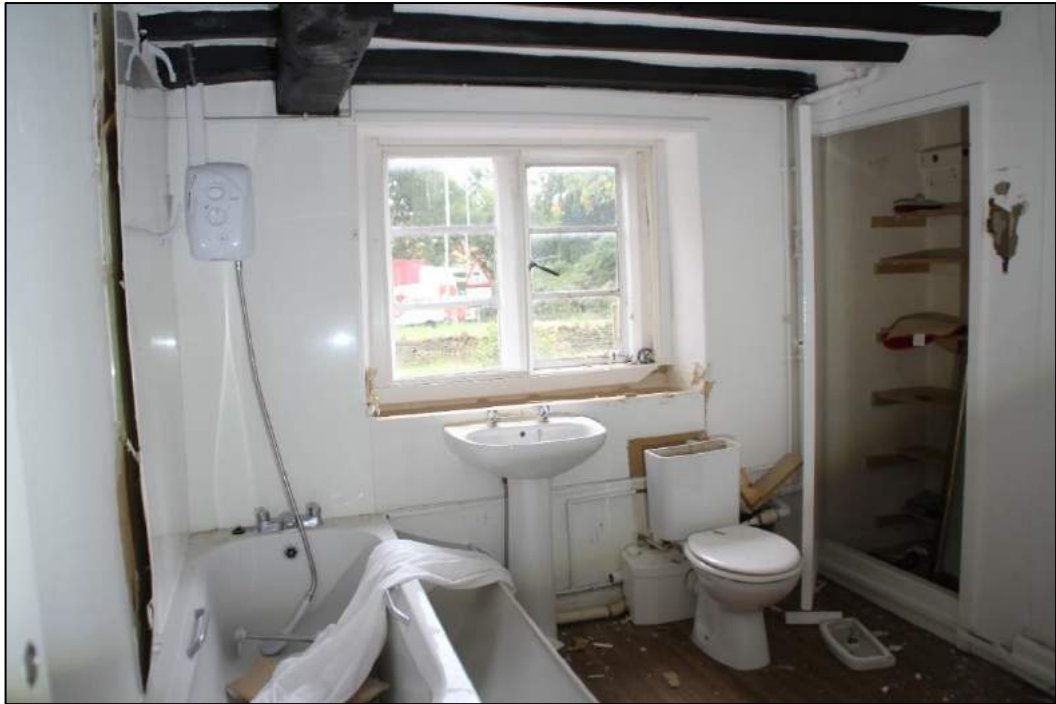
4.45. Room 11 is a bathroom, with evidence of some abandoned renovations. The original main rough cut beam and joists are visible in the ceiling (Photos 55 and 56). The window is the same two light mullion casement with metal three pane insert seen in Rooms 9 and 10 and it has also been secondary glazed.

Photo 55 View of Room 11, looking east

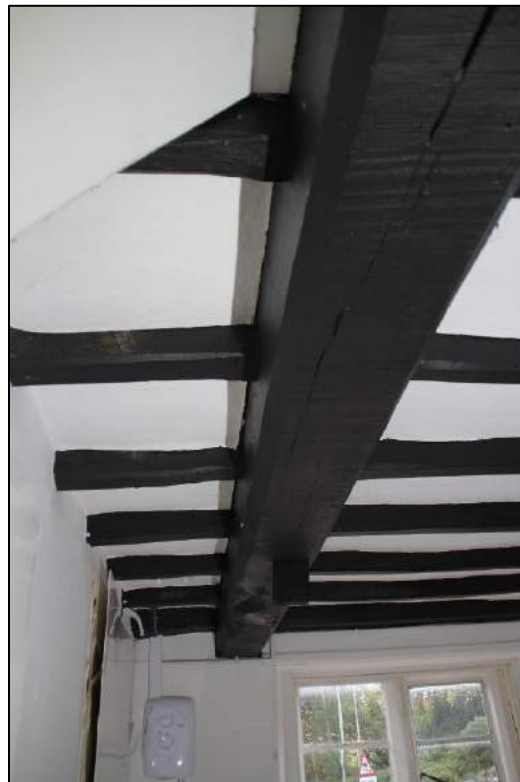
Photo 56 View of beam and exposed joists, Room 11

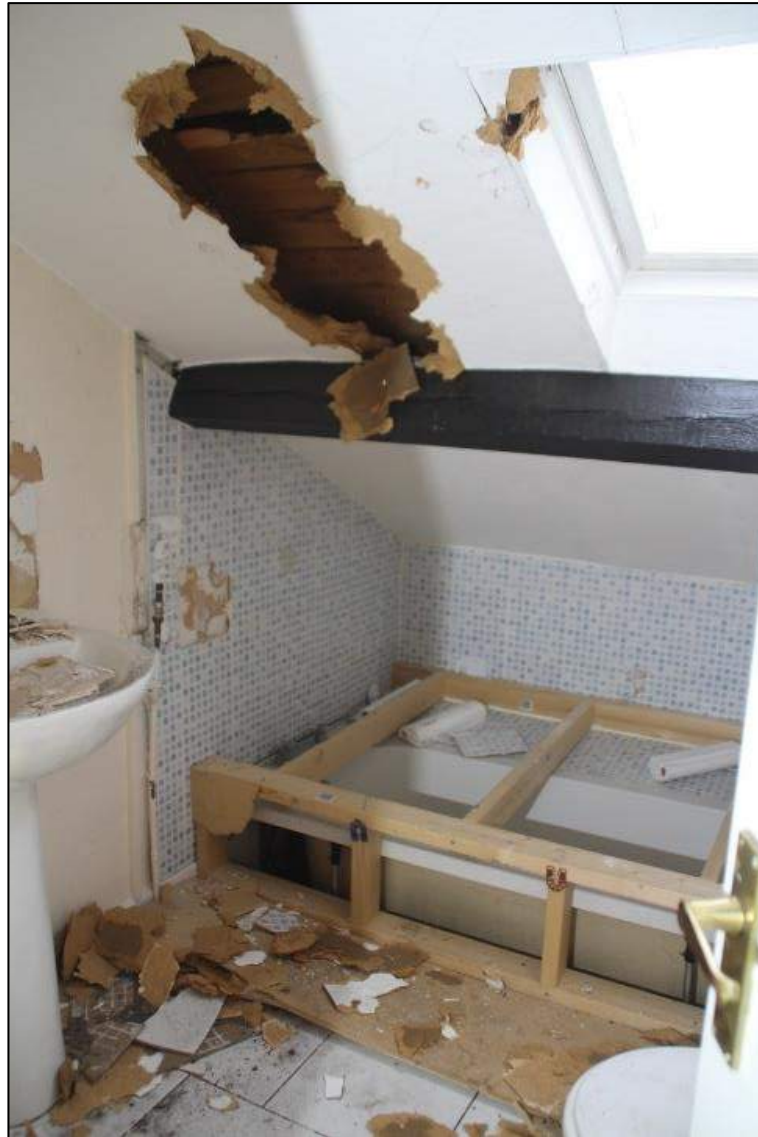
4.46. Room 12 (Photo 57) is located over an extension that was constructed in the mid-20th century (between 1920 and 1974 according to the mapping in Figure 2). It is also a bathroom, with the sunken bath placed under the low eaves. An area of

plasterboard has been removed to reveal sarking boards on the underside of the lean-to roof, which suggests the plasterboard and plaster is a later roof underside covering.

Photo 57 **View of Room 12, looking west**

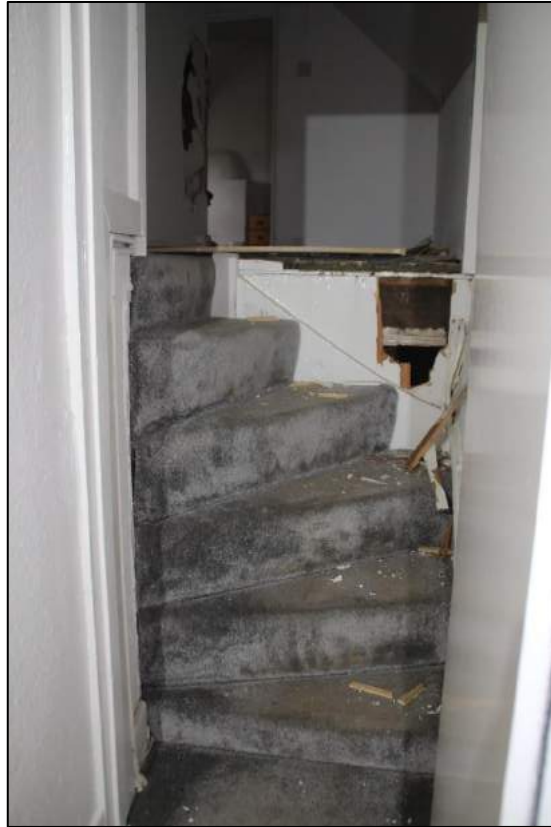
- 4.47. Rooms 13 and 14 are located at a higher level than the northern half of the Building. This is to account for the site levels which slope upwards to the south of the site, and the fact that the southern building section has been constructed at a higher level than the northern section. Therefore a small rise of stairs curving east provide access between north and south sections (Photo 58). The stairs rise to a small lobby which has been subdivided to create the lobby and a bedroom (Photo 59), Room 13, which is a modernised bedroom space (see Figure 4c.

Photo 58 The small flight of stairs to Rooms 13 and 14

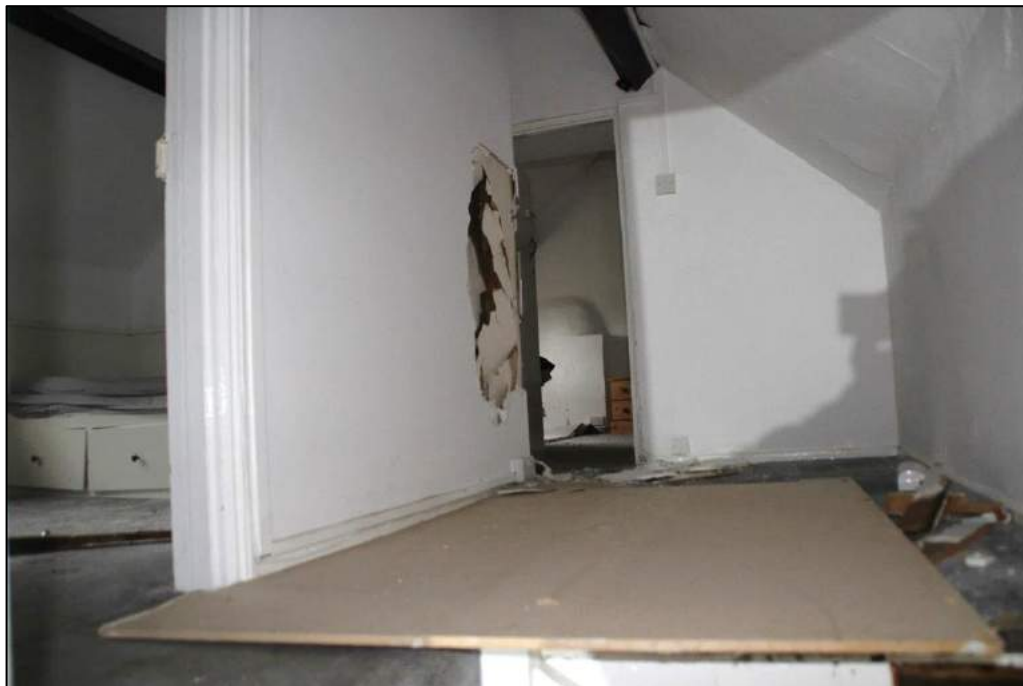
Photo 59 The upper lobby and Room 13 on the left

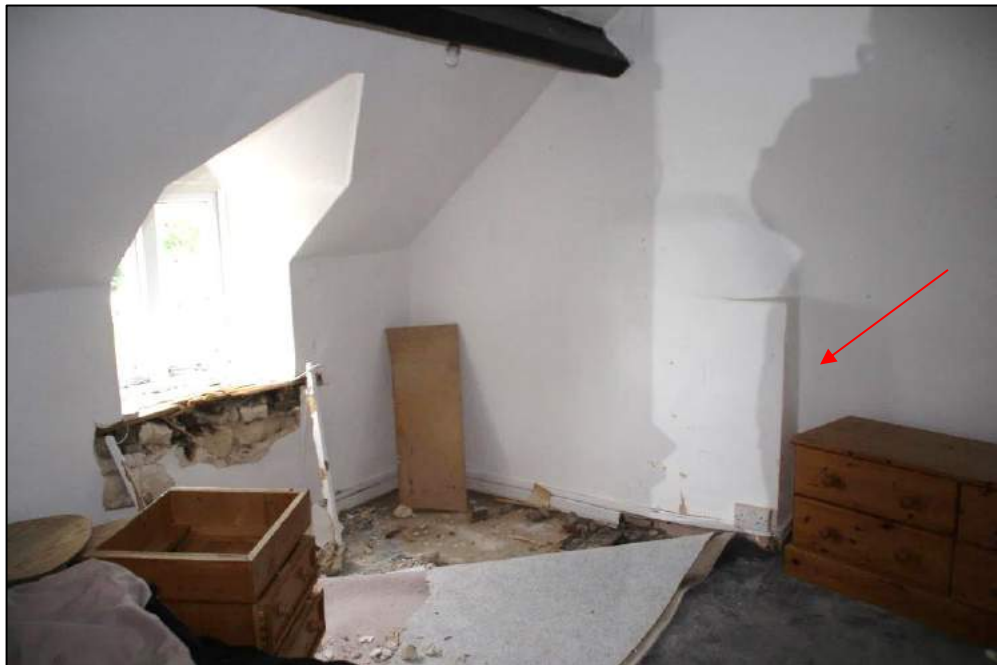
An interesting linear feature sits on the southern gable wall, it appears to be one side of a thin fireplace (a chimney is present above) with the other side being amalgamated within the plastered wall. This is seen on Figure 4a and in Photo 60 below.

Photo 60 Room 14 with the gable linear feature, possible former fireplace

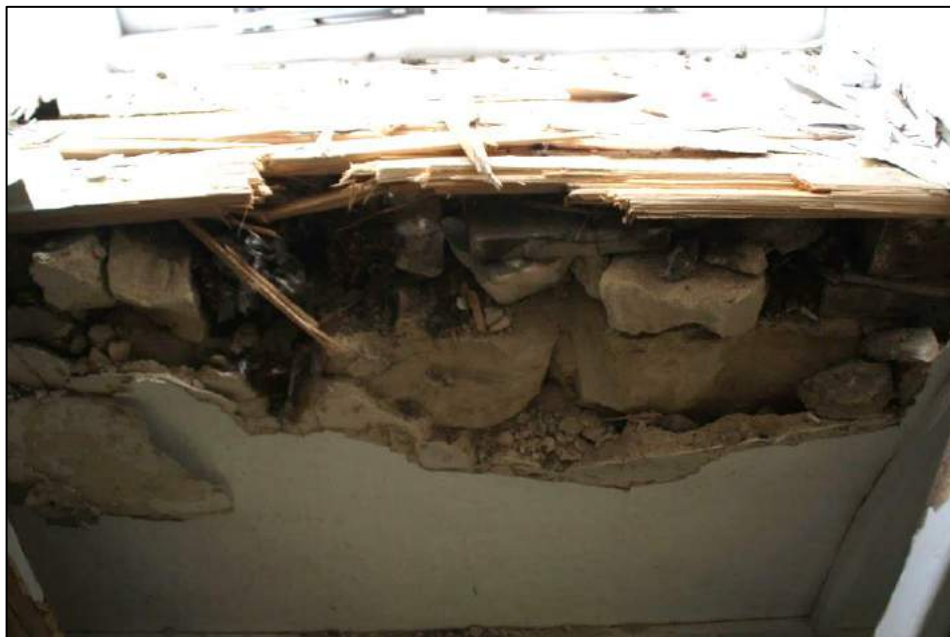
4.49. Part of the timber, plaster board and hard modern plaster covering of the window reveal has been removed to reveal thick rubblestone masonry below (Photo 61).

Photo 61 The window cill and masonry below in Room 14

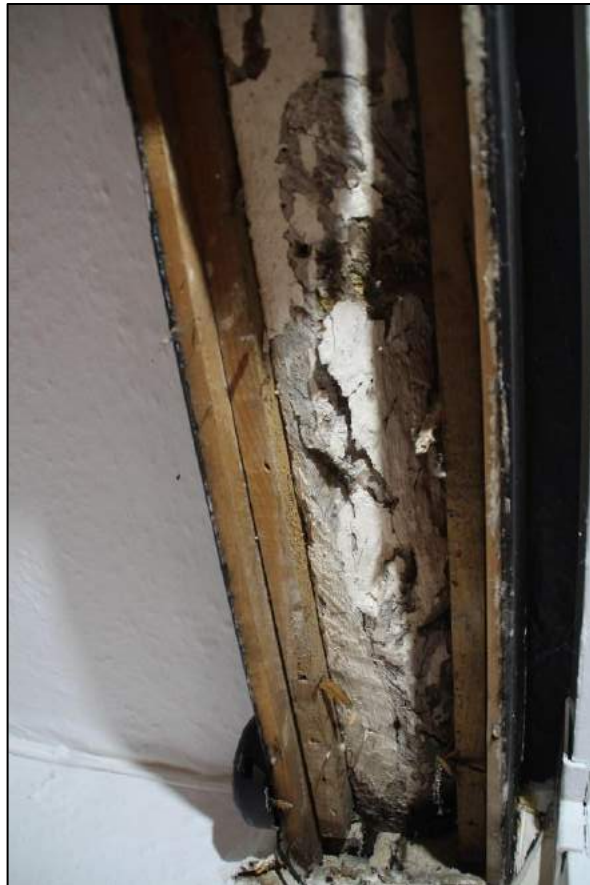
Photo 62 An historic timber beam in poor condition ‘sandwiched’ by modern timbers

4.50. There is evidence across the first floor of phases of refurbishment, for example a timber beam within the main corridor has been repaired via a sandwich arrangement with modern timber (Photo 62) which has been clad over the historic piece so that the repair appears like a beam. There is evidence of historic lathe and plaster construction covered with modern plasterboard within a corridor doorway (Photo 63). A chamfer stop timber beam is present in the corridor alongside exposed joists (Photo 64) though it is always possible that elements such as these, especially when painted, may actually be later 20th century cladding of older, cruder timber. Some historic, likely 19th-century wallpaper, was seen underneath other layers, also in the main first floor corridor (Photo 65). The modern plaster and woodchip layer/s over the top evidence that this floor has been subject, as above, to consecutive phases of redecoration and refurbishment, likely associated with changing interior design fashions.

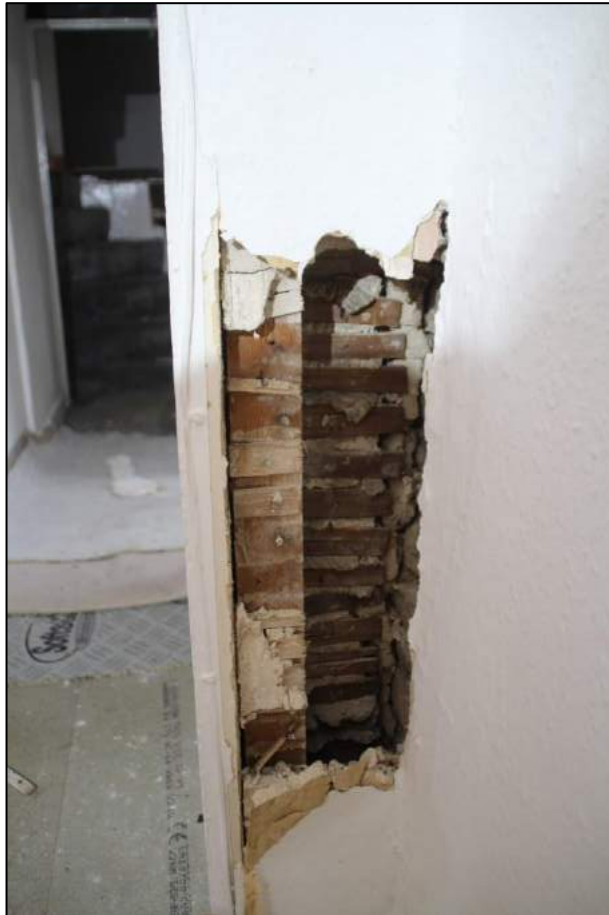
Photo 63 Remains of lathe and plaster in corridor

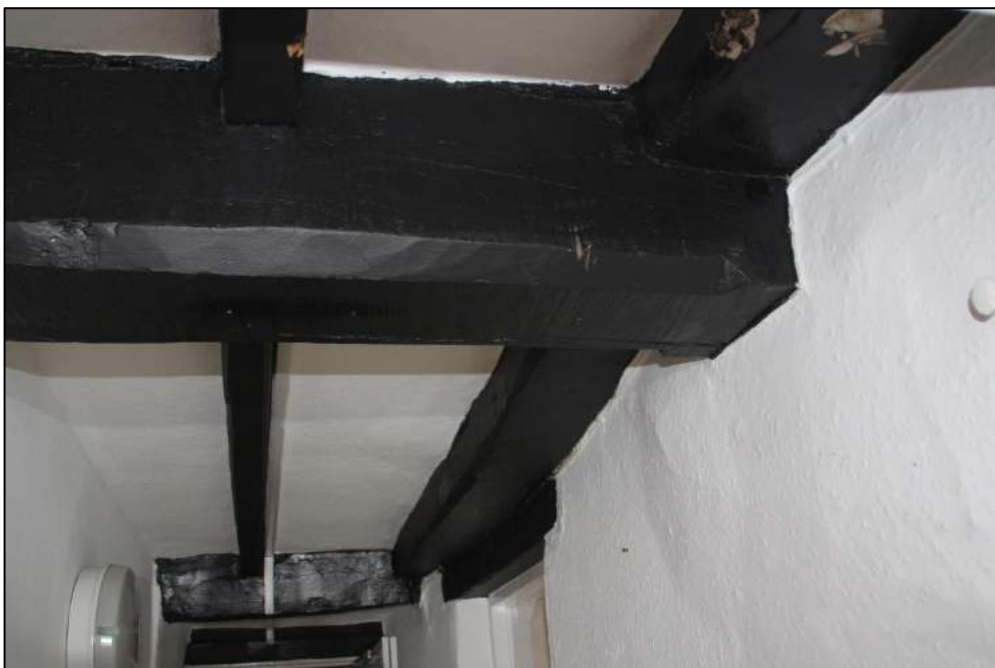
Photo 64 Section of a main beam, first floor corridor

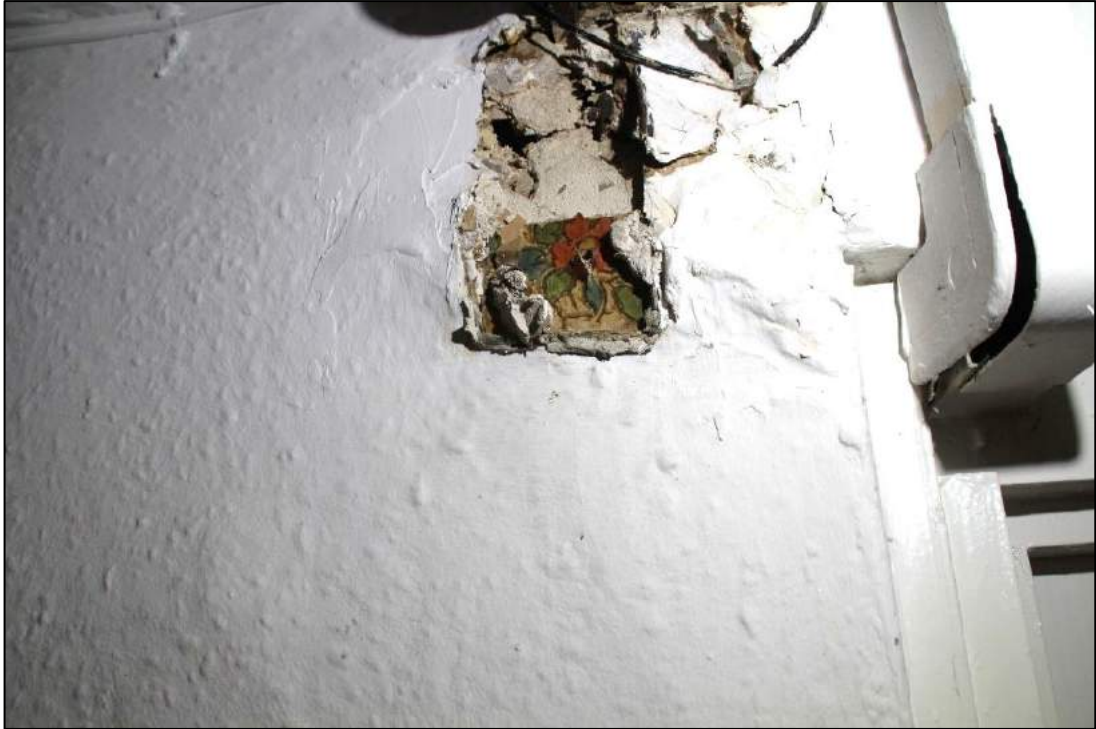
Photo 65 **A remnant of historic wallpaper under modern wall coverings**

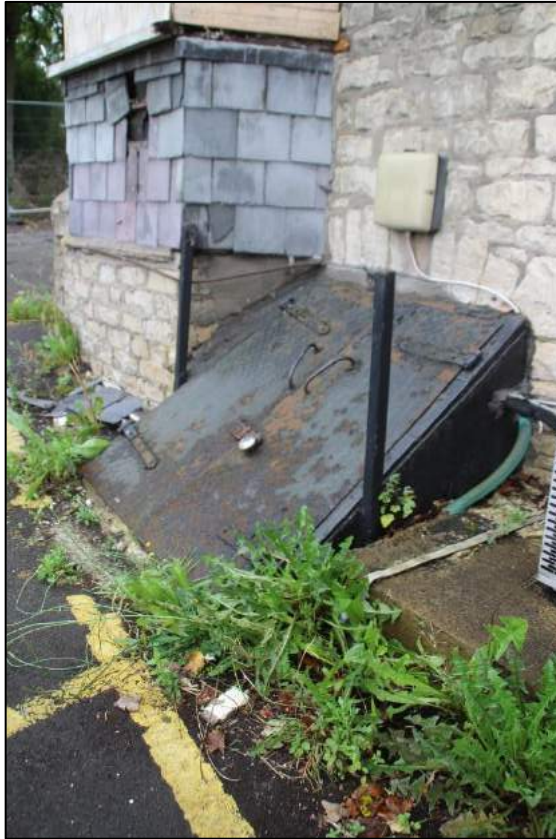
- 4.51. The cellar is located underneath the northern section of the Building. The slope of the hill precluded any further below ground spaces. It is accessed via a set of metal cellar doors (Photo 66) which open onto a set of steep cellar steps with barrel rolling platforms either side (Photo 67). The stone arch to the opening suggest that the cellar access is an historic one. Once inside the cellar, it is clear it has been subject to some structural propping and modernisation to receive modern pipe equipment, and that a former set of stairs up to the ground floor has been infilled (Photo 68). Of note is the presence of what appear to be historic timber floorboards above that have been covered over by subsequent floor surfaces on the ground floor (Photo 69).

Photo 66 **The cellar doors on the northern elevation**

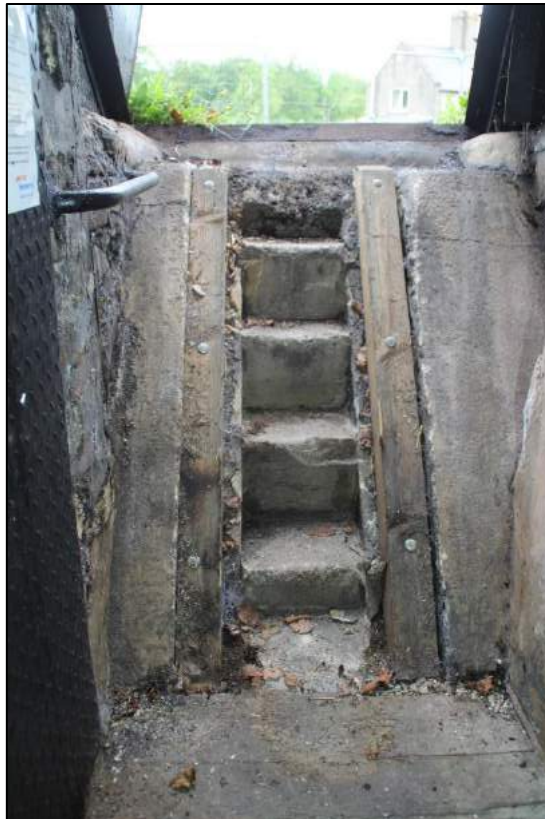
Photo 67 **The cellar stairs with barrel slope**

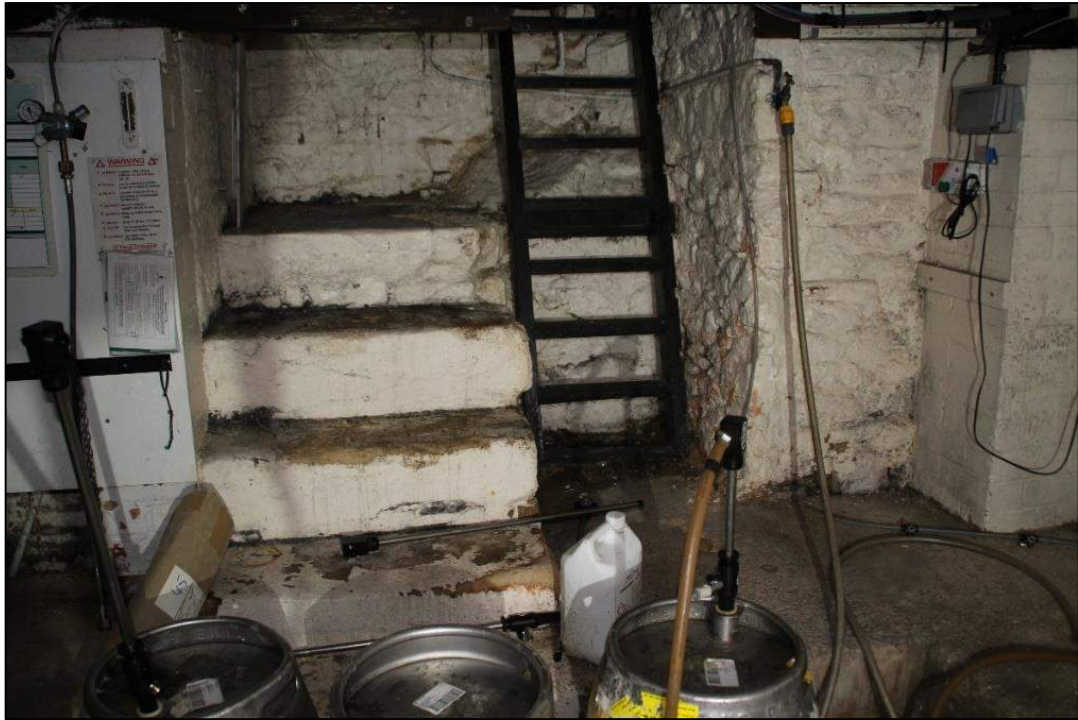
Photo 68 The southern wall of the cellar with infilled former stairway to the interior of the pub
