**The Air Balloon Public House
Birdlip
Gloucestershire**

*Historic Building Recording
Level 3*

CA Project: CR1437

CA Report: CR1437_1

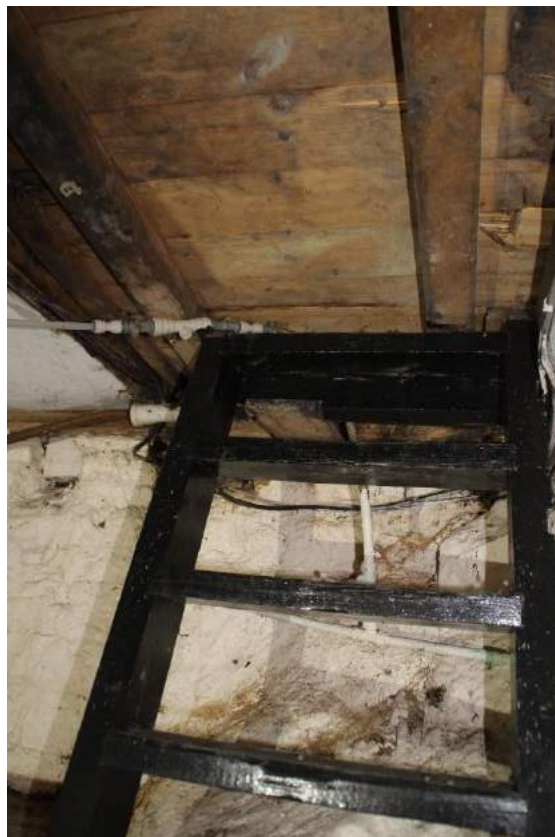
- 4.51. The cellar is located underneath the northern section of the Building. The slope of the hill precluded any further below ground spaces. It is accessed via a set of metal cellar doors (Photo 66) which open onto a set of steep cellar steps with barrel rolling platforms either side (Photo 67). The stone arch to the opening suggest that the cellar access is an historic one. Once inside the cellar, it is clear it has been subject to some structural propping and modernisation to receive modern pipe equipment, and that a former set of stairs up to the ground floor has been infilled (Photo 68). Of note is the presence of what appear to be historic timber floorboards above that have been covered over by subsequent floor surfaces on the ground floor (Photo 69).

Photo 69 The underside of the ground floor surface, showing what appear to be historic timber floorboards and joist
