**MERCHANTS ALMSHOUSES
KING STREET
BRISTOL**

ARCHAEOLOGICAL EVALUATION

CA PROJECT: 2756
CA REPORT: 08250

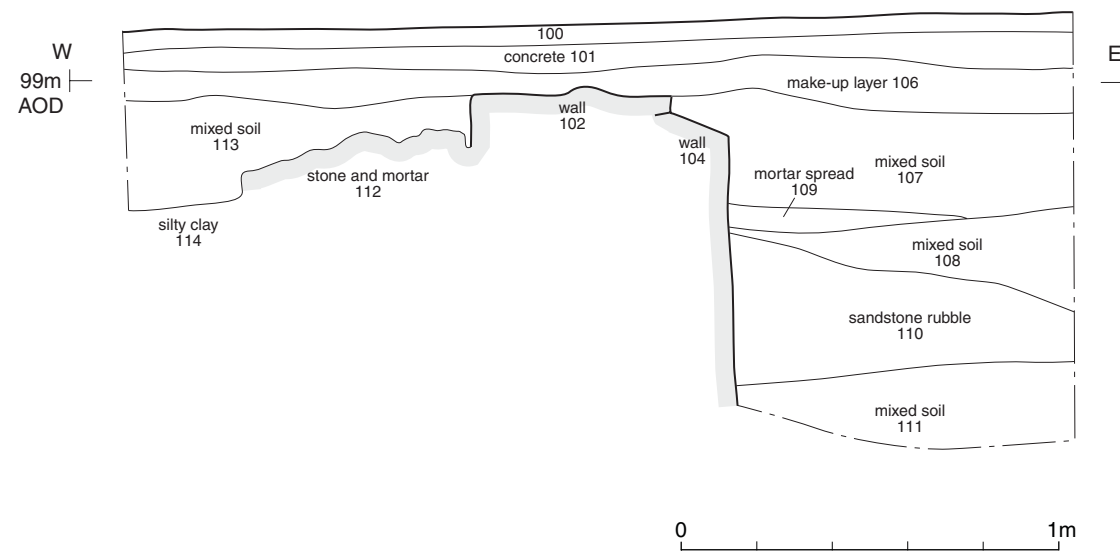
Section AA

- 2.5 A dark mixed soil deposit, 111, was encountered against the west facing elevation of the wall at the base of the trench. This layer was then sealed by a layer of loose sandstone rubble, 110, that included a lens of crushed slate which could represent the demolition of the structure associated with wall 104. Above this were further layers of mixed soils, 108 that contained two pieces of late 17th to 18th-century pottery and a clay tobacco pipe dated c.1690-1710. Partially overlaying this was a small spread of mortar, 109. Both 108 and 109 appear likely to be associated with the construction phase of the west wing of the almshouse in 1696.

- 2.7 A layer consisting of redeposited stone and crushed mortar, 112, was identified between the western face of wall 102 and the northern face of wall 103. This partially overlay 114 a clayey deposit, which is very similar to 119 to the south of wall 103. Deposit 119 was overlain by 118, a layer of demolition rubble possibly from the demolition of the west wing of the almshouse.

- 2.8 A mix of redeposited soil, mortar and stone 107 was noted in section to the east of wall 102, overlying wall 104 and abutting the face of 102. It probably represents make-up related to the construction of the original yard within the three wings of the almshouses. To the west of wall 102, in the area delimited by it and wall 103, a darker layer consisting mainly of re-deposited soils, 113, was recorded, representing the demolition phase of the wing in the 1940s.

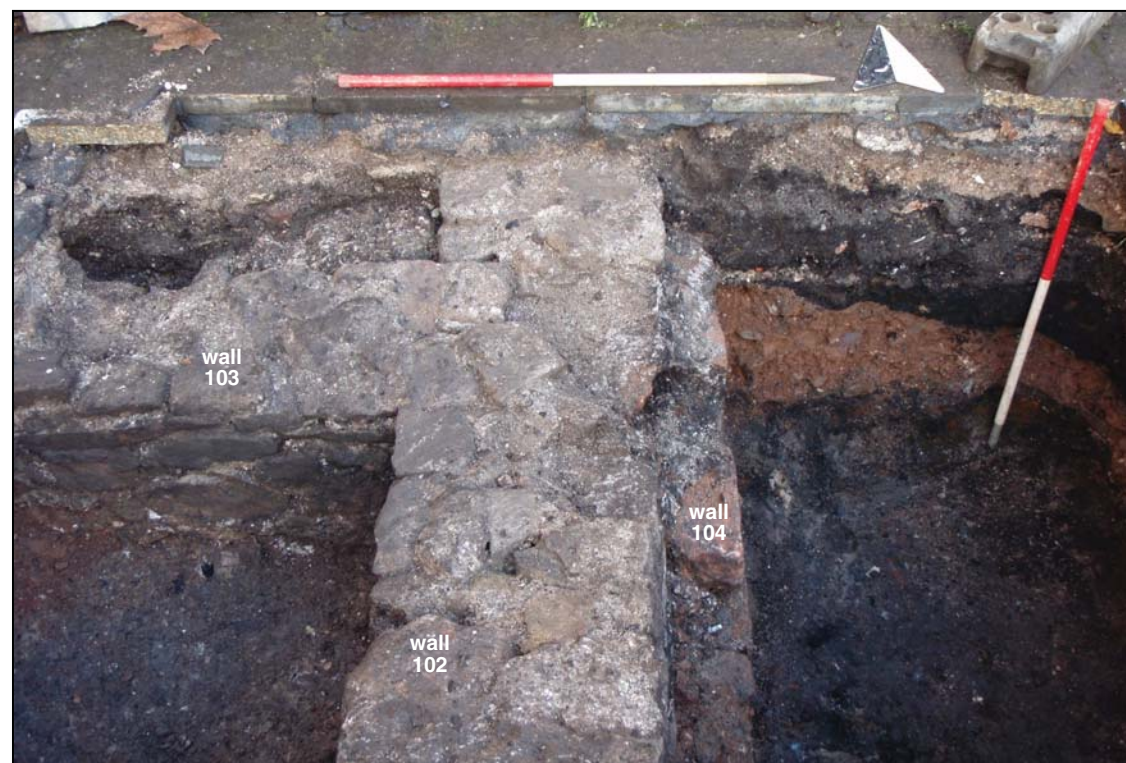
Photograph of Trench 1, looking east

- 2.3 A north/south aligned wall, 104, was exposed close to the centre of the trench. This was partially visible below a later wall, 102 and was constructed from roughly worked sandstone blocks bonded together with a pink sand-based mortar. Patches of the exposed east facing elevation had been re-pointed with a lime mortar.

- 2.4 Wall 104 was very uneven in height, and appears unlikely to have been the foundation level for wall 102. It appears more likely to be the remains of a former structure that has been reused to carry wall 102.
