**HAILES HOUSE
HAILES, STANWAY
GLOUCESTERSHIRE**

ARCHAEOLOGICAL WATCHING BRIEF

CA PROJECT: 2700
CA REPORT: 08229

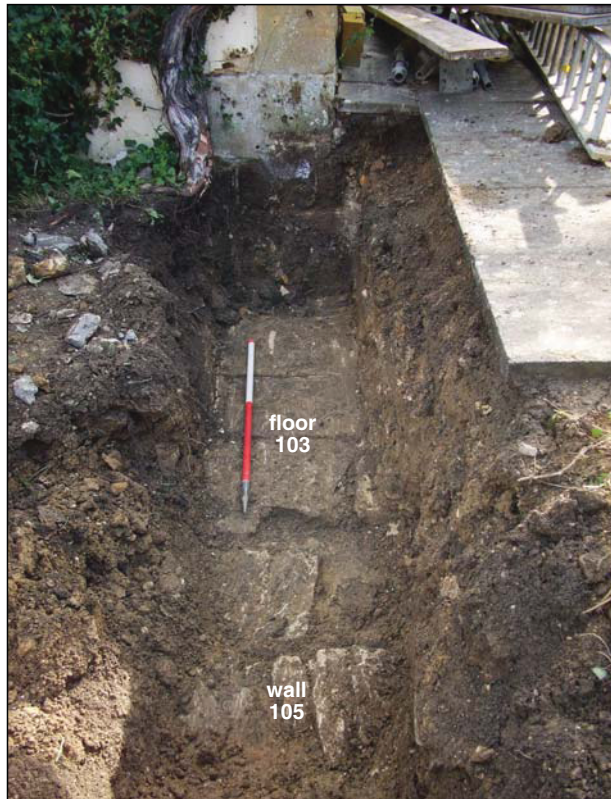
- 2.2 The walls were all of similar build, comprising roughly-faced limestone courses with a rubble core, all bonded with brown clay. Walls 105 and 207 were both aligned north-east/south-west and were 0.6m wide. Their location and alignment suggests that they may have formed parts of a single, if slightly offset, wall. Wall 302 was aligned approximately east-west and was 0.7m wide.
- 2.3 Surface 103 abutted wall 105 and consisted of smoothly-dressed, unbonded limestone slabs. Culvert 204 was also built from unbonded limestone slabs. The structural remains were sealed by 1m-1.4m thickness of post-medieval or modern make-up layers and garden soil deposits.
- 2.4 No artefactual material was recovered during the watching brief.

3 Wall 105 & Floor 103, looking south

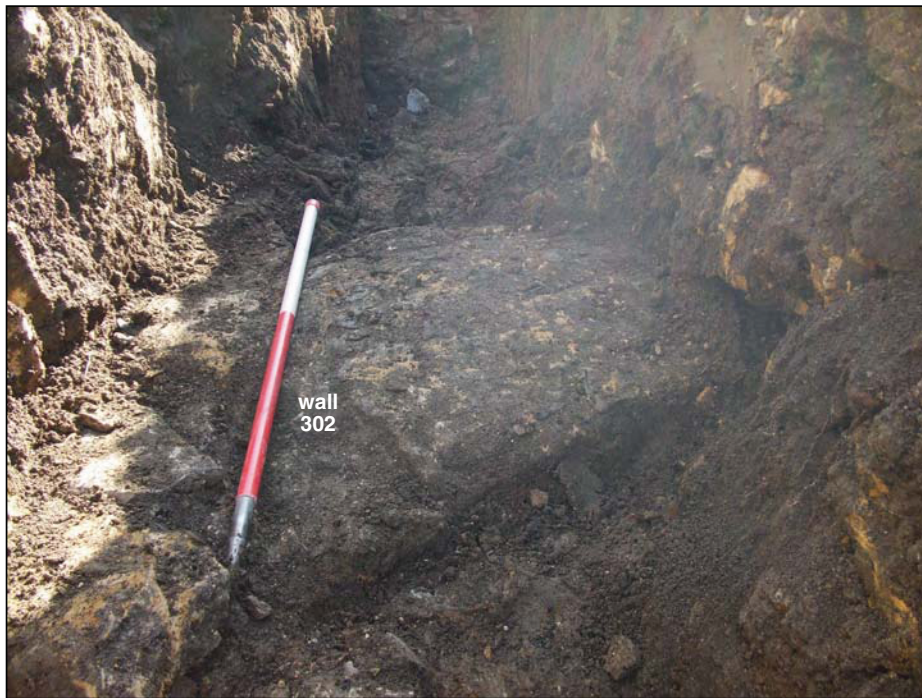
4 Wall 302, looking east
