**THE WILLOWS
CHURCH STREET
HELSTON
CORNWALL**

BUILDING RECORDING

CA PROJECT: 2609
CA REPORT: 08110

JULY 2008

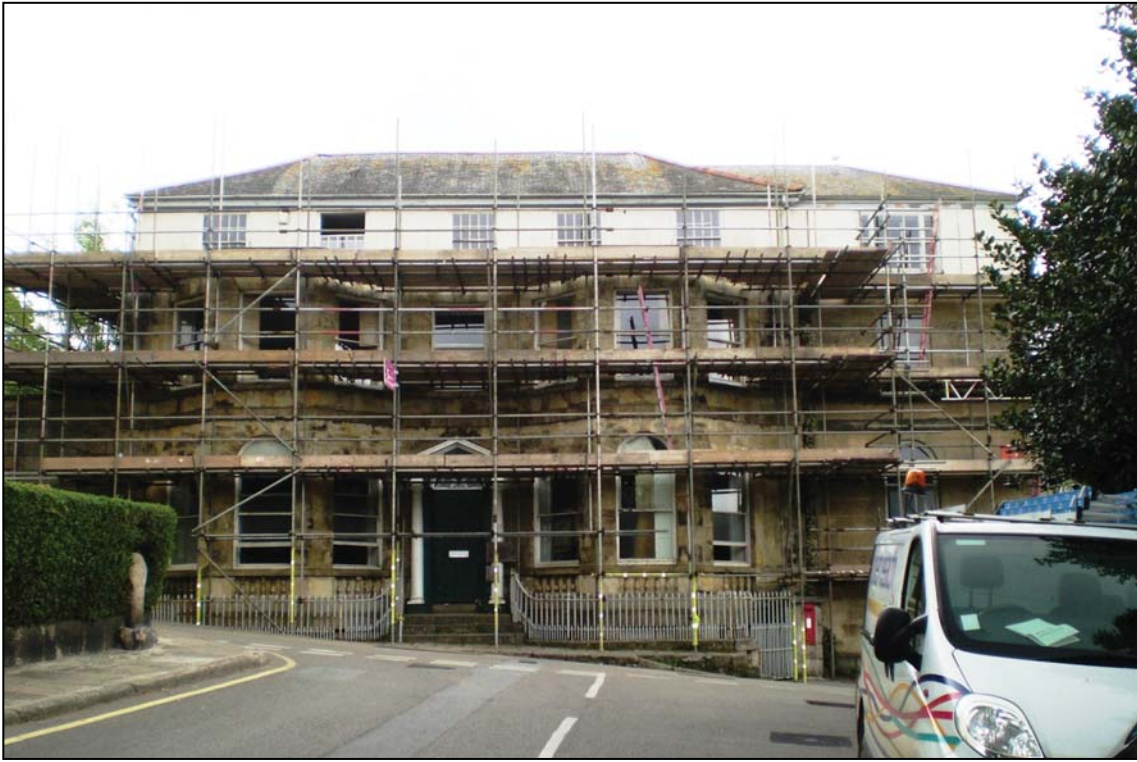
7 West elevation

- 2.1 The external walls are made of fine Newham or Elvan stone ashlar on the main or west façade (Fig. 7). This is a stone available locally. The basement here is of finely cut, but necessarily coarser, granite. The pavement and railed-off areas outside are an integral part of the construction, also of massive granite slabs. The central front door with its fine Doric porch is central to the flanking, canted bay windows, which have recessed panels of blind balustrading under each window in the bay (Fig. 9). The central windows are segmentally arched, the side ones, flat-arched. Sash frames are essentially original, but on the ground floor the sliding panels have been replaced in the central window of each bay and the southern window of the northern one, and the glazing bars, probably six-over-six, have been removed and the glazing is now plate glass. The first floor windows have also been partly replaced and reglazed. The top floor is set back, having no bay windows. It is timber-framed and rendered on the street front but the stone side walls continue up to form its lateral element. The original hipped roof is still in place. Its covering now extends over the roof timbers of the south block, but the structure is substantially intact inside. All external stacks have been removed, and the roof covering, of small slates, clearly post-dates this demolition.

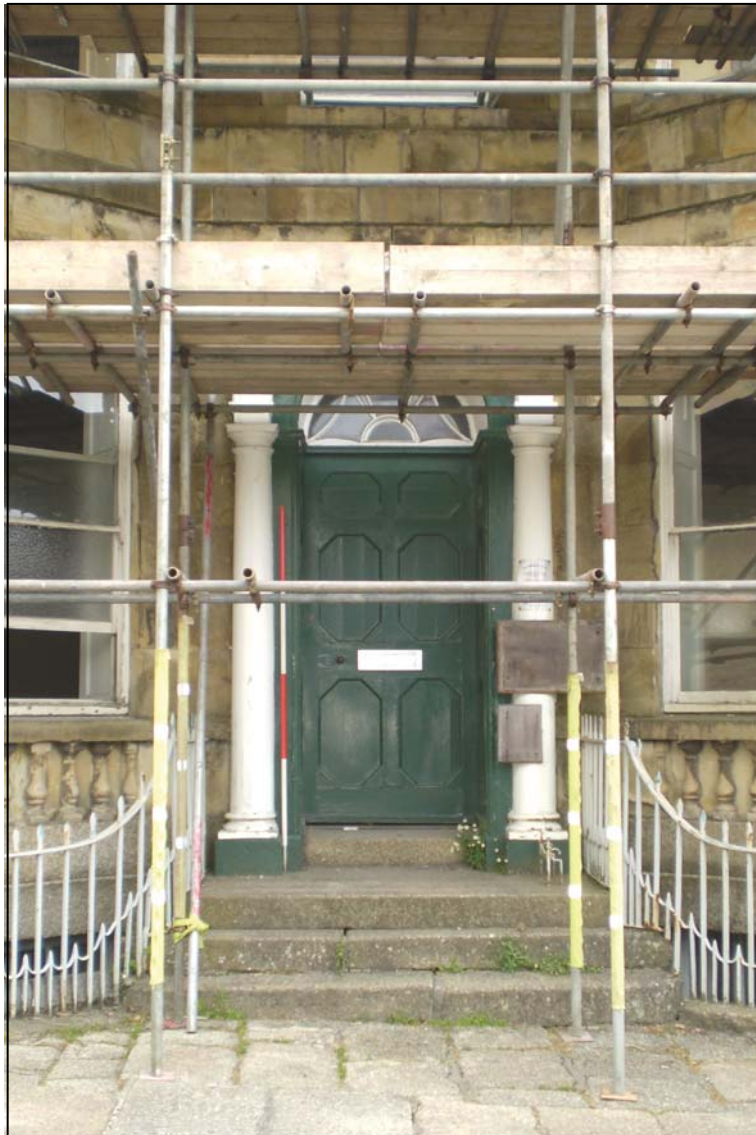
9 The front doorcase and bays from the west, scale 2m

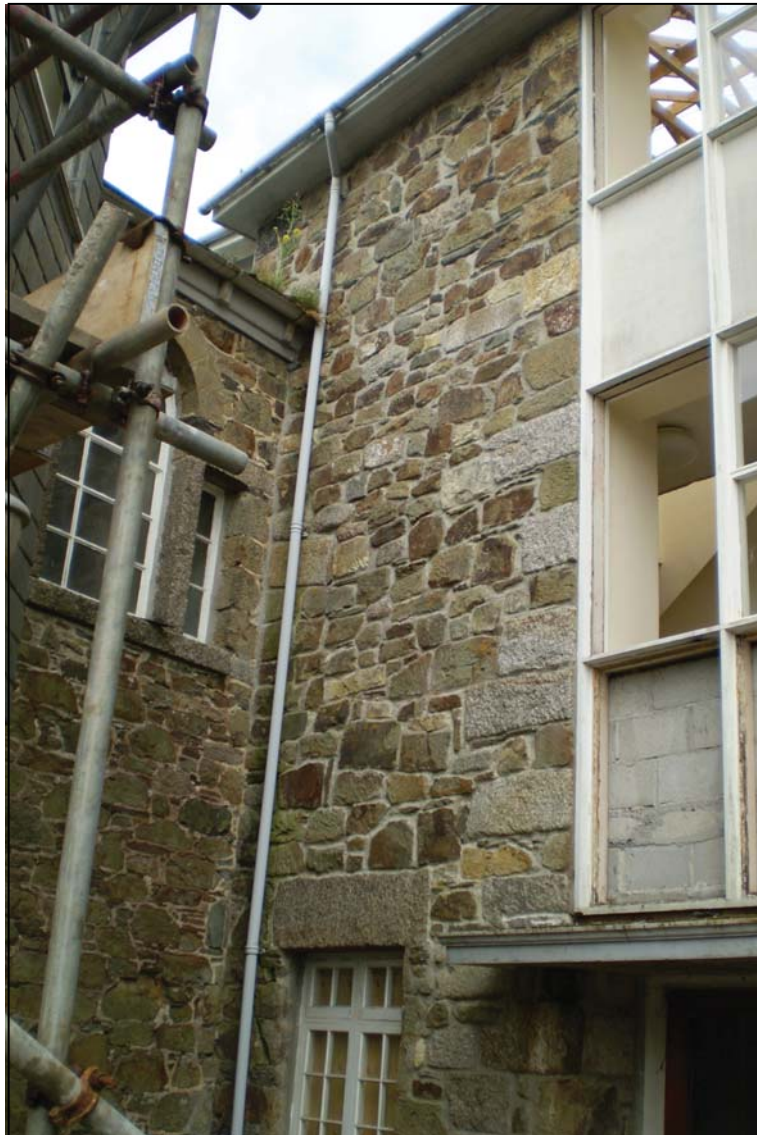
10 The south wall of the original rear wing, looking north-west

- 2.3 A stone wall projects eastwards from the side of this wall for about 2.5m (probably meaning that the rear wing was designed to be 8 feet deep) and where the current mid 20th-century wing abuts is finished with granite quoins. This wall represents the south wall of the rear wing of the 18th-century house, all that remains of this element. Its original sloping top continuing the line of the existing roof can be seen lining up with the highest granite quoin. The wall continues above this point with sandstone quoins and is part of the mid 20th-century wing (Fig. 10).

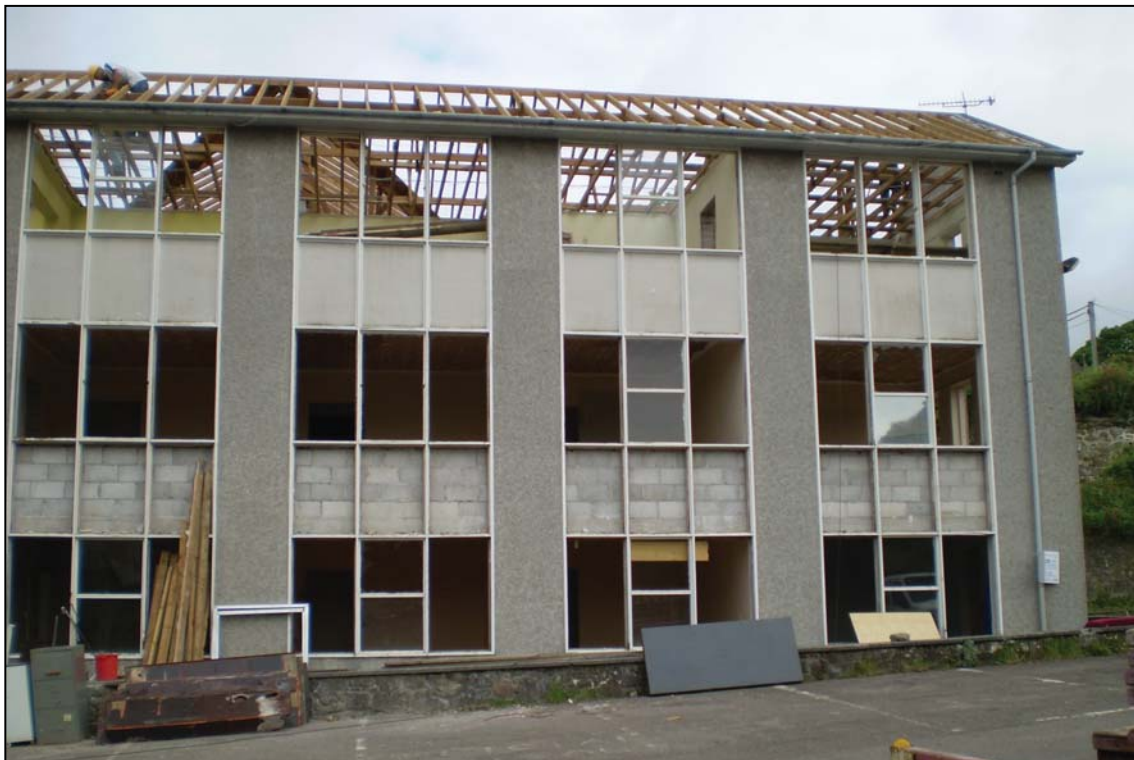
11 The 1960s rear wing, the eastern end, looking north

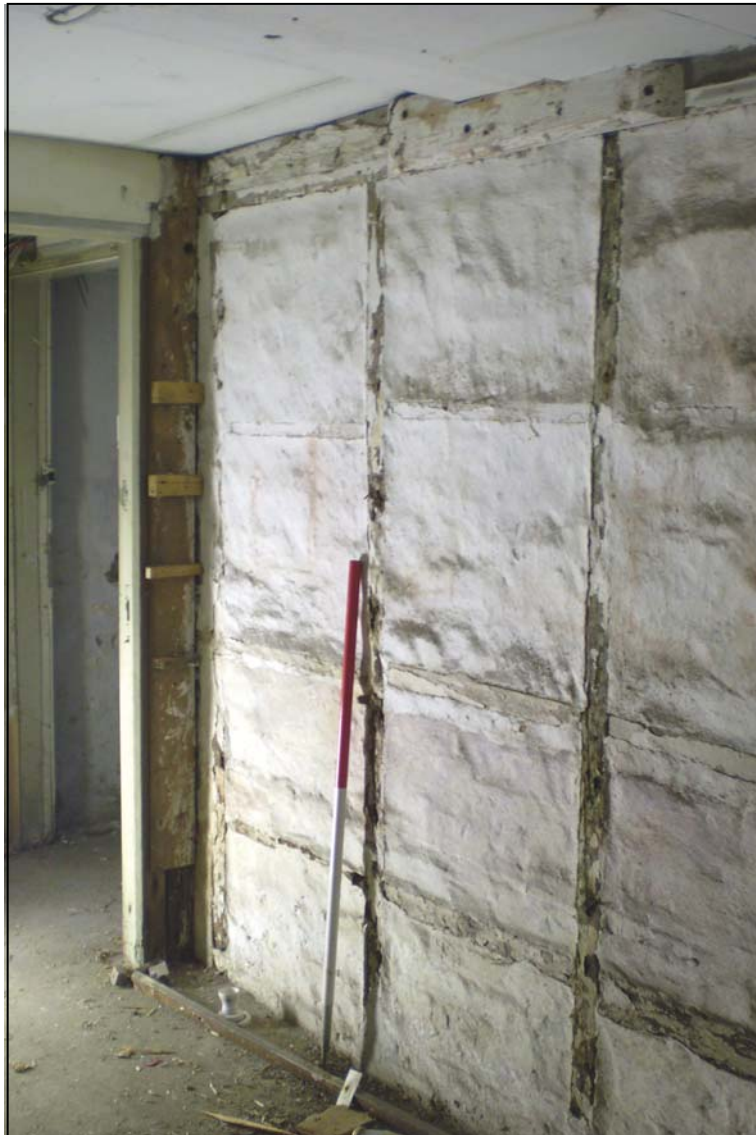
12 The box frame wall in the basement, looking south-west. The doorways are both original. Scale 1m

- 2.8 The wall separating B16 from B4 is a timber box-frame with brick infill, heavily whitewashed (Fig. 12). The doorways into it and B4 from B17 are 18th-century style with simple beading on the arrises.

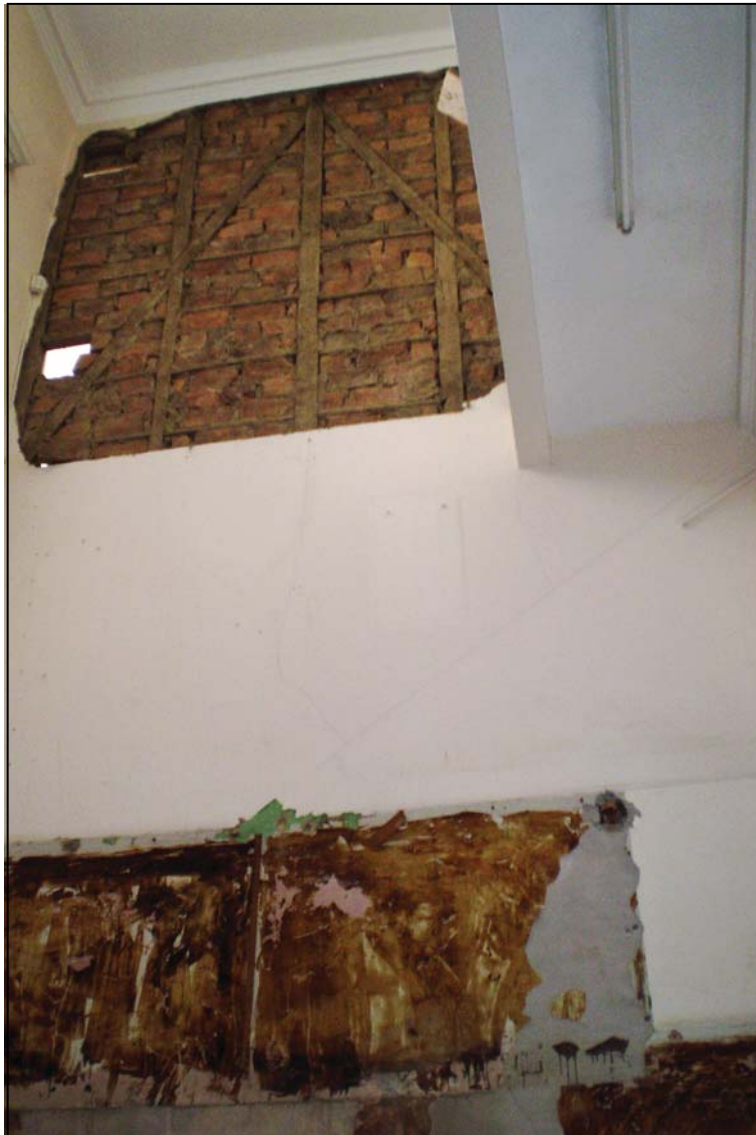
13

<p>13 The south wall of the stair well (ST1), showing the stud and brick construction and the line of the original stair (running from the green paint, lower centre, to to the coving under the gallery)</p>

- 2.14 East of G9 is the staircase hall ST1. Until recently this contained a mid-20th century stair of odd design, replacing the 18th century one. Its insertion resulted in major changes to the staircase hall. The stair of 1776 can be reconstructed on the basis of a line in the plaster on the south wall showing the line of the final flight (Fig. 13) and the existence of a blocked doorway leading to the exterior in the east wall (Fig. 14). These two observations meant that the top flight had to run from a landing above the lintel of the door to a landing at the position of F3, the present space behind the shallow apse of F1. To reach the first landing a stair would have to rise around the north and east sides of the staircase hall via a landing in the north-east corner. The width of the stair is given by the distance from the top of the blocked door to the base of the line in the plaster on the south wall.

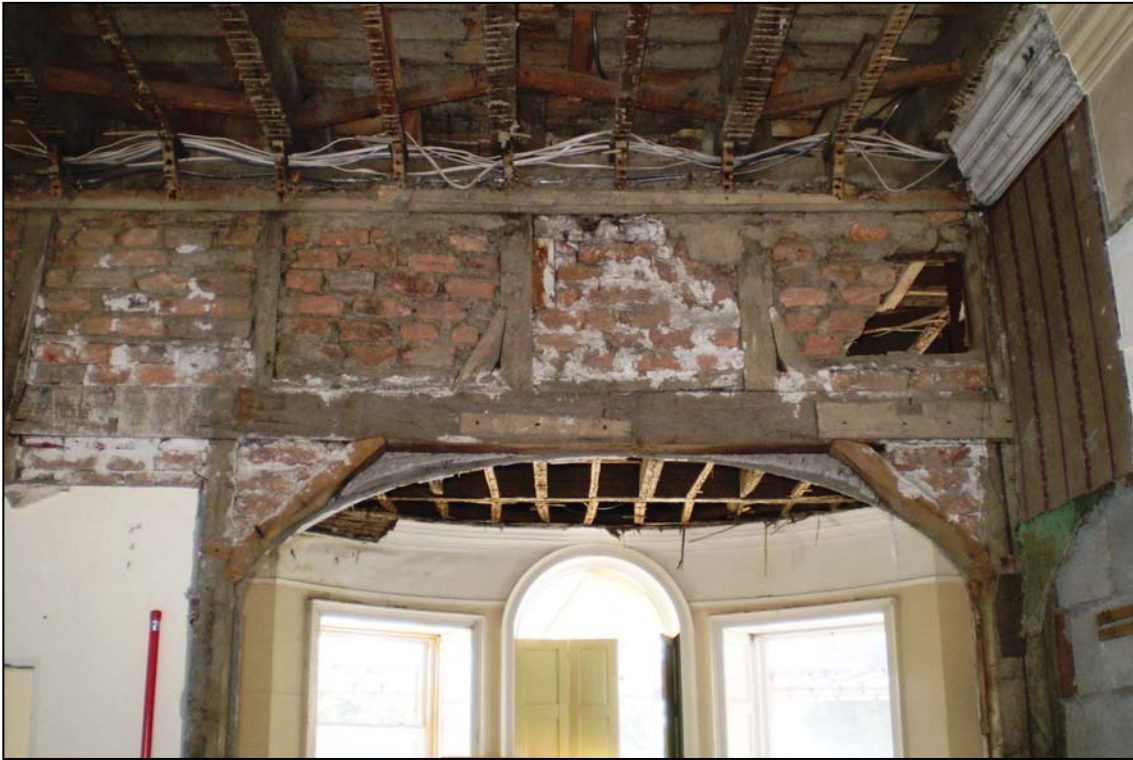
15 The curved interior of the bay window in G6, seen from G7 and the arch between them

- 2.18 The bay window at the west end is, like all the bay windows internally, segmental in plan rather than canted as externally (Fig. 15). The panelling, cornicing and window embrasures are curved to follow this shape. All the windows on the main front on the ground and first floors have full folding shuttering which is stored away in recesses on either side of the window openings in normal Georgian mode (Fig. 16).

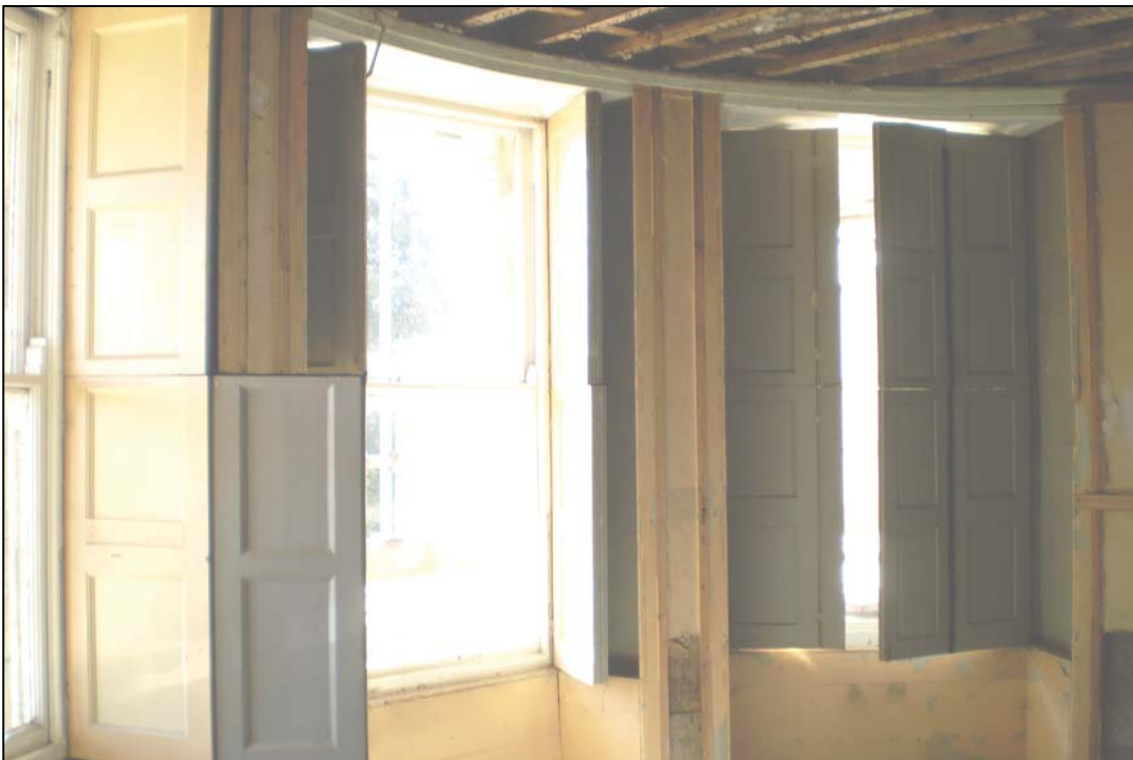
- Figure 16 The window shutters in the south bay of room F1
- Figure 17 The steels, concrete and new wood and the cornice corner where the new bay joins room G7, looking south-east

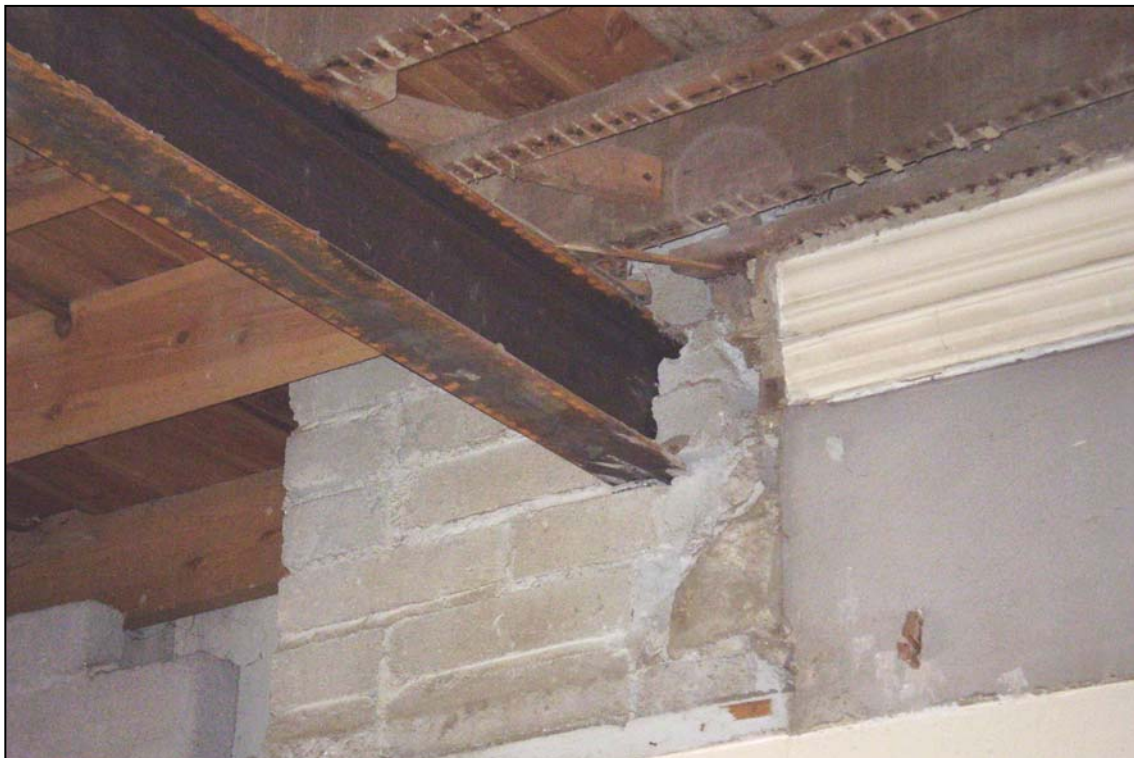
17 The steels, concrete and new wood and the cornice corner where the new bay joins room G7, looking south-east

- 2.20 All the openings into this room other than the arch were recent. The large bay at the east end is mid 20th century. The new blockwork, steels and timber were clearly evident and the original line of the main part of the east wall was shown by the cornicing (Fig. 17). Slight thickenings on the south wall indicated the chimney breasts for each room (G6 and G7), the flues being largely within the thickness of the end walls.

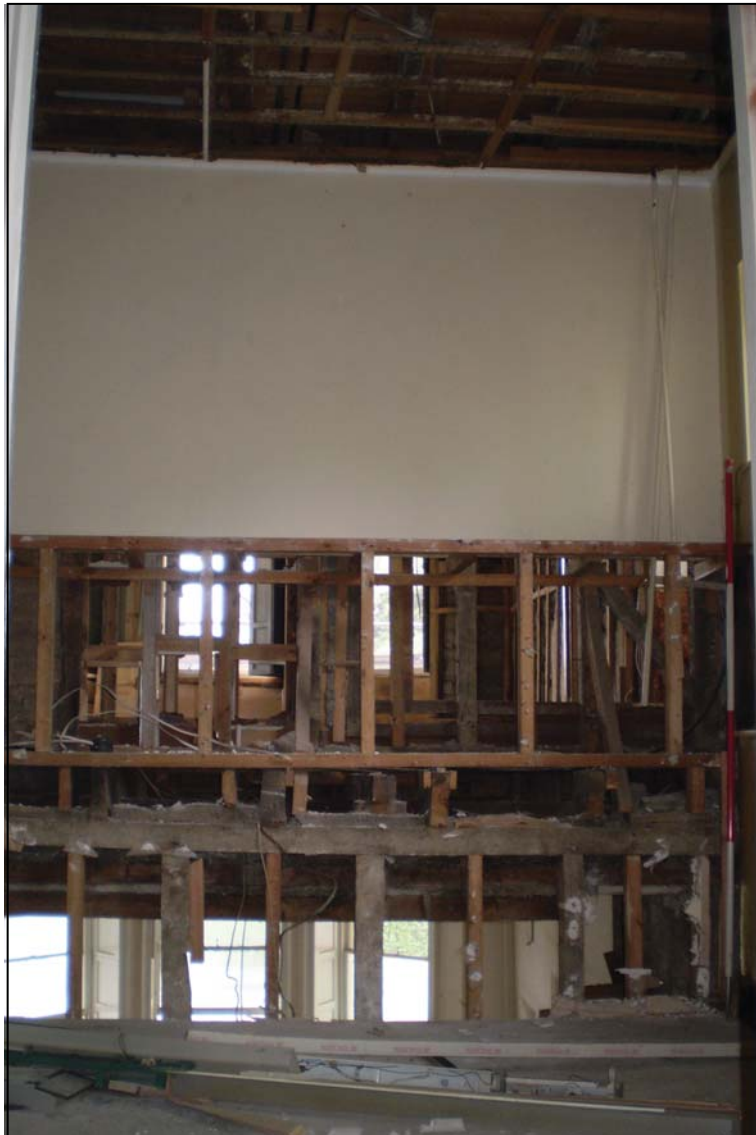
18 The interior of room F4, looking west. The floor has been lowered as can be seen from the studwork and the floor of F1 ahead

- 2.23 Both G10 and G13 have had the ceiling lowered by about 0.90m as the room above (F4) was altered to align with the 1960s rear wing (Fig. 18).

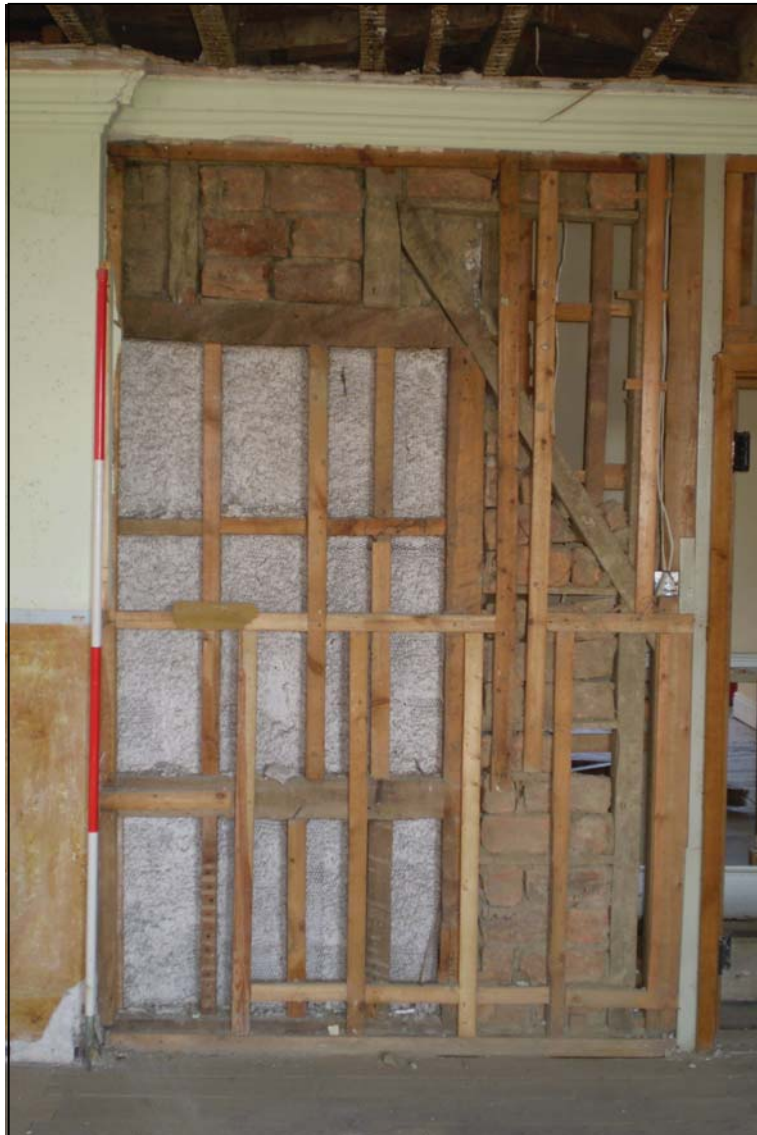
19 Blocked door and fragment of 18th century studding in F1, looking east. Scale 2m

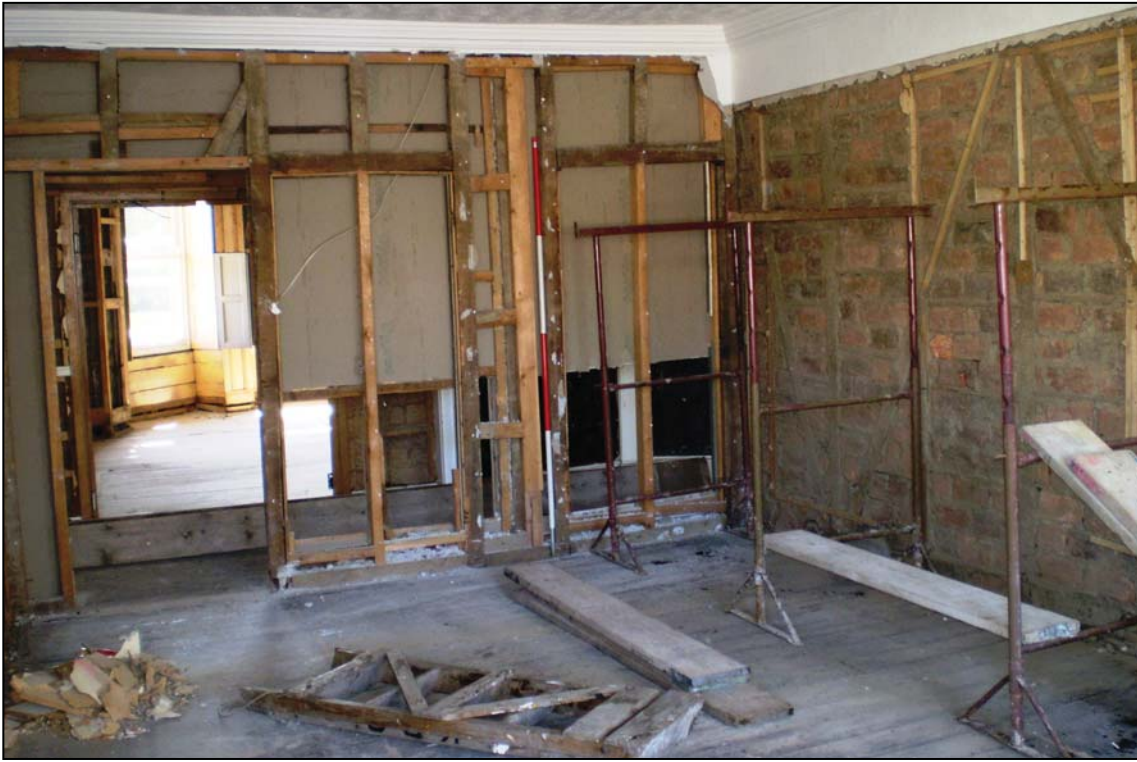
20 The north and west walls of F2, looking west.
Scale 2m

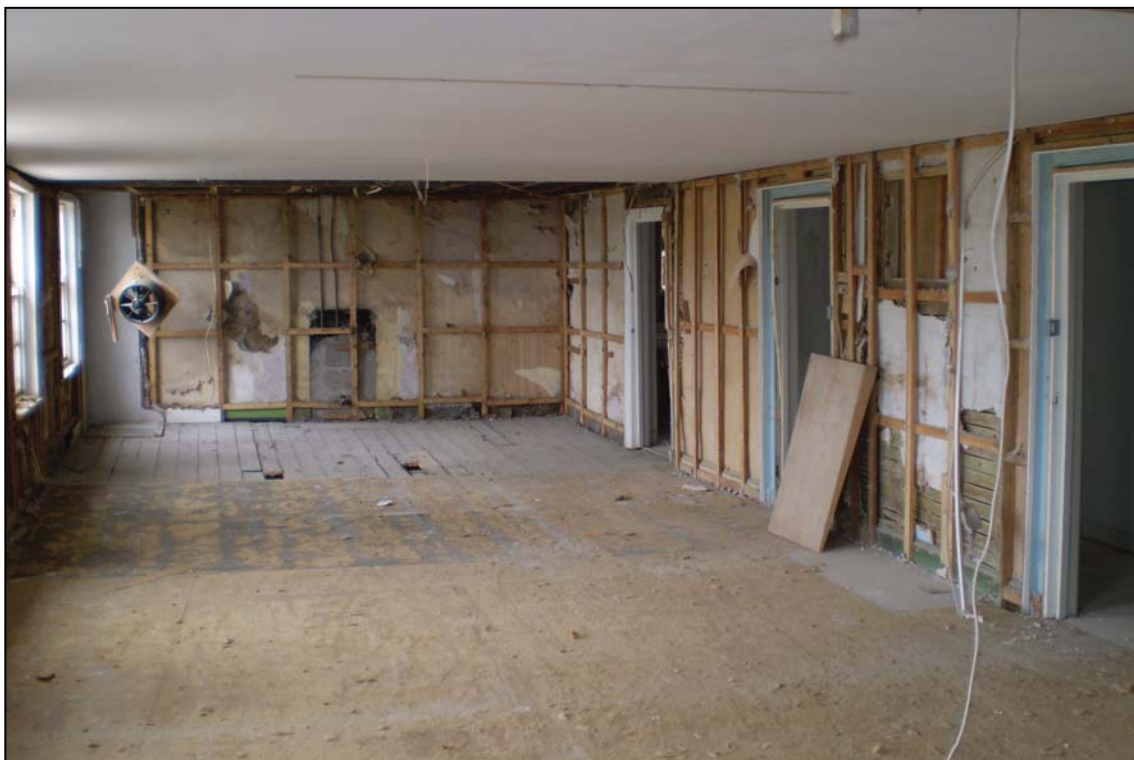
22 Room S1/2/3 looking north. White painted door architraves were set within the blue painted originals and boxed them in. The dry-lining studwork is contemporary with the later door frames

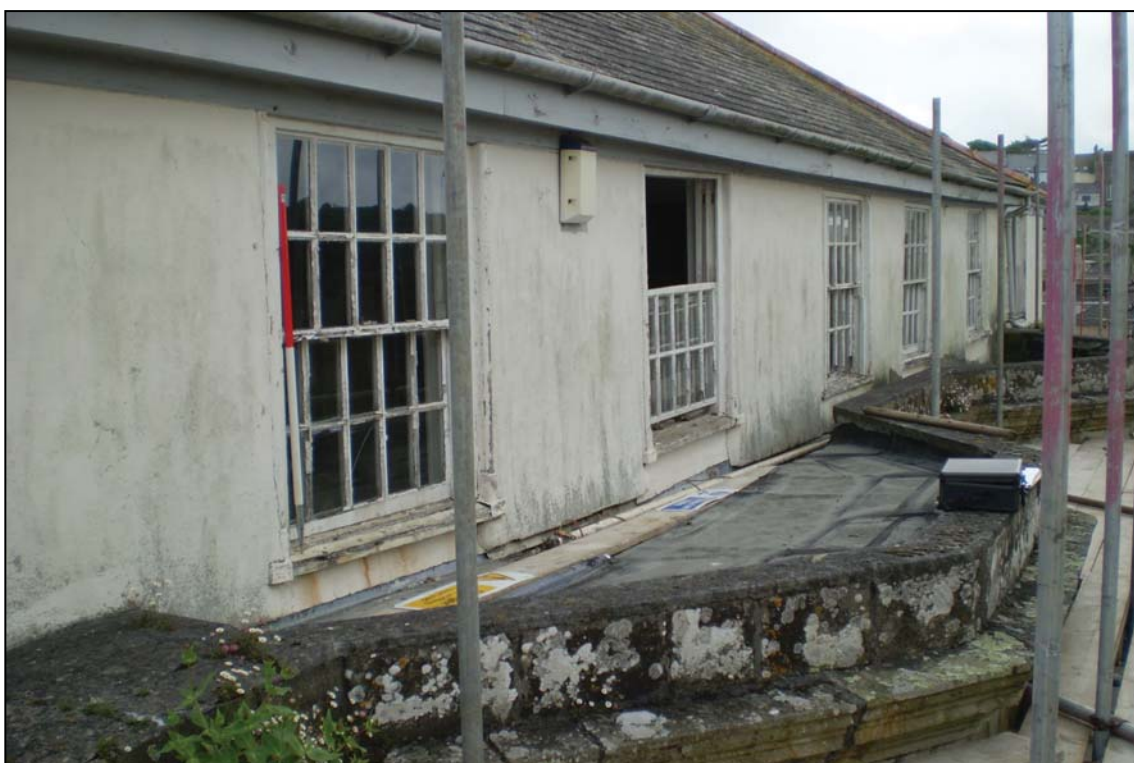
23 The top floor, west front, looking south. Scale 1m

- 2.35 The front or west wall is timber-framed, of studwork similar to the other studwork, but with no brick as far as can be seen (Fig. 23). It was finished in render externally and lath and plaster internally. Five sash windows were set in it. The sash boxes are original but the sliding panes are mid 20th-century replacements, with plain horns and minimal glazing bar mouldings, a mere chamfer in all but the central window.
