**REDCLIFFE VILLAGE  
BRISTOL**

**ARCHAEOLOGICAL WATCHING BRIEF**

**CEREP REDCLIFFE SARL**

CA PROJECT: 2204  
CA REPORT: 08125

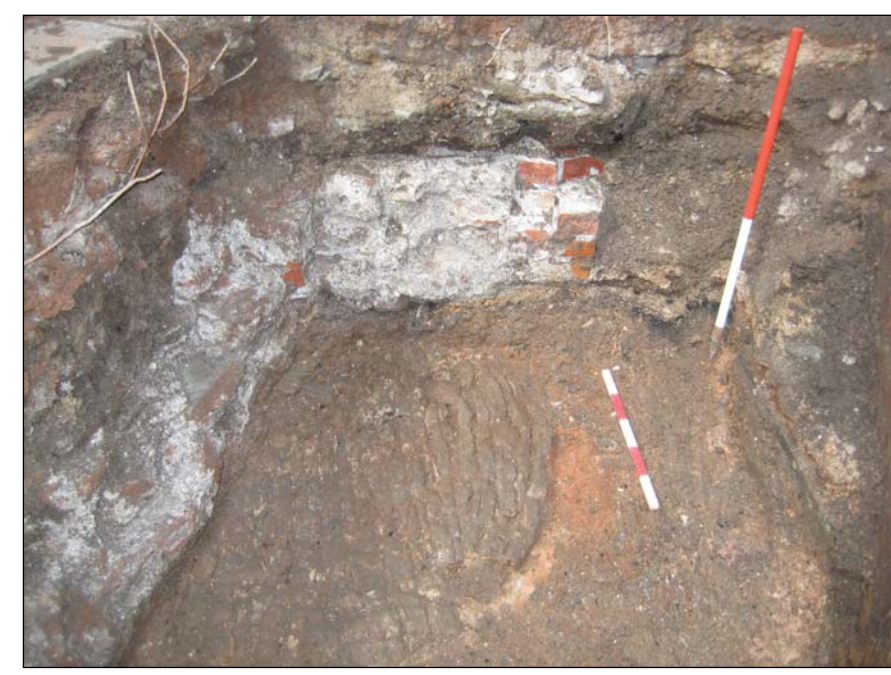
- 2.20 Excavation of trial pit 14 ceased at a partially-revealed circular structure 1405, with a pitched sandstone base and robbed stone wall, probably representing a medieval or later dye-vat base. An adjacent stony-clay floor 1406 was cut by an undated irregular intrusion of undetermined function 1407 containing a charcoal fill 1408. An overlying structure 1404, comprised of sandstone blocks and bricks bonded with a hard, grey, ashy-mortar, was only partially revealed but might represent a former floor or foundation. A stony-clay dump deposit 1403 was overlain by a sandstone flagstone floor 1402, and was covered by hardcore for modern concrete floor 1401.
- 2.21 Trench 14a was halted at a depth of approximately 1.5m within the modern infill 1409 of a known cellar, upon encountering apparently fuel-contaminated water.

?medieval dye-vat base 1405, looking south-west

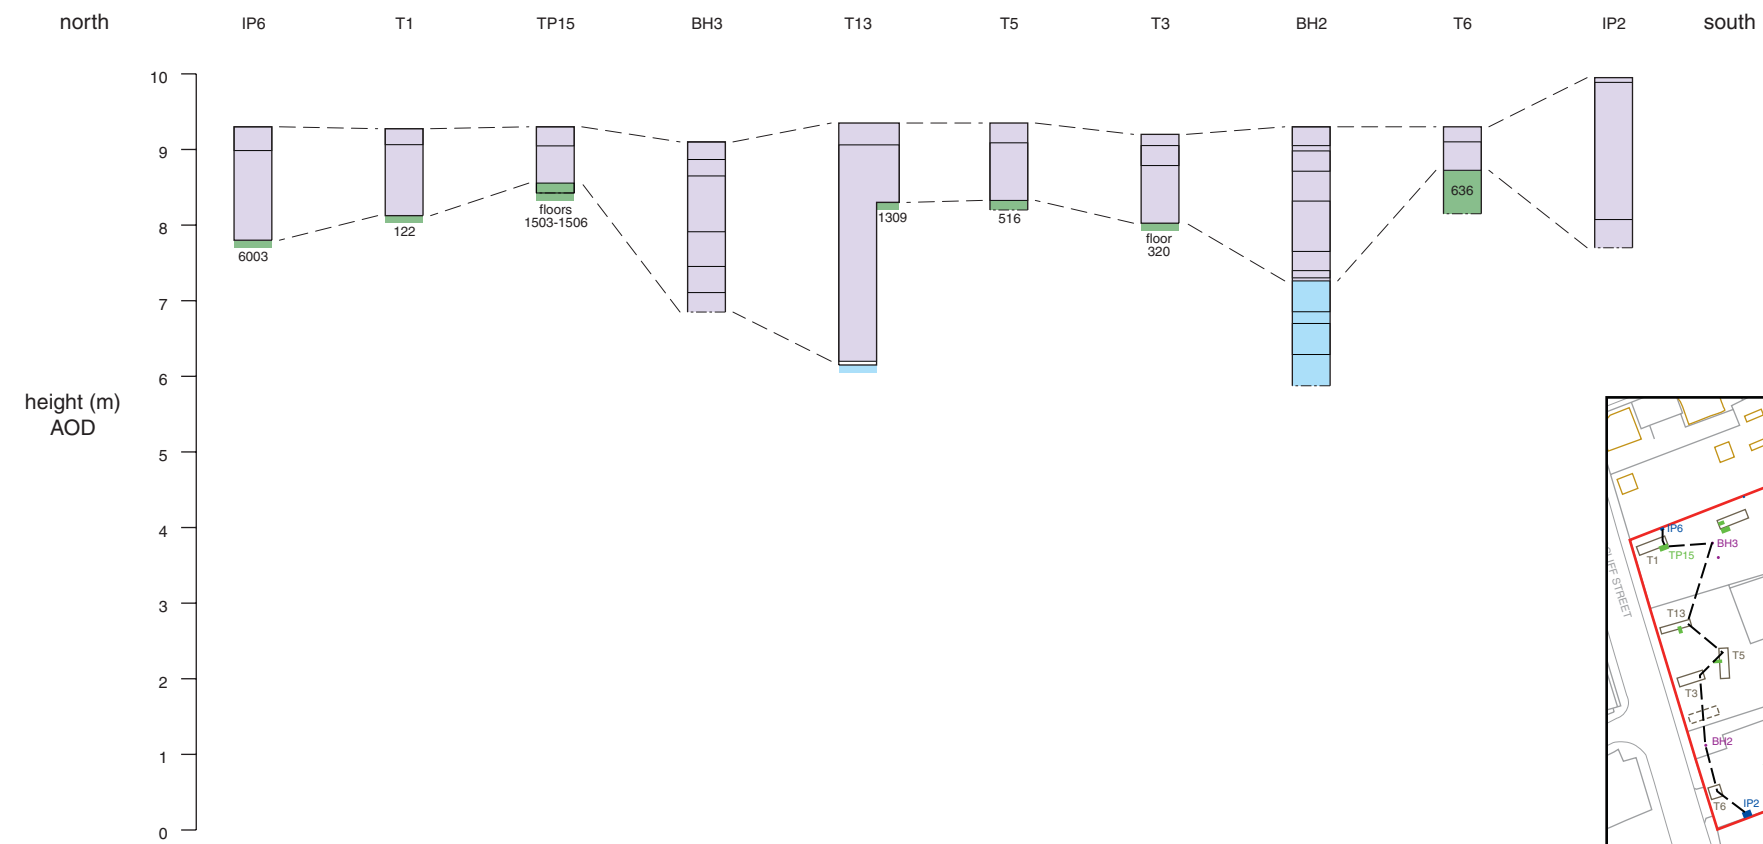
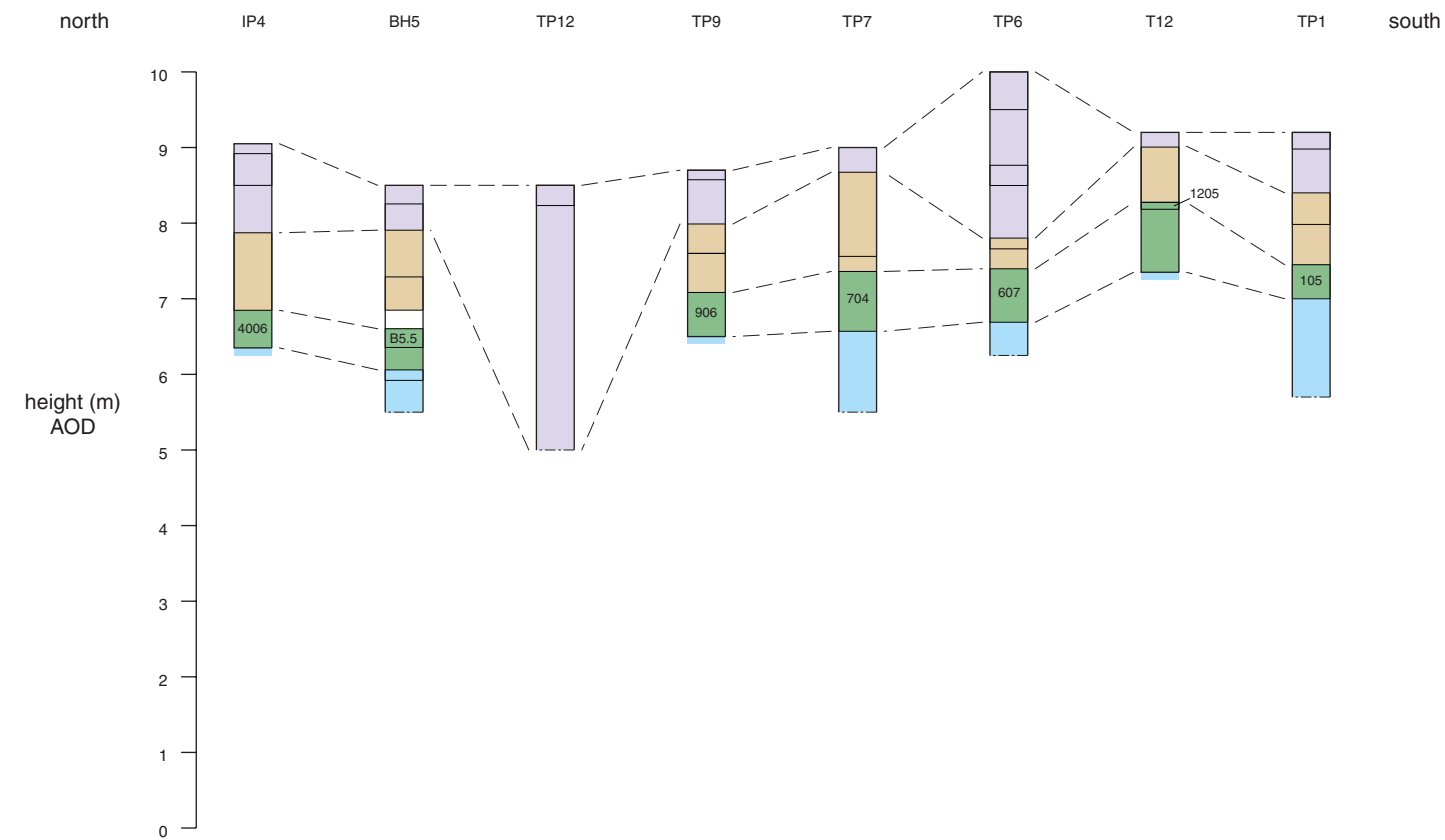
- 3.2 Natural sandstone bedrock was encountered at depths of 13.3m to 14.3m bpgl, throughout the site, overlain by estuarine alluvium typically encountered at 6.5 to 6.8m AOD. Although other investigations in the site locality have identified a layer of bioturbated alluvium, thought to have resulted from trampling of the flood plain surface in the 11th to 13th centuries AD (CA 2006), no such deposits were discernible within these small-scale trial pits and test trenches. The watching brief has, however, identified extensive overlying dump deposits, consisting of clays with sparse charcoal and sandstone inclusions and some 11th to 13th-century pottery sherds. In combination with similar deposits noted during preceding evaluation trenching (CA 2008) these clays suggest widespread dumping to reclaim low-lying marsh areas prior to medieval development.

### Redcliff Street Frontage

### St Thomas Street Frontage
