**NORMAN ARCH COTTAGE
HEREWARD ROAD
CIRENCESTER**

ARCHAEOLOGICAL EVALUATION

CA PROJECT: 2931
CA REPORT: 09142

SEPTEMBER 2009

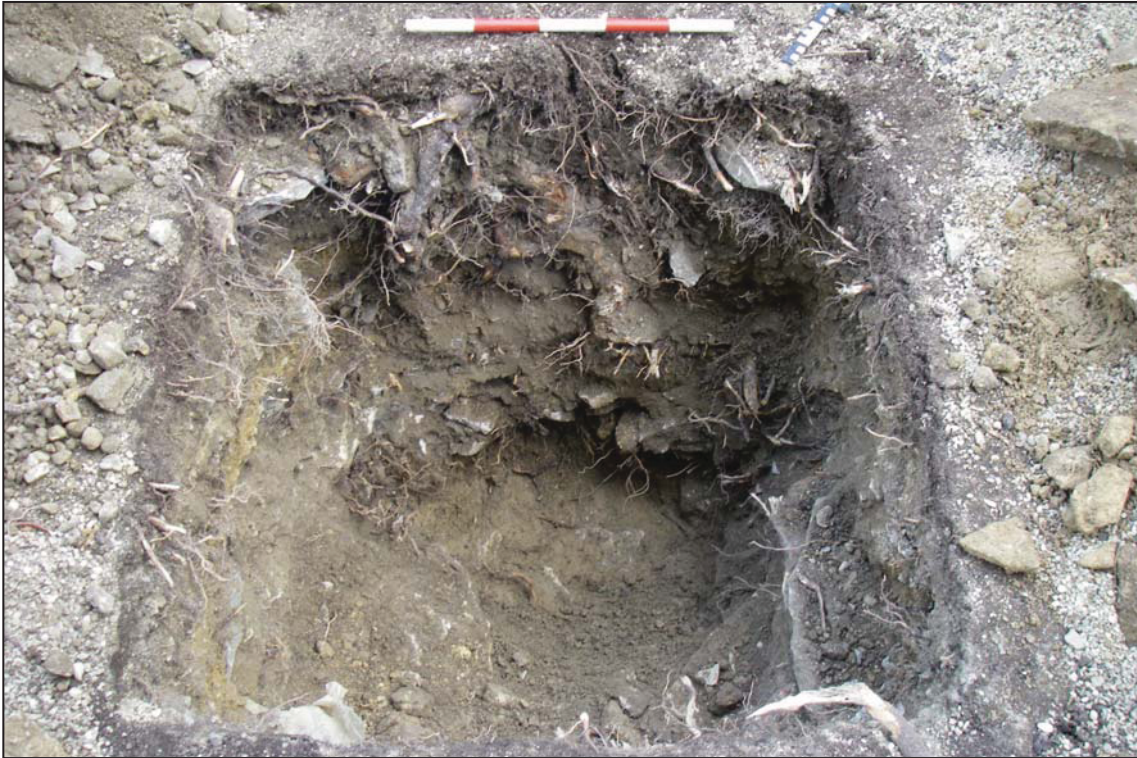
- 2.1 This section provides an overview of the evaluation results; detailed summaries of the recorded contexts are to be found in Appendix A. Details of the relative heights of the principal deposits and features expressed as metres Above Ordnance Datum (m AOD) appear in Appendix B.
- 2.2 The silty clay natural substrate 104 was identified at 1m bpgl. It was sealed by loose limestone rubble 103, from which modern pottery was recovered. Layer 103 was sealed by gravel make-up 102, again containing modern material. This was sealed by root-disturbed topsoil 101, which was covered by modern landscaping gravel layer 100.

COTSWOLD ARCHAEOLOGY	
		<small>PROJECT TITLE</small> Norman Arch Cottage, Hereward Road, Cirencester, Gloucestershire	
		<small>FIGURE TITLE</small> Photograph of trench 1, looking north-west	
<small>DRAWN BY</small>	<small>SCALE</small>	<small>PROJECT NO.</small>	<small>FIGURE NO.</small>
RK	n/a	2931	3
