**ST MATTHEW'S CHURCH
LANGFORD
OXFORDSHIRE**

ARCHAEOLOGICAL WATCHING BRIEF

CA PROJECT: 2683
CA REPORT: 09126

SEPTEMBER 2009

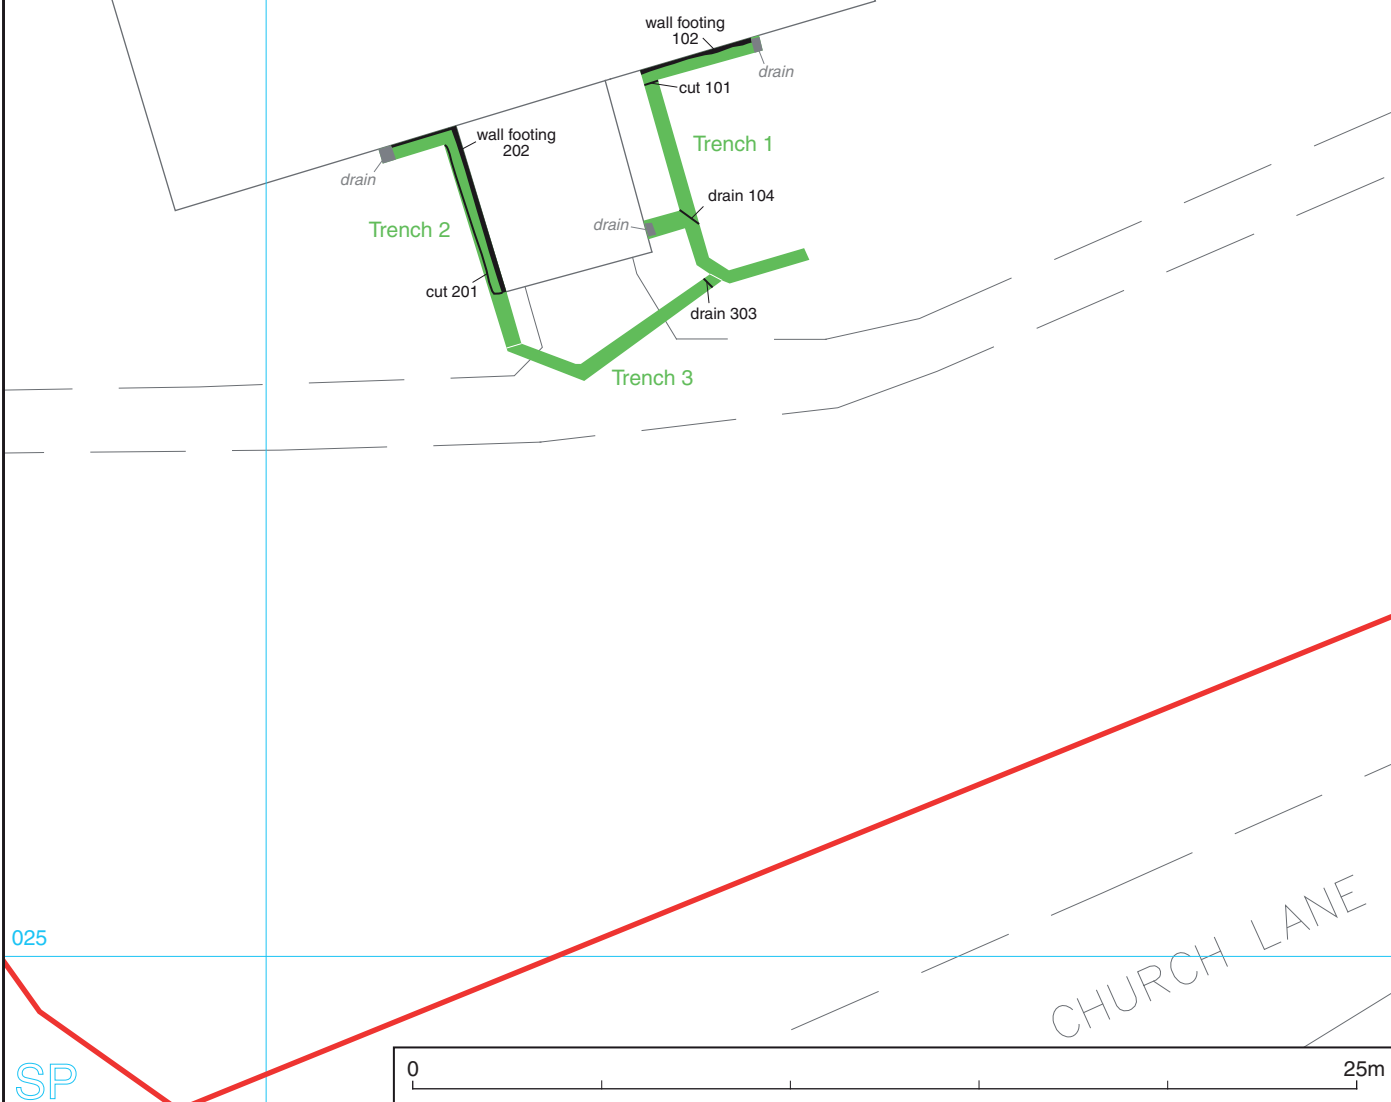
Location of observed groundworks

- 1.4 The site, covering an area of approximately 10m², comprised the churchyard around the north, south and east of the porch of the medieval St Matthew's Parish Church which is situated east of the centre of Langford village (Fig. 2).
- 1.5 The underlying solid geology of the area is mapped as second terrace river gravels of the Quaternary era (BGS 1982). The natural substrate was encountered during excavations.

- 1.8 The fieldwork followed the methodology set out within the WSI (CA 2008). An archaeologist was present during intrusive groundworks comprising the excavation of shallow trenches to install new drainage around the front of the porch (Fig. 2).
- 1.9 Where archaeological deposits were encountered written, graphic and photographic records were compiled in accordance with CA Technical Manual 1: *Fieldwork Recording Manual* (2007).
- 1.10 The archive from the watching brief is currently held by CA at their offices in Kemble. Subject to the agreement of the legal landowner the archive will be deposited with Oxfordshire County Museum. A summary of information from this project, set out within Appendix B will be entered onto the OASIS online database of archaeological projects in Britain.

- 2.1 This section provides an overview of the evaluation results; a detailed summary of the recorded contexts is to be found in Appendix A.
- 2.2 The earliest deposit encountered during the groundworks was natural substrate 106 in Trench 1 comprising orange brash. Cut into this was 101, the foundation trench for the church wall footings 102. It was backfilled with deposit 103. Drain 104 also cut the substrate. All were sealed by topsoil layer 100. In Trenches 2 and 3 the earliest deposits encountered were the graveyard soil layers 208 and 301 containing

disarticulated human bone, no *in situ* burials were observed. In Trench 2 208 was cut by the wall footings of the porch within construction cut 201. Drains 205, 207 and 302 cut through the graveyard soil, and these were sealed by topsoil and turf layers 200/304. Paving stones 300 lay over the topsoil.
