**COLEHAM HEAD FAS PHASE II  
WAKEMAN SCHOOL  
SHREWSBURY**

**ARCHAEOLOGICAL WATCHING BRIEF**

CA PROJECT: 2940  
CA REPORT: 09174

JANUARY 2010

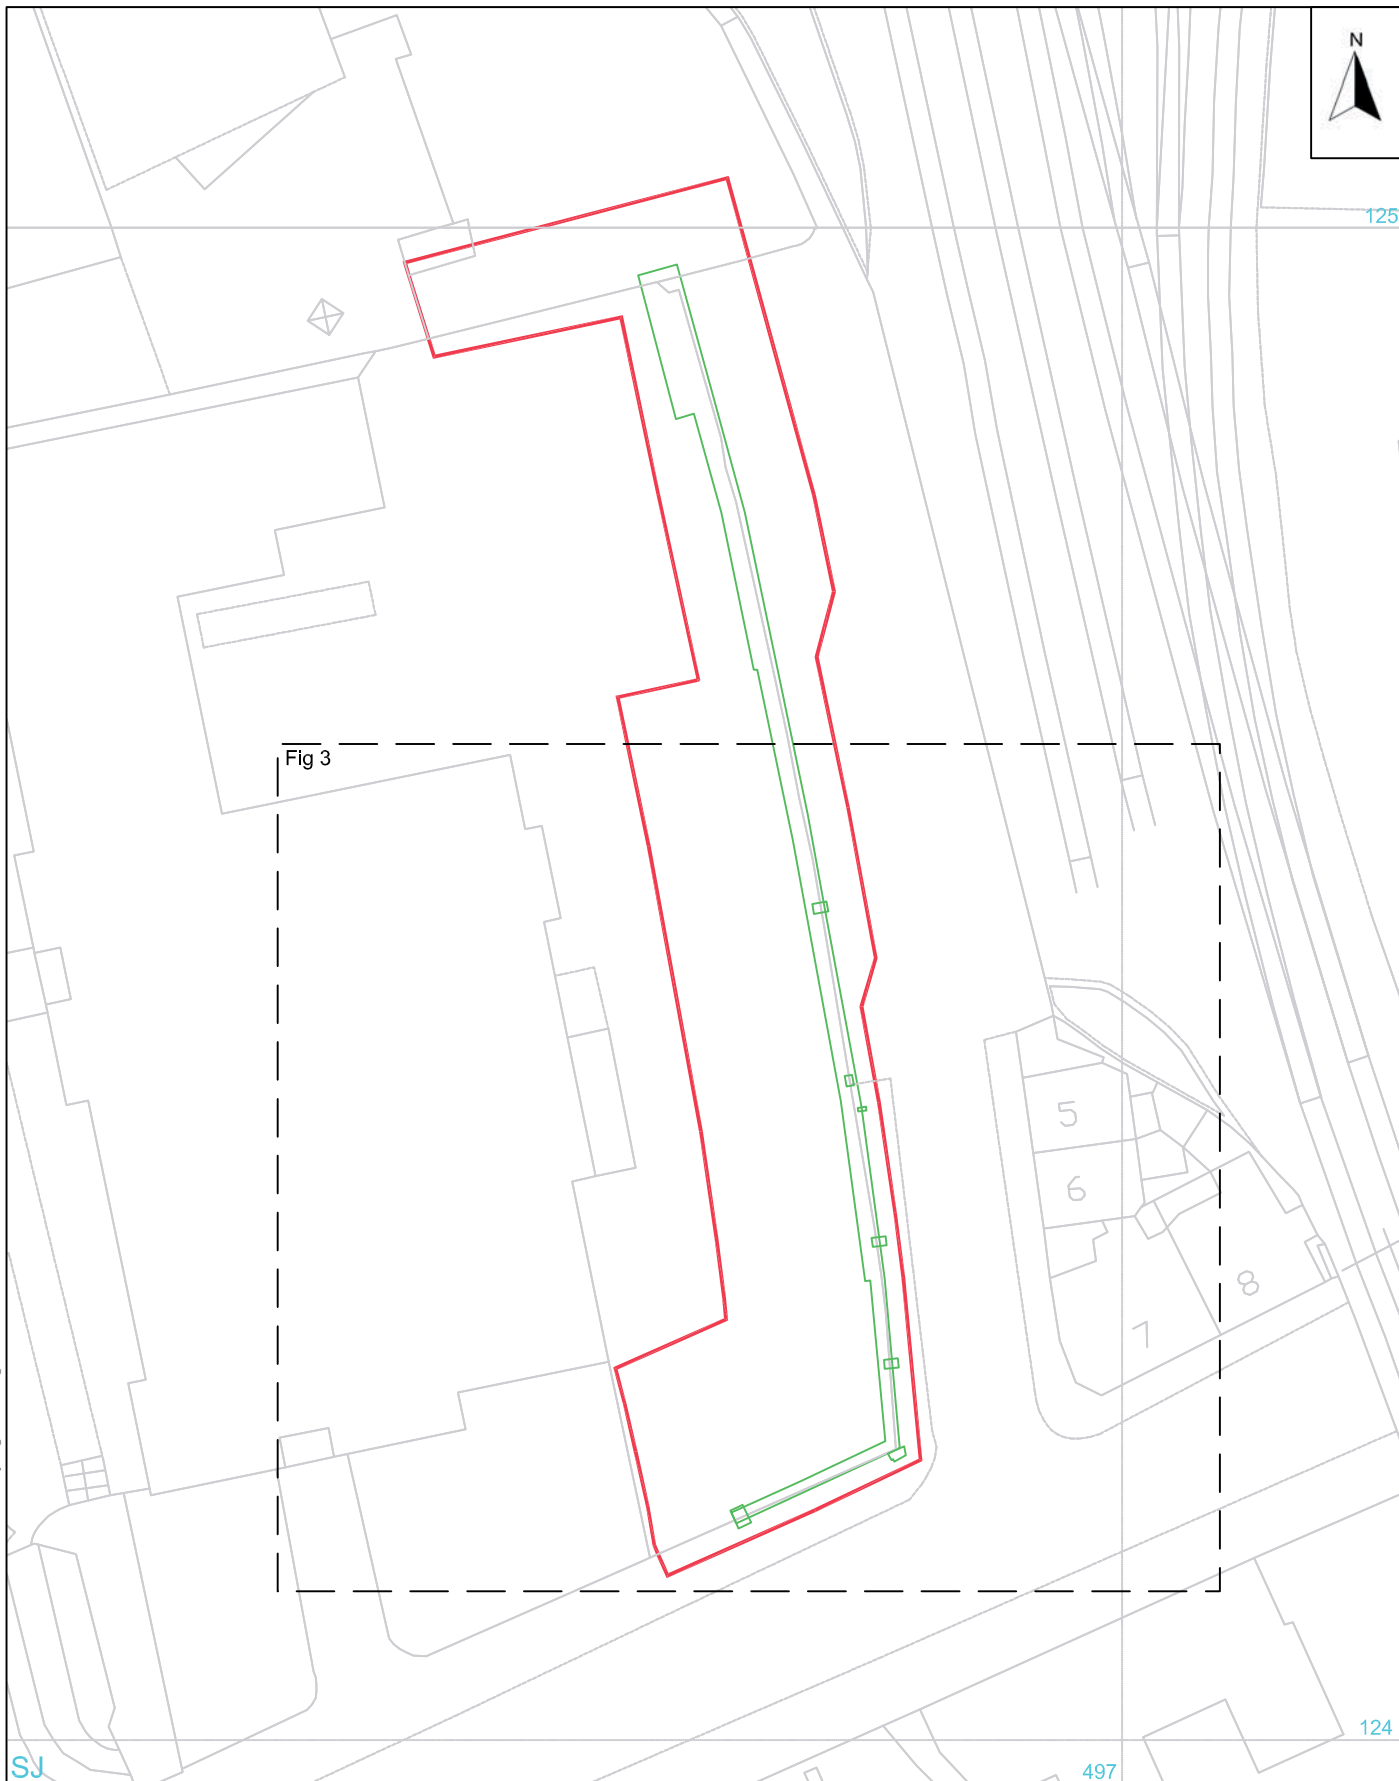
**2**

**The site, showing location of  
observed groundworks**

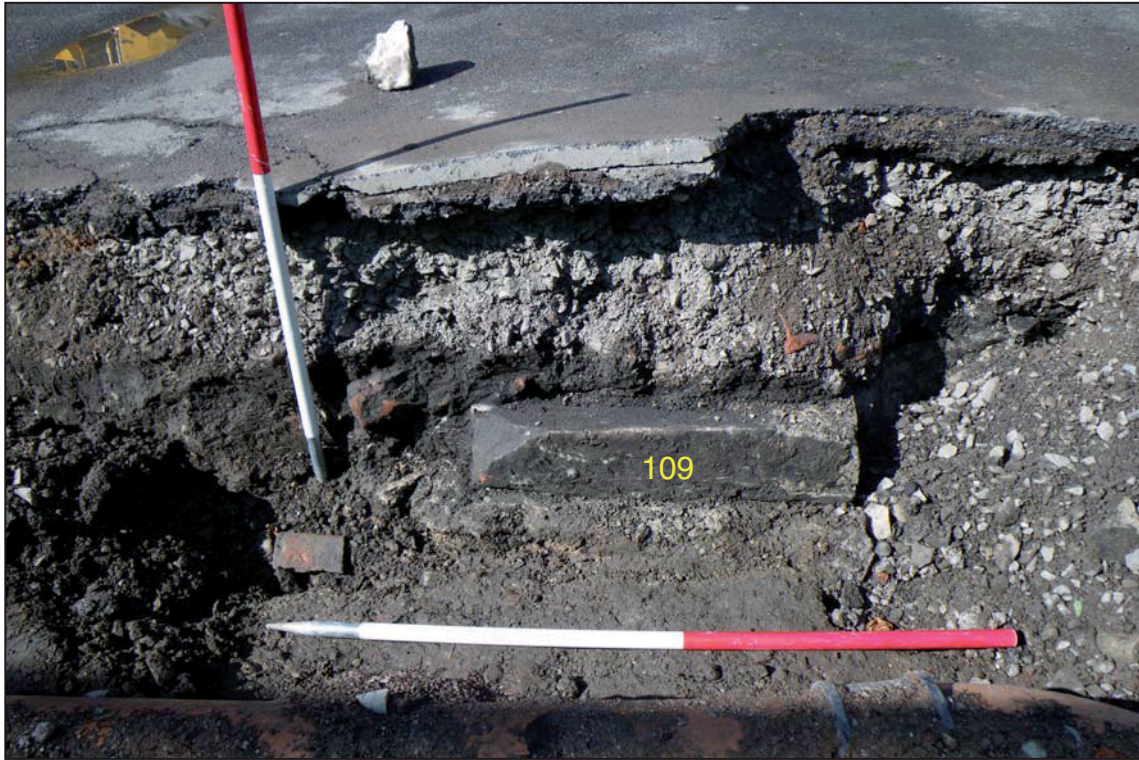
- 2.2 The earliest deposit identified at the north-eastern end of the trench was sandy silt layer 110. This deposit was identified at a depth of c. 0.75m bpgl and was overlain by a thin mortar bedding layer for two sandstone blocks, 109, clearly *in situ* and with worn upper surfaces (Fig. 4).

4 Trench 1 (south); stone slab 109, looking north

- 3.3 Wall foundations 108/139 appeared to represent the frontage of a number of buildings depicted on the First Edition Ordnance Survey map of 1881 fronting Abbey Foregate and the lane leading to the north (Fig. 11). Stone slabs 109 probably represented the door step of a building located at this intersection. This building was surrounded to the east and north by a garden or open space. The date of this building is unknown, but the bricks and mortar in wall foundation 108/139 could be of late 18th-century date or later.

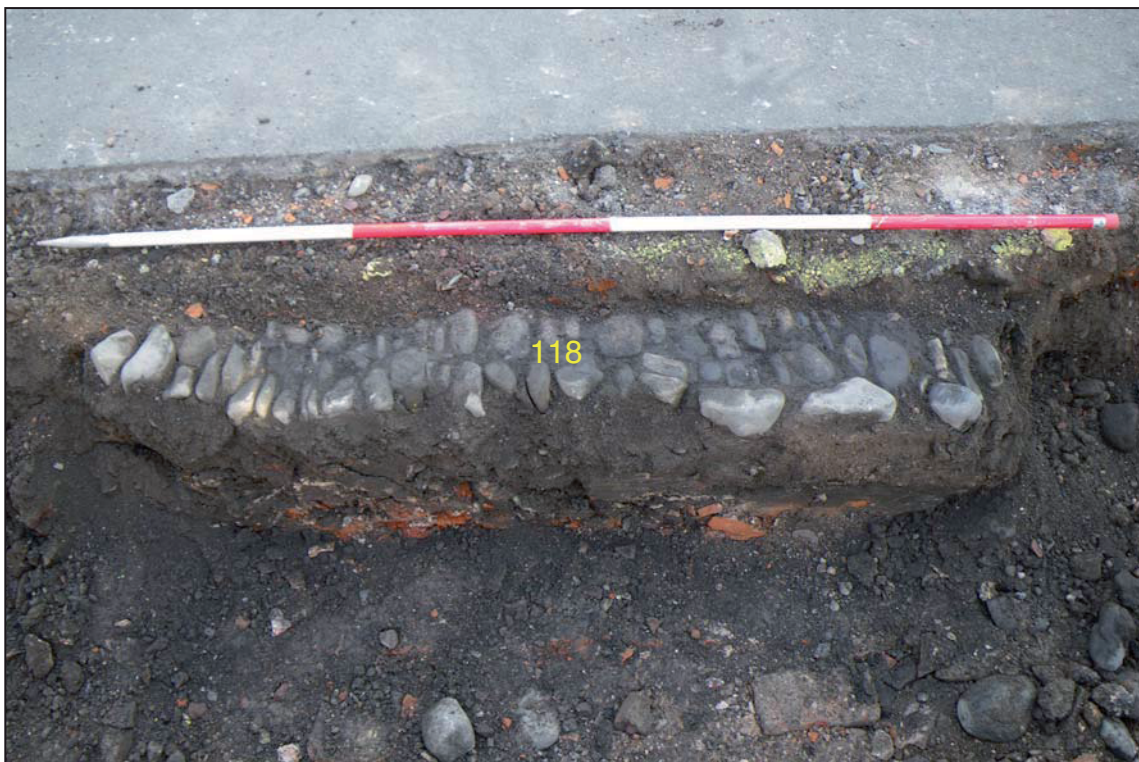
- 2.5 Cobbled surface 118 was identified to the north (in the vicinity of Test Pit 4). The surface was located to the east of wall 139 and comprised river worn cobbles set on a bed of brown mortared rubble. The upper cobbles were covered by grey brown silty clay 117, which was deposited during their use.

5 Trench 1 (east); cobbled surface 118, looking east

- 3.6 The cobbled surfaces, 118, 138, 406 and 506 identified to the east of wall foundation 139 probably represent the surface of the lane leading north from Abbey Foregate.

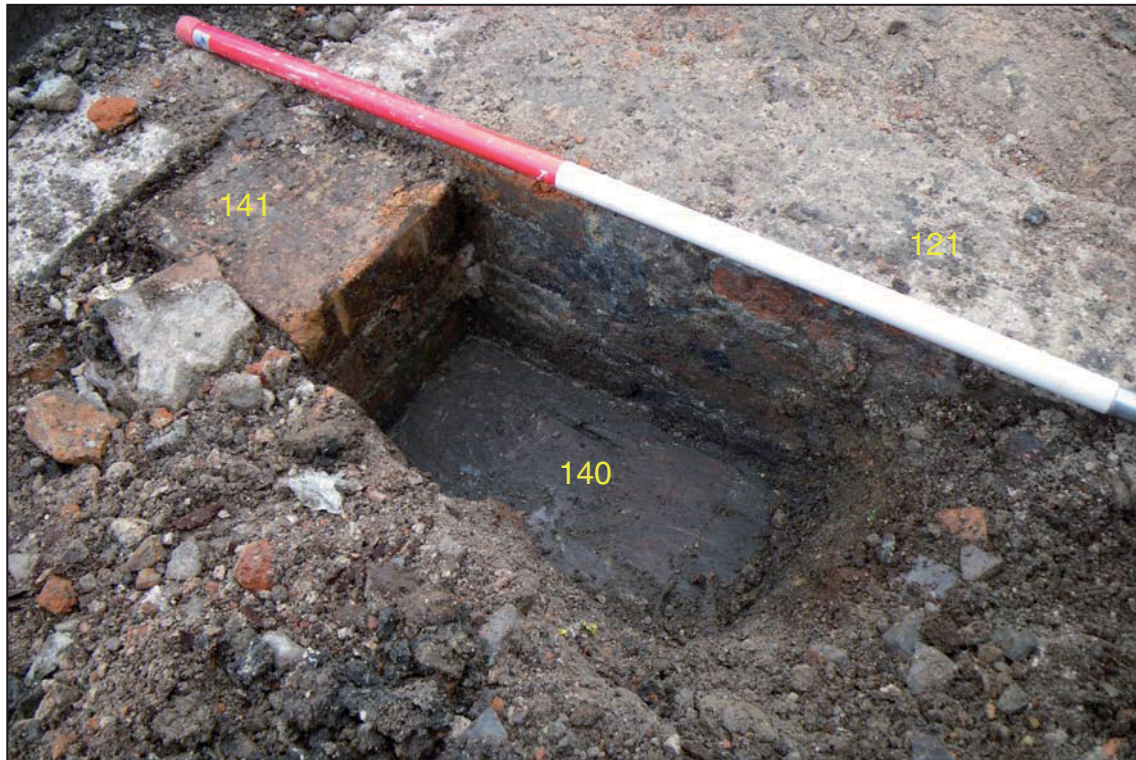
- 2.7 Wall foundation 121 was of a similar character to wall 123 located to the south and abutted the western side of wall 139. At the edge of the trench the wall turned to the south. It extended 0.4m in this direction and may have represented a respond or another corner. The eastern face of this return was plastered and painted green. Small brown, rectangular wall tiles were identified at the southern end of this part of the wall foundation. A brick pavior floor 140/605 was identified to the north of wall foundations 121. Brick pier 141 was constructed at the intersection of wall foundations 121 and 139, above floor 140 (Fig. 6).

- 6 Trench 1 (east); wall foundation 121, brick pavior surface 140 and brick pier 141, looking south-west**
- 7 Trench 1 (east); wall foundations 127 and 128 and concrete floor 129, looking north-west**

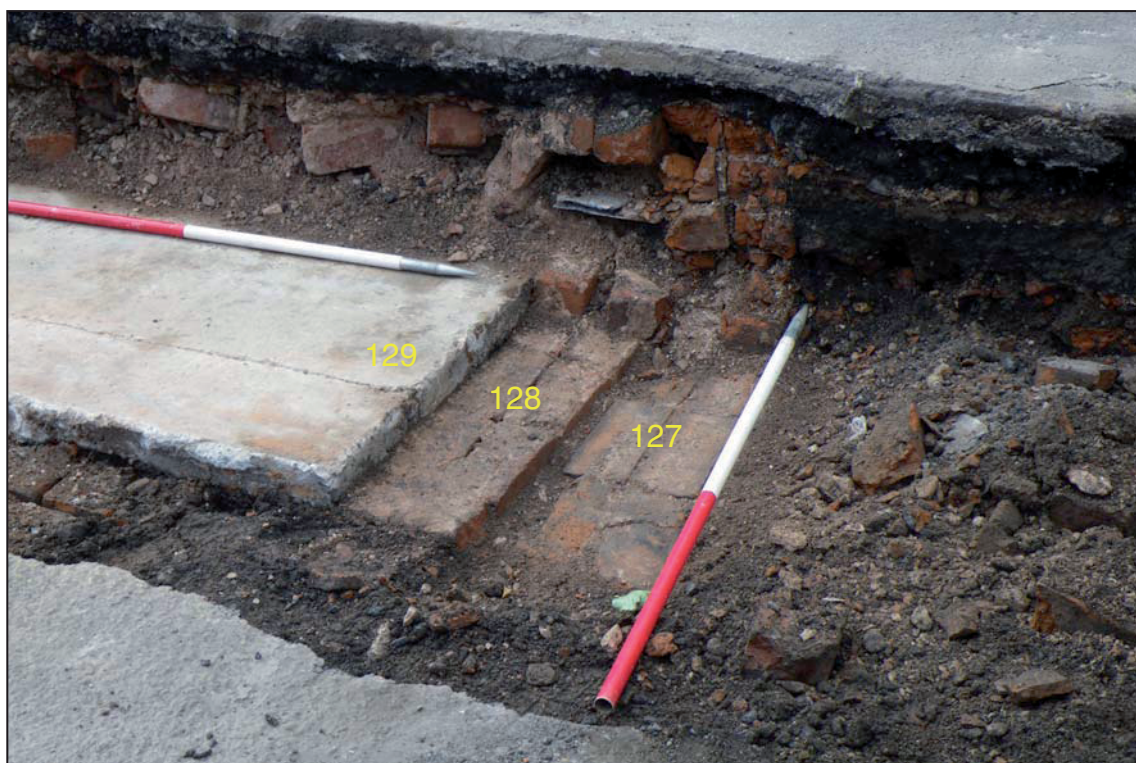
7

- 2.9 To the north (in the vicinity of Test Pit 7) was east/west orientated wall foundation 128 which was of a similar character to wall foundation 123 and was built entirely in stretcher bond, probably bonded into wall foundation 139. Wall foundation 128 was abutted by parallel wall foundation 127 which was located immediately to the south and was built entirely in English garden wall bond (Fig. 7). Wall foundation 127 comprised red bricks (which had been made in a metal mould) set in a soft pink mortar with a slate damp course and it abutted wall foundation 139. Walls 128 and 139 were abutted by concrete floor 129 which was identified at a depth of 0.48m bpgl.

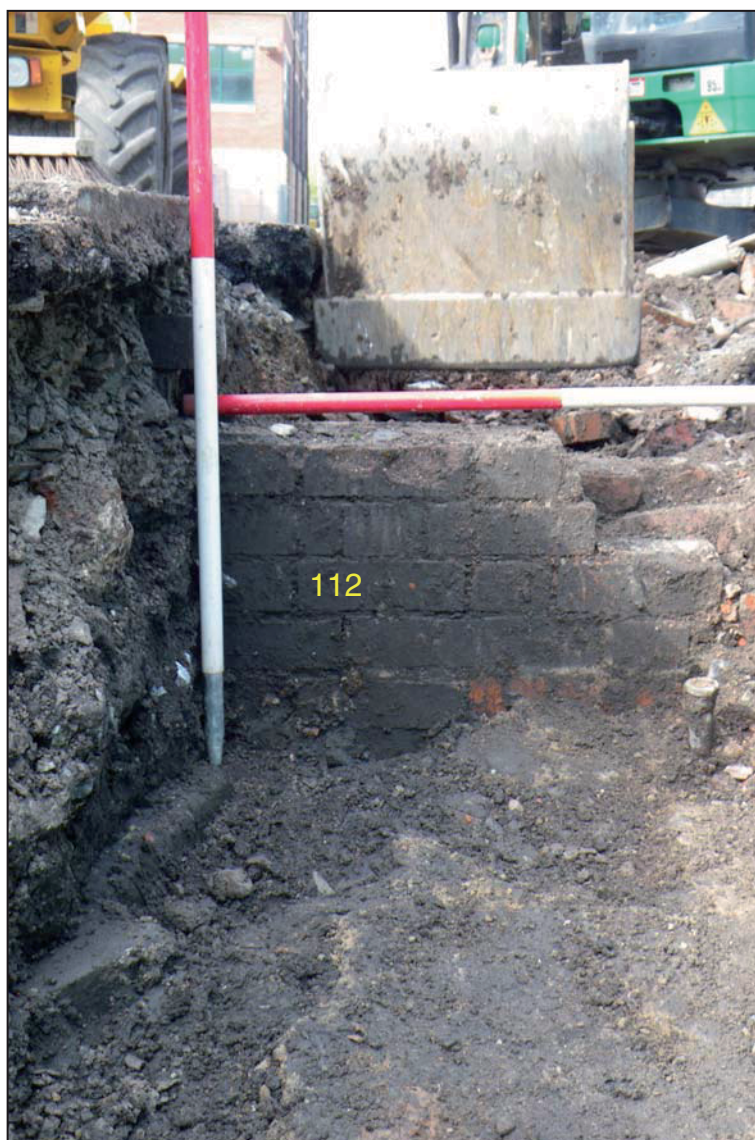
- 2.4 In the southern part of the trench wall 139 was abutted by east/west orientated wall 112/114. This wall was 0.45m in width and the northern face was made of shiny red commons whilst the southern face was made of purplish stock bricks with channelled joints in cement mortar. The southern face was the finished or visible face.

8 Trench 1 (east); wall foundation 112, looking north

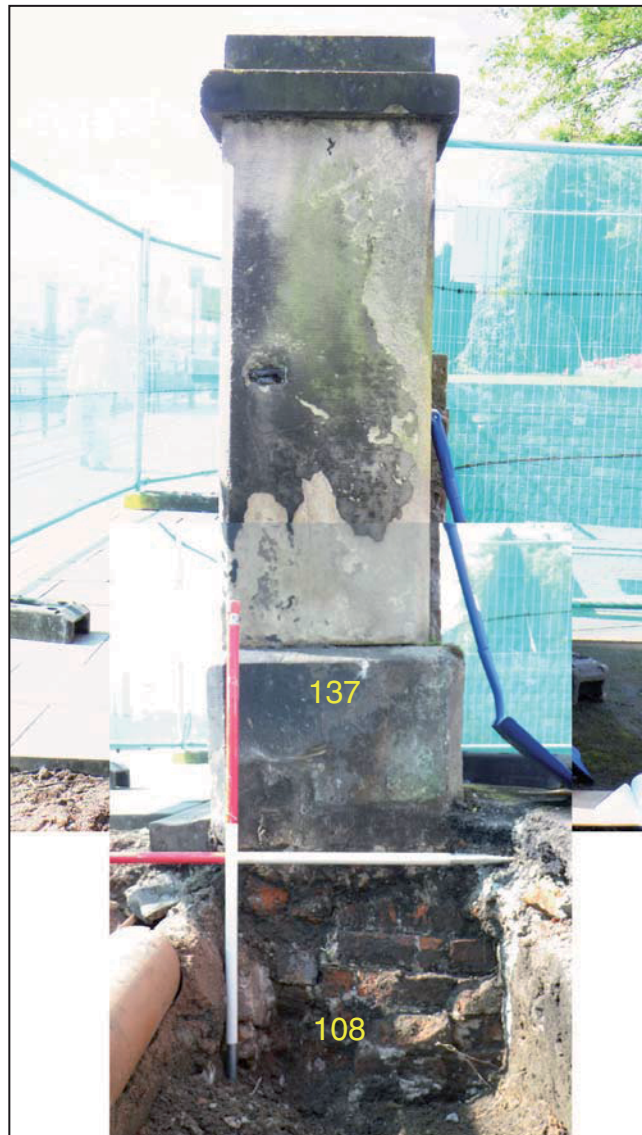
9

- 2.11 The earliest deposit identified within Test Pit 1 was clay silt layer 107. This deposit was identified at c. 0.75m bpgl and was overlain by brick-built wall foundation 108 which was orientated north-east/south-west. Wall foundation 108 comprised 3" (76.2mm) thick red bricks, softer and coarser in finish than the modern wall, in a

matrix of lime mortar possibly in Flemish or Flemish Garden Wall bond. Wall foundation 108 was overlain by stone gate pier 137 (Fig. 9) which appeared to be of late Georgian or Victorian date.

**9 Test pit 1; wall foundation 108 gate pier 137, looking west**

- 3.5 Gate pier 137, identified in Test Pit 1, at the western end of Trench 1 (south), is in one build with the wall foundation 108, and is presumably the gate pier of the entrance into the garden of Abbey House which is depicted on the First Edition Ordnance Survey map and which was demolished to build Wakeman School after the Second World War. The gate pier is very plain but not inconsistent stylistically with a late 18th or early 19th-century date.

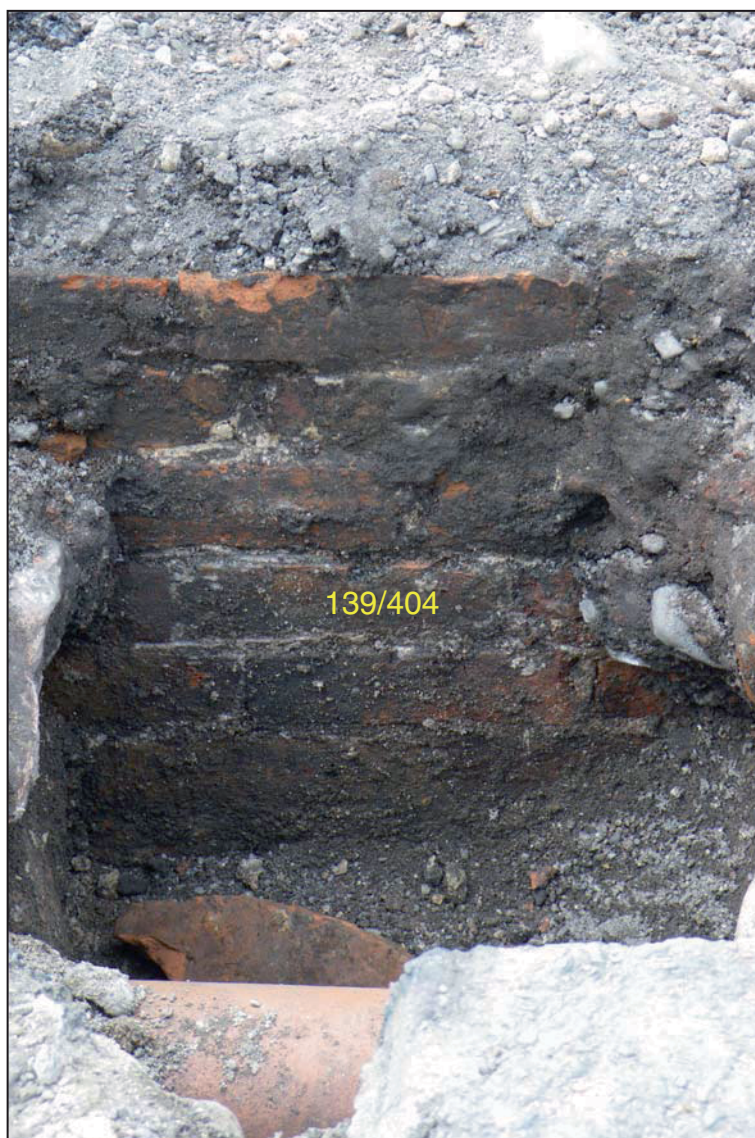
- 2.12 Wall foundation 139/305 was identified in Test Pit 3. The earliest deposit identified in Test Pit 4 comprised rounded cobbles in grey silty clay matrix 406. This deposit appeared to represent a continuation of cobbled surface 118 identified immediately to the south. It was covered by what appeared to be a construction drip of lime mortar, 405, which was recorded at the base of the test pit sloping away from wall foundation 404/139 located to the east. Seven courses of wall foundation 404/139 survived in this location. The fill of the modern service trench identified within Test Pit 4 also contained fragments of 18th-century building material. The same stratigraphic sequence was identified in Test Pit 5

10 Test pit 4; wall foundation 139/404, looking west

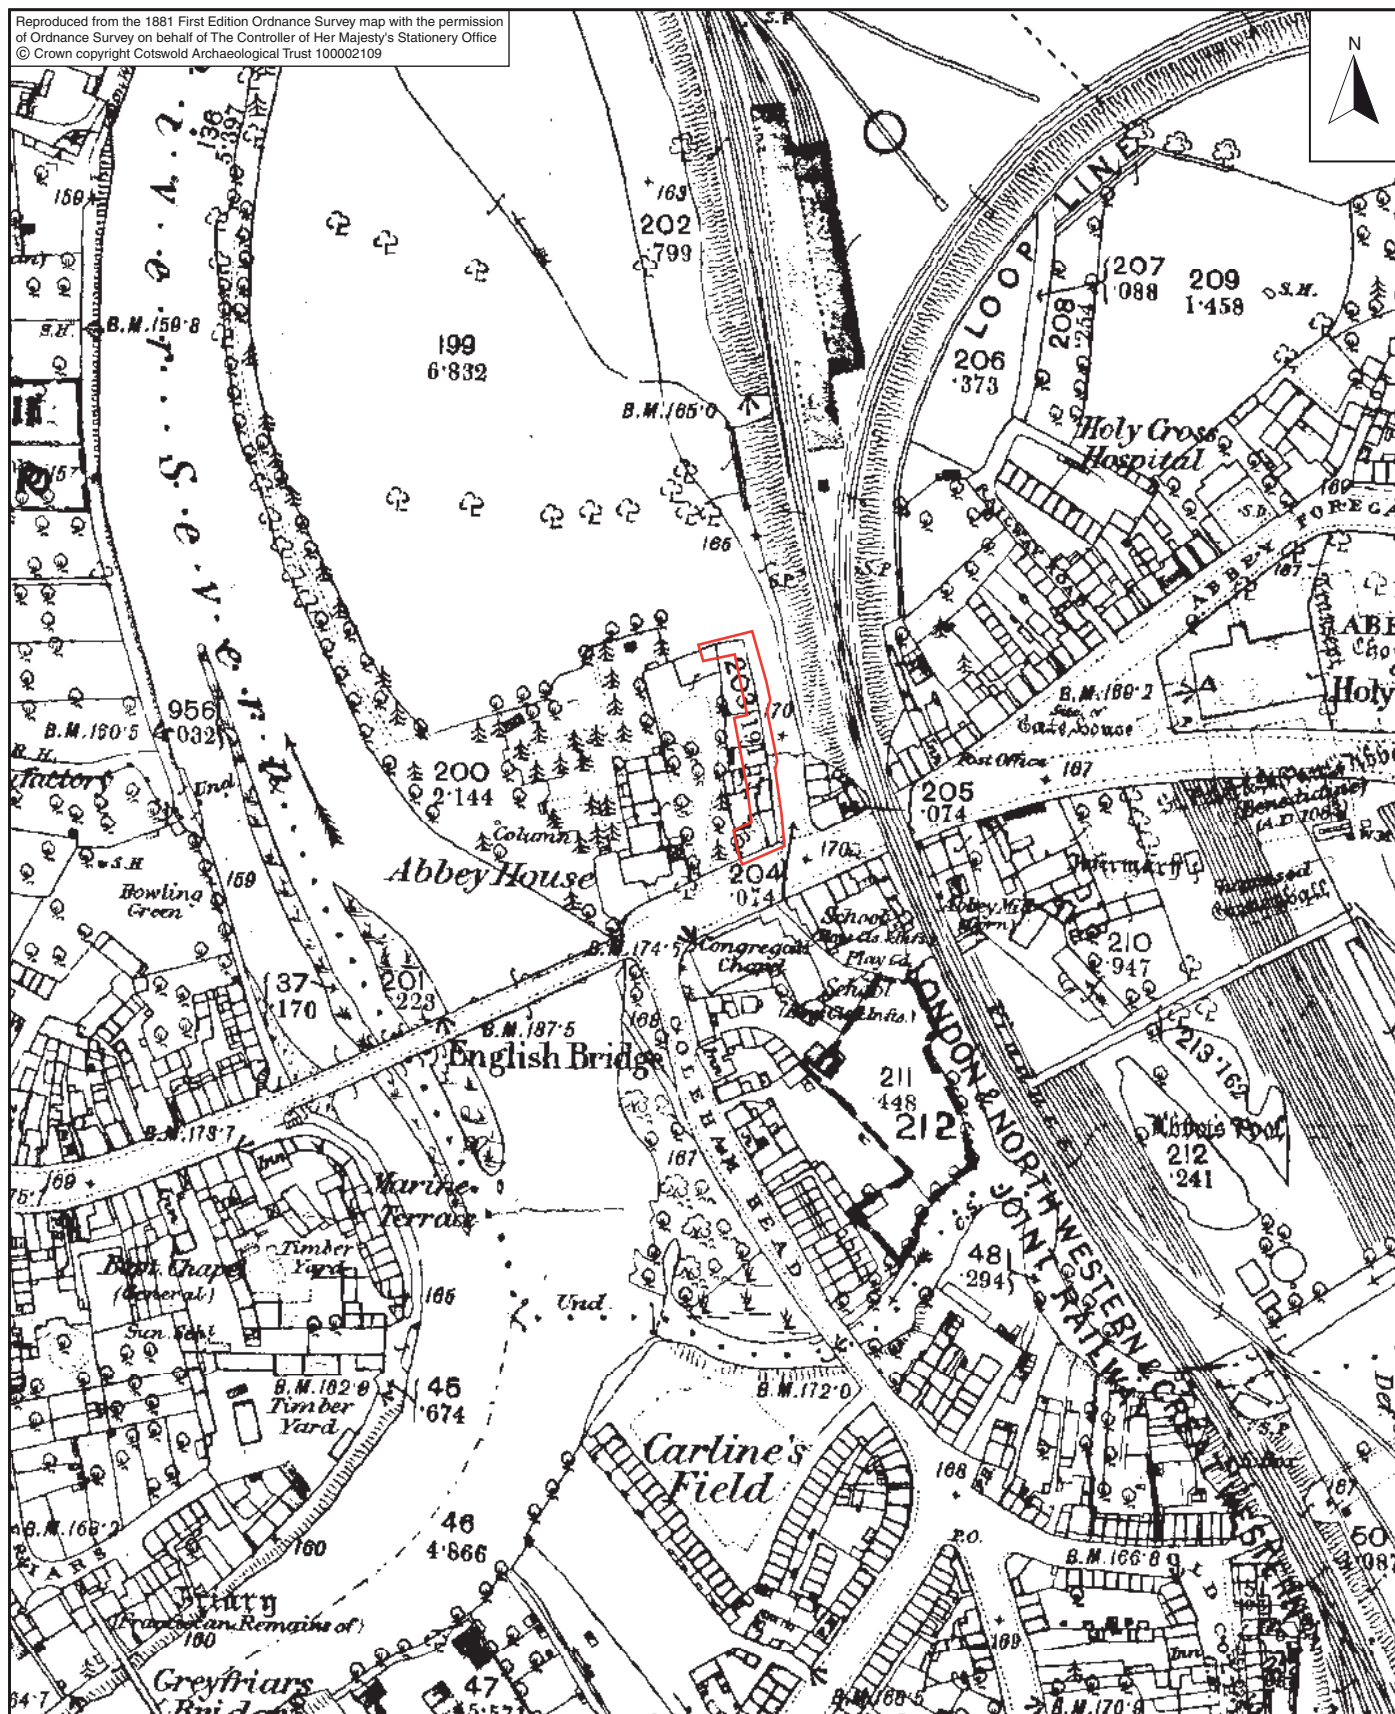
11

Extract from the First Edition  
Ordnance Survey map of 1881
