**THE FORMER 'CLUTCH CLINIC'
6 COMMERCIAL ROAD
GLOUCESTER**

**ARCHAEOLOGICAL EVALUATION
AND WATCHING BRIEF**

CA PROJECT: 2954
CA REPORT: 09191

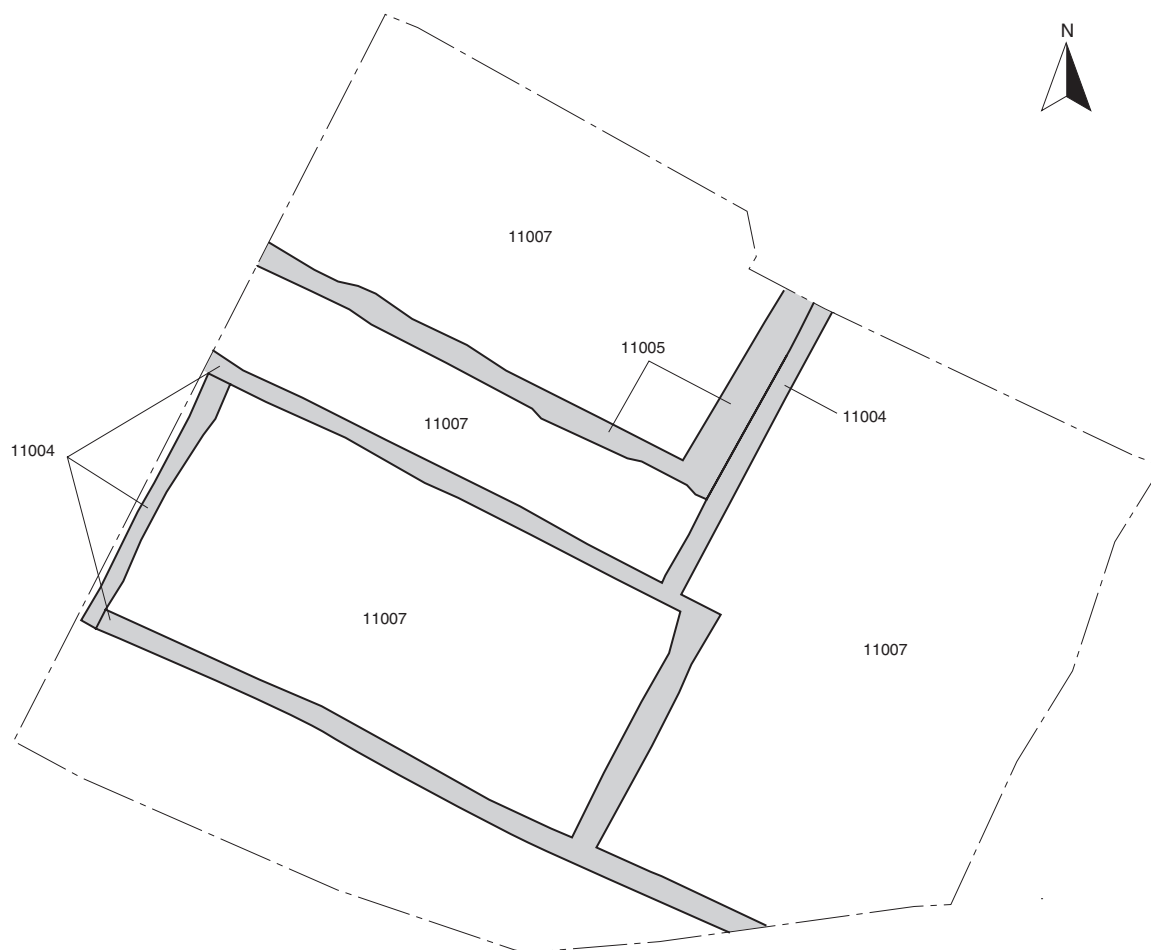
4

Area of observed watching brief ground-
works (during removal of fuel tanks)

- 2.3 A watching brief was undertaken during the removal of the fuel tanks and the earliest deposit encountered was 11007 a large concrete slab (1.33m bpgl, 16.59m AOD) forming the base of brick built structures 11003, 11004 and 11005. These structures housed the fuel tanks and were backfilled with sand 11001. All the deposits were sealed by hardcore 11008 for modern concrete surface 11000. No finds were recovered during the watching brief. A previously unidentified fuel tank was also revealed in Trench A (within structure 12053). Following the completion of evaluation works this was also removed under archaeological watching brief.

- 2.4 Following the completion of the evaluation and the watching brief during the removal of fuel tanks a further watching brief was undertaken during the removal of the remaining areas of the concrete slab (except within the showroom). No evidence for any additional fuel tanks was identified, although the possibility that such features may have been masked by later deposits cannot be discounted. Modern make-up deposits, 11009, were identified.

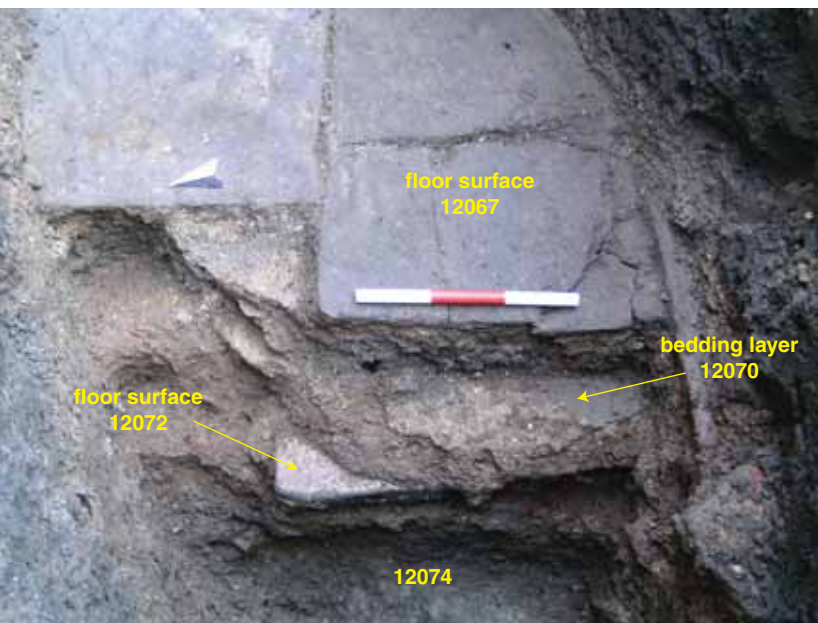
View, looking east of Trench A

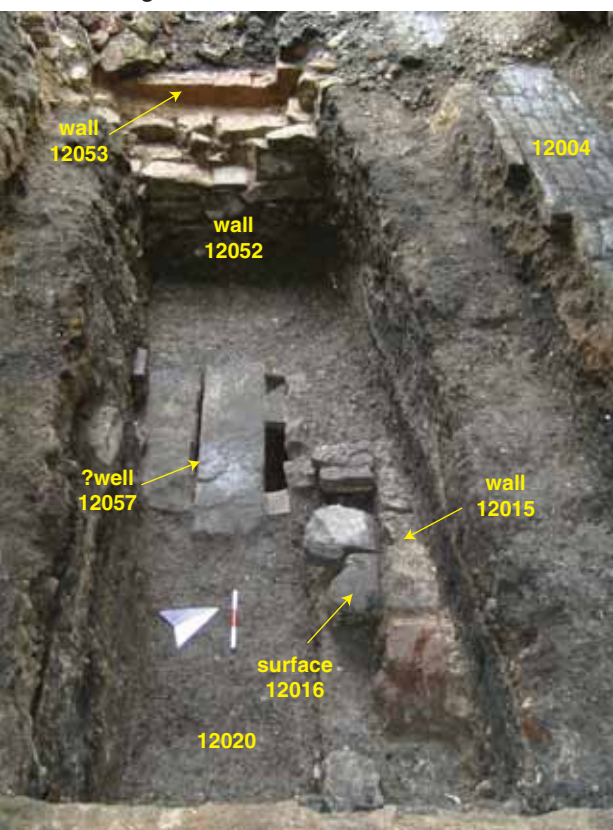
View, looking north-west of Trench A

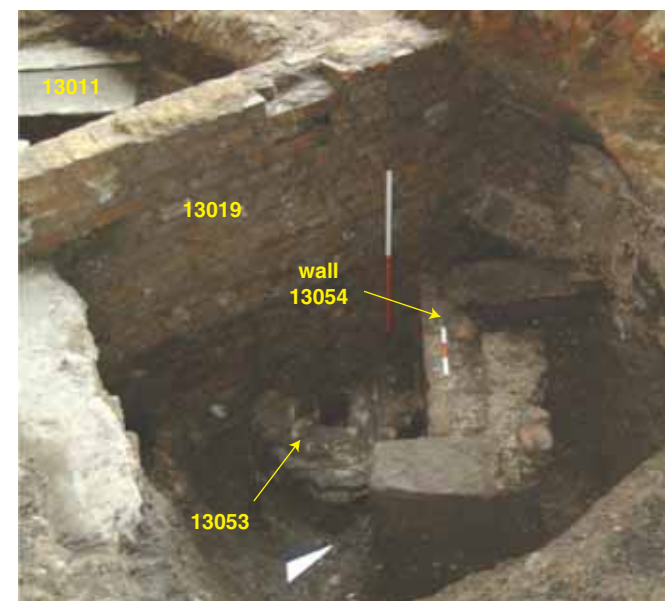
View, looking north-west of Trench B

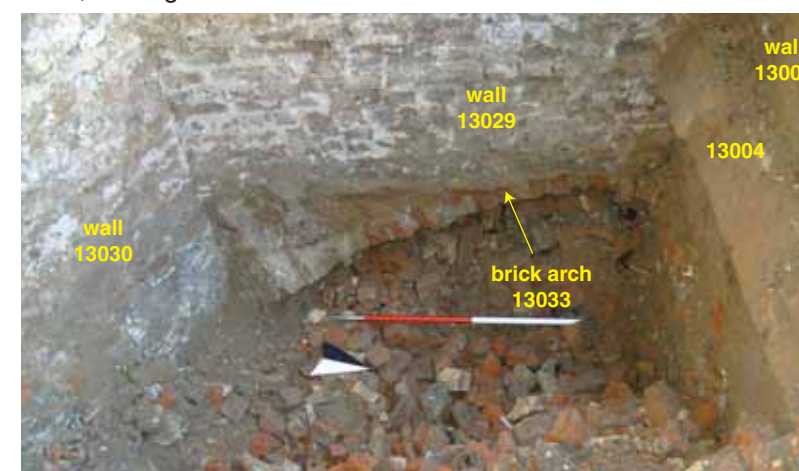
View, looking west of Trench B

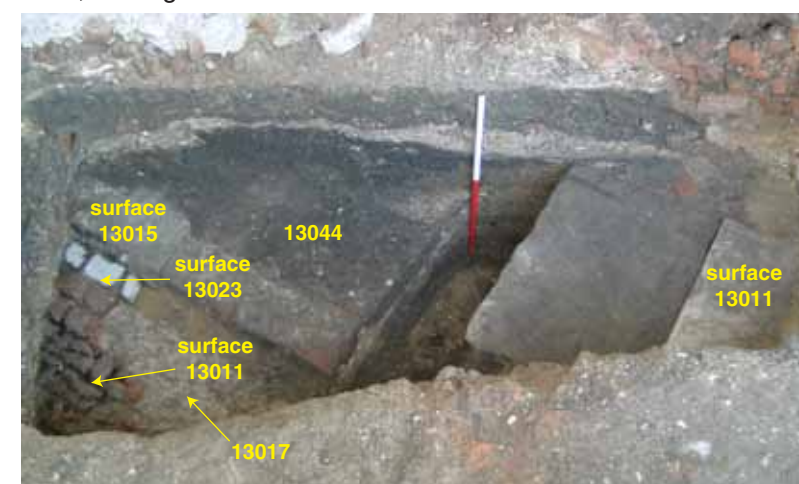
View, looking north of Trench B

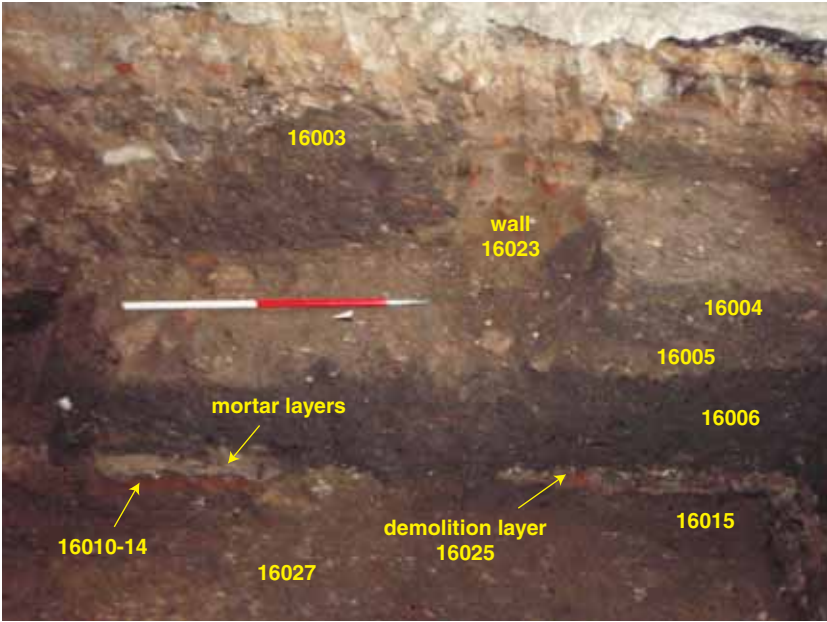
West facing section of Trench C

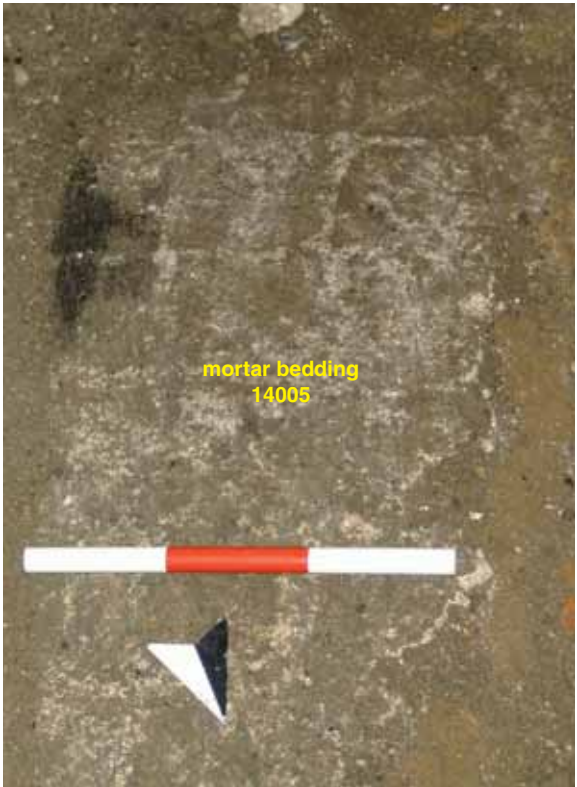
View, looking south of mortar bedding 14005

- 2.26 At the southern end of the trench deposit 14012 was directly overlain by a sandy levelling layer 14006, which was in turn overlain by mortar bedding layer 14005 (1.93m bpgl, 15.88m AOD) which contained the impressions of square tiles c. 120mm long and 120mm wide (Fig. 10, section AA and photograph). This was cut by a later wall 14008 constructed of hand-made red bricks dated to the late 18th/19th century (1.61m bpgl, 16.2m AOD). These features were overlain by two demolition layers 14004, containing fragments of 13th to 14th-century floor tiles and large stone blocks including fragments of late medieval worked stone associated with the priory, and 14003. The latter was sealed by modern make-up deposit 14002, which contained one sherd of residual post-medieval pottery, and by modern surfaces.

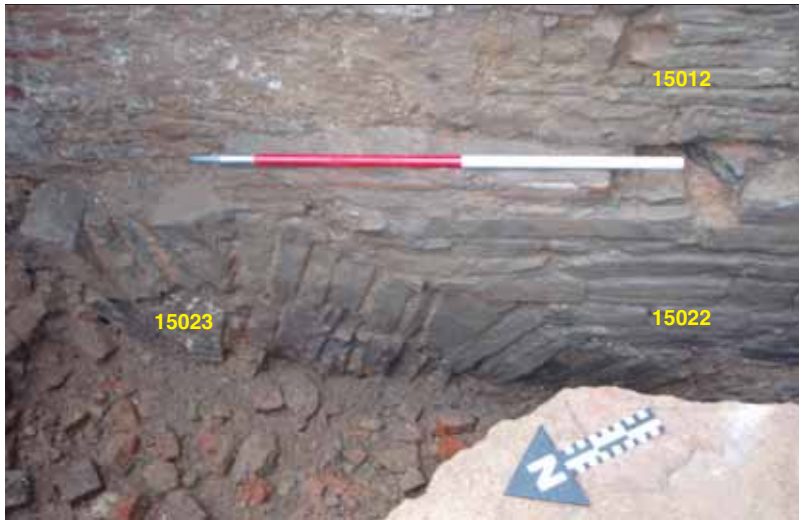
View, looking east of medieval arch 15023

- 2.27 In the southern part of Trench F the earliest features identified were north-east/south-west orientated stone wall foundations 15022/15023 (Fig. 11, sections AA) (2.25m bpgl, 16.15m AOD) which probably dated to the medieval period. Within the fabric of the wall 15023 a stone rubble arch was identified (Fig. 11, photograph). Constructed on top of these foundations and on the same alignment was undated stone wall 15012 which along with wall 15022 was cut by red brick wall 15014 dated to the 18th/19th-centuries, which formed the back wall of a building comprising 13010 and 13020 identified in Trench B to the south.
