**PRESTBURY FLOOD ALLEVIATION SCHEME  
CHELTENHAM  
GLOUCESTERSHIRE**

**ARCHAEOLOGICAL EVALUATION**

**ENVIRONMENT AGENCY**

CA PROJECT: 2972  
CA REPORT: 09208

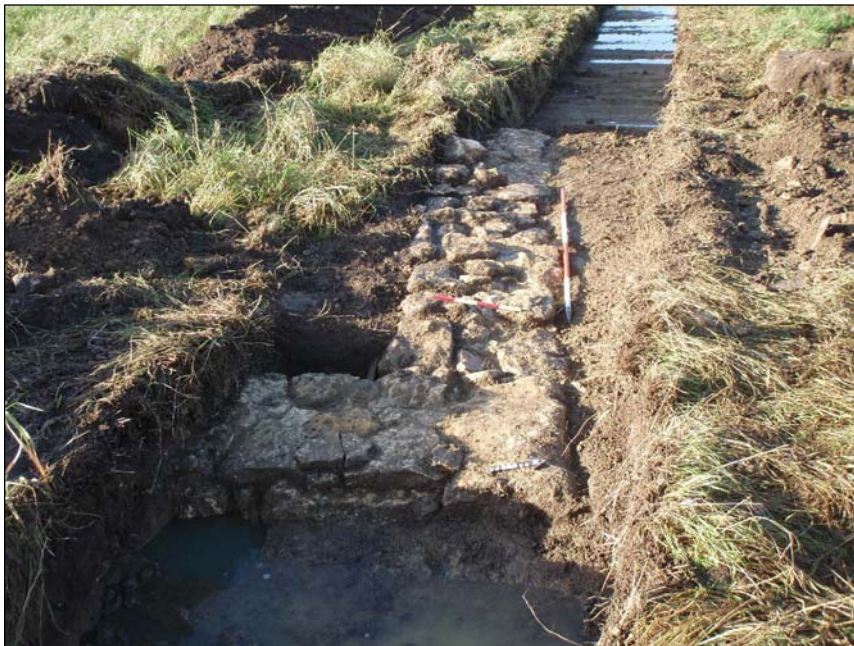
Wall 5003, looking west. 0.5m and 2m scales

2.4 The undisturbed natural substrate 5004/5005 was first encountered at 0.8m bpgl. This was sealed by alluvium 5002 and subsoil 5001. Cut through the subsoil and founded on the alluvium was wall 5003, which consisted of two courses of very roughly hewn limestone blocks. These were laid in random courses and were not bonded. The wall was orientated north-west/south-east with a right angled return to the south at the south-eastern end. The top of the wall lay at 76.54m AOD. This wall is likely to represent part of the northern wall of a building identified in the geophysical survey (EA 2009, 5). This structure corresponds with a small building depicted on the 1887 1st edition Ordnance Survey map and which still appeared on the 1947 Ordnance Survey map (ibid.). The wall was sealed by topsoil 5000. Concentrated around the wall within the topsoil 5000 were large fragments of limestone demolition rubble and post-medieval and/or modern roof tile (not retained).

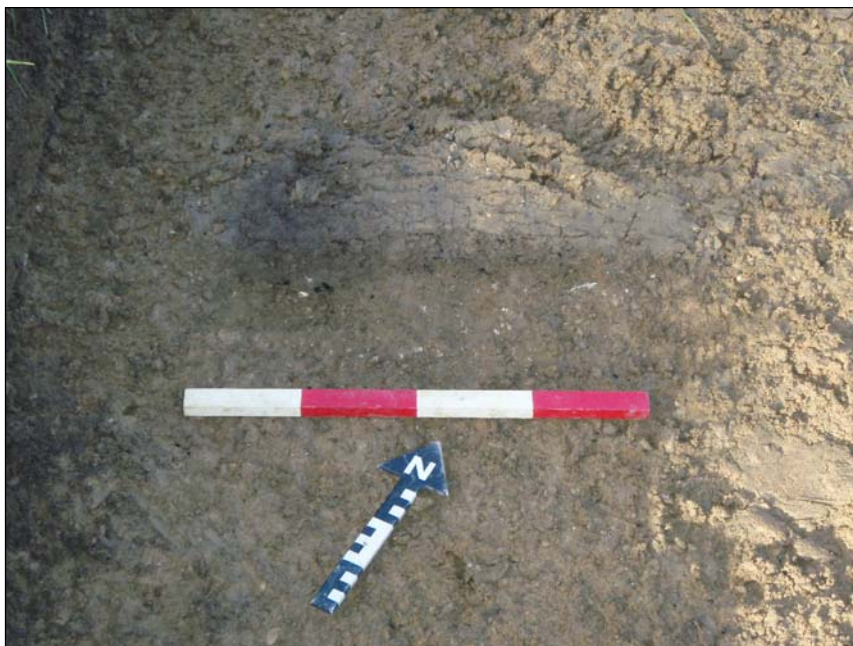
Posthole 8004, looking north-west. 0.5m scale.

- 2.6 The undisturbed natural substrate 8002 was first encountered at 0.9m bpgl. This was sealed by alluvium 8006. Cut in to the alluvium was shallow, sub-circular posthole 8004. It measured 0.5m by 0.35m and was only 0.08m deep. It had a single fill 8005 containing a pottery sherd, a fragment of bone and an iron nail. A darker patch in this fill may represent the remains of a postpipe (Fig. 4). The top of the fill lay 0.25m bpgl (82.67m AOD). The small fragment of pottery recovered was very abraded. It has a quartz and limestone tempered fabric suggesting an Iron Age date. The fragment of animal bone is identifiable as sheep-sized and is clearly burnt to a white colour, indicating it was burnt at a high temperature. The nail is a medieval or post-medieval nail for attaching horseshoes. The pit was sealed by subsoil 8001 and topsoil 8000.

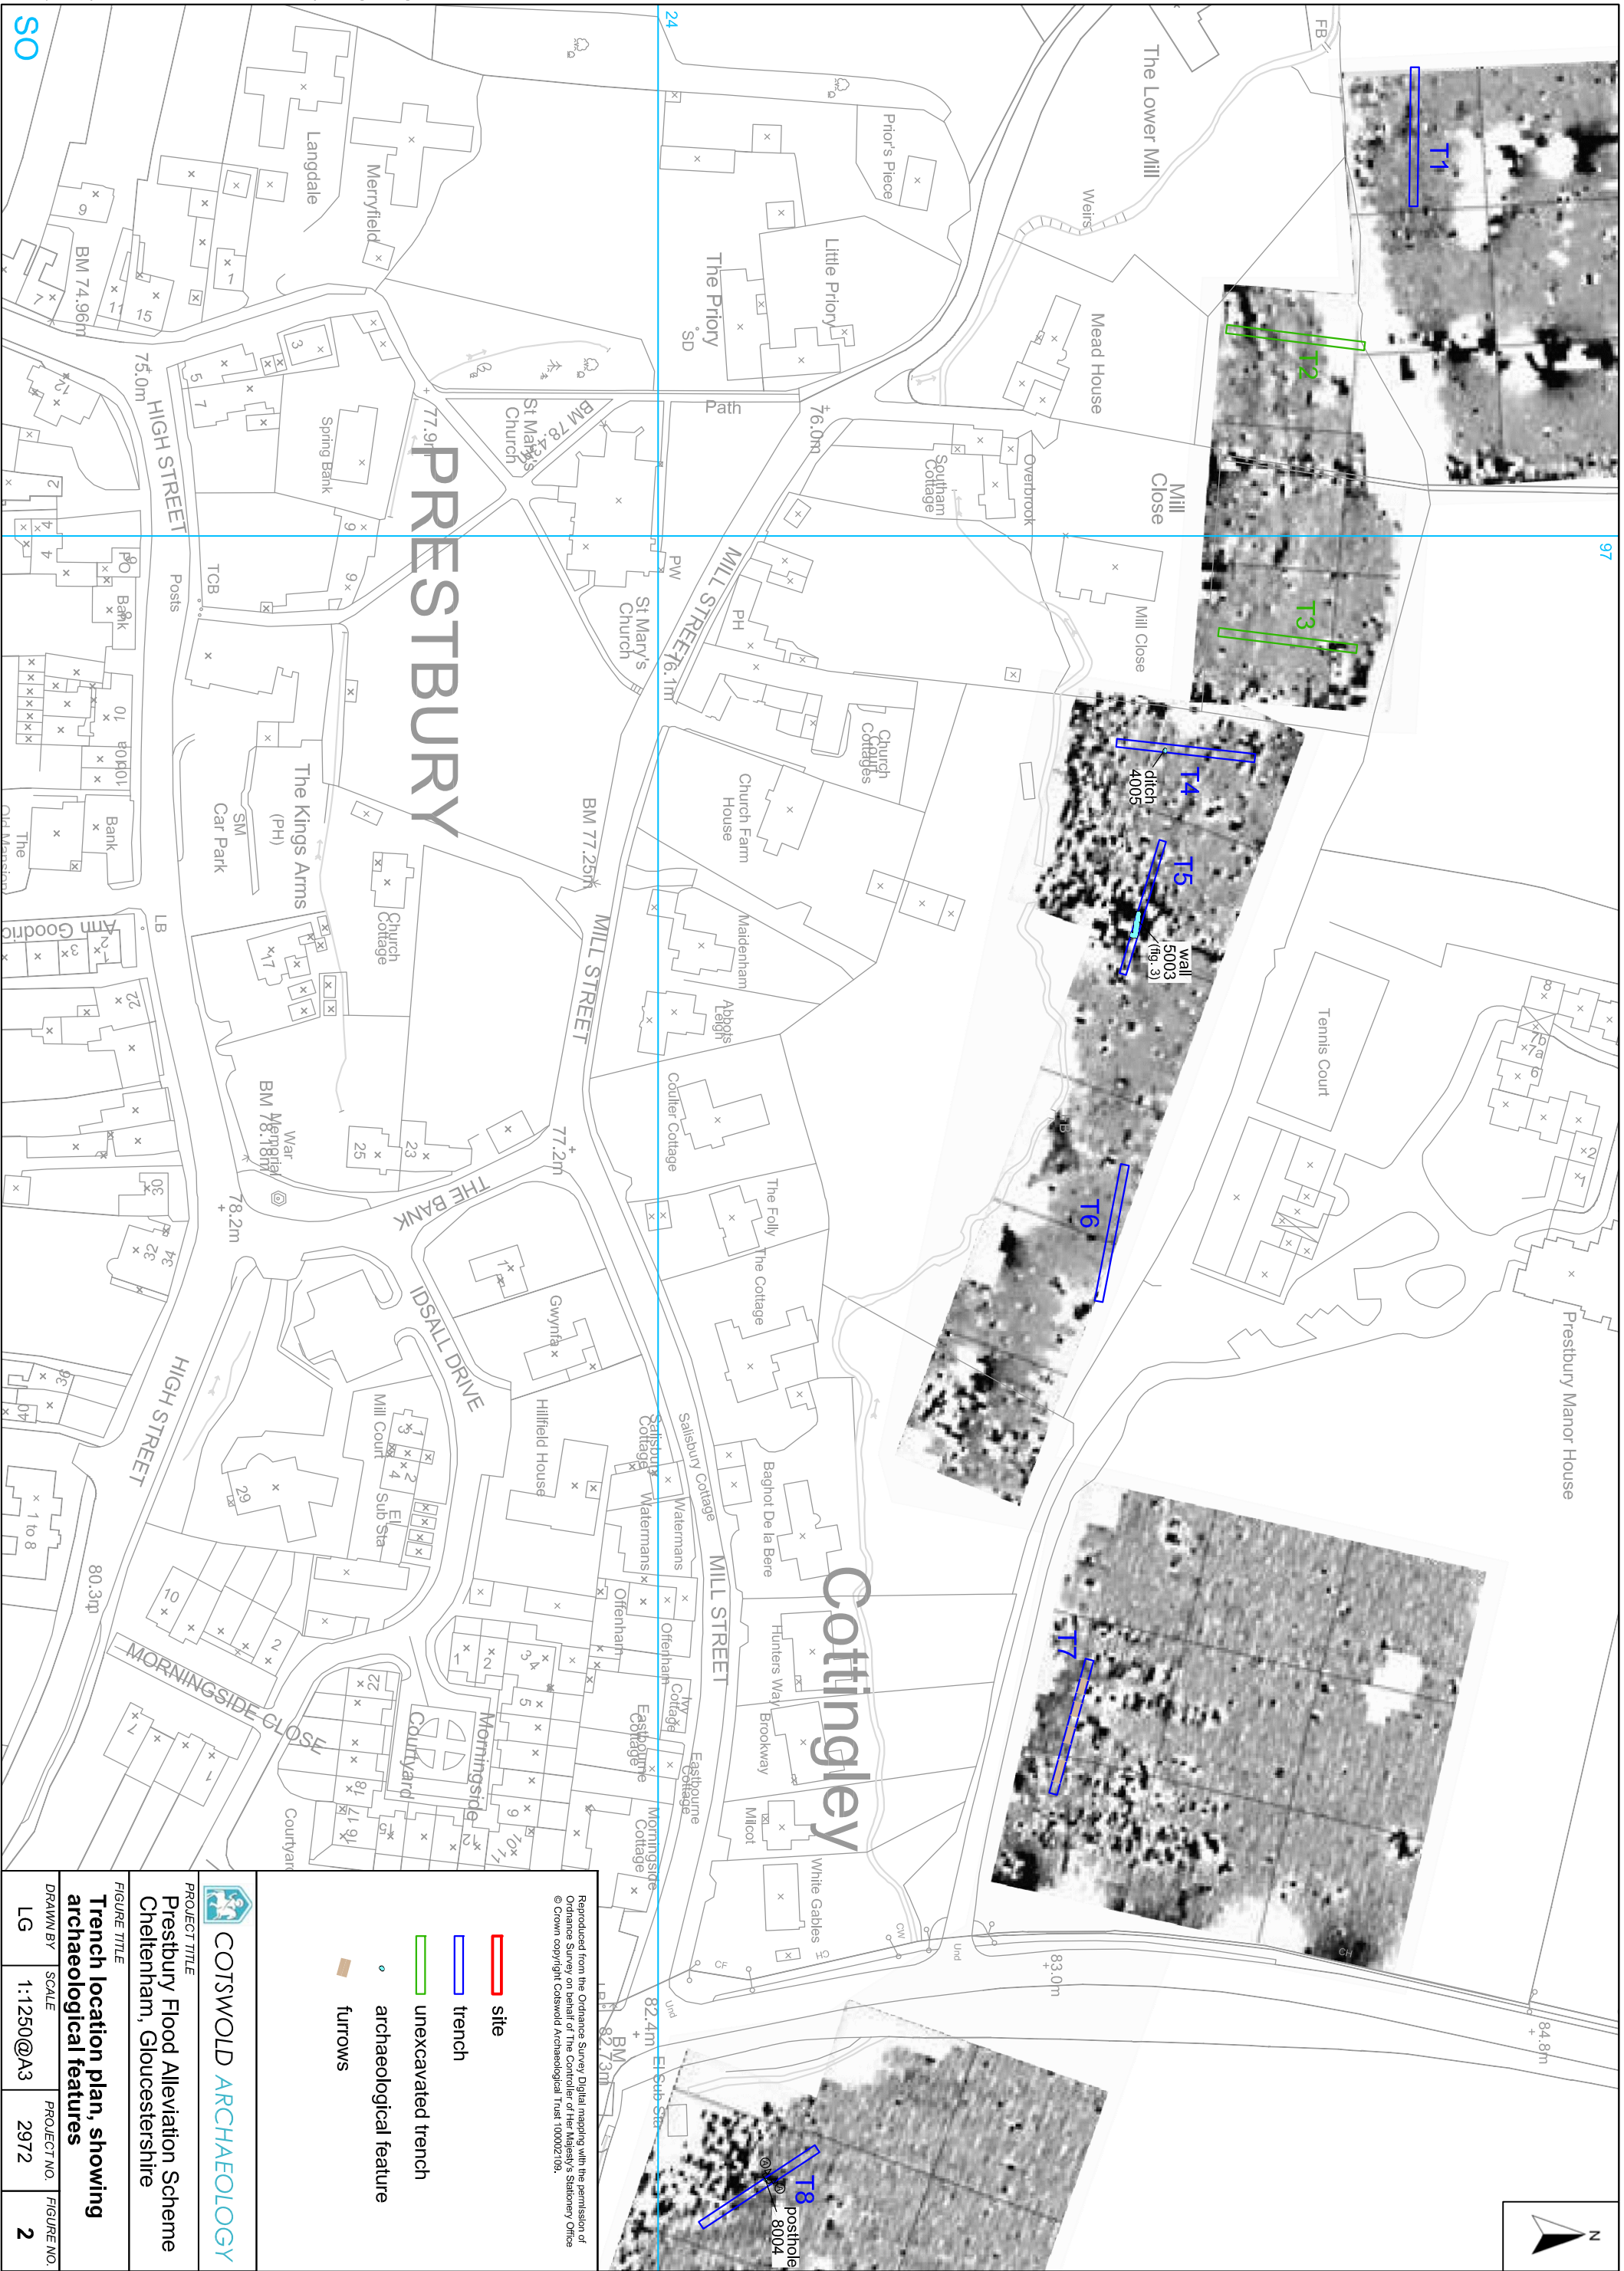
**COTSWOLD ARCHAEOLOGY**  
 PROJECT TITLE  
 Prestbury Flood Alleviation Scheme  
 Cheltenham, Gloucestershire  
 FIGURE TITLE  
**Trench location plan, showing  
 archaeological features**  
 DRAWN BY SCALE PROJECT NO. FIGURE NO.  
 LG 1:1250@A3 2972 2

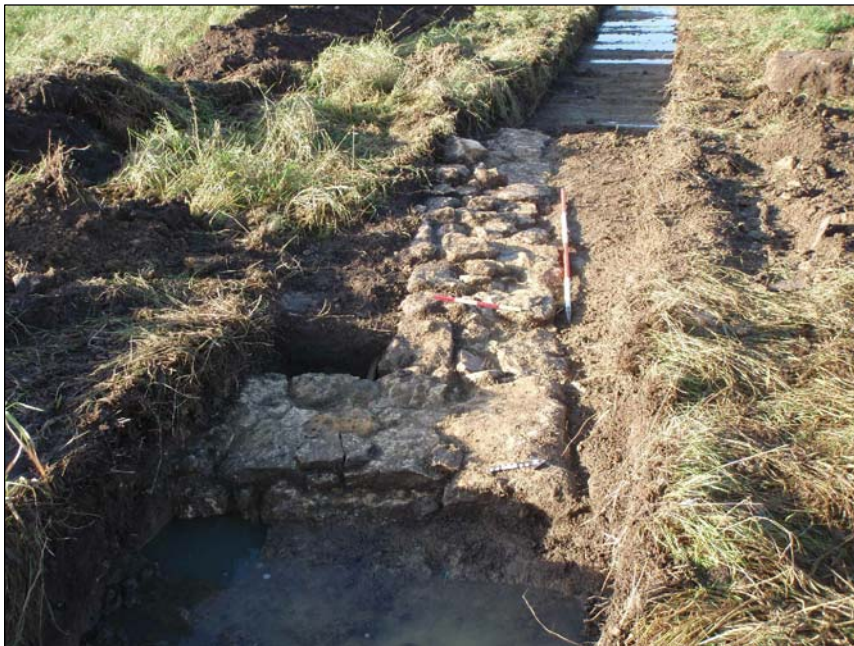
Wall 5003, looking west. 0.5m and 2m scales

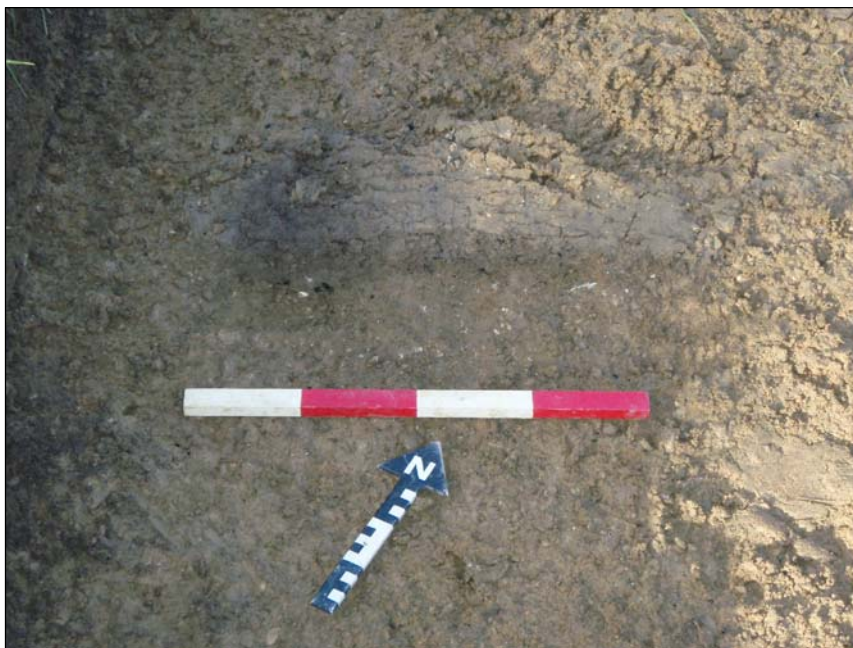
Posthole 8004, looking north-west. 0.5m scale.
