**DEERHURST
FLOOD ALLEVIATION SCHEME
GLOUCESTERSHIRE**

**ARCHAEOLOGICAL EVALUATION AND
WATCHING BRIEF**

CA PROJECT: 2911
CA REPORT: 10002

APRIL 2010

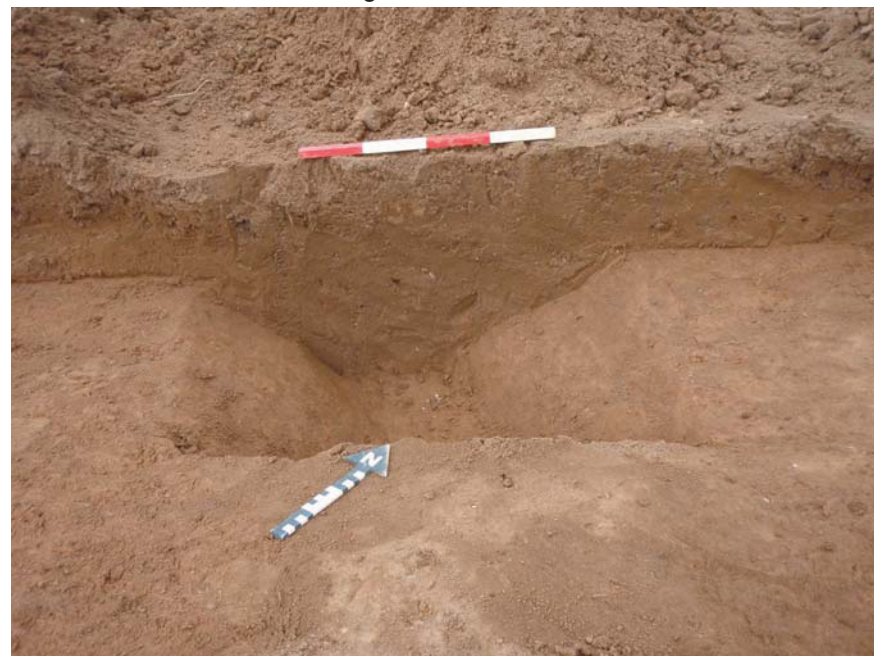
- 2.4 Ditch 25003 lay towards the south-western end of Trench 25 on a north-west/south-east alignment and was cut into the underlying natural substrate. It contained a single sandy silt fill 25004, the top of which lay at a height of 11.13m AOD and from which six sherds of Severn Valley Ware pottery of Romano-British date were recovered.
- 2.5 Ditch 25005 lay towards the eastern end of Trench 25 on a north/south alignment and was cut into the underlying natural substrate. It contained a single sandy silt fill 25006, the top of which lay at a height of 10.40m AOD and from which thirteen sherds of mid to late 1st-century AD pottery were recovered.

Trench 25, ditch 25003, looking north-west

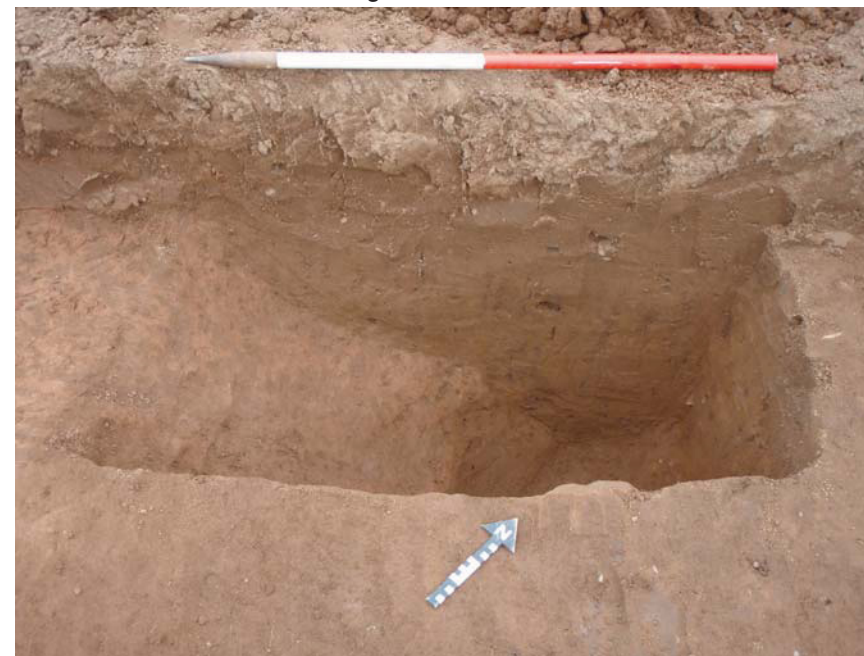
Trench 25, ditch 25005, looking north-west

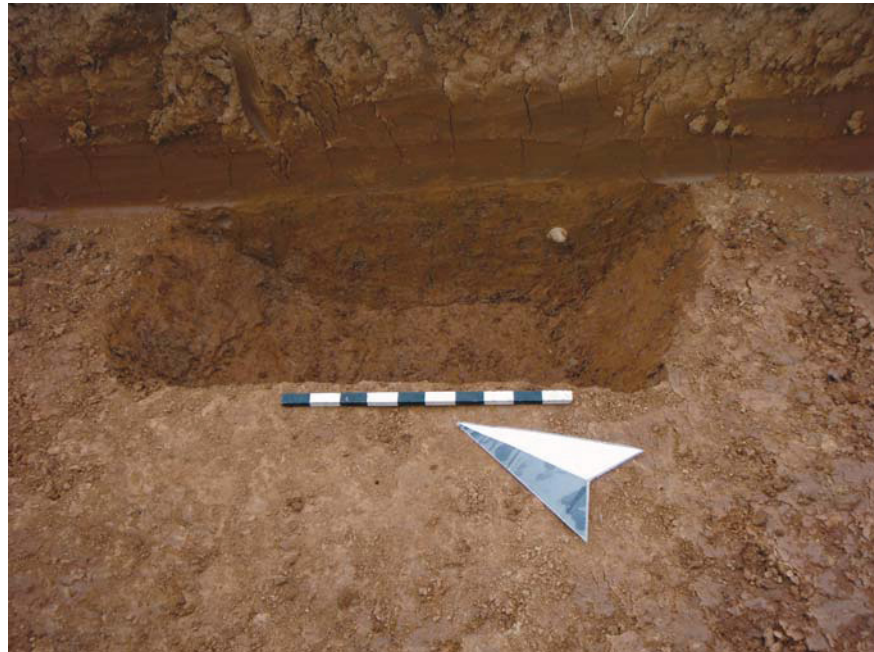
- 2.8 Ditch 37003 lay in the north-eastern half of Trench 37 on a north-west/south-east alignment and was cut into the underlying natural substrate. It contained a single silty clay fill 37004, the top of which lay at 10.81m AOD, and from which no finds were recovered.
- 2.9 Pit 37005 lay in the south-western half of Trench 37 and was cut into the natural underlying substrate. It contained a single clay silt fill 37006, the top of which lay at 10.79m AOD, and from which no finds were recovered.

Trench 37, ditch 37003, looking north-east

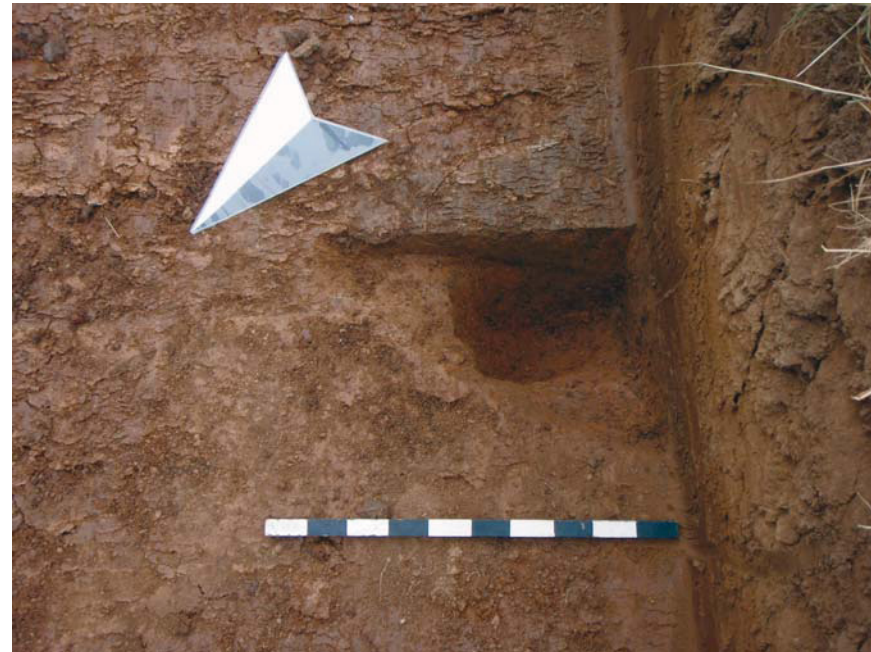
Trench 37, pit 37005, looking south-east

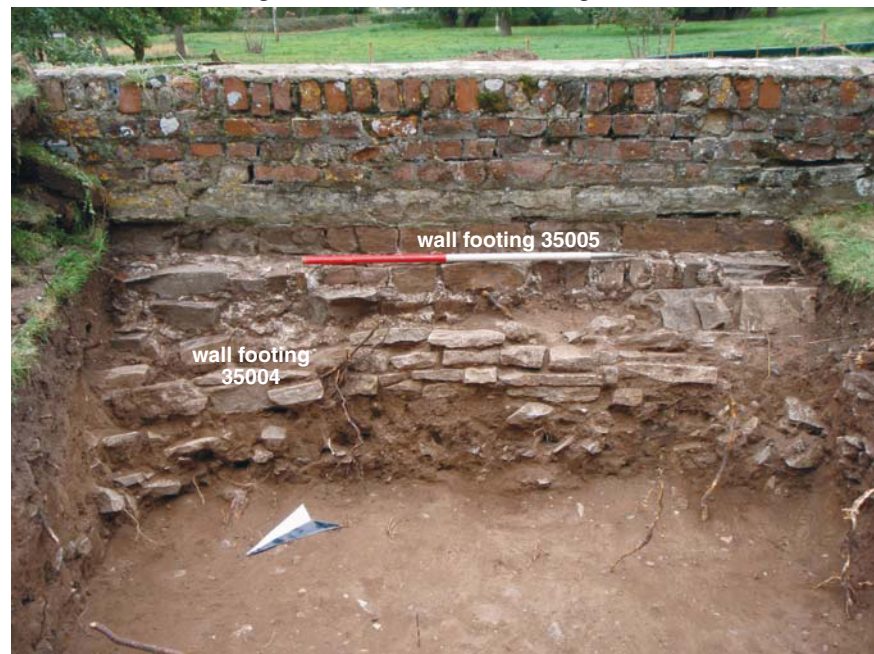
- 2.10 Trench 35 was located over the footprint of proposed floodgates within the churchyard. The trench was excavated to a depth of 0.6m below the existing ground level. A silty sand subsoil 35001/35007 was observed throughout the trench although the full depth of this deposit was not established. Five sherds of post-medieval pottery were recovered from this deposit together with seven sherds of residual medieval pottery.
- 2.11 Wall footing 35004 was located at the eastern extent of Trench 35 and comprised randomly coursed rough-hewn limestone fragments, the top of which lay at 11.80m AOD. It is likely that the footing post-dated the underlying churchyard subsoil 35001 although the footing appeared to be tipping towards the south-east and no construction cut was visible. The footing was butted by the stone and brick footing 35005 for the existing churchyard wall.

Trench 35, wall footings 35004 and 35005 looking south-east

- 3.3 Elsewhere archaeological evidence was limited to showing (in Trench 35) that the existing churchyard wall had been built upon an earlier wall footing. The earlier footing is likely to have constructed in the post-medieval period although the evidence for this date was not conclusive. The limestone edging blocks uncovered in trench 9 below the current footpath are likely to represent a previous footpath.

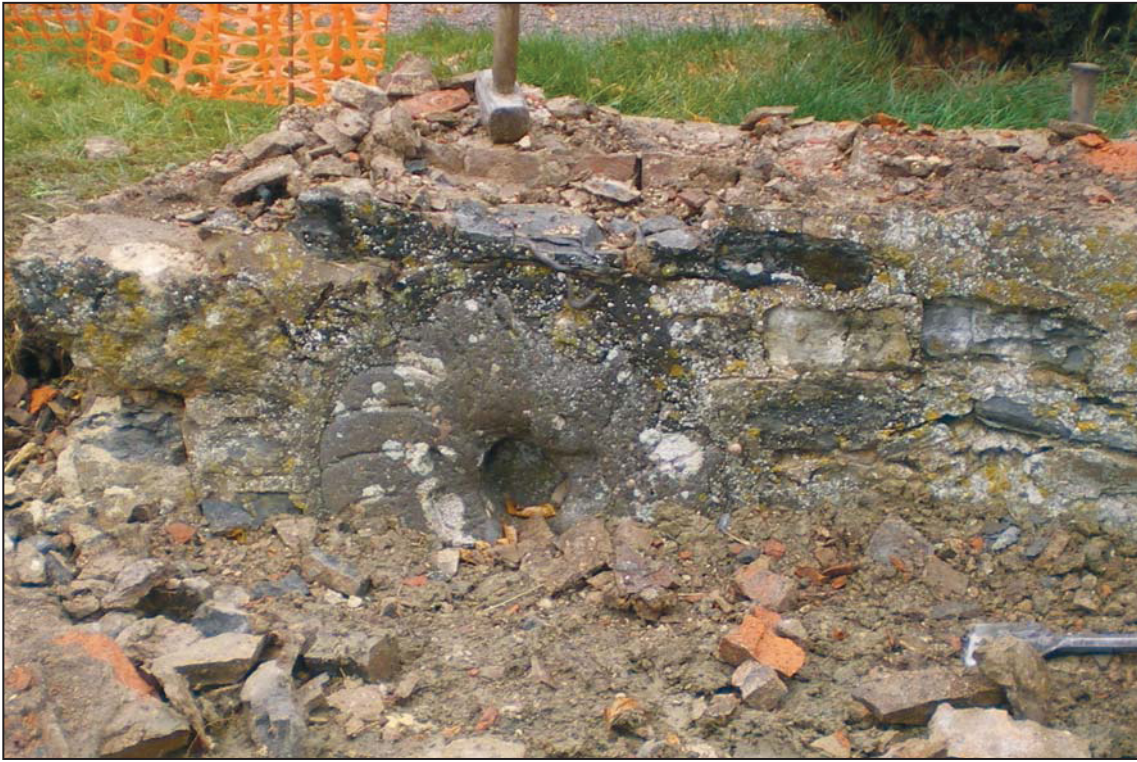
- 2.13 The reconstruction of the boundary wall on the southern side of St Mary's Church was monitored to allow the retention and examination of any worked stone. A laser scan carried out prior to the works had highlighted the presence of a millstone. This was duly recovered and recorded as the wall was dismantled (Fig. 8). It was then safely stored in the church and reinstated when the wall was rebuilt.

a Millstone *in situ* in exterior face of Churchyard wall, looking south-east
