**THE FORMER 'CLUTCH CLINIC'
6 COMMERCIAL ROAD
GLOUCESTER**

**ARCHAEOLOGICAL WATCHING BRIEF
AND HISTORIC BUILDING RECORDING**

CA PROJECT: 3015
CA REPORT: 10110

JANUARY 2011

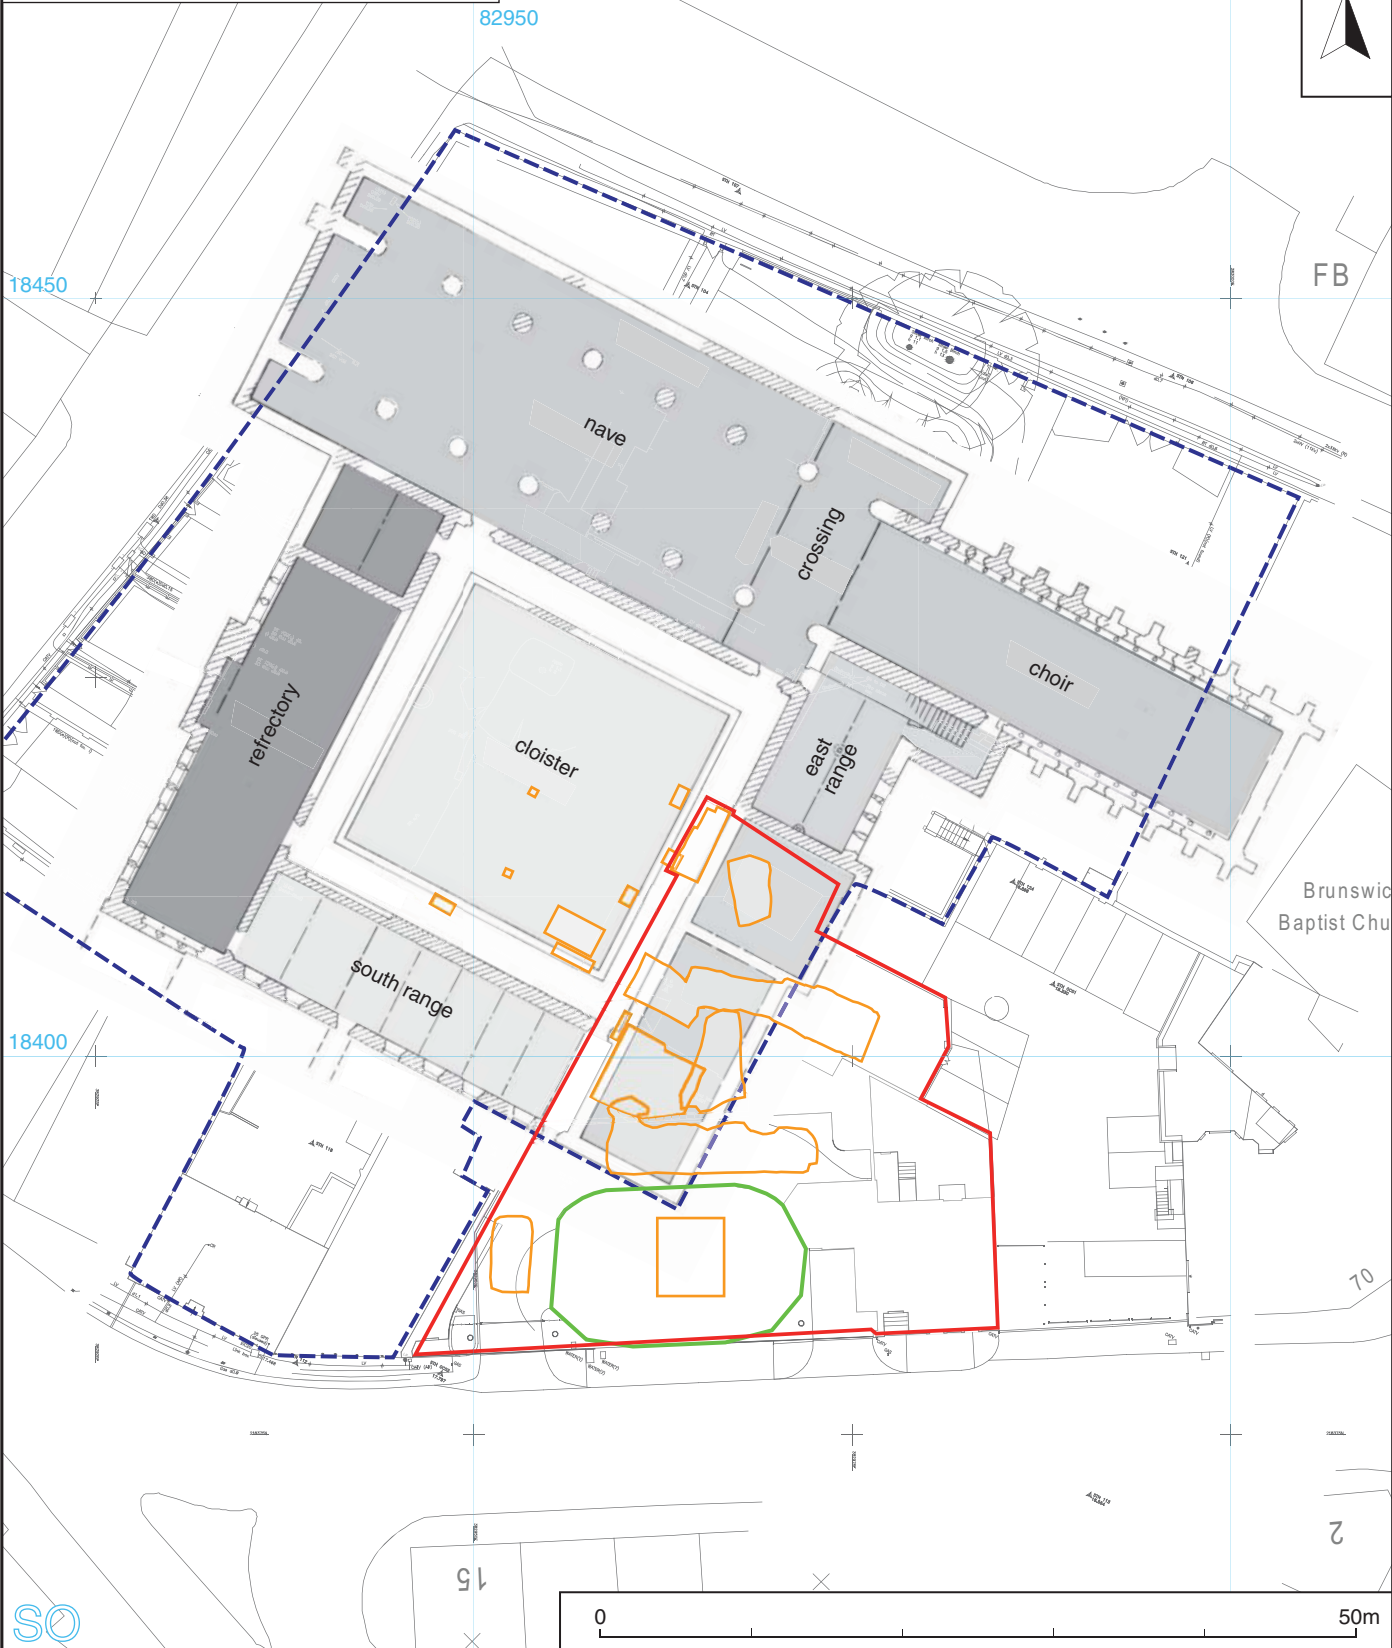
**Trench location plan showing
 archaeological interventions**

- 2.1 This section provides an overview of the watching brief results; detailed summaries of the recorded contexts are to be found in Appendix A.
- 2.2 The lowest deposits observed were seen at a depth of approximately 1m below present ground floor level (bpgl), but only in a few limited areas when steel stanchions of the Talbot Works/Clutch Clinic were removed. In the watching brief observations the material (context 31002) up to the underside of the concrete slab floor of the Clutch Clinic all appeared to be brick rubble. The layers at this depth were previously sampled here in Trench G in the earlier evaluation (CA 2010) where comparable layers were noted.

- 2.3 This rubble was sealed by the concrete slab (31001) forming the floor of the frontage building to Commercial Road. This proved to be only 0.20m thick on average. No features or deposits of archaeological interest were observed during these groundworks.

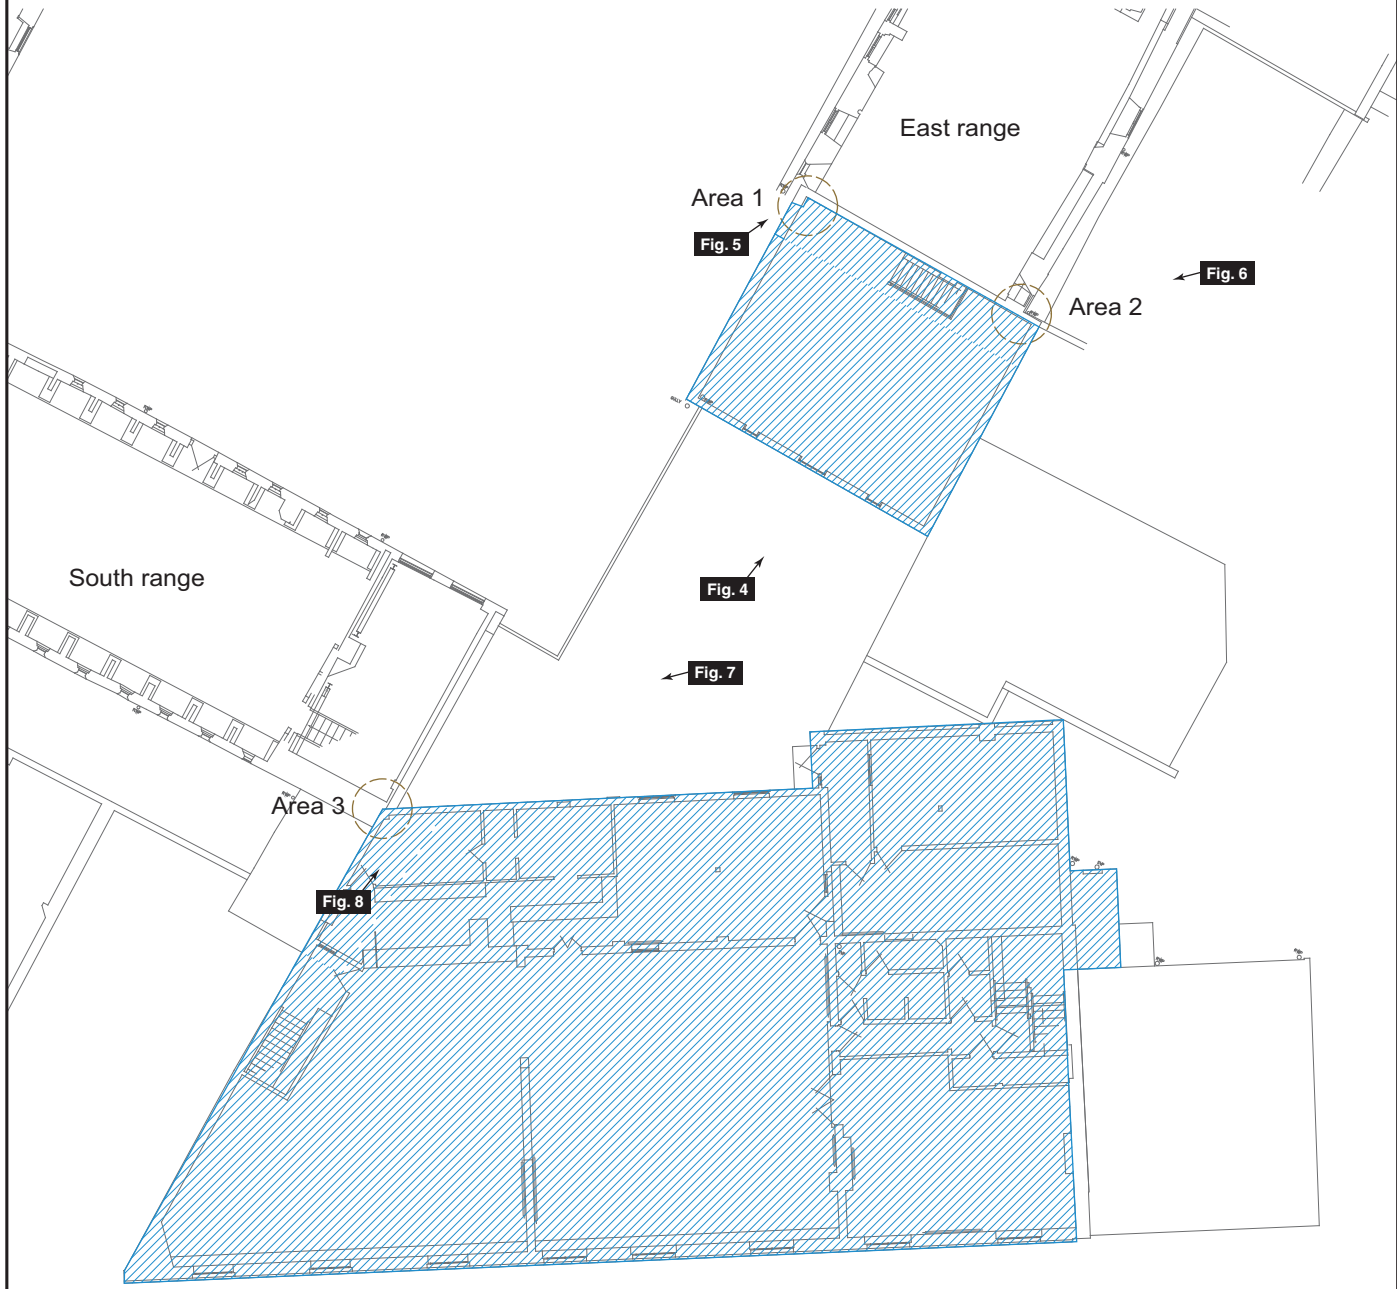
| FIGURE TITLE Location of observations and photographs of standing buildings | | | |

- 2.4 Three specific areas were monitored: The junctions of the rebuilt part of the East Range of the cloister with the surviving medieval building (Areas 1 and 2); and where the rear of the street frontage building of 1874 met the south-eastern corner of the South Range (Area 3). These are shown on Fig. 3.

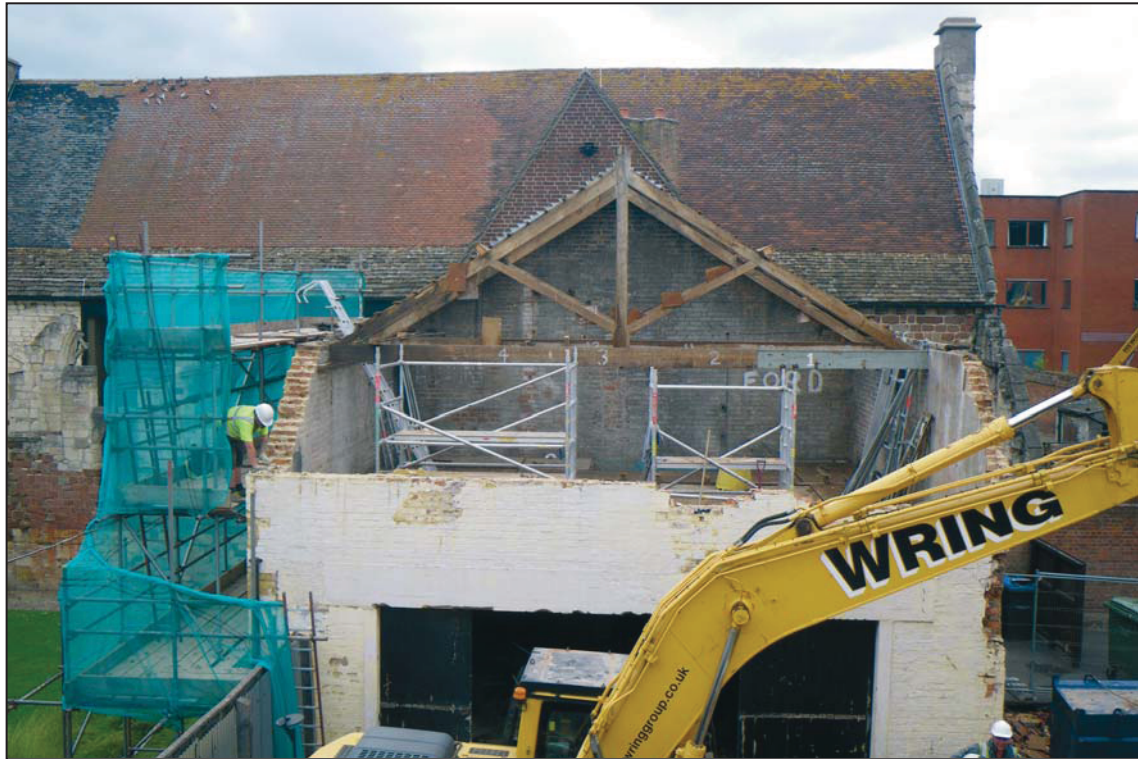
- 2.5 The 1874 addition to the south end of the medieval East Range was a traditional brick structure with a timber truss purlin roof (Fig. 4, Areas 1 and 2). Its northern gable acted as the common gable with the stub of the medieval East Range and was left in place, the rest of the structure being divided from it by sawing, its removal thus not directly affecting the older structure at all. It was noted that the east and west walls of the medieval range had been made good when the 1874 gable was built against them and probably tidied up during later conservation work (Figs 5 and 6). It was also noted that the upper part of the gable, closing the steeper roof of the medieval range, had been rebuilt in closely matching, but not identical brick and that the brick wall facing the cloister had been rendered.

4 Demolition of the 19th-century southern end of the East Range in progress, showing the brick gable, including the rebuild of the higher, steeper gable of the medieval East Range

- 3.2 The demolition of the brick, southern end of the East Range built in 1874 revealed no new information on the medieval building, as the gable end of that rebuild was left *in situ* (Figs 4 and 6, Areas 1 and 2). Observation indicated that both wall ends of the original east range had been made good prior to the addition of the now-demolished brick block. On the east, the brick gable extends east of the original gable end and here the northern side of the junction is rendered, presumably over made-good masonry (Fig. 6). On the west side the wall of the medieval range projects slightly further west than the later addition and new quoins appear to have been inserted in the upper part of the wall here (Fig. 5). This is almost certainly the result of “tidying up” during the Ministry of Works programme in the 1960s and 70s, as was the rebuilding of the apex of the gable in matching brickwork (Fig. 4) and the rendering of the Victorian brickwork facing the cloister (Fig. 5).

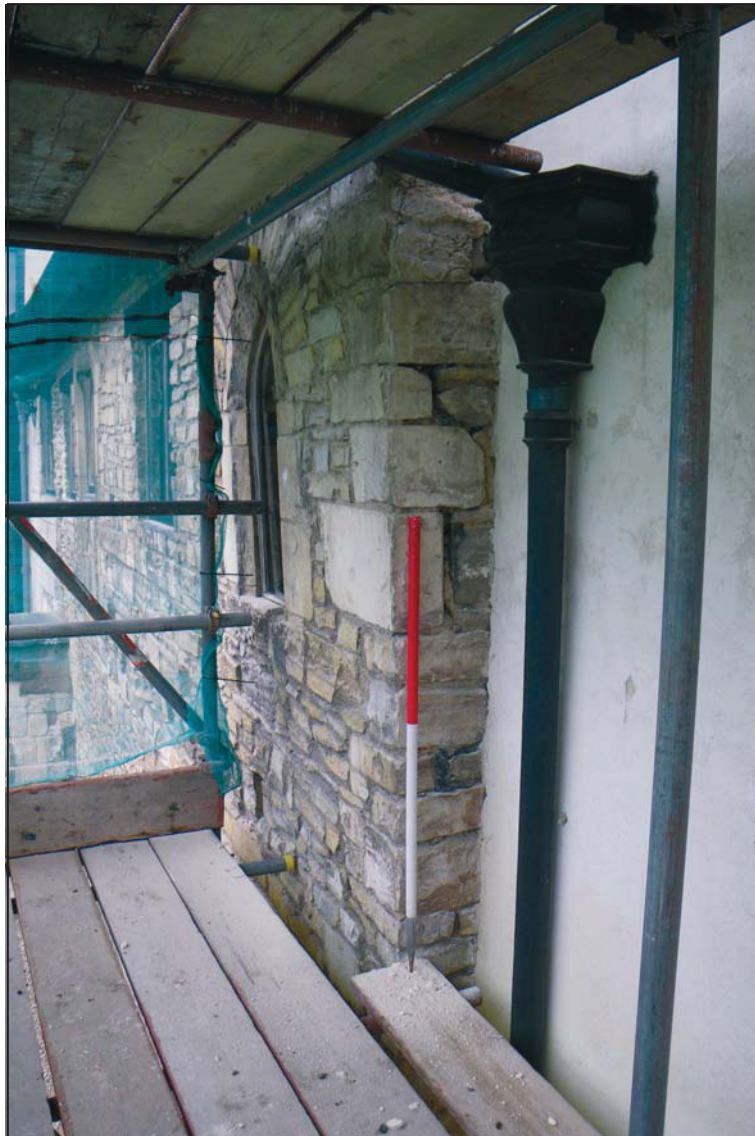
5 The repaired masonry and quoins in the south-western corner of the medieval East Range (Area 1). The rendered wall to the right, butting the quoins, is the western wall of the now-demolished brick part of the East Range. Scale 1m

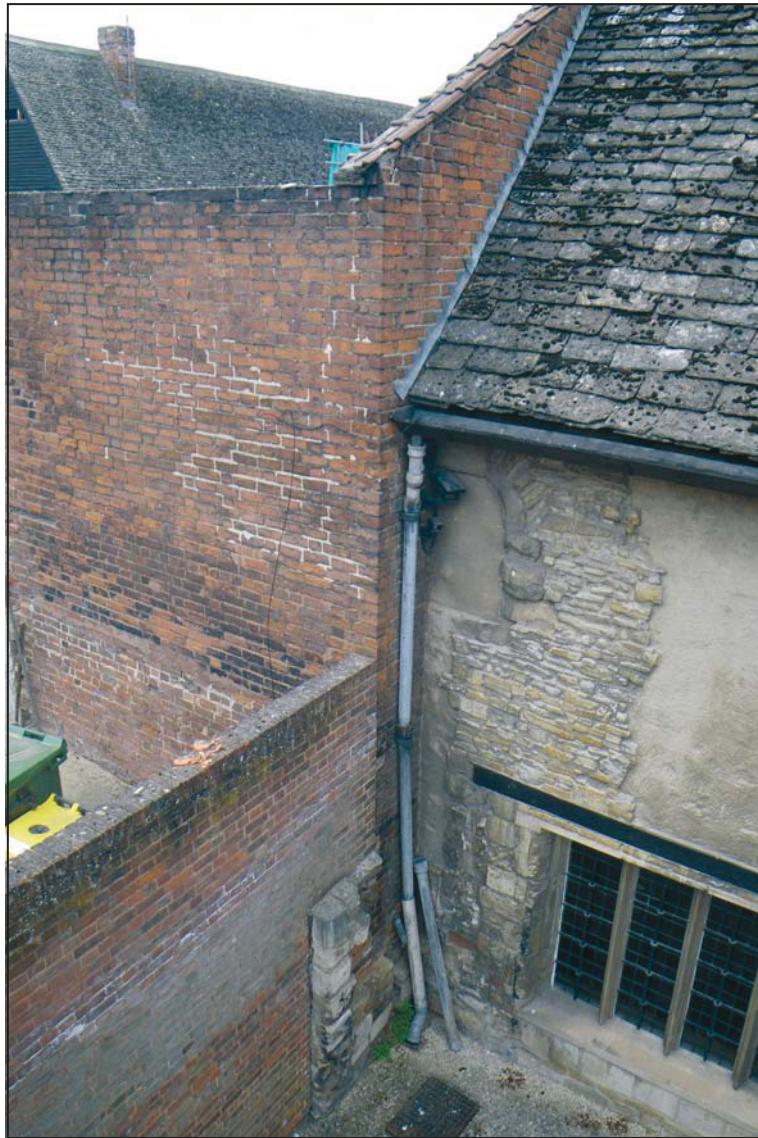
6 The eastern wall of the East Range, junction of medieval and 19th-century brick sections (Area 2)

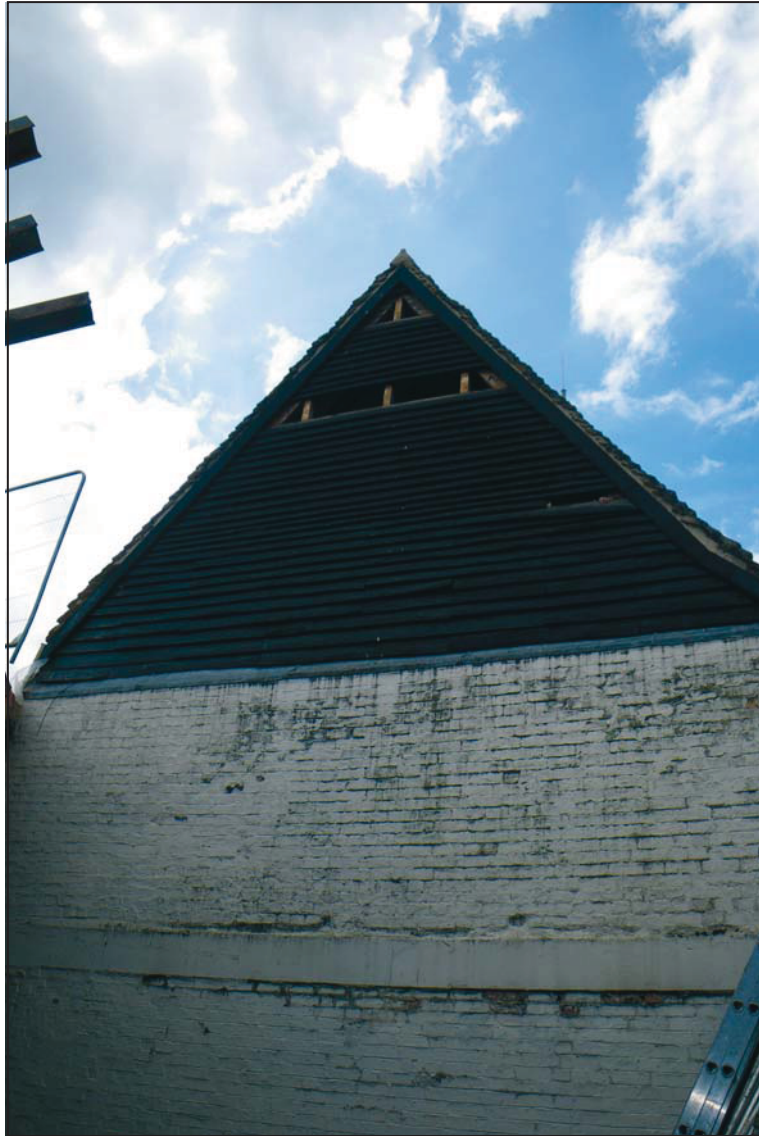
- 2.7 The eastern gable end of the South Range of the Blackfriars cloister is essentially brick-built with a timber and clapboarded upper gable (Fig. 7). It exhibits at least three phases of work, not counting the blocking of the large ground floor opening.

- 2.10 This wall was largely replaced by the present wall which abutted it (Figs 7 and 8). It is built in bricks of the same size and is three bricks thick (c.13½" [0.34m], or more, due to the thickness of the vertical jointing). The bond is rather mixed but appears to be English Bond on the south merging into Flemish bond on the north. This might suggest a two-phase work but no join could be described. A very wide opening on the ground is contemporary with this work, its steel lintel supporting it. The opening has been blocked in more brickwork. This construction all appears to be 19th or early 20th century, the bricks (apart from the blocking, which could not be inspected) being laid in lime mortar.

- 2.12 The current upper gable in timber and clap boarding appears to be modern, and was pinned back to the main roof truss as part of the 2010 demolition works (Fig. 7).

7 The eastern gable-end wall of the South Range

- 3.3 The removal of the brick work of the frontage building from the South Range of the Blackfriars (Area 3) revealed more of the complexity of the history of the east gable end, indicating two phases of building prior the present configuration, itself of more than one phase (Figs 7, 8 and 9). These phases will be the result of the alterations to the east end consequent upon the building of the probably 18th-century house that pre-dated the bottling works on this site and which seems to have been the occasion for the partial rebuilding of the east end of the South Range (Root 2004, Figs 7 and 9; Rodwell, 2001b). The construction of the bottling plant in 1874 was the occasion for the demolition of this house and the retention of parts of it in the remodelled South Range. The latest phase of brickwork in the east end of the South Range, and the large opening in it, now blocked, are the result of the building works of 1874 and later. The timber gable seems to have been built during the Ministry of Works’ programme in the 1970s.
