**ULEY LONG BARROW  
(HETTY PEGLAR'S TUMP)  
GLOUCESTERSHIRE**

**ARCHAEOLOGICAL EXCAVATION**

CA PROJECT: 3076  
CA REPORT: 10068

JUNE 2010

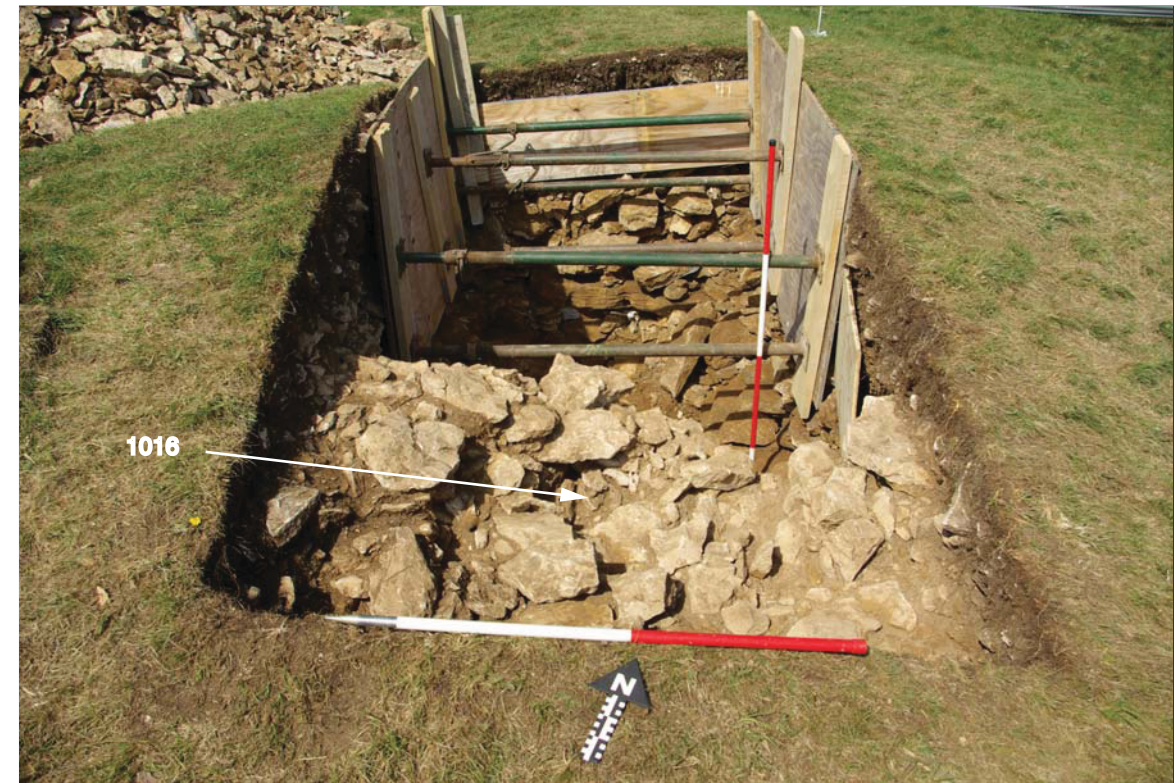
PROJECT TITLE Uley Long Barrow (Hetty Peglar's Tump), Gloucestershire			
FIGURE TITLE Plan, sections and photograph			
DRAWN BY JB	SCALE 1:50@A3	PROJECT NO. 3076	FIGURE NO. 4

View of intact mound construction material 1016, looking north-west

Section AA

Section BB

Section CC

- timber support
- dry stone walls/capstones of burial chambers

- 2.3 A compact deposit 1016 of sub-rounded, angular and flat limestone fragments and sandy-clay was encountered within the southern part of the trench at 0.15m to 0.35m below present ground level (bpgl) (Fig 4 Section BB and Figs 5 and 9). This deposit, which was in excess of 1.6m thick, was not excavated. No artefactual material was recovered during surface cleaning. The compact nature and high stone content of deposit 1016, together with the inclined angle of the flat limestone fragments within its upper 1m (lain to rise upward towards the central spine of the mound) suggests that this is undisturbed Neolithic mound construction material. A thin stony soil 1011 overlying deposit 1016 appeared to represent further, weathered and/or tree root-affected, mound material (Fig. 4 Section AA).

1021, only partially exposed, appeared to represent one of a series of orthostats known from internal examination of the western chamber to form part of its southern side (Fig. 4 Section BB and Fig. 7). The orthostat lay immediately adjacent to, and north of, a horizontally-lain limestone slab 1022 which might represent undisturbed mound material or a deliberate packing stone behind orthostat 1021. The orthostat was partially overlain by at least three courses of loose limestone wall stones 1020 (thought to mask further, underlying, orthostats known from internal examination of the chamber) supporting a large horizontal limestone capstone 1019. It should be noted that this capstone 1019 is currently supported on a modern timber insert as shown in Fig. 4, section BB (and also see section 1.1). A small void within wall coursing 1020 allowed a restricted view into the western burial chamber. At least four courses of dry stone walling could be discerned inside the chamber, overlying the orthostats of the southern side of the chamber and supporting capstone 1019. Capstone 1019 overlies a stone deposit 1023, identical to post-medieval backfill 1014, indicating that it had been removed and repositioned during documented 19th-century investigations (Fig. 8).

- 2.5 No orthostats associated with the south-western burial chamber were encountered, although these are likely to have been obscured by a series of horizontally lain limestone slabs 1018 which were not excavated (Fig 4 Section CC and Fig. 7). It is uncertain whether these undated slabs are associated with removal and replacement of the south-western chamber capstone, the latter perhaps implied since the capstone does not directly overlie the chamber orthostats. A small void within the uppermost course of these slabs allowed a restricted view into the south-west corner of the south-west burial chamber. A horizontally-lain limestone capstone 1017 rested upon stone slabs 1018.

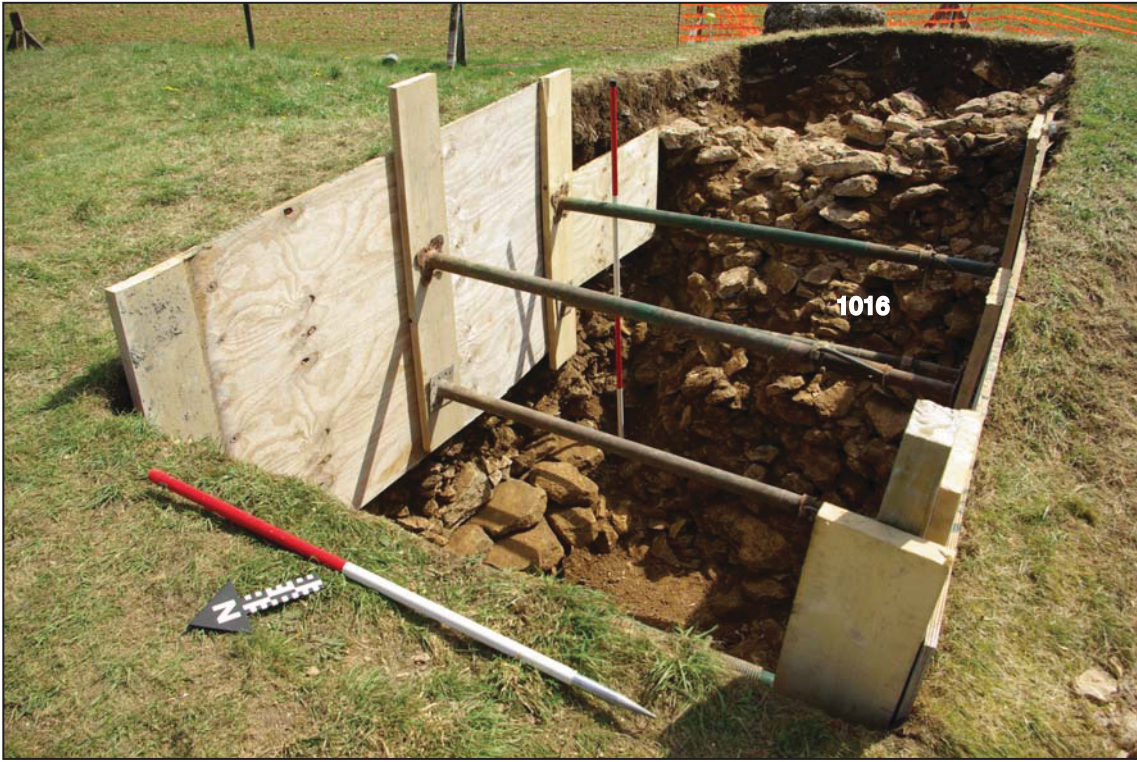
- 5 View of intact construction material 1016 and southern edge 1015 of previous investigation, looking south-east (1m and 2m scales)
- 6 View of rear of south-western burial chamber structure, looking north-east (1m scale)

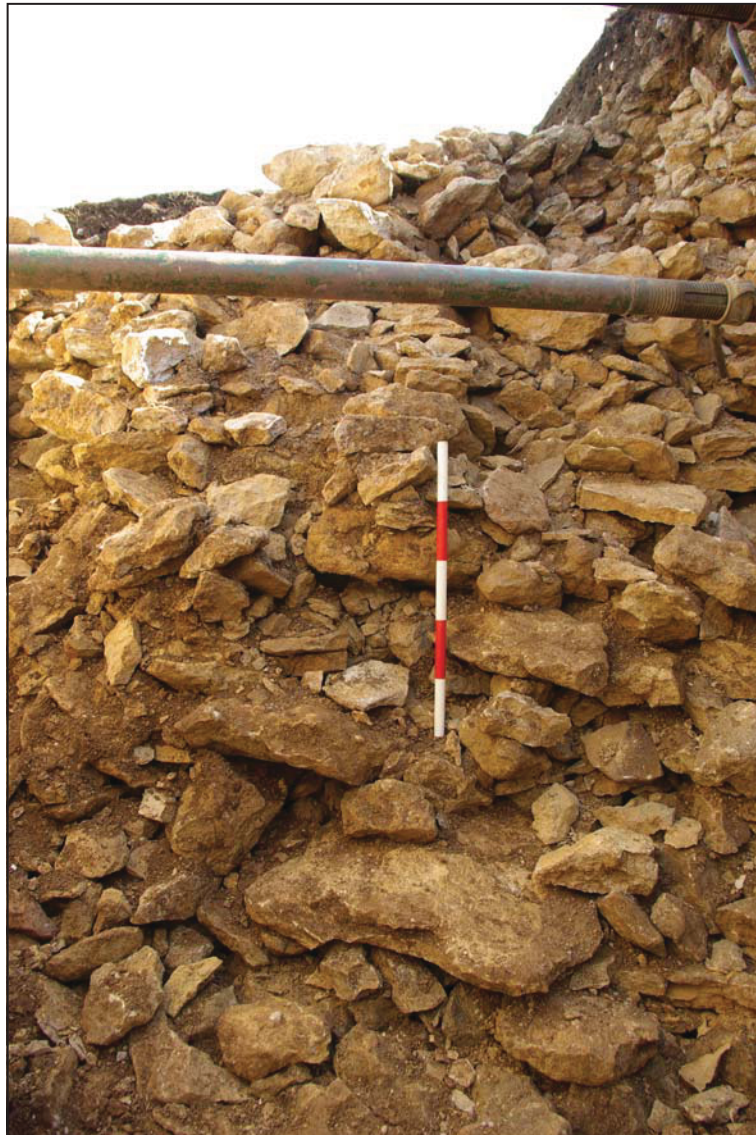
9

**9 View of intact mound construction material 1016 looking south (0.5m scale)**

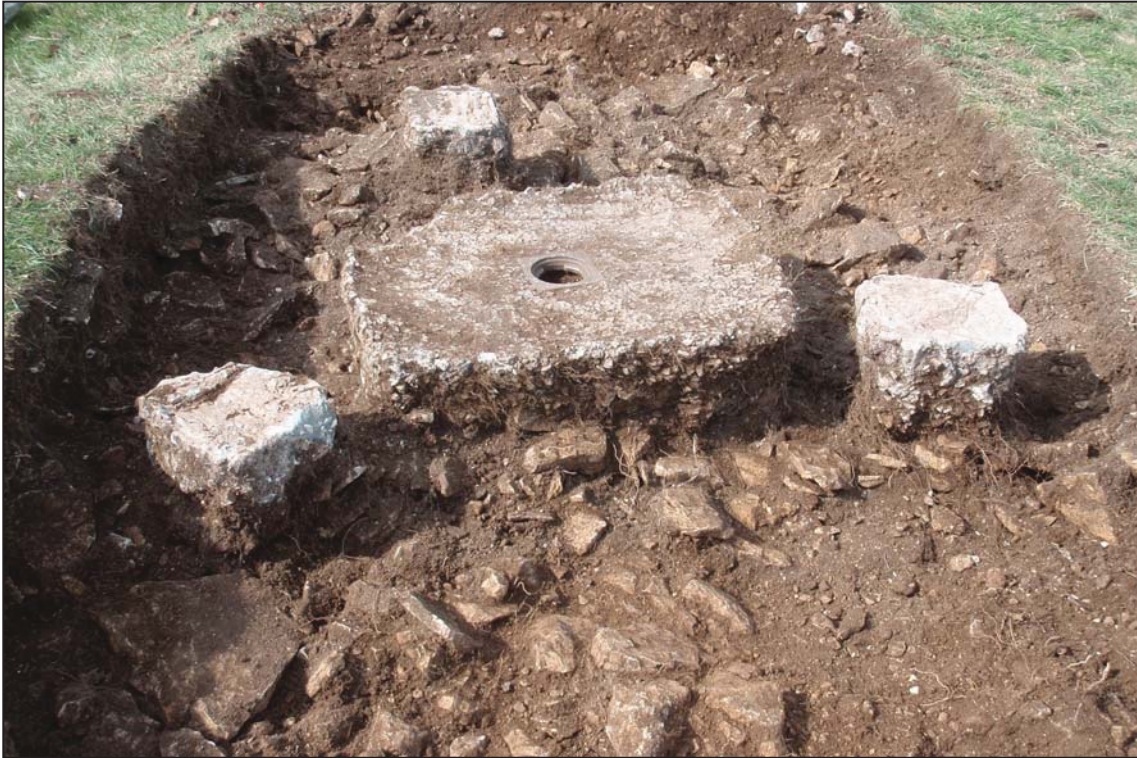
10

**10 View of Ordnance Survey trig point, looking north**

- 2.7 Modern topsoil 1002, which overlay disturbed/weathered mound material 1011 and uppermost backfill deposit 1013, had been cut through during the insertion of a concrete foundation pad 1010 and smaller outlying pads 1004, 1006 and 1008 for an Ordnance Survey trig point (Fig. 10). This structure, within the centre of the trench, was sealed by a thin modern topsoil 1001.
