**HAILES ABBEY
GLOUCESTERSHIRE**

ARCHAEOLOGICAL WATCHING BRIEF

CA PROJECT: 2994
CA REPORT: 10066

An archaeological watching brief was undertaken by Cotswold Archaeology during groundworks associated with the location and assessment of an existing stone-built culvert within the grounds of Hailes Abbey, Stanway, Gloucestershire.

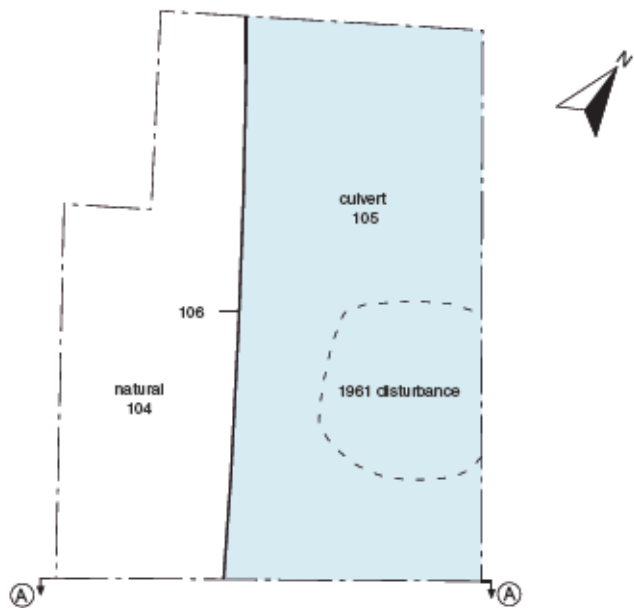
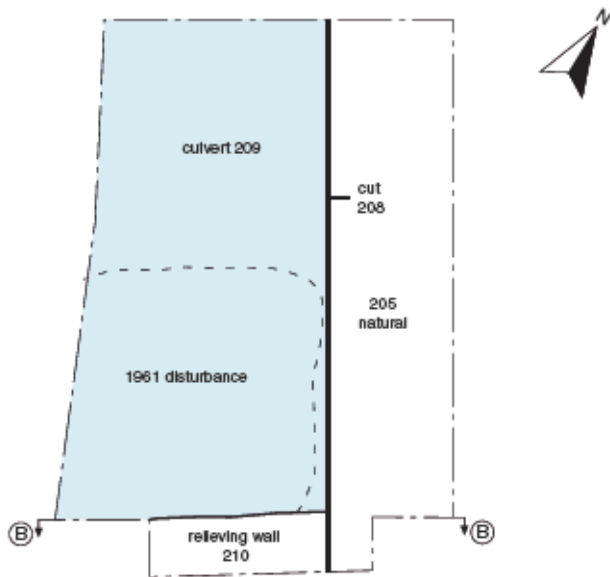
FIGURE TITLE
**Trench plans, showing
archaeological features**

2.2 During the watching brief a medieval culvert was identified within trenches 1 and 2. Within trench 2 a relieving arch contemporary with the culvert was also identified. Exploratory trenches excavated in 1961 were also identified. The natural geological substrate consisting of light brown and bluish grey clays was revealed in trenches 1 and 2. In addition levelling deposits pre-dating and post-dating the construction of the medieval culvert were identified.

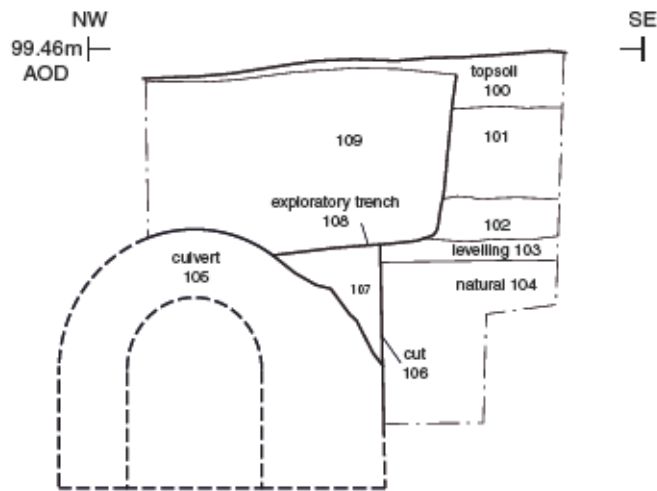
Section AA; trench 1, north-west facing section of culvert 105

2.3 The natural geological substrate 104 consisting of bluish grey clay, was revealed at a depth of 1.4m below present ground level. This was overlain by a levelling deposit of orange brown clay 103 containing frequent limestone fragments which averaged 0.14m in thickness. Both the natural substrate 104 and levelling deposit 103 were truncated by the construction cut 106 for the vaulted medieval culvert 105. Orientated north-south, the visible outer surface of the culvert 105 consisted of irregular, unfaced and uncoursed limestone blocks measuring between 0.05m and 0.3m in diameter. A drill passed through the vault from above revealed the roof to be 0.45m thick. The culvert construction cut 106 was subsequently backfilled by orange brown silty clay 107 containing both unworked and worked limestone fragments up to 0.2m in diameter.

2.4 Two additional levelling deposits 101 and 102 overlay deposit 103, however their stratigraphic relationship with the culvert 105 was not ascertained due to truncation by exploratory trench 108 excavated in 1961. All the above deposits and features were sealed by modern topsoil horizon 100 consisting of brown silty clay.

- 3.2 Both trenches 1 and 2 suggest the culvert was trench built, the internal portion of the culvert being built first of faced rectangular limestone blocks bonded with clay and silt mixed with a limestone aggregate. The outer part of the walls and vault not on display were then constructed of more irregular limestone blocks and rubble set in clay and silt with coarse aggregate using the vertical edge of the construction trench cut as the form. The remaining portion of the trench cut above the culvert roof was then backfilled with up cast natural clay from the construction cut and construction debris.

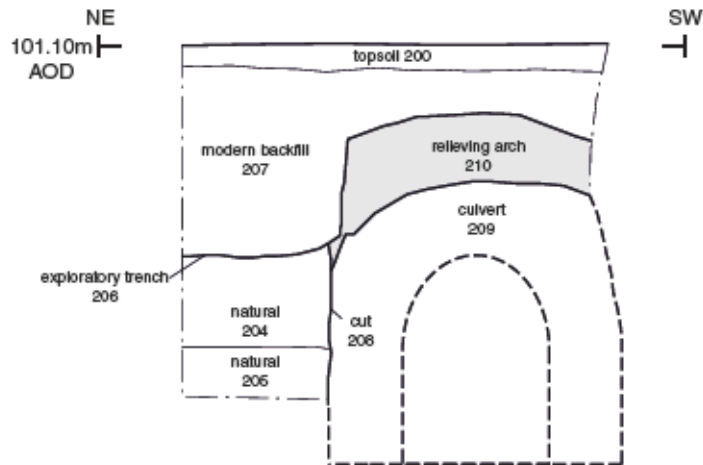
Section BB; trench 2, north-west facing section of culvert 209

2.5 The natural geological substrate 205 consisting of bluish grey clay, was revealed at a depth of 2.0m below present ground level. This was sealed by brown clay natural substrate 205, the top of which lay at a depth of 0.66m below present ground level. The natural substrate 204 and 205 was truncated by the construction cut 208 for a

vaulted medieval culvert 209, a continuation of culvert 105 observed in trench 1. Orientated north-west/south-east, the upper portion of the outer surface of the culvert 209 consisting of the arch and upper walls were constructed of irregular unfaced and uncoursed limestone blocks measuring between 0.05m and 0.35m in diameter. The lower portion of the culvert wall consisted of uncoursed rectangular limestone blocks. A drill passed through the vault from above revealed the roof to be between 0.48m and 0.51m thick. Relieving arch 210 was observed at the south-eastern end of trench 2 over the vaulted roof of the culvert. It was constructed of lime mortared rectangular limestone blocks and provided strengthening of the culvert where it passed beneath a substantial wall to the south-east. The culvert construction cut 208 was subsequently backfilled by brown silty clay 211 containing limestone fragments up to 0.05m in diameter.

- 2.6 The fill of the culvert construction cut was overlain by brown clay levelling deposit with frequent limestone fragments 203, measuring 0.35m in thickness. This was subsequently sealed by a modern hardcore surface 202 and red clay surface 201. An exploratory trench 206 excavated in 1961 truncated the above deposits and features and was subsequently sealed by a modern topsoil horizon 200 consisting of brown silty clay.
- 2.7 Laboratory analysis of material recovered from the culvert jointing produced no conclusive evidence that a lime mortar was employed during the original construction of the culvert. The results indicate that a combination of local limestone aggregate and clay/silt (not bound by lime as a mortar) were employed in the construction process (R. Thompson pers. Comm.).
