**CHEDWORTH ROMAN VILLA  
GLOUCESTERSHIRE**

**ARCHAEOLOGICAL EVALUATION**

CA PROJECT: 2943  
CA REPORT: 09158

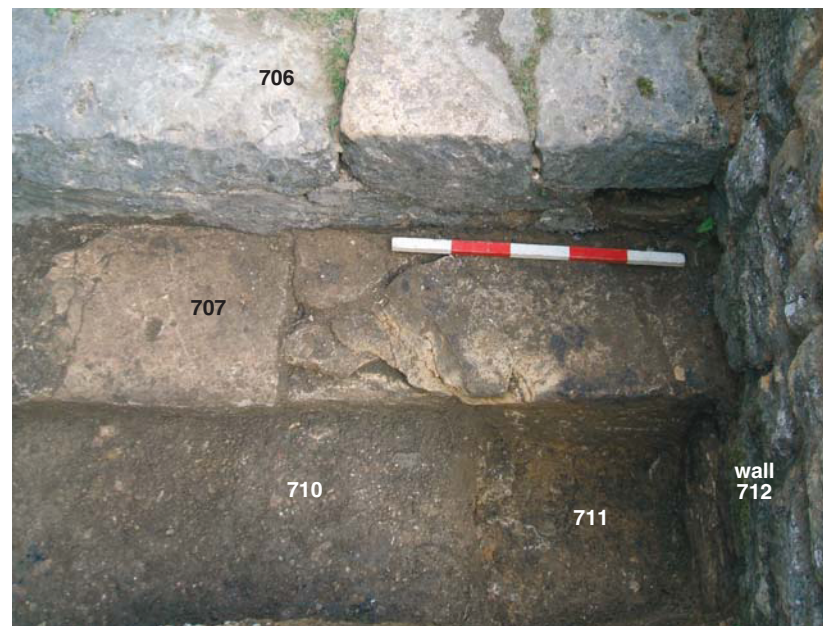
Trial pit 7, looking north, showing 712 and step structure

- 2.8 At the limit of excavation, 0.4m bpgl, stony-clay 711 appeared to represent a foundation deposit for a limestone block step structure 706/707 which abutted wall courses 704/705 and 712/713. Step 706 was abutted on its northern side by a deposit 702 of crushed roof tile representing a bedding layer or floor within the West Range Corridor, at 0.12m bpgl. To the south of step 706/707, a gravel-rich stony-clay probable post-Roman soil 710 overlay 711 and appeared to abut Roman limestone block structure 708, which was also abutted by a stony-clay deposit 709. Modern make up deposit 701 was overlain by tarmac surface 700.
