**REMAINS OF THE INNER COURT  
LLANTHONY PRIORY  
GLOUCESTER QUAYS**

**ARCHAEOLOGICAL EVALUATION**

CA PROJECT: 2498  
CA REPORT: 09043

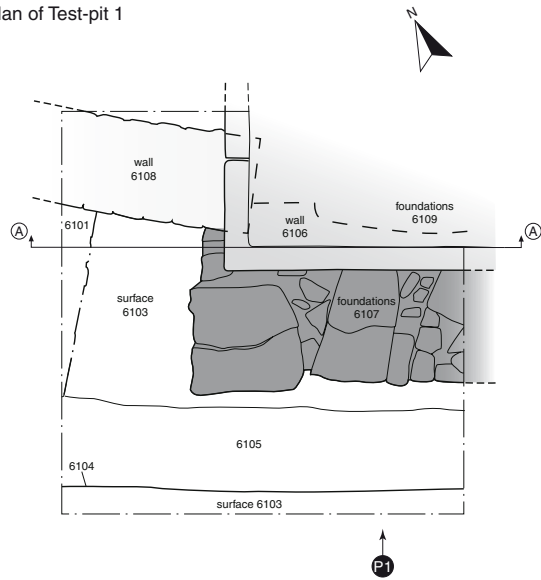
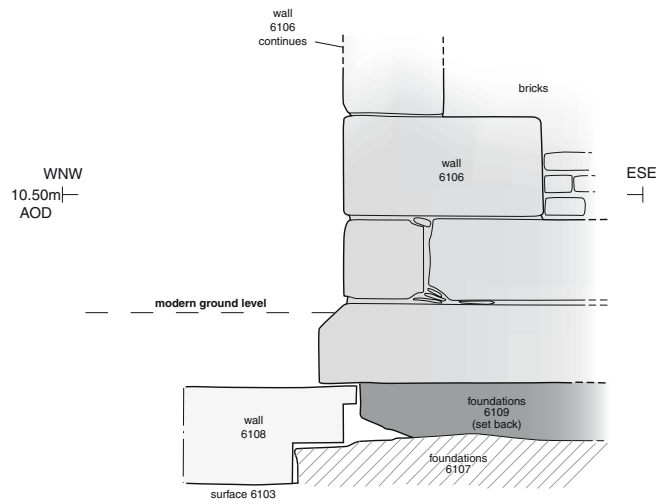
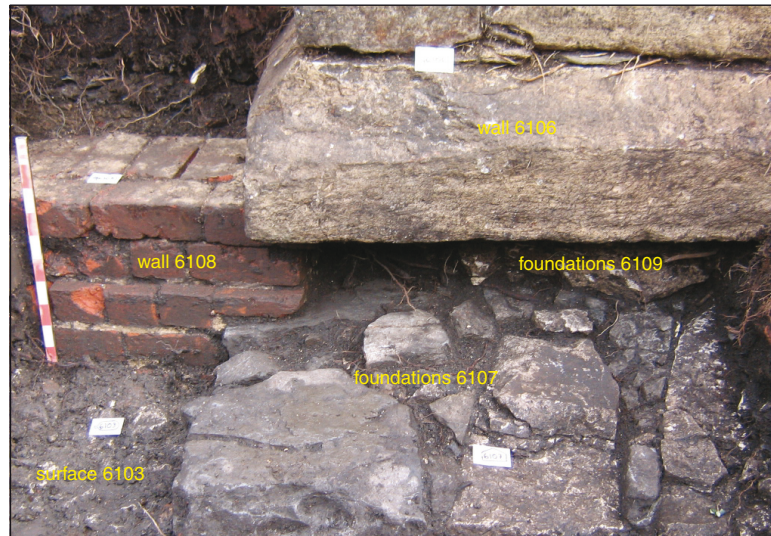
### **Test-pit 1** (Fig. 3)

2.2 Test-pit 1 was located adjacent to the south-western corner of the brick building.

2.3 The south-western corner of foundations 6107, comprising oolitic limestone and Lias Mudstone blocks were exposed at a depth of 0.55m below present ground level. These were at least 0.6m wide and 0.2m deep, extending beyond the base of the test-pit and beyond the northern and eastern limits of excavation. The foundations were not mortared and the voids between individual stones were filled by dark brown clay silt. A roughly-hewn, undressed limestone block (6109), at least 0.75m long and 0.2m thick, appears to represent the uppermost course of foundations 6107. Constructed onto this course, and overhanging it by up to 0.25m, was the wall of the brick building, 6106, comprising brick with limestone quoins, bonded with buff-coloured limestone mortar.

2.4 Abutting foundations 6107 was possible surface 6103, comprising limestone rubble with frequent inclusions of brick. Evidently cutting through deposit 6103 and inserted into the gap between foundations 6107 and the stable wall 6106 were brick foundations 6108. These were aligned approximately north-west/south-east, on a slightly different alignment to the brick building and the earlier foundations. The brick foundations were at least 0.35m deep and extended to 0.15m under the first course of the brick building.

2.5 Possible surface 6103 was cut by linear feature 6104, which was filled by dark grey clay containing very frequent demolition debris, including both slate and ceramic tiles, as well as limestone rubble. This material, 6105, also abutted brick wall 6108. Overlying deposit 6105 were modern deposits 6101 and 6100, each up to approximately 0.3m thick. Deposit 6100 sealed brick foundations 6108 and abutted wall 6106.

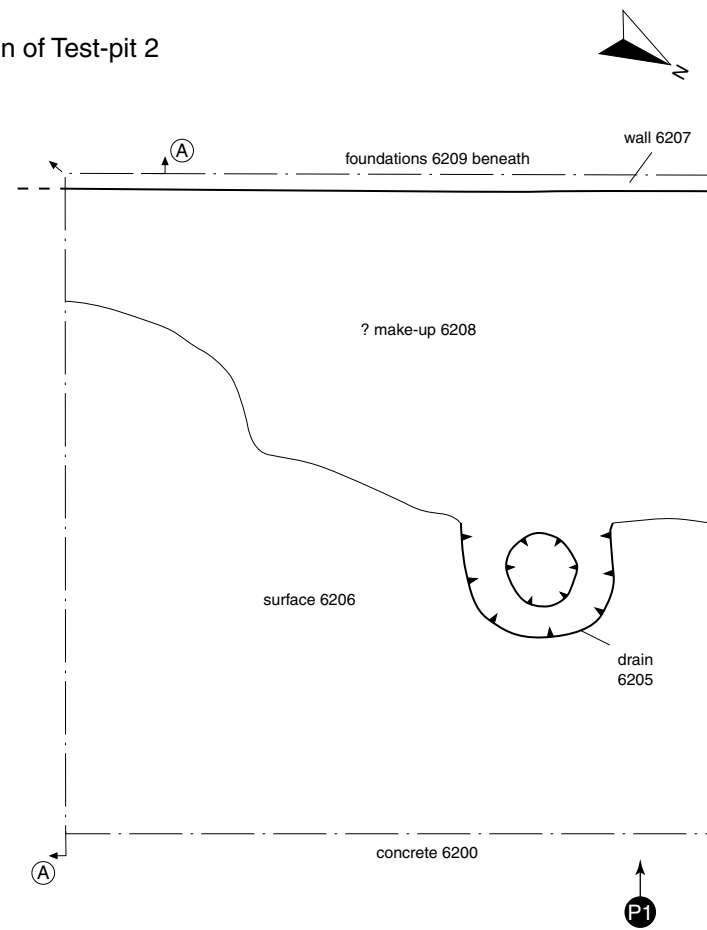
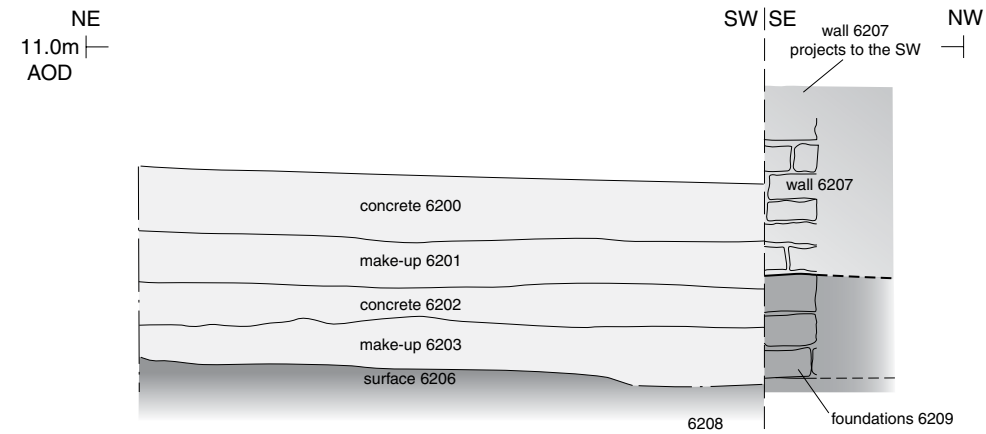
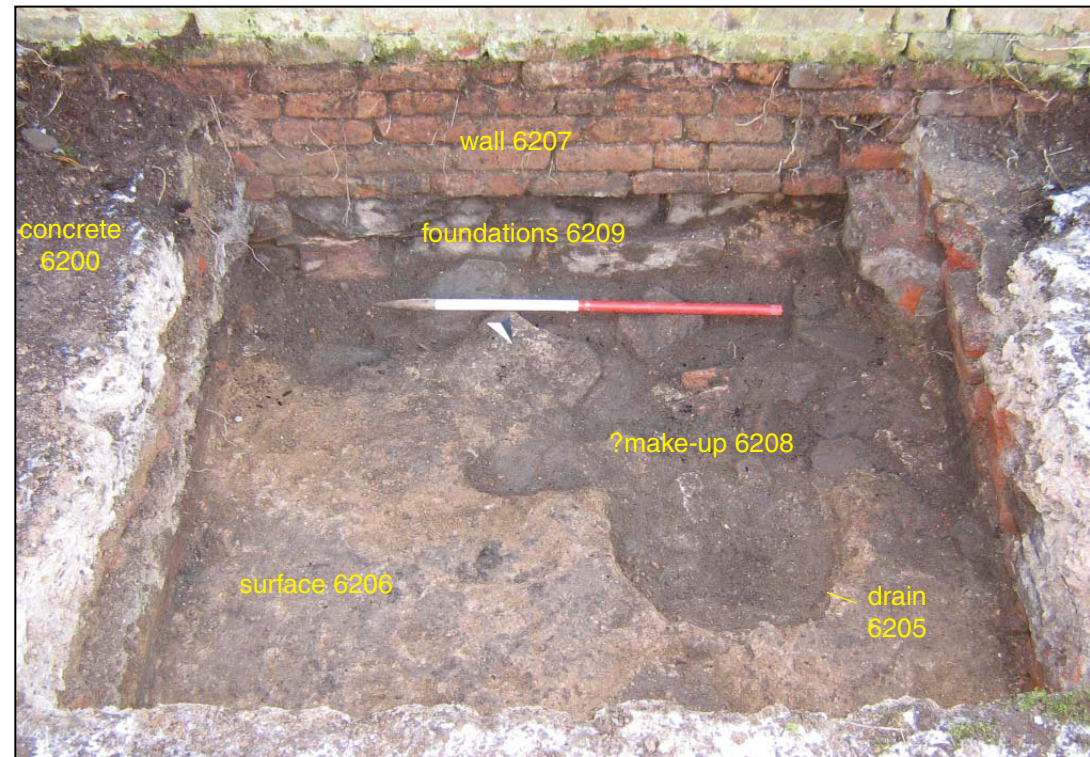
**Test-pit 2** (Fig. 4)

- 2.6 Test-pit 2 was located inside the brick building, adjacent to the rear (southern) wall.
- 2.7 Wall 6209 was identified at a depth of 0.25m below present ground level. This comprised at least three courses of grey Lias Mudstone blocks, each up to 0.55m long and 0.1m thick, bonded with orange sandy mortar. Constructed onto the wall was the rear wall of the brick building, 6207. This comprised mostly stretchers with occasional headers, often in pairs or threes, bonded with buff-coloured limestone mortar.

- 2.8 Deposit 6208 was identified at a depth of 0.55m below present ground level, abutting foundations 6209. It comprised mostly rubble, containing limestone, sandstone tiles and fragments of ceramic building material. This material may represent levelling material or make-up for overlying mortar surface 6206. Layer 6206 was at least 0.05m thick and may have represented a floor contemporary with the earlier building, however this is uncertain as it did not extend as far as the wall. This may have been due to the presence of some kind of structure against the wall, of which no physical evidence survives.

- 2.9 Overlying surface 6204 and deposit 6208, and abutting the stone and the brick walls, were a series of modern make-up layers and concrete surfaces, cumulatively 0.55m thick. Concrete surface 6202 included drain 6205 which cut down into deposit 6208.

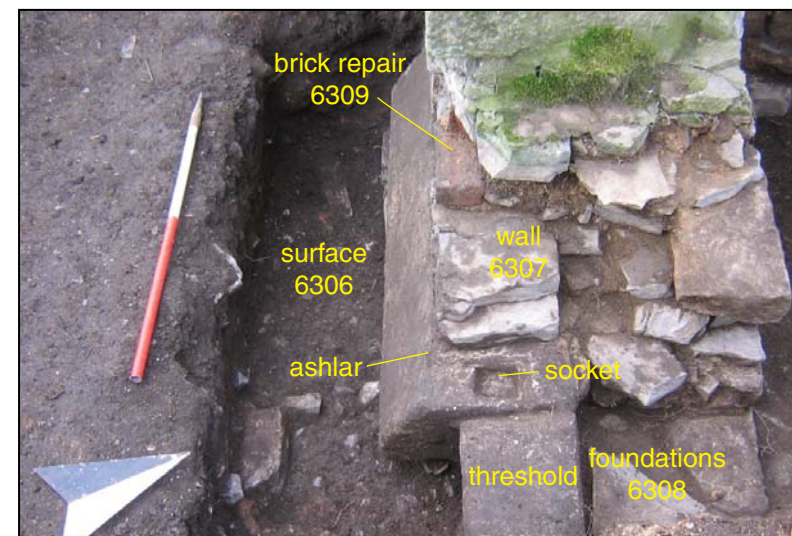
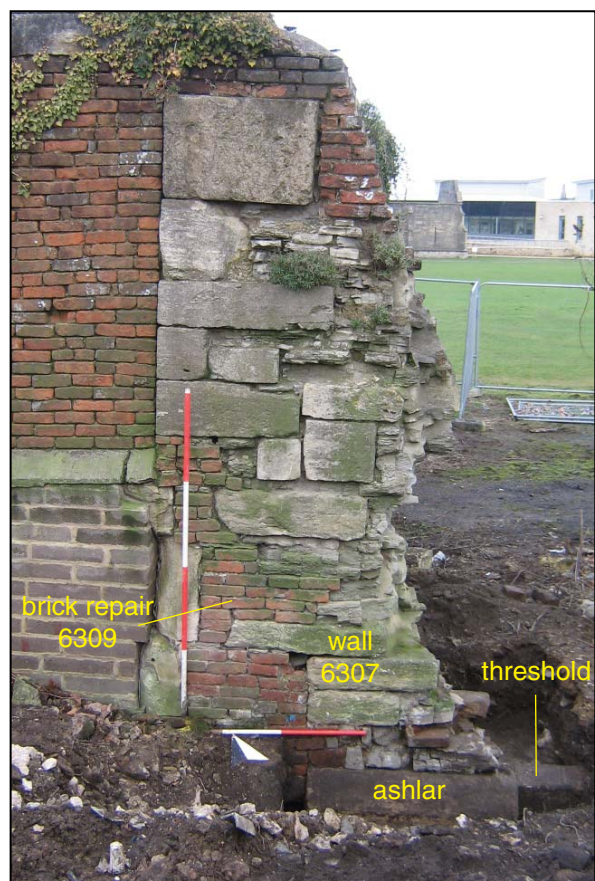
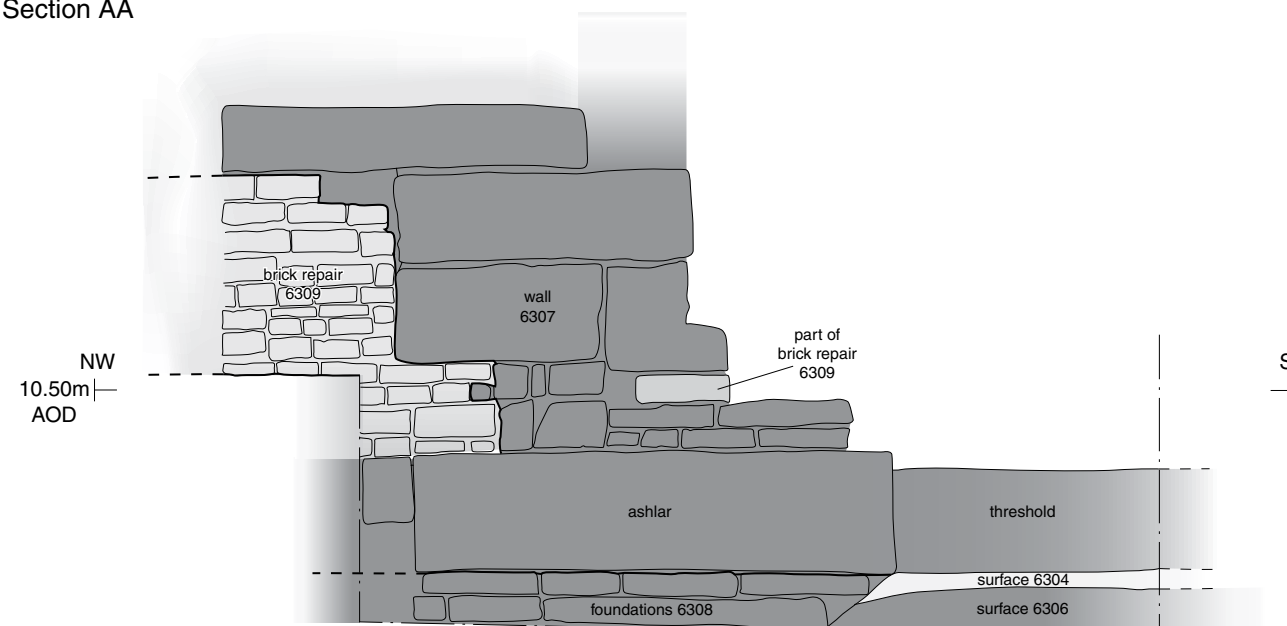
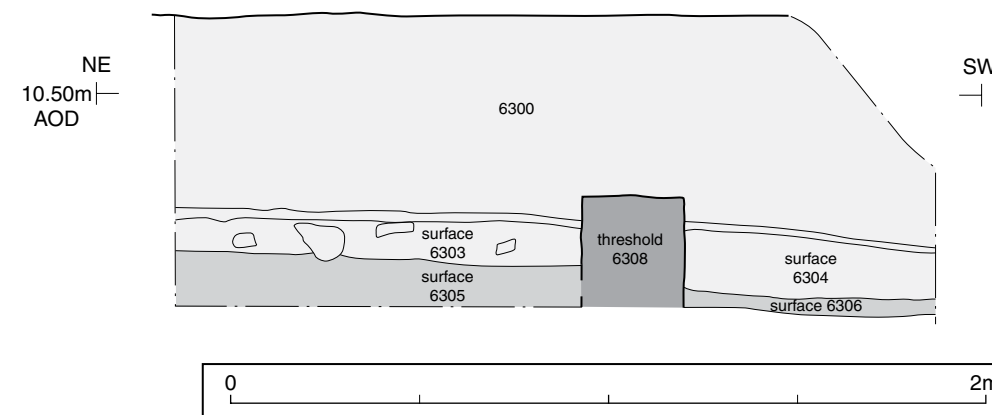
PROJECT TITLE Remains of the Inner Court Llanthony Priory, Gloucester Quays			
FIGURE TITLE <b>Test-pit 3; plan, sections and photographs</b>			
DRAWN BY	SCALE	PROJECT NO.	FIGURE NO.
RK	1:20@A3	2498	5

- 2.10 Test-pit 3 was located adjacent to the remains of an earlier structure which was abutted by the south-eastern corner of the brick building.
- 2.11 The uppermost two courses of foundations 6308 were identified at a depth of 0.5m below present ground level. These comprised unmortared Lias Mudstone blocks, each up to 0.75m in length and 0.08m deep. Constructed onto the foundations was wall 6307, the initial course of which comprised a large chamfered limestone ashlar, 1.25m long, 0.5m wide and 0.3m deep. A large rectangular limestone block abutted the eastern end of the ashlar, evidently representing a threshold. The uppermost

face of the large ashlar contained a shallow rectangular recess, approximately 0.35m long and 0.2m wide, in the base of which was a rectangular socket which measured 0.11m in length and 0.08m in width. This is likely to have provided the setting for a wooden door jamb. Above the first ashlar, wall 6307 comprised outer courses of grey Lias Mudstone and limestone ashlar with a rubble core of mudstone, all mortared with light buff-coloured limestone mortar.

- 2.12 The external face of wall 6307 had been repaired in the same brick used in the construction of the 'stable', presumably at the time when the later building was constructed.

- 2.13 Abutting foundations 6308, on either side of the threshold, were similar rubble surfaces. Deposit 6305 abutted the northern face of the threshold block at a depth of 0.6m below present ground level. Externally, surface 6306 abutted the threshold block at a depth of 0.7m below the present ground surface. These layers comprised compacted stone and brick rubble within a clayey silt matrix.

- 2.14 Overlying surfaces 6305 and 6306 were modern surface deposits 6303 and 6304 respectively. These layers were comprised of the same gravelly clay material, however deposit 6304 was thicker, at 0.15m thick compared to 6303 which was approximately 0.1m thick, resulting in a similar level on either side of the threshold. Deposits 6303 and 6304 were in turn sealed by a thin layer of clinker (6301/6302) and a layer of modern overburden, 6300, up to 0.5m thick.
