**TALLY HO COTTAGE  
CONDICOTE  
GLOUCESTERSHIRE**

**ARCHAEOLOGICAL WATCHING BRIEF**

CA PROJECT: 2623  
CA REPORT: 09132

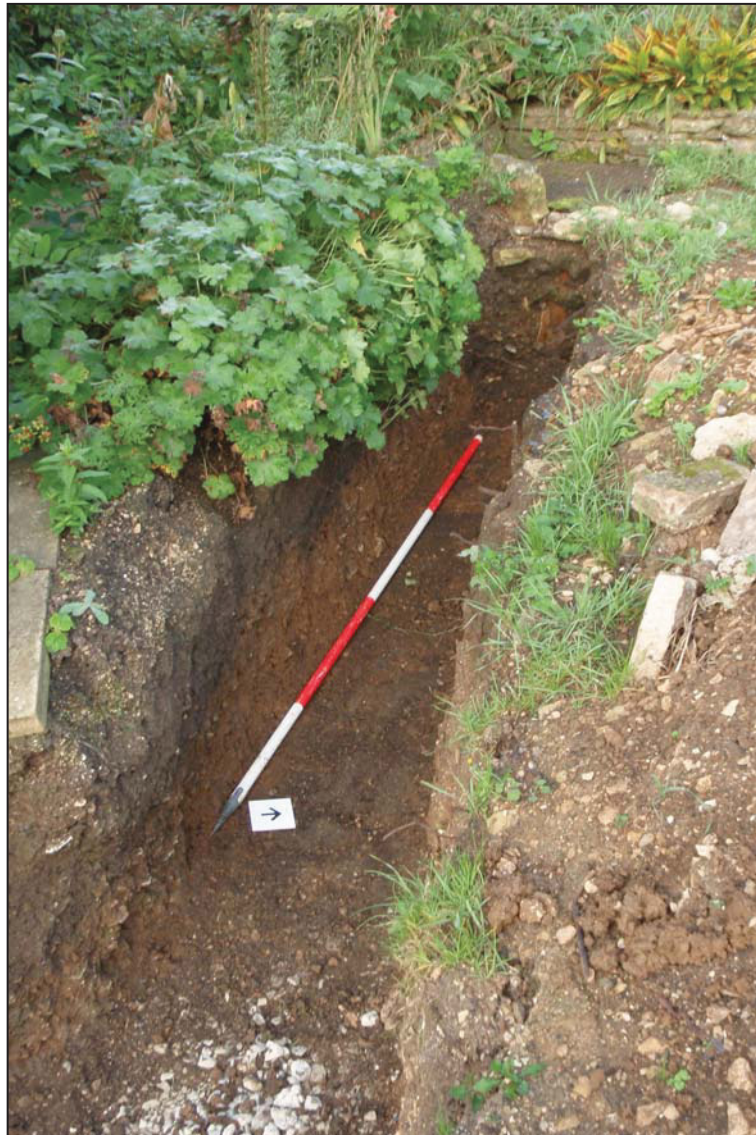
**Photograph of branch drain showing  
probable bank material, looking west**

- 2.3 Probable bank material 402 and 403 was revealed within the branch drain trench and was sealed by topsoil 401. A manhole for a modern drain cut deposits 402 and 403.
