Nungate Bridge Wash House, Haddington, East Lothian

Data Structure Report

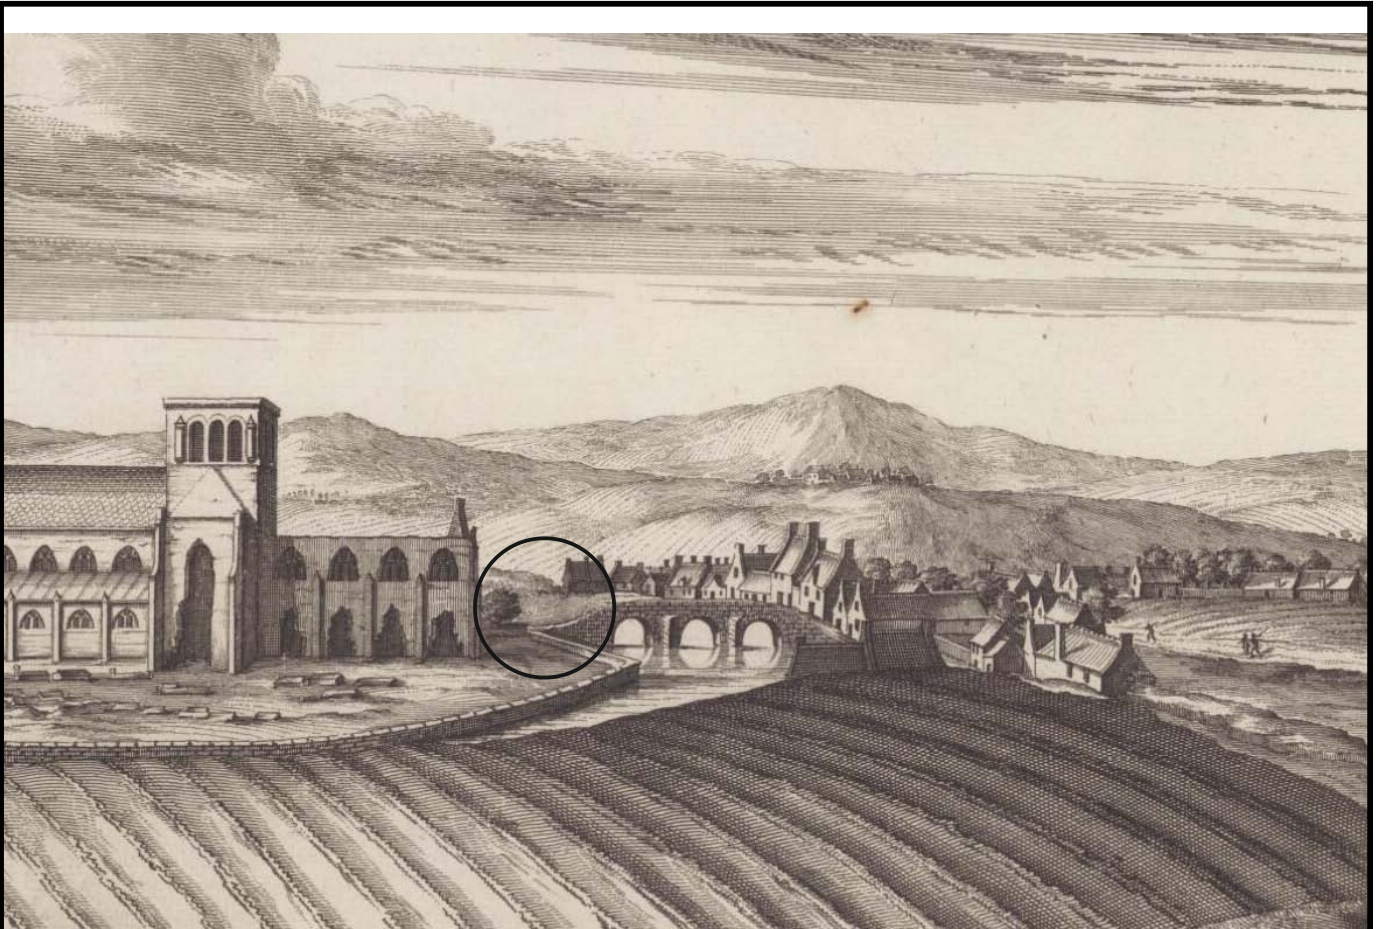
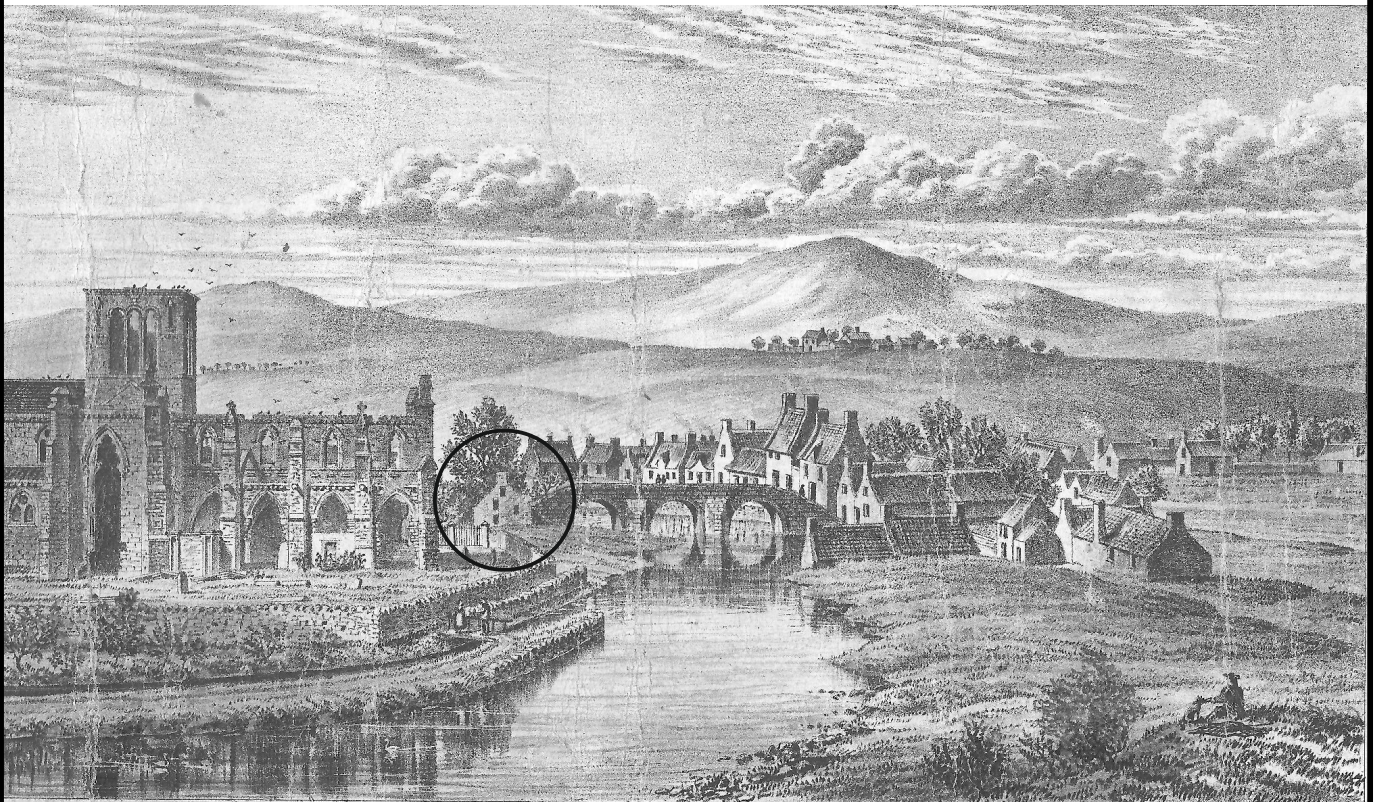
Figure 2: Slezer view of Haddington and later copy (pre 1860s) that now contains the 18th century house (circled) that predates the Wash House.

- 2.1.3. An engraving of Haddington from *Theatrum Scotiae* by John Slezer and dated to 1693 shows no buildings on The Sands apart from the Nungate Bridge. However, a later image (pre-1860s) which uses Slezer's engraving as a backdrop, has inserted a three storey 'step gabled' house to the south west side of the bridge, just off Church Street. (Figure 2). This house was called Nungate Brig-end and was occupied by the Preston family until the mid 19th century.

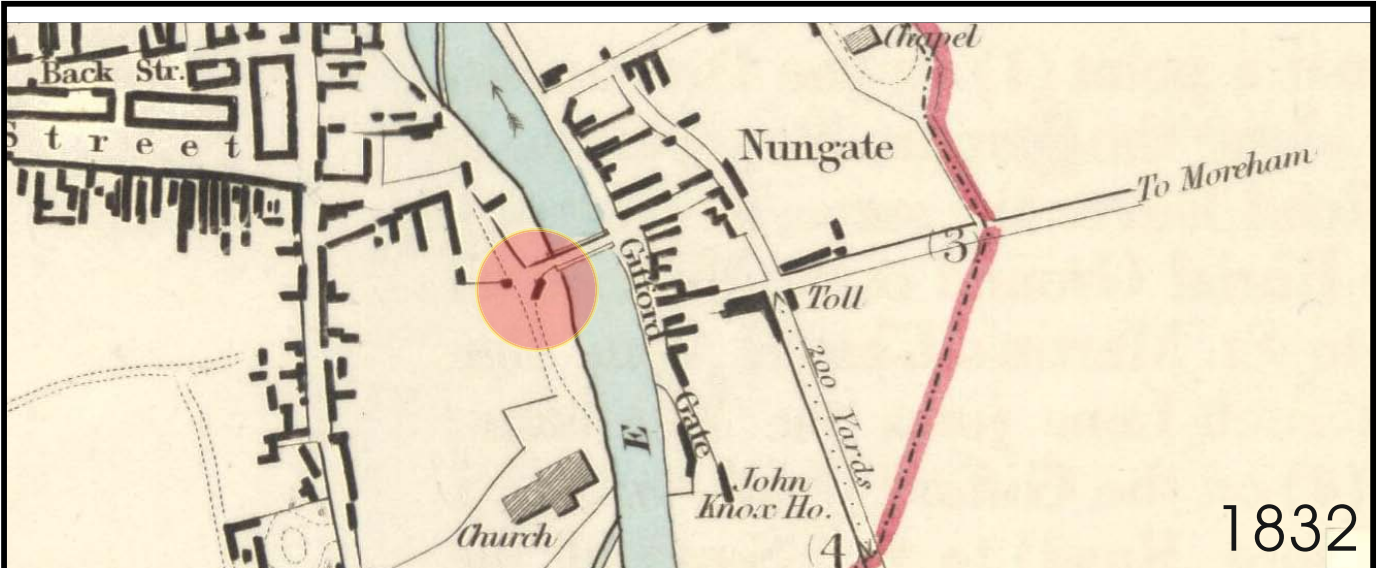
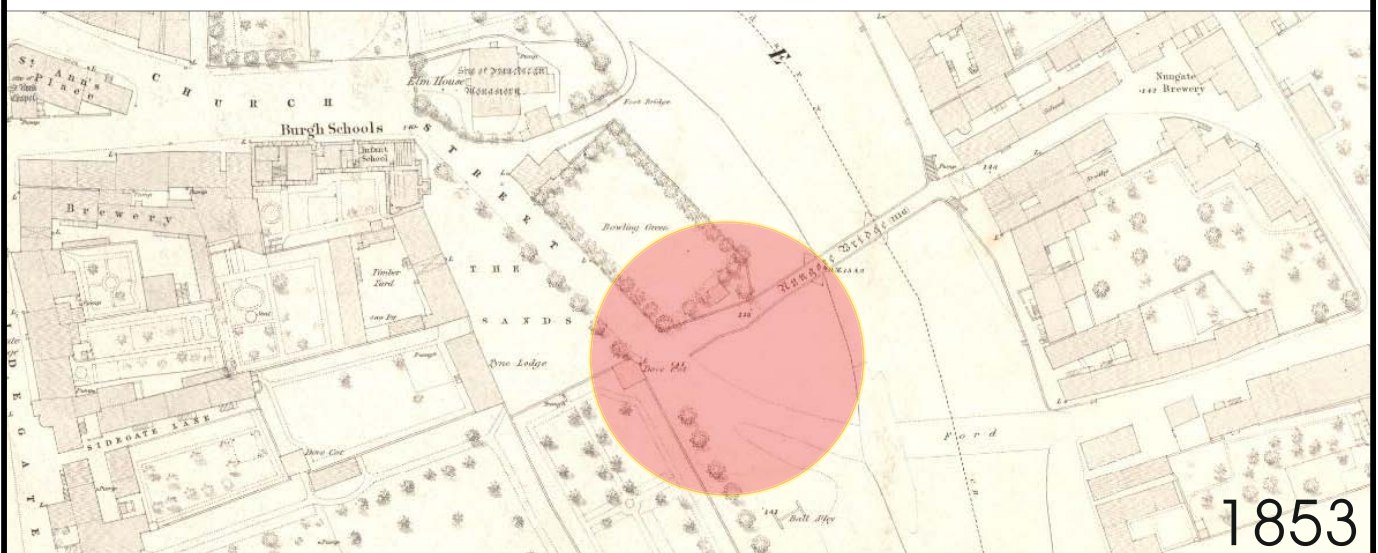
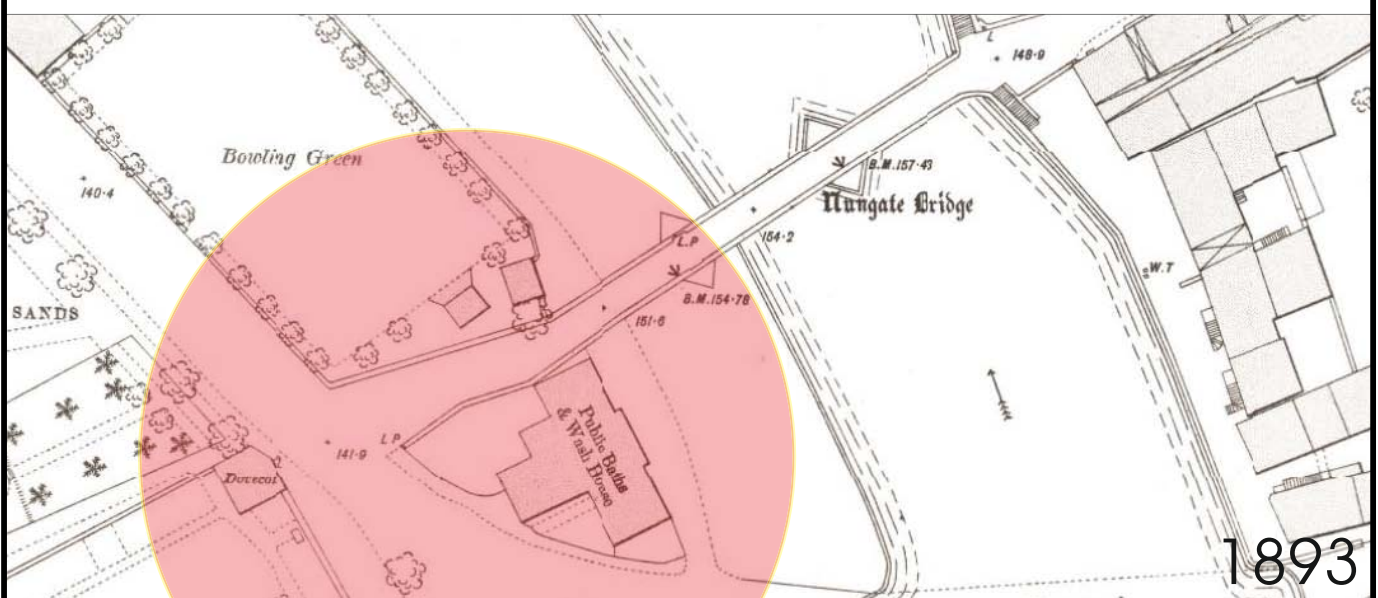
Figure 3: Great Reform Act Plans and Reports, 1832

Ordnance Survey large scale Scottish town plans, Surveyed: 1853 Scale: 1:1056

Ordnance Survey large scale Scottish town plans, Surveyed: 1893 Scale: 1:500

- 2.1.4. *The Great Reform Act Map of Haddington* dated to 1832 also shows the house of Nungate Brig-end clearly marked and lying on a northeast/southwest alignment. However, the 1853 *Ordnance Survey* map shows no building at the same location, indicating that it has already been demolished. The 1893 *Ordnance Survey* map shows the Wash House now standing in roughly the same location as Brig-end House (Figure 3).

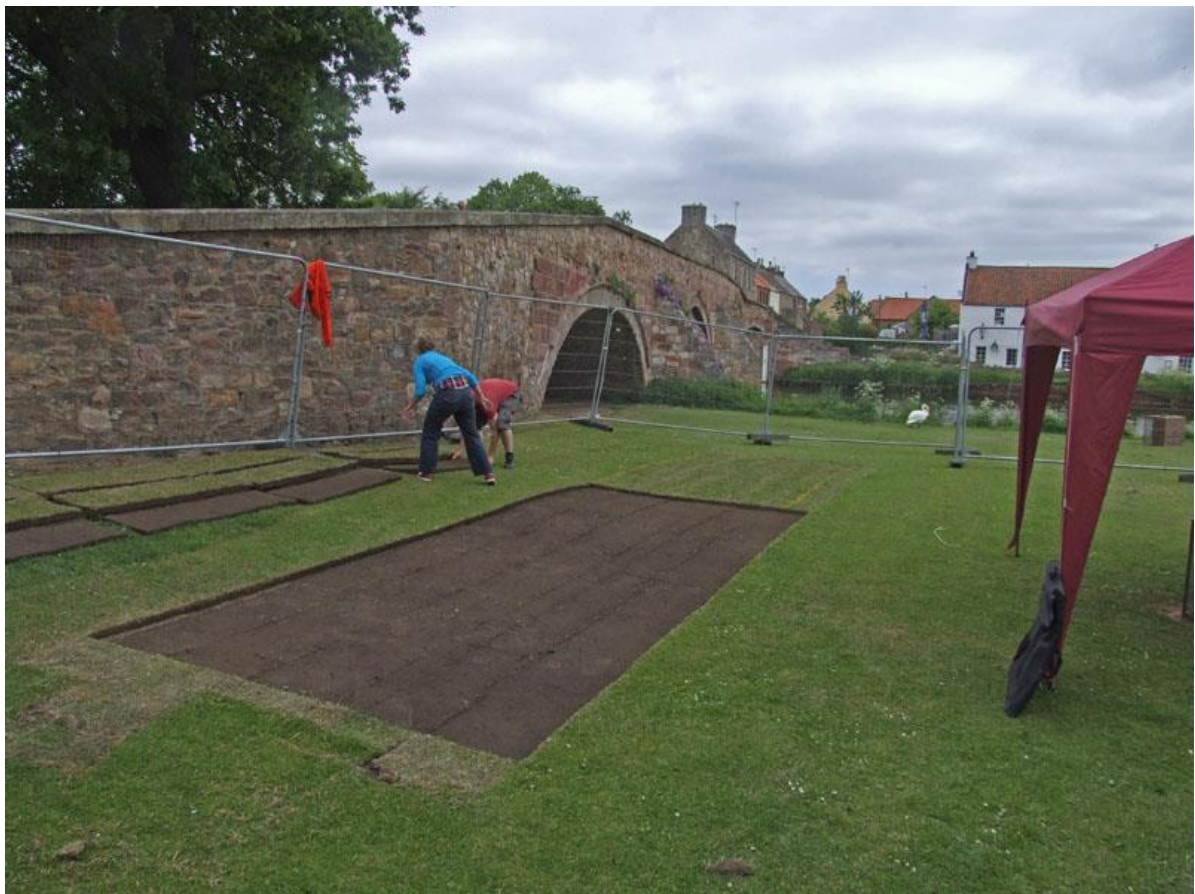
Plate 2: The trench was located on the south side of the west end of Nungate Bridge. Removal of turf prior to excavation.

- 4.2.2 The turf was removed by a mechanical turf cutter revealing the topsoil [001]. The sub soil [005] consisted of a homogenous layer where most of the finds were retrieved.

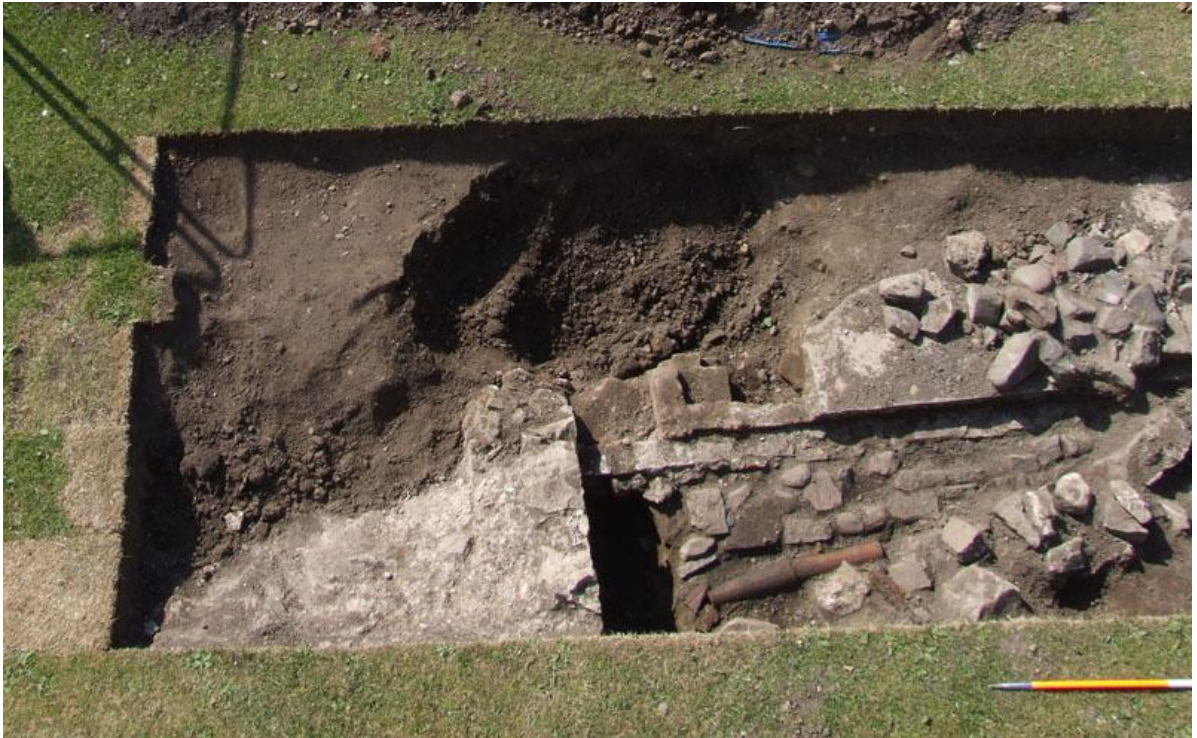
Plate 3: Adjacent (to east) to exterior cobbled surface is a truncated stone wall running north to south.

- 4.2.3 A section of stone wall [008] 0.61m wide running north-south for 1.40m in the northeastern area of the trench was uncovered. This wall was truncated at its southern end by the later cutting through of service trench [007]. This service trench also cut through [006], a thick layer of demolition phase mortar and rubble in the northeastern corner.

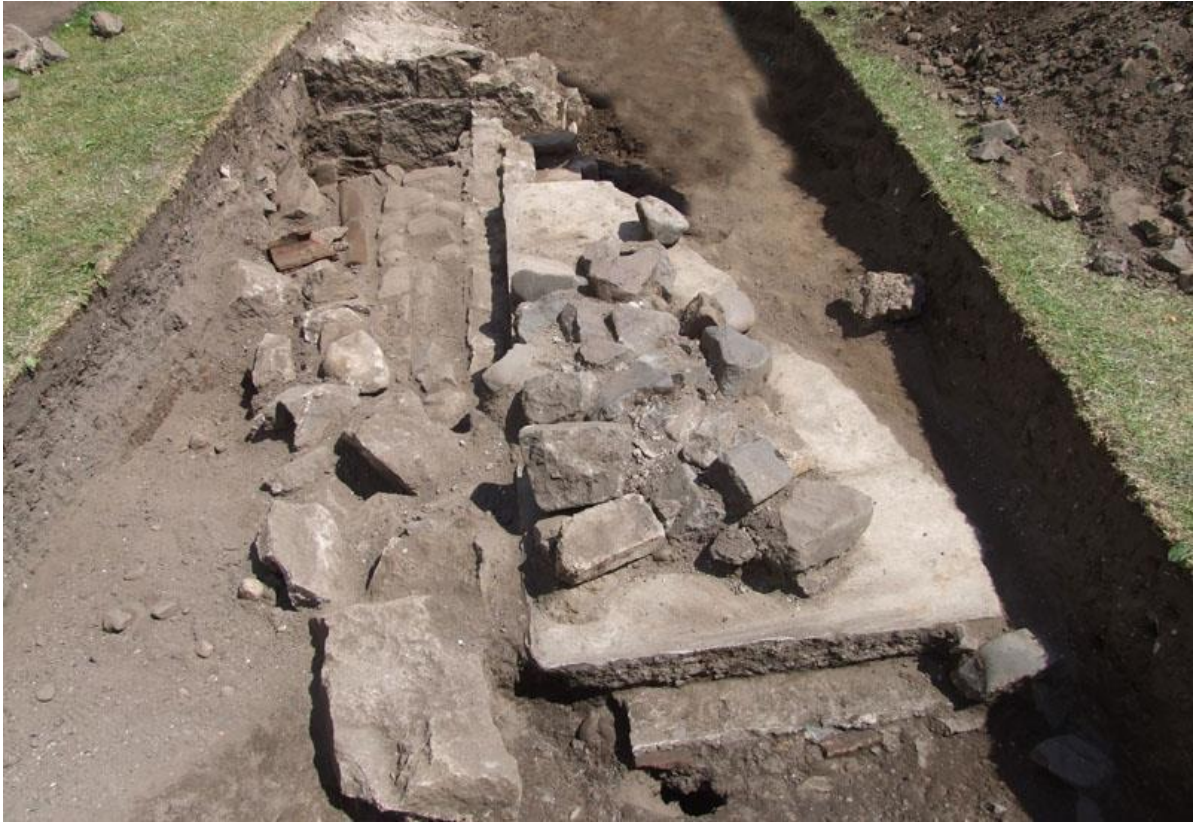
Plate 4: To the left (north) of the poured concrete floor and brick wall is the cobbled surface of an exterior courtyard.

- 4.2.4 A section of poured concrete floor [009] was revealed measuring 2.20m x 1.10m. On its north side it abutted the foundation layer of a brick exterior wall [015] which ran east to west and adjoined the western side of stone wall [008]. A small brick u – shaped structure [016] supported the concrete floor [009] as well as housing the lead water piping for one of the wash house sinks/tubs.

- 4.2.5 Directly to the north of the brick exterior wall [015] were the remnants of an outside cobbled courtyard area [023] surviving for 2.50m x 0.40m. A later pipe clay field drain [014] was cut through this cobbled feature. The field drain respected the edge of the concrete floor [009] at its western edge and skirted around it in a northerly direction before cutting diagonally through the courtyard.

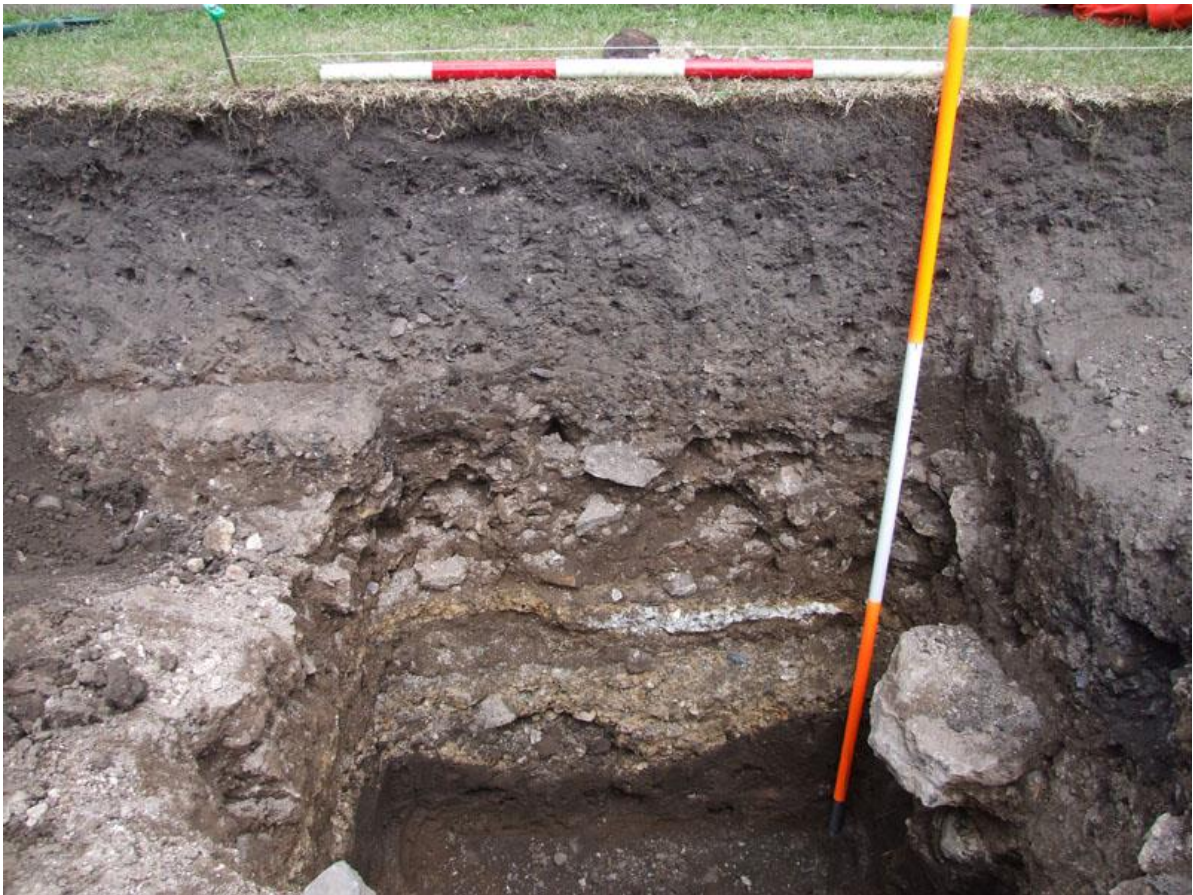
Plate 5: Sondage in the western portion of the trench, with the purpose of locating Nungate Brig-end house.

- 4.2.11 The western end of the trench was subjected to a 1.00x 1.00m sondage with the purpose of locating Nungate Brig-end house. Underlying sub soil [005] was a 0.40m deep layer [010] containing large pieces of stone and mortar. Directly underlying this was a mortar layer [017], 0.05-0.07m in depth throughout. Underneath this was a sterile layer [018] 0.10m thick consisting of a loose mid brown silty sand which sat directly above another mortar deposit [019] up to 0.12m thick. The final layer [020] before hitting natural consisted of 0.40m silty clay and contained 18th century window glass, an animal bone and a clay pipe stem.

- 5.1.5 The sondage at the west end of the trench revealed an interesting, though difficult to interpret sequence of archaeological deposits which included two thick mortar layers. This is possible evidence of the demolition of the 18th century Nungate Brig-end house. It is also possible that one of the mortar layers could represent the preparation works for re-modelling the western entrance of the Nungate Bridge.

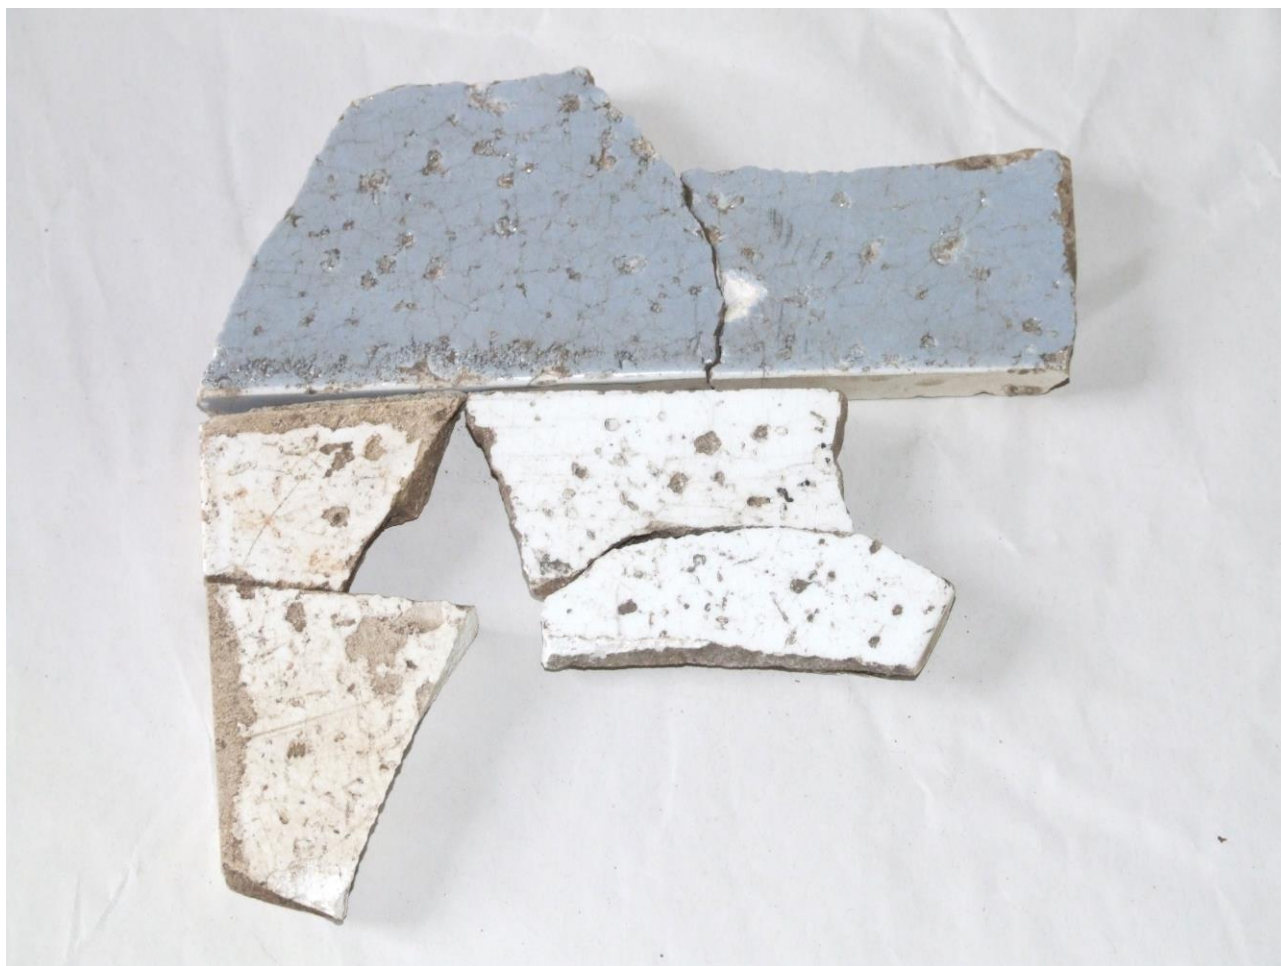
Plate 6: Fragments of floor and wall tile from the Wash House.

- 4.3.3 A few glazed but undecorated fragments of interior wall/floor tiles were uncovered – both plain white and light blue - of 19th/20th century date; A number of iron fittings and nails as well as a single window latch were recovered representing Wash House fixtures and fittings after demolition. A single fragment of H&R Johnson mustard glazed floor tile was found which post dates 1901 much abraded and with the makers mark on the rear. This confirms an early 20th century remodelling of the building.

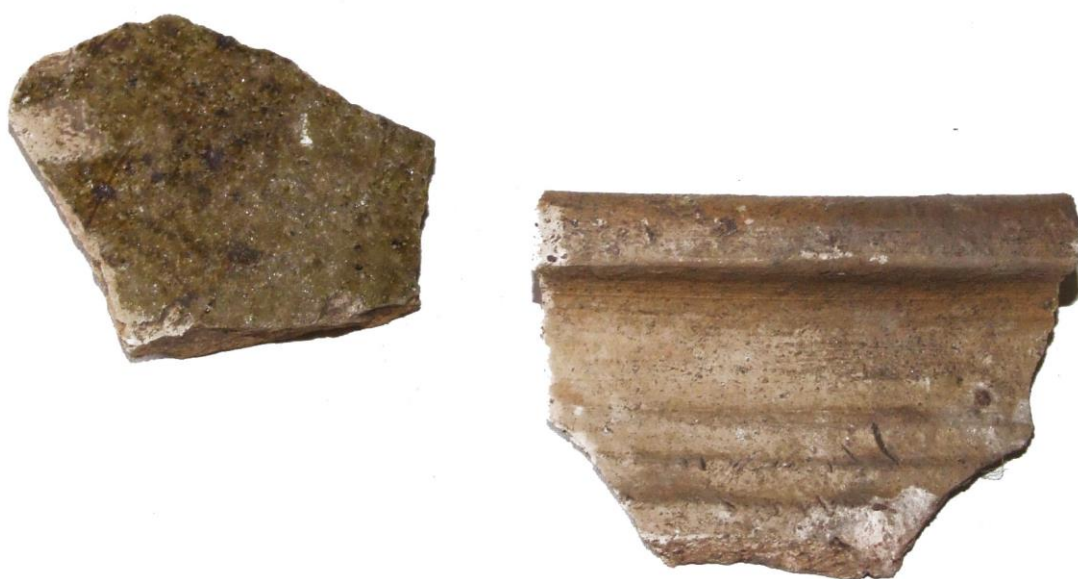
Plate 7: Medieval pot sherds (15th-16th century).

- 4.3.1 In general the assemblage of finds represents a general mix. Most were of 19th and 20th century date collected mainly from the subsoil including a variety of low denomination coins reflecting the use of the area as a fair until the 1970s and considering the close proximity to a bridge, the money may also have been thrown into the river as good luck tokens and washed up in the many floods. The earliest artefacts found consisted of a few small sherds of medieval glazed and unglazed pot.

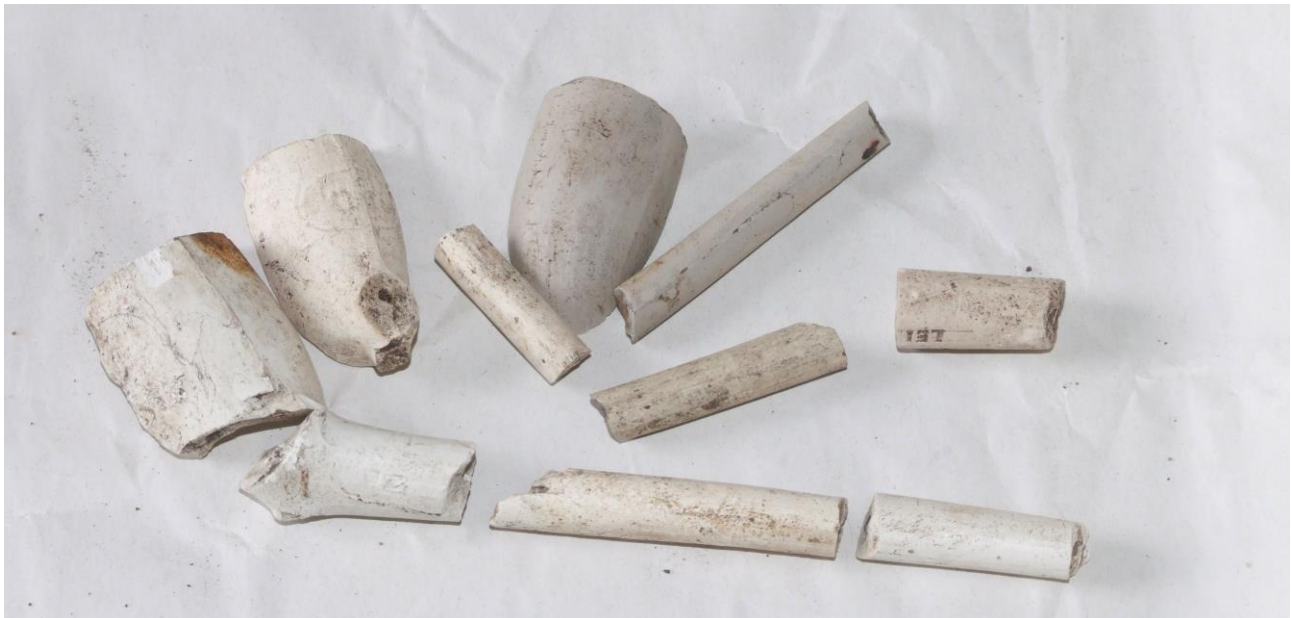
Plate 10: Various pipe bowls and stems.
