GARLETON HILL TRANSMISSION RELAY TOWER

AUGUST 2015

CARRIED OUT ON BEHALF OF LOTHIAN BROADBAND

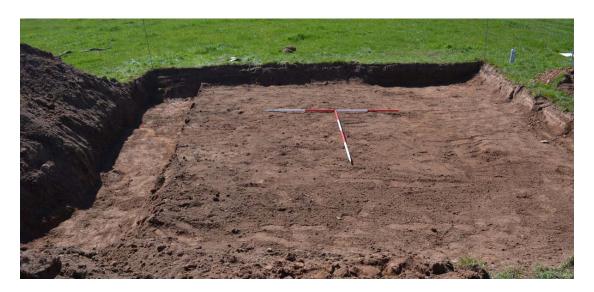
- **5.1** The work was undertaken over 1 day where the weather conditions were dry;
- 5.2 In general the topsoil was up to 120mm deep and this came down onto a subsoil [1002] which in turn overlay a dirty stony natural [1003] that lay at the interface of the glacial till deposit that varied little across the section of trenching.

- 5.3 No features were recorded within the 7x7m trench or associated cabling trench.
- 5.4 All sections were examined, and the base was hand cleaned with trowel and hoe to examine any potential for features cut through the natural soils.

- 5.5 A sondage was cut 1.2m in width on the SW side of the main trench, to investigate the depth of the glacial till natural. The sondage reached a depth of 600mm which is the final construction depth for the concrete base. Natural soils extended down 260mm from the subsoils, no natural stone geology was uncovered during the investigation

Plate 1 – Trench – post excavation, with natural throughout

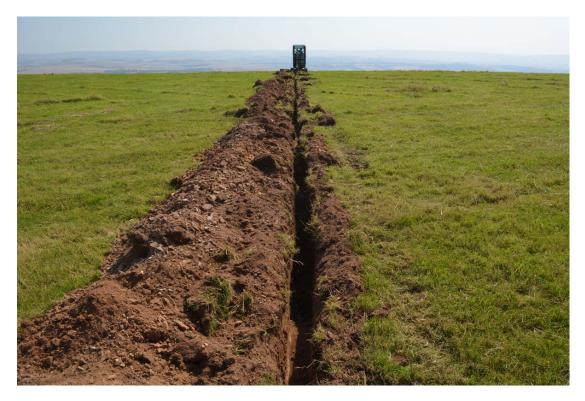
5.6 A narrow cable trench was cut to the south of the concrete base for a distance of 45m, to depths varying from 800mm at the north end, to 900mm at the south. However, bedrock rose steadily to 300mm before dipping back down again . Along the entire length, no archaeology was observed.

Plate 2 – Cable Trench – post excavation

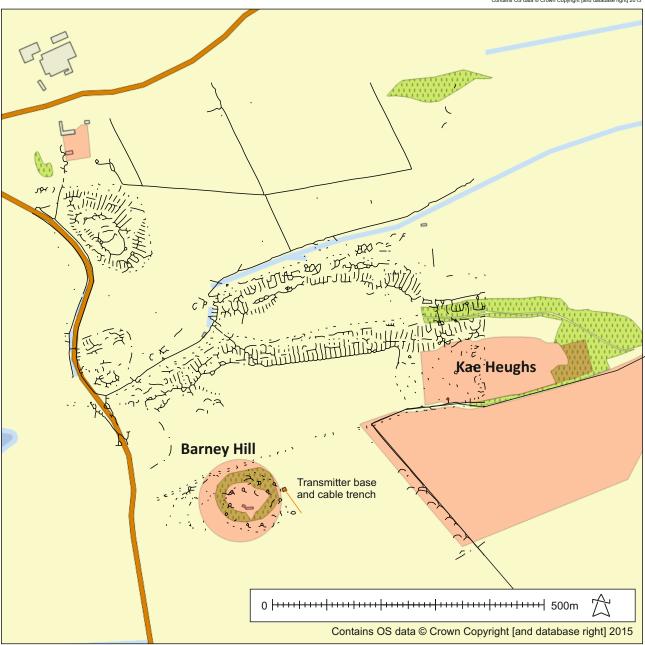
The present site lies outwith this settlement and although no features are known and map regression undertaken on the area (Figure 2), shows no structures or development from the 1750s (Roy's Military Survey) to the present, excepting the location of transmitter masts.

Figure 2: Trenching and investigation with 2nd edition Ordnance Survey Haddingtonshire Sheet V.SW revised: 1893
