Sir John de Graham's Castle and Kirk o'Muir Community Project, Carron Valley, Stirlingshire

Data Structure Report

Sir John de Graham's Castle & Kirk O' Muir Community Project

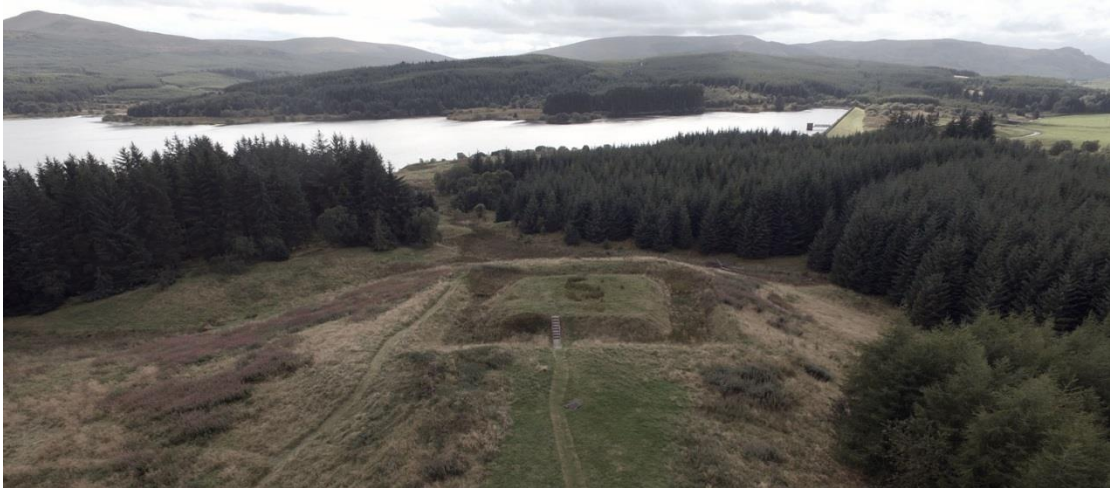
Plate 1: SUA aerial image of Sir John de Graham's Castle, with now flooded Carron Valley in the background, view to the south.

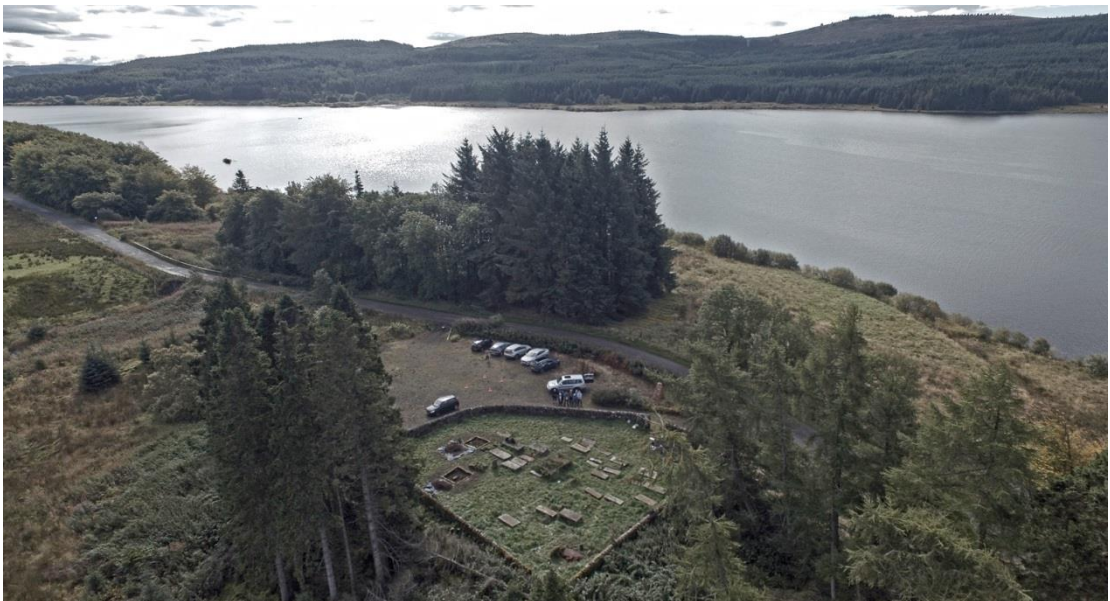
Plate 2: SUA aerial image of the Kirk o' Muir graveyard, with now flooded Carron Valley in the background, view to the southeast.

Kirk o' Muir (Canmore ID 45979) comprises a small burial ground enclosed in a stone boundary wall (**Plate 2**). A chapel, dedicated to St Mary, allegedly founded around the middle of the 15th century, is reported to have stood somewhere within the bounds of the graveyard for about two hundred years. This end date appears to coincide with the earliest dated grave stones identified within the graveyard to date. The RCAHMS' inspection of the site identified the earliest decipherable stone as 1695 (RCAHMS 1963: 160), while the subsequent survey (June 1969) of the site, found two earlier stones of pre-1700 dates, including one dated 1678 (No. 29) and one partial dated 167... (No. 19) (Mitchell & Mitchell 1973: 190-92). These dates were surpassed by the most recent survey (**Plate 3**), which found the eldest gravestone identified so far, dated 1651 (Booij forthcoming; see also below). Correspondingly, based on the 1969 survey, the latest recorded date for the burial at Kirk o' Muir (excluding recent scatterings of ashes) is that of Jane Adam in December 1876 (Mitchell & Mitchell 1973: 192).

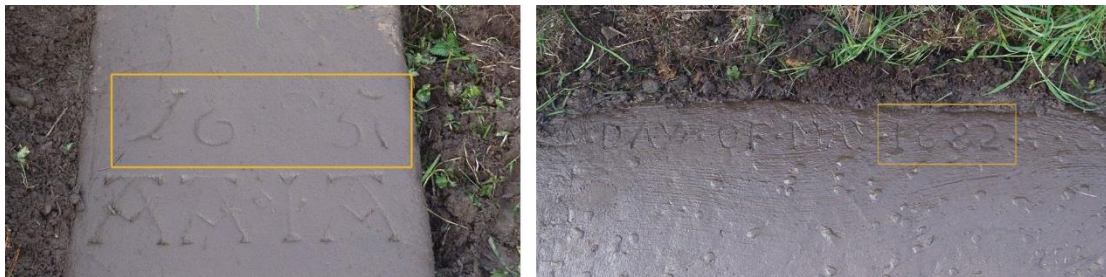
Plate 3: Grave slabs identified at Kirk o' Muir during the most recent survey of the site— the one dated 1651 (left) is the eldest grave marker identified at Kirk o' Muir to date; 1682 (right).

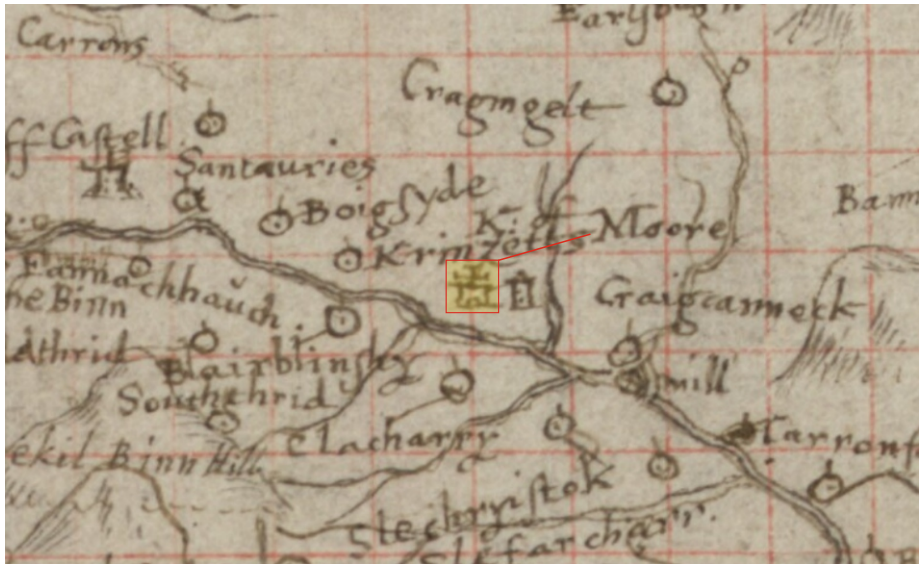
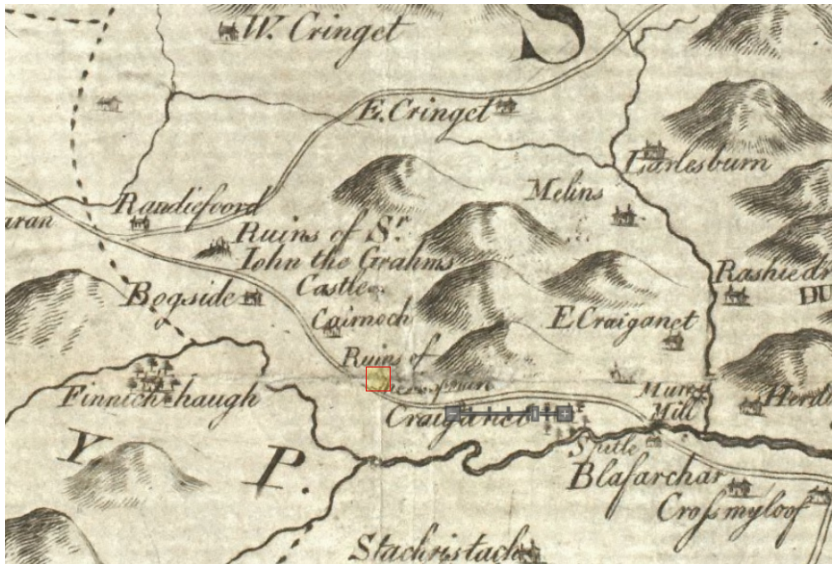
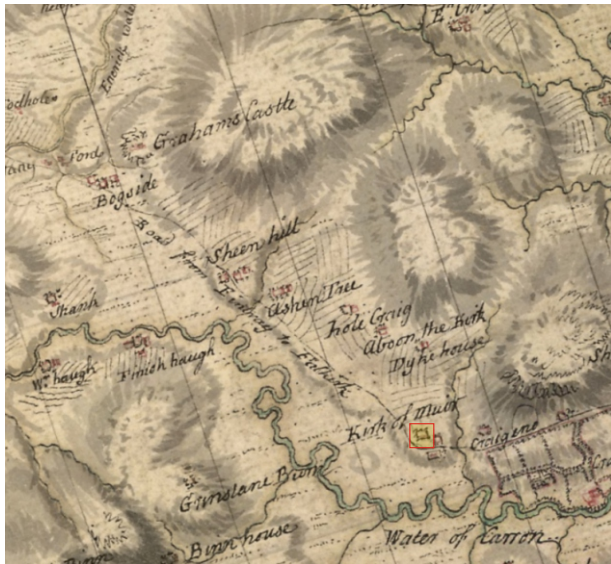
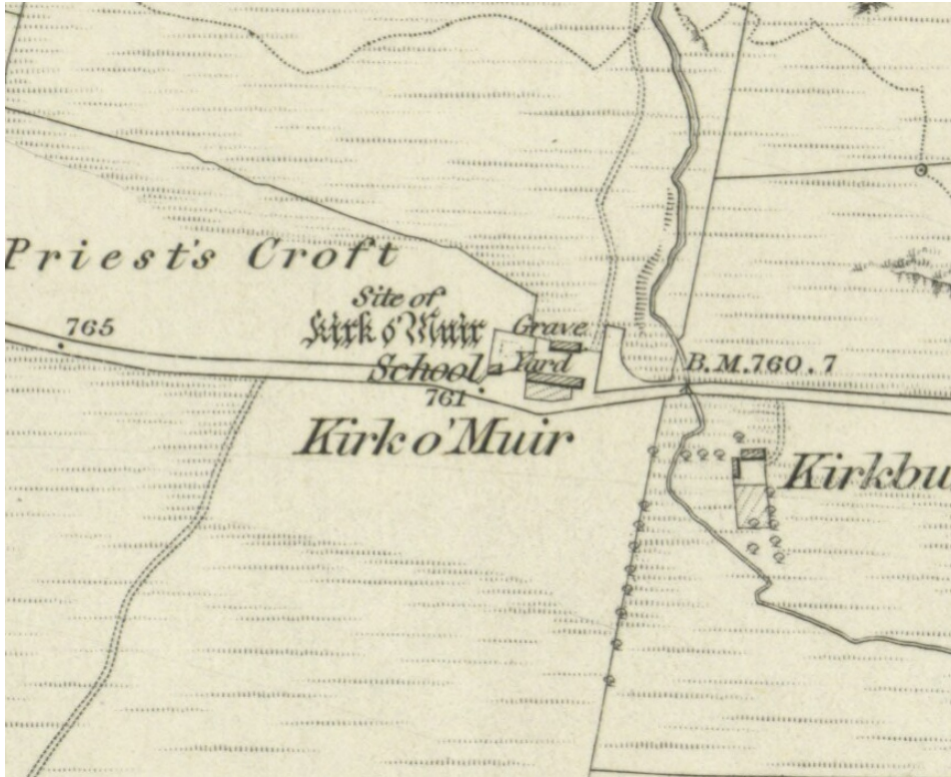
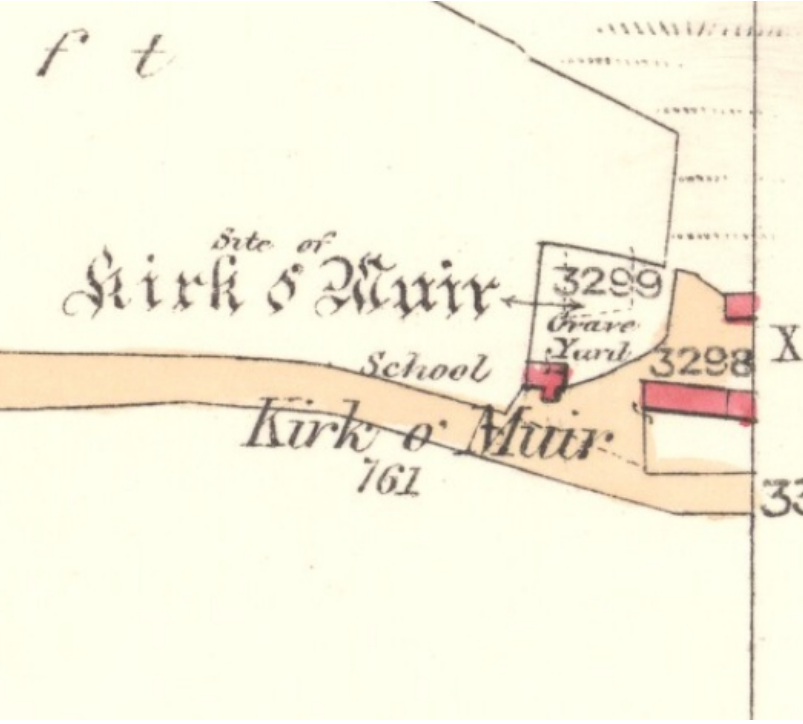
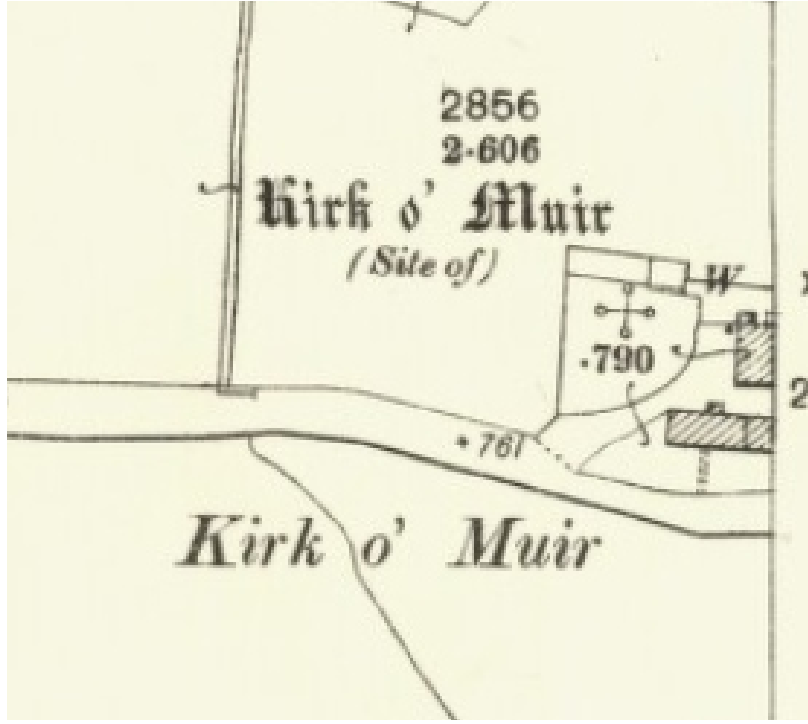
Figure 2: Kirk o' Muir map regression

[The East Central Lowlands (Stirling, Falkirk & Kilsyth)]- Pont 32 [ca. 1583-96]

A map of Stirlingshire from a Survey by William Edgar in 1745 © 2002 Edinburgh University Library

William Roy. Military Survey of Scotland, 1747-55

Ordnance Survey, Stirlingshire, Sheet XXII (includes: Campsie; Fintry; Kilsyth; St Ninians) Survey date: 1859-61 Publication date: 1864

Ordnance Survey, Stirling Sheet XXII.11 (St. Ninians) Survey date: 1859 Publication date: 1864

Ordnance Survey, Stirling Sheet 22.11 (St. Ninians) Survey date: 1896 Publication date: 1897

The existence of the former chapel at the Kirk o' Muir burial ground is also supported by cartographic evidence— the map regression research (**Figure 2**) clearly suggesting that the chapel was in existence as an upstanding building into the later 18th century, albeit as a ruin from the 17th century onwards. 'K. of Moore' is shown on Pont's map of the late 16th century (c. 1583-1596), but Edgar's map, surveyed in 1745, marks it as 'Ruins' (Edgar 1777). Roy's Lowland Survey map (1752-55) has the outline of the boundary at 'Kirk of Muir' but no obvious structures within. In contrast, John Grassom's map of Stirling (1817) notes three structures on the site but none as ruins, although it is not clear what these structures are and whether they

may relate to the School or the graveyard and the farm of Kirk o' Muir. Given that William Edgar's 1745 map marks the chapel as a ruin as does Ainslie's map (1821; 'Muirkirk Ruins') and that both NSA and OS Name Books suggest it is gone by 1840s/1850s, this implies that the ruined structure was entirely removed between 1822 and 1841.

The map regression research (**Figure 2**) points to the same conclusions. The school structure appears on the first edition OS six-inch map for Stirlingshire (surveyed 1859-61; published 1864) in the southwest corner of the graveyard, marked as 'school'. The school is not depicted on the subsequent maps— i.e. OS 25inch (revised 1896; published 1897) or the second edition OS six-inch map (revised 1896; published 1899), and was presumably removed by the 1890s.

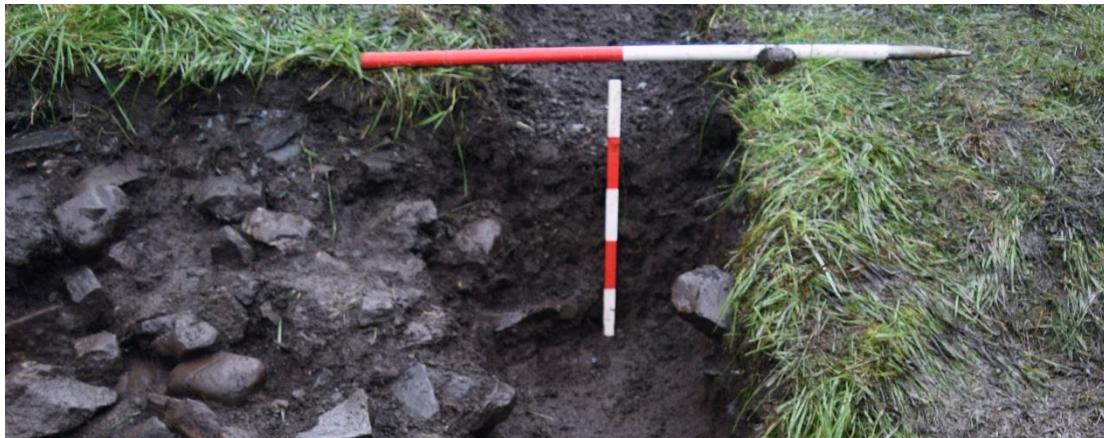
Plate 5: Deposit of slates forming a distinct layer [102] beneath the topsoil [101] at the north end of Trench 1.

The excavations in Trench 1 uncovered a topsoil [101] of dark brown/black rich organic character and which contained material of both 19th and 20th century provenance, including a large number of ceramic sherds, bottle and window glass sherds, two bottle stoppers, assemblage of corroded iron objects and animal bone (some butchered), as well as building material, roof slate fragments (some with corroded nails attached) brick and tile fragments, relating to demolition.

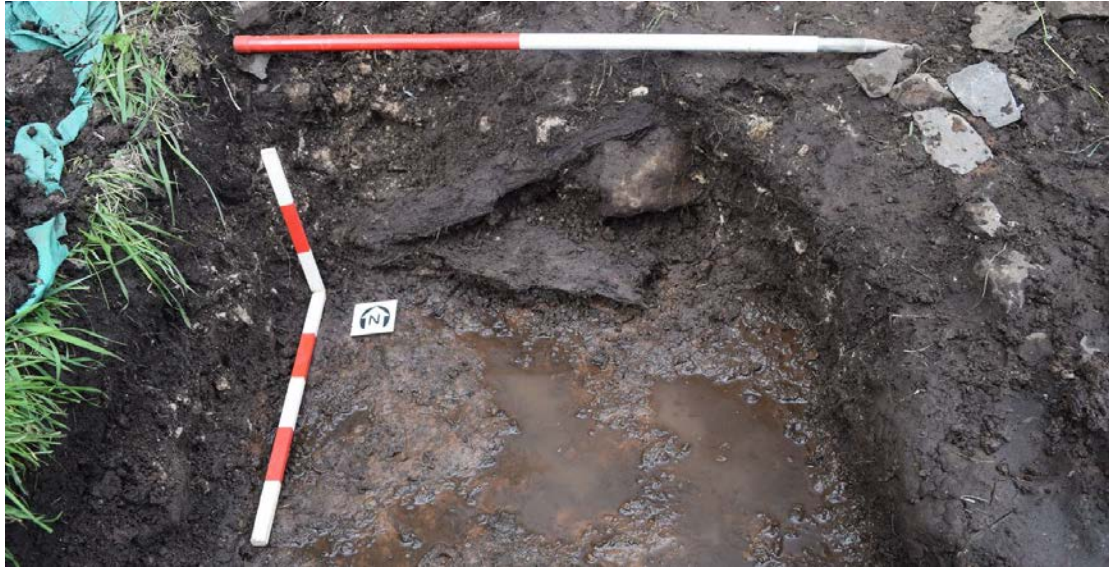
Plate 6. Solid mortar surface [105] with remains of wooden joist floor, part of demolition deposit [104], above.

In the small sondage in the southwest corner of the trench the demolition deposit [104] overlay an in situ solid mortar surface of light beige/orange colour [105] (Plate 6), which would have likely formed a surface for former building over which the sprung wooden floor was constructed. Another sondage in the northeast corner of the trench confirmed presence of a retaining bank/ wall [106] (Plate 7), made of medium to large sub-angular/angular stones, which would have served to prevent the graveyard soil from slumping/eroding towards the building to the south and at the same time forming the rear north wall of the school. The south face of the wall was plastered on the hard with light cream/beige plaster [107]. The wall [106] was set within made ground soil of the graveyard [109], consisting of medium light reddish brown clayey silt with significant gravel component.

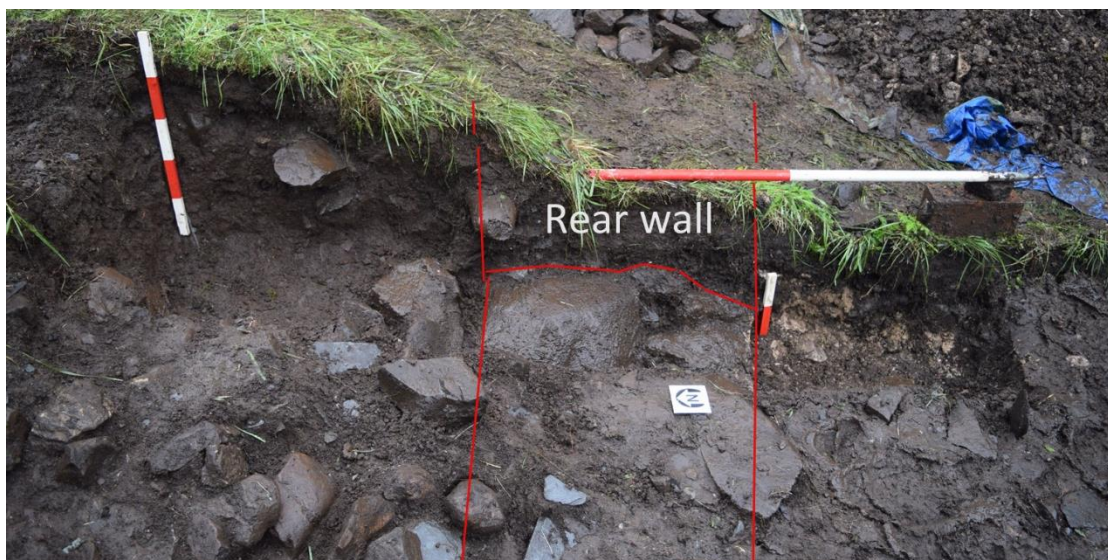
Plate 7: Partial west facing section of Trench 1 showing rear school wall/ retaining wall [106], with plaster on the interior wall face [107] and rough revetment behind (note slates from demolition layer [104]).

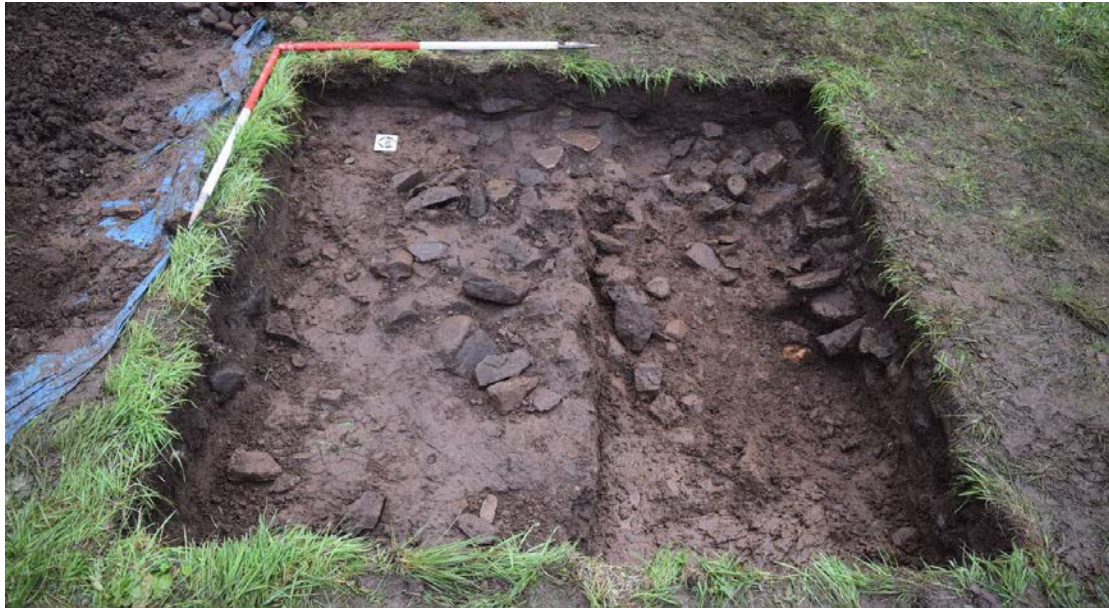
Plate 8: Trench 2 to the east, with the extent of the stony deposit [202] and [203] exposed.

Trench 2 (**Plate 8**) measured 2.0m by 2.0m and was excavated to a maximum depth of c. 0.65m (in a sondage). The excavations revealed a topsoil [201] of dark brown/black rich organic clayey silt, which included finds of largely 19th century provenance (with some early 20th century), including a large number of ceramic sherds, one clay pipe stem fragment, bottle glass sherds, roof slate assemblage, as well as some metal finds, including one lead object and some heavily corroded nails amongst others.

Immediately below the topsoil [201] lay a deposit of lighter reddish brown sandy/silty clay (c.40%), with a large number of gravel and angular to sub-angular stones (c. 60%), many shattered (**Plate 8**). This was investigated further in a sondage in the southwest corner of the trench to the depth of c. 0.65m, where it became waterlogged. The deposit is similar to deposit [109] identified in Trench 1 and interpreted as made ground, corresponding to the later 19th century burial activities and ground adjustments. The deposit included ceramic sherds assemblage of 19th century provenance, a single clay pipe stem fragment and a sheep tooth. The slate assemblage, with two different slate types identified, suggests that some of the thicker dark purple grey slate variety may be of medieval date (as opposed to the thinner lighter blue slate) and therefore feasibly from the former chapel.

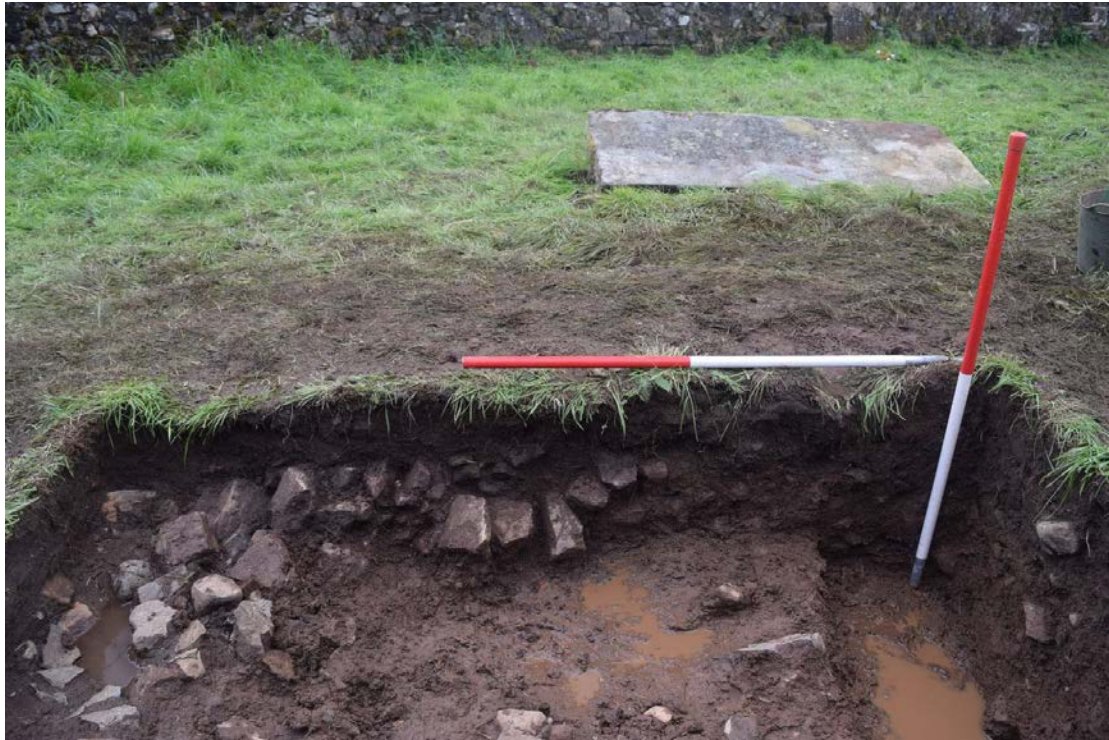
Plate 9: North facing section of Trench 2– showing the layer of angular to sub-angular stone [203] sloping to east; and a sondage to right.

Situated below the topsoil [201] largely in the east and southeast area of the trench was a stony deposit spread [203], comprising some 85% angular to sub-angular stones and mixed with reddish brown sandy/clayey silt (**Plate 9**). This probably represents a dump of stones/or levelling episode associated with the ground adjustments (and therefore part of the same provenance as deposit [202]) rather than a fill of a discreet cut feature, although it was initially interpreted as possibly part of a grave cut. A careful sondage through this deposit [203] of the possible cut feature in the southeast of the trench did uncover more stony deposit [204] of similar character to [203], but which contained larger amount of coal inclusions and some charnel (teeth and long-bone fragments), as well as metal parts of coffin furniture, which were reburied. Although no unequivocal evidence of a grave-cut or other cut feature was uncovered, there still appears a possibility that the putative cut in the northeast corner of the trench may represent a grave-cut. Given this latter possibility and the waterlogging, the deposit [204] was not investigated further. On balance of evidence, the spread of stones [203] and [204] is probably result of ground levelling/adjustment works associated with burial ground use in the later 19th century.

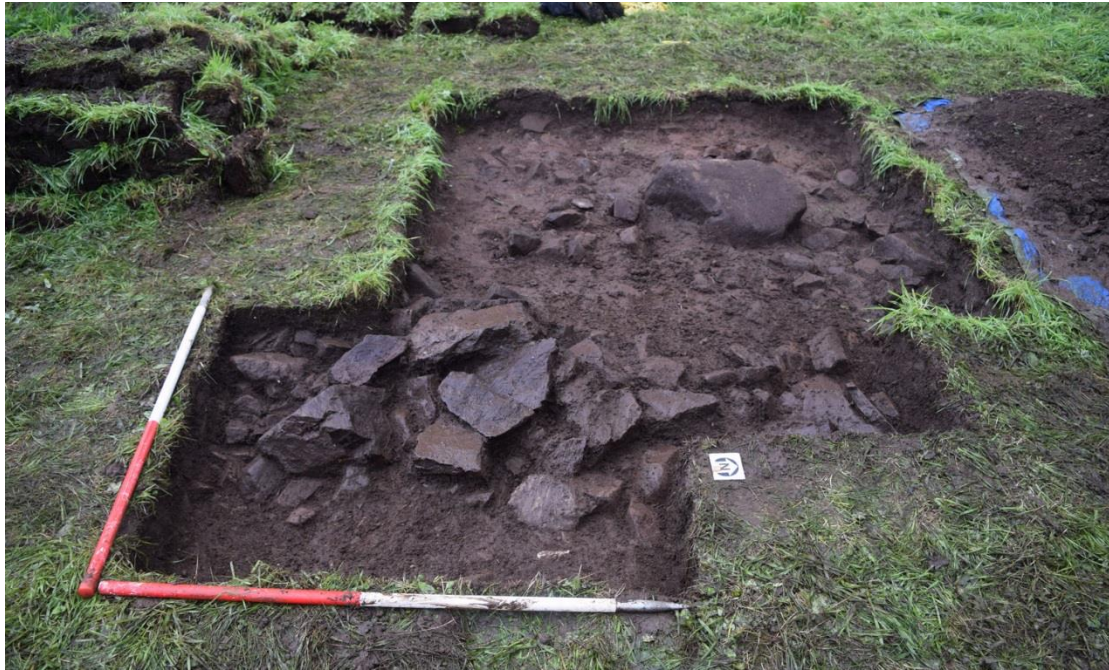
Plate 10: Trench 3; view to west— showing deposit [302] in the background and linear stone rubble spread [303] in the foreground; also note an area largely devoid of stone (possible cut feature) centrally and large boulder [304] in background.

Trench 3 (**Plate 10 & 11**) was situated to the northwest of Trench 2, near the north boundary wall. It was originally 2.0m by 2.0m and was later extended to the east and southeast by about 0.95m (east-west; south end)/0.55m (east-west; north end) and c. 1.95m (north-south). The trench was excavated to the depth of some 0.20m, though in a small sondage (in the southeast corner, the depth reached was 0.59m). As in Trenches 1 and 2, the topsoil [301] comprised dark brown/black organic rich clayey silt and included ceramic sherds of largely 19th century provenance, slate assemblage and bottle glass (some of 20th century). Other inclusions consisted of brick fragments, slag, cinder and coal, as well as some corroded iron nails. One sherd (rim) of post-medieval oxidised/reduced ware [SF 19] was also uncovered, suggesting earlier activity on the site (c. 16th /17th century?), perhaps associated with the former chapel.

A north-south aligned linear feature [303] (**Plate 10 & 11**), originally interpreted as possible remains of a wall footings was uncovered below the topsoil [301] in the east extension of the trench. The width was approximately 0.85m and the feature continued beyond the limits of the excavation towards north and south. The feature was made up of sub-angular to angular stones of mostly large to medium size. Further investigation (a small slot, 0.40m wide by 1.25m long) (**Plate 10**) through the feature in the southeast corner, failed to produce any unequivocal in situ evidence of former chapel. This feature may simply be rejected stones from the former structure (chapel?), given that some of the stones appear to have been accidentally broken in half as they were thrown on the pile, which may imply nearby demolition activity.

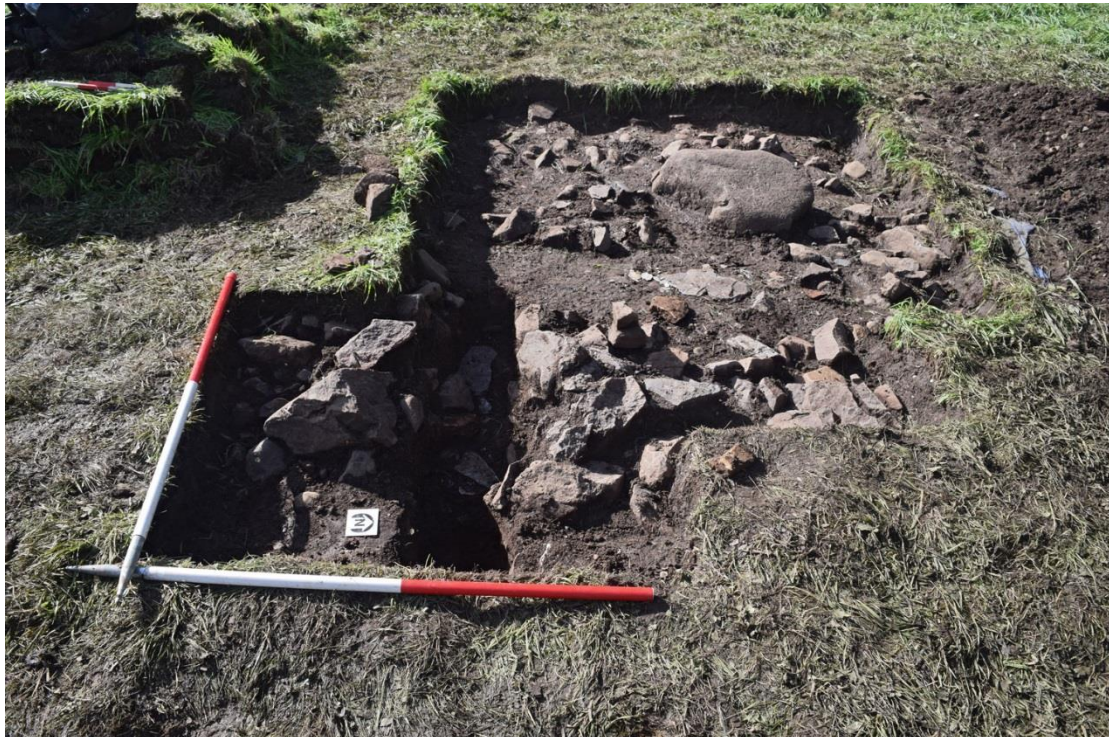
Plate 11: Trench 3; view to west—showing the slot through the spread of rubble [303]; deposit [302] and boulder [304] in the background.

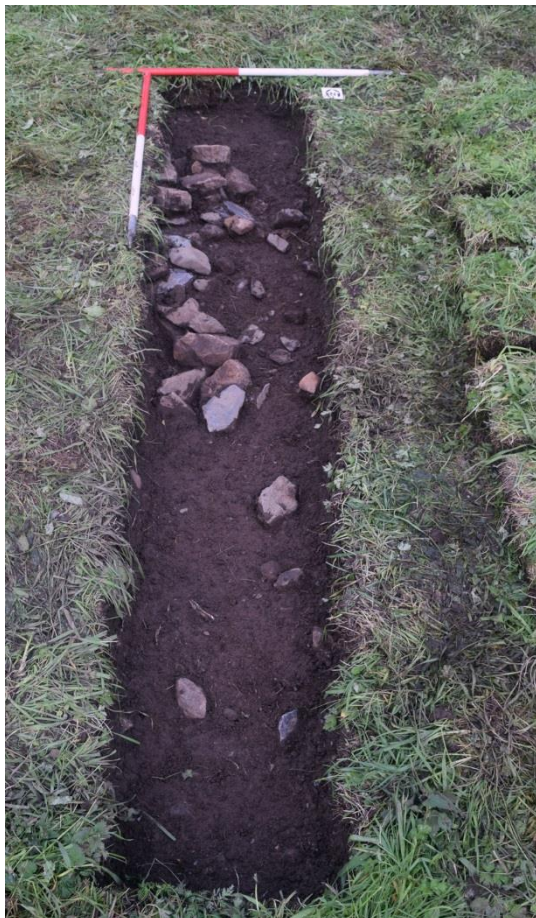
Plate 12: Trench 5, showing linear spread of rubble [502] and slate [503].

Trench 5 (**Plate 12**) was excavated to the west of Trench 3 and measured 3.0m (north-south) by 0.55m (east-west), reaching depth of c. 0.14m. The uppermost deposit of topsoil [501] comprised dark brown/black humic clayey silt, which included some small sherds of white glaze pottery (19th /20th century), as well as large number of chanel and coffin furniture, including coffin handle and nails, all of which were subsequently reburied in the trench.

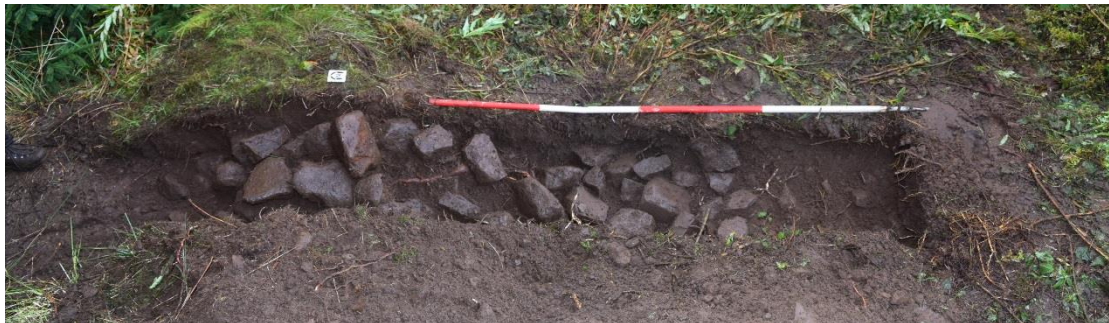
Plate 13: East facing section of Trench 4– showing wall/bank [402], and stone collapse [403] to the south.

The uppermost deposit [401] consisted of dark brown/black humic/peaty clayey silt (similar to rich organic forest soils) and included a large number of smaller roots. The finds consisted of several sherds of 19th century ceramics, fragments of ceramic drain, modern bottle glass and some slate fragments of the thinner variety. The topsoil overlay drystone bank [402] and bank tumble/levelling deposit [403] to the south of the bank (**Plate 13 & 14**).

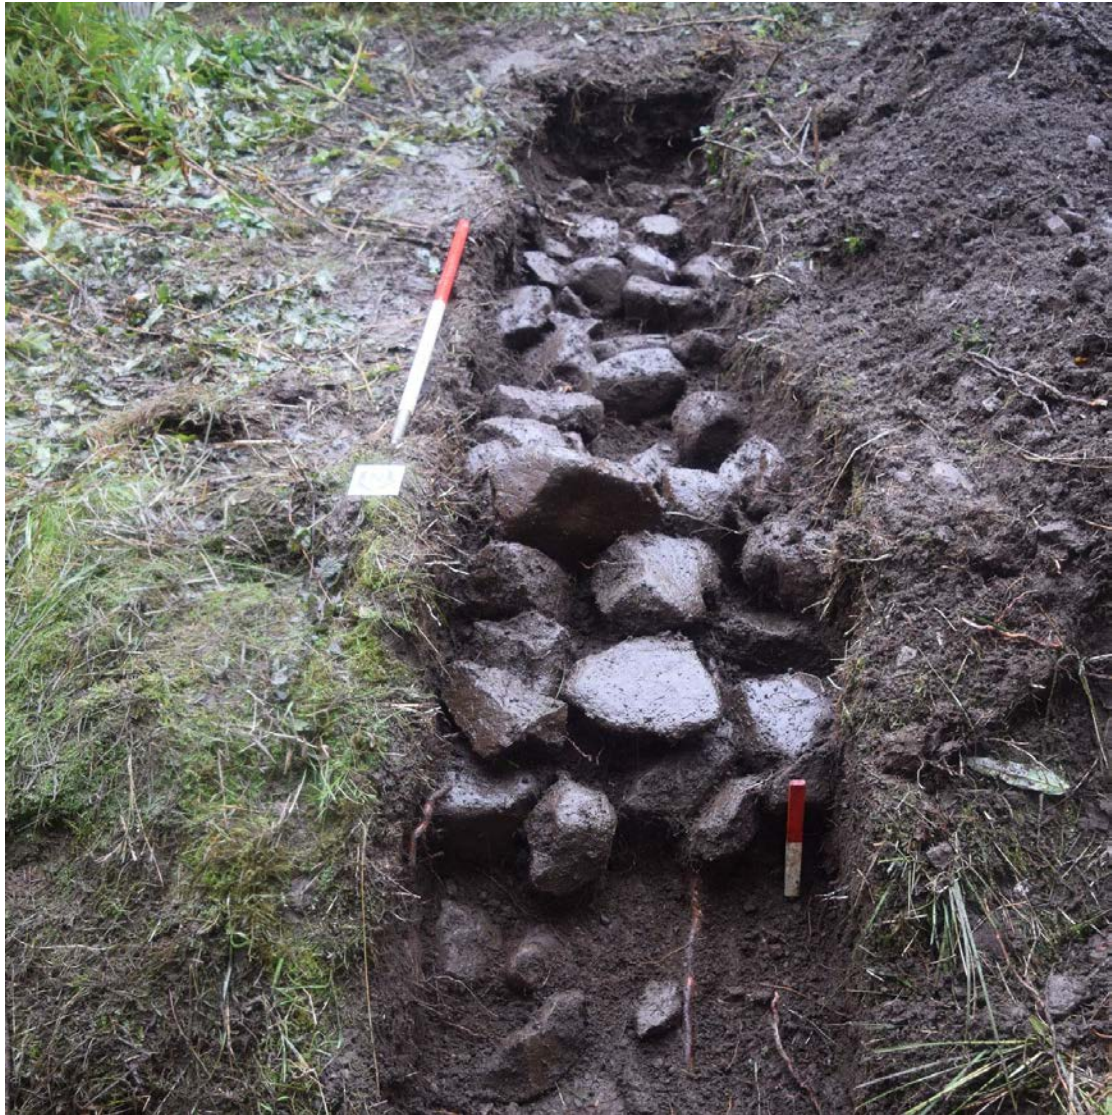
Plate 14: Trench 4, view to south— showing wall/bank [402] with preserved north face (foreground), and stone collapse [403] in the background.

Spreading from the bank [402] towards south was a stony deposit [403], mostly consisting of medium sized sub-angular to sub-round stones, but including some larger sized ones, mixed with medium dark brown silty clay and heavily bioturbated by roots from the shrubs. The deposit was interpreted as deriving partially from the natural erosion of the bank and deliberate levelling episode aimed at making the ground outside the current cemetery wall more regular. A single fragment of roofing slate was recovered from the deposit.

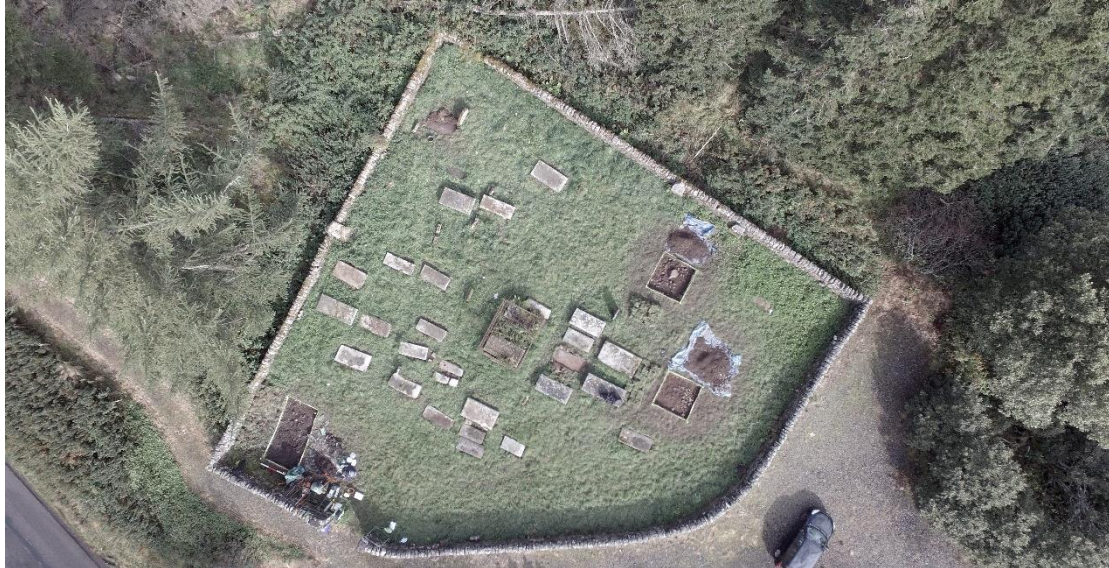
Plate 16: Aerial view of the Kirk o' Muir showing Trenches 1, 2, 3 and 4 under excavations.

The 2017 community excavation at the site of Kirk o' Muir (**Plate 16**) was successful on several levels, from training of volunteers in archaeological excavation and recording techniques, to confirming historical, and uncovering new, evidence for the site's use.

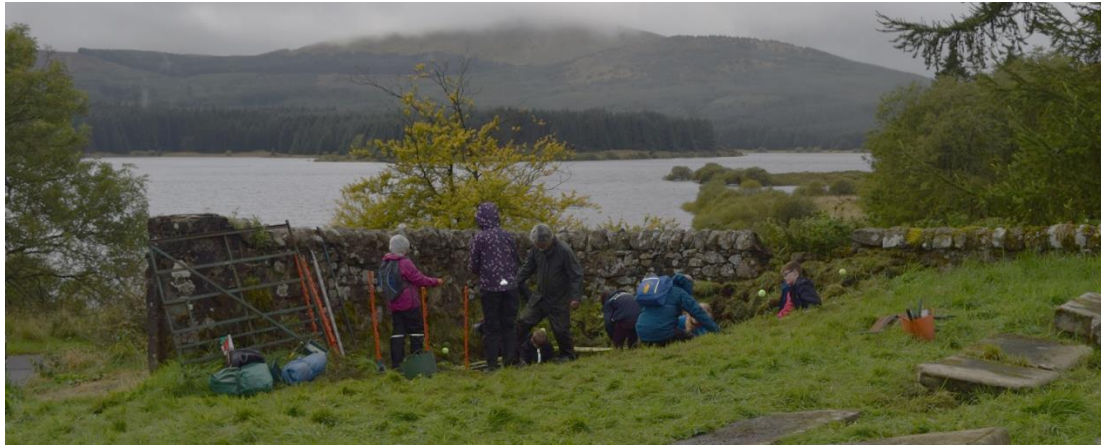
Plate 17: View to southwest corner of graveyard, showing the drop in level from the exterior surface to the interior.

The results have shown that the rear wall of the school was terraced into an already raised graveyard (**Plate 17**), and the interior wall face, which also served as a retaining wall, was plastered on the hard, as evidenced from frequent large sections of mortared plaster recovered from the demolition layers, as well as surviving plaster on the wall itself. Moreover, the hard mortared surface at the base level of the excavation, with large timber elements overlying it, suggest the floor originally comprised a sprung timber over a hard standing. In addition, the later deposits of modern material, mixed in the topsoil or just below, show that the area had been used for a certain amount of localised dumping in the 20th century.

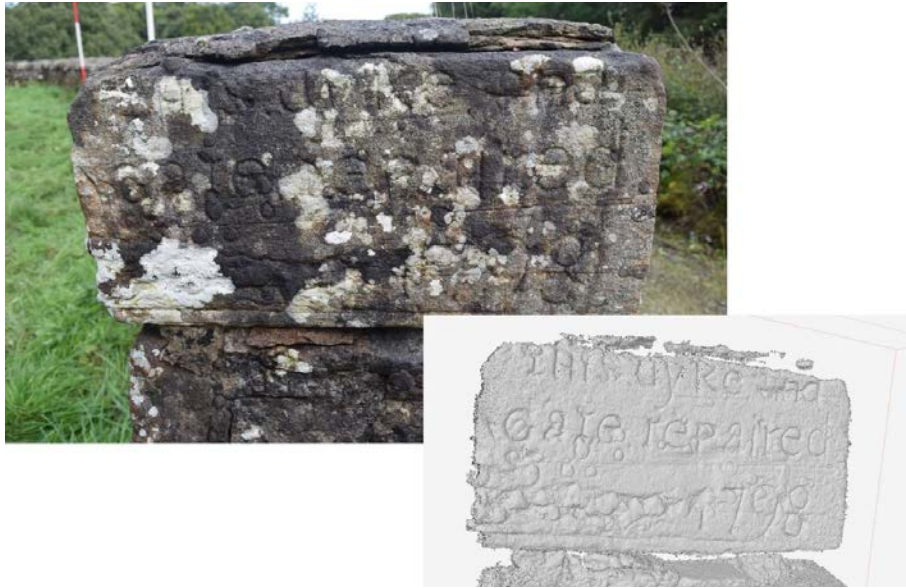
Plate 18: Inscription on the stone inserted into the eastern gate pier; "This dyke and gate was repaired 1798".

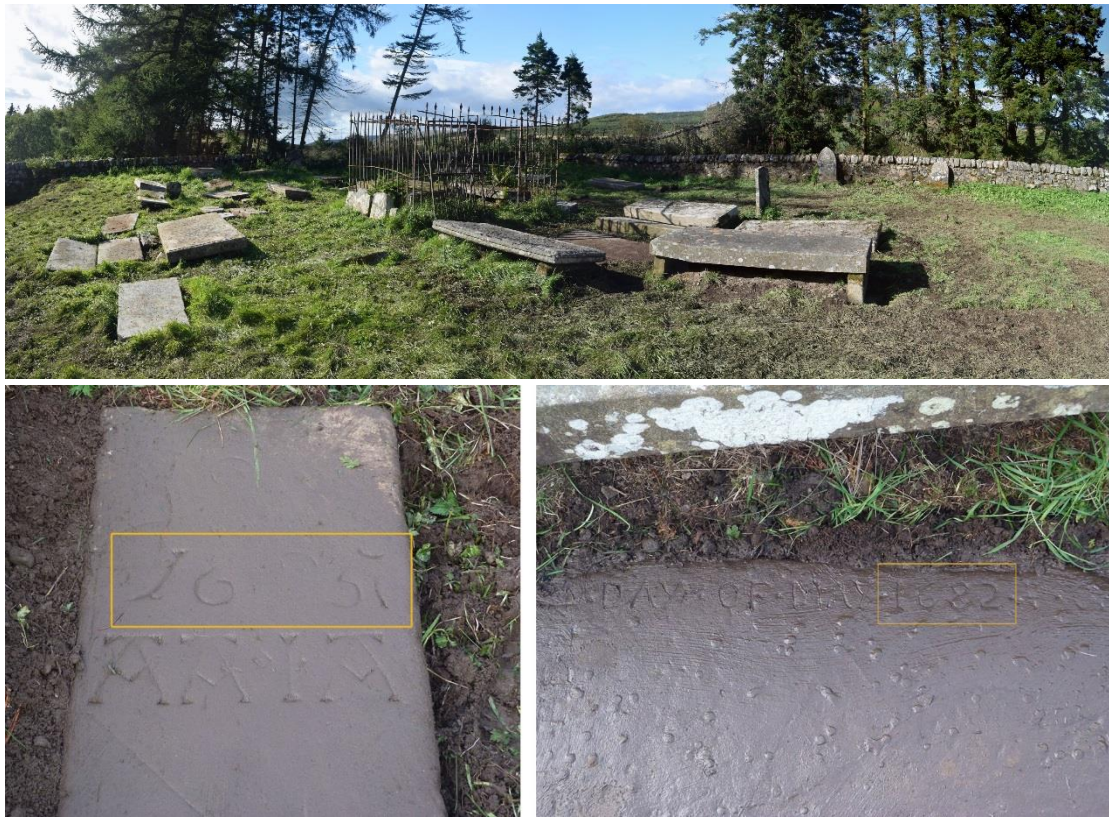
Plate 19: Top—View of the graveyard, looking northwest, with table stones lying within the nineteenth century ground; Bottom—the earliest grave slabs dated 1651 (left) and 1682 (right) respectively.

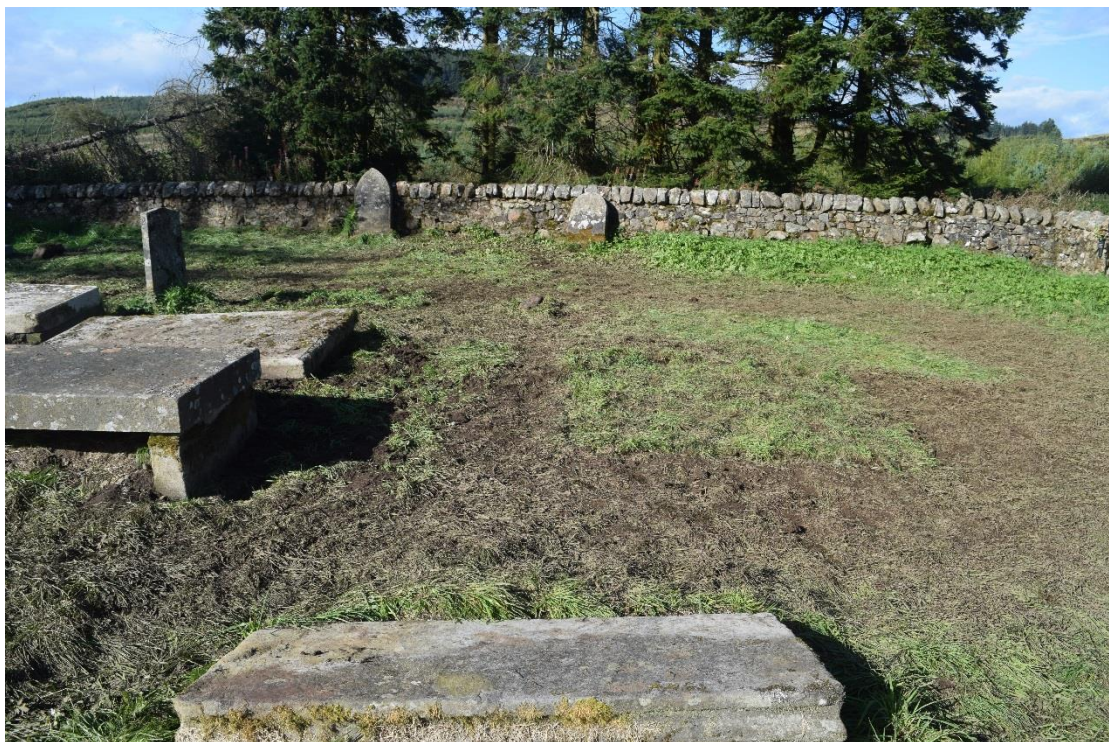
Plate 20: Post-excavation shot of the northeast area of the cemetery, showing the space devoid of any obvious grave stones.

Correspondingly, given the obvious paucity of grave stones/slabs visible on the surface within this northeast area of the cemetery (**Plate 20**), which was more or less confirmed by the excavations, this may be indicative of avoidance of this area, during the initial 19th century 'reuse' of the graveyard, due to physical restrictions such as the dumping of stony material in this area. Although charnel and coffin furniture fragments were uncovered in all three trenches, and possible grave cuts identified in Trench 2 and 3, these represent the later burials after the chapel had long fallen into disrepair, been demolished and buried.
