Pitcox Old Smithy, Pitcox, East Lothian

Data Structure Report

December 2017

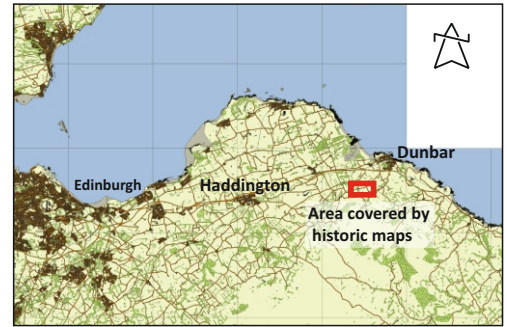
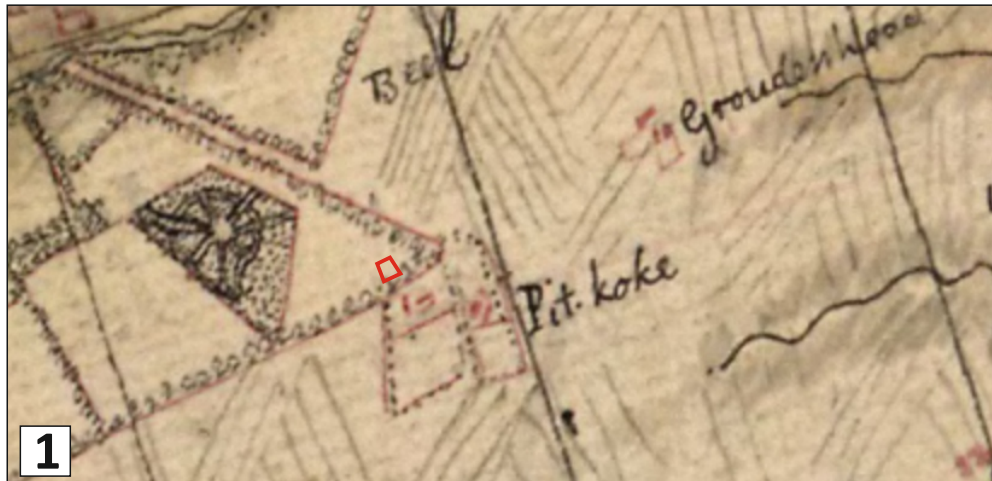
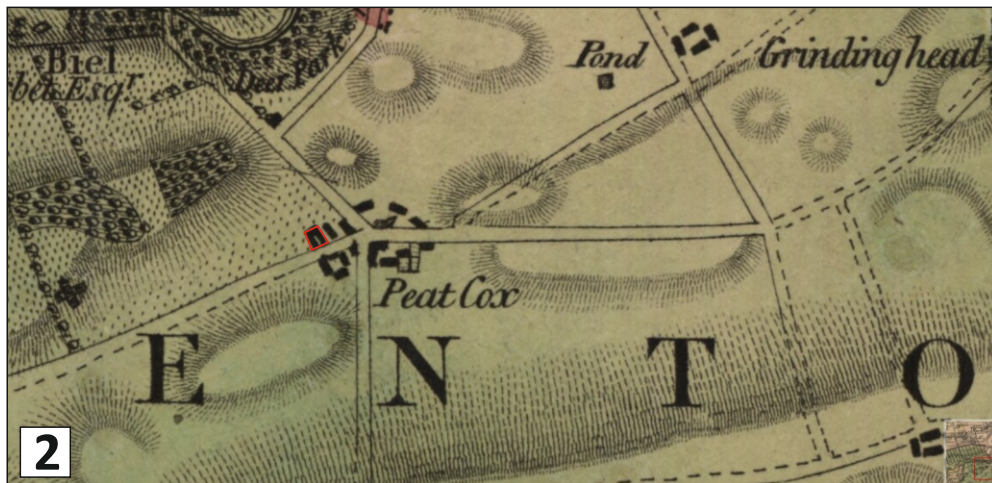
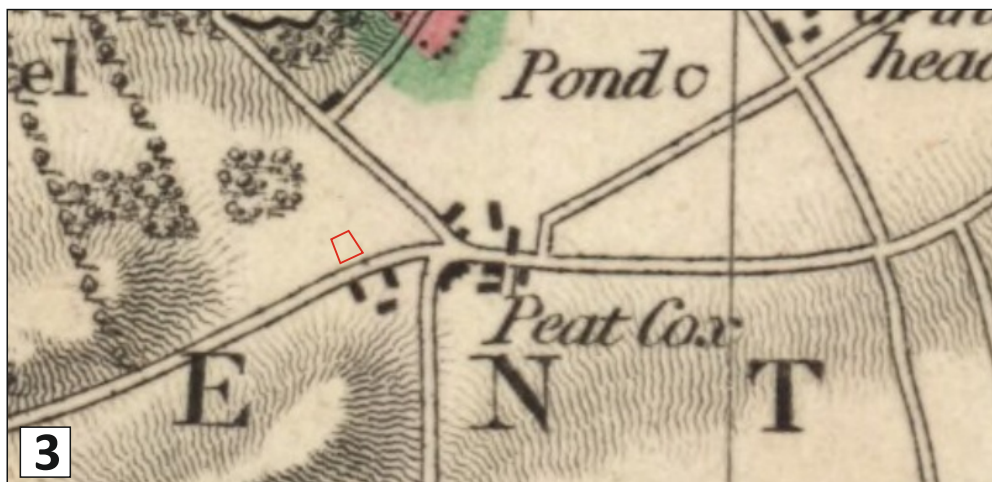
Figure 2: Historic map regression

Map regression research shows the settlement at Pitcox first appears on the Pont's map of the Lothians (compiled between c. 1583-1614; Printed 1630). However, the map gives little detail, apart from naming the place as 'Pitcoks', and a symbol denoting a small settlement. This is replicated in the subsequent maps—Gordon's map of Eastern Scotland (1636-1652) and Blaeu's Atlas (published 1654), to which Robert Gordon was a key contributor. The first clear image of the settlement's layout and structures appears on Roy's map (*Military Survey of Scotland*; 1747-1755), where the farm, named 'Pit. Koke' (or possibly Koks), is depicted as a typical small agricultural holding, with several structures surrounded by rig & furrow (runrig) fields (Figure 2).

None of the early maps show structures on the site of the current Pitcox Smithy ranges, which first appear on the 1799 map of Haddingtonshire (Forrest 1802; North East Section; Figure 2), which shows the 'Peat Cox' settlement and depicts what appears as a U-shaped arrangement of structures. No boundary wall is depicted. The subsequent Thomson's map (1822; published 1832; Figure 2) fails to depict any structures on or near the site of the Smithy ranges, despite the fact that he seems to have copied almost everything else from the previous Forrest's map. Structures reappear on the site again on the 1825 'Map of the county of Haddington' (Sharp, Greenwood & Fowler), albeit without much detail, suggesting omission rather than the structures not being present in 1822.

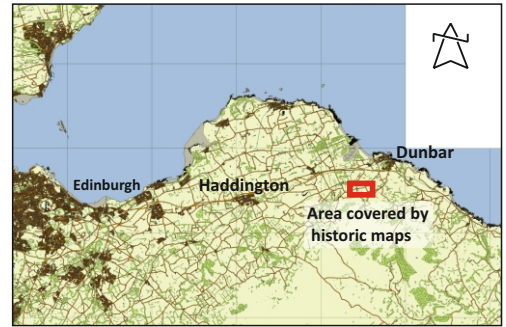
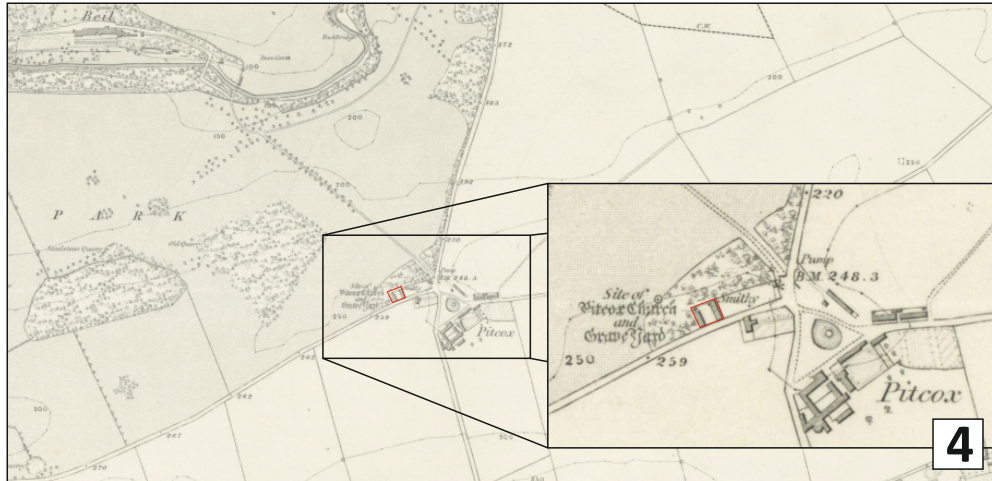
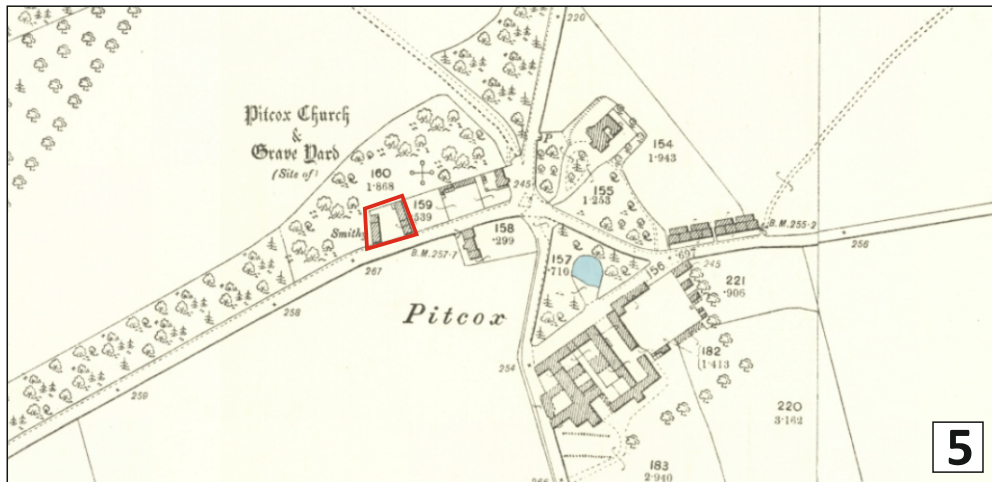
Figure 3: Historic map regression

The smithy and associated structures are first clearly shown on the Ordnance Survey 6-inch map of Haddingtonshire (surveyed 1853; published 1855; Sheet 11; Figure 3), depicted as two elongated ranges/buildings (east and west) surrounded by a boundary wall (this continuing towards the E, beyond the site area), with what appears as additional small rectangular structure to the N of the west range, in the northwest corner of the boundary. The north end of the east range projects slightly from the main façade. The west range is depicted as running parallel to the east range, while in

reality it is at slightly different angle (being northeast-southwest aligned). This arrangement is correctly depicted on the subsequent OS 25-inch map (Haddingtonshire 011.03; surveyed 1893; published 1894; **Figure 3**), which has the word Smithy attached to the west range, while the OS 1-inch map (2nd edition; sheet 33; revised 1895; published 1898) shows the word 'Smithy' across the road, near the group of structures towards the southwest. The location of the word Smithy on the above maps should not be seen as significant, however, as by this time, the entire group of structures is probably taken together as smithy buildings. The layout from the previous OS 25-inch map is more or less retained on the 1906 OS 6-inch map (2nd edition; revised 1906; published 1908; **Figure 3**), which depicts the ranges, minus the northwest corner structure and the projection on the northwest façade of the east range.

In addition, the site of the former Pitcox church (**Canmore ID 57716**), thought to have stood somewhere in the vicinity of the site area to the north or west is depicted on several maps, but intriguingly not on any of the earlier maps prior to the nineteenth century. On the Ordnance Survey 6-inch map of Haddingtonshire (surveyed 1853; published 1855), the church location is depicted to the northwest of the Smithy site; while the subsequent OS 25-inch map (1893; published 1894) has a cross to the northeast of the site, with words 'Pitcox Church and Grave Yard, site of' to the northwest (**Figure 3**). The 1893 location and description of the church is mirrored on the 1906 OS 6-inch map (2nd edition; revised 1906; published 1908). The 1926 OS map (1-inch popular; surveyed 1922-23; published 1926) retains the 'Church (site of)' and cross towards the northeast of the Smithy range site (**Figure 3**).

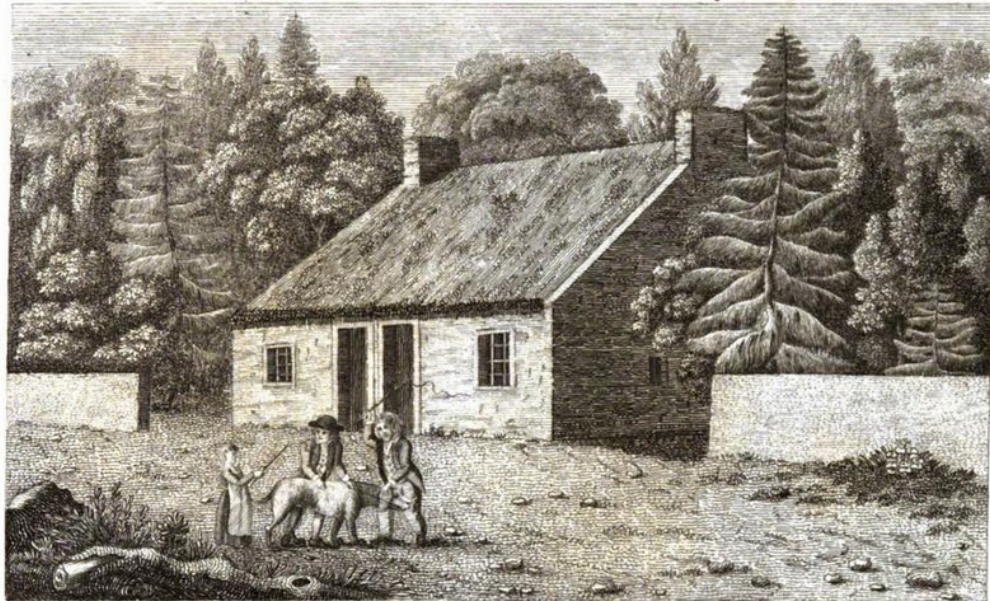
Figure 4: View of hinds cottage (18th century) and later model cottage (mid 19th century)

MID LOTHIAN COTTAGE.

Double hinds' cottage in Midlothian, c. 1790. Each section forms a single roomed dwelling, the roof is thatched; note the reversed symmetry of the facade, with single small window opening and chimney stacks at either end. (After Robertson, *General View of the Agriculture of the County of Midlothian*, Edinburgh 1795. p166)

The similarity between the two chamfered style dripstones, suggest that the N chimney [045] and therefore the fireplace/range in Room 5.1, are later additions, as the E range structures are later, as opposed to the W range (Structure 4 and 5). This would also agree with the suggestion that the earlier cottage (Structure 5) would originally had chimney in the N, to mirror situation in the S cottage (Structure 4). Similar situation has been noted elsewhere in Scotland, as in case of the c. 1790s hinds' cottages in Midlothian (Cheape 1983: 97, **Figure 4**).

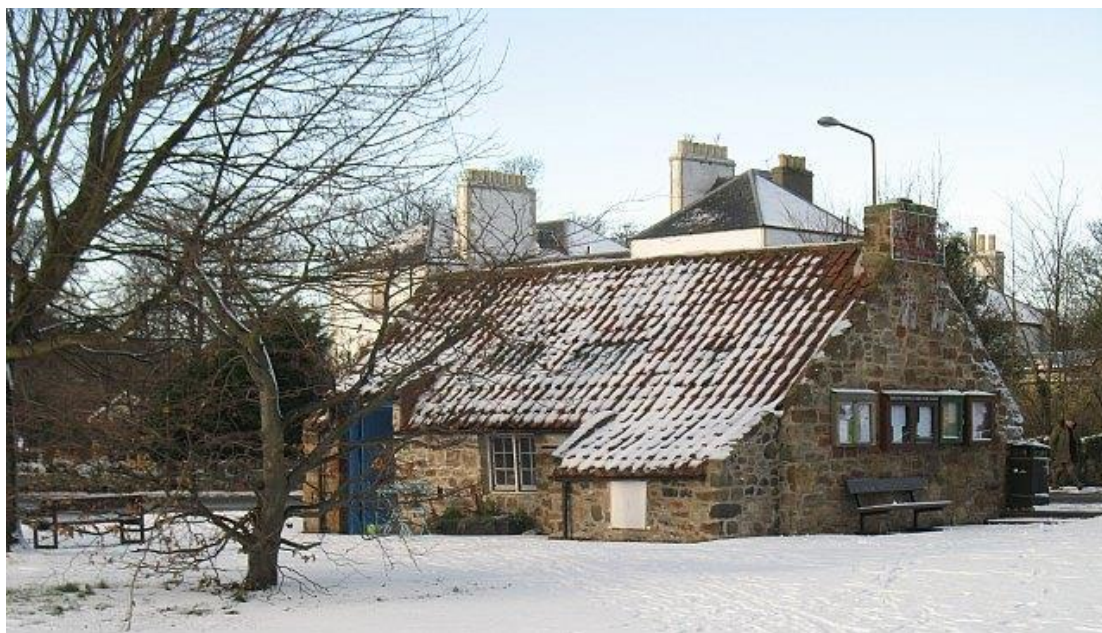
Plate 4: Gullane Old Smiddy; note the low extension at the front for the bellows © Copyright [Richard Webb](#) and licensed for [reuse](#) under this [Creative Commons Licence](#).

No address or location is given for the previous Bell residence and smithy workshop (or subsequently) but it clearly must have existed somewhere at Pitcox and would have been in the Bell family until 1880s and presumably, could have dated to at least 17th century or earlier (given the long line of Bell blacksmith quoted above). Other presumably 18th (or earlier) century smithies are noted elsewhere in East Lothian—including East Saltoun smithy (**Canmore ID 54685**), which was rebuilt c. 1800, or Gullane smithy (**Canmore ID 55059**), which is originally 17th century (**Plate 4**).

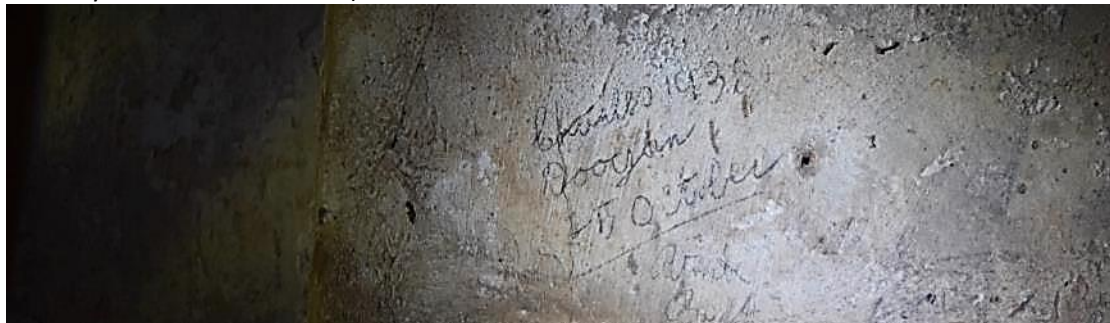
Plate 5: Graffiti from 1936 on the S wall of Room 4.1, above the fireplace [014].

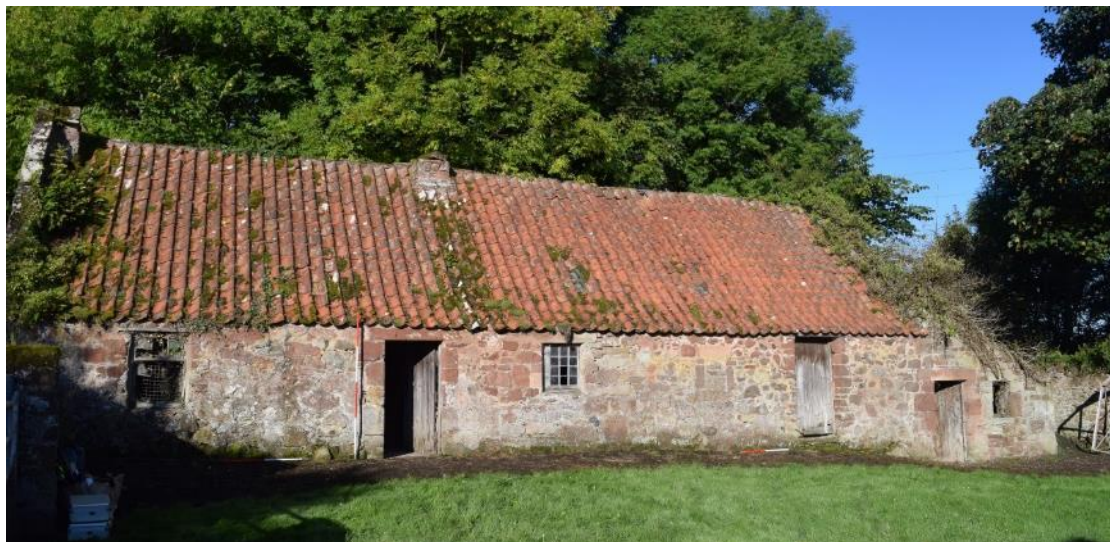
Plate 6: View of the principal E elevation of the W range, comprising Structures 4 to 6 (from left to right).

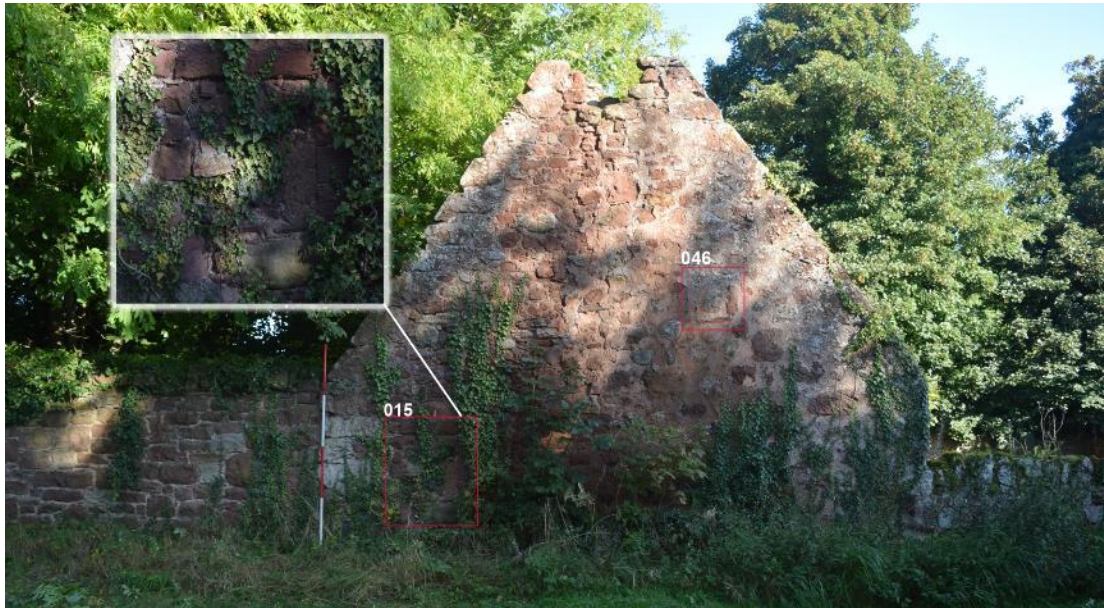
The S wall of the W range (**Plate 7; Figure 7**), corresponding to the S gable end of Structure 4, comprises steeply pitched gable (with the uppermost portion missing), consisting of random rubble built wall, constructed of rounded field-derived stones mixed with sub-rectangular red sandstone. The lime mortar is of gravelly, shelly character with charcoal inclusions. There is evidence of cementitious, slaister re-pointing in places (especially E and E upper portions of the S gable), suggesting later interventions to the structure. The S gable end has steep chamfered skews and skew puts. Two blocked openings are noticeable on the exterior wall– a larger rectangular one [015] at a ground level to the W and smaller square one [046] on the upper middle level to E. The elevation is surmounted by remains of a chimney [044] (see also below, roof)

Plate 7: View of the S gable end of the W range (Structure 4), with blocked windows [015] and [046].

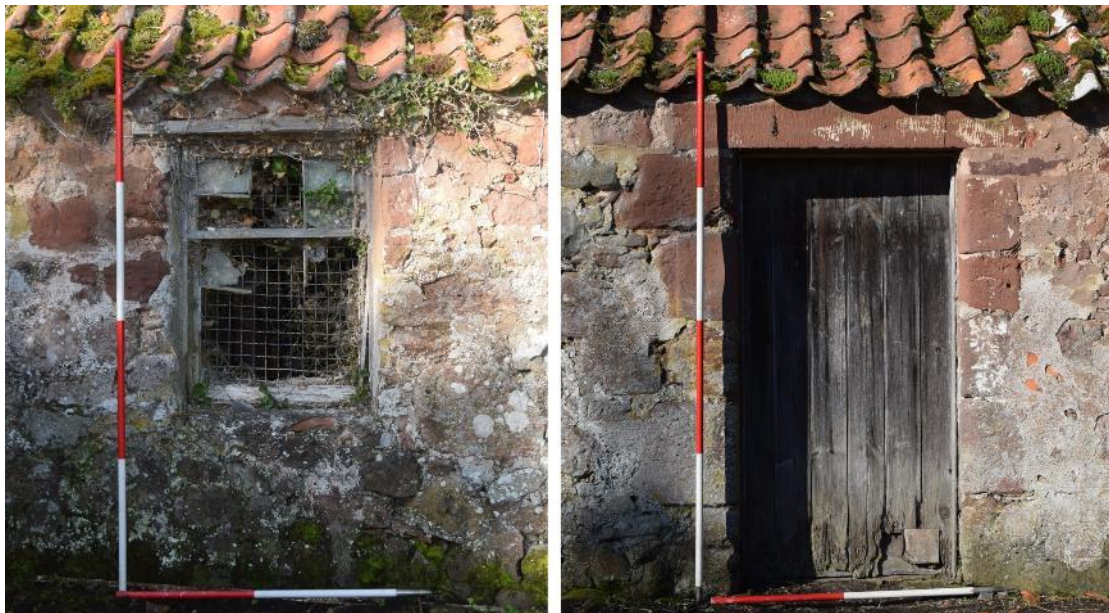
Plate 8: Structure 4, E elevation (partial) with window [001] and entrance [002].

character of the stonework around the door suggests it was probably remodelled at some point in the 19th century. There is a noticeable thickening of the wall at the base S and N of the entrance [002].

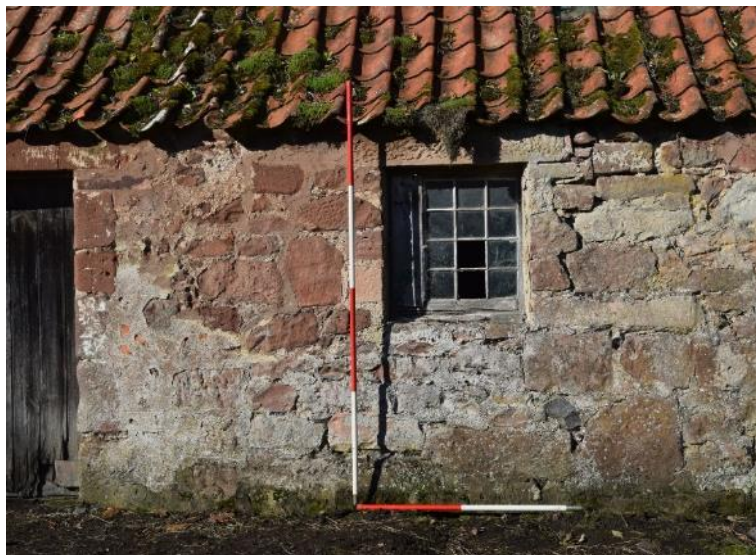
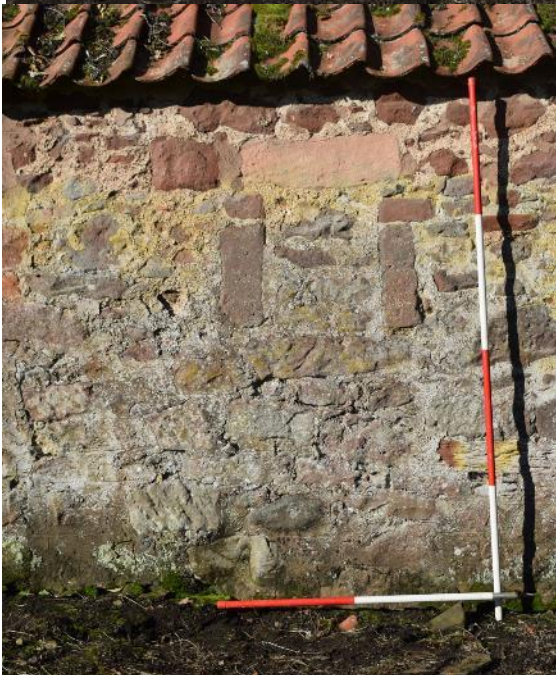
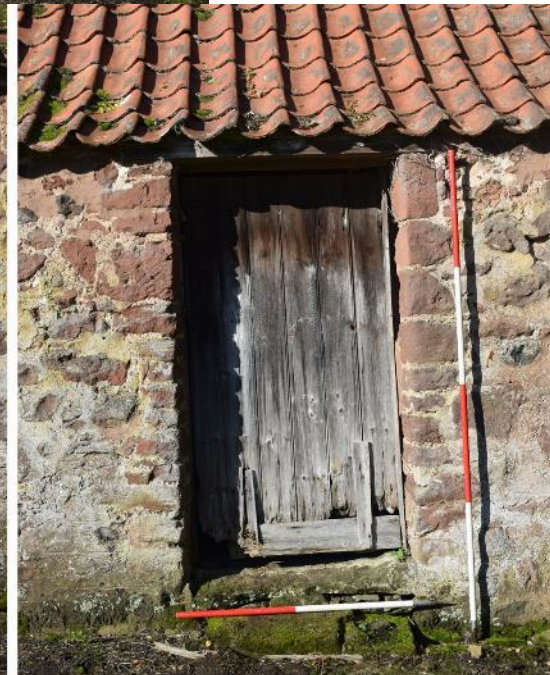
Plate 9: Structure 5, E elevation (partial) with window [003]; blocked opening [004] and entrance [005].

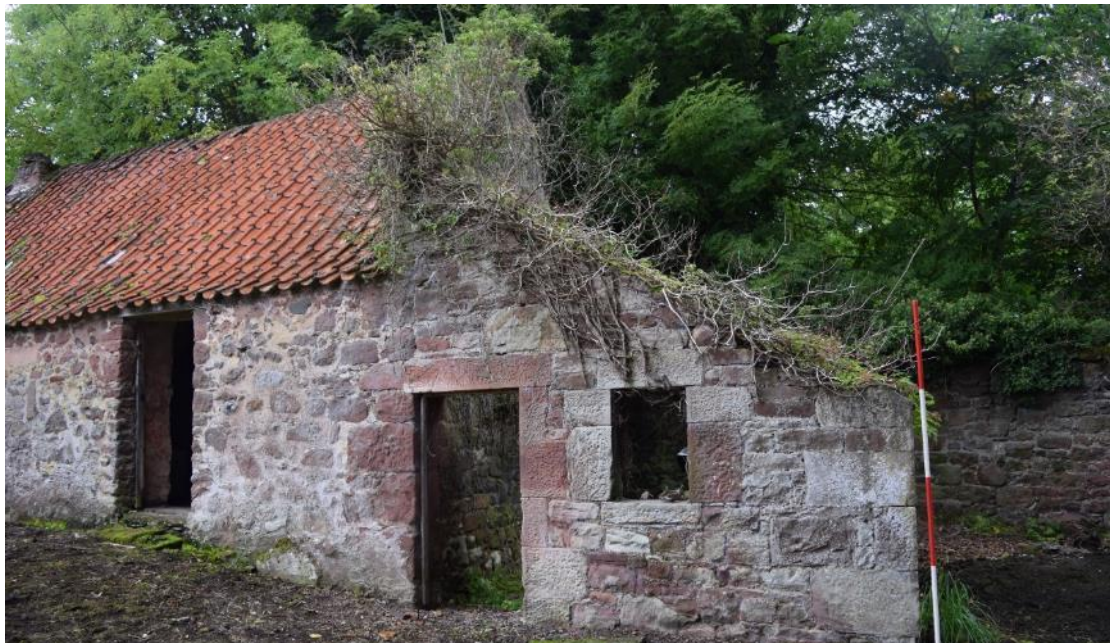
The E wall of Structure 6 (**Plate 10; Figure 6**) is skewed down to N and constructed of much finer and more regularly coursed sandstone blocks/masonry, than either of the two structures to the S. It retains a single entrance [006] to S and a window [007] to N. The entrance retains finely dressed (stugged) red sandstone lintel with narrow droved margin and large similarly dressed sandstone surrounds to N, each with narrow droved margins, suggesting the entrance is original. The surrounds (jambs) to S are formed of former quoins of Structure 5, formed of large sandstone blocks, of lesser refinement, some with wider stugged marks. These were reused as surrounds/jambs for the entrance, when Structure 6 was added to the existing range. The entrance retains timber frame and a vertical planked ledged door. The window [007] to N also

Plate 10: E elevation of Structure 6, with entrance [006] and window [007].

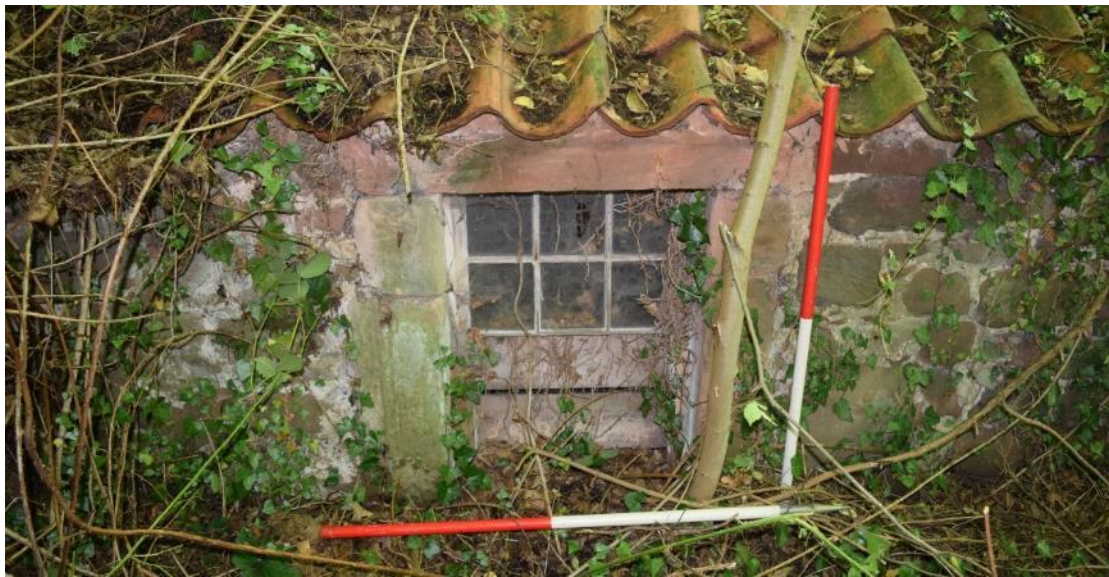
The W wall of Structure 4 is formed of random coursed rubble with some larger sub-rectangular sandstones and round field-derived stones included. It retains single window [016], with finely dressed surrounds and lintel, suggesting later remodelling (**Plate 11**). The red sandstone lintel is a large rectangular block; the S jambs are also of red sandstone blocks, while the N surrounds are of grey coloured sandstone blocks, these with finer finish. The line of the ground surface reaches above the former window base/cill suggesting it was built up after the wing was in place.

Plate 11: Structure 4, partial W elevation with window [016].

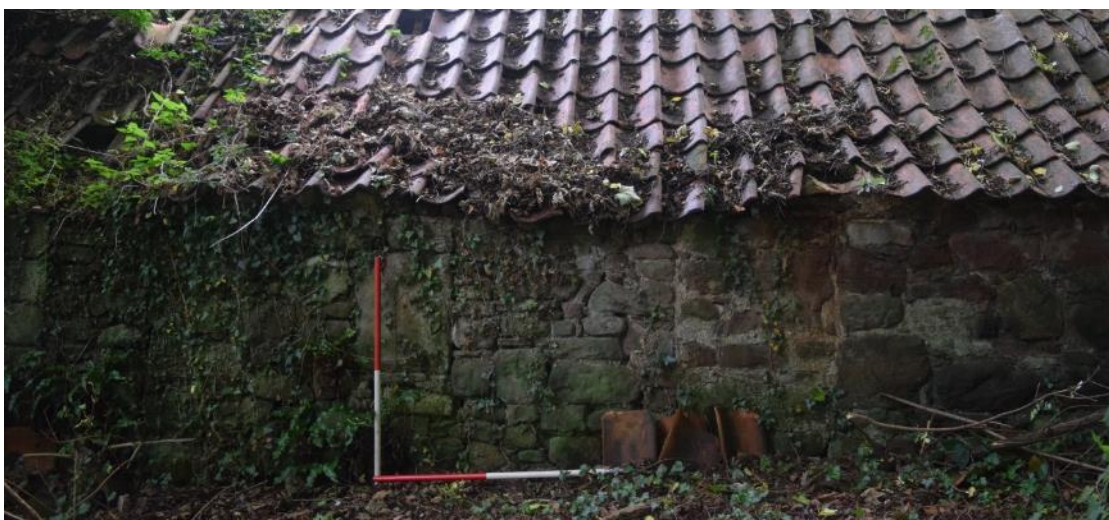
The W wall of Structure 5 is formed of random coursed rubble with some larger sub-rectangular sandstones and round field-derived stones included. The wall retains one window [019] to S, this with cement surrounds and a cill, suggesting later

Plate 12: Structure 5, partial W elevation with blocked large opening [020].

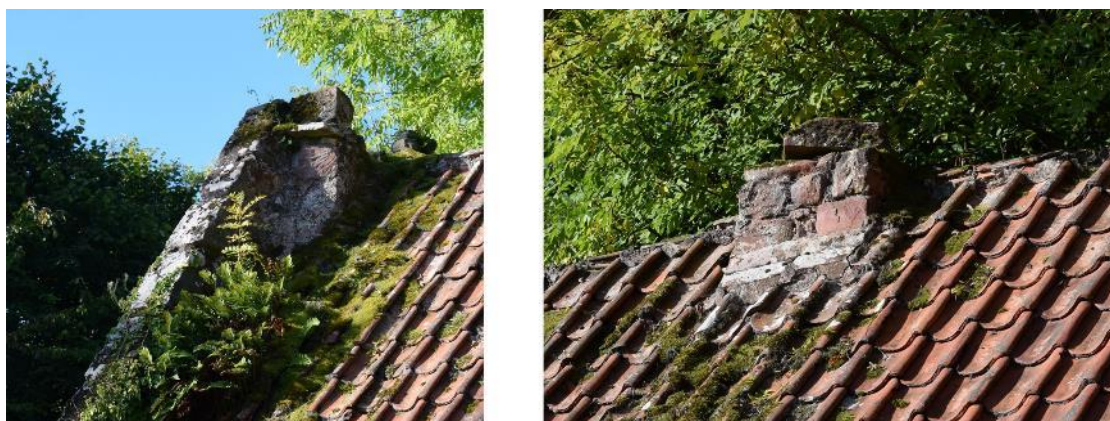
The roof of Structures 4 and 5 is pitched and tiled with red pantiles (**Plate 13**). The bottom 3 courses are splayed for water discharge away from the walls and occasional glass pantiles are included in the roof of Structure 5, forming supplementary lighting for the interior. The roof ridge comprises pantile mortar flashing with frequent cement repair, greatly degraded. Structure 6 is unroofed.

The range has two chimney stacks (both damaged and missing the chimney pot), formerly serving Room 4.1 [044] and 5.1 [045] respectively (**Plate 13**), with no evidence of further chimney to the N end of the range. The S chimney stack [044], composed of roughly squared rubble has projecting flat drip stone, located high above the current roof surface, which, coupled with the depth of the gable, suggests the structure (Room 4.1) was once thatched and the pantile roof represents later alteration to the structure.

Plate 13: Roof and chimney stack [044] of Structure 4 (left) and Structure 5 [045] (right); note the drip stone on the chimney [044] and the depth of the gable.

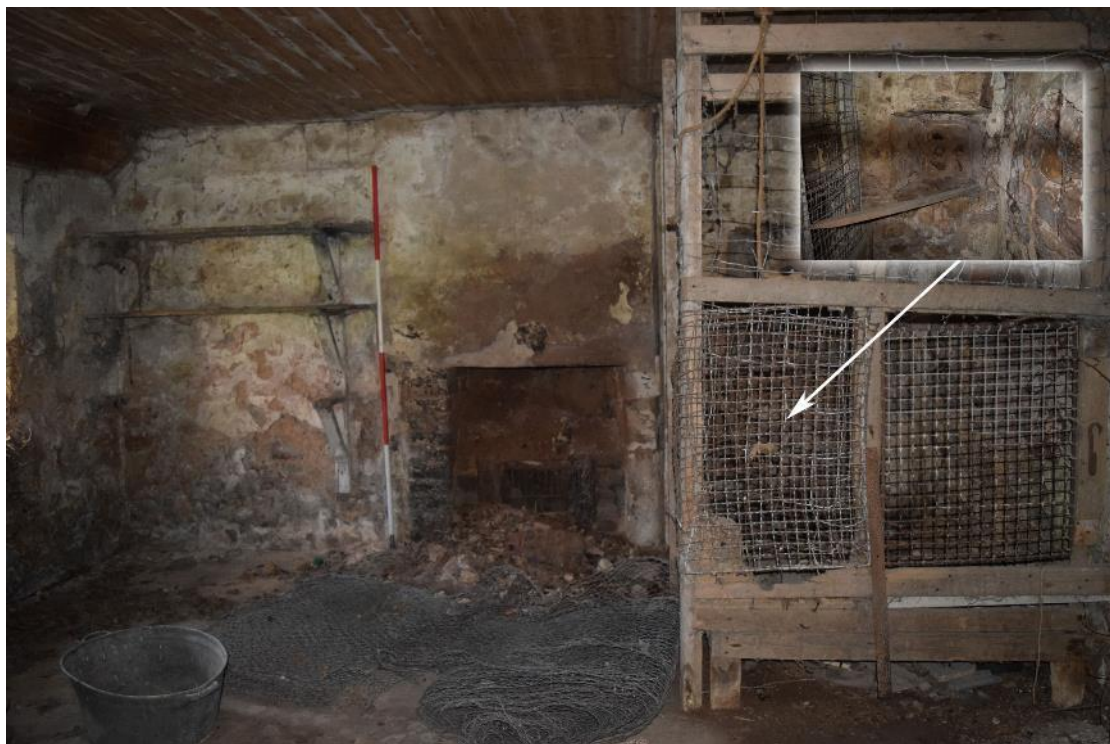
Plate 14: S elevation of Room 4.1, with shelving unit to left and fireplace [014] to right; also note the 'cage' construction and blocked opening [015] in the corner (detail).

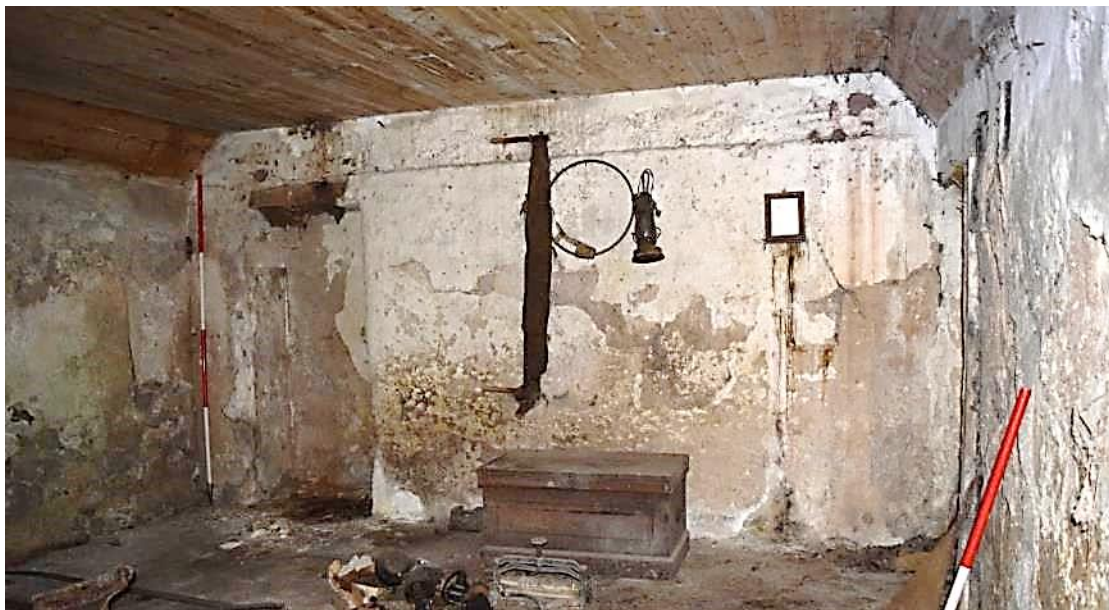
The N elevation (**Plate 15**) retains a line for the original trusses of the roof, situated c. 2.10m above the current floor level. Blocked former doorway [017] is located in the W corner of the elevation, later remodelled into a recess, presumably for shelving unit (portions of strappings remain). The recess retains large timber lintel (composite?) and would have previously served as an access point between Structure 4 and 5. Tool marks are visible at the base of the N elevation, E of the recess [017], where the plaster/render has been chipped off.

Plate 15: N elevation of Room 4.1, with line for the original roof trusses and recess [017] on the left.

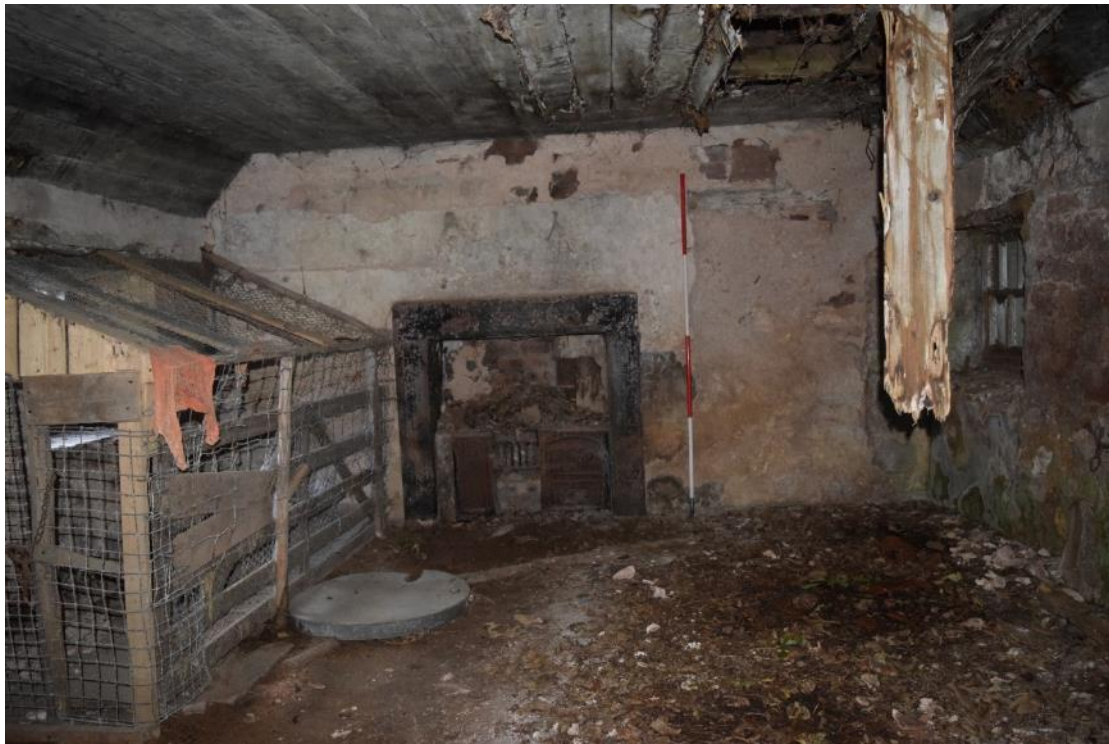
Plate 16: S elevation of Room 5.1, with fireplace/range [018] and blocked former entrance [017] to the left; also note the coved ceiling and cage construction in the corner.

The ceiling of Room 5.1 is coved (**Plate 16 & 19**) to E and W and made of timber panels, this representing later alteration, as the line on the S elevation, indicates where the former trusses of the original roof sat. The space was probably originally opened to the rafters and the roof consisted of a simple frame. Parts of the ceiling are missing or collapsing.

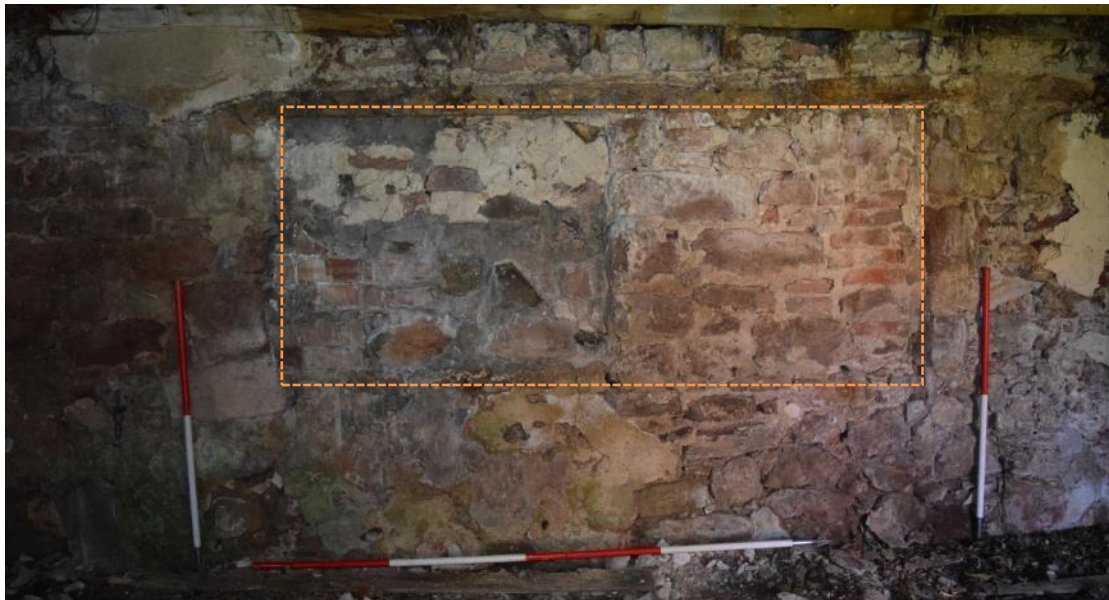
The W elevation retains evidence of three openings (**Plate 17 & 18**)– one [019] still functioning as window, the other two, [020] and [021], since blocked and [021] reused as a niche. Window [019], situated to the S of the elevation, is splayed on the N side and consists of sash, 3 over 3 panes, with all the glass panes broken. It retains composite timber lintel.

Plate 17: Partial W elevation of Room 5.1, showing large blocked opening [020].

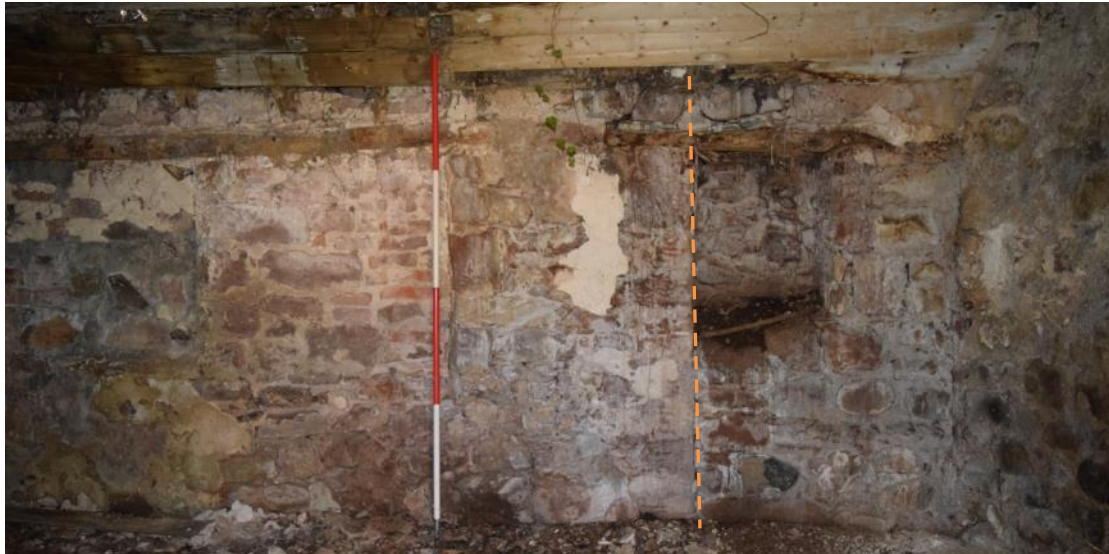
blocked by stone rubble and mortar material. The niche retains composite timber lintel. The northernmost masonry/walling clearly abuts the former quoins of the original northwest corner of Structure 5 (**Plate 18**).

Plate 18: Partial W elevation of Room 5.1, with partial blocked opening [020] on the left and niche [021] to right; also note the former end of the W wall (dotted orange line), marked by quoins later reused as southern jambs of opening/recess [021].

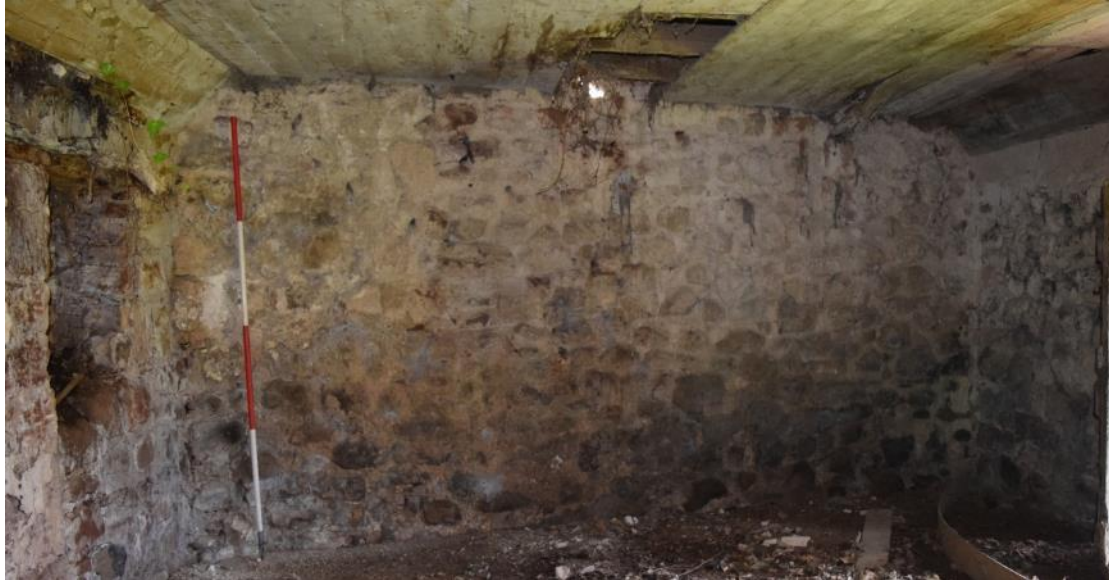
Plate 19: N elevation of Room 5.1, representing later extension of the room; also note the covered ceiling.

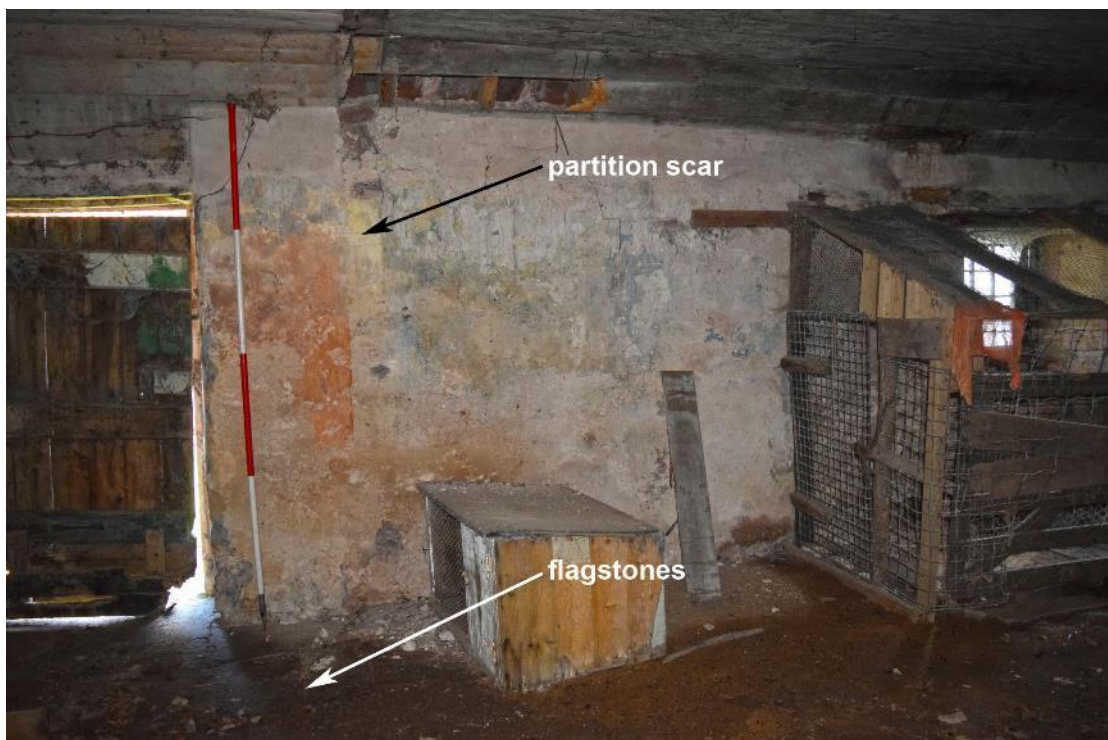
The E & S elevations are plastered/lime-washed, the N and most of the W elevations are stripped bare. Scarring from former partitions (c. 0.15m wide), indicating former room divisions can be seen on the E elevation, as well as the floor and ceiling. Ochre paint scheme around the entrance on the E elevation indicates outline of a former porch, while line of rectangular mortice holes on the ceiling running W indicate the line of the former divisions/walls (**Plate 20**). These suggest the current one-roomed arrangement previously consisted of a porch and further two rooms– one to N and another to S.

Plate 20: Partial E elevation of Room 5.1, with differential paint scheme and marks and scarring from the former wall partitions visible on the elevation and the ceiling.

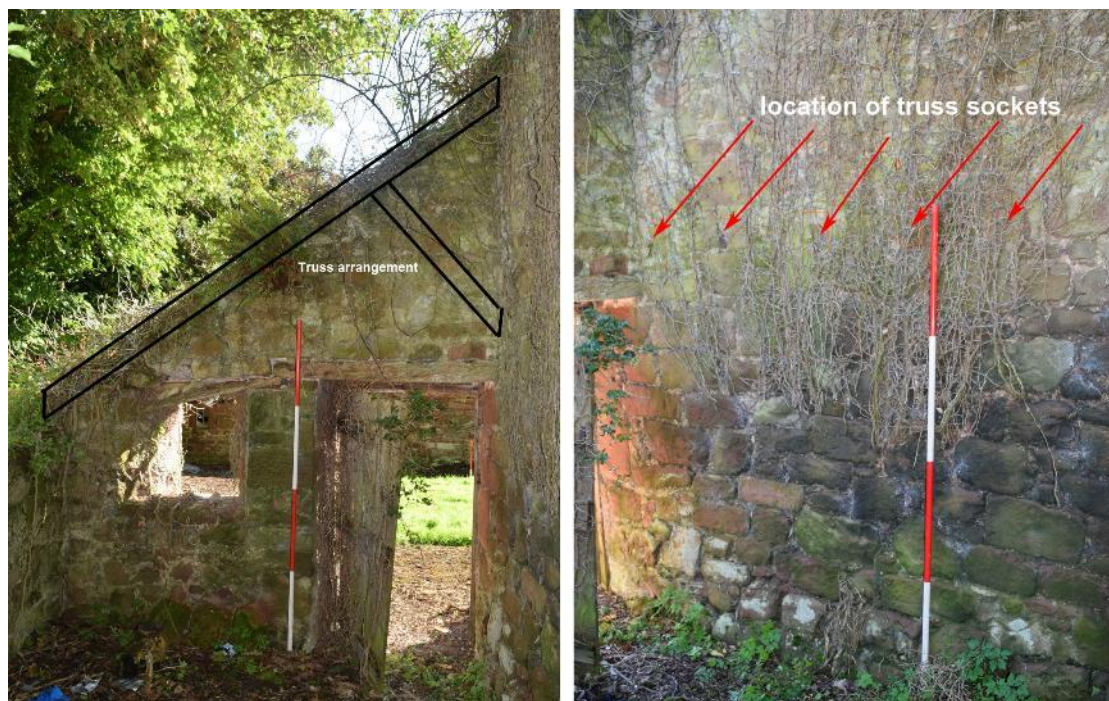
Plate 21: E elevation of Room 6.1, with entrance [006] and window [007] (left); S elevation with line of sockets for former roof trusses (right).

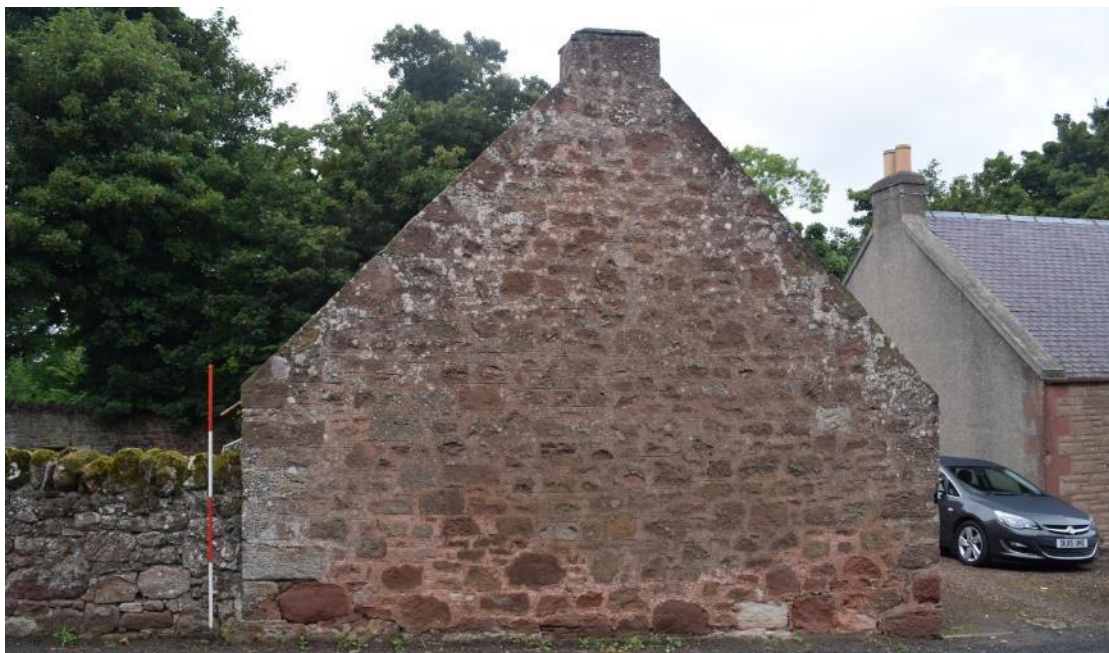
Plate 22: S gable end of Structure 1, surmounted by a low chimney [041].

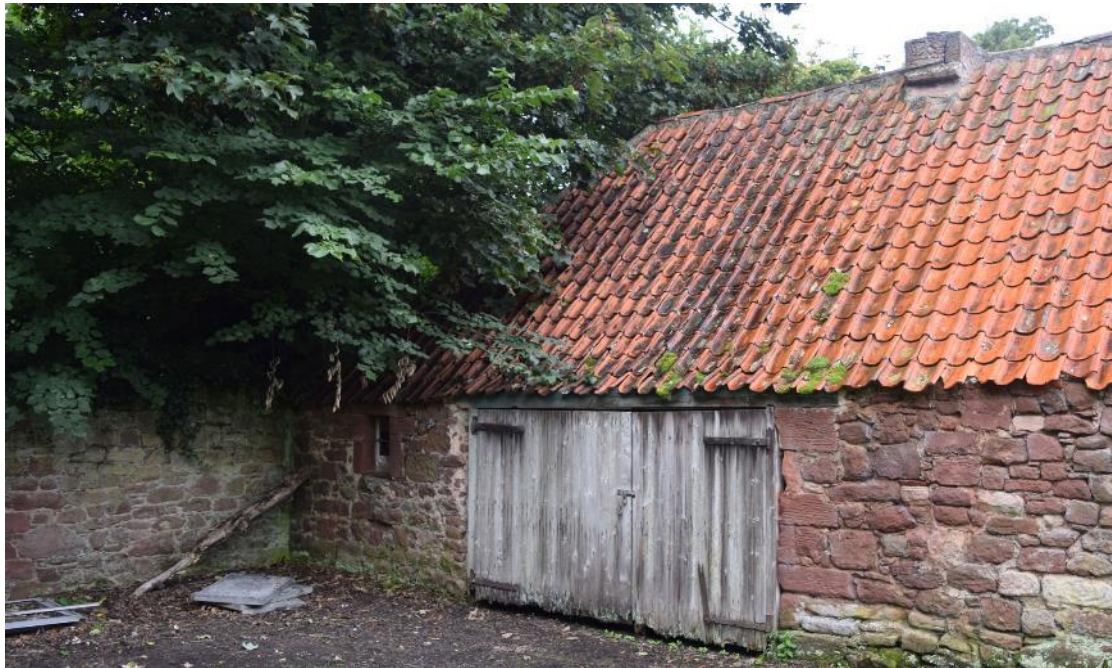
Plate 23: The N end of the E range, showing piended roof of Structure 3 (left) and joint between the N wall of Structure 3 and the boundary wall.

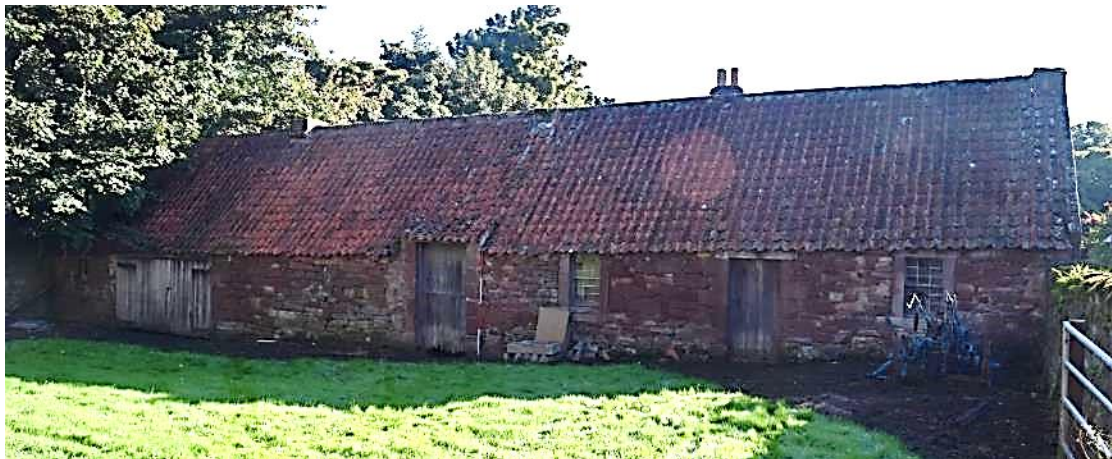
Plate 24: The principal W elevation of the E range, with openings [008-013].

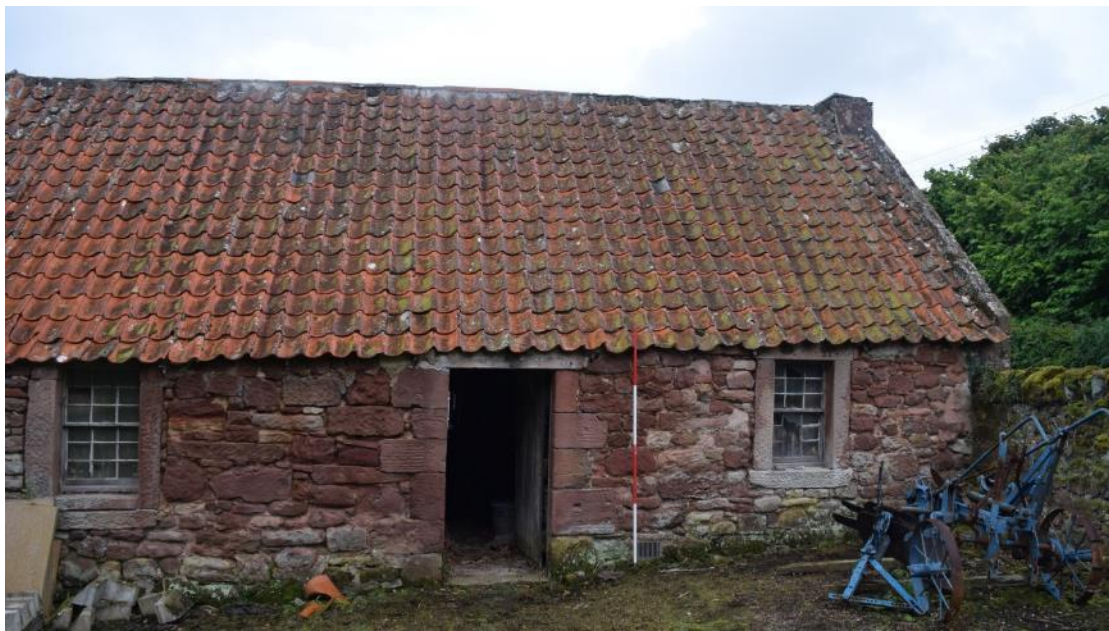
Plate 25: W elevation of Structure 1, with windows [008] and [010] and entrance [009].

Window [010] also retains finely dressed stugged surrounds, comprising two jambs and a cill, this with another sandstone slab on top; the two jambs have narrow droved margins. The window has had the original sandstone lintel replaced by a wooden beam, this resting on the remains of the original lintel. The window is again of sash type, with 9 over 9 panes, and retains timber frame and all of the glass panes, some broken. Both windows are near identical in character, suggesting similar provenance. The centrally located entrance [009] has fine cut and squared dressed red sandstone quoins of the jambs, with broad margins and broad droving marks. The lintel is a cut timber composite. The entrance retains a vertical planked ledged door, with door knob handle and a key-hole.
