Pitcox Old Smithy, Pitcox, East Lothian

Data Structure Report

December 2017

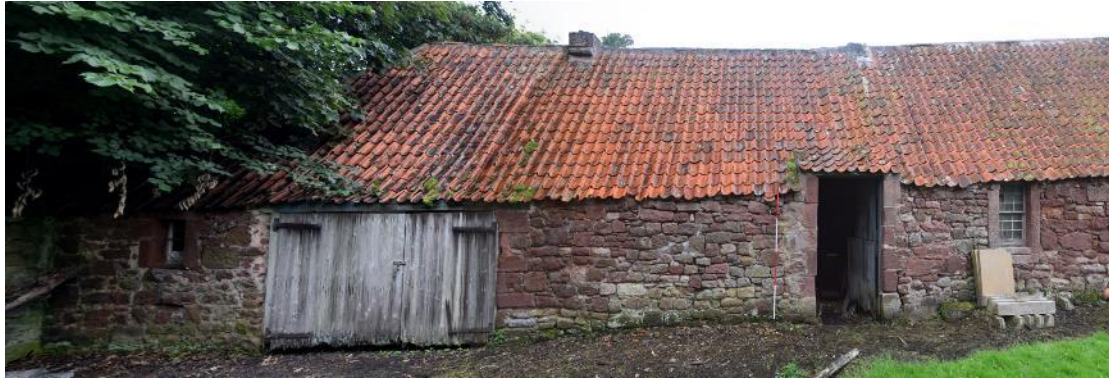
and reused quoin jambs, some with stugged tool marks; the lintel is a cut timber composite. Cementitious repair can be seen around the top corners of the entrance and down its sides, where the quoins have been re-inserted. The entrance retains timber frame and a 'Dutch or stable' vertically planked door, with base greatly decayed.

Plate 26: W elevation of Structure 2, with tall entrance [011]; Structure 3 to left.

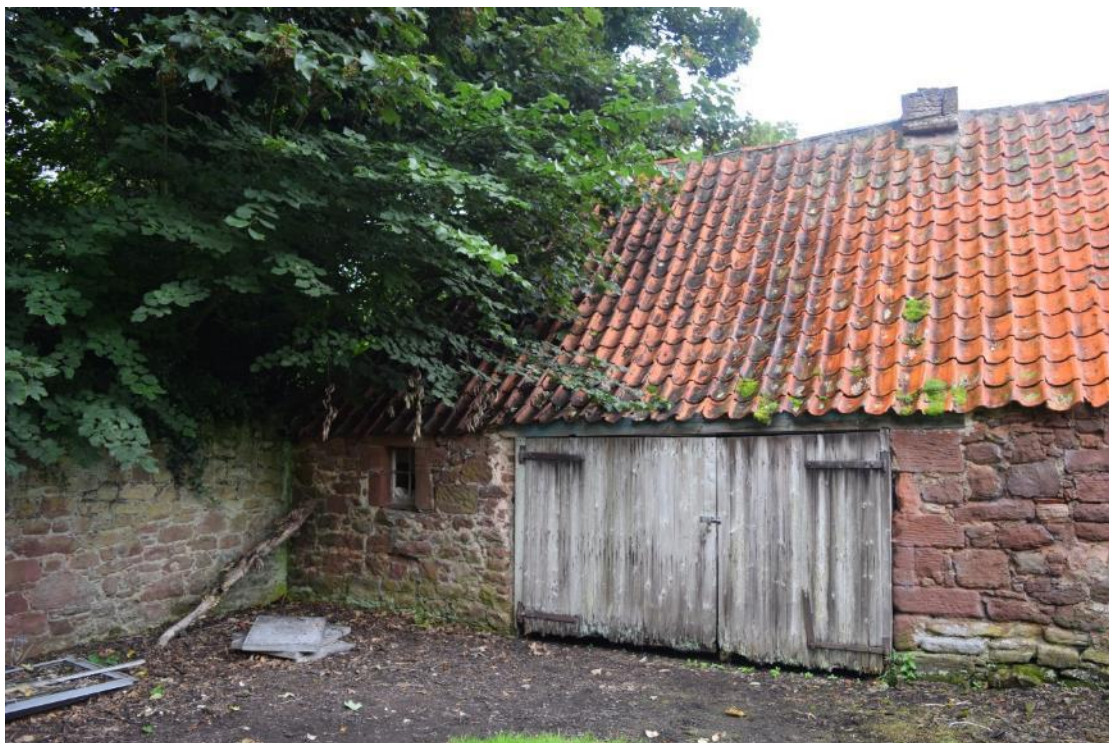
Plate 27: W elevation of Structure 3, with wide double entrance [012] and window [013].

planked door, the base decayed, and cut square timber composite lintel. The small window [013], N of the entrance [012], is of fixed pane (4 panes) variety and retains finely dressed red sandstone surrounds, including jambs with broad margins.

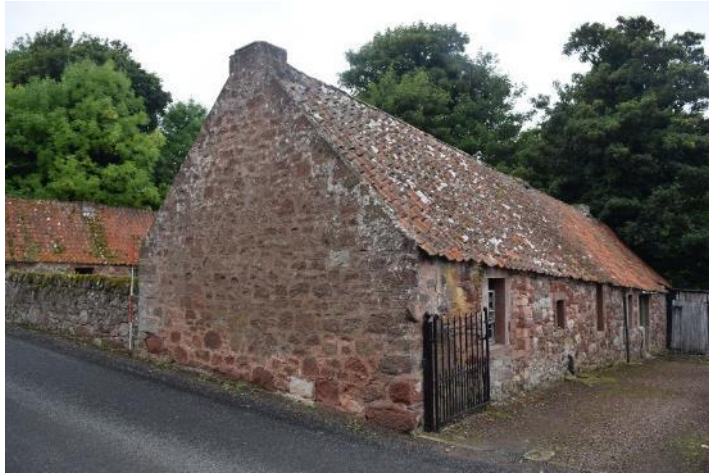
The E elevation of the W range (**Plate 28; Figure 7**) faces onto a courtyard of neighbouring property (former Grieve house). The elevation is penetrated by six openings, comprising one entrance, [047] and five windows (from S)– [026], [027], [029], [036] and [035].

Plate 28: complete E elevation of the E range from the southeast.

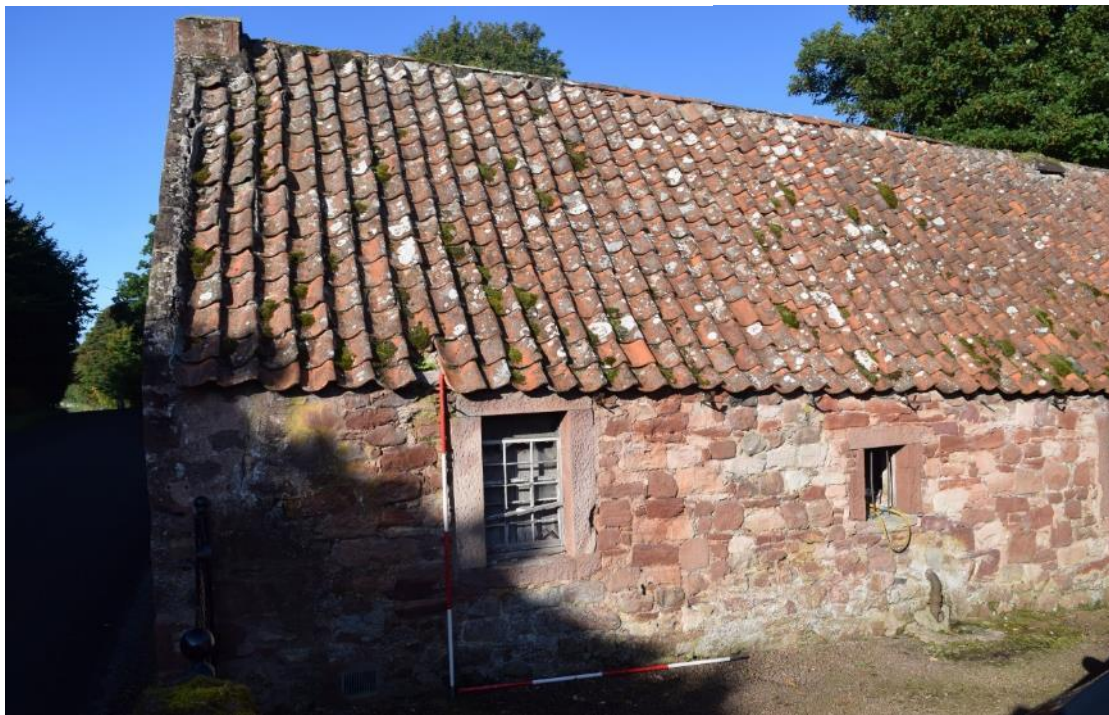
Plate 29: Partial E elevation of Structure 1, with windows [026] and [027].

The E elevation of Structure 1 (**Plate 29**) is built of random coursed sandstone rubble with occasional sandstone blocks and some rounder field-derived stones. The elevation is penetrated by three openings/windows [026-029]. All have fine stugged sandstone surrounds, but the northernmost [029] has its original sandstone lintel replaced with a timber one. The windows are of varied sizes but appear in their original position and differences either reflect placement to accommodate rooms with varied functions– i.e. larger window [026] lighting larger Room 1.3, as opposed to smaller window [027] which provides light for smaller pantry/washroom. Windows [026] and [029] are sash–9 over 9 and 9 over 6 respectively, with frame and window panes

retained, showing varied degree of decay; window [027] has fitted vertical steel/iron bars.

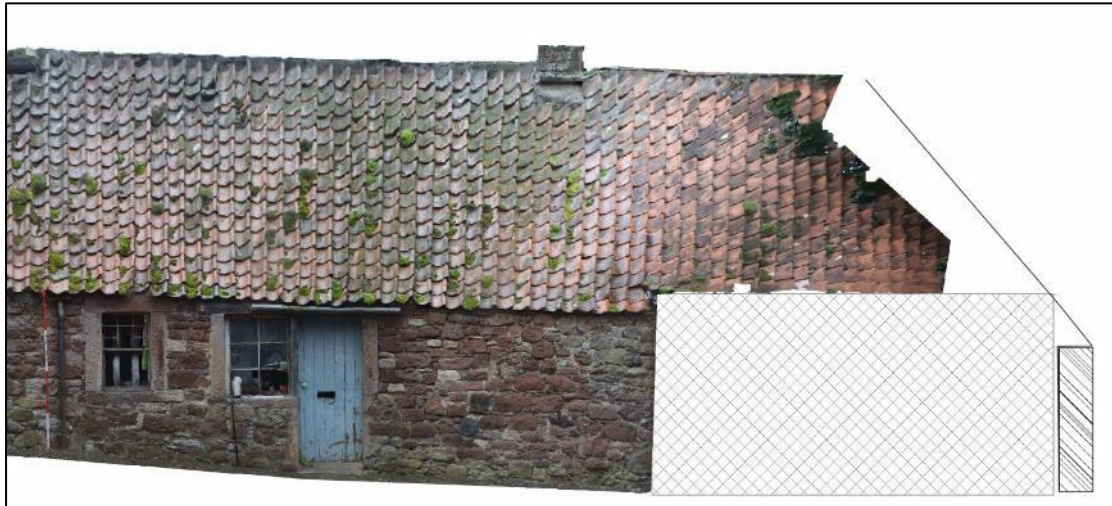
Plate 30: E elevation of Structure 2, with windows [036] and [035]; also note entrance [047] and later timber structure added to the façade (cross-hatched area).

Correspondingly, the entrance [047] and window [035] have also evidence of reuse of stonework and change from original configuration. The window [036], which is sash (formerly 9 over 9) type, has fine stugged sandstone surrounds, with narrow droved margin; all glass window panes are missing. Window [035], which is of fixed 6 pane variety, retains fine stugged sandstone jamb, with narrow droved margin, to S and a cill, but the former sandstone lintel has been replaced with timber one (this shared with entrance [047]), while the jamb to the N is missing, replaced by a door frame/door jamb of entrance [047].

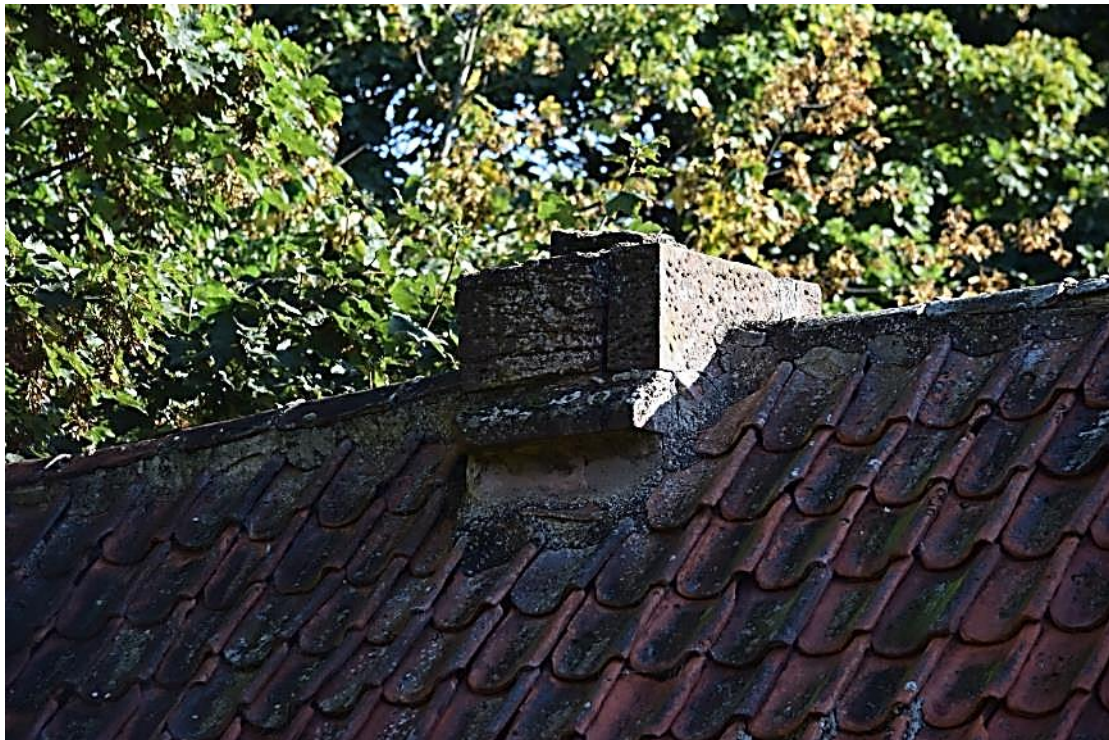
Plate 31: Detail of the chimney stack [043], with projecting chamfered drip stone.

There are three chimney stacks, the one to the S [041] serving Room 1.3; the middle one [042] (much damaged) Room 1.4 and the one to the N [043] Room 2.1 respectively. The chimney stacks to the S and N are well preserved, made of fine sub-rectangular red sandstone blocks, some with droved, some with stugged tool marks. Portion of a drip course/stone remains on top of chimney [041], while a complete chamfered stugged dripstone is retained on the chimney [043] (**Plate 31**), similar to the one on central chimney of the W range [045]. The middle chimney stack [042] is much damaged and only a single course remains visible, with chamfered dripstone visible on the E side.

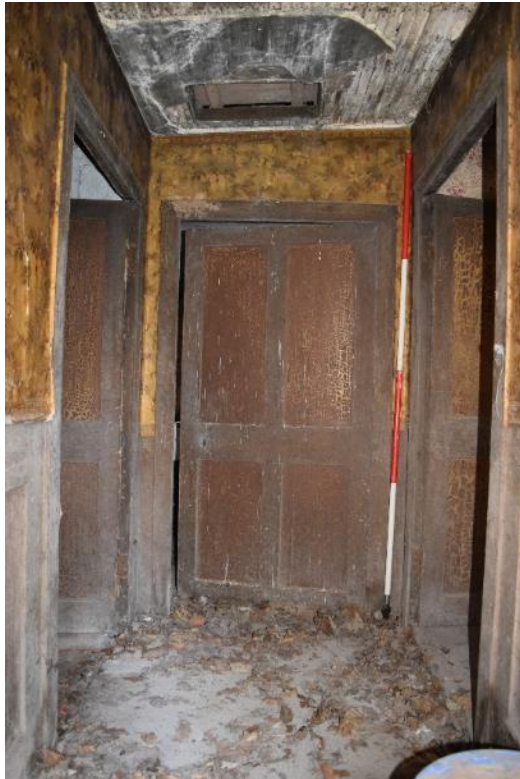
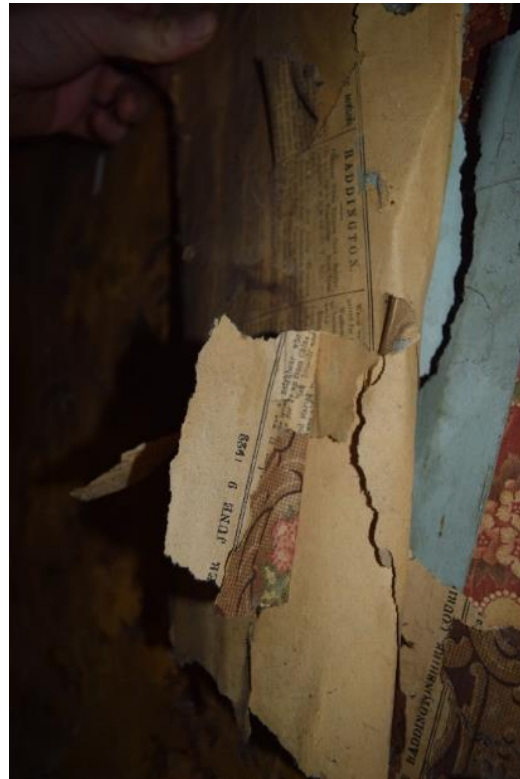
Plate 32: Structure 1, Room 1.1– Left: door [024] into Room 1.2; also note the small roof hatch in the lath ceiling and panelled walls; right: wallpaper and newspapers on the panelling of S elevation.

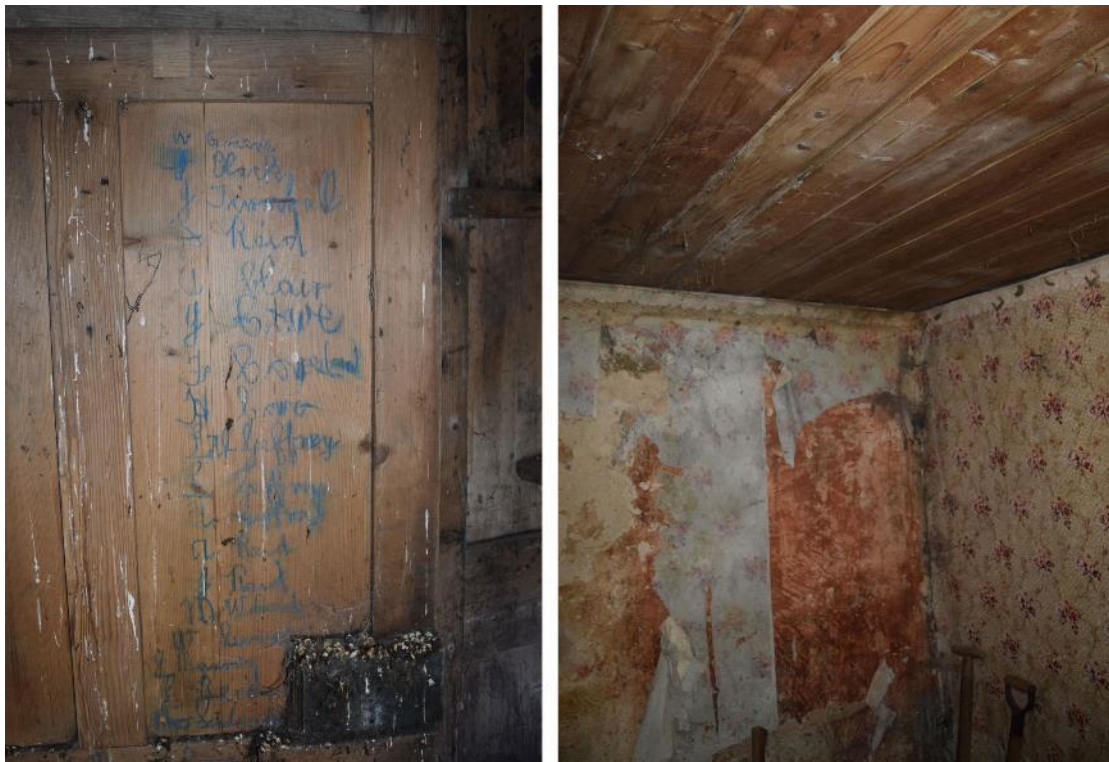
Plate 33: Room 1.2– door [024], with graffiti (left); Room 1.3, with decorative scheme and wallpapers (right)

The E, S and W interior walls are stone and decorated with wallpaper of varied degree of decay and diverging decorative flower pattern schemes (**Plate 33**). There are also remains of pink-ochre paint. The N wall consists of a timber recessed panelling also with wallpapers.

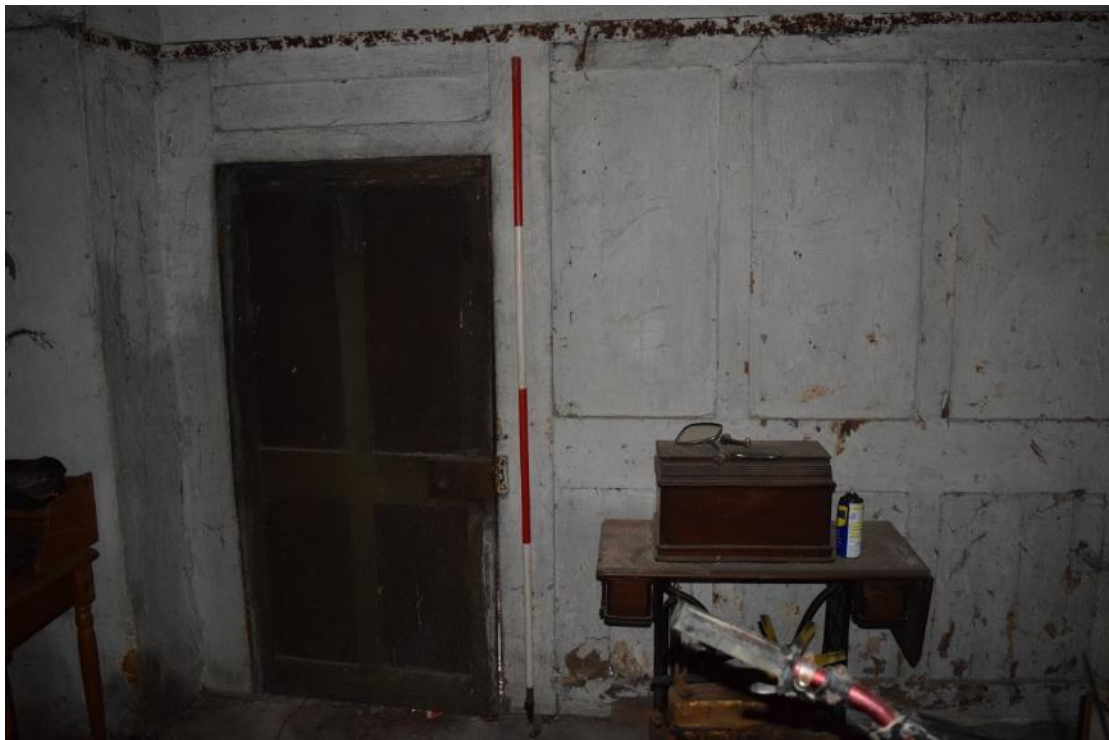
Plate 34: S elevation of Room 1.4– with door [022] and wooden panelling.

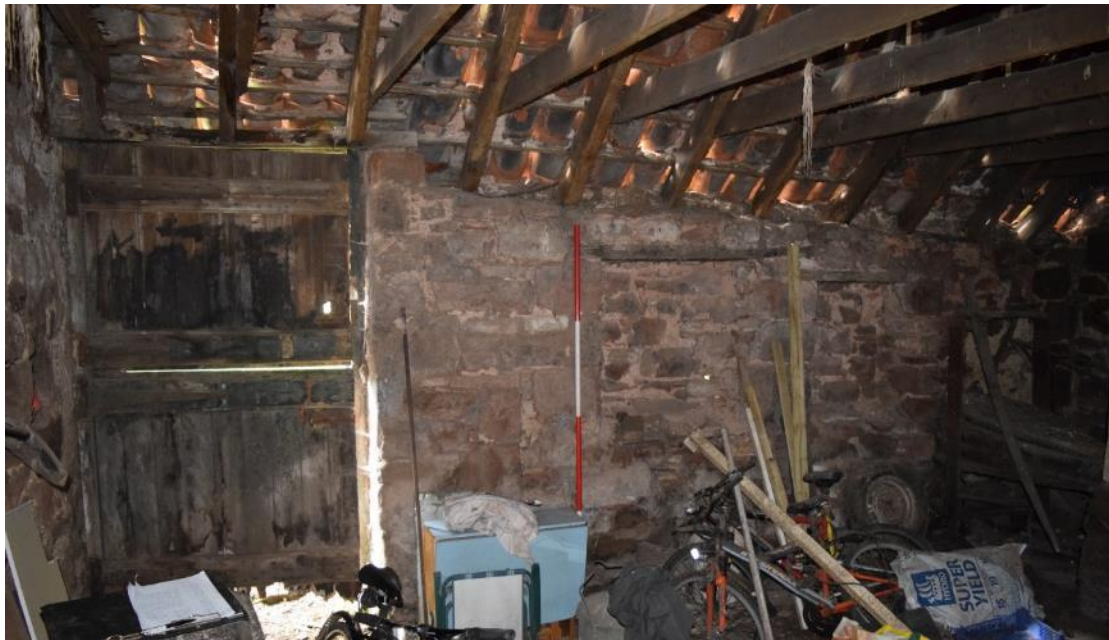
Plate 35: W elevation of Room 2.1– with entrance [011] and niches [030], [031] and [032] to left.

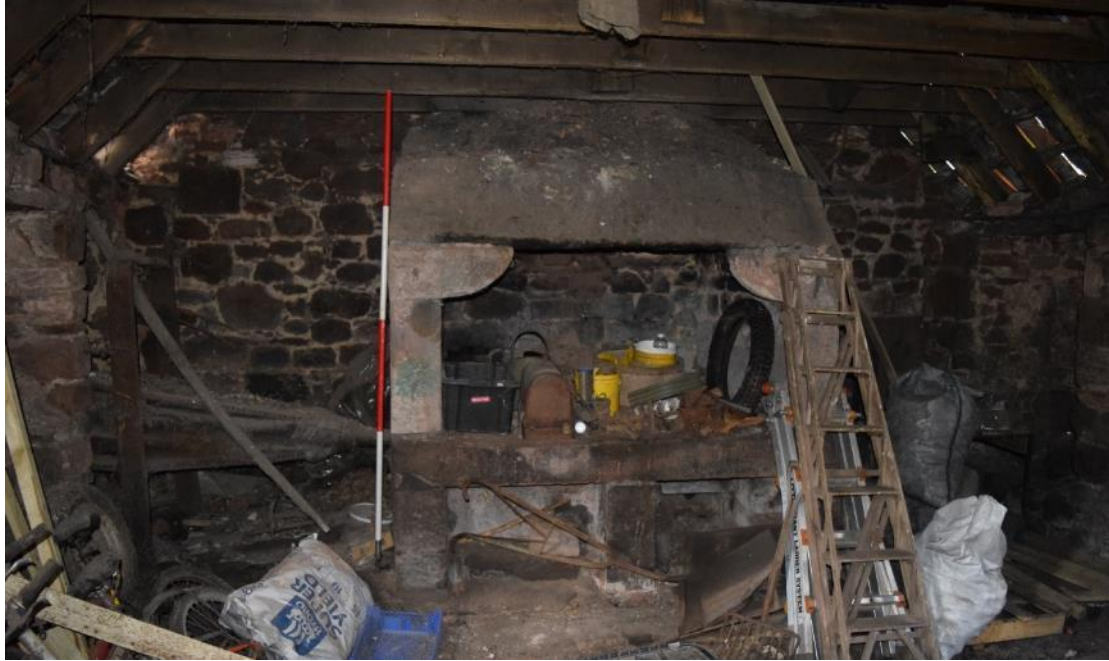
Plate 36: Room 2.1, N elevation with massive lugged hooded forge and bellows to left.

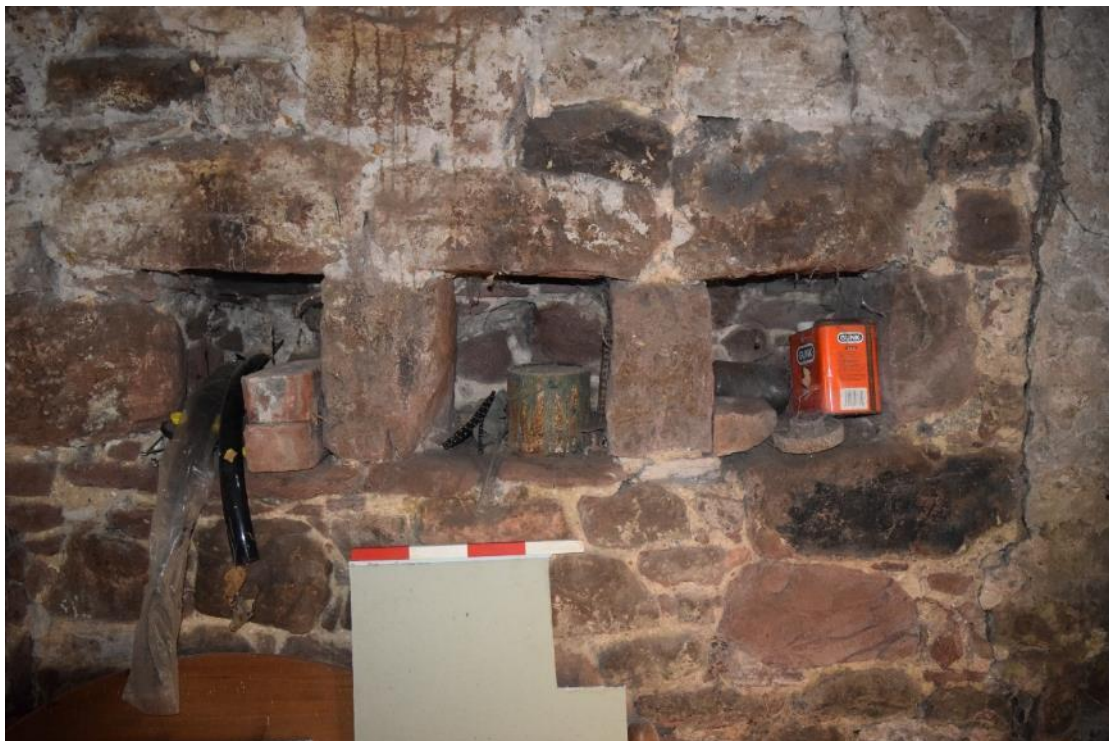
The S elevation includes a line of three small roughly cut rectangular niches [037]; [038] and [039] to the W (**Plate 37**), approximately centrally (height), and a single iron ring to the E (probably for tethering horses; see also below). A brick repair of a chimney flue [042], for the range in Room 1.4, can be seen at the base of the S wall.

Plate 37: Partial S elevation of Room 2.1– with three small niches [037], [038] and [039].

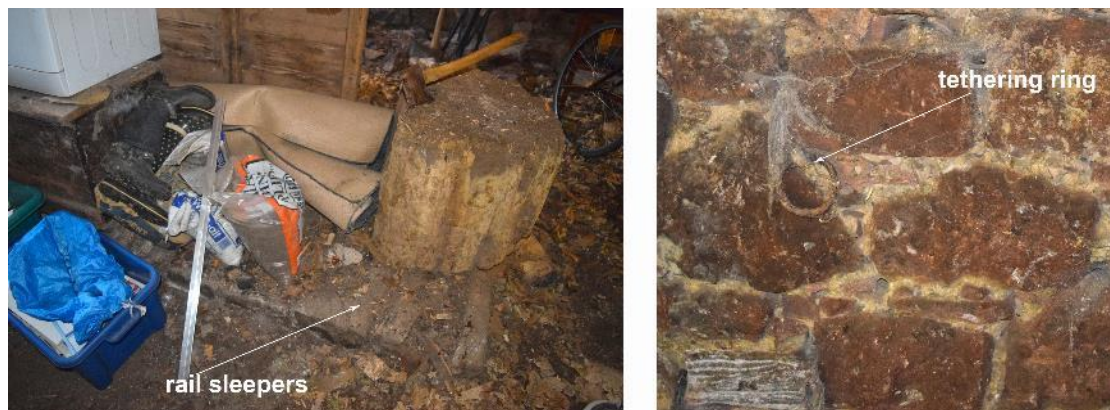
Plate 38: Room 2.1, detail of sleeper beam flooring (left) and iron 'tethering' ring on the S elevation (right).

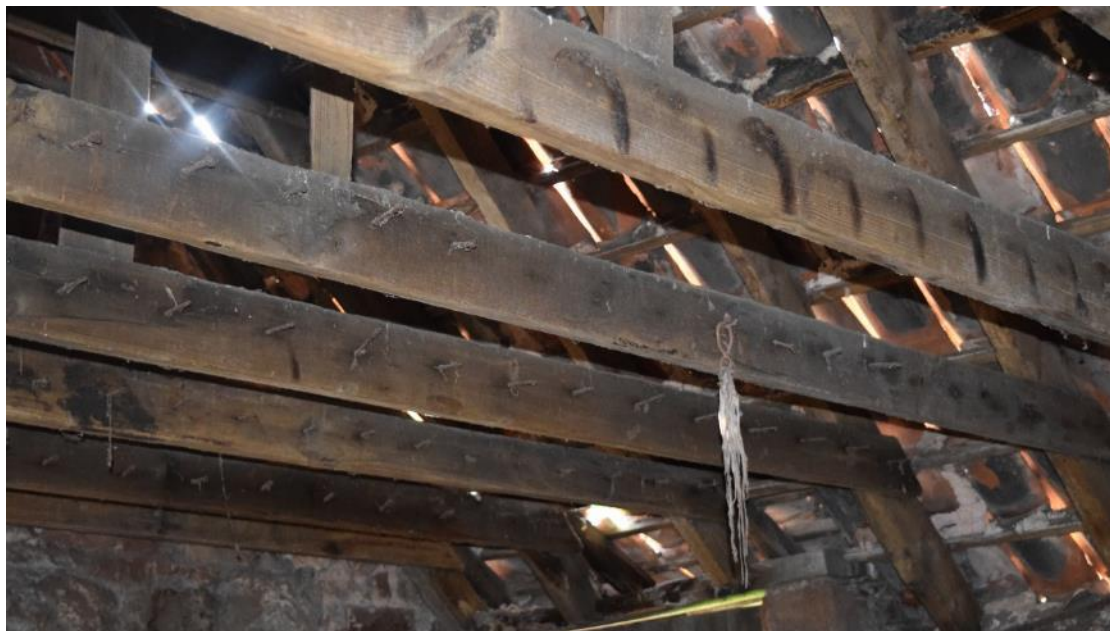
Plate 39: A-frame roof with kingposts; Room 2.1, with nails and horseshoe scorch marks on the lower cross beams.

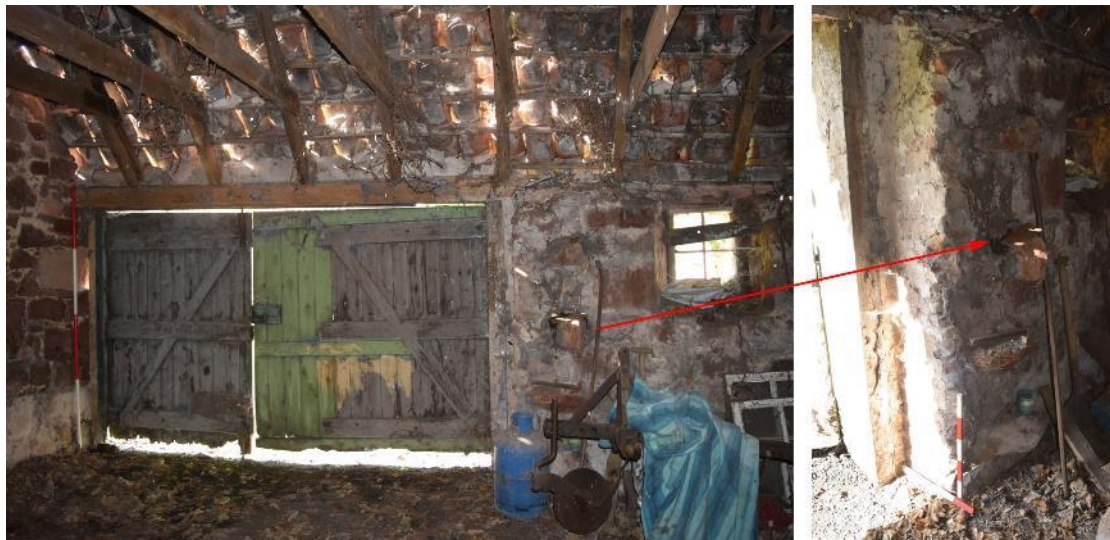
Plate 40: W elevation of Room 3.1, with large entrance [012] and small window [013] (left); tasking stones N of the entrance [012] (right).

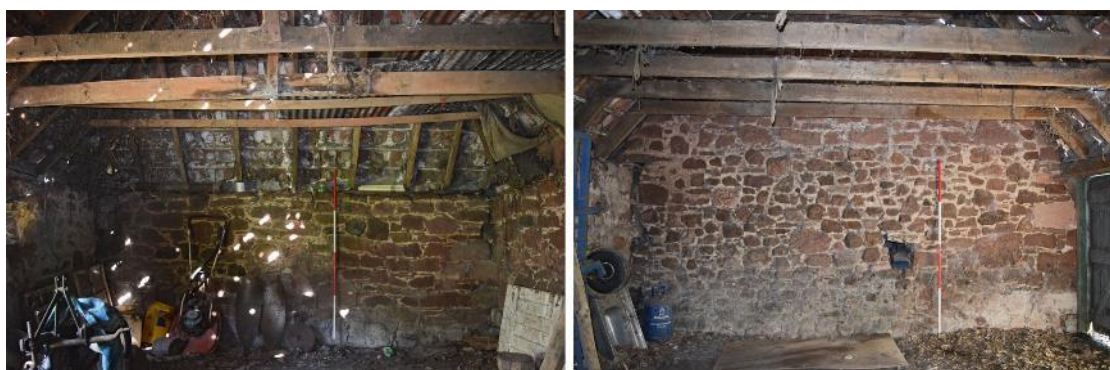
Plate 41: Room 3.1, Left– N elevation formed by boundary wall; with sloping piended roof; Right– S elevation with opening [040].

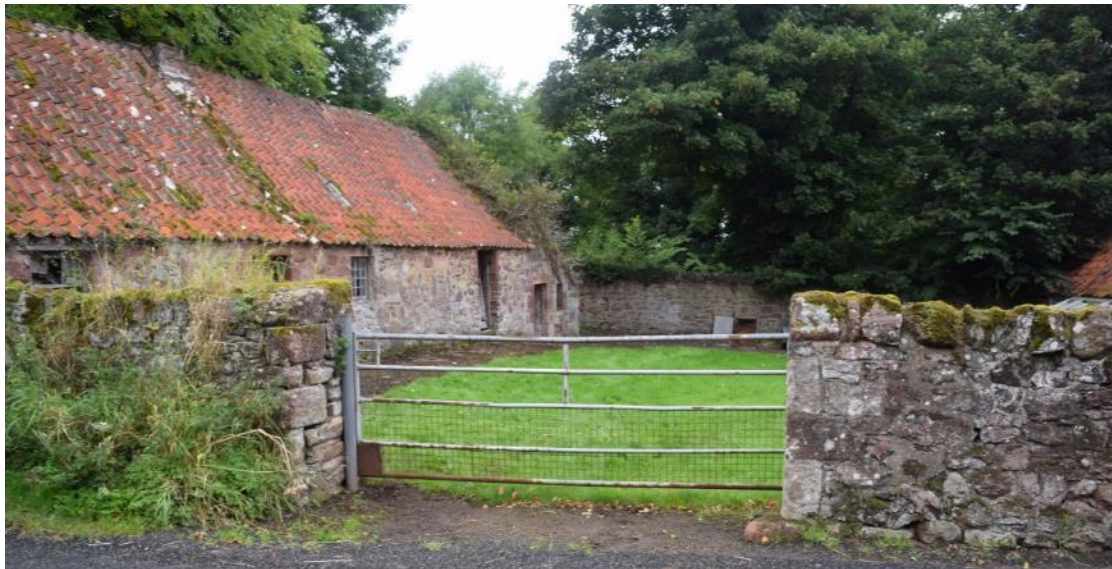
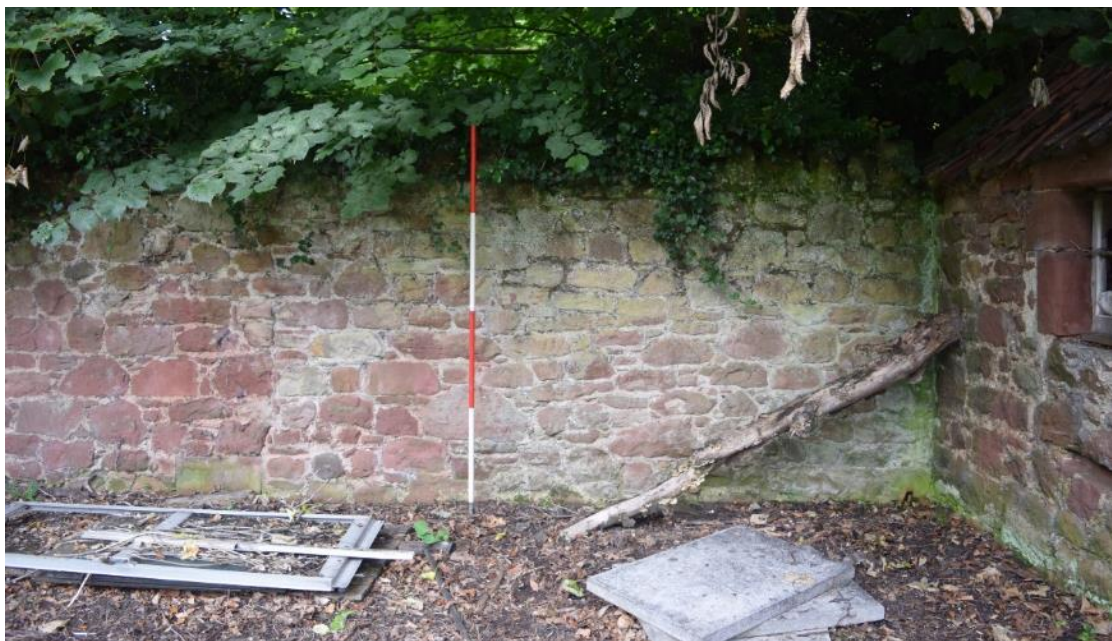
Plate 42: S portion of the boundary wall, with wide gate (top); N portion of the boundary wall, with possible joint between E and W sections to left of the ranging rod (bottom).

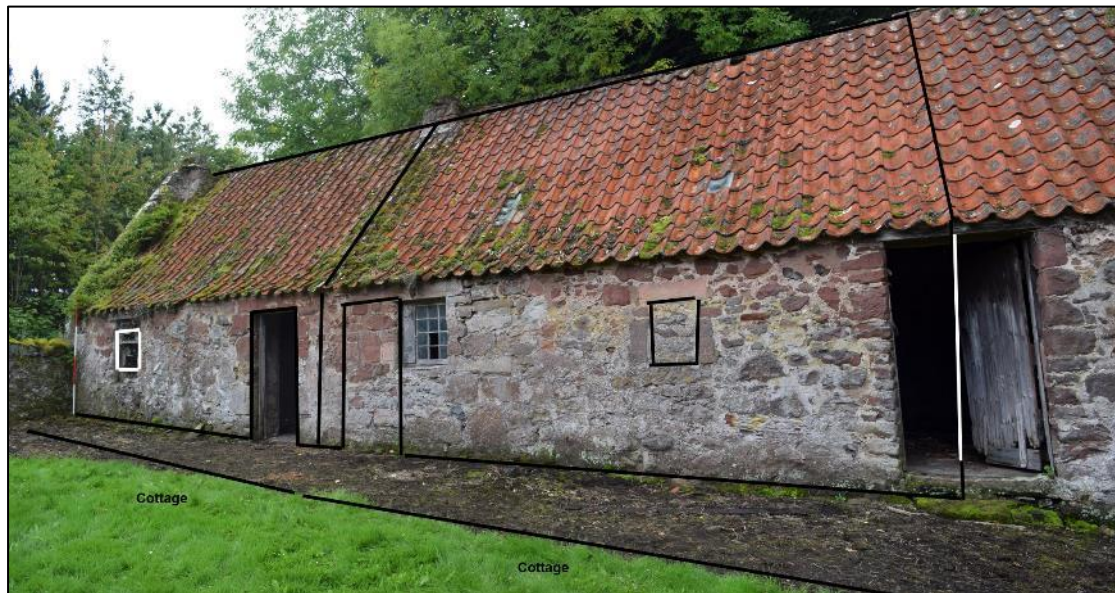
Plate 43: View to SW, showing the original formerly thatched cottage (Structure 4) to left; with abutting Structure 5 to right. Conjectural double hinds' cottage marked with black lines.

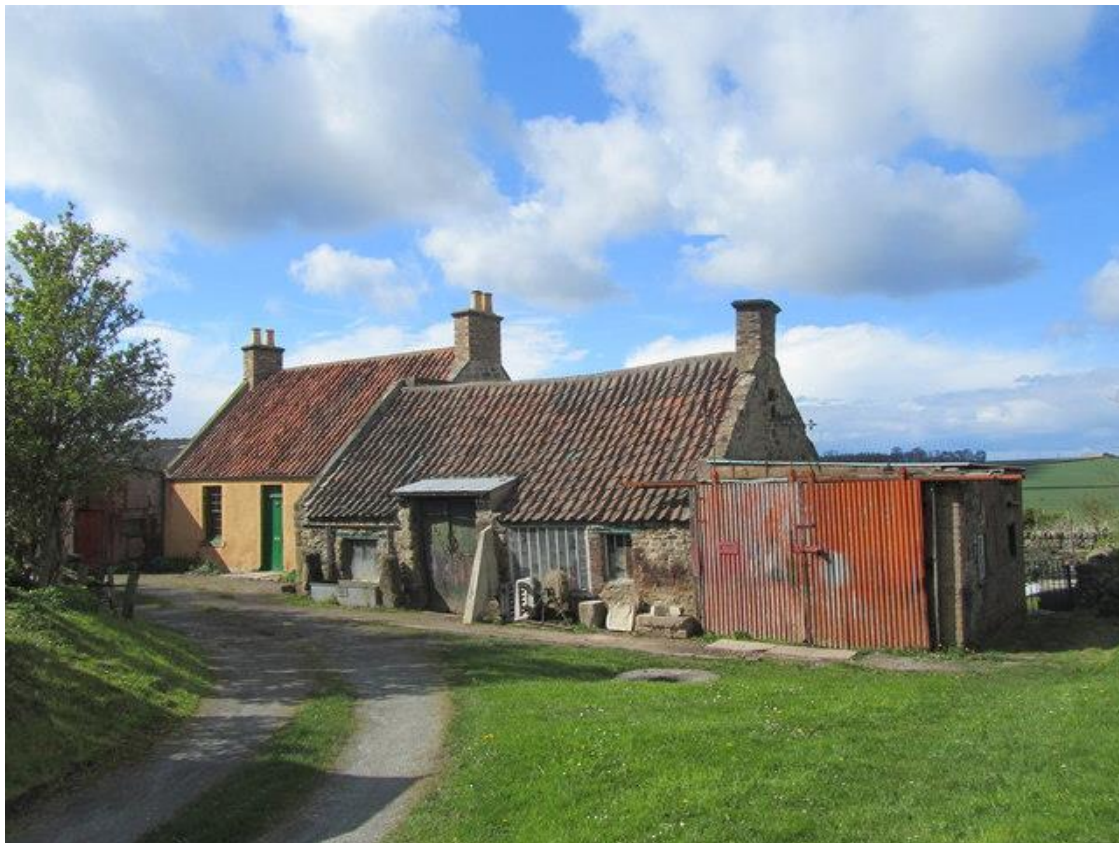
Plate 44: Early 18th century Smithy at Cousland, with later alterations; note the large window next to the central entrance, which served to provide increased light for the smithy workshop (© Copyright [C.L.T Smith](#) and licensed for [reuse](#) under this [Creative Commons Licence](#))

Having said that, the evidence for a thatched roof on both structures (4 & 5) argues against the likelihood of Room 5.1 serving as a smithy. Alternative site for the earlier Smithy might therefore be sought elsewhere within the Pitcox settlement/ farmstead. Alternatively, it can be suggested that the original hind's cottage (Structure 5), may have been later converted to smithy, associated with change in roofing (from thatch to pantile roof), and therefore the large window [020] may likewise be associated with this change (however temporary) into a smithy. Larger windows can be found on other contemporary smithies, such as the late 18th century Cousland Smithy (**Canmore ID:** 96423), which has two larger windows, as well as the large central door (**Plate 44**).

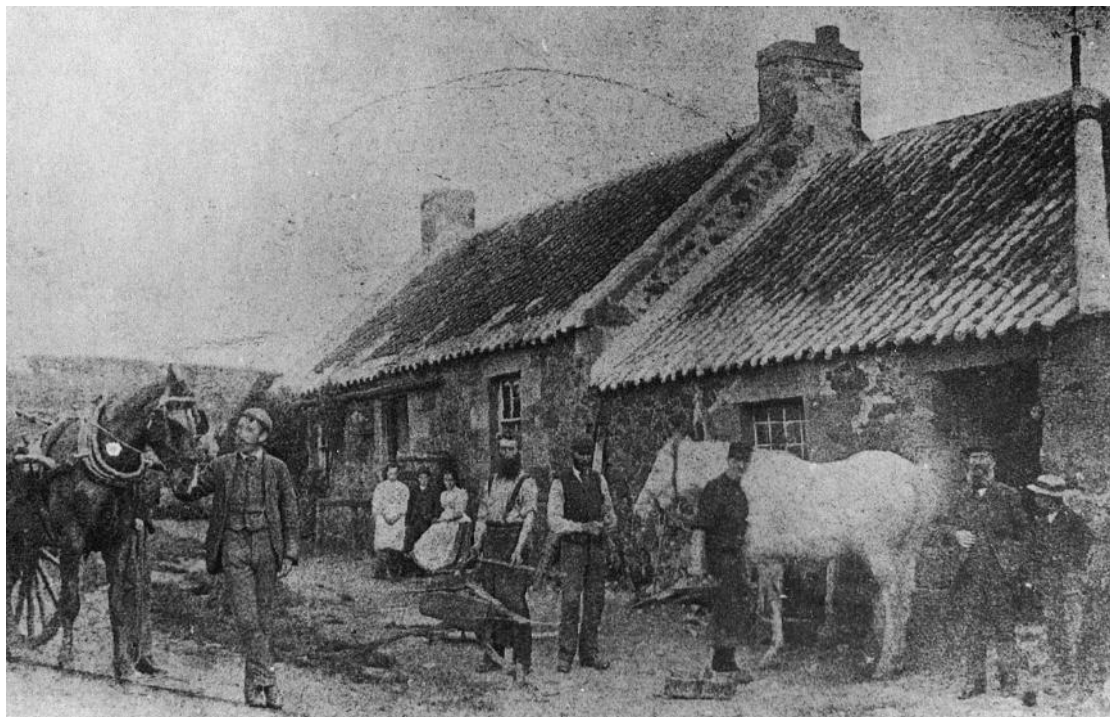
Plate 45: The Old Smithy at Oldhamstocks village in 1900, with tall door to fit horses (image from HS 2000: 24).

Phase IV is represented by considerable alterations to the layout and character of Structure 2, associated with its transformation into a smithy. As suggested earlier, this most likely occurred sometime during the late the 19th century (c. 1880s), probably associated with new blacksmith Mr Crozier, taking over the business in the village. The character of the smithy at this time and its use would probably not be dissimilar to the one at Oldhamstocks village, run under local Smith Mr Tom Hogg (**Plate 45**; information from interpretation panel in the Oldhamstocks Parish Church).
