Harmony Hall, Melrose, Rear Courtyard

November 2008

Carried out on behalf of the National Trust for Scotland

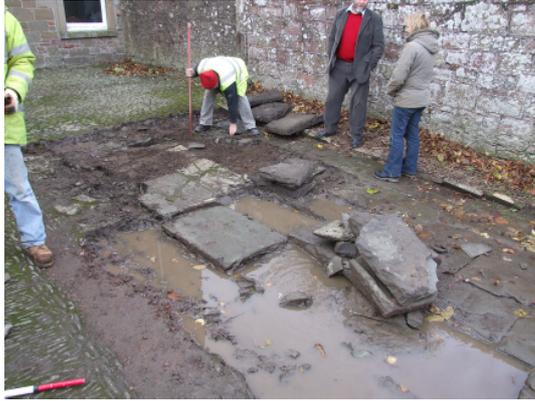
HHM08_001.JPG

Photo Record List – Harmony Hall - Melrose				
Photo ID	Digital	Description	Direction to	Date
1	HHM08_001	Record shot of Trench 1 – during lifting of slabs [1001]	SW	10/11/2008
2	HHM08_002	Record shot of Trench 1 – during lifting of slabs [1001]	S	10/11/2008
3	HHM08_003	Record shot of standing area, with parallel ‘carriage tracks, [1004] and west ‘retaining wall’ [1005] beneath	Vert	10/11/2008
4	HHM08_004	Record shot of standing area, with parallel ‘carriage tracks, [1004] and west ‘retaining wall’ [1005] beneath	Vert	10/11/2008
5	HHM08_005	View over northern end of investigation area, with the mixed layer [1006] to the left and the ‘standing area’ to the right showing the interface between the two. Note earlier 1998 intervention in top left [1007]	Vert	10/11/2008
6	HHM08_006	View over southern end of investigation area, with the mixed layer [1006] to the left and the ‘standing area’ to the right	SE	10/11/2008

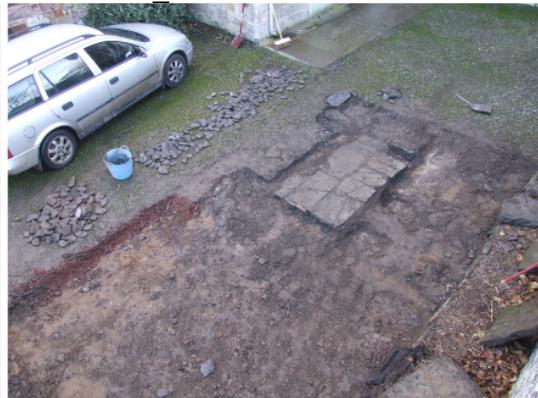
HHM08_006.JPG

7	HHM08_006	View over northern end of investigation area, with the mixed layer [1006] to the left	E	10/11/2008
