GEOPHYSICAL SURVEY REPORT

Twin Yards Farms, Beristowe Lane, Hilcote

Global Renewable Construction Ltd

**Detailed magnetic survey –
Gradiometry**

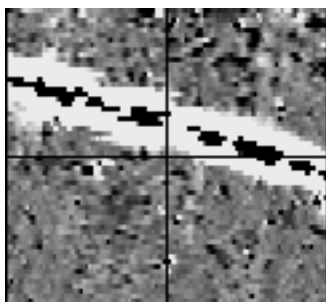
Positive linear anomaly with associated negative response

A positive linear anomaly which has a negative anomaly located adjacently. This will be caused by a single feature. In the example shown this is likely to be a single length of wire/cable probably relating to a modern service. Magnetically weaker responses may relate to earthwork style features and field boundaries.

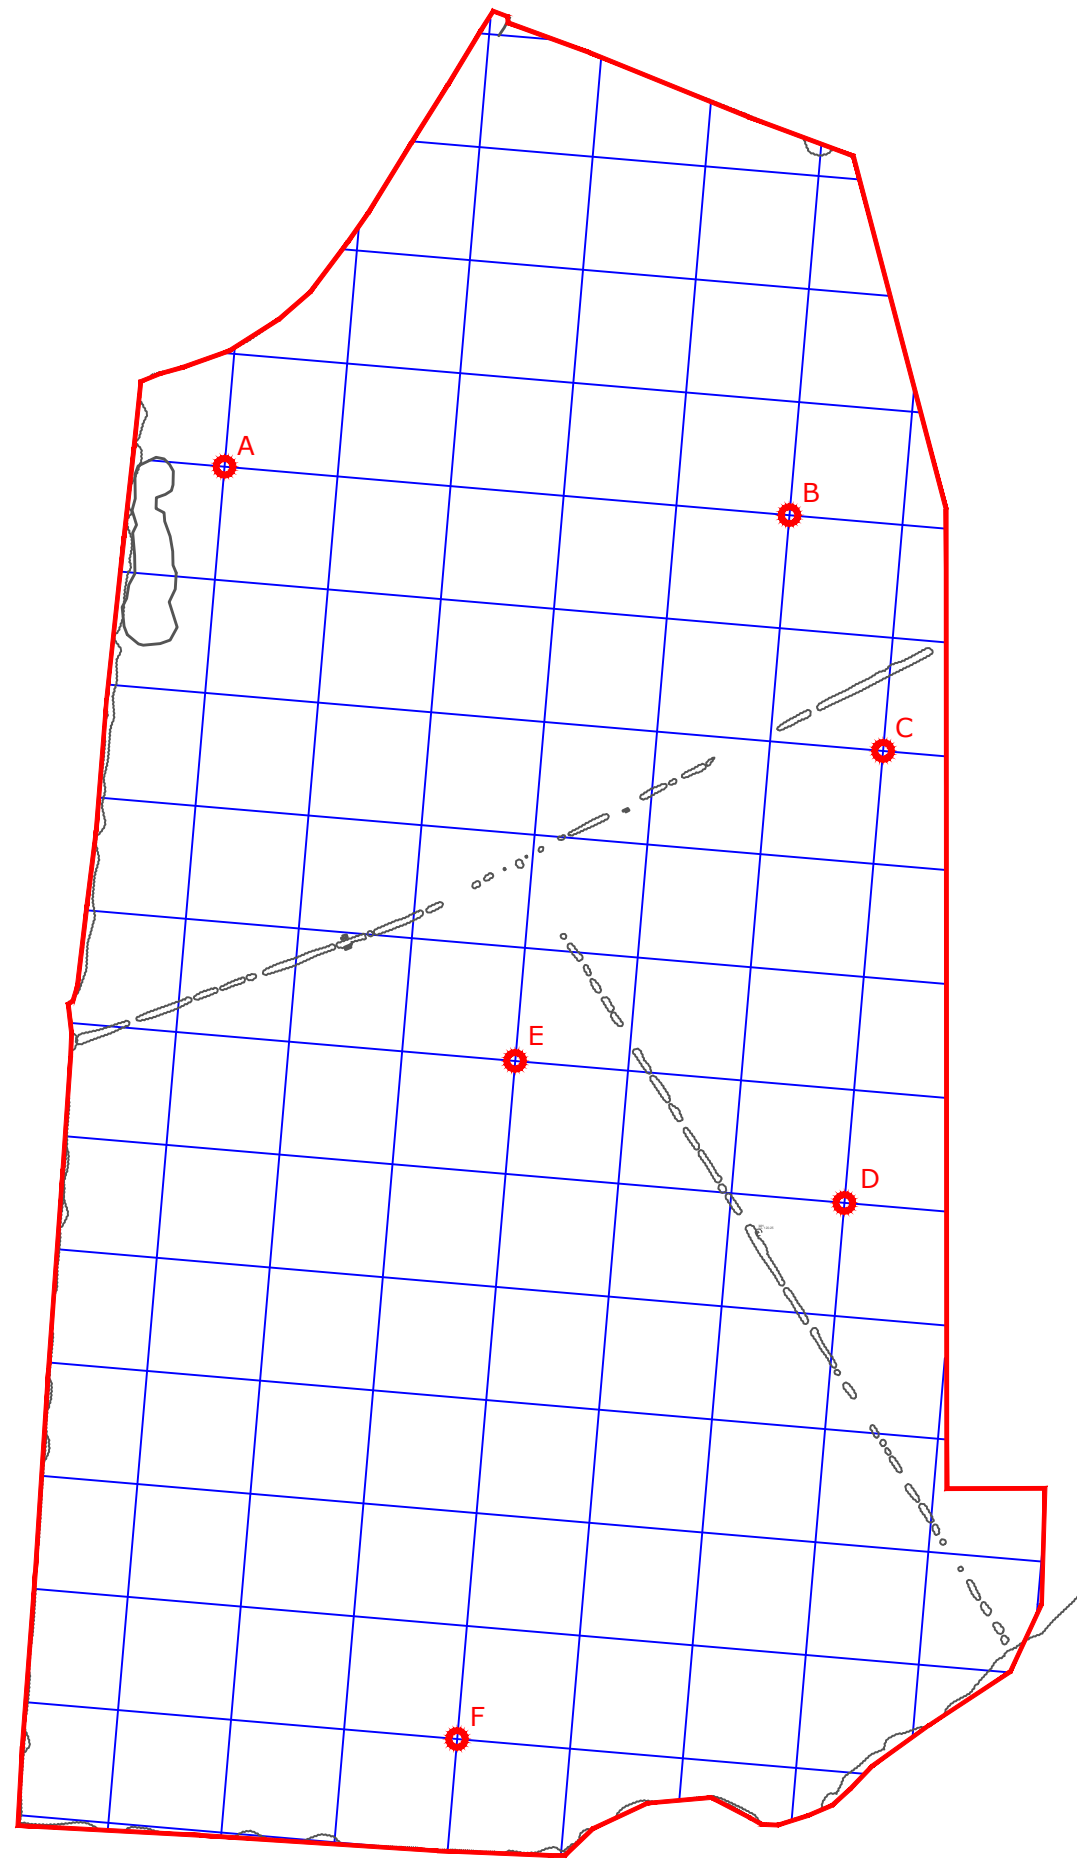
Plot A3	Checked by DGE	Issue No. 01
Survey date MAY 15	Drawn by TR	Figure No. 02

A	445652.76, 358154.49
B	445802.21, 358141.68
C	445826.98, 358079.34
D	445816.73, 357959.78
E	445729.62, 357997.35
F	445714.26, 357818.01

Subject
**LOCATION OF SURVEY GRIDS AND
REFERENCING**

The location of the survey grids has been plotted together with the referencing information. Grids were set out using a Leica 705auto Total Station and referenced to suitable topographic features around the perimeter of the site or a Leica Smart Rover RTK GPS.

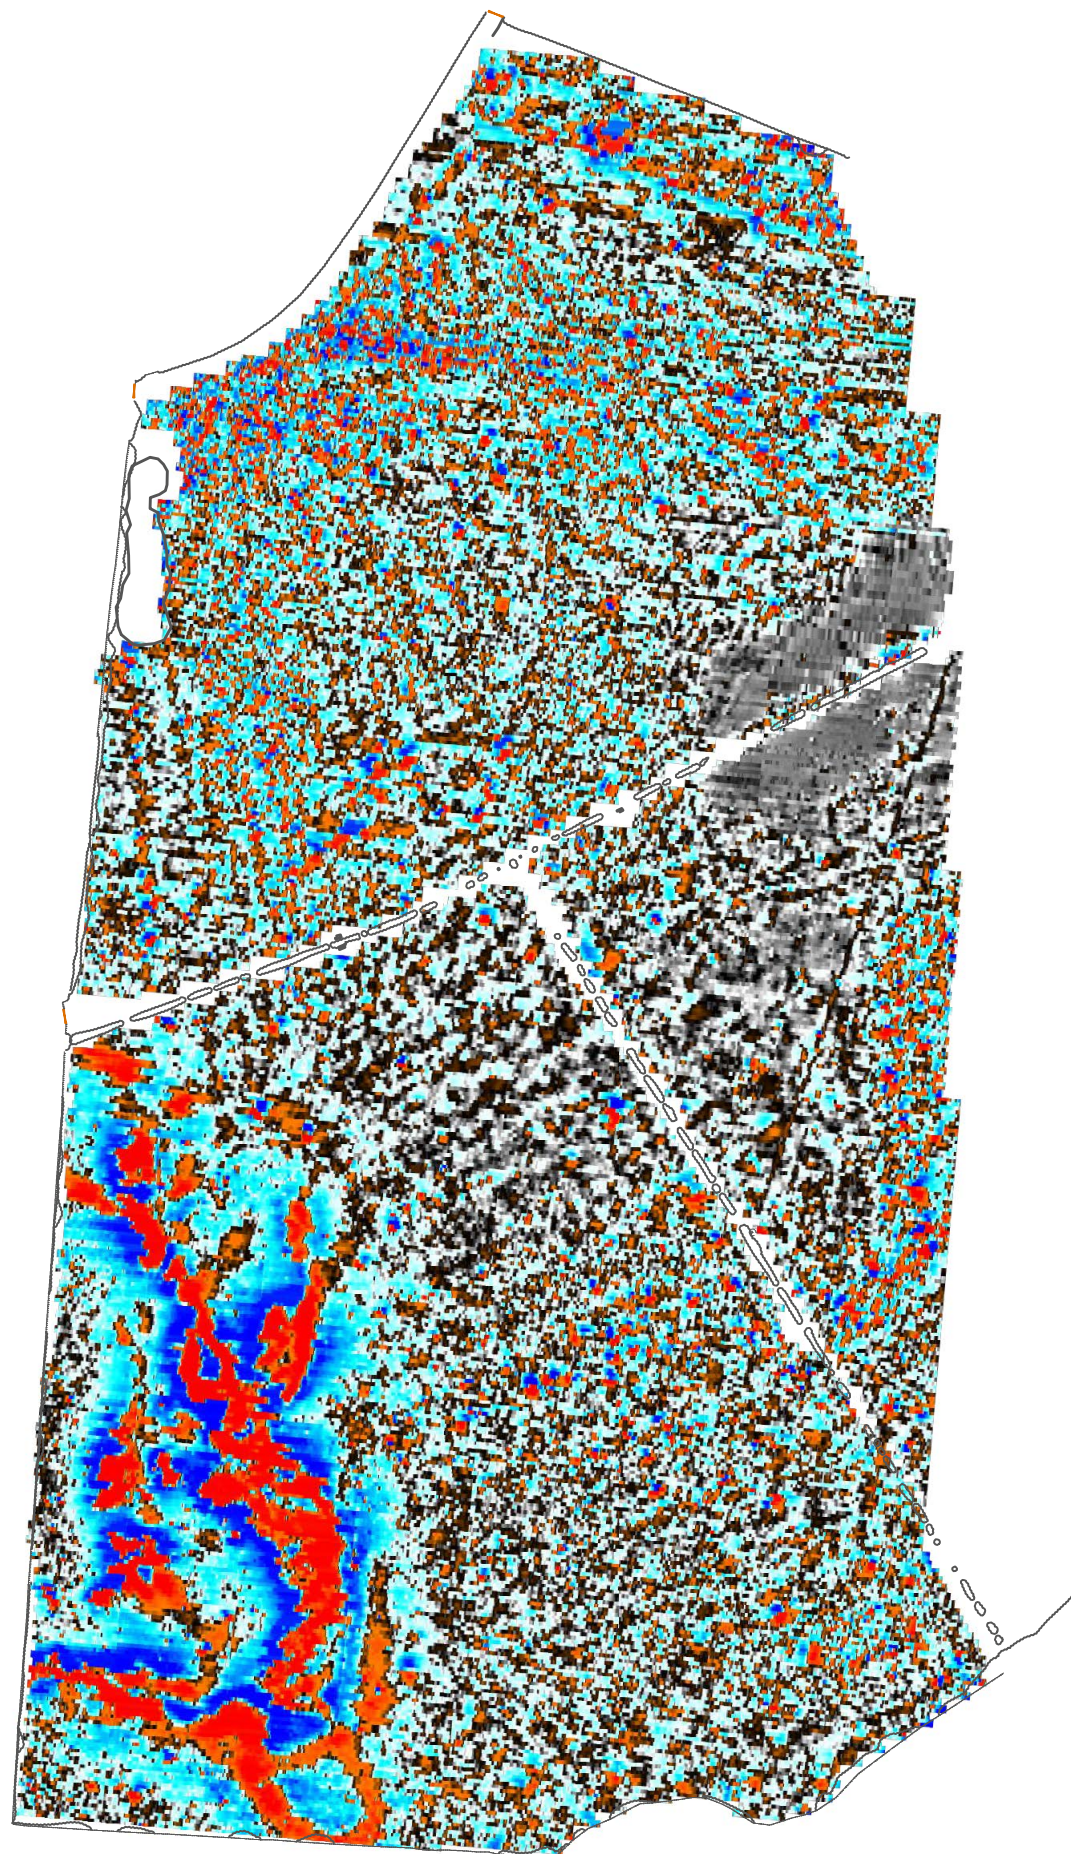
Plot A3	Checked by DGE	Issue No. 01
Survey date MAY 15	Drawn by TR	Figure No. 03

Maximum +100nT (red)
Minimum -100nT (blue)

Subject
**COLOUR PLOT OF GRADIOMETER
DATA SHOWING EXTREME VALUES -
OVERVIEW**

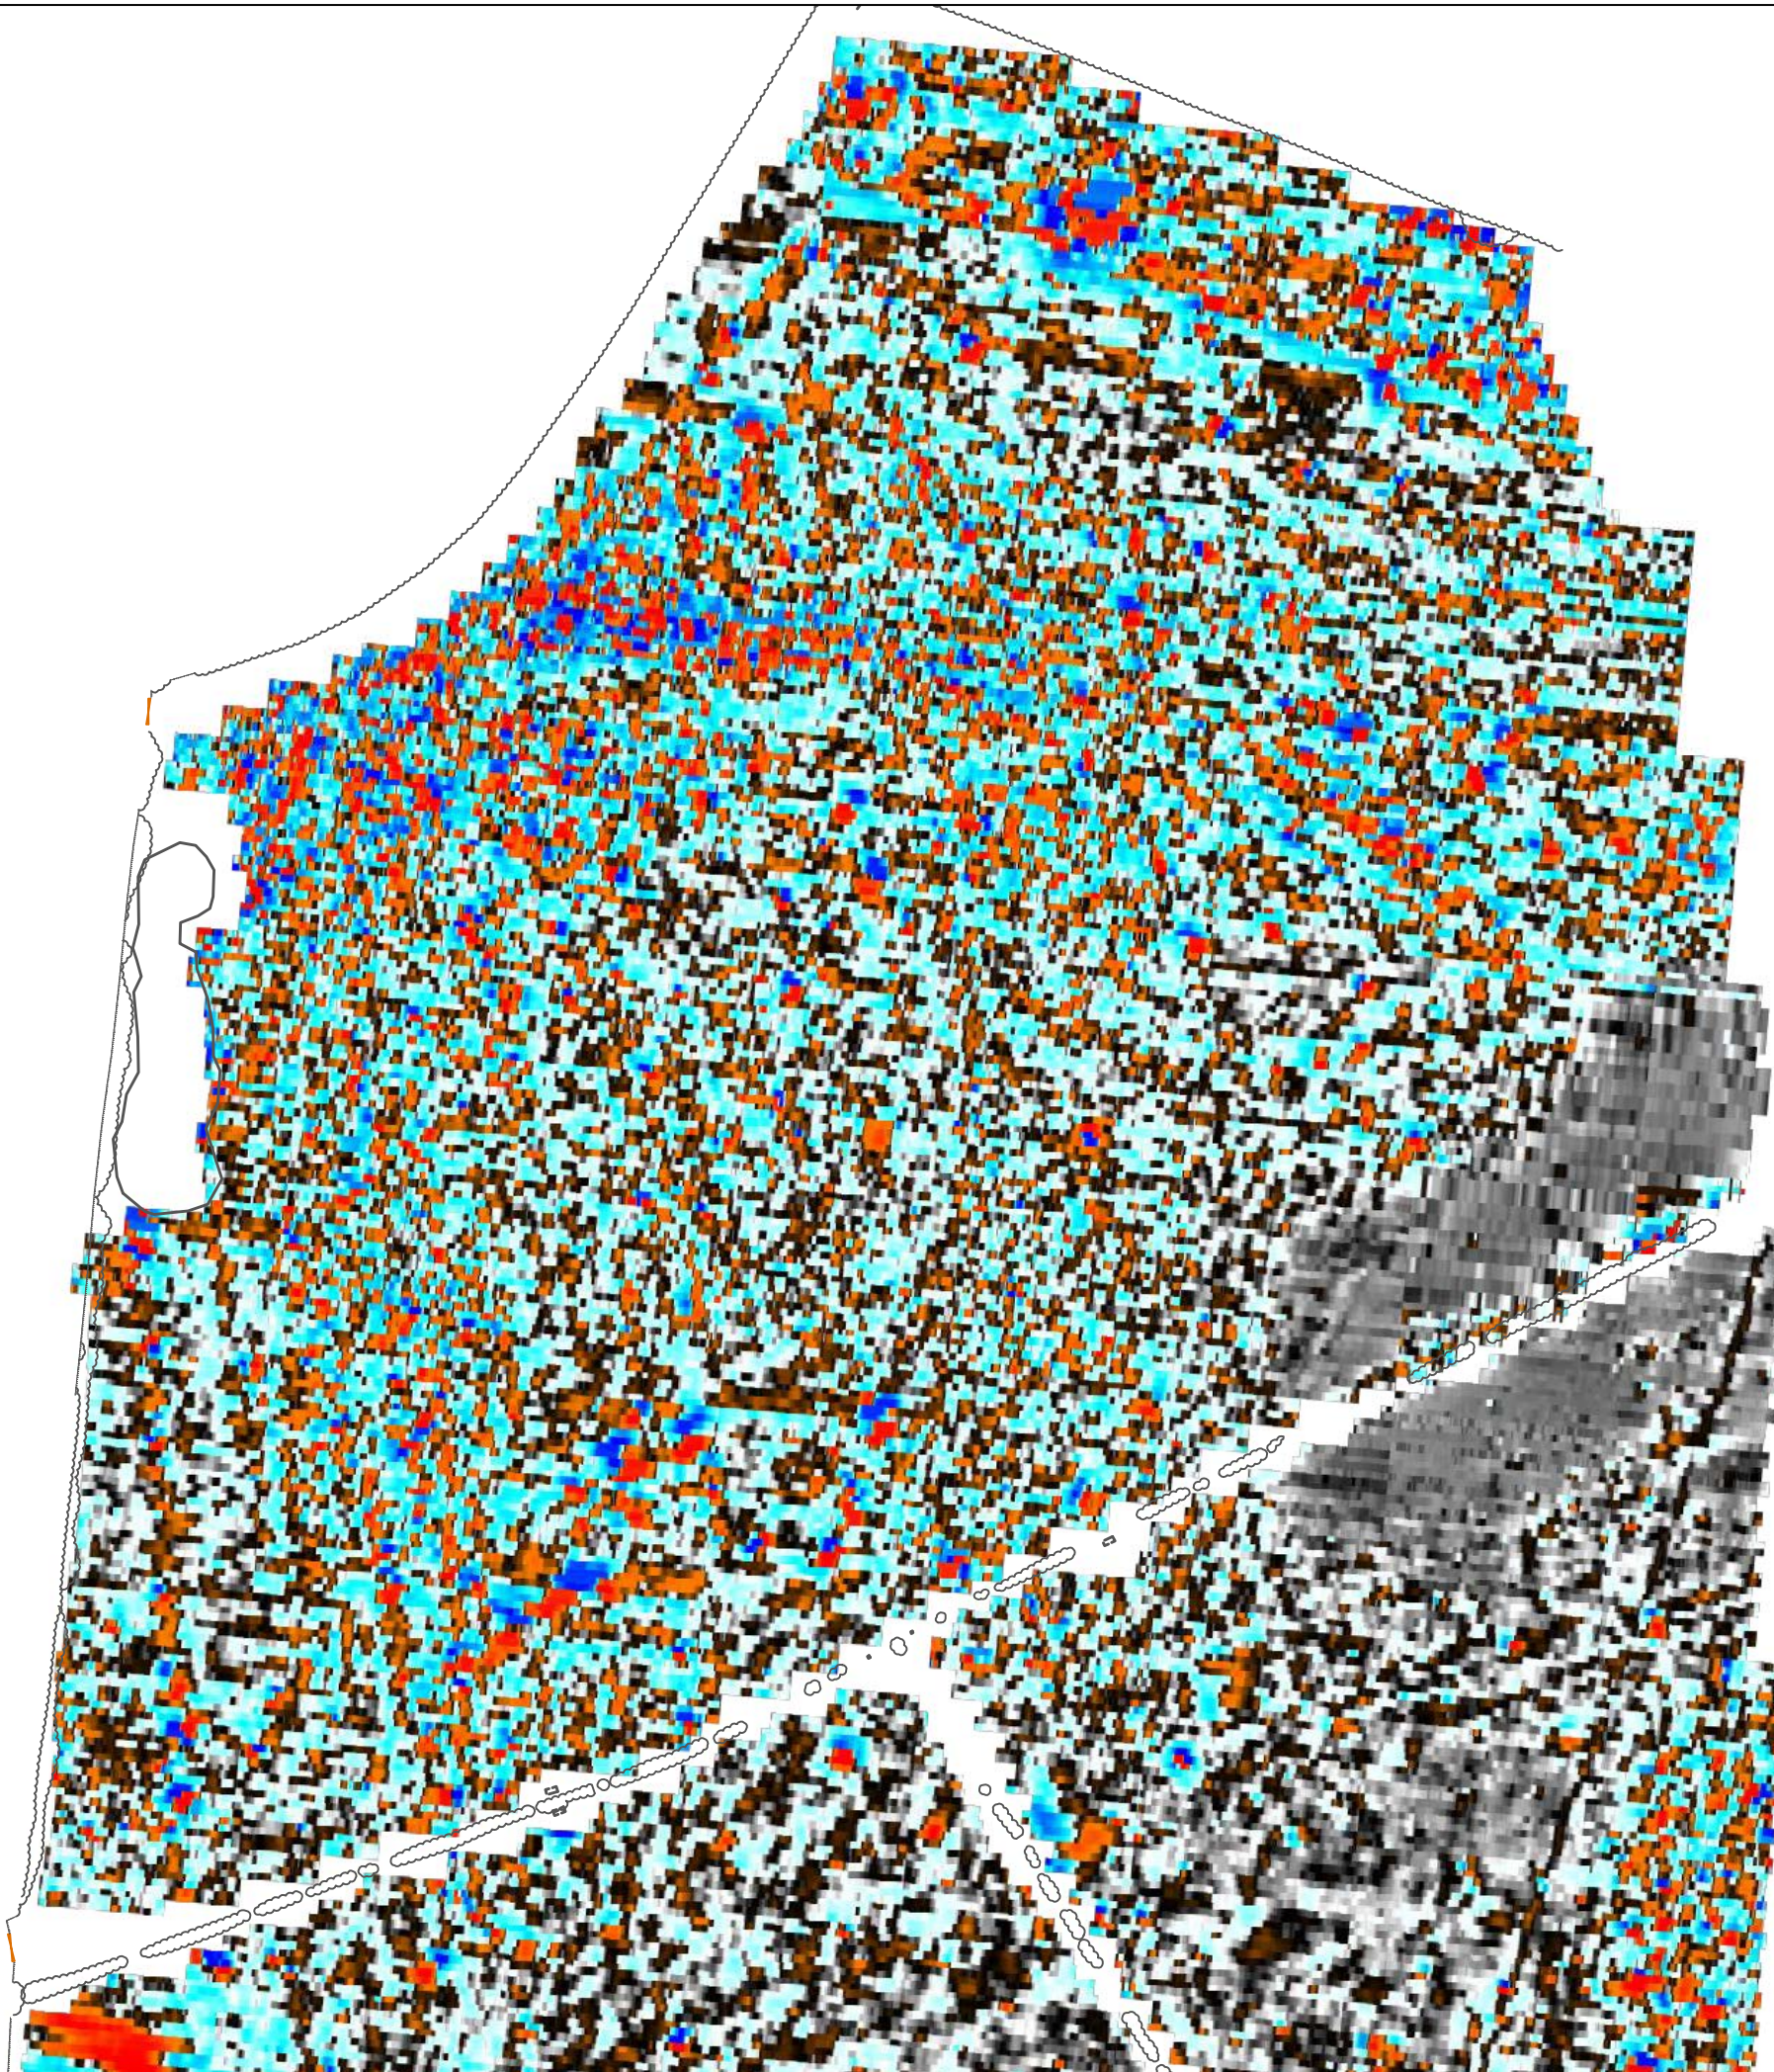
Plot A3	Checked by DGE	Issue No. 01
Survey date MAY 15	Drawn by TR	Figure No. 04

Maximum +100nT (red)
Minimum -100nT (blue)

Subject **COLOUR PLOT OF GRADIOMETER DATA SHOWING EXTREME VALUES - NORTH**

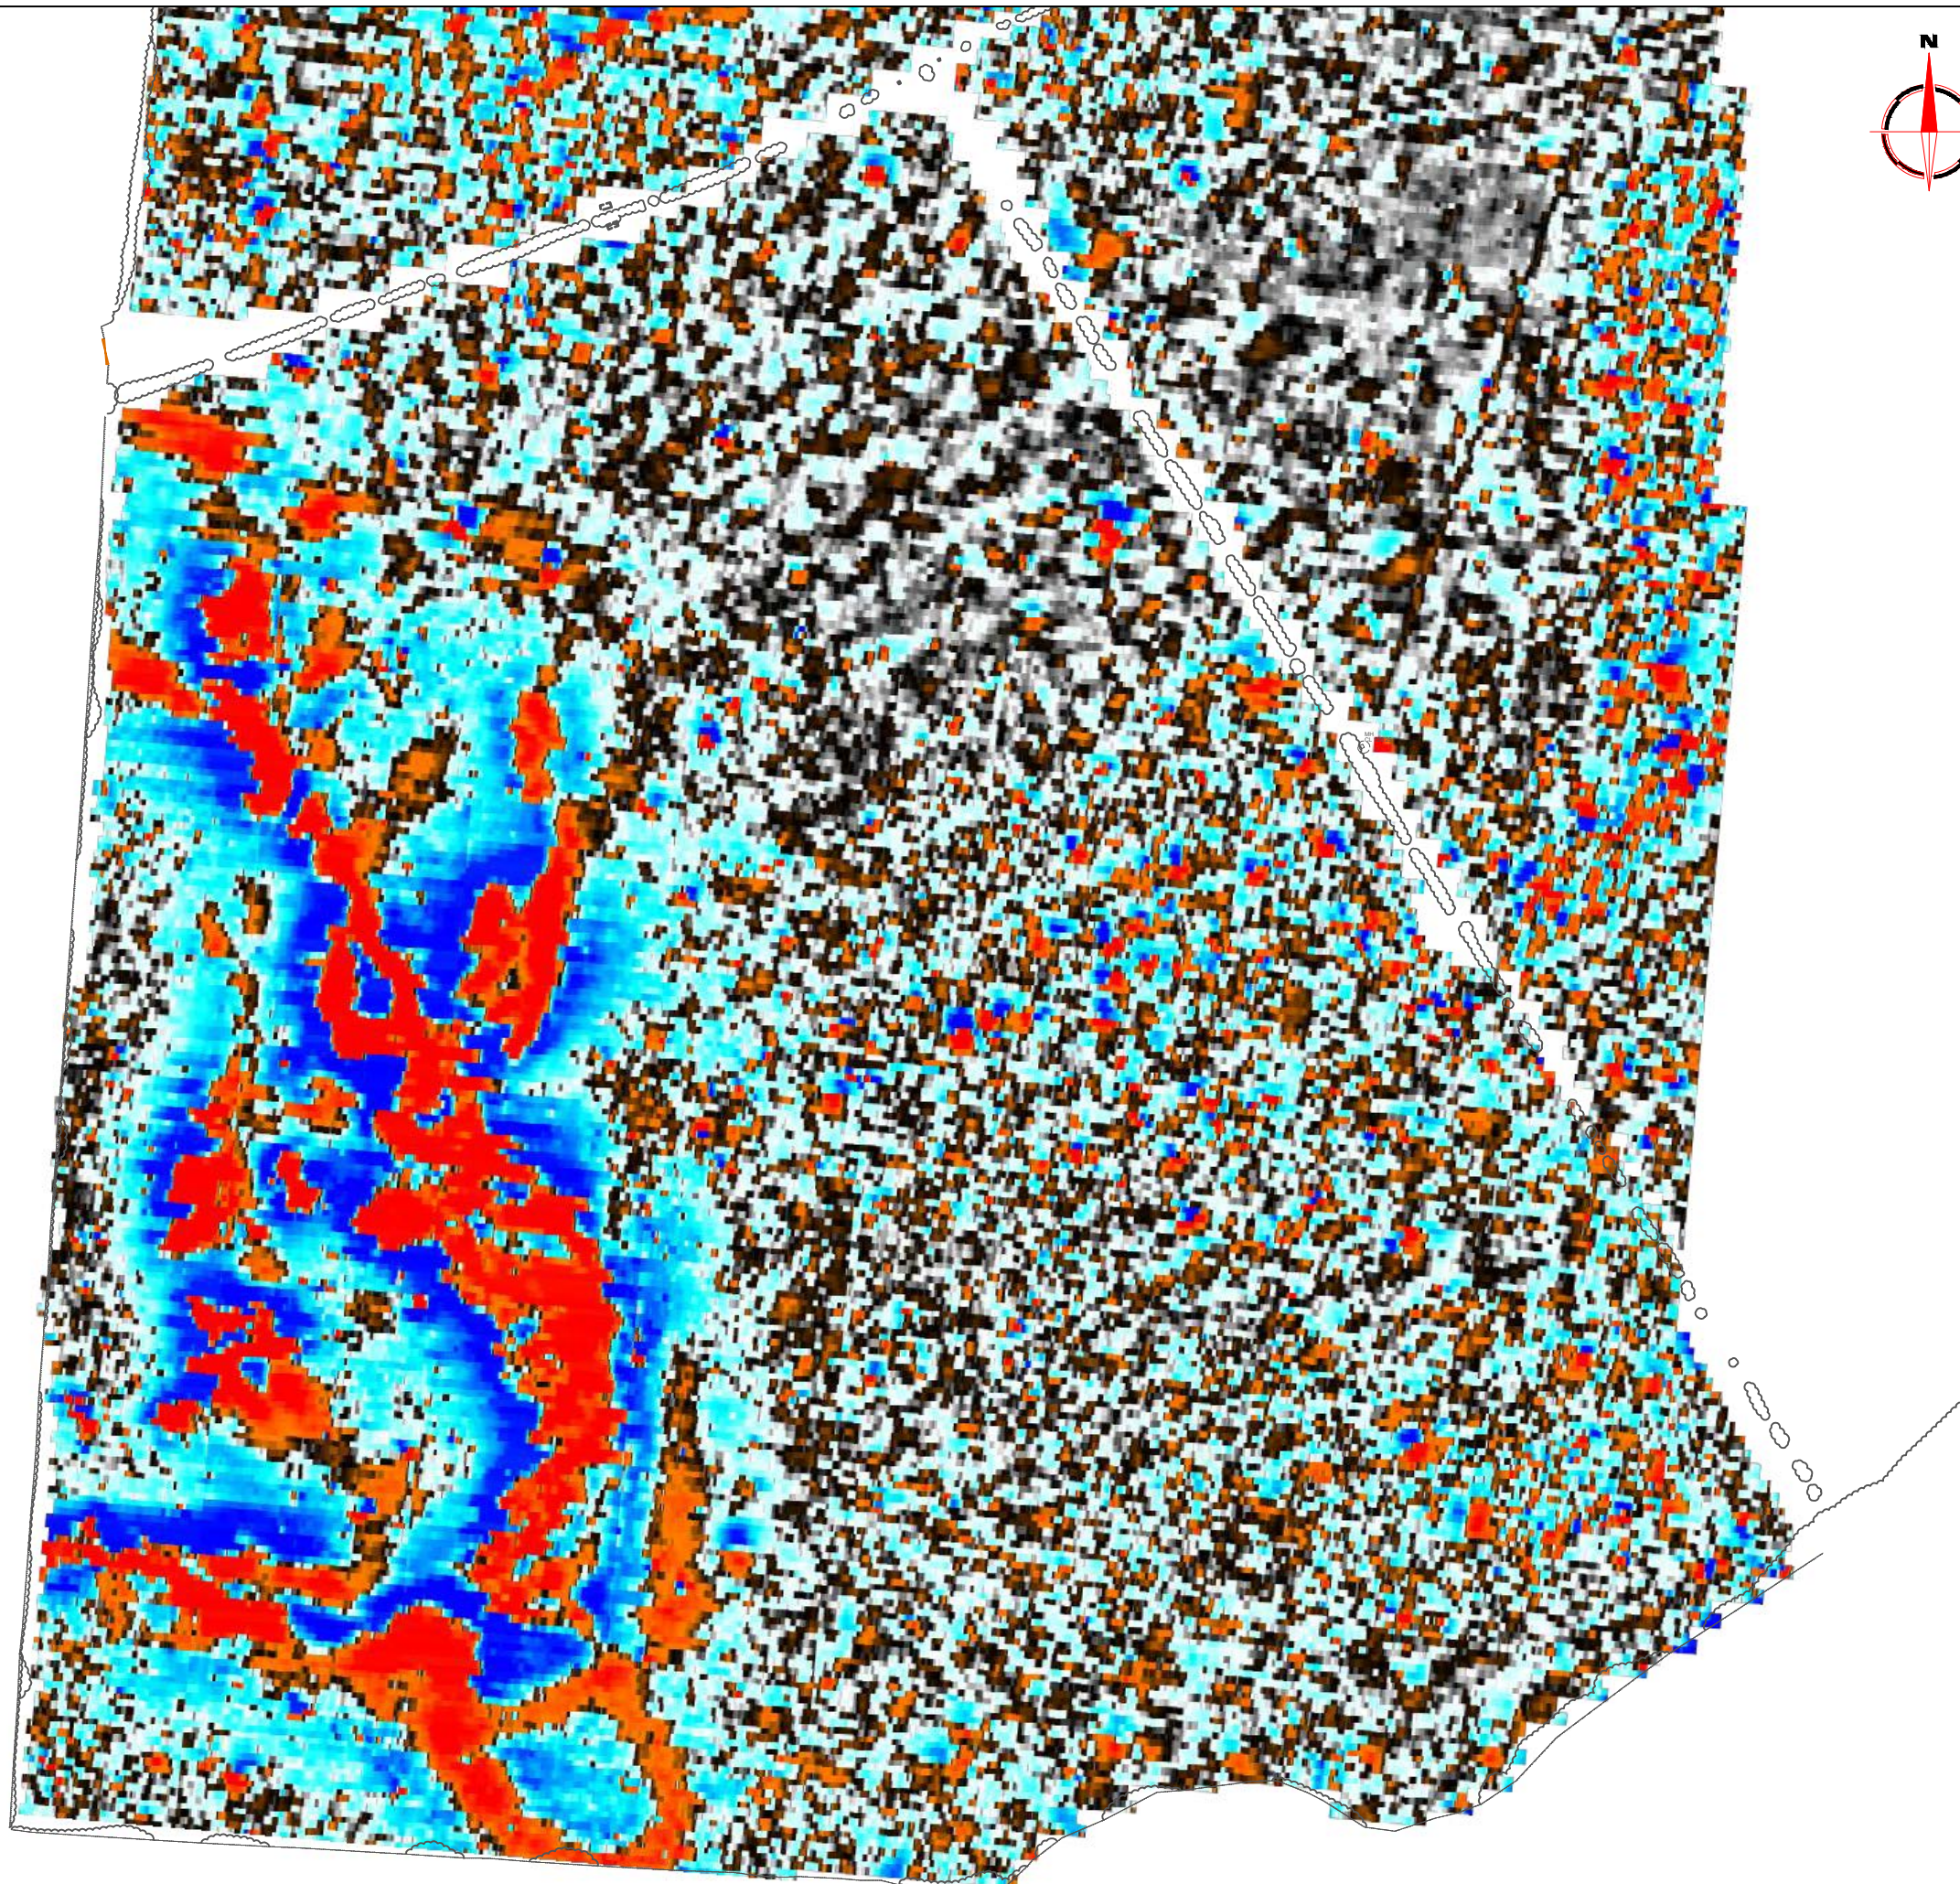
Plot A3	Checked by DGE	Issue No. 01
Survey date MAY 15	Drawn by TR	Figure No. 05

Maximum +100nT (red)
Minimum -100nT (blue)

Subject
**COLOUR PLOT OF GRADIOMETER
DATA SHOWING EXTREME VALUES -
SOUTH**

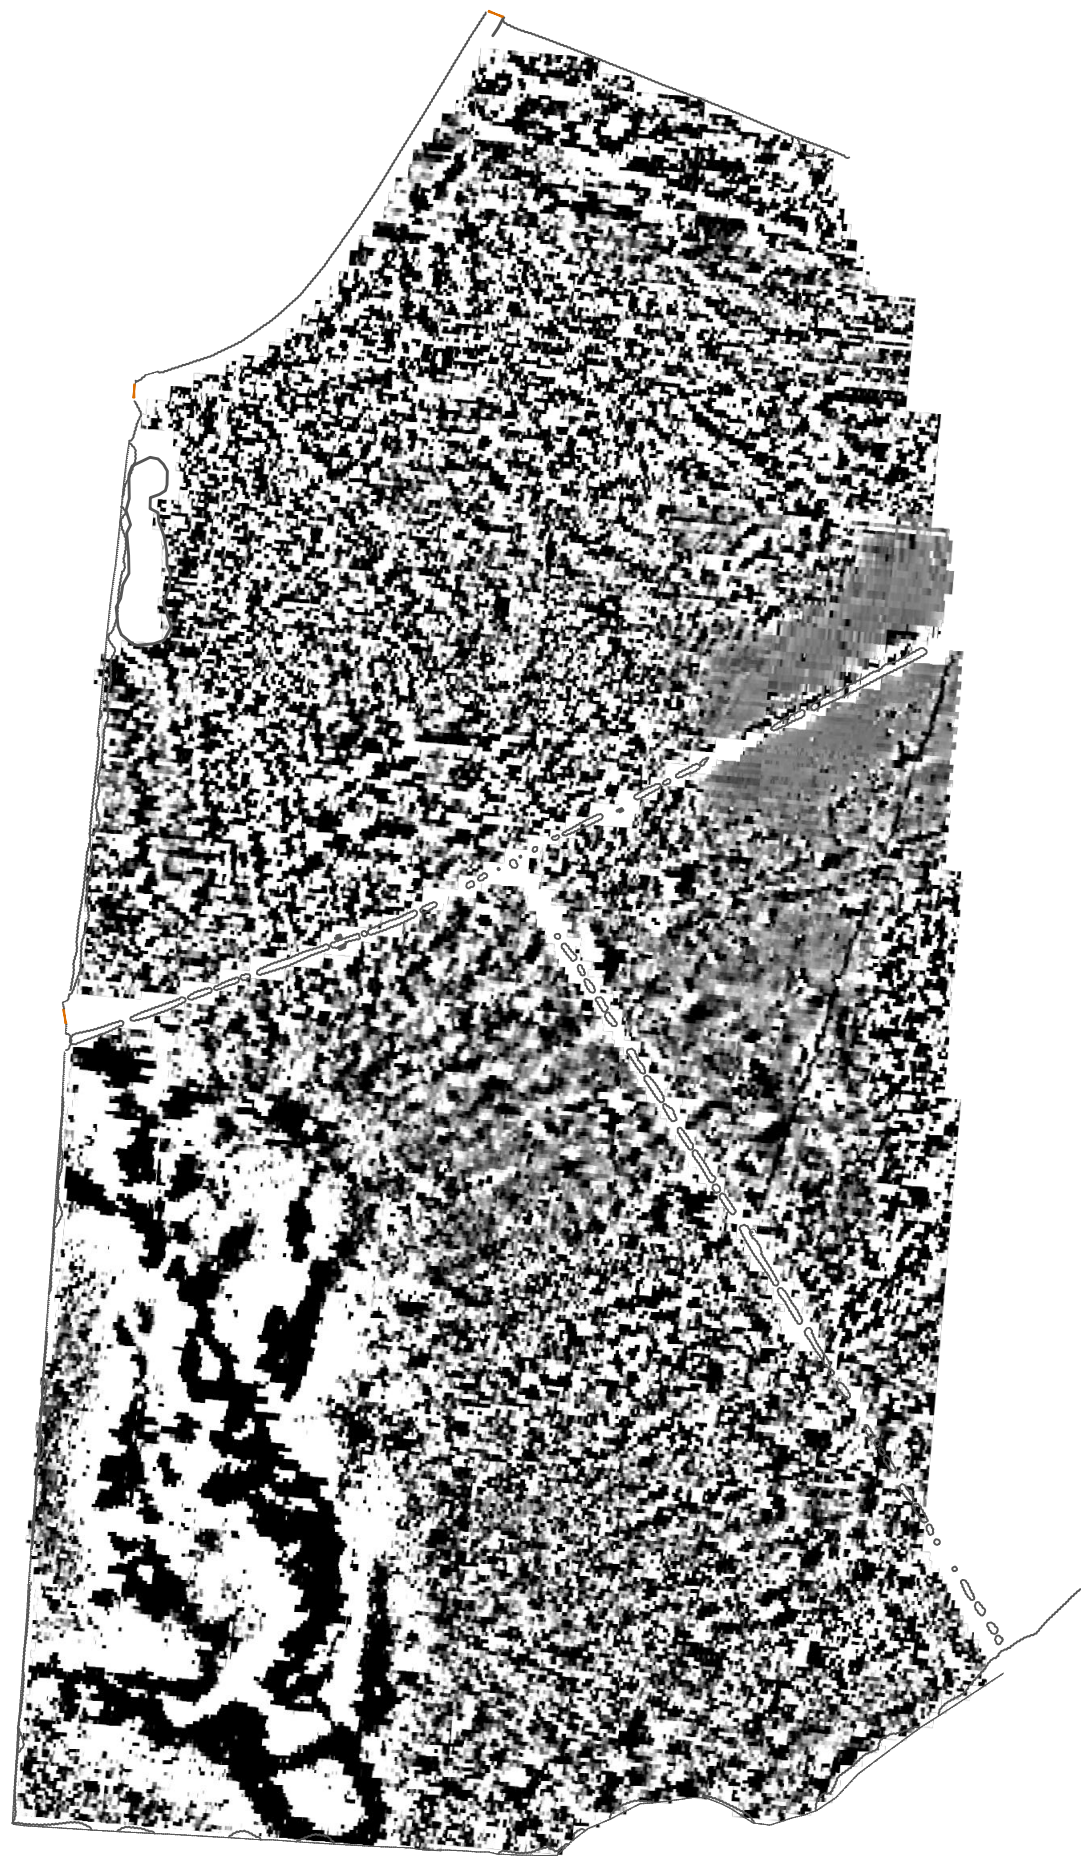
Plot A3	Checked by DGE	Issue No. 01
Survey date MAY 15	Drawn by TR	Figure No. 06

Maximum +5nT (black)
Minimum -5nT (white)

Subject
PLOT OF MINIMALLY PROCESSED GRADIOMETER DATA - OVERVIEW

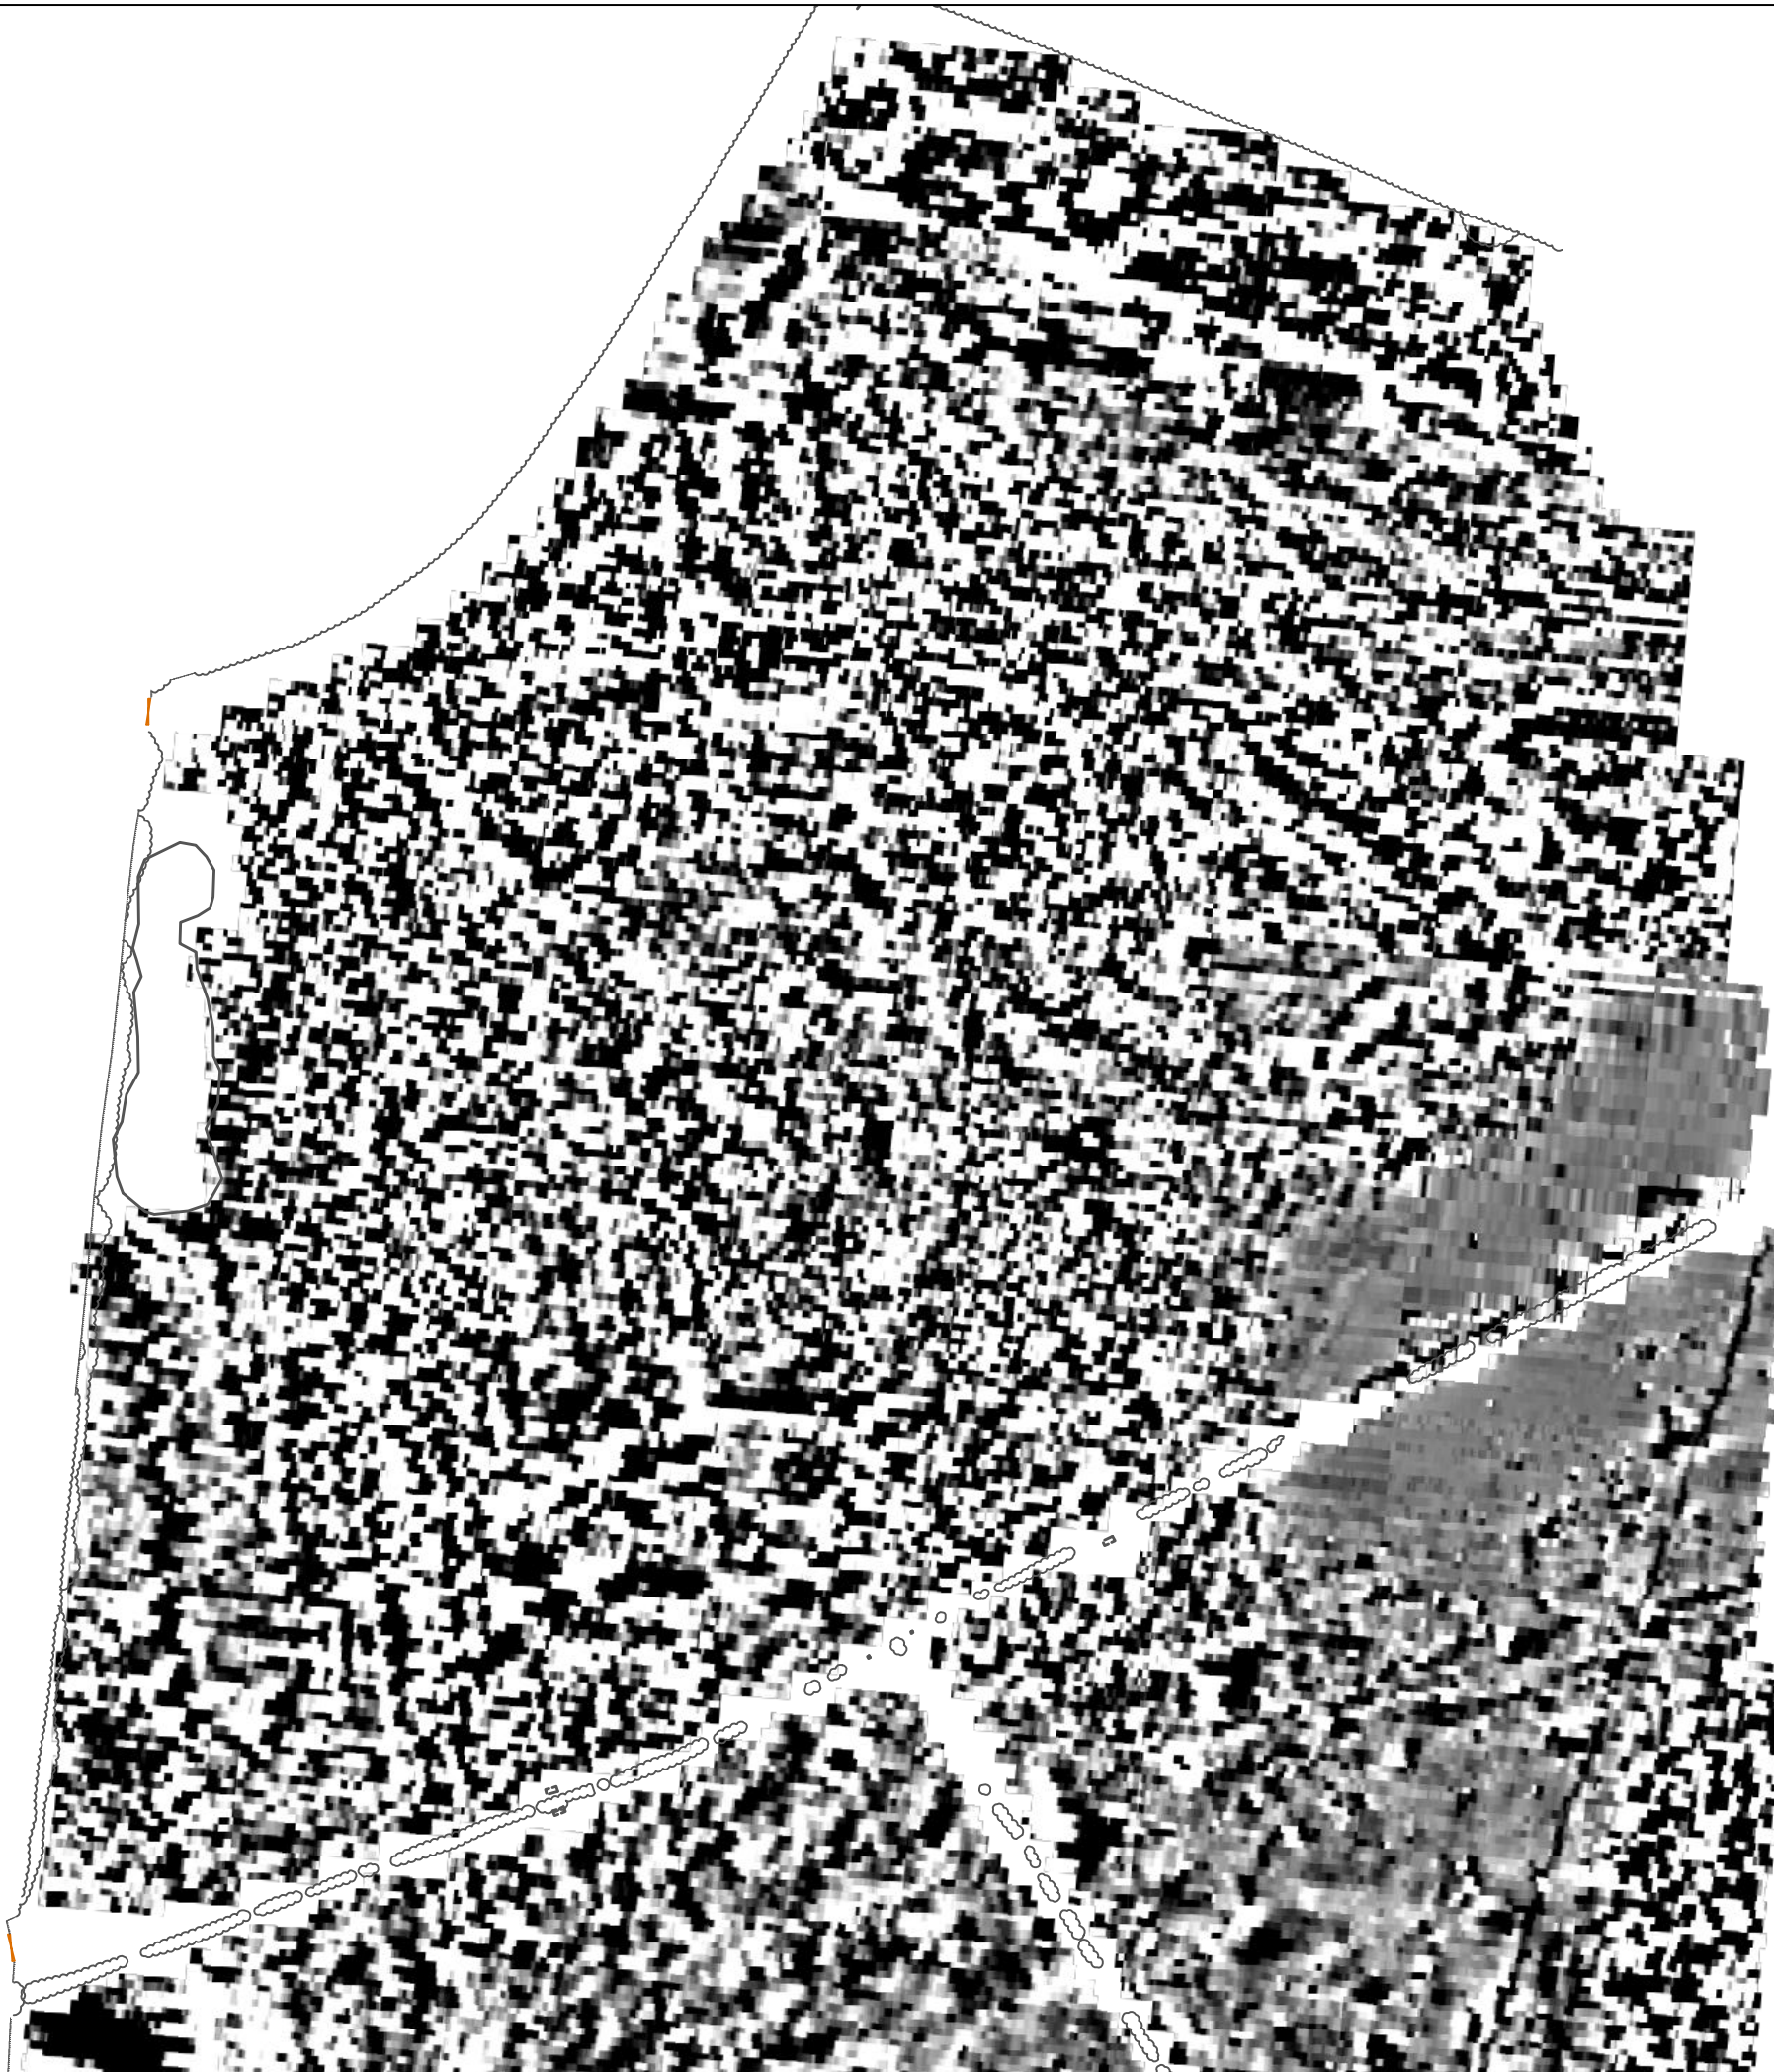
Amendments		
Issue No.	Date	Description
-	-	-
-	-	-
© Stratascan Ltd - ----		
Plotting parameters		+5nT
Maximum +5nT (black)		
Minimum -5nT (white)		
Client		GLOBAL RENEWABLE CONSTRUCTION LTD
Project Title	Job No. J8411	
TWIN YARDS FARM, BERISTOWE LANE, HILCOTE, DERBYSHIRE		
Subject		
PLOT OF MINIMALLY PROCESSED GRADIOMETER DATA - NORTH		
STRATASCAN™ GEOPHYSICS FOR ARCHAEOLOGY AND ENGINEERING VINEYARD HOUSE T: 01684 592266 UPTON UPON SEVERN E: info@stratascan.co.uk WR8 0SA www.stratascan.co.uk		
Scale	0m 10 20 30 40 50	
1:1000		
Plot	Checked by	Issue No.
A3	DGE	01
Survey date	Drawn by	Figure No.
MAY 15	TR	07

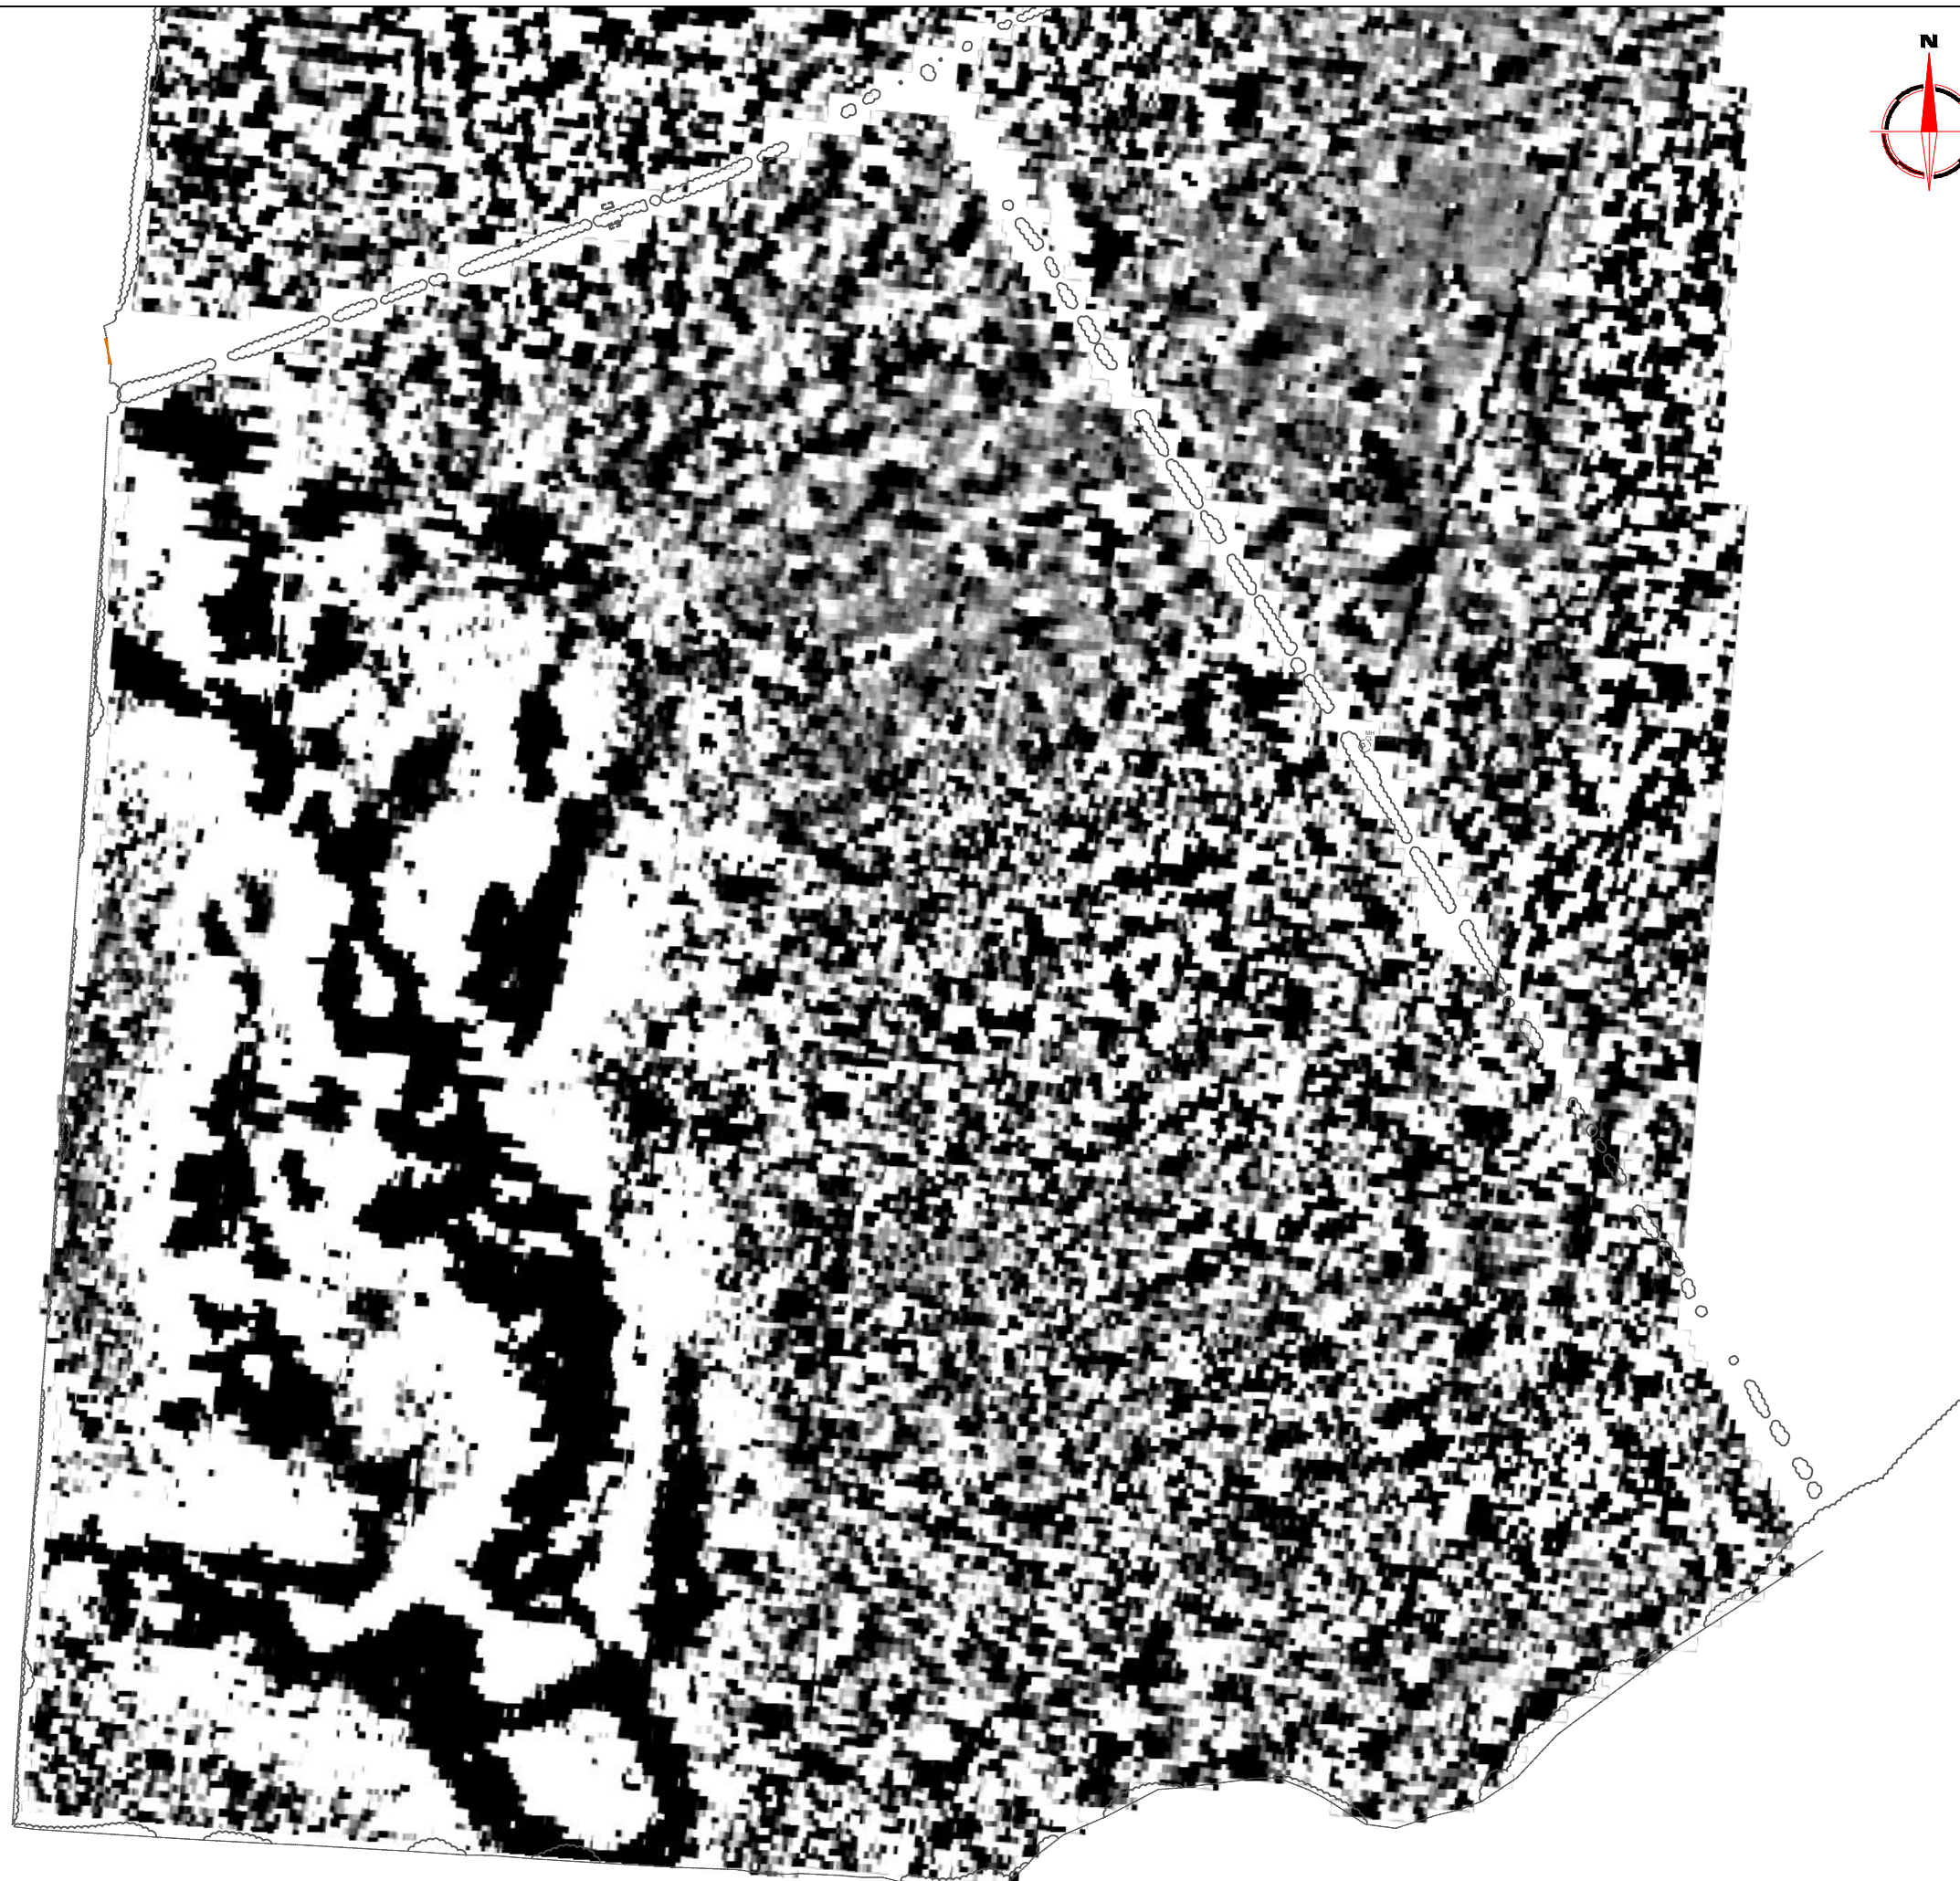
Amendments		
Issue No.	Date	Description
-	-	-
-	-	-
© Stratascan Ltd - ----		
<p>Plotting parameters</p> <p>Maximum +5nT (black) Minimum -5nT (white)</p>		
Client		GLOBAL RENEWABLE CONSTRUCTION LTD
Project Title	Job No.	J8411
TWIN YARDS FARM, BERISTOWE LANE, HILCOTE, DERBYSHIRE		
Subject		
PLOT OF MINIMALLY PROCESSED GRADIOMETER DATA - SOUTH		
<p>VINEYARD HOUSE T: 01684 592266 UPTON UPON SEVERN E: info@stratascan.co.uk WR8 0SA www.stratascan.co.uk</p>		
Scale 1:1000		
Plot	Checked by	Issue No.
A3	DGE	01
Survey date	Drawn by	Figure No.
MAY 15	TR	08
