Geophysical Survey Report

Hailes Abbey Gloucestershire

for
English Heritage

March 2006

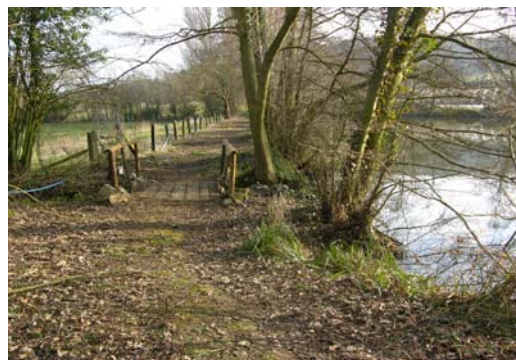
The survey area consists of approximately 8ha of land surrounding Hailes Abbey. A pond on adjacent property to the south east of the site has developed a leak through its dam (Plate 1) making this area very wet with water erupting from the ground in various places (Plate 2).

Plate 1. Showing the dam separating the pond on the right and Abbey grounds on the left.

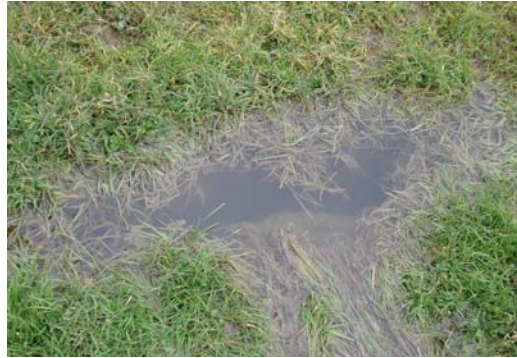
Plate 2. Water spring presumably being supplied from the leaking dam.
