Project Title Job No. 2155
**GEOPHYSICAL SURVEY -
WATER SEWAGE TREATMENT
NEAR EXETER AIRPORT**

Subject
**PLOT OF PROCESSED
GRADIOMETER DATA
- AREA 3F**

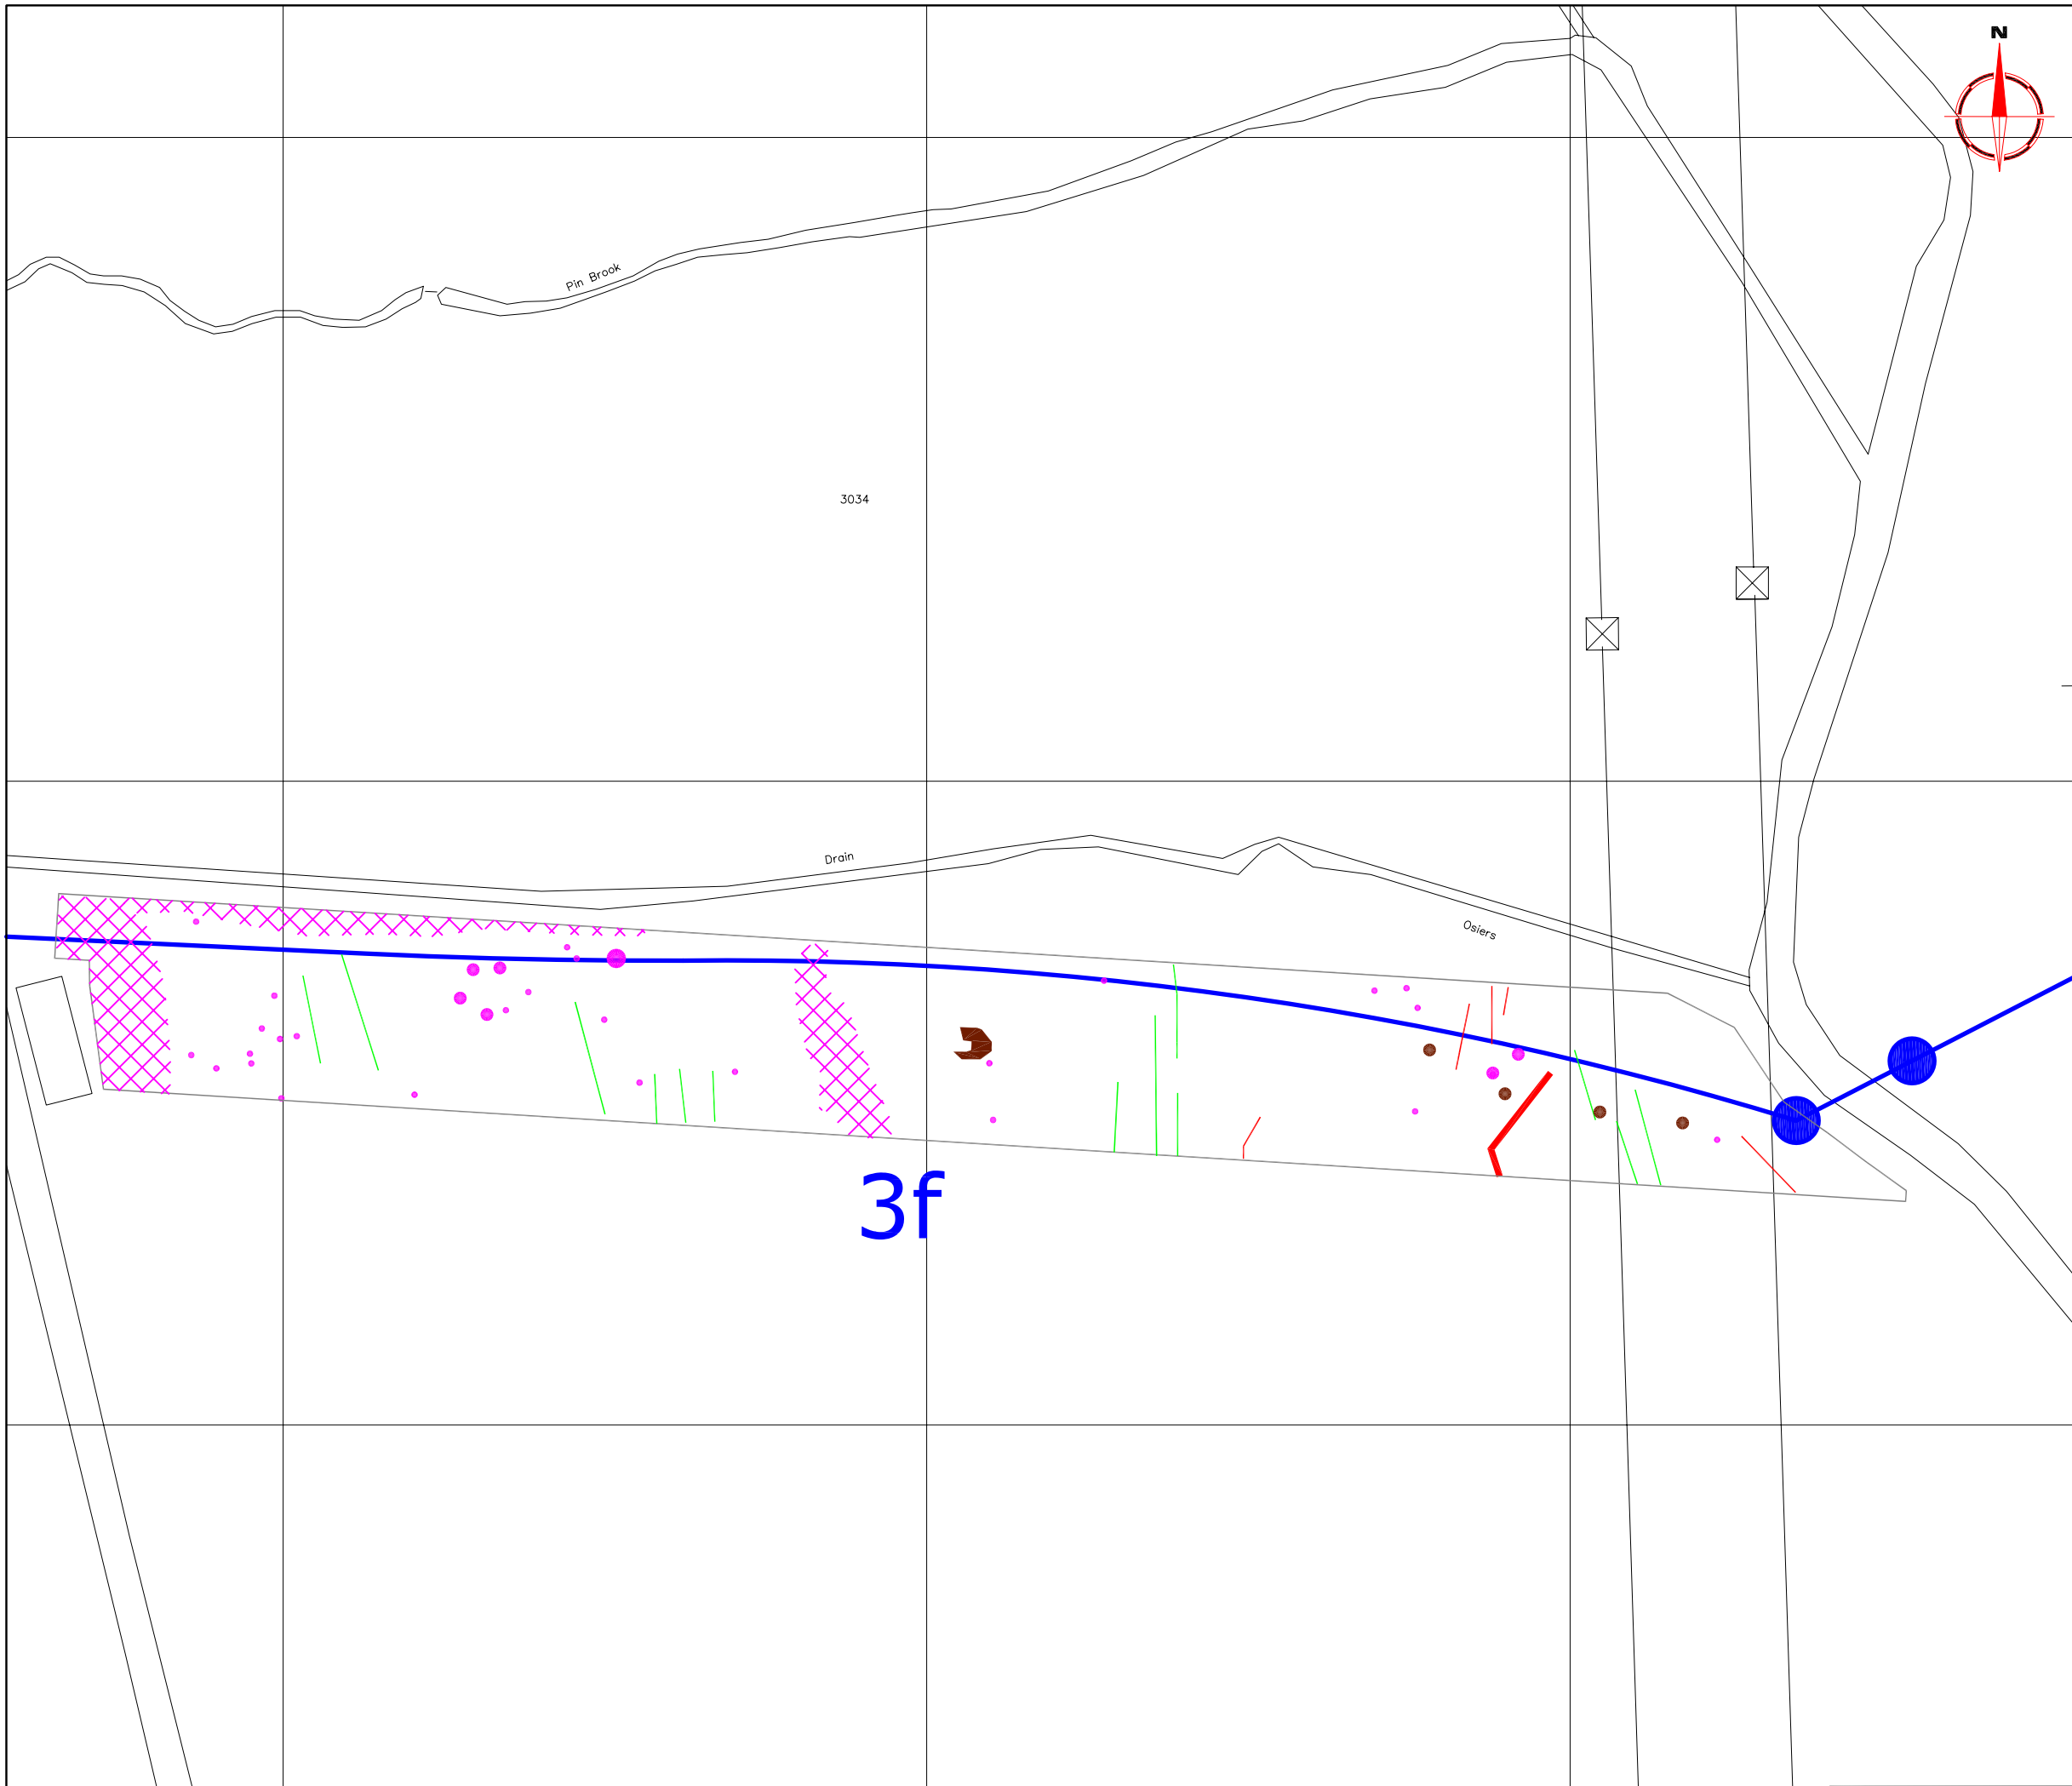
| Figure No. | 32 | |

| KEY | |
|---|---|
| | Discrete positive anomaly - possible pit |
| | Positive anomaly with associated negative response - ferrous object |
| | Positive linear anomaly - possibly relating to agricultural activity |
| | Positive linear anomaly - cut feature of possible archaeological origin |
| | Area of magnetic disturbance - associated with nearby field boundaries, roads or services |

| Subject | ABSTRACTION AND INTERPRETATION OF GRADIOMETER ANOMALIES - AREA 3F | |

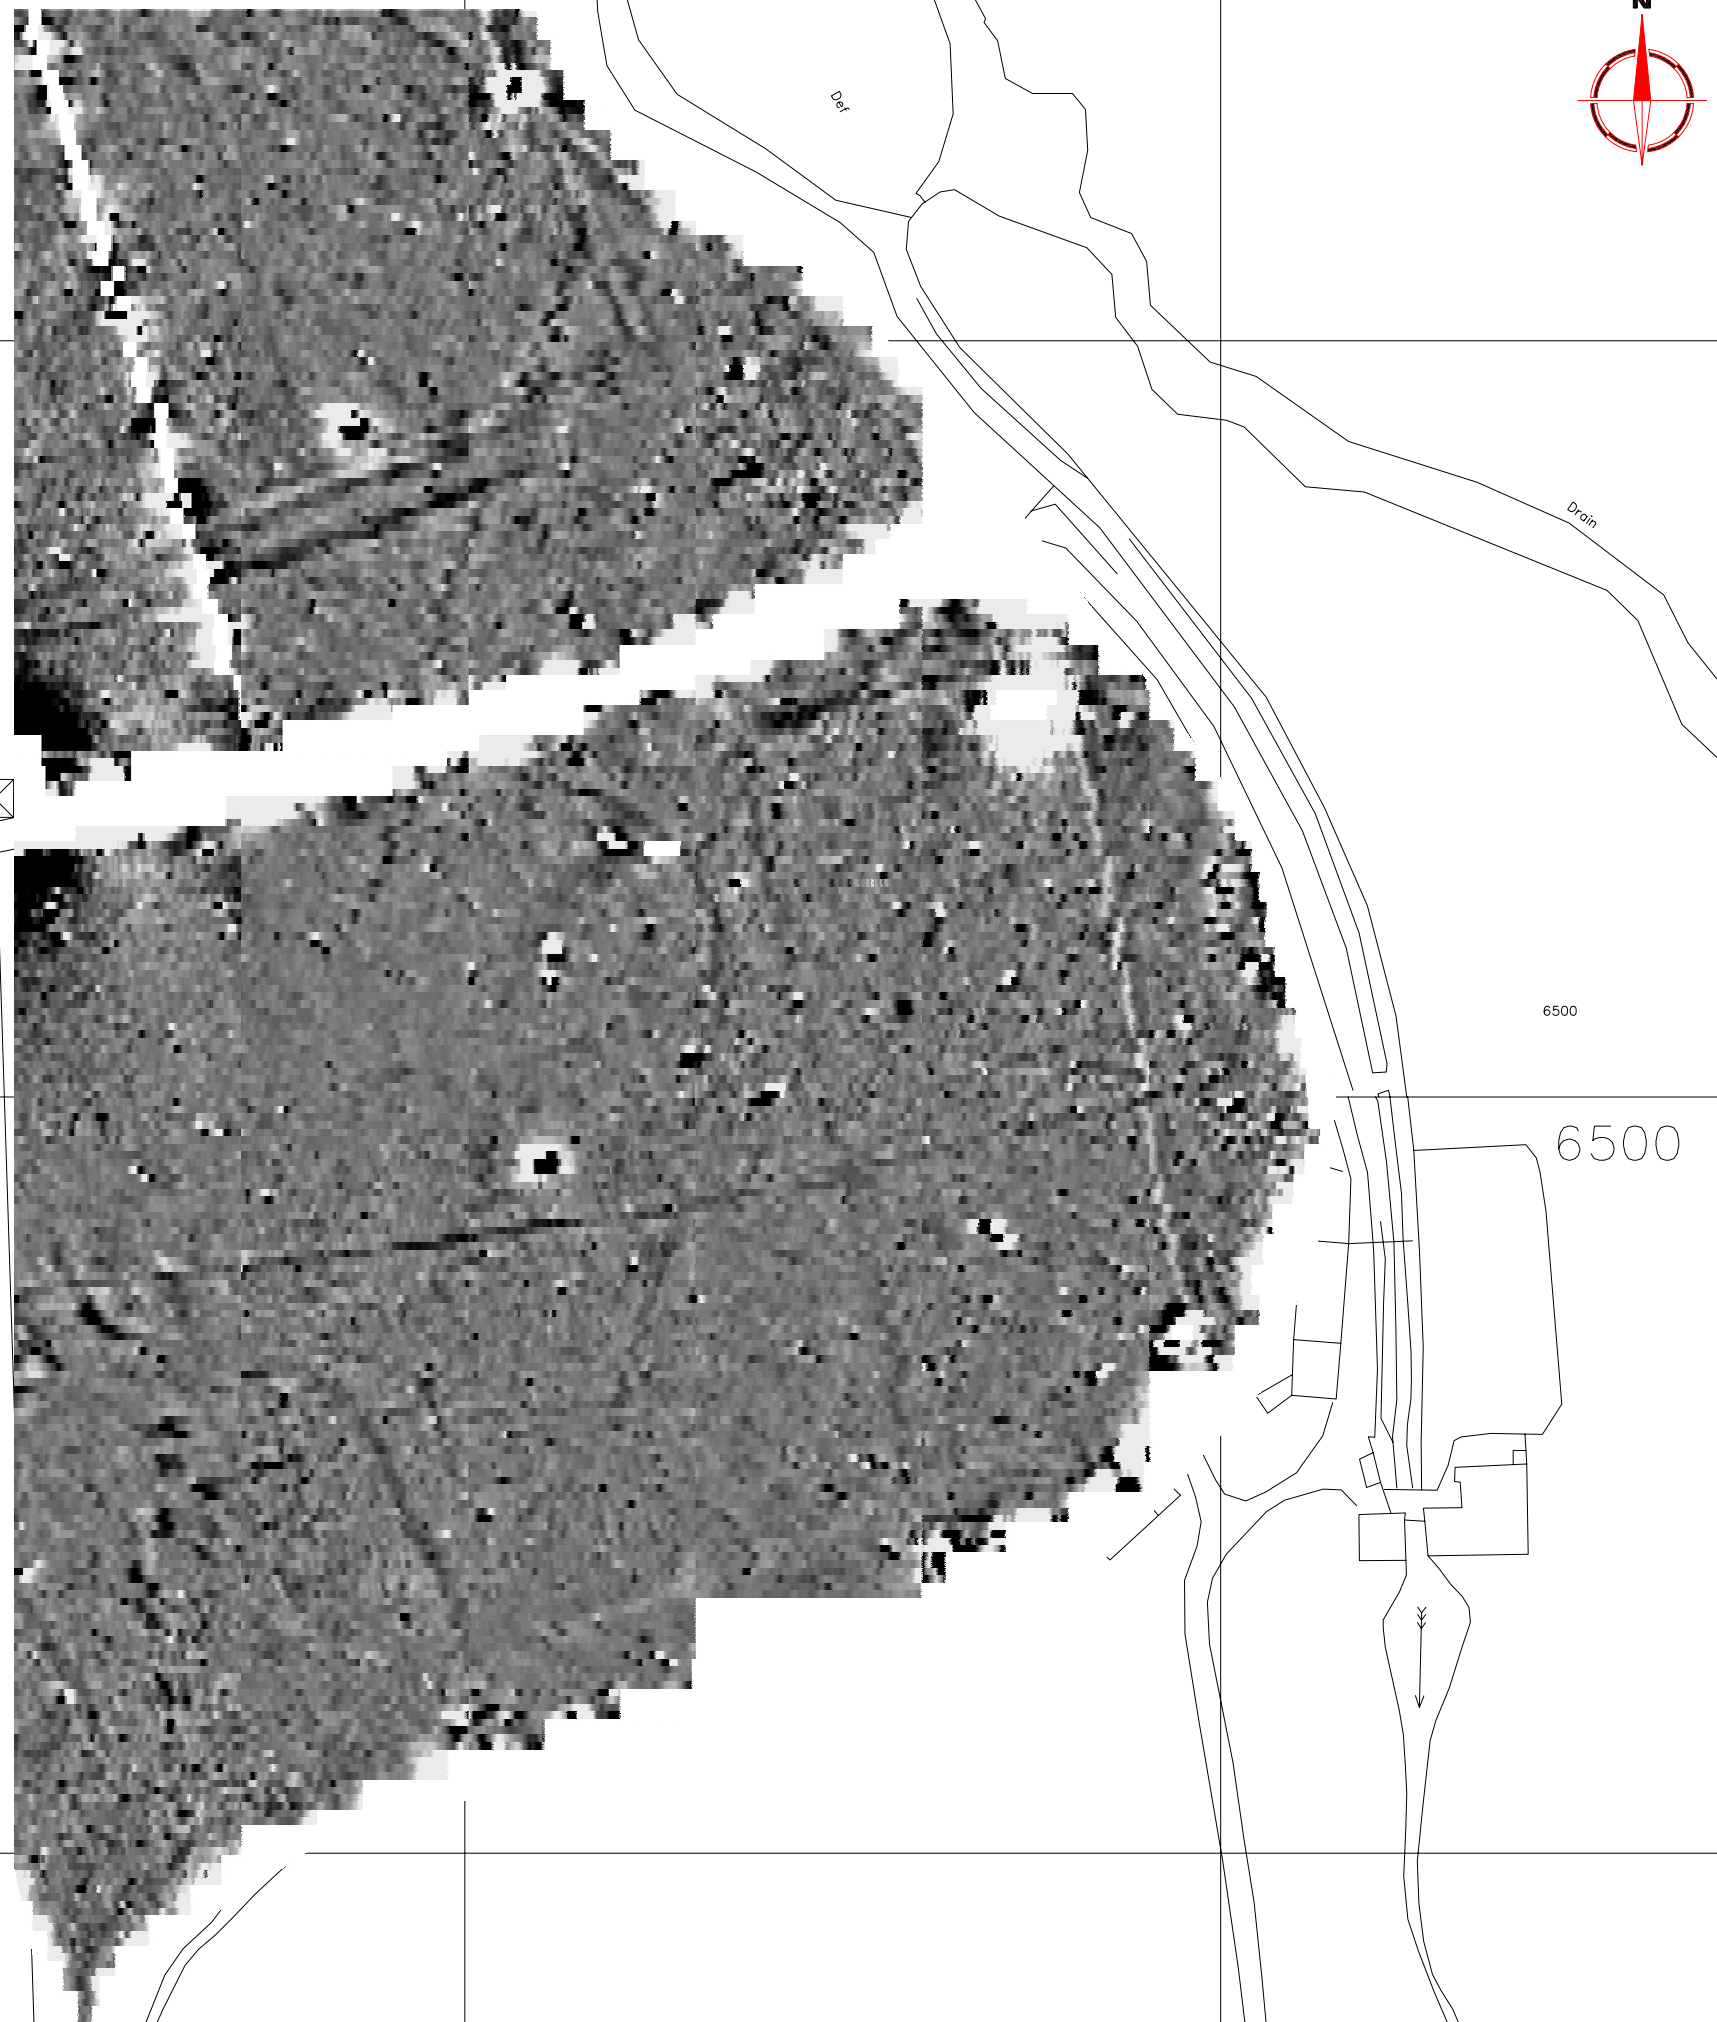
| Survey date JUNE 06 | Drawn by HH | Figure No. 33 |

Maximum +3nT (black)
Minimum -3nT (white)

Subject
PLOT OF RAW GRADIOMETER DATA AREA 4

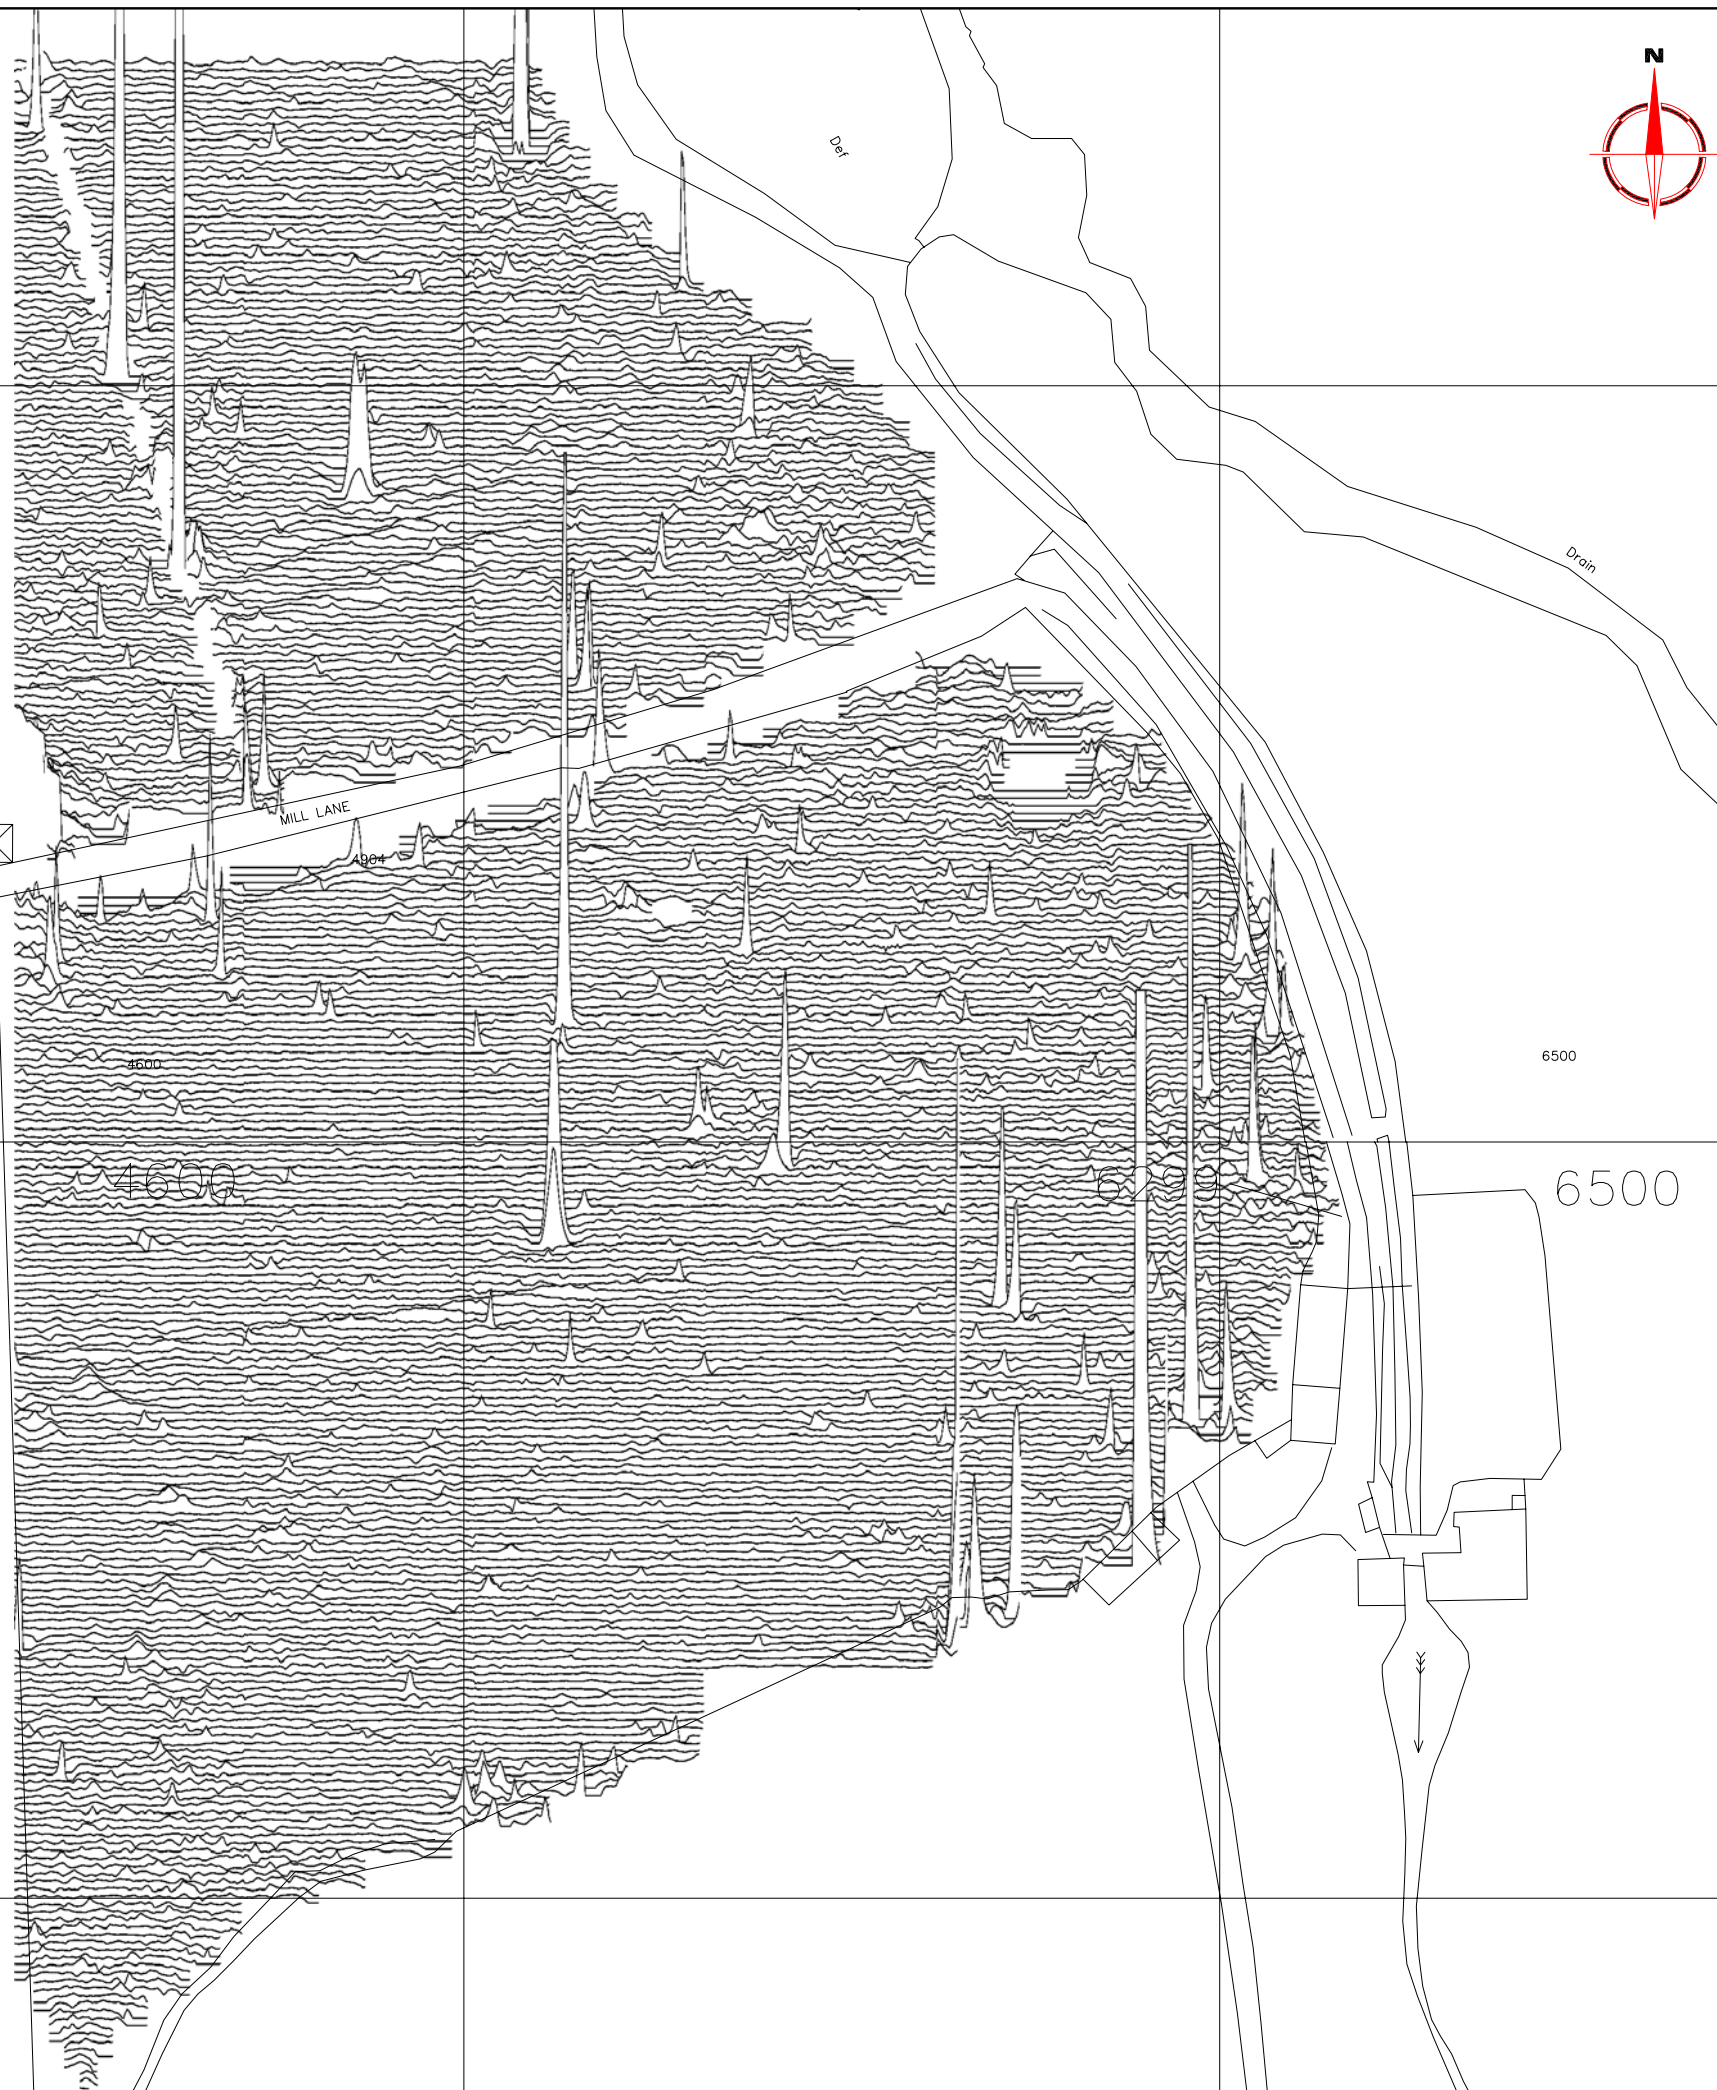
| Survey date JUNE 06 | Drawn by HH | Figure No. 34 |

| (Positive values displace above the trace line. Hidden values have not been plotted. Data clipped at 200nT) | 120nT |

Subject
TRACE PLOT OF GRADIOMETER DATA SHOWING POSITIVE VALUES AREA 4

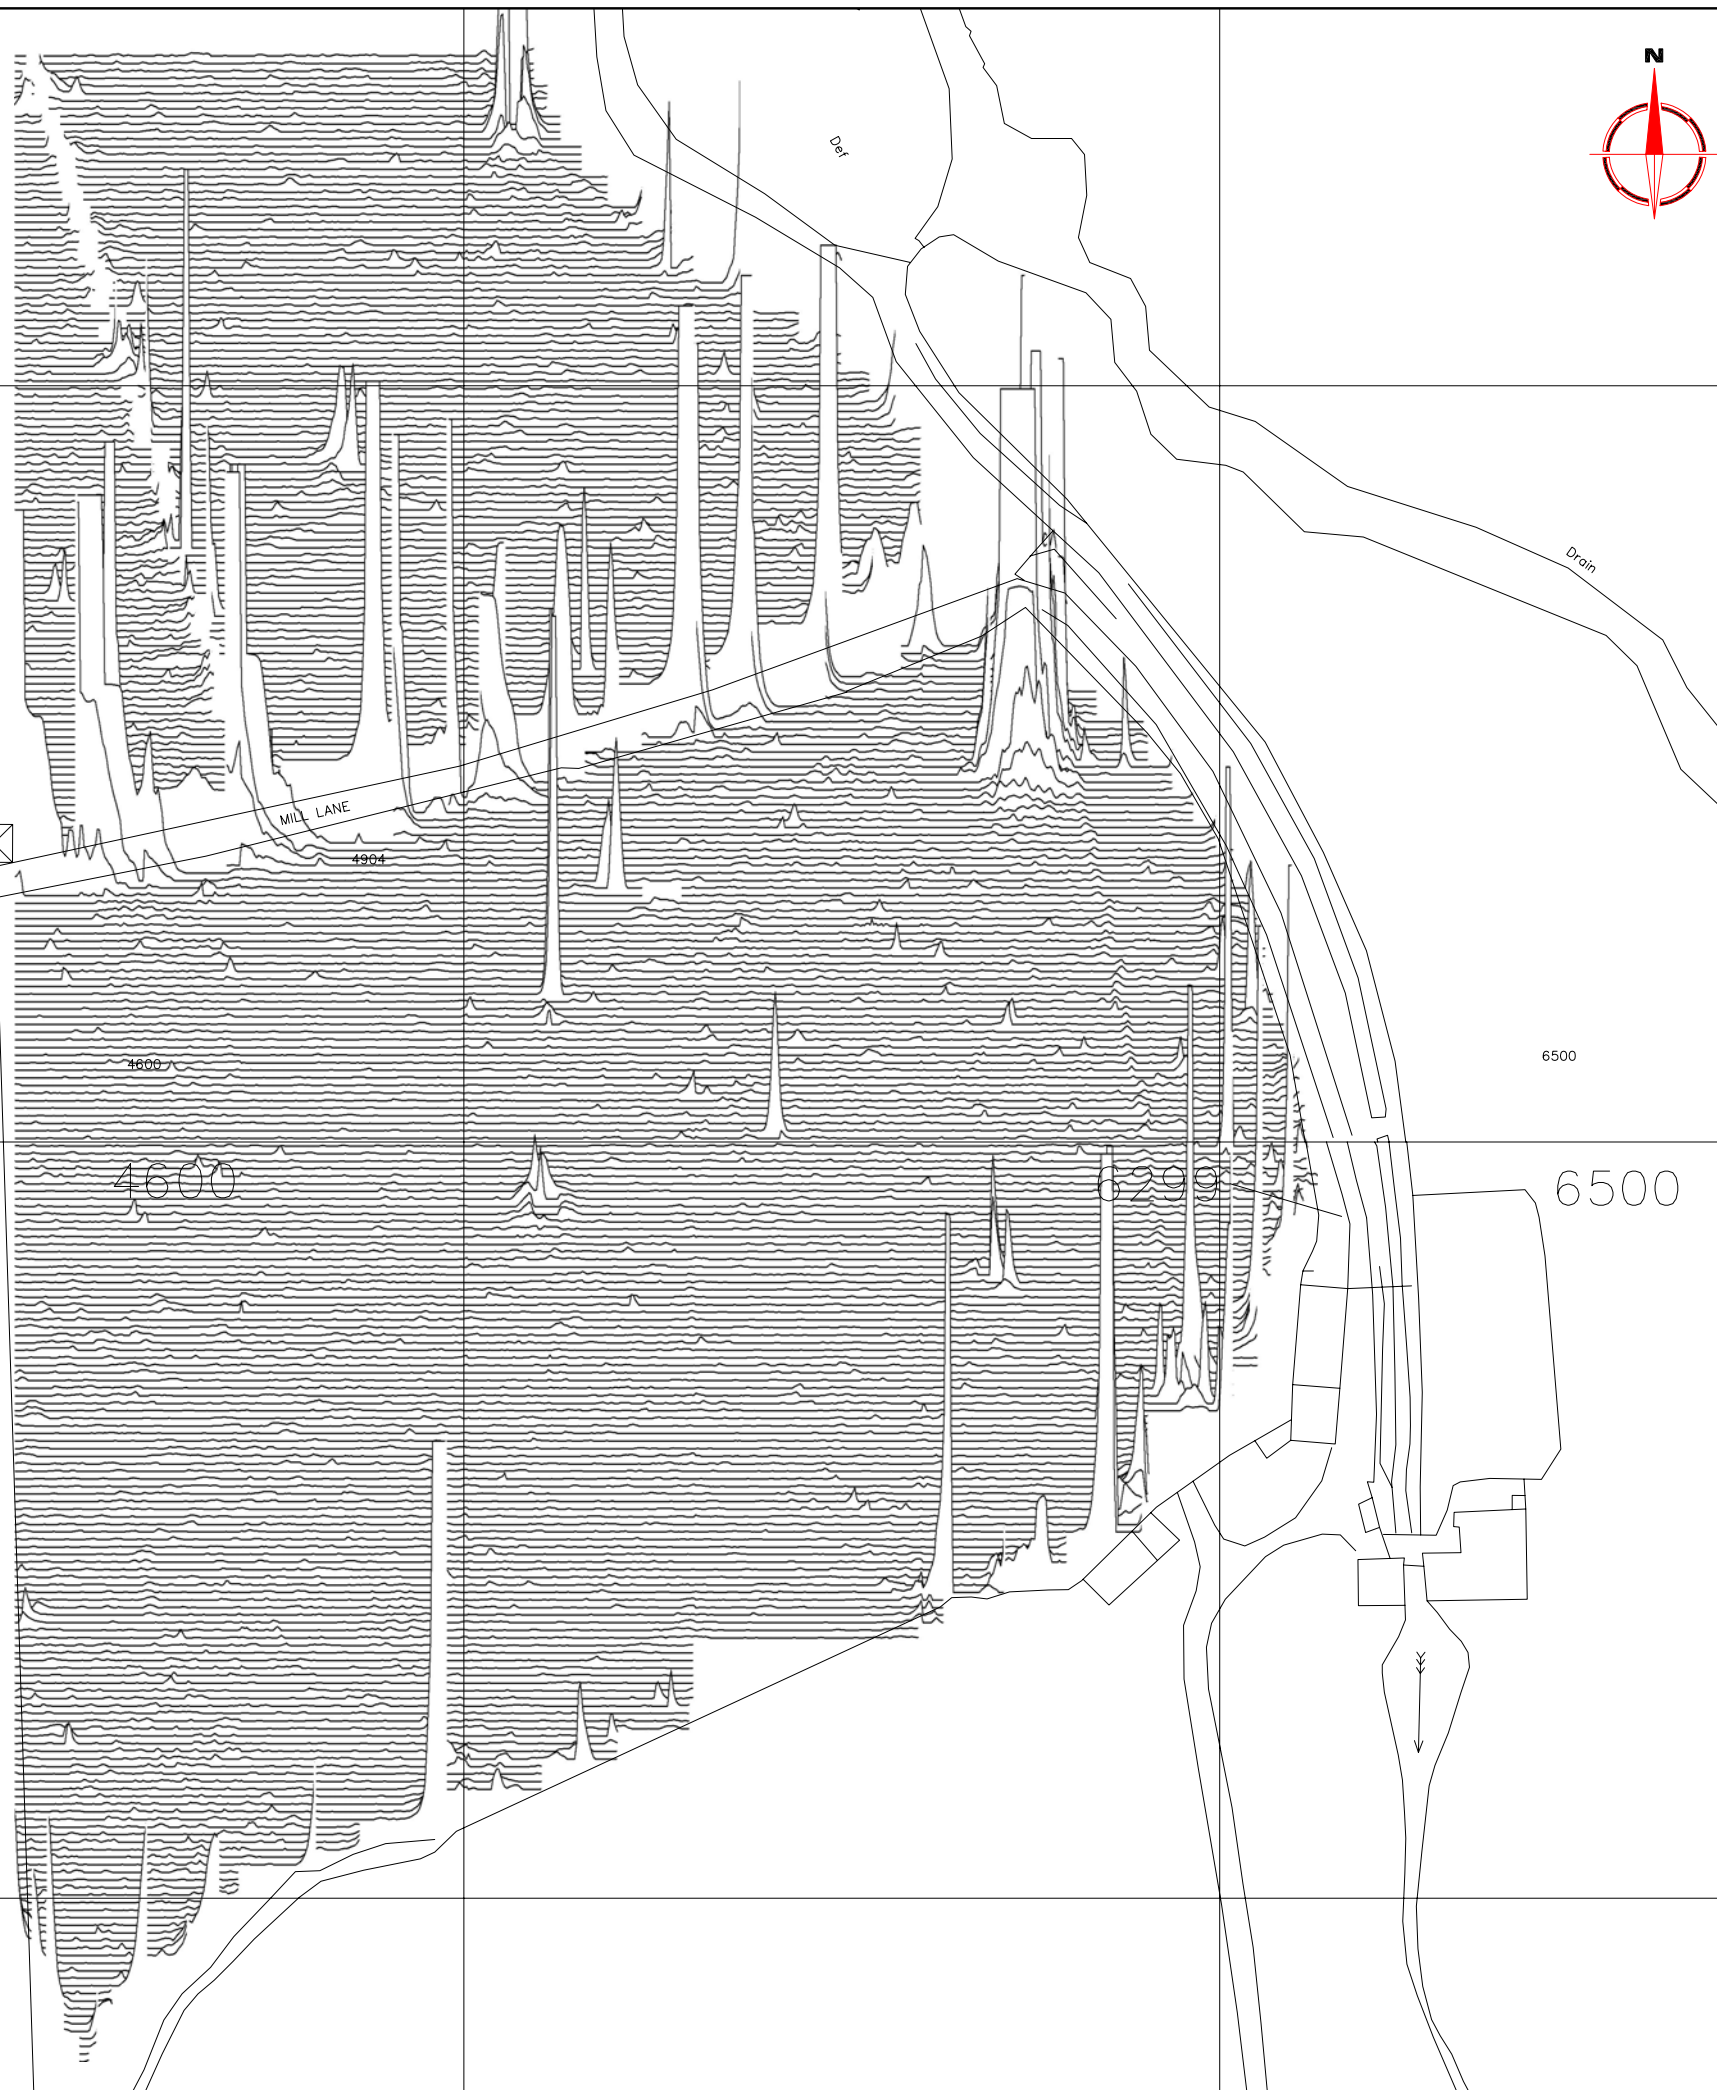
| Survey date JUNE 06 | Drawn by HH | Figure No. 35 |

| (Negative values displace above the trace line. Hidden values have not been plotted. Data clipped at -200nT) | -120nT |

Subject
TRACE PLOT OF GRADIOMETER DATA SHOWING NEGATIVE VALUES AREA 4

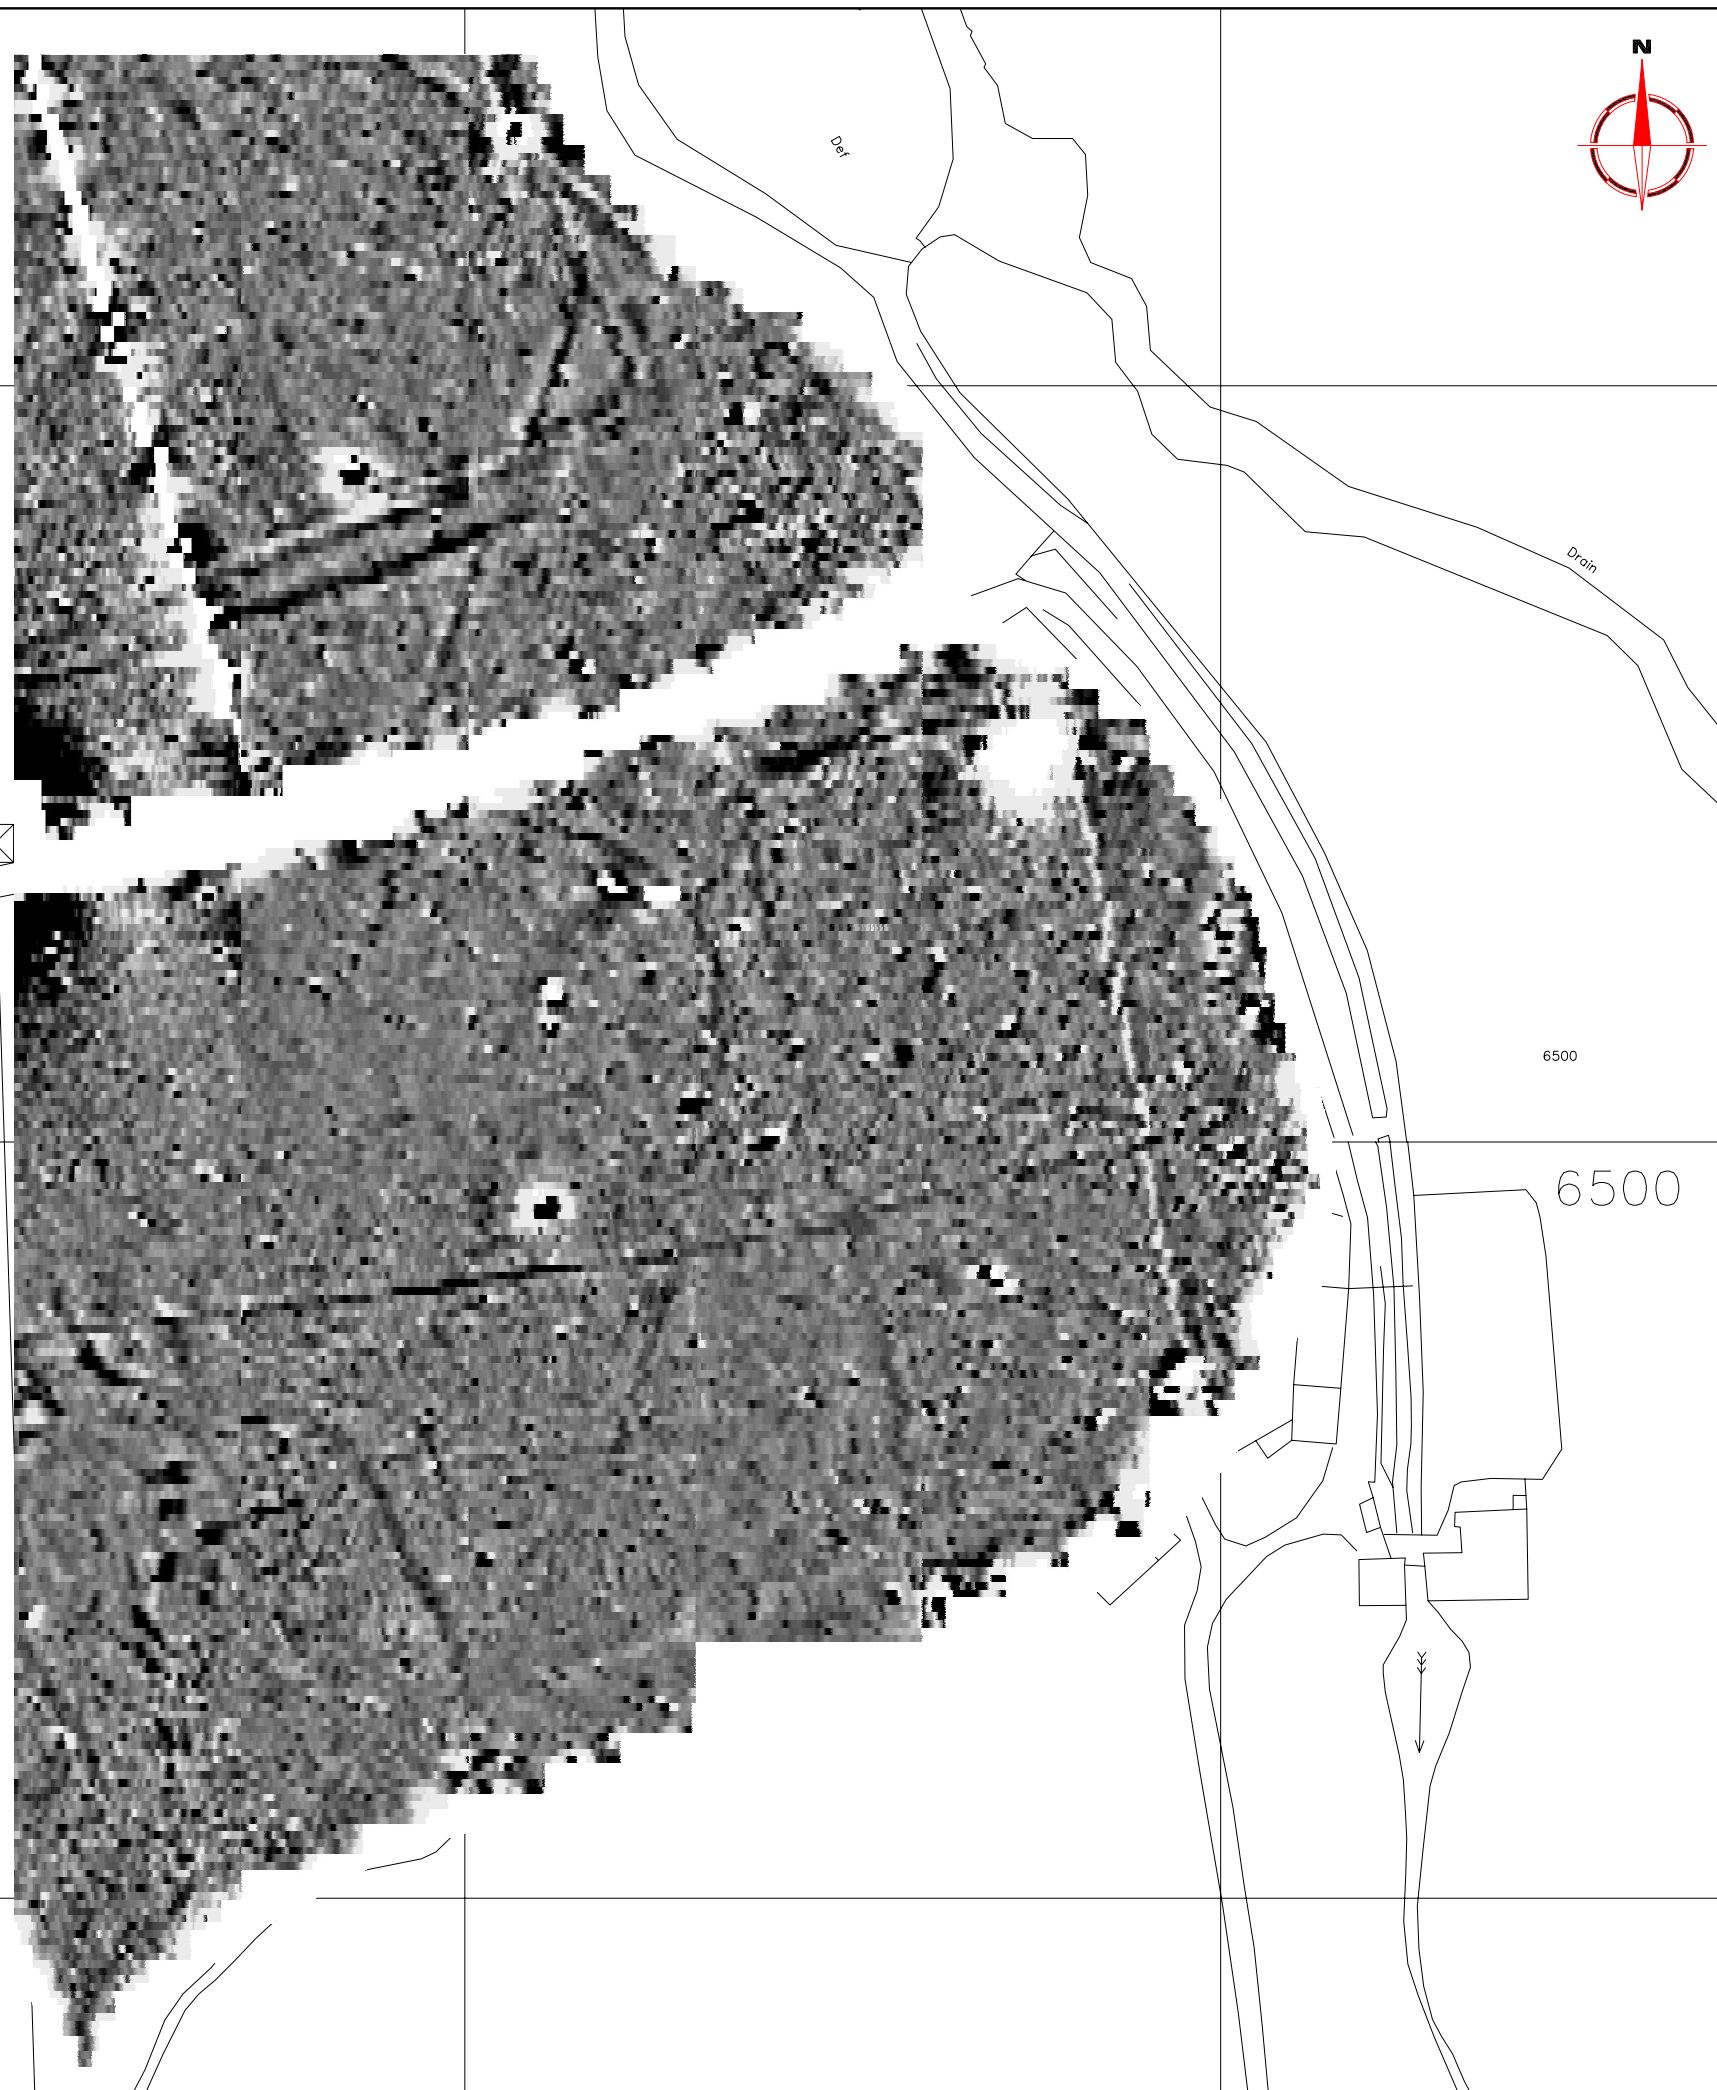
| Survey date JUNE 06 | Drawn by HH | Figure No. 36 |

Subject
PLOT OF PROCESSED GRADIOMETER DATA AREA 4

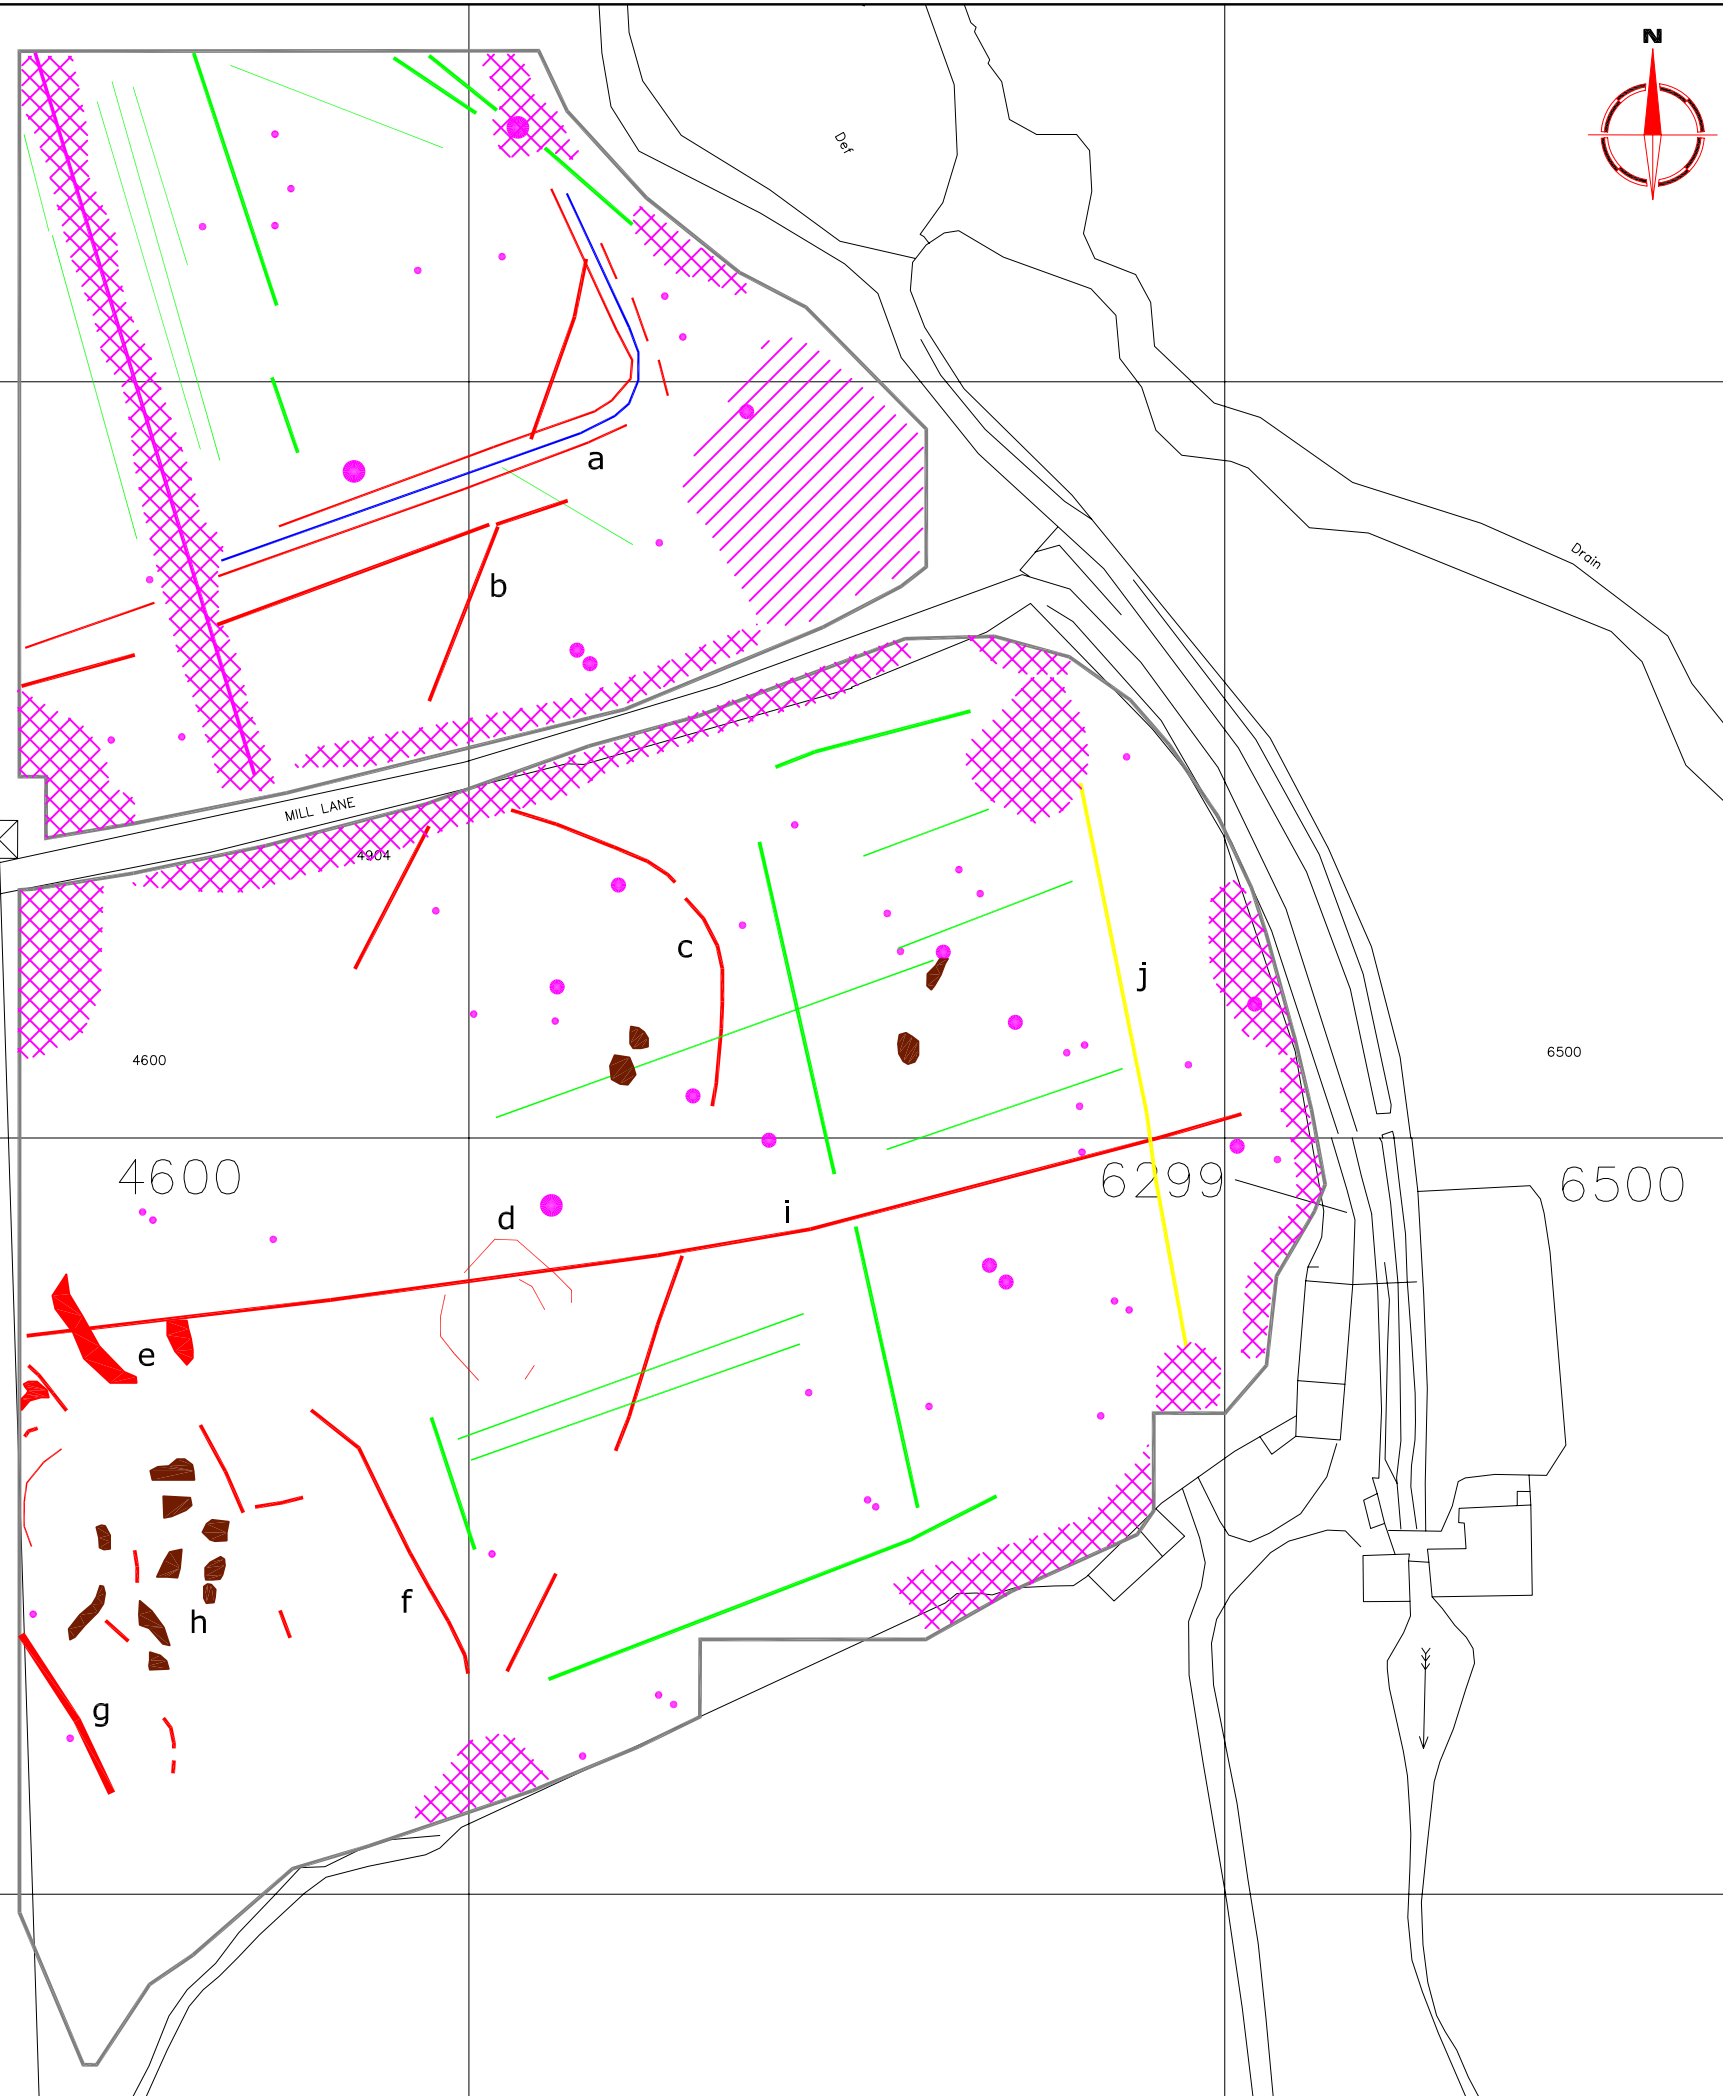
| Survey date JUNE 06 | Drawn by HH | Figure No. 37 |

| KEY | |
|---|--|
| | Discrete positive anomaly - possible pit |
| | Positive anomaly with associated negative response - ferrous object |
| | Magnetic disturbance - associated with fenceline |
| | Positive linear anomaly - agricultural mark |
| | Linear anomaly - possible service |
| | Positive linear anomaly - cut feature of possible archaeological origin |
| | Negative linear anomaly - possibly bank or previous earthwork |
| | Area of magnetic debris - possibly relating to ground disturbance |
| | Area of magnetic disturbance - associated with nearby pylon, animal feeders and field boundaries |

Subject
ABSTRACTION AND INTERPRETATION OF GRADIOMETER ANOMALIES - AREA 4
