Project Title Job No. 2155
**GEOPHYSICAL SURVEY -
WATER SEWAGE TREATMENT
NEAR EXETER AIRPORT**

Subject
**PLOT OF PROCESSED
GRADIOMETER DATA
- AREA 3F**

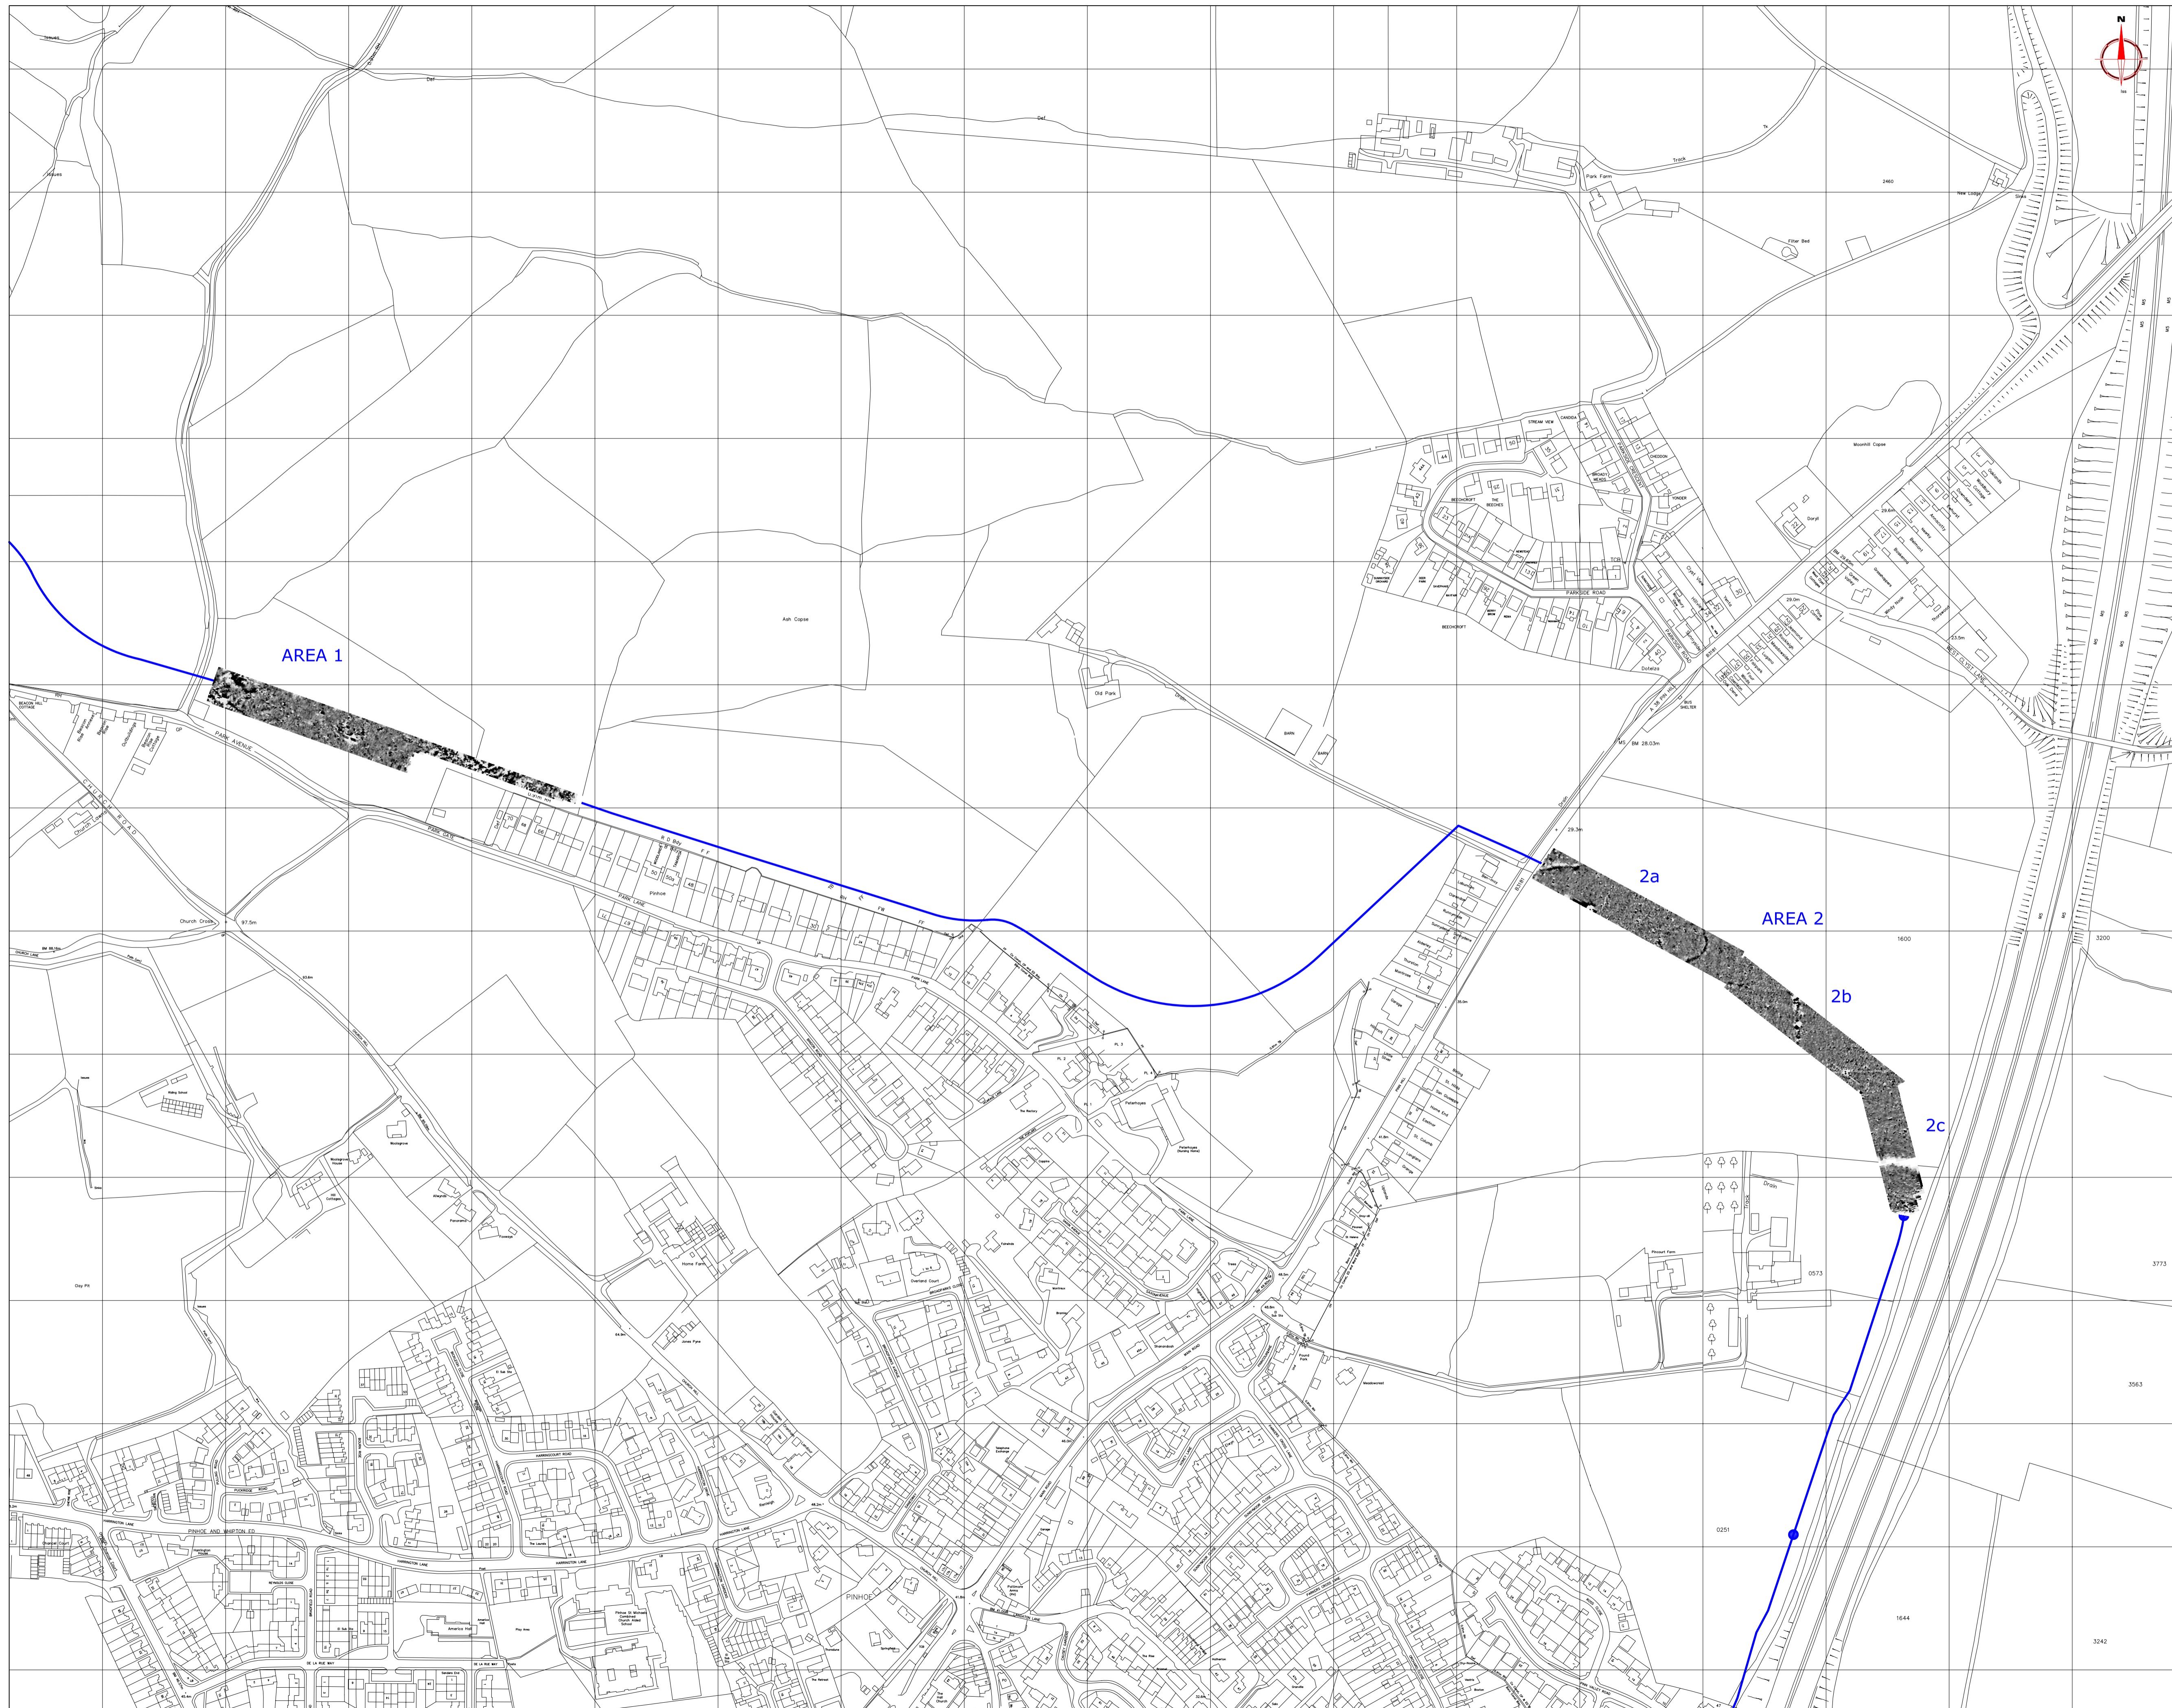
| | | Figure No. | 38 |

| Subject | PROCESSED GRADIOMETER DATA AREAS 1 AND 2 | | |

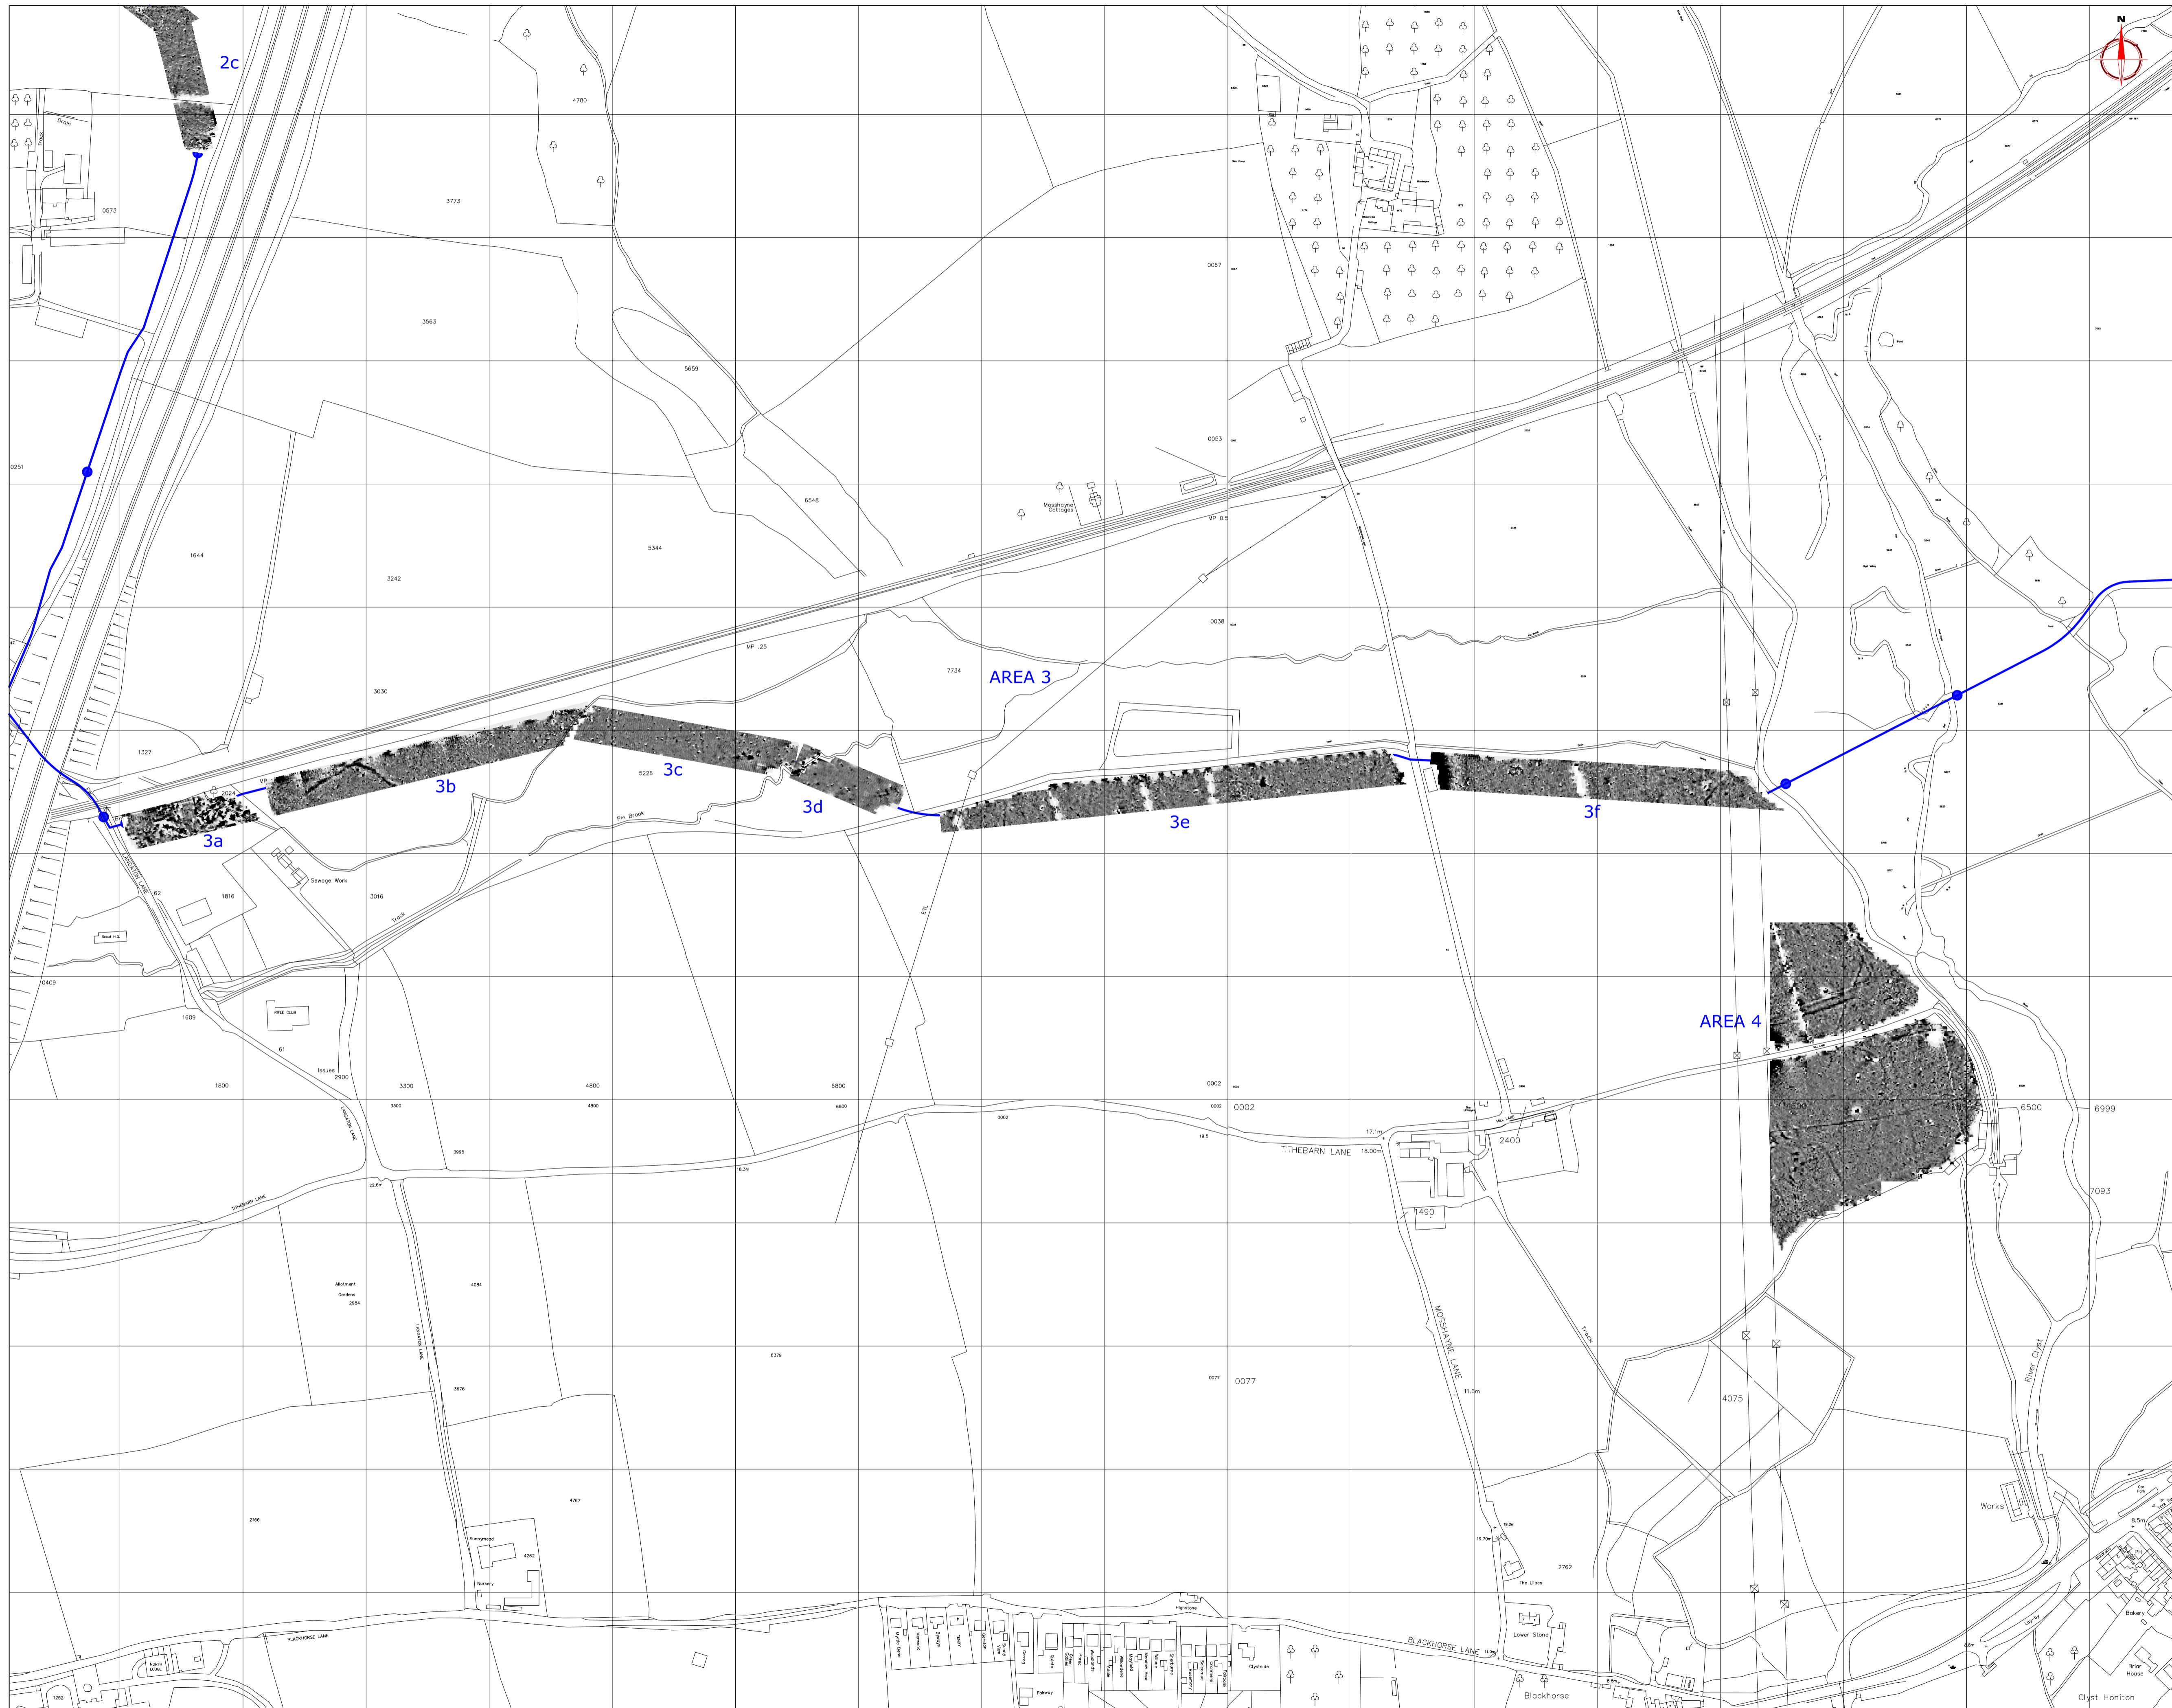
| Issue No. | 01 | Figure No. | 39 |

| Subject | PROCESSED GRADIOMETER DATA AREAS 3 AND 4 | | |

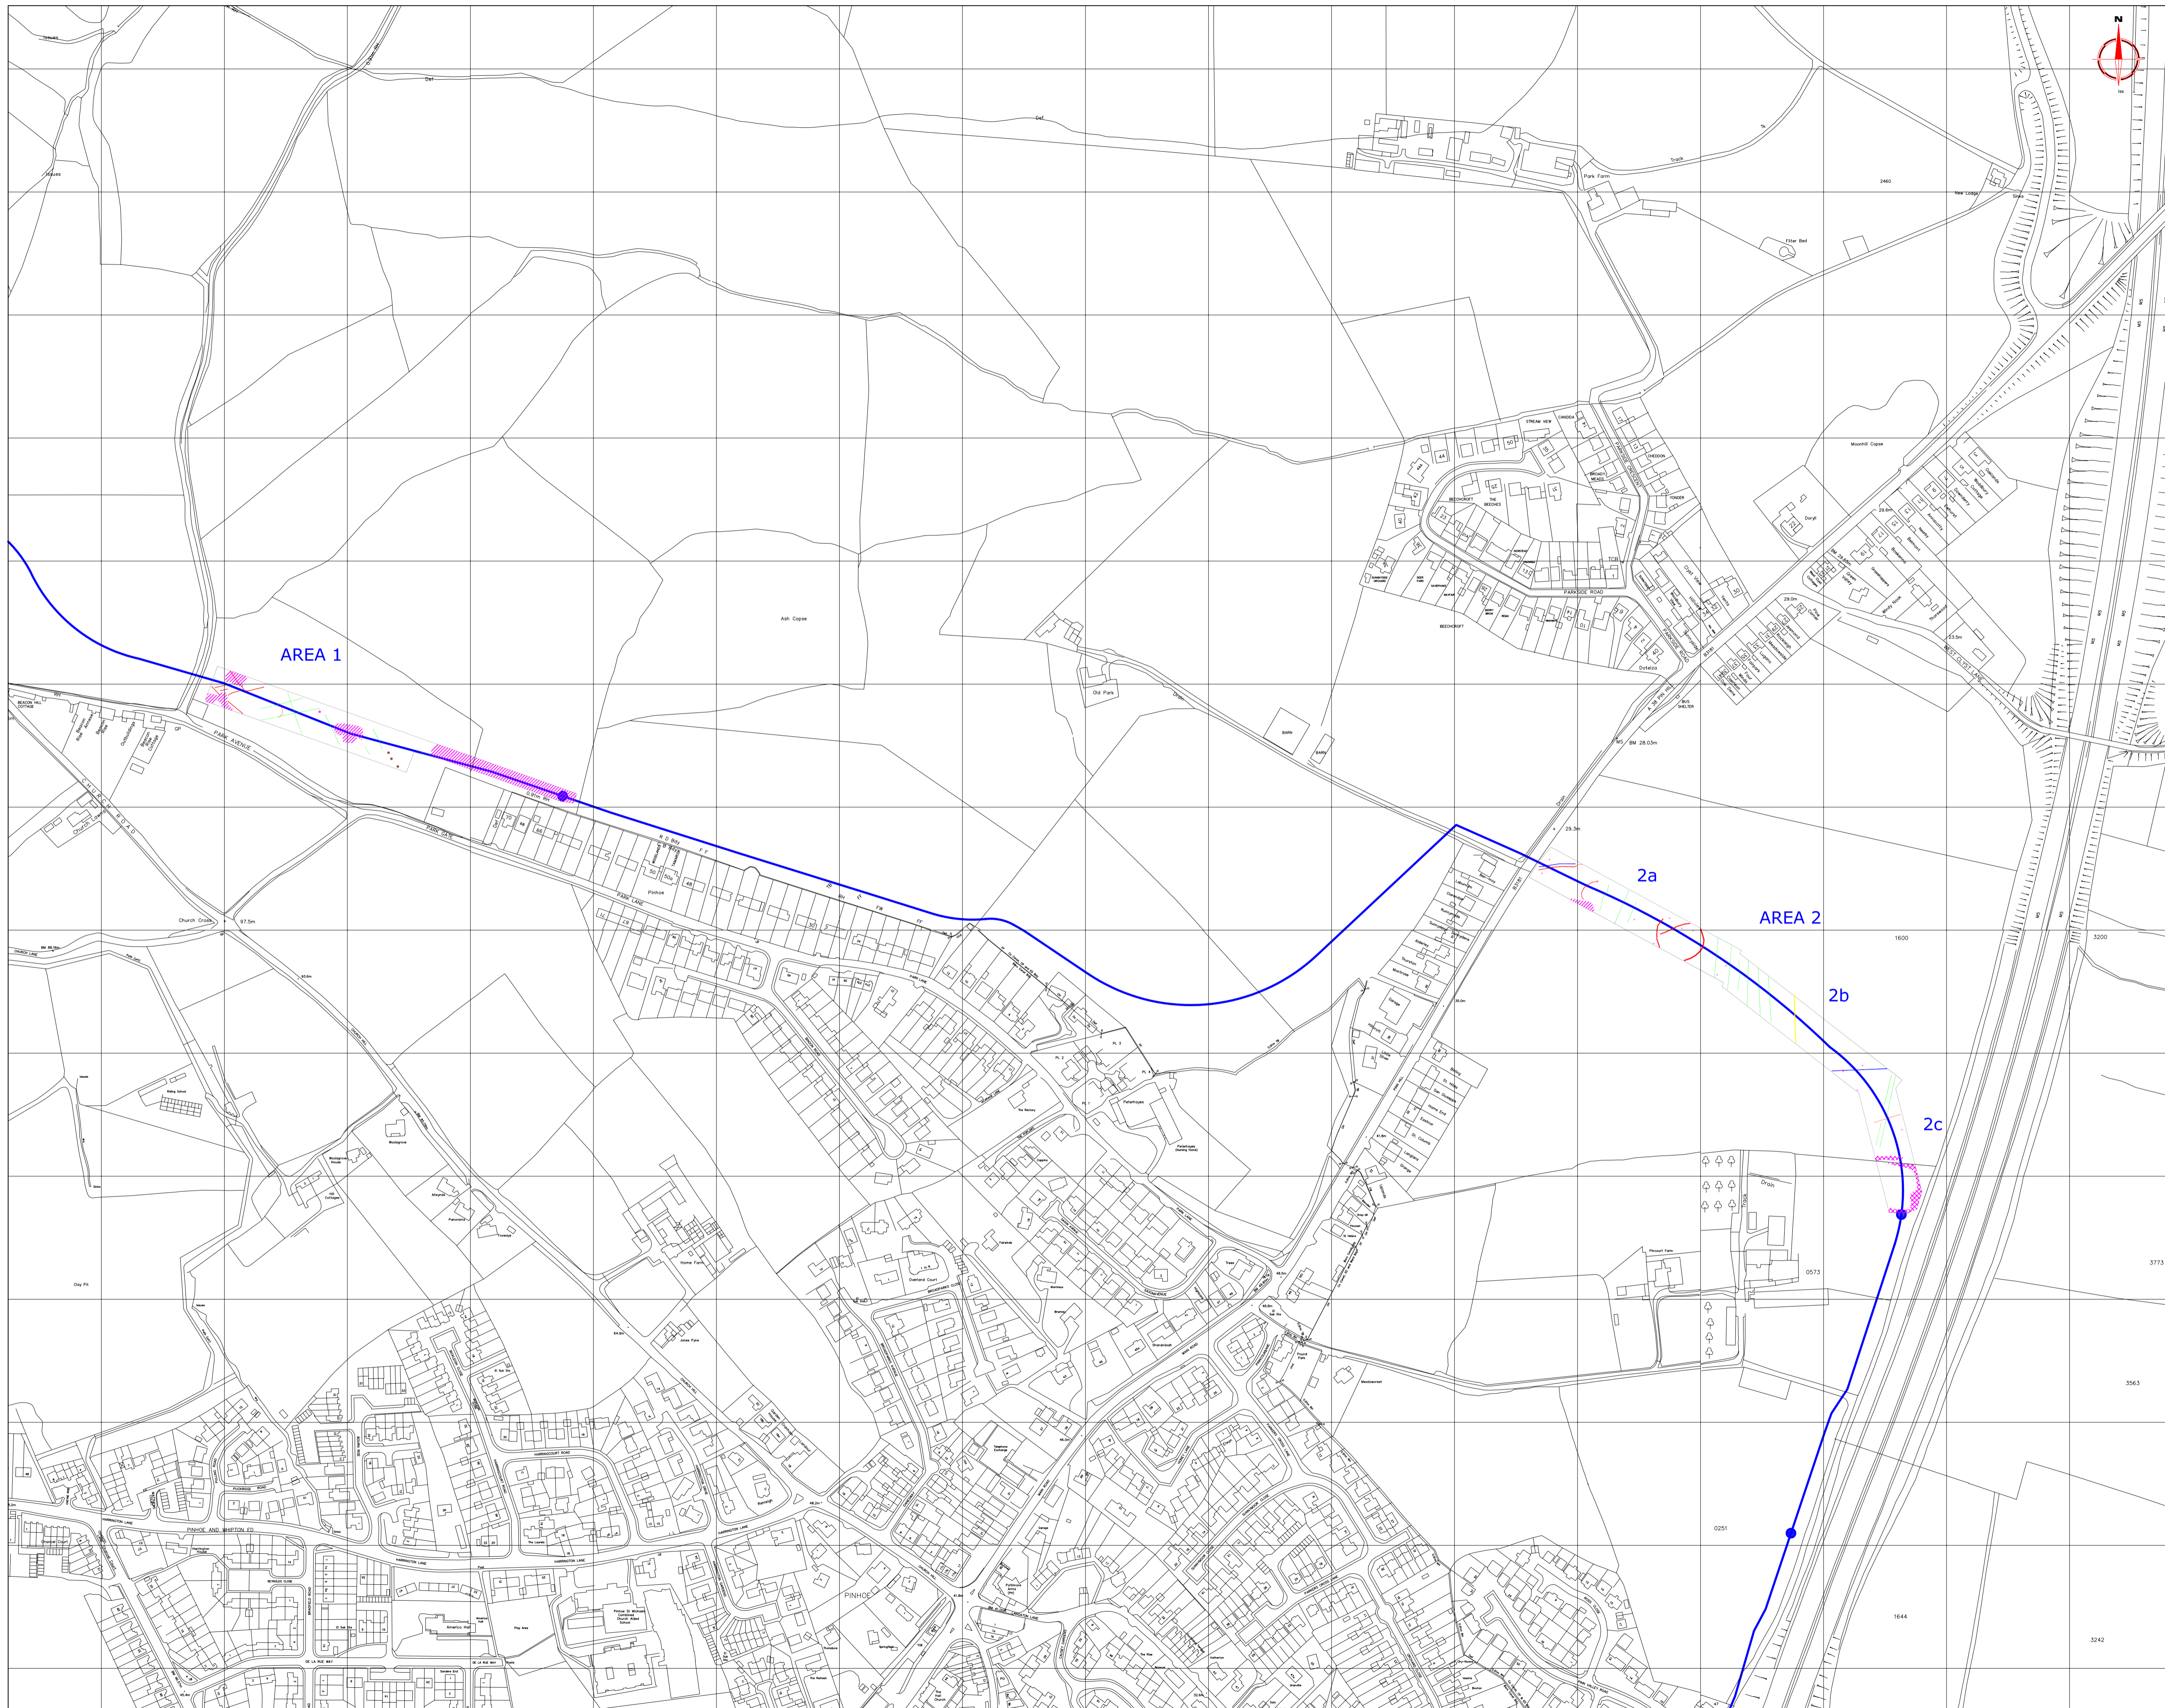
| Issue No. | 01 | Figure No. | 40 |

| KEY | |
|---|--|
| | Discrete positive anomaly - possible pit |
| | Positive anomaly with associated negative response - ferrous object |
| | Magnetic disturbance - associated with fenceline |
| | Positive linear anomaly - agricultural mark |
| | Linear anomaly - possible service |
| | Positive linear anomaly - cut feature of possible archaeological origin |
| | Negative linear anomaly - possibly indicating a bank or previous earthwork |
| | Positive linear anomaly associated with stream |
| | Area of magnetic debris - possibly relating to ground disturbance |
| | Area of magnetic disturbance - associated with nearby pylon, animal feeders, field boundaries, roads or services |

| Subject | INTERPRETATION PLOT AREAS 1 AND 2 | | |

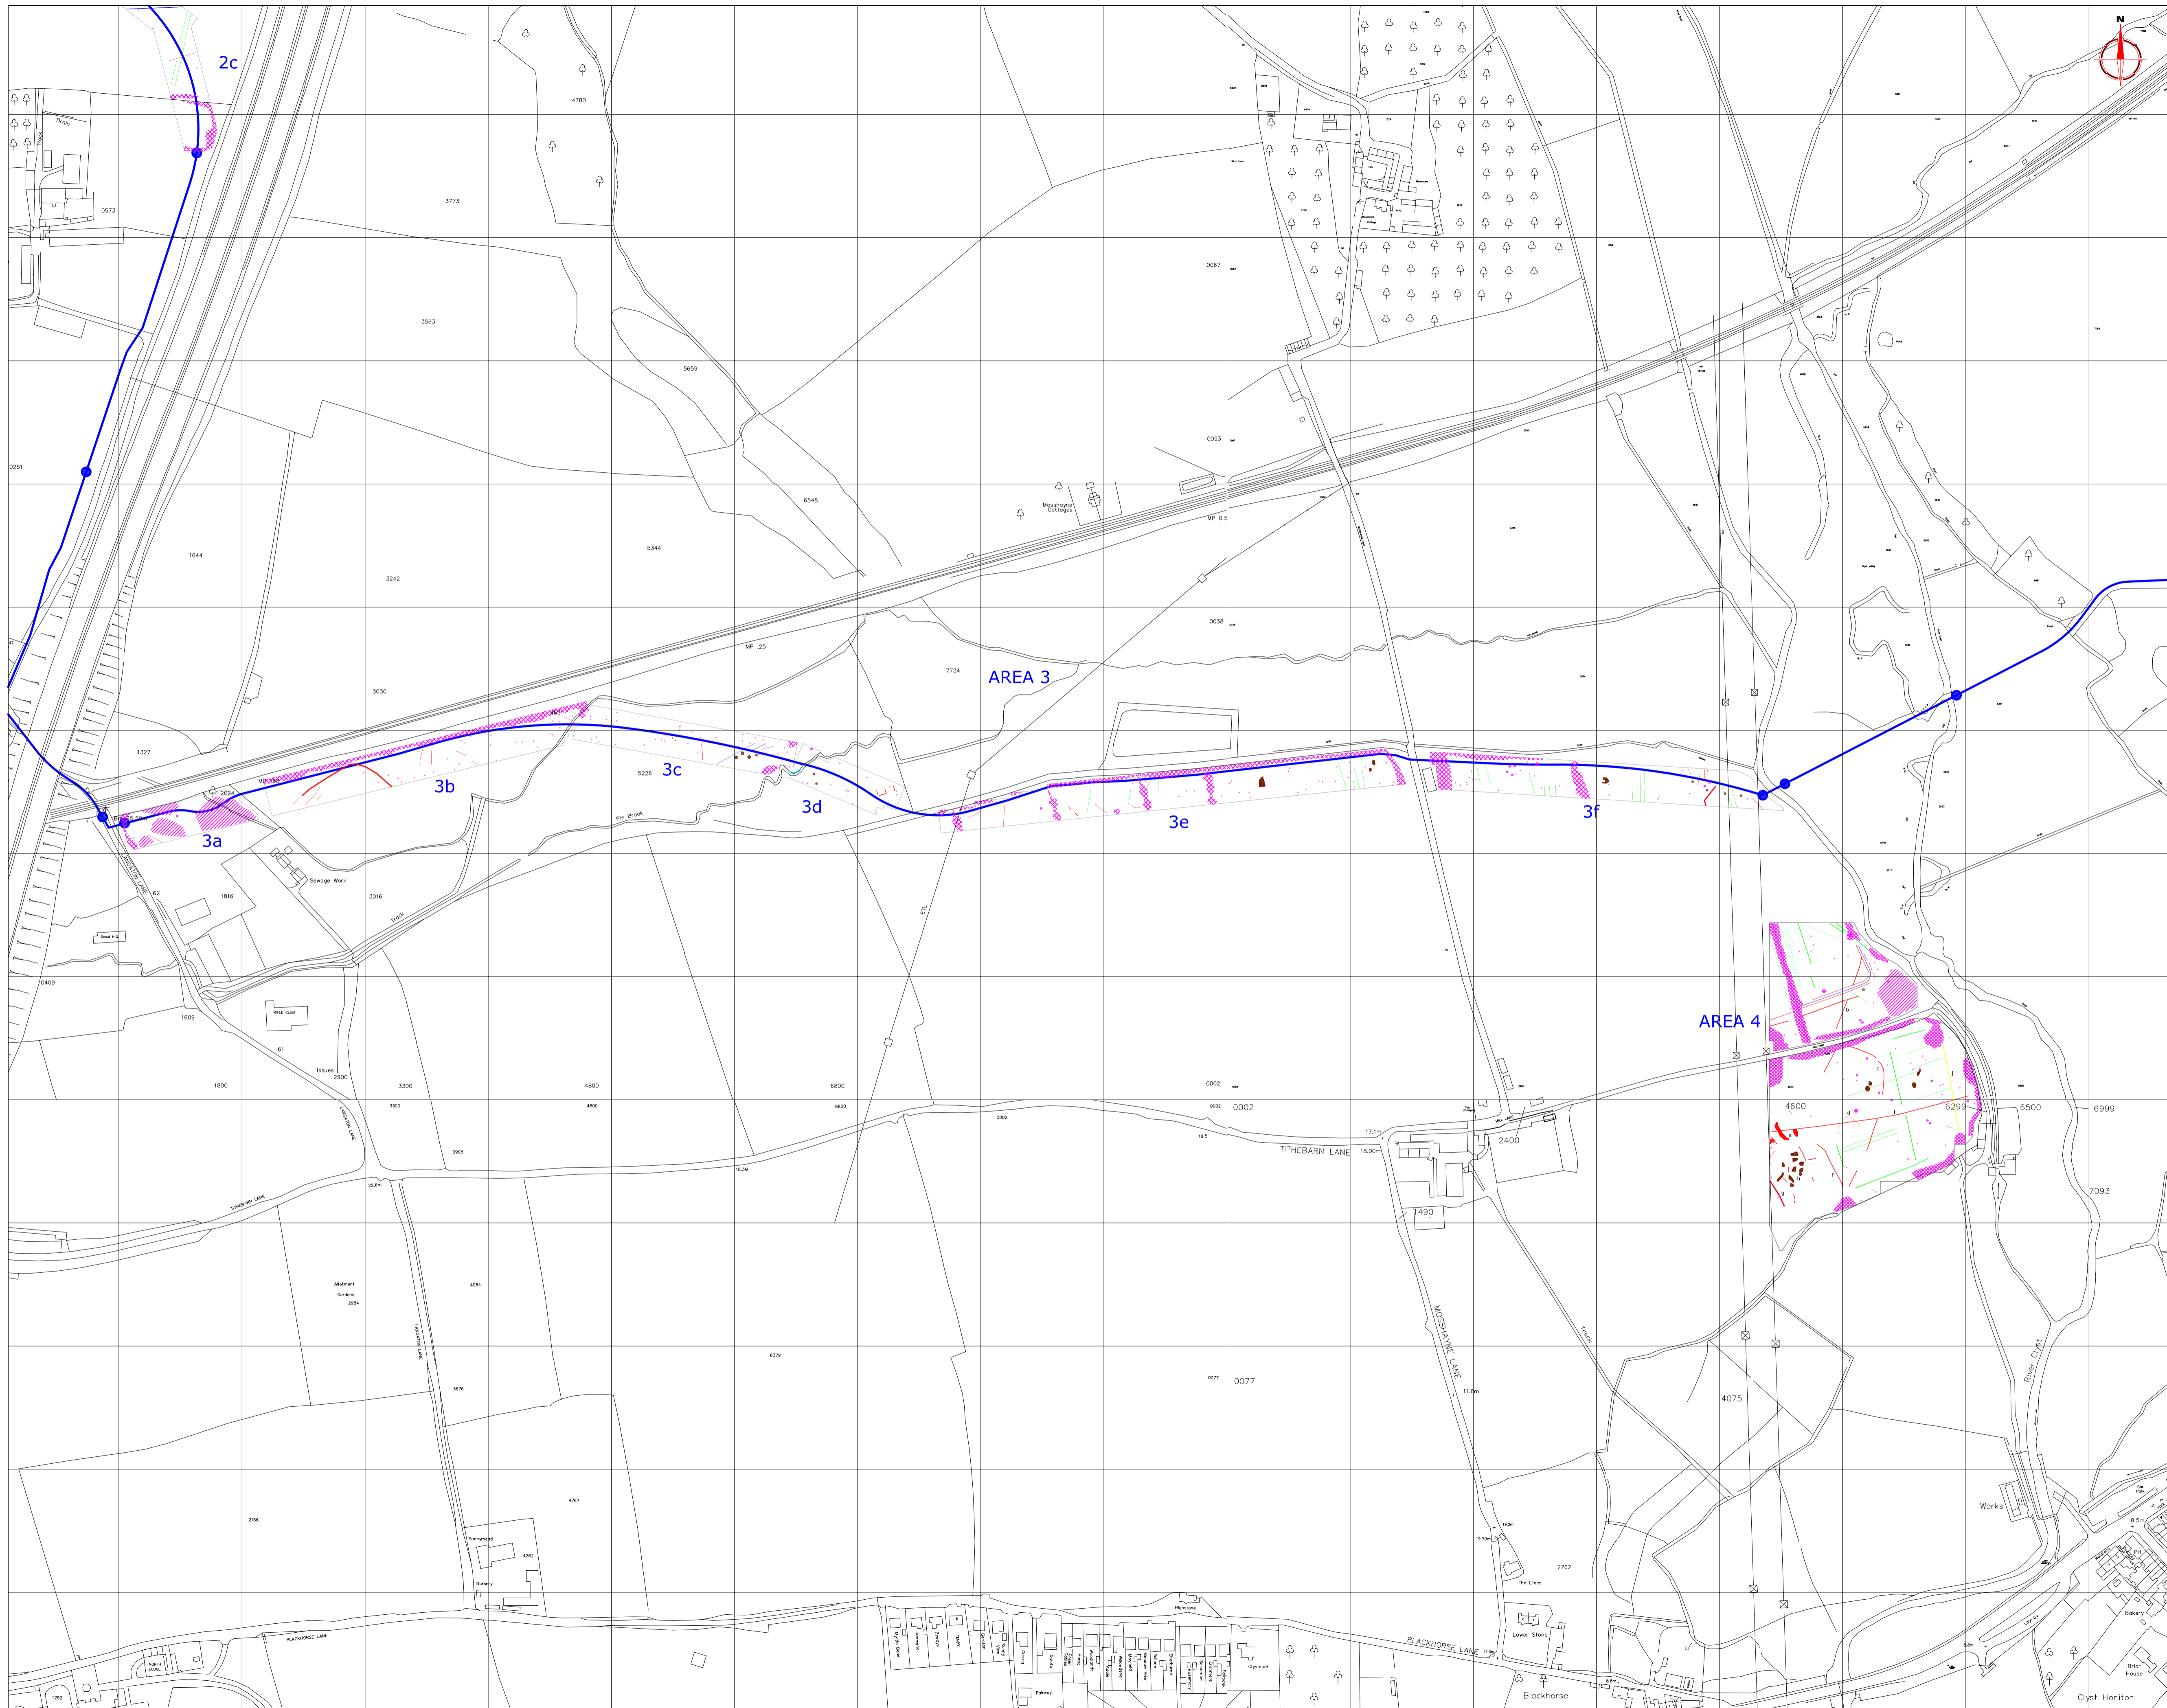
| Issue No. | 01 | Figure No. | 41 |

| KEY | |
|---|--|
| | Discrete positive anomaly - possible pit |
| | Positive anomaly with associated negative response - ferrous object |
| | Magnetic disturbance - associated with fence/line |
| | Positive linear anomaly - agricultural mark |
| | Linear anomaly - possible service |
| | Positive linear anomaly - cut feature of possible archaeological origin |
| | Negative linear anomaly - possibly indicating a bank or previous earthwork |
| | Positive linear anomaly associated with stream |
| | Area of magnetic debris - possibly relating to ground disturbance |
| | Area of magnetic disturbance - associated with nearby pylon, animal feeders, field boundaries, roads or services |

| Subject | INTERPRETATION PLOT AREAS 3 AND 4 | | |
