Site Code: LPL06  
LCCM Accession No.: 2006.141  
Planning Application Nos.: 2005/0770/F &  
2005/0771/LBC  
NGR: SK 98025/71664

**Extension at Pottergate Lodge,  
Pottergate, Lincoln**

Archaeological Watching Brief

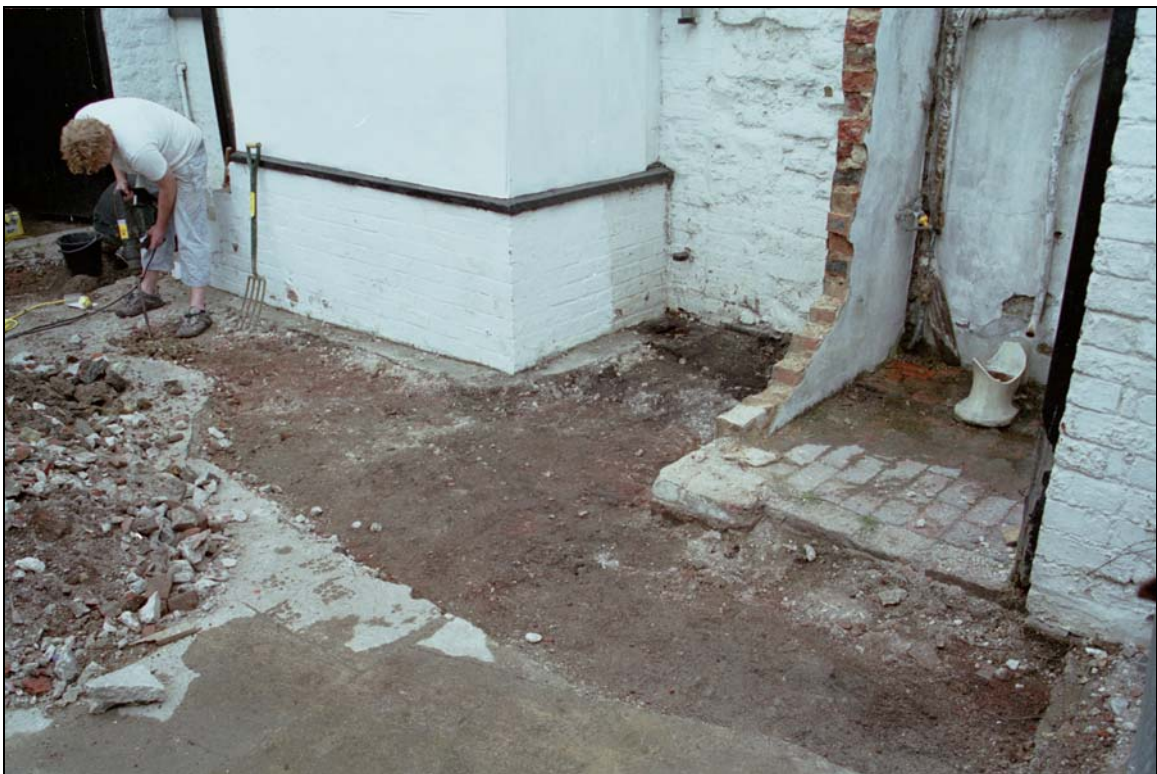
**Plate 2:** General view of site for new 'sun room', following localised removal of concrete yard surface & partial demolition of existing outside toilet - looking north-west

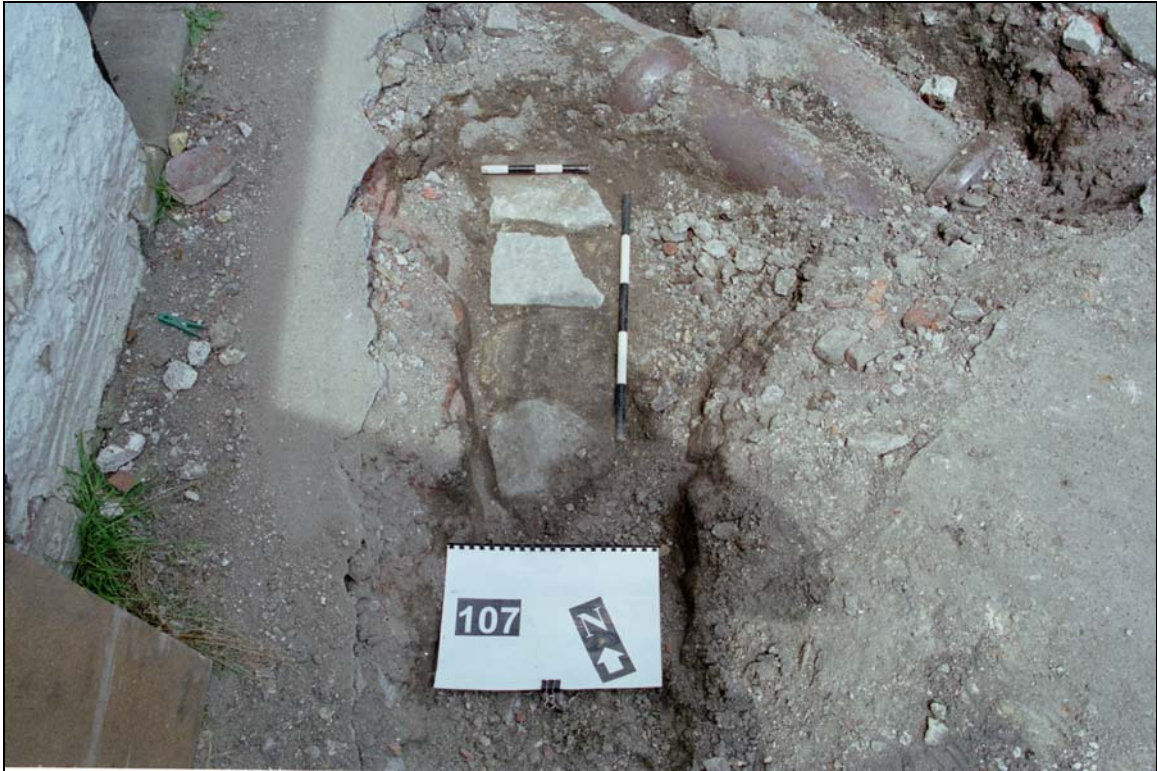
**Plate 3:** Overall view of possible wall remains, [107] - looking generally north

The second feature was situated close to the western boundary of the site, adjacent to the present garage. The trench in this area was relatively shallow (excavated in an unsuccessful attempt to locate an existing drain run), but revealed a small section of a possible NE-SW oriented stone wall, [107], at a depth of *c.* 250mm below existing yard surface. While this was only partially revealed, at least one course of roughly worked limestone

pieces was identified, with a possible rough face to the west. There was no evidence of mortar bonding, and a single machine-made red brick was incorporated into its fabric at the southern end, but the remnant appeared to share a common alignment with the original western wall of Pottergate Lodge (visible as a distinct 'edge' in the south elevation of the standing building), and therefore possibly represents part of an associated boundary wall or outbuilding (see Figure 3).

The only possible exception to this was the remnant of wall revealed towards the west of the site, which may be associated with the original (or, at least, an early) phase of Pottergate Lodge, and might therefore date from the late 18<sup>th</sup> century. Unfortunately, as excavation in this area was very limited in scope and no dating material was recovered from the feature, this hypothesis remains unproven.

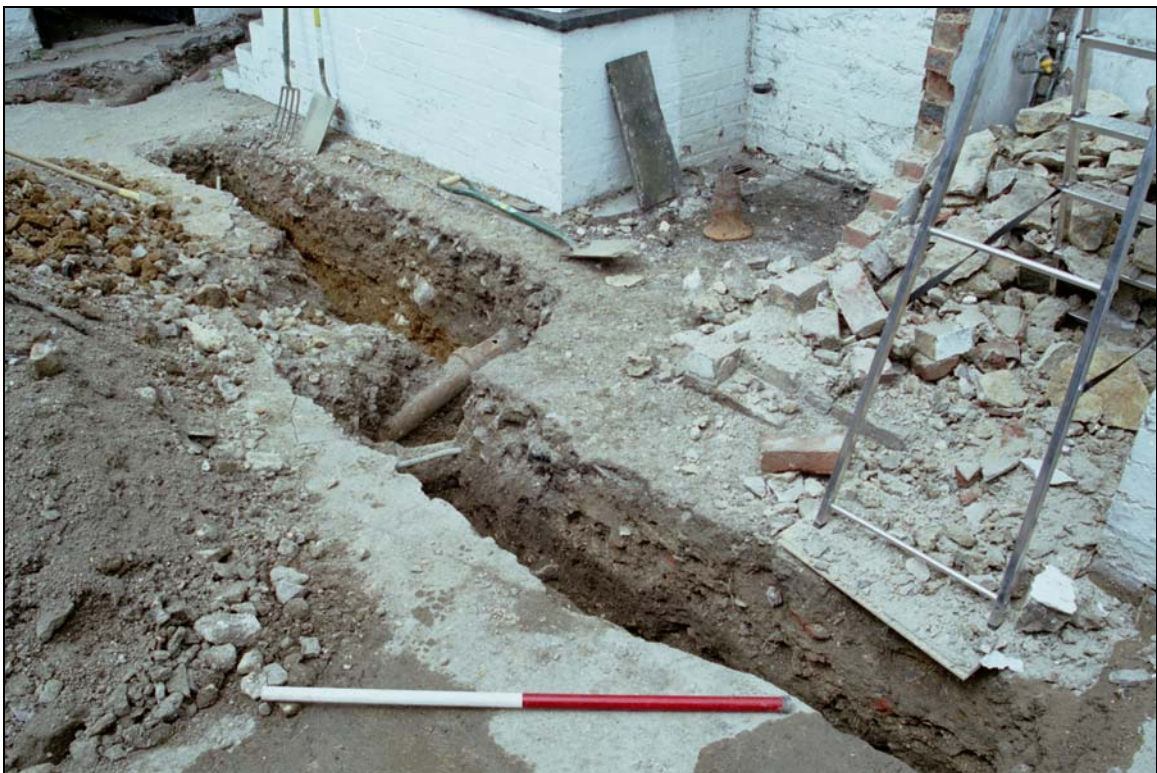
**Plate 4:** General view of completed foundation trench for new 'sun room' - looking north-west
