**Archaeological Monitoring of a Gas Pipeline Installation at
St Nicholas Church, Dersingham, Norfolk**

August 2011

Report No. 1036
ENF 124571

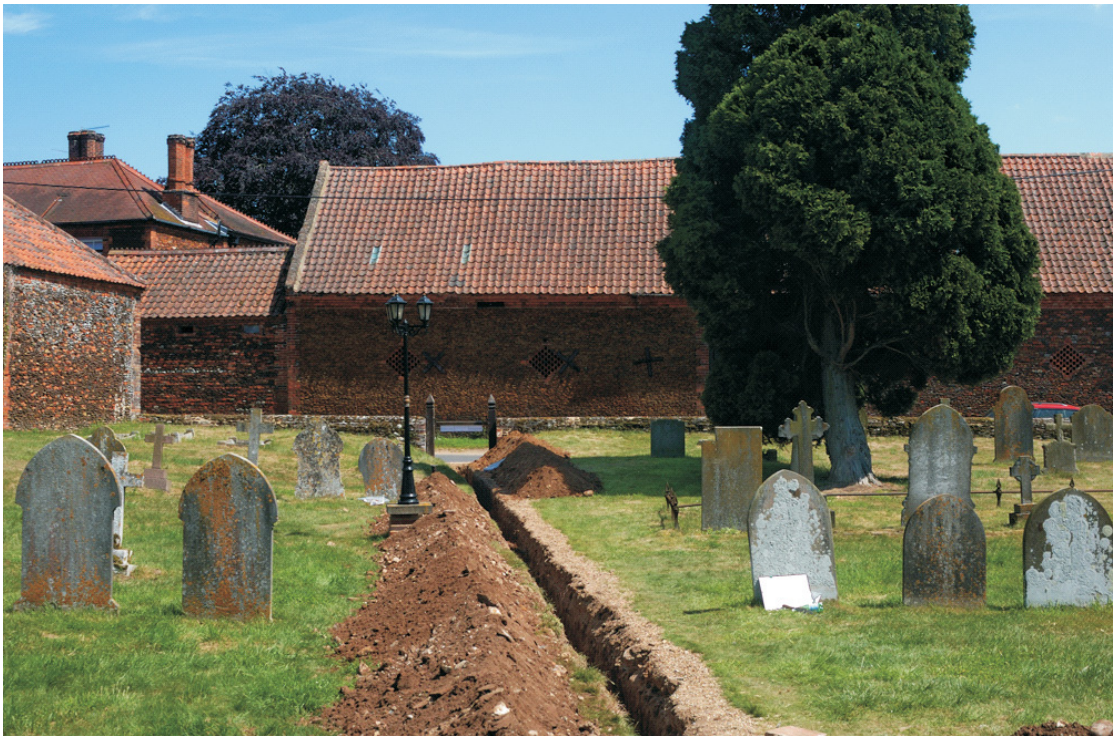
Figure 2. Location of gas pipeline trench (above) and photograph looking east along the trench (below)

The trench commenced adjacent to the buttress at the north east corner of the north aisle and continued for 3m in an easterly direction before following the course of a North-South aligned gravel path leading from the north side of the church. The trench followed the path for 3m before turning in an easterly direction following the course of an east-west gravel path aligned parallel with the north side of the church.

The initial cut across the grassed area adjacent to the church revealed a dark grey humic sandy loam top soil (depth 0.00m – 0.15m); beneath this was a reddish brown sandy subsoil. As the cut continued and followed the gravel path the upper strata comprised a layer of compacted gravel (depth 0.00 – 0.05m) overlying a layer of made up ground (depth 0.05 – 0.30m) consisting of building rubble. The made up ground beneath the gravel path included some material (glass, slate and stone) that could have originated from the later restoration work of the Church; however, some of the material (eg; red brick, grey pantiles) could not be matched with the fabric of the Church or adjacent structures.

Between 15 to 20 meters along the gravel path a quantity of animal bones (Fig 2; B) were recovered from the layer of made up ground (depth 0.05 – 0.30m). Other material included slate tiles, glass, stone (similar to material used for the church), red brick and grey pantiles. The animal bone recovered included cow, sheep/goat and red deer. Many of the bones exhibited marks typical of de-fleshing for meat, in particular some of the vertebrae had been chopped in a manner typical of 16th century butchery. The recovery of large quantities of butchered animal bone and building fabric that could not be matched to any buildings in close proximity to the church yard suggests that the made up ground originated from elsewhere, possibly a local farmyard. A fragment of dressed stone, semi-circular in profile, was also recovered and may have been a mullion from the church discarded during alterations to the church. A dark greyish brown sherd from a jar lid probably originates from the Roman period.

Between 24 to 25m along the gravel path a quantity of animal bones were recovered (Fig 2; C) from the layer of made up ground (depth 0.05 – 0.30m), from the lower sub soil fragments of disarticulated human bones were recovered along with fragments of possible medieval pottery.
