# Haslingfield Manor, Cambridgeshire

Archaeological Monitoring of Topsoil Stripping and Moat Cleaning

September 2011

**Report No. 1040**  
**Event No. ECB 3577**

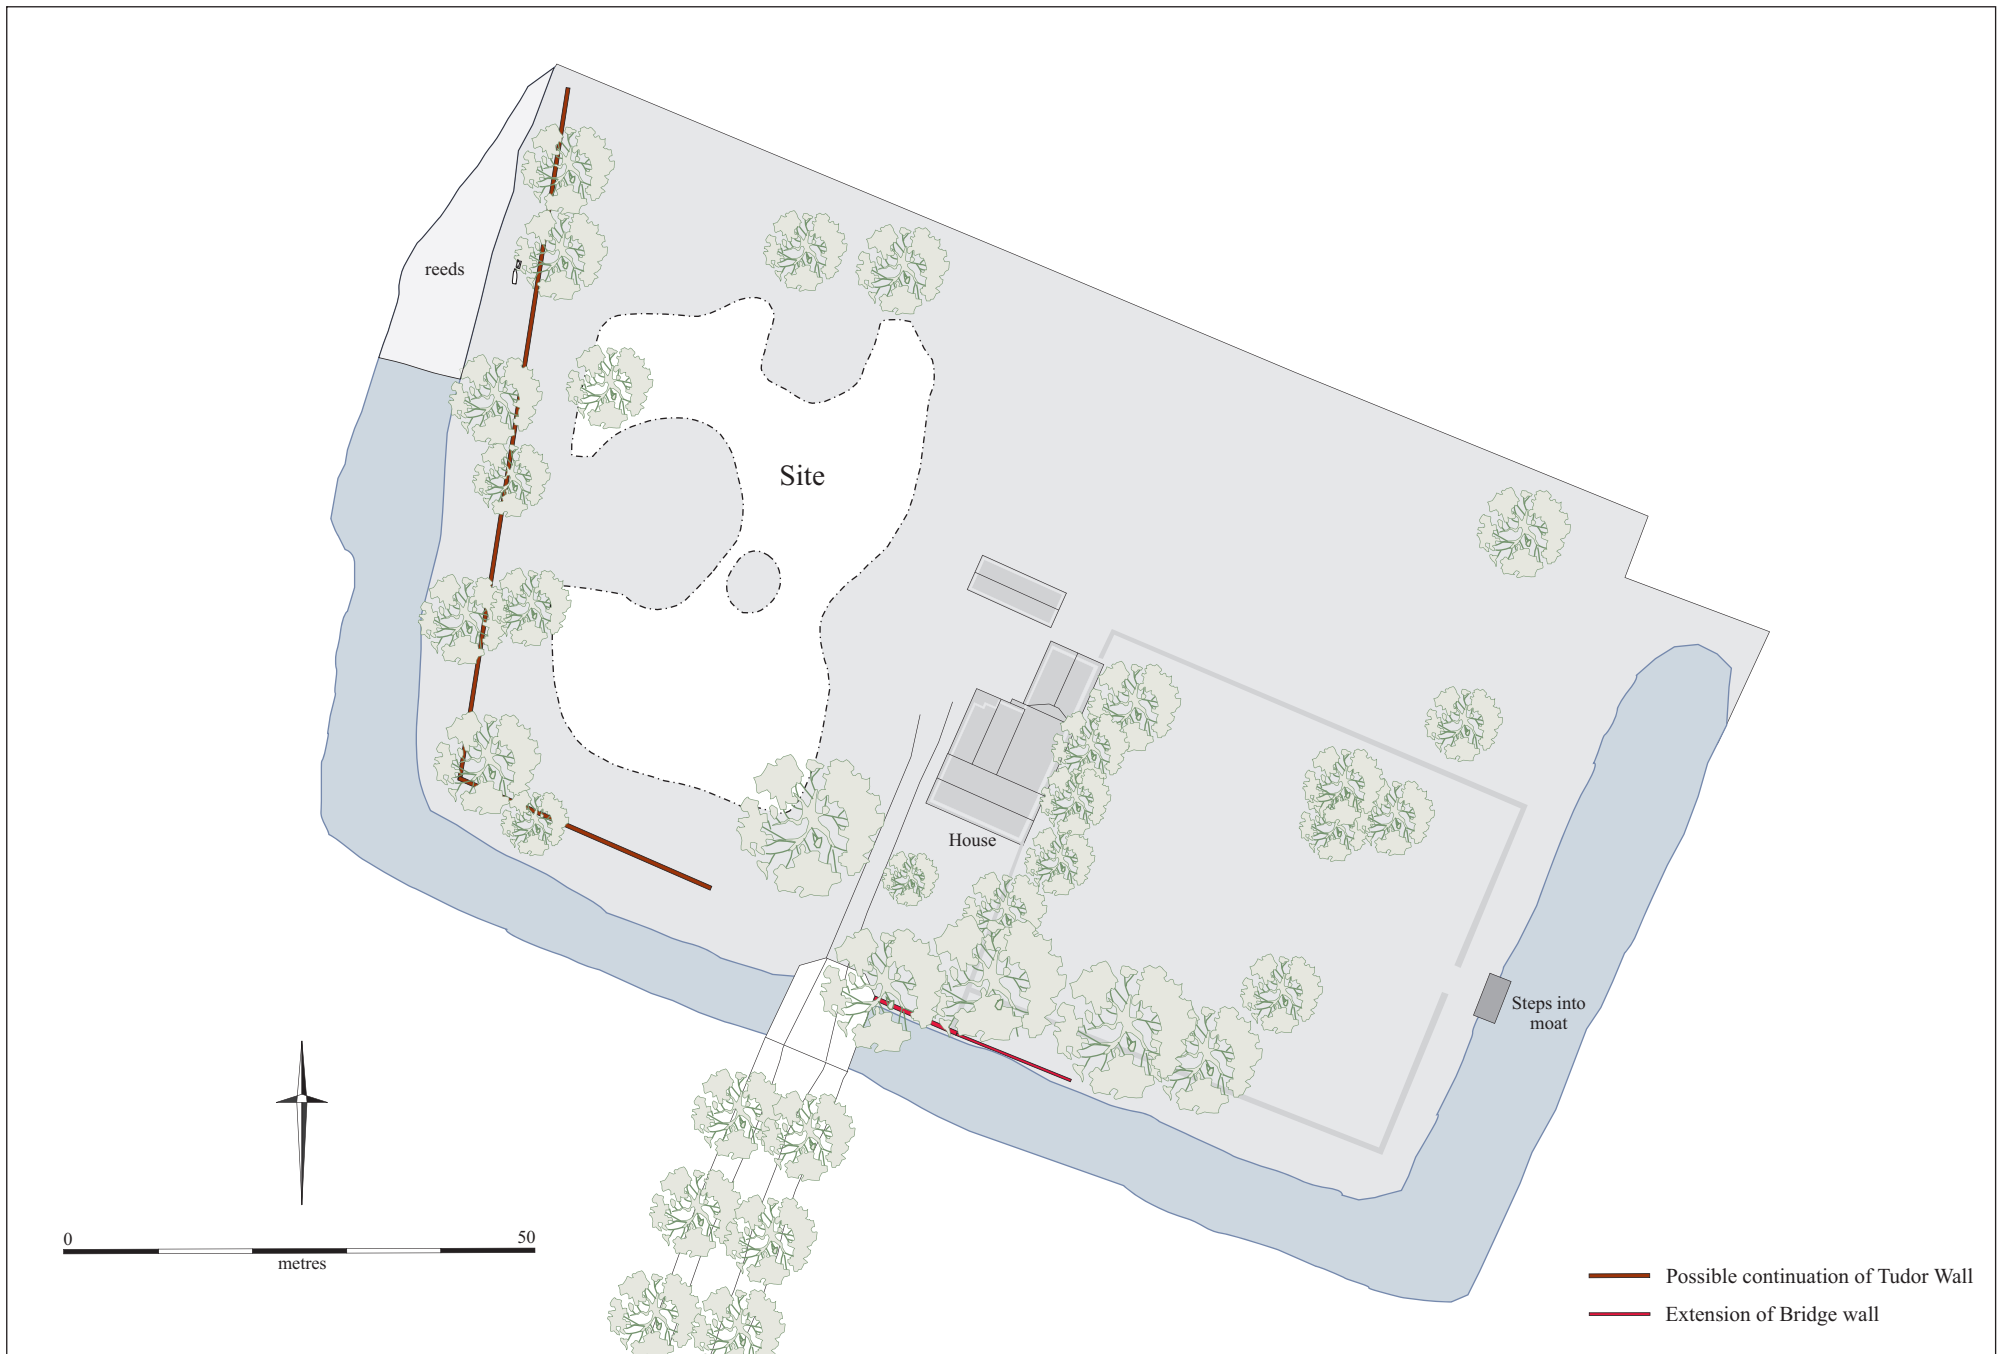
Figure 2. Haslingfield Manor

The topography of the area of investigation was characterised by an area of flat lawn surrounded by a three-sided moat with interspersed mature trees. The southern part of the western moat was straight and even sided that turned at an 80° angle and became much wider and irregular in plan. The northern tip of the western arm of the moat incorporates a reed bed (see Figure 2).

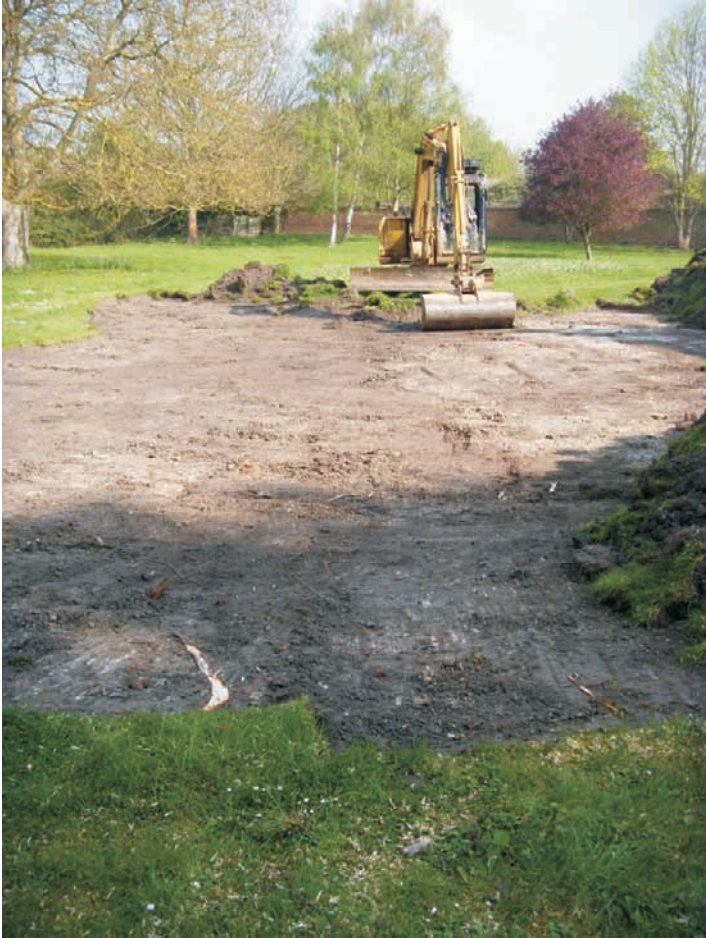
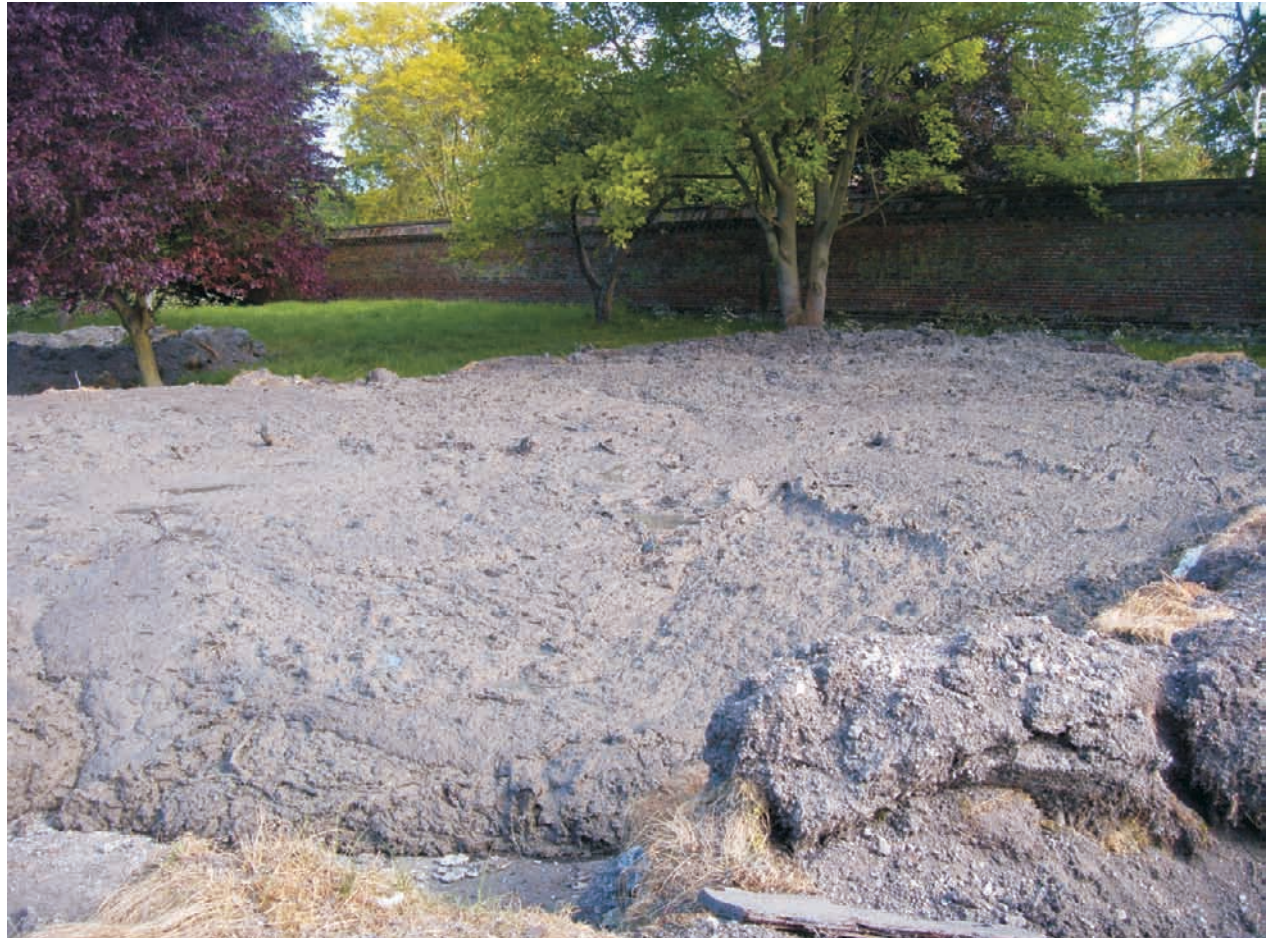
Figure 4. The demolition area F.1 and excavated moat fills

The topsoil strips revealed an area of disturbance that related to the demolition of the pre-existing house and contained rubble material that included bricks, tiles and domestic debris dated from the 16<sup>th</sup> to 19<sup>th</sup> century. Two pit features were uncovered that dated to the 19<sup>th</sup>-20<sup>th</sup> century. Domestic debris that dated from the 17<sup>th</sup> to 19<sup>th</sup> century was also recorded throughout the stripped area that was incorporated in a deposit that derived from the re-cutting of the moat and was used to level the interior of the site. The recent excavated moat sediments contained little artefactual evidence suggesting that the moat had been extensively cleaned, sometime prior to the 20<sup>th</sup> century.

The removal of topsoil for the storage area highlighted an area where the original footing of the house was located and the mixed nature of the artefact assemblage highlighted the fact that there was a lot of disturbance and mixing of contexts. The mixed nature of the assemblage was also evident in the re-deposited natural layer [003] potentially derived from the 'digging' or re-cutting of the moat, with the excavated material used to level the interior of the moated site. There was little evidence of material recovered that dated prior to the 17<sup>th</sup> century, indicating that occupation of an older date potentially lies deeper, as highlighted in the evaluation (Mackay 2003).

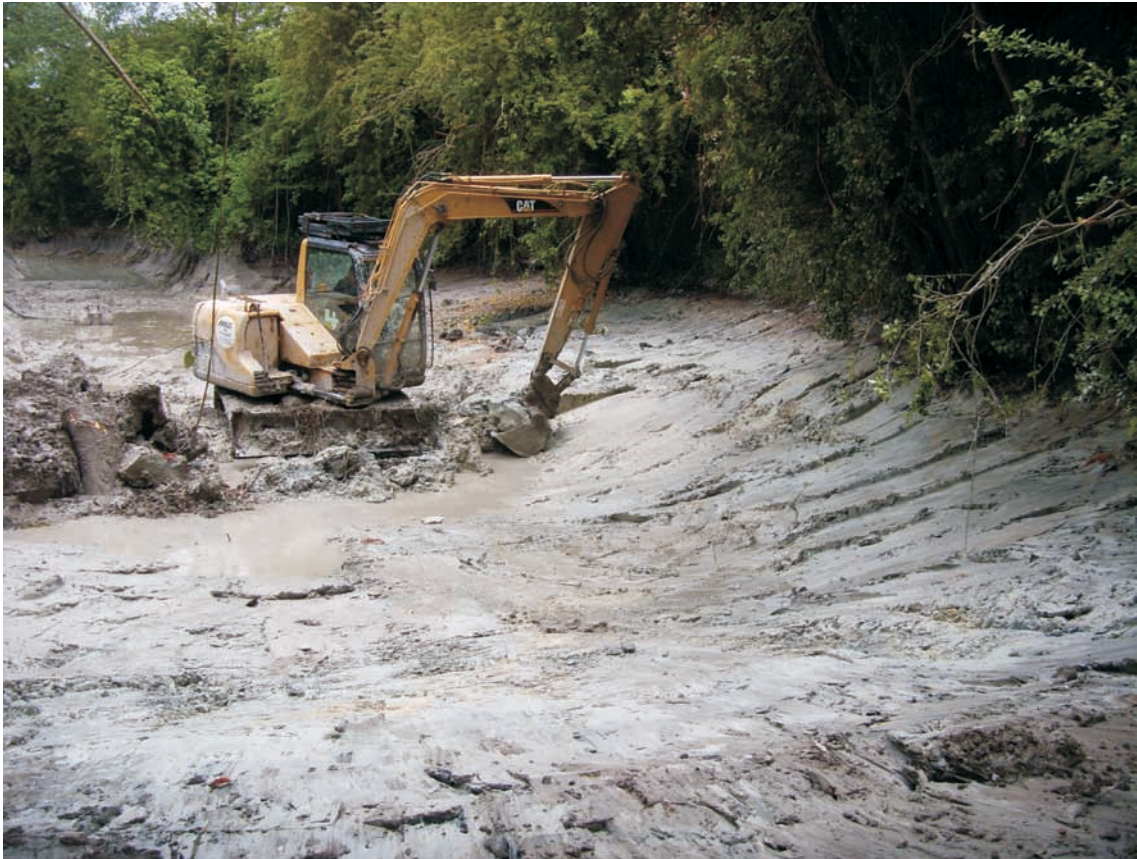
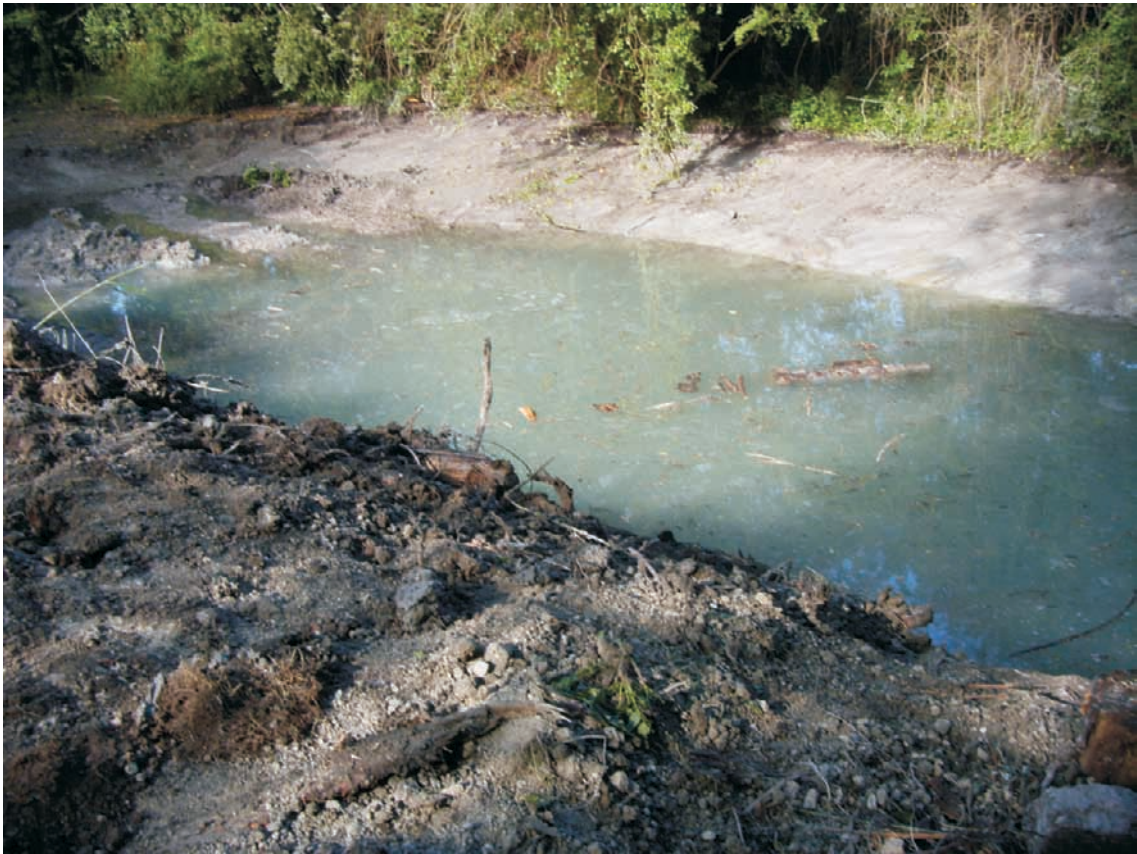
Figure 5. Eastern arm of the moat during cleaning and silt pond post-cleaning

The profile of the southern part of the moat had moderately steep straight sides on the outer edge with a sharp break of slope and flat base which suggested that it had been cleaned and perhaps re-cut (see Figure 7). The inner bank appeared to be steep and more vertical, although this could not be clarified due to the nature of the excavation and for the protection of the buried wall. The western part was much wider and irregular, perhaps due to an existing pond incorporated into the moat or because it was extended afterwards. On the western side of the moat, the outer edge had gradually sloping straight sides with a gradual break of slope and flat base with the inner side continuing at a much steeper angle (see Figure 5).

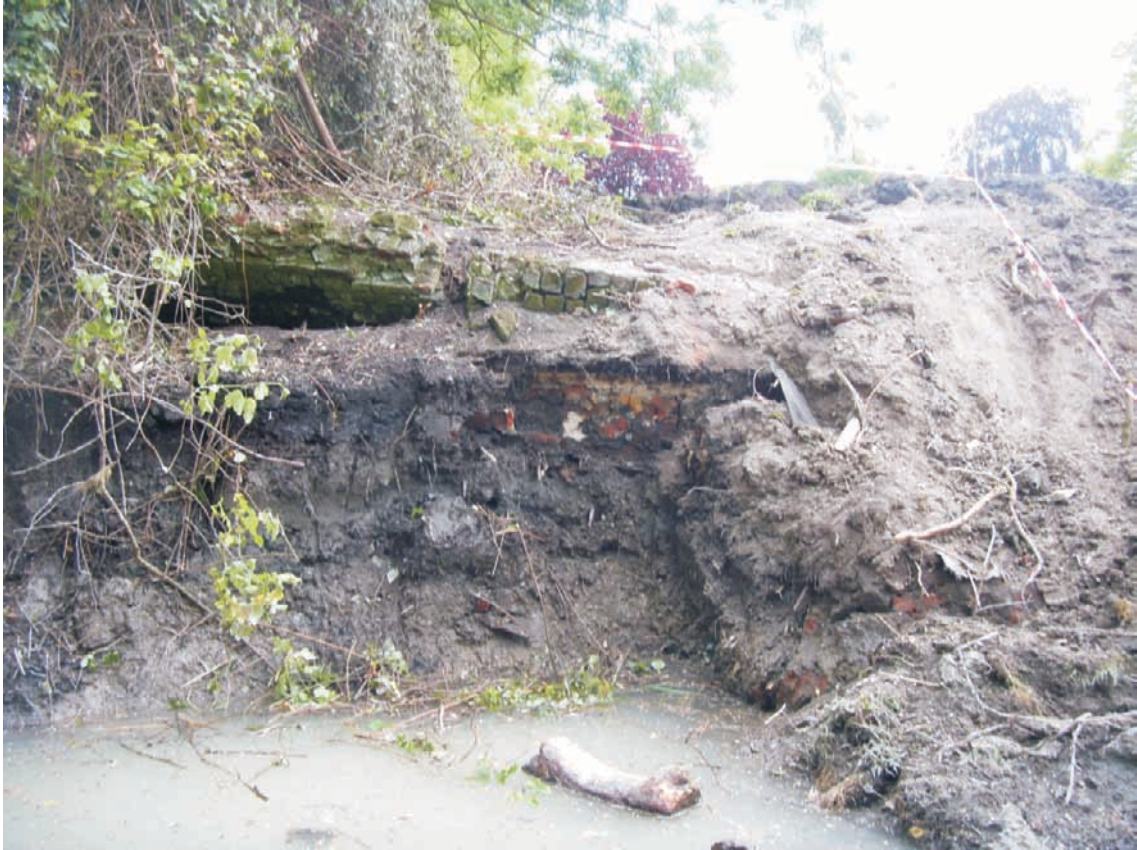
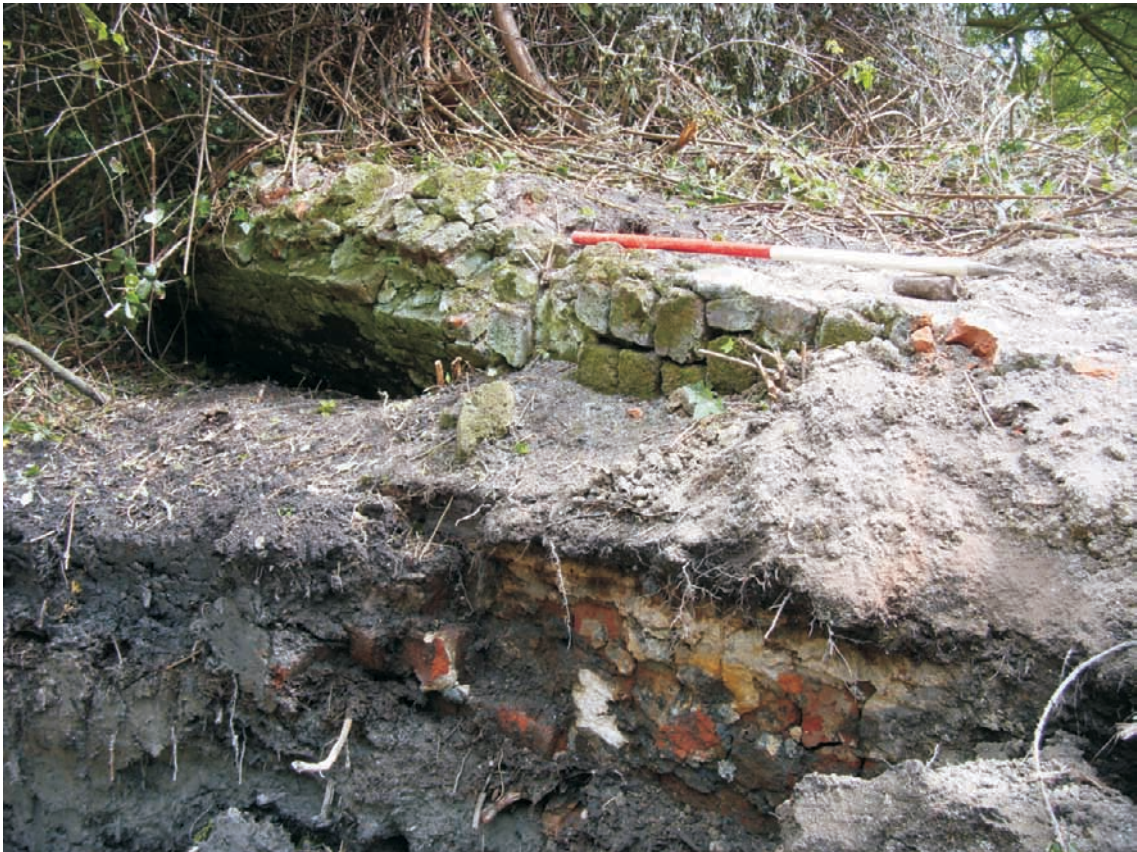
Figure 6. The collapsed moat wall F.4

During the clearing of brambles and overgrown vegetation at the northern point of the western moat, part of a collapsed wall, **F.4**, was observed at the edge of the moat that connected to the previously located 17<sup>th</sup> century wall (see Figure 3). This had several courses of brickwork and was constructed in the style of a English Garden Wall (see Figure 6). The exposed portion of wall was surveyed and recorded and it was observed that it continued northwards towards the turning point of the existing wall of the garden to the north. Beneath this collapsed wall was a 19<sup>th</sup> or 20<sup>th</sup> century construction, which was seen after that area of moat was cleaned (see Figure 6). This suggests that the 17<sup>th</sup> century wall was perhaps still standing upright at the time when the later more modern feature was constructed.

symmetry between the two arms of the moat. The remains of the collapsed wall suggested that the inner edge of the moat was perhaps walled and was a continuation on from the wall adjacent to the bridge at the front of the site (see Figure 7). The lack of archaeological evidence in the form of material culture or environmental remains suggest that the moat was re-cut thus removing all previous evidence of any earlier activity that could have provided an accurate date. There is little evidence of disturbance on the eastern moat and therefore the potential of recovering evidence of earlier activity is much higher, as suggested with the environmental boring sampling strategy conducted by Steve Boreham.

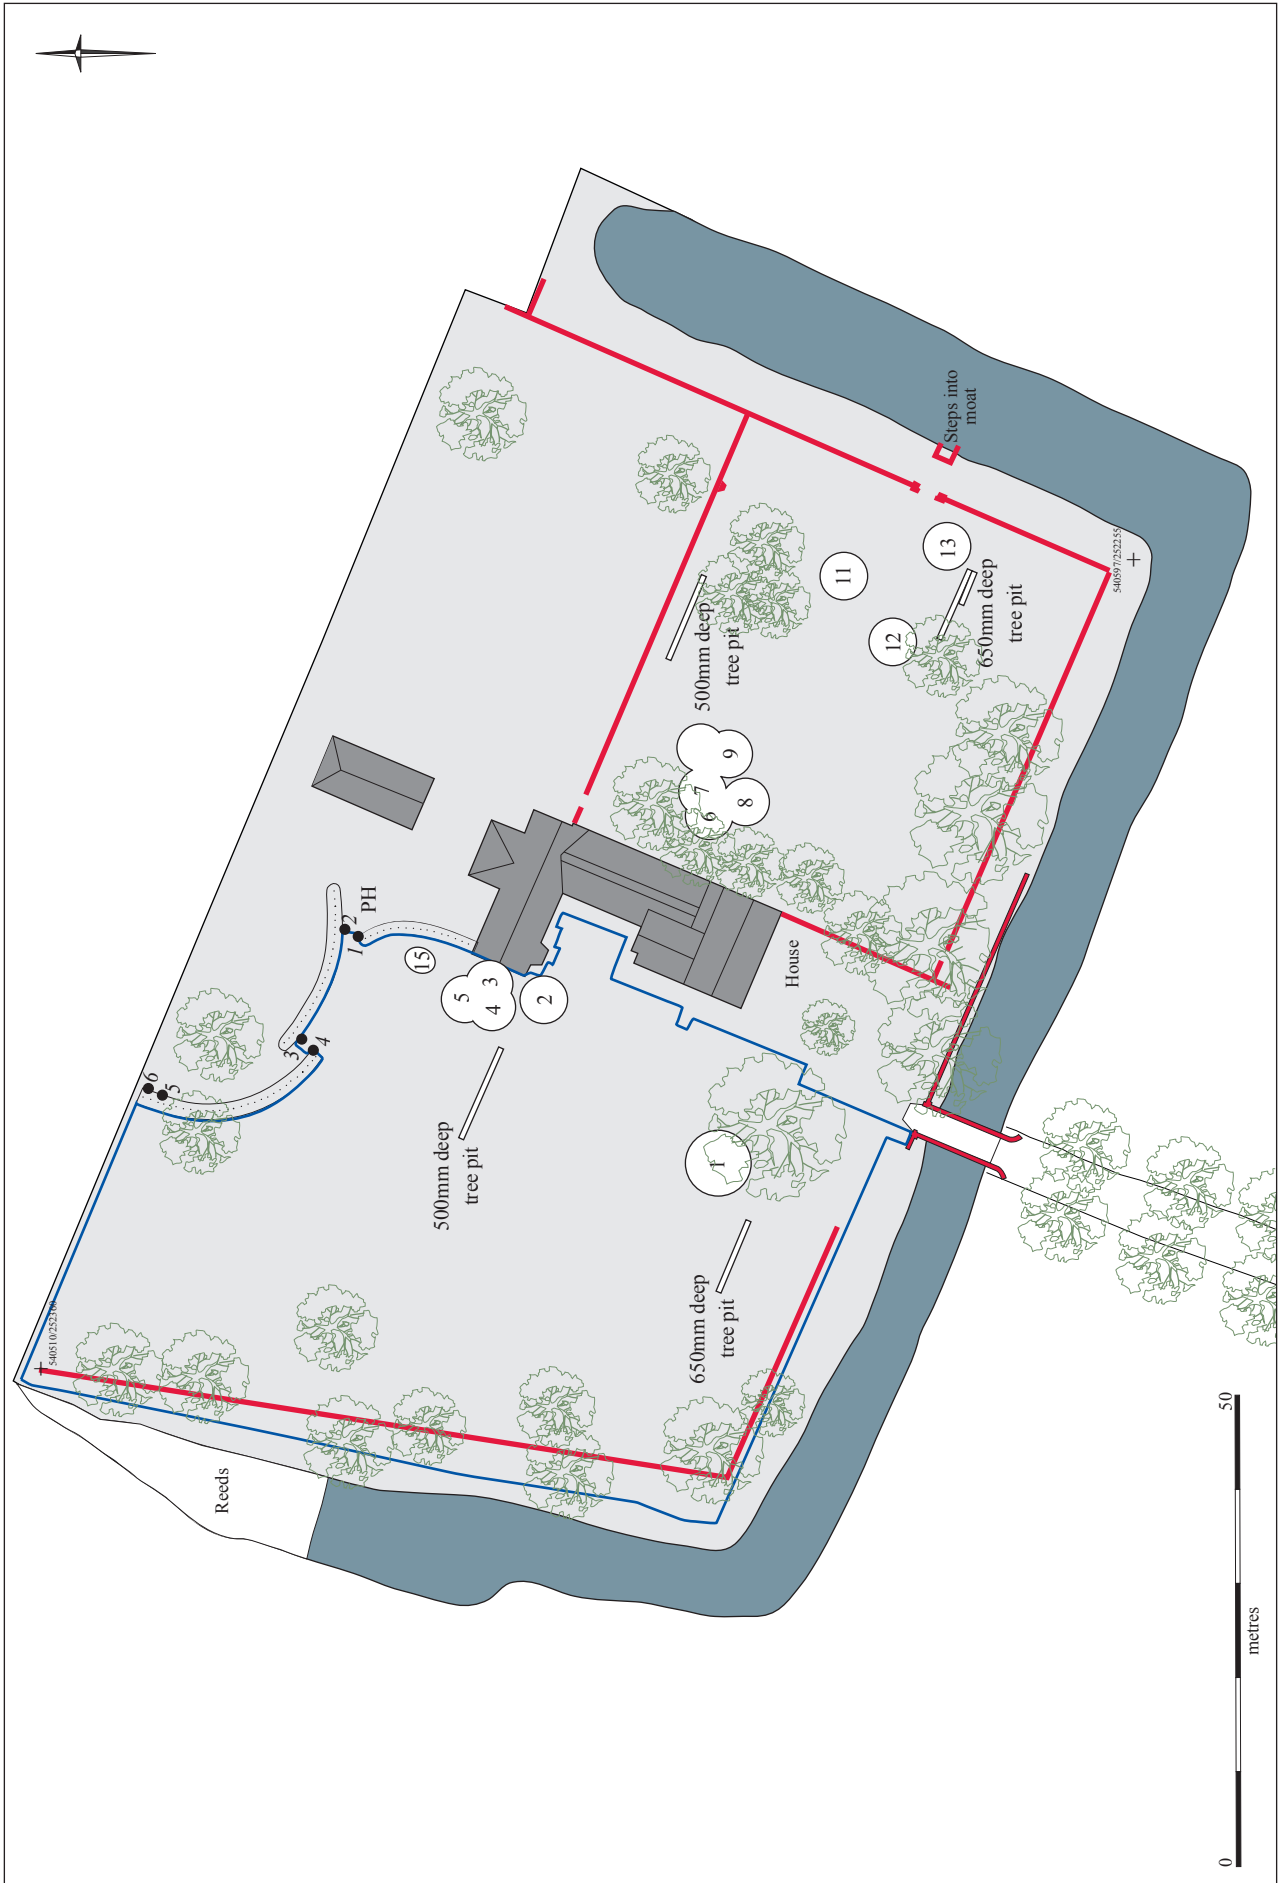
Figure 8 Tree Pit and Post Hole Locations December 2011

Archaeological monitoring was undertaken of the excavation of 13 tree planting holes for and six postholes for the insertion of gates within the front and rear gardens of the house on Tuesday 14th December 2011 (Figure 8).
