The Old Rectory, Kingston, Cambridgeshire

An Archaeological Evaluation

© **CAMBRIDGE ARCHAEOLOGICAL UNIT**
University of Cambridge
October 2011
Report No. 1056
Event Number: **ECB 3662**

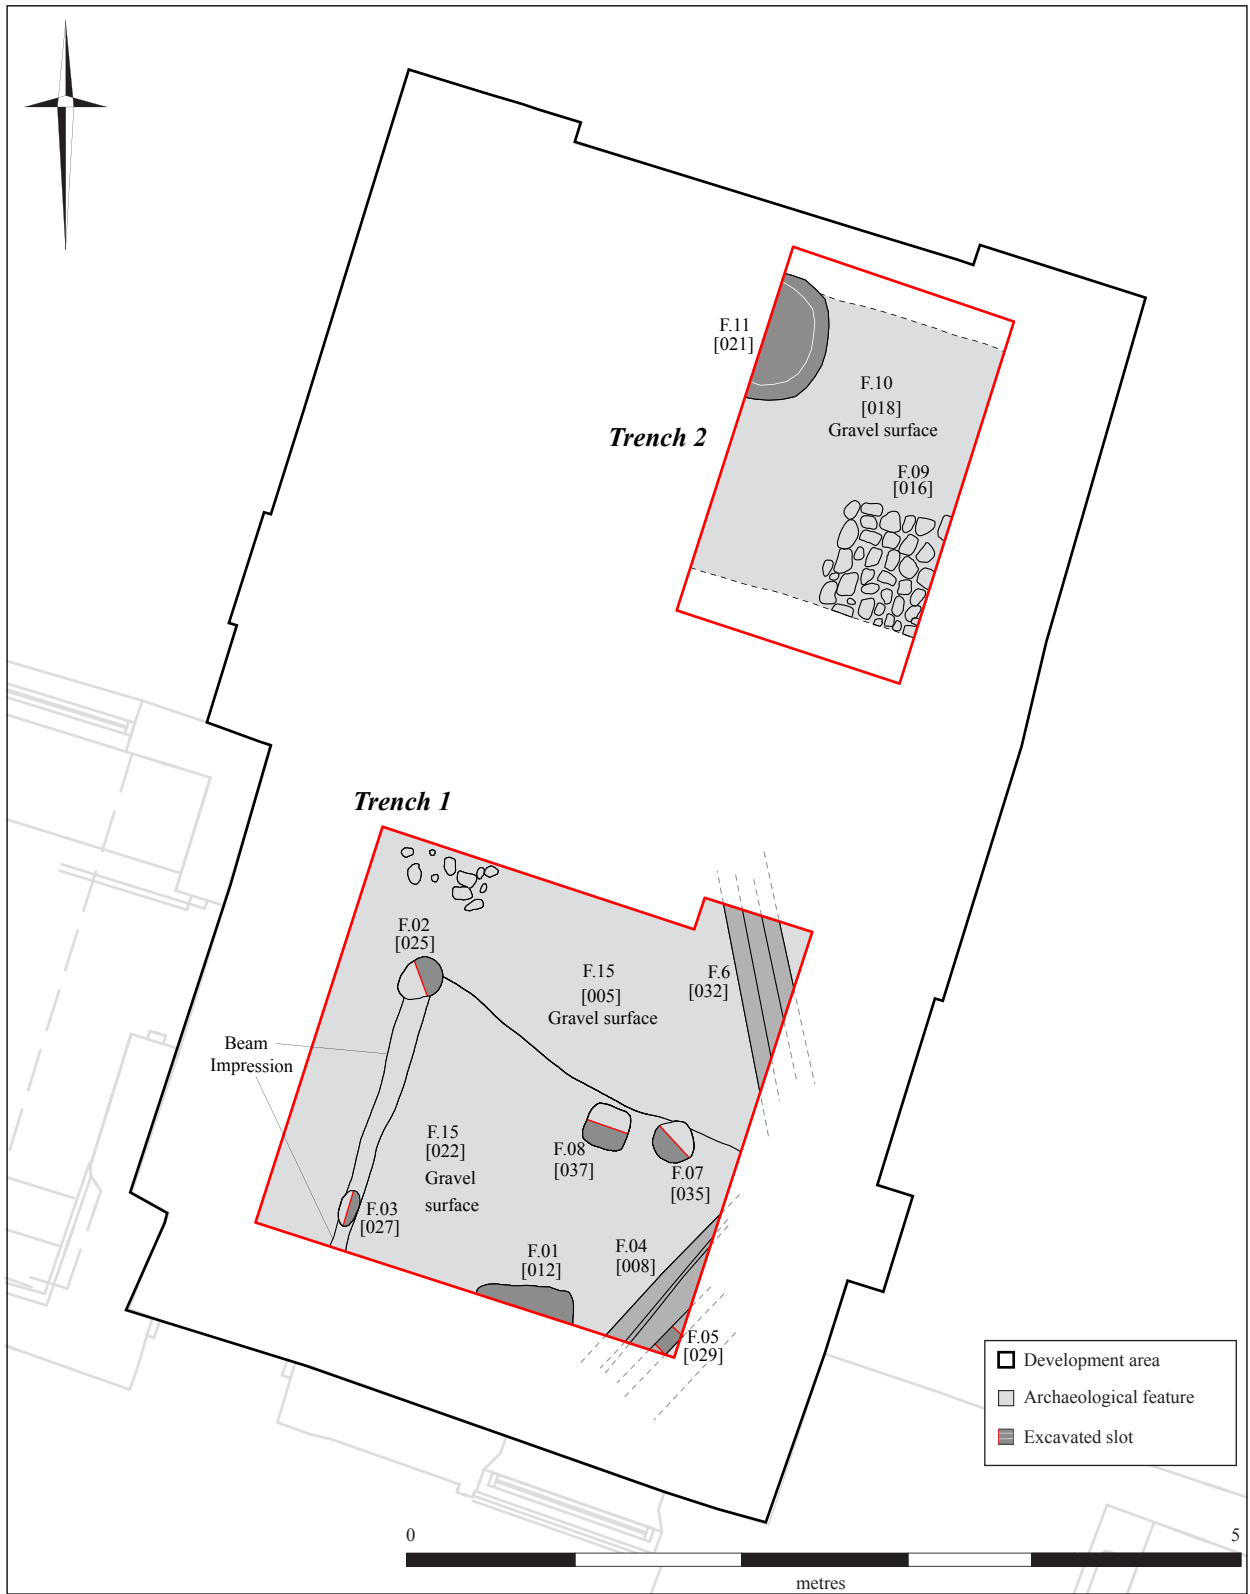
Figure 3. Plan of the Phase 2-3 features

In Phase 2 a substantial gravel surface was established in Trenches 1 (**F.13/F.15**) and 2 (**F.10**) (Figures 3–5). This was 0.04–0.12m thick and covered an area of at least 6.5m by 2.7m, representing a significant event. The earth resistance survey of the area indicated the presence of a high resistance area anomaly covering an area including Trenches 1–2, this was interpreted as possible structural remains/debris or hard or compacted ground (Graham 2009, figure 9). It is probable that this is the metalled surface revealed in Trenches 1–2, suggesting that it covered an extensive area.

Part of the metalled surface in Trench 1 was covered by a timber structure. This was represented by postholes **F.02** and **F.07**, post-pad **F.08**, board slot **F.03** and the impression of a timber beam which had been laid over the gravel connecting **F.02** and **F.03**. The presence of the timber structure meant that the metalled surface weathered differently inside and outside (**F.13/F.15**). The overall size of this timber building is unknown. It appears that the timber from at least posthole **F.02** was removed, and the backfilling of this feature contained 14th–15th century pottery. In Trench 2 part of the metalled surface was covered by cobbled surface **F.09**, but as only a small area of this was revealed its function is unclear. Wedged into this surface was some 13th–15th century pottery.

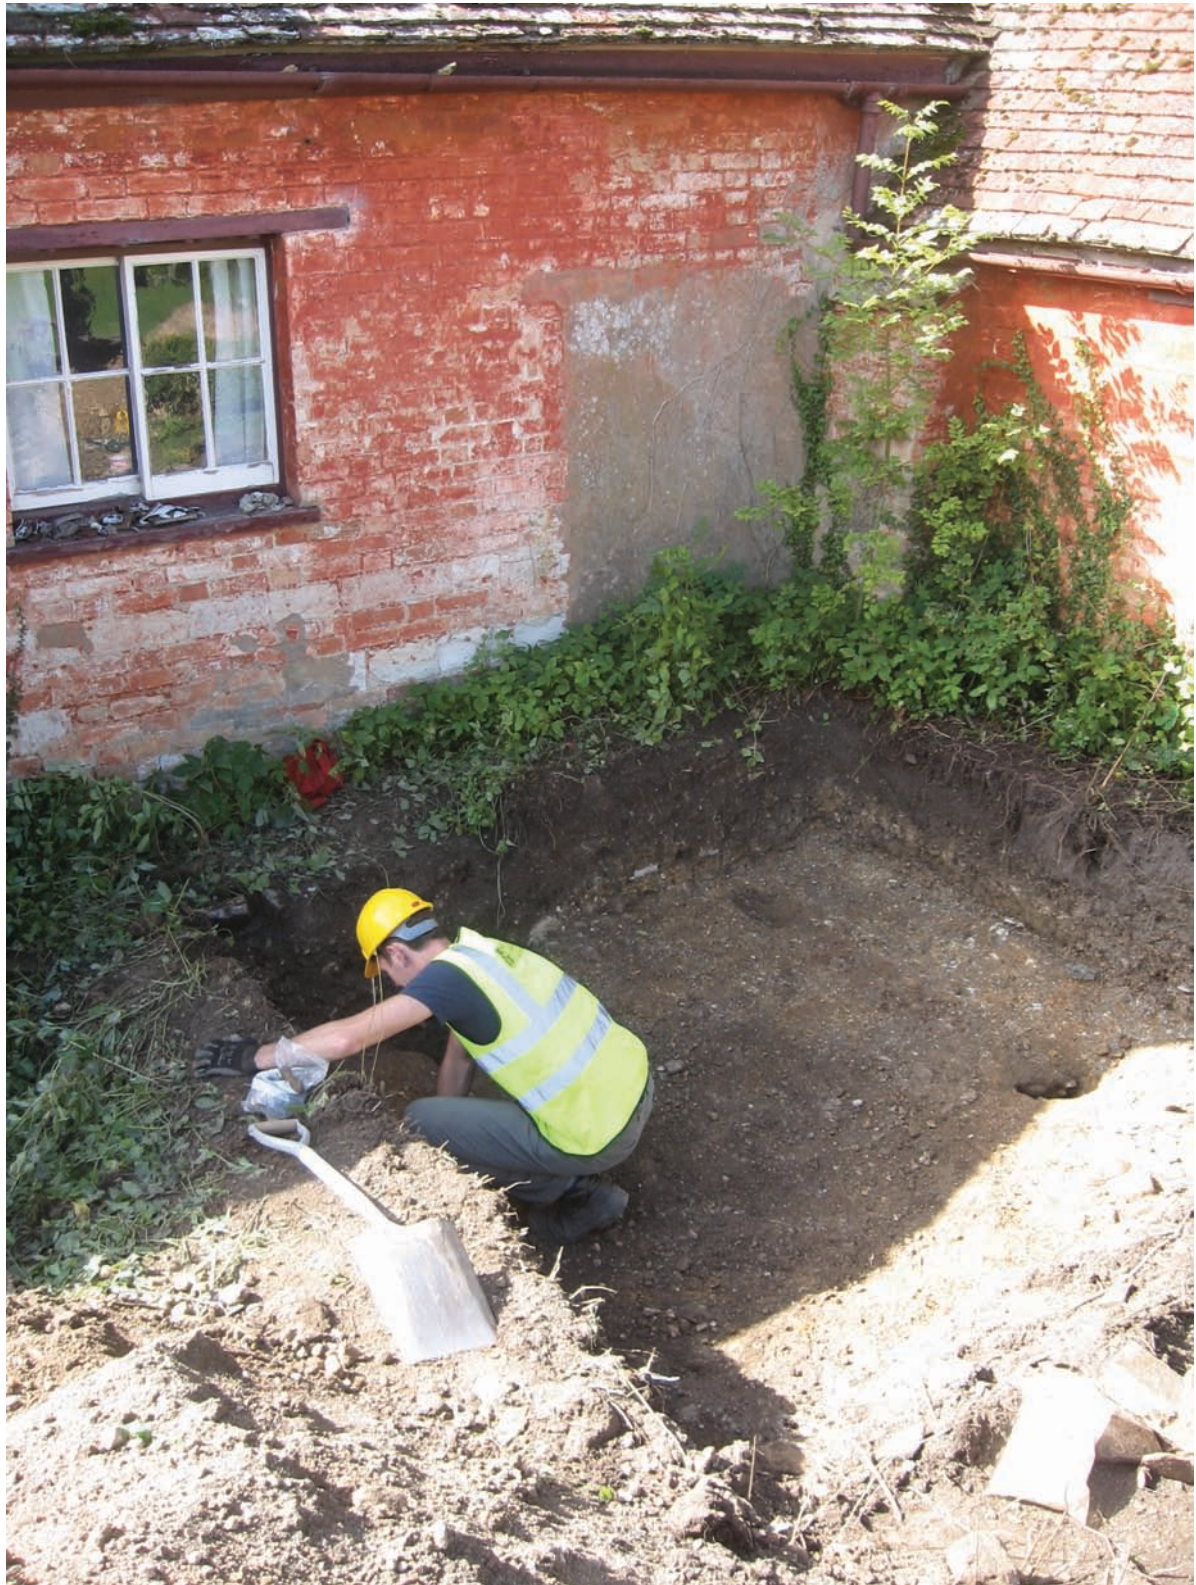
Figure 5. Photograph of Trench 1, facing sothwest, showing metallated surface F.13 / F.15 with posthole F.02, board slot F.03 and connecting beam impression visible
