Rectory Manor, Pirton, Hertfordshire

An Archaeological Investigation

Report No. 1095

May 2012

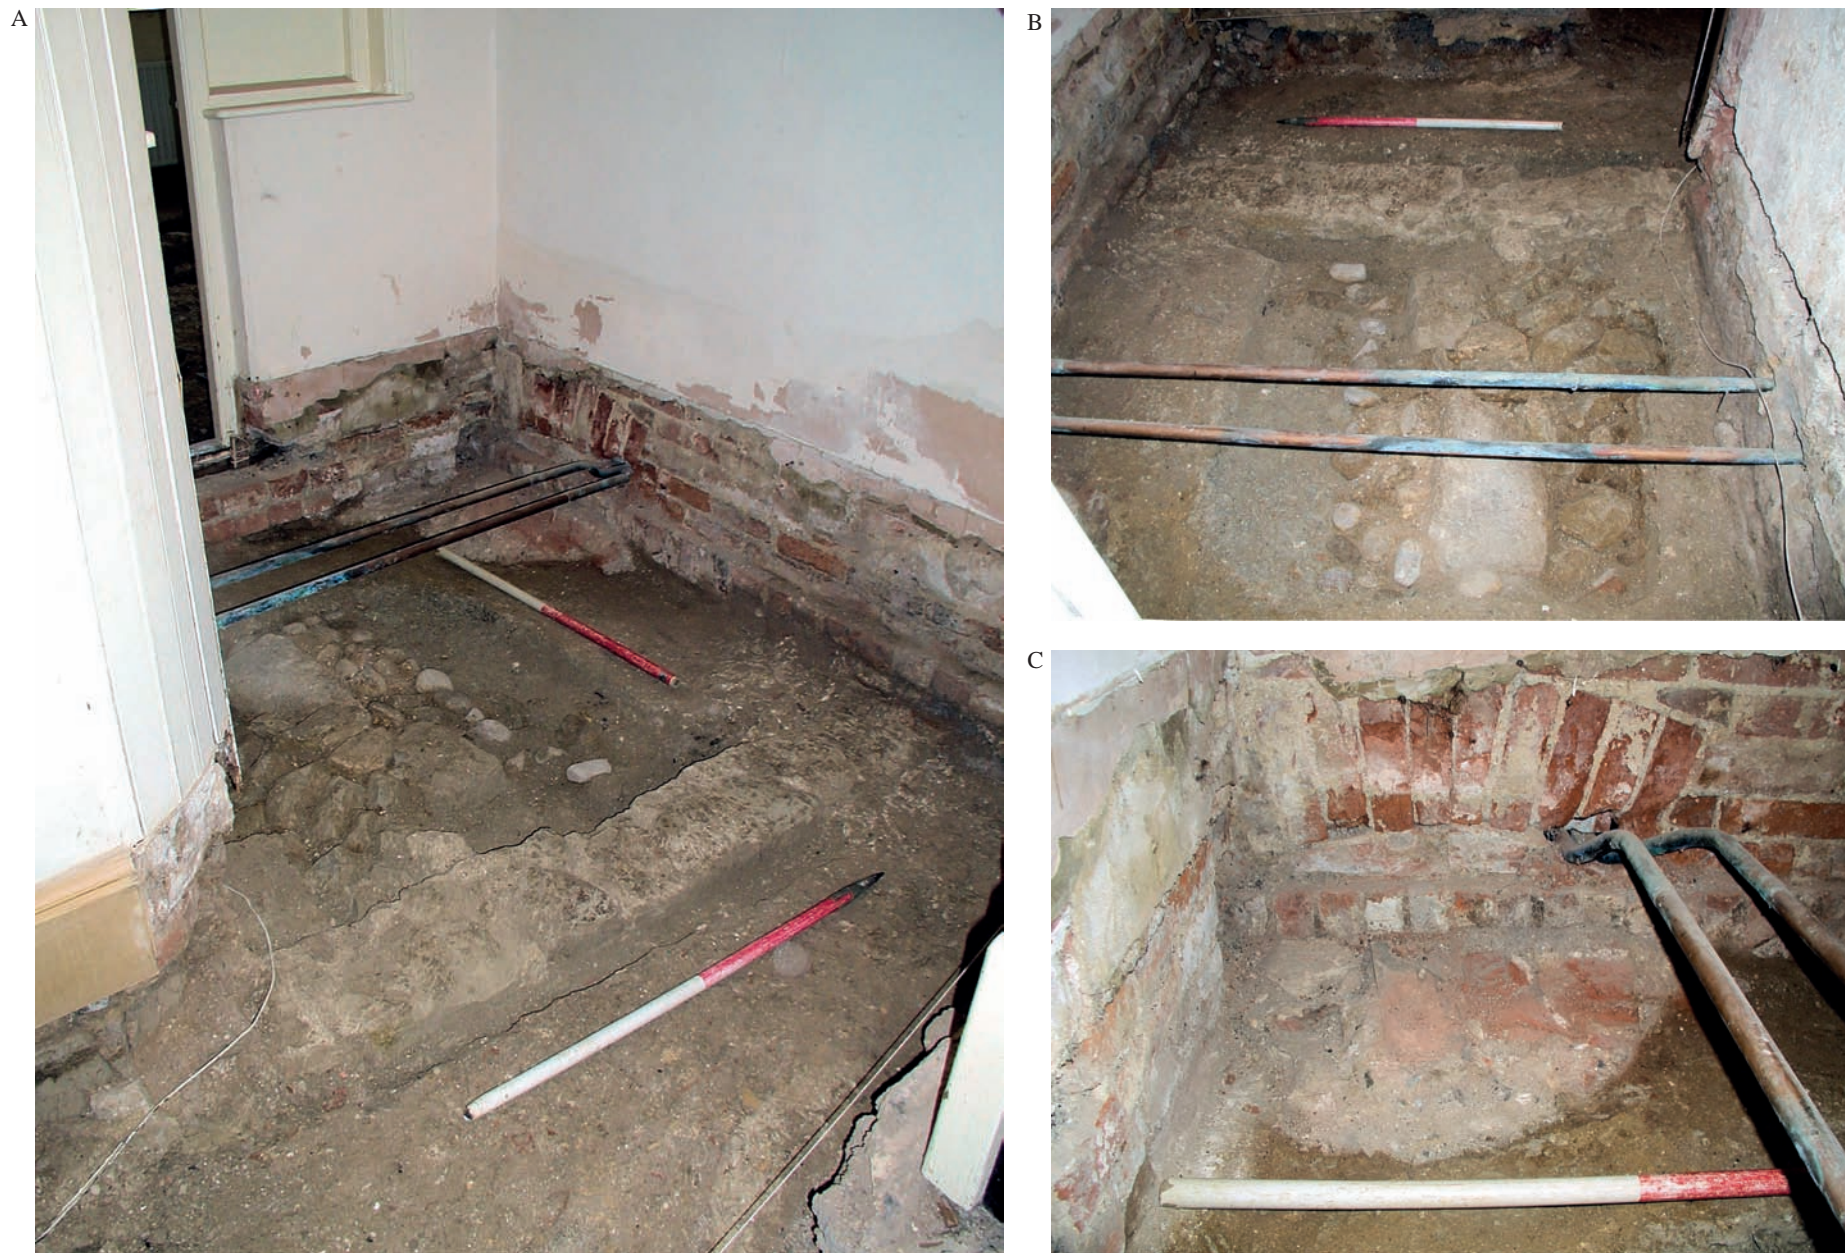
F.02 located at the western stairwell end of the Hallway is a roughly northwest-southeast aligned wall foundation over 0.9m wide [**016**] and of unknown depth (Figure 4b). It consisted of an outer face of roughly squared clunch and limestone blocks 0.25–0.45m by 0.2–0.25m in extent and 0.1–0.15m thick. These contained a core of un-mortared clunch fragments, typically 0.15m by 0.1m by 0.1m in size set at a steep pitch with voids between. On the outside of the facing blocks located within the construction cut [**017**] was a *c.* 0.2m wide strip of sub-rounded field stones, typically 0.1m by 0.07m in extent and 0.03m thick. Wall footing **F.02** was truncated by **F.01**.

F.01 located at the western stairwell end of the Hallway is a 0.28m (c. 1ft) wide southwest-northeast aligned wall footing [013] consisting of moderately sized c. 0.2–0.35m by 0.15–0.2m roughly squared blocks set in pale buff grey coloured firm 'mortar', which appears to consist of a 'paste' made from crushed clunch to which water has been added (Figure 4a). The depth of the wall footings is unknown. This wall footing lay within a steep almost vertically sided 0.58m (c. 2ft) wide construction cut [015]. The fill of this cut [014] consisted of a pale to mid grey silty clay containing occasional charcoal and chalk flecks plus oyster shell. There was also a significant quantity of peg tile and brick fragments (c. 75%) of the deposit; these were a homogenous assemblage in a single red fabric similar fabric to those in **F.17**.

F.03 located at the western stairwell end of the Hallway consists of a low arch [019], set into the still extant wall, built from red handmade bricks that are 225mm long and 60mm thick (Figure 4c). Although only 0.75m of the arch span was revealed its total extent was probably c. 0.9–1.0m (c. 3ft). Located adjacent to this was a cut of unknown extent and depth [020], which had been backfilled with red brick fragments set in a firm light grey mortar [018]. **F.03** probably represents a 17th–18th century brick-lined arched drain or soakaway.

Figure 4. Photographs in the Hallway, A) Wall F.01, facing south, B) Wall F.02, facing north-northwest, C) Arched drain or soakaway F.03, facing west

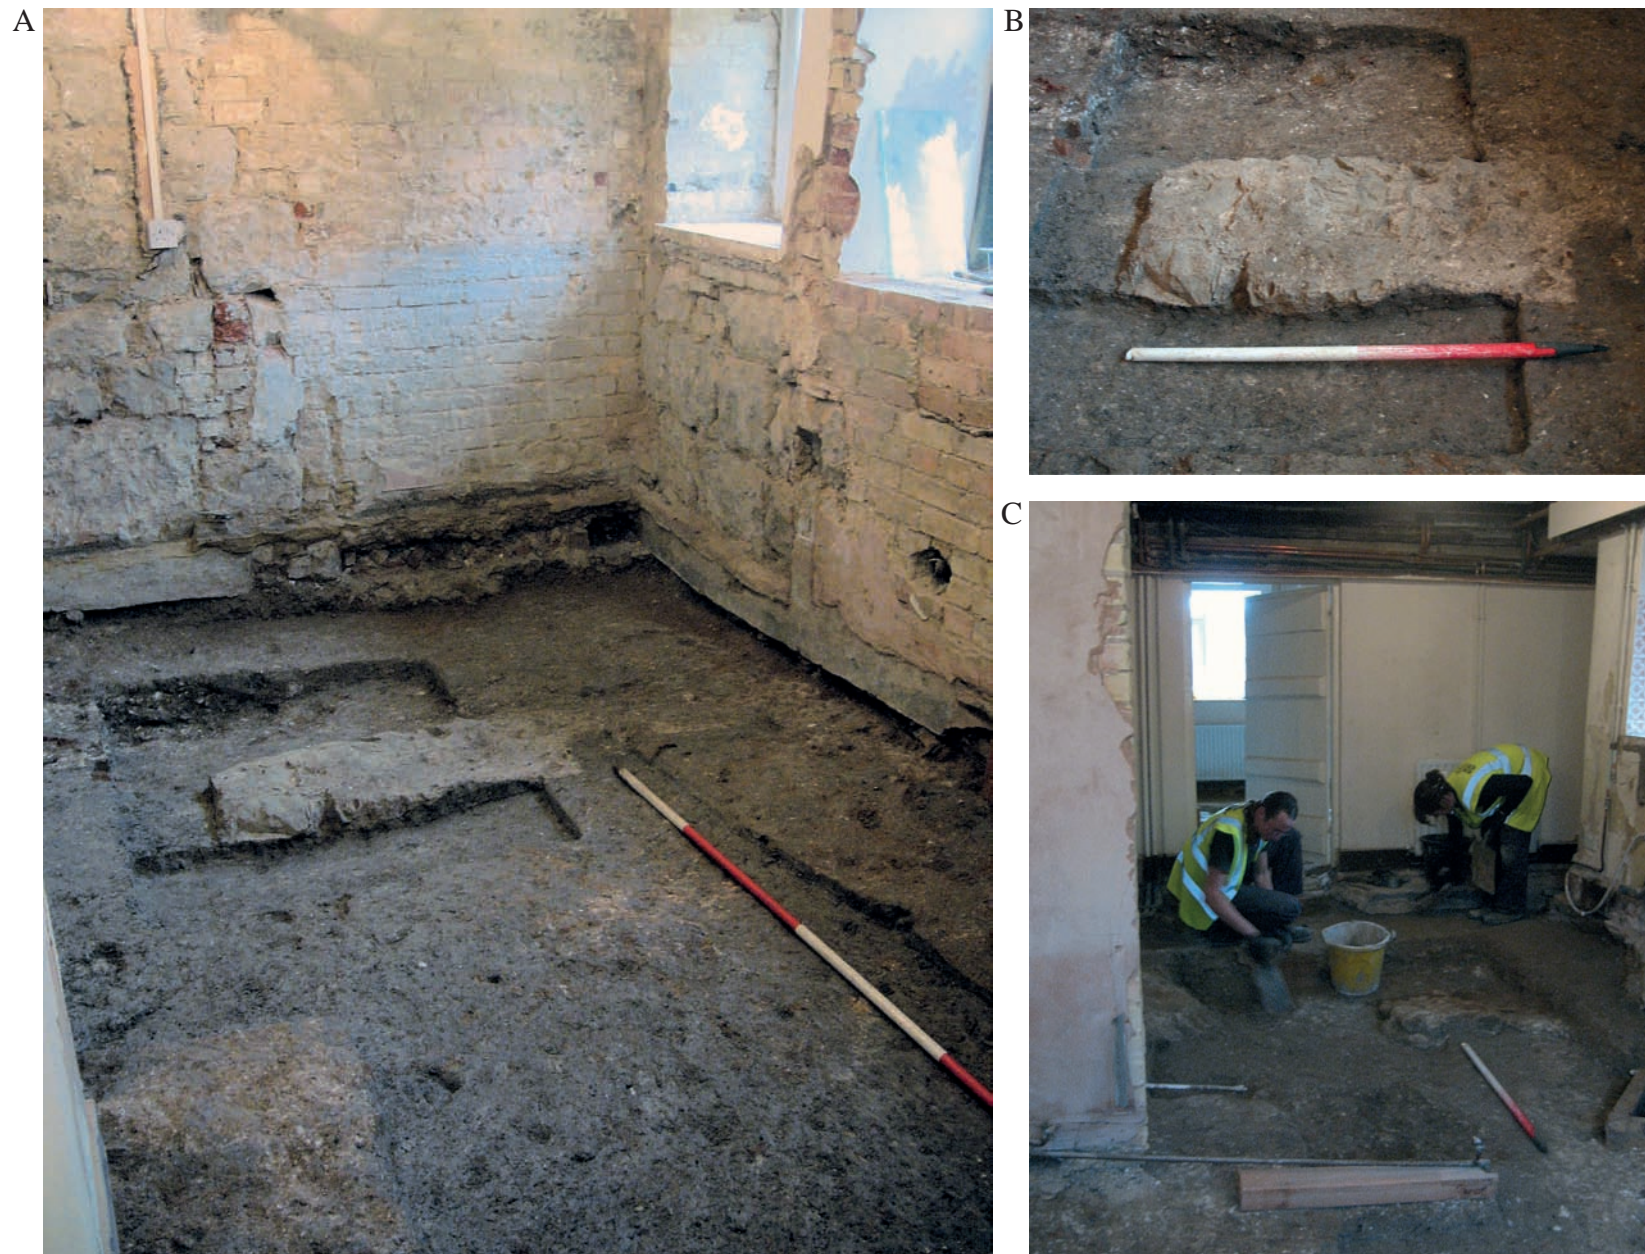
F.05 located in Room 6 consists of a 0.97m (c. 3ft) long by 0.45m (c. 1½ft) wide footing aligned northwest-southeast constructed of a mixture of roughly squared blocks and irregular fragments of clunch [023] set in pale buff grey coloured firm 'mortar', which appears to consist of a 'paste' made

from crushed clunch to which water has been added (Figures 5a–b). The surviving depth of the footing was 0.11m. The feature was built within a vertically sided flat bottomed cut [024], which was tight to its edges. The ends of **F.05** are extremely regular, demonstrating that this represents the footing for a plinth rather than a wall footing which has been truncated. The function of plinth **F.05** is uncertain; it does however appear to broadly align with some clunch blocks in the wall to the north indicating that it may be related to this wall.

Figure 5. Photographs in Rooms 6/7, A) General view with plinth F.05 in background, facing west-northwest, B) Plinth F.05, facing west-northwest, C) Working shot, facing south-southeast

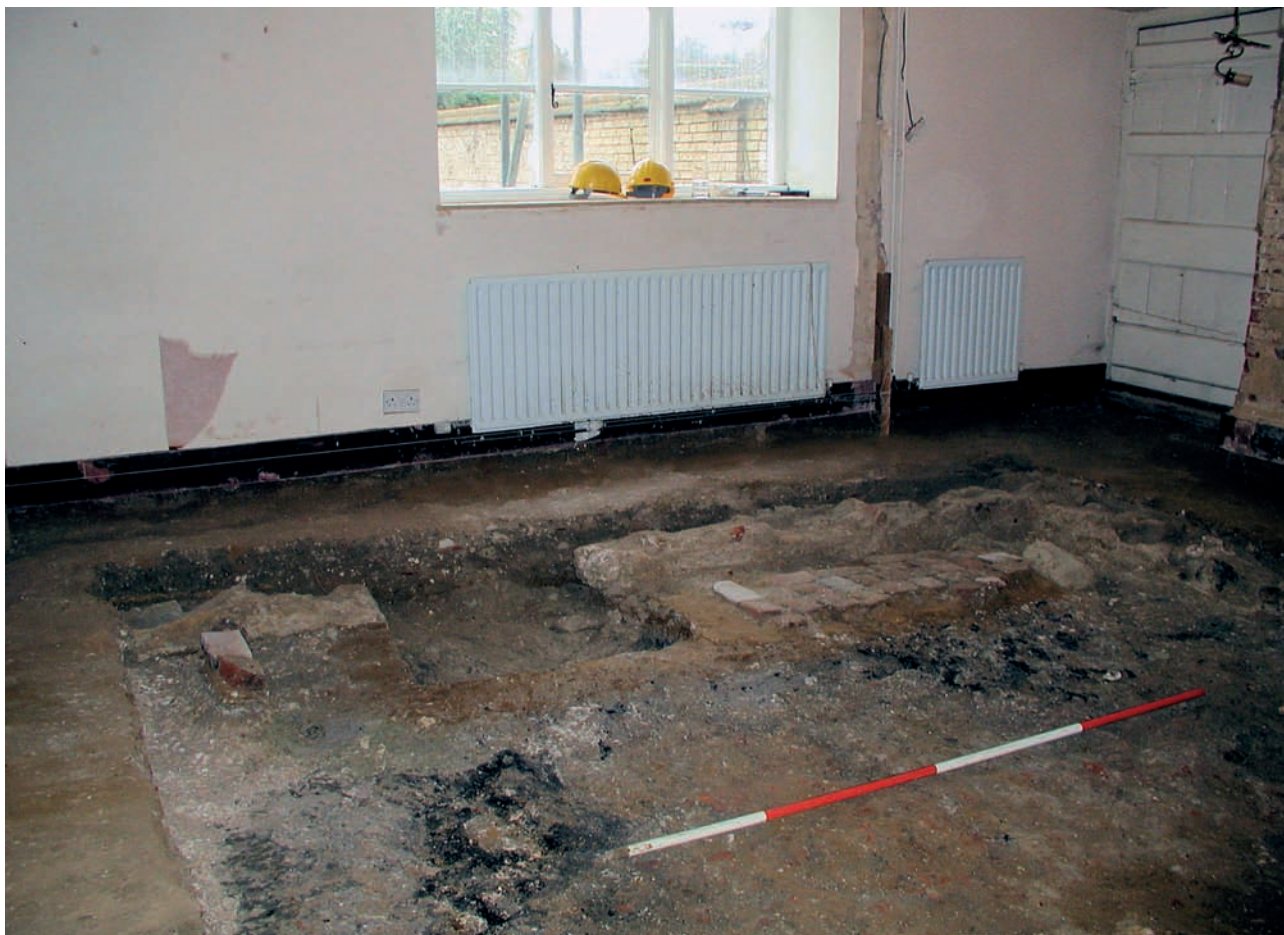
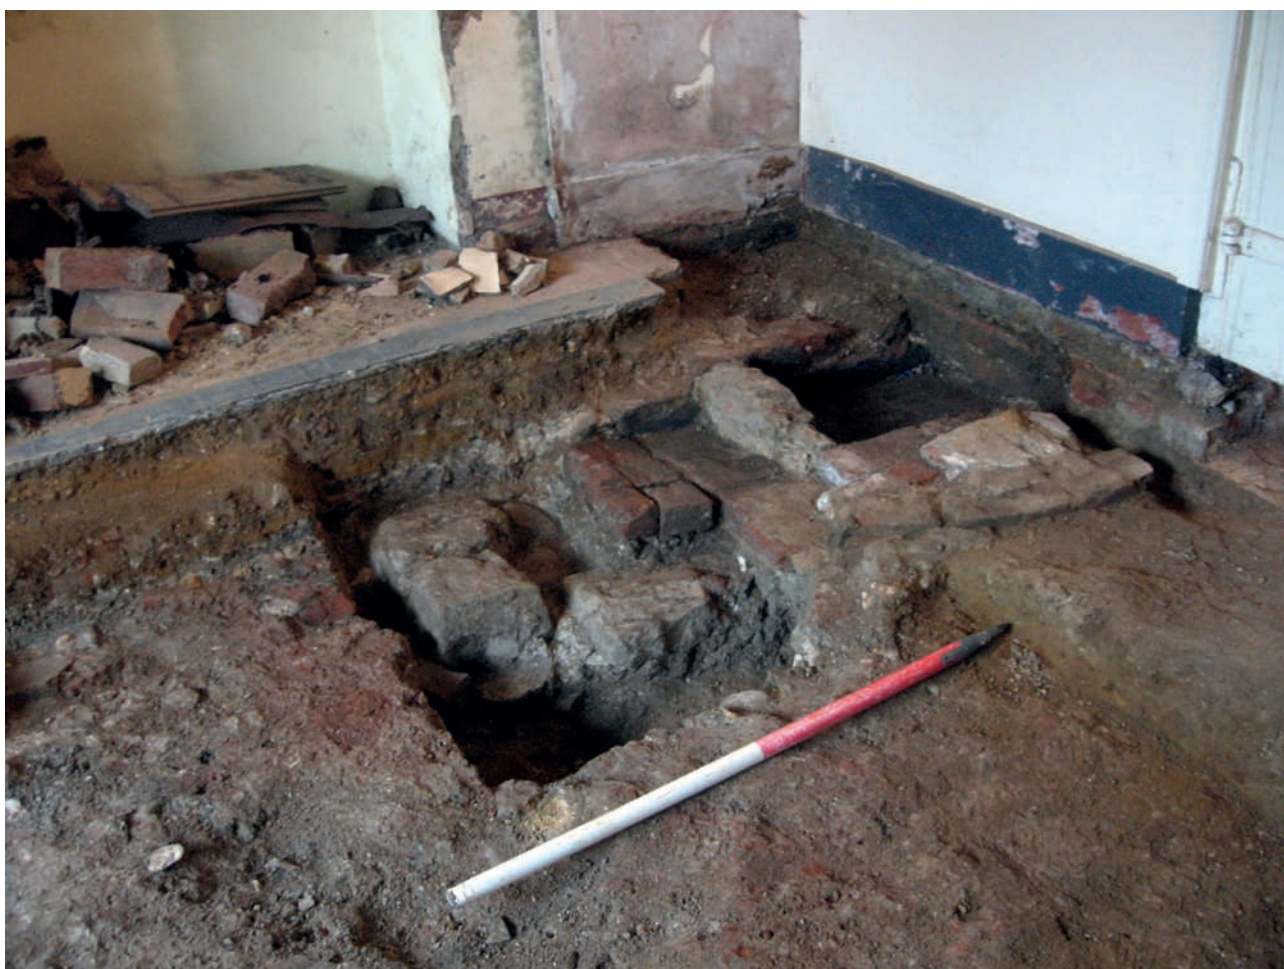
F.10 located in the northwest corner of Room 8 is a structure 1.2m (*c.* 4ft) by 0.9m (*c.* 3ft) in extent (Figure 6b). It was constructed within a steep sided flat bottomed cut [036] that must have originally been *c.* 0.4–0.5m deep. Into this were placed some carefully laid roughly squared clunch blocks [037], which were *c.* 0.25m by 0.20m in extent and 0.15m thick. Over these blocks was laid a floor [038] built from handmade un-frogged red bricks that were 215mm long by 105mm wide and 50mm thick, set in a firm yellow sandy mortar. These bricks formed a rectangular area, with a curving semicircular arc at one end. Over floor [038] a brick-lined area was constructed using the same type of bricks and mortar, this effectively created a box [039], which was two courses (*c.* 0.22m) high enclosing an area of 0.45m (*c.* 1½ft) by 0.35m (*c.* 1ft). Lying over the bricks in the base of this box was a thin spread of coal dust [040], which was *c.* 5mm thick. **F.10** presumably relates to the still extant large adjacent chimney and fireplace to the west and would have created an area of firm standing and a box to contain dirty material, this would have served both to reduce the risk of fire and to contain the area of dirtiness associated with activities involving the fireplace.

F.11 was an area of brick floor [041] located in Room 8 and constructed of red handmade bricks, which are of a similar fabric to others revealed during the investigations but of a unique size at 235mm long by 115mm wide and 35mm thick (Figures 6a and 7a). The brick floor, which was bounded on one side by a row of clunch blocks, covered an area of 1.5m west-east and was over 0.5m north-south. The bricks were not mortared in position, but had been well bedded onto a deposit of fine yellow sand that was 50mm thick [041]. The upper surface of the brick floor lies at 62.78m OD. It appears that floor **F.11** is contemporary with walls **F.14/15**; although the floor was not directly connected to the walls it appears that the intervening gaps originally contained some form of timber beam.

F.12 is located in Room 8 and is a putative very small area of surviving brick floor [044] with sand makeup [043], with the upper surface of the bricks at 62.85m OD (Figure 6a). In form and the types of bricks used **F.12** is identical to **F.11**.

F.14/15 are the southwest-northeast and northwest-southeast aligned wall foundations of a wall located in Room 8 (Figures 6a and 7a). **F.14** is a 0.28m (c. 1ft) wide wall footing **[063]** consisting of highly variable crudely shaped clunch blocks up to 0.4m long by 0.15m and 0.15m thick plus occasional brick and tile fragments set in pale buff grey coloured firm 'mortar', which appears to consist of a 'paste' made from crushed clunch to which water has been added. The foundation survived to a depth of 0.15–0.20m and would originally have been c. 0.4–0.5m deep. This wall footing lay within a vertically sided flat bottomed construction cut **[064]** that was tight to the footing. **F.14** was fully bonded into **F.15**, this wall **[065]/[066]** which projected slightly beyond the end of **F.14** was of identical construction but was slightly wider at 0.34m (c. 1ft).

Figure 6. Photographs in Room 8, A) General view with floor F.11/12 and walls F.14/15, facing south-west, B) Fireplace related feature F.10, facing north-west

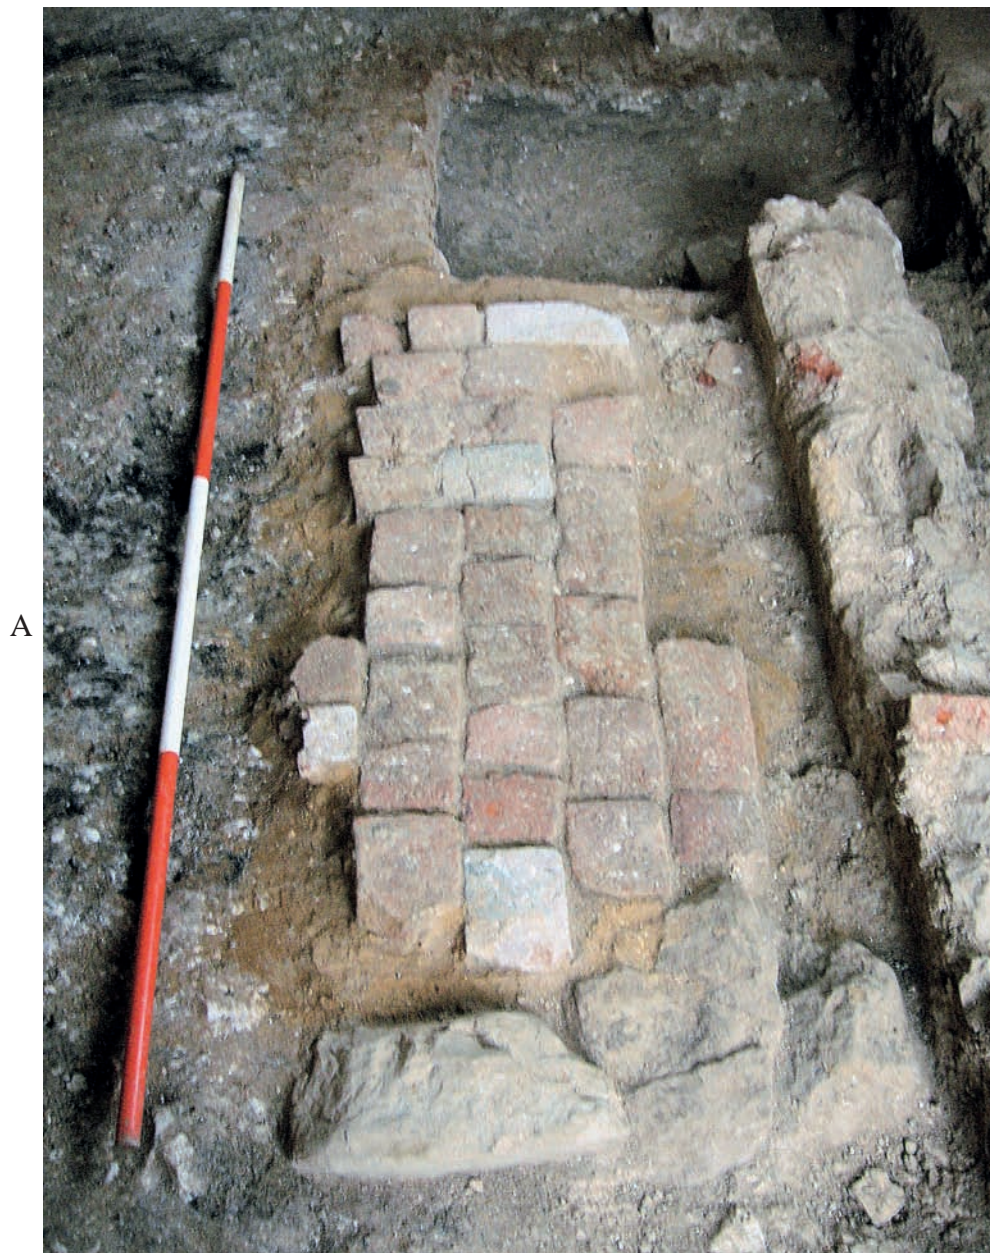
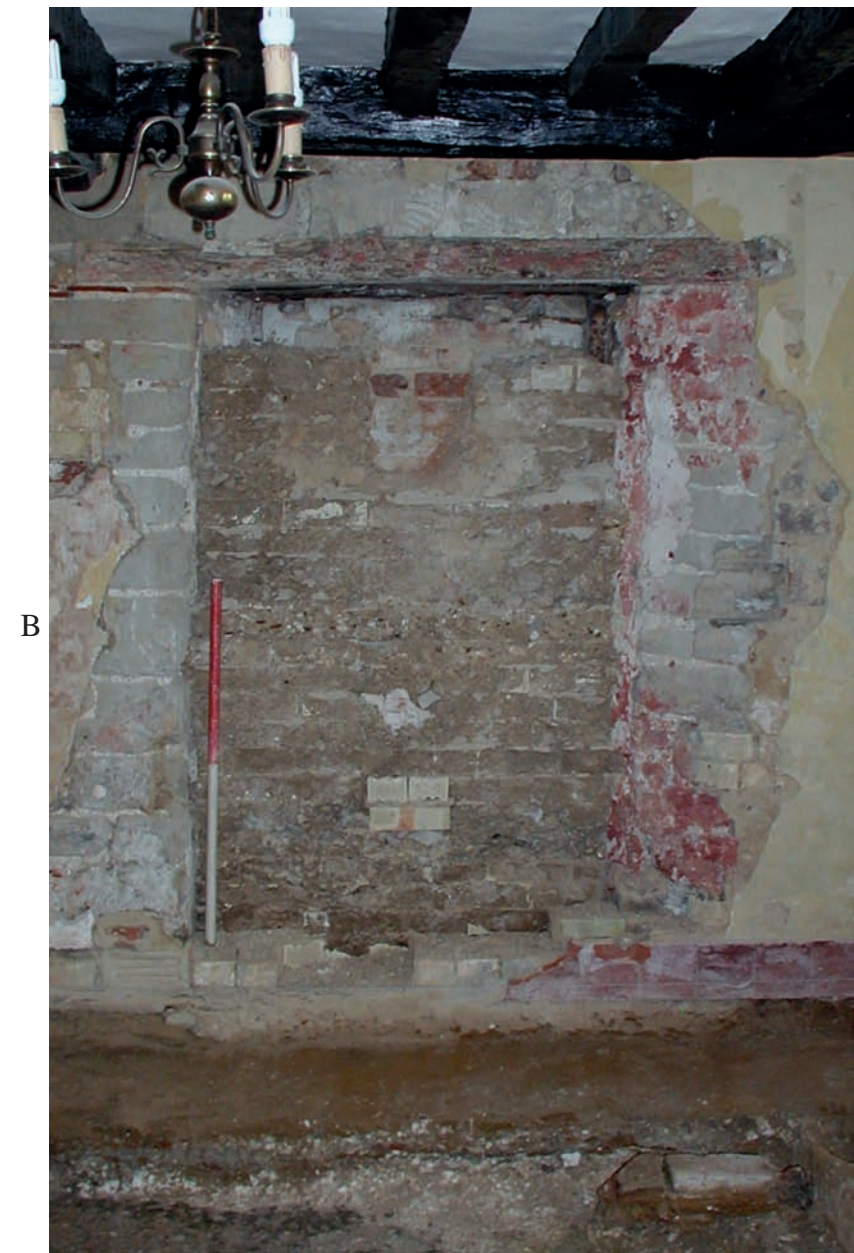
F.13 [045] represents a blocked doorway in the eastern wall of Room 8 (Figure 7b). The doorway is 1.15m wide (*c.* 4ft) and 1.85m (*c.* 6ft) high with a timber lintel. The northern side is constructed from

squared clunch blocks, while the southern side has a distinct chamfer which had been plastered and painted red. The doorway was eventually blocked by two brick walls, enclosing a mortar core.

Figure 7. Photographs in room 8, A) Floor F.11 with wall footings F.14 beside, facing east-northeast, B) Blocked doorway F.13, facing east-northeast
